NASA CR-925

TWO-STAGE POTASSIUM TEST TURBINE

Volume IV
Materials Support of Performance
and Endurance Tests

Prepared by
GENERAL ELECTRIC
Cincinnati, Ohio
for Lewis Research Center

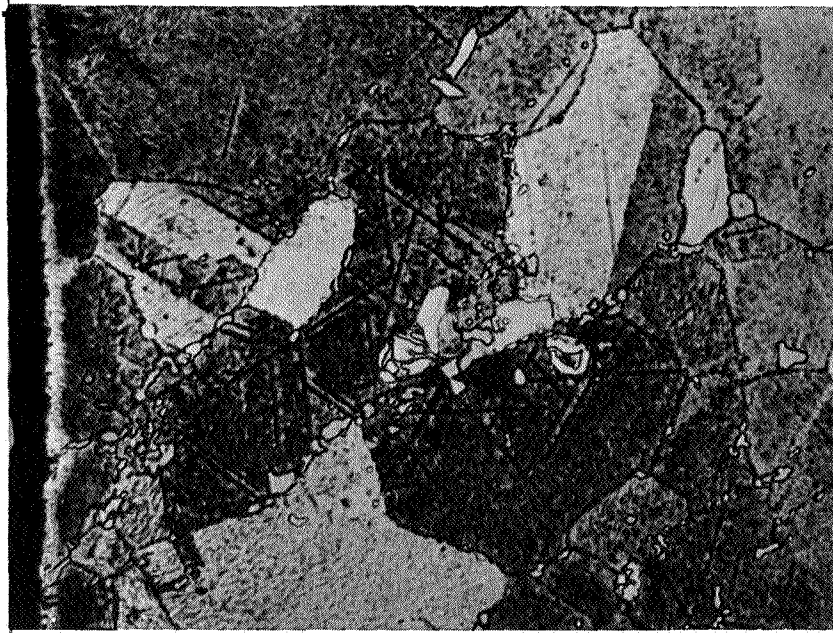
Figure 6. First Stage U-700 Blade Dovetail After 2000-Hour Endurance Test Showing Concentration of Accicular Structure Presumed to be Sigma Phase. (B322411)

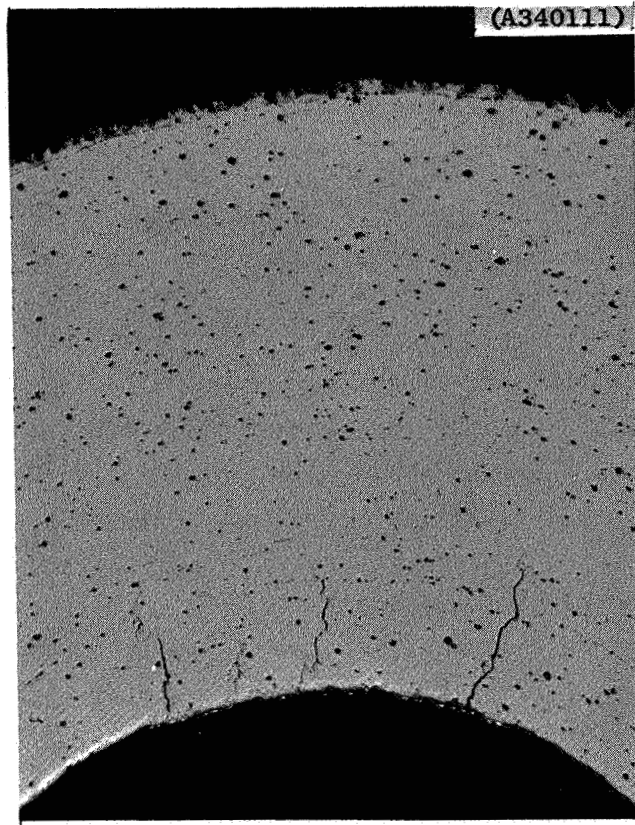
3. Turbine bucket locking strips were increased in thickness for the performance test. These strips failed by strain age cracking in the sharply bent forward radius. This problem was eliminated by using a more generous bend radius and by re-solution treating the fabricated locking strips before installing them in the turbine wheel assembly; the locking strips were aged in place during turbine operation.

Figure 8. Forward Radius of Rene' 41 Turbine Blade Locking Strip Showing Strain Age Cracking. (A340111)

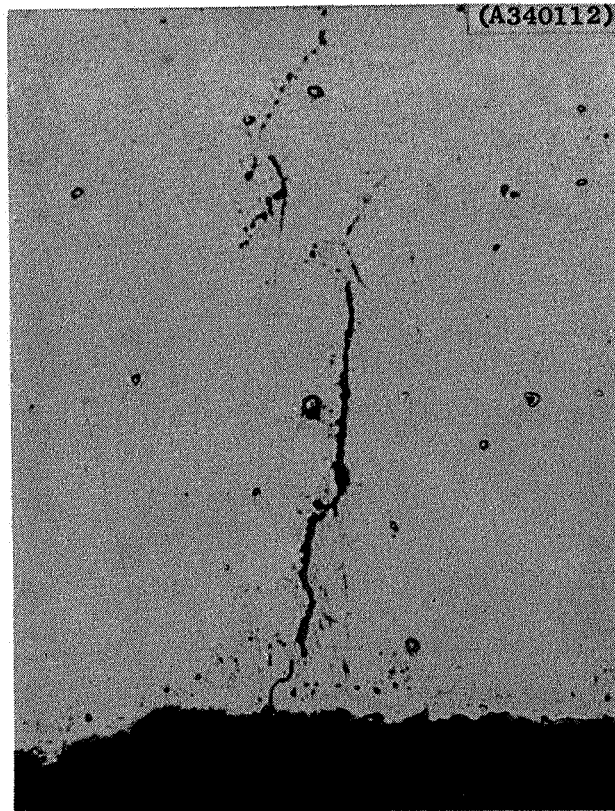
Figure 9. Forward Radius of Rene' 41 Turbine Blade Locking Strip Showing Strain Age Cracking. (A340112)

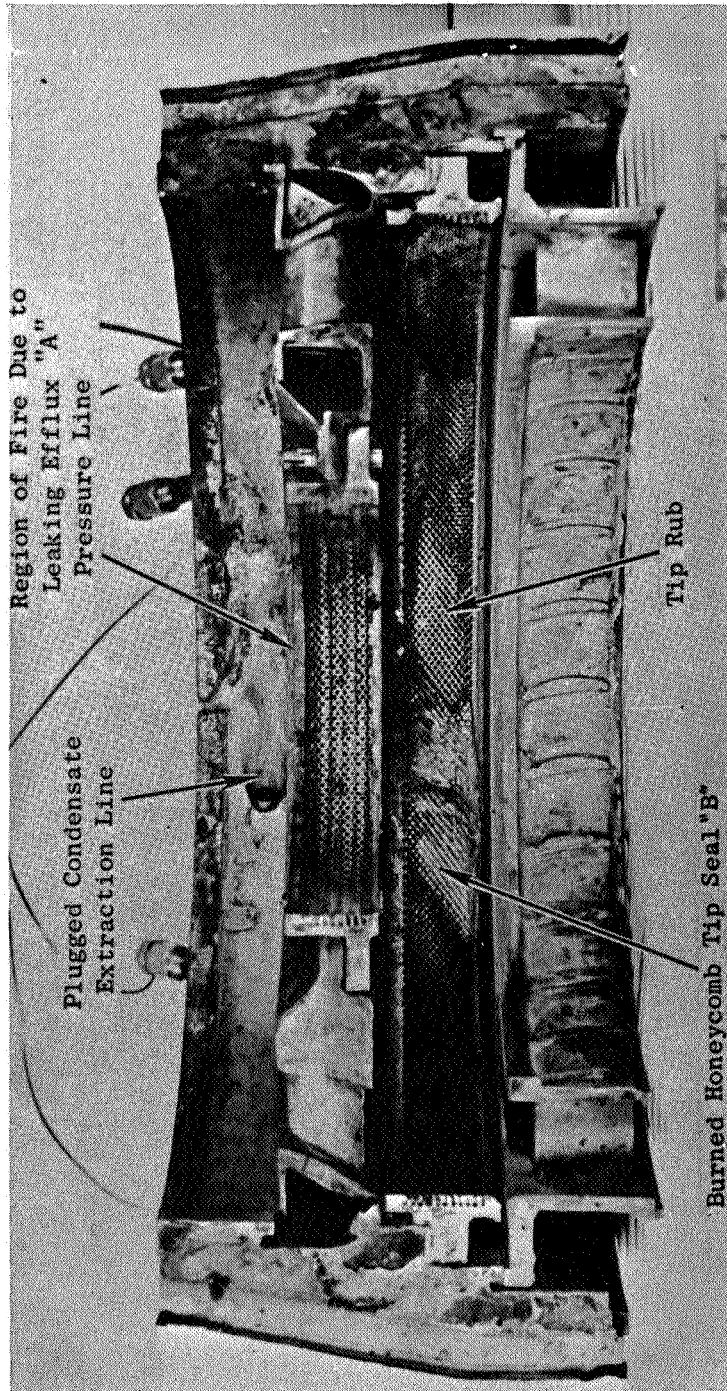
Figure 36. Fire Damage in Second Stage Tip Seal During 35-Hour Turbine
 Checkout. (C64120413) Mag: 1/2X

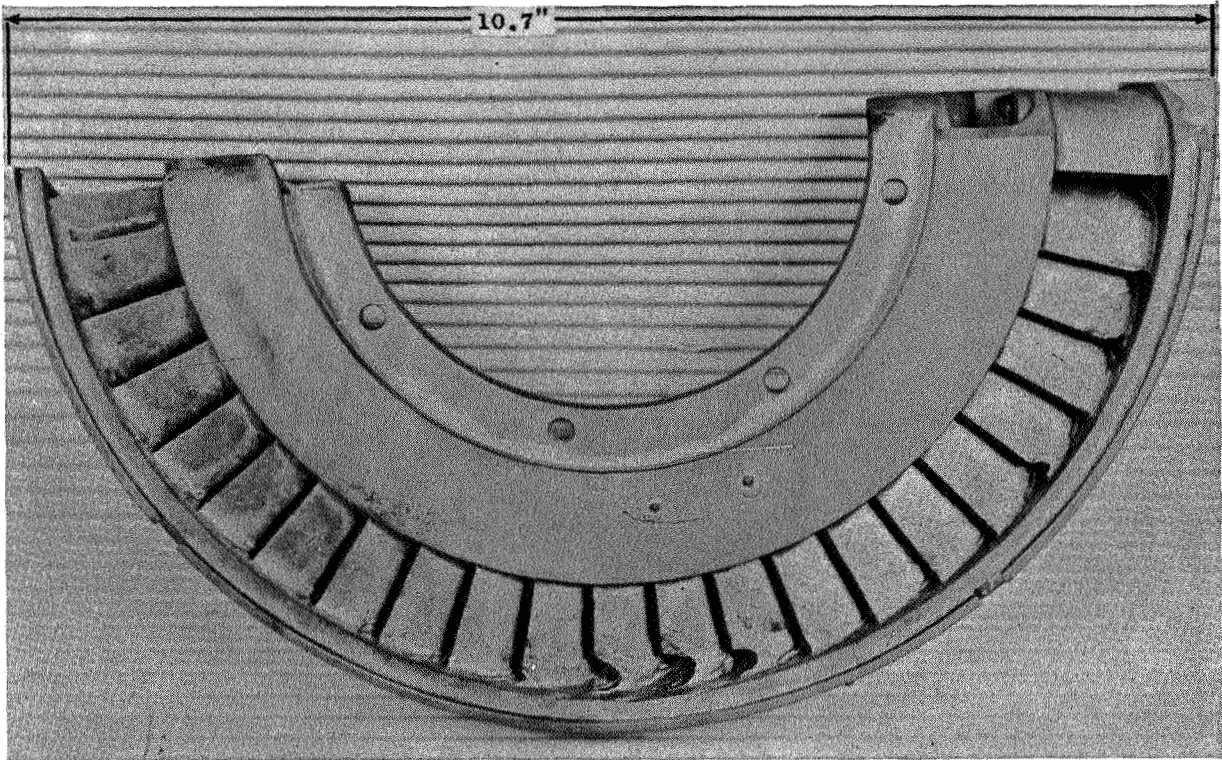
Figure 38. Fire Damage to Second Stage Nozzle Diaphragm Vanes During 35-Hour Turbine Checkout. (C64121803)

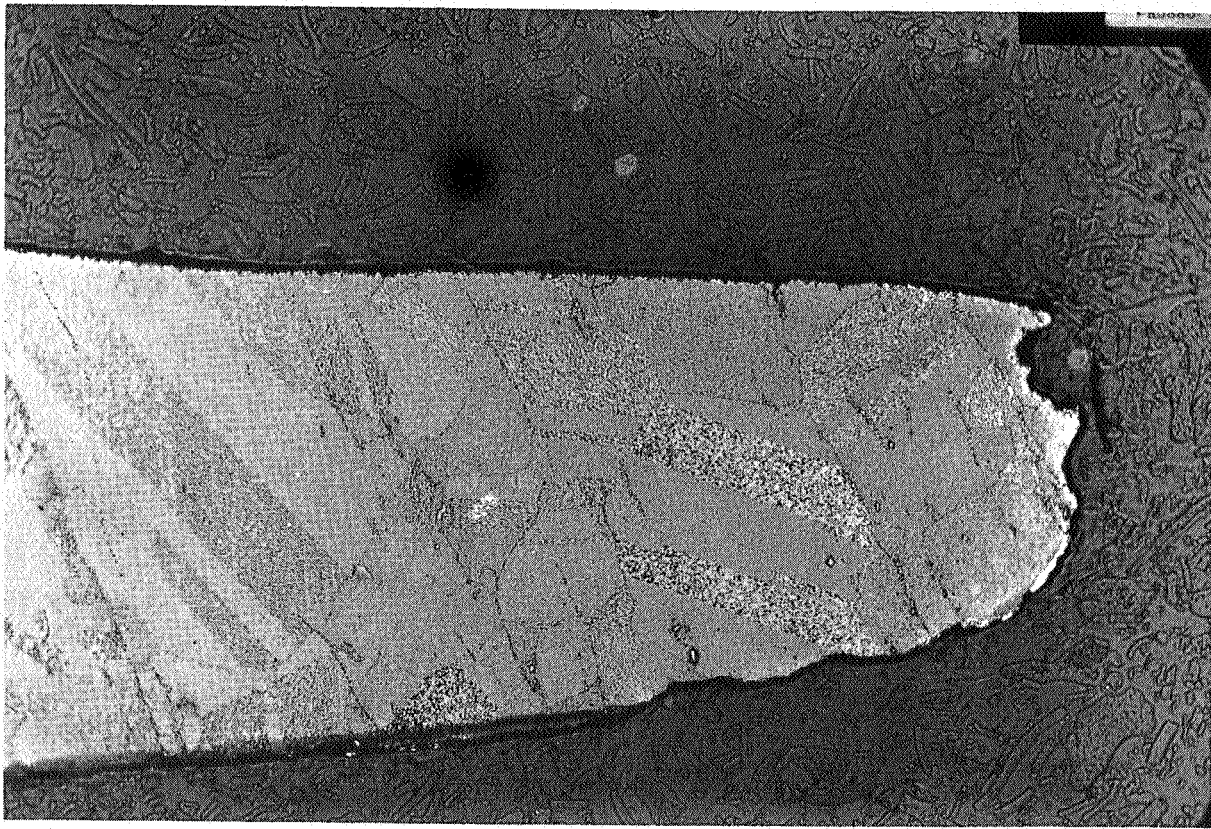
Figure 41. Suspected Cavitation Corrosion in First Stage Blade Trailing Edge After 35-Hour Turbine Checkout. (K5880)

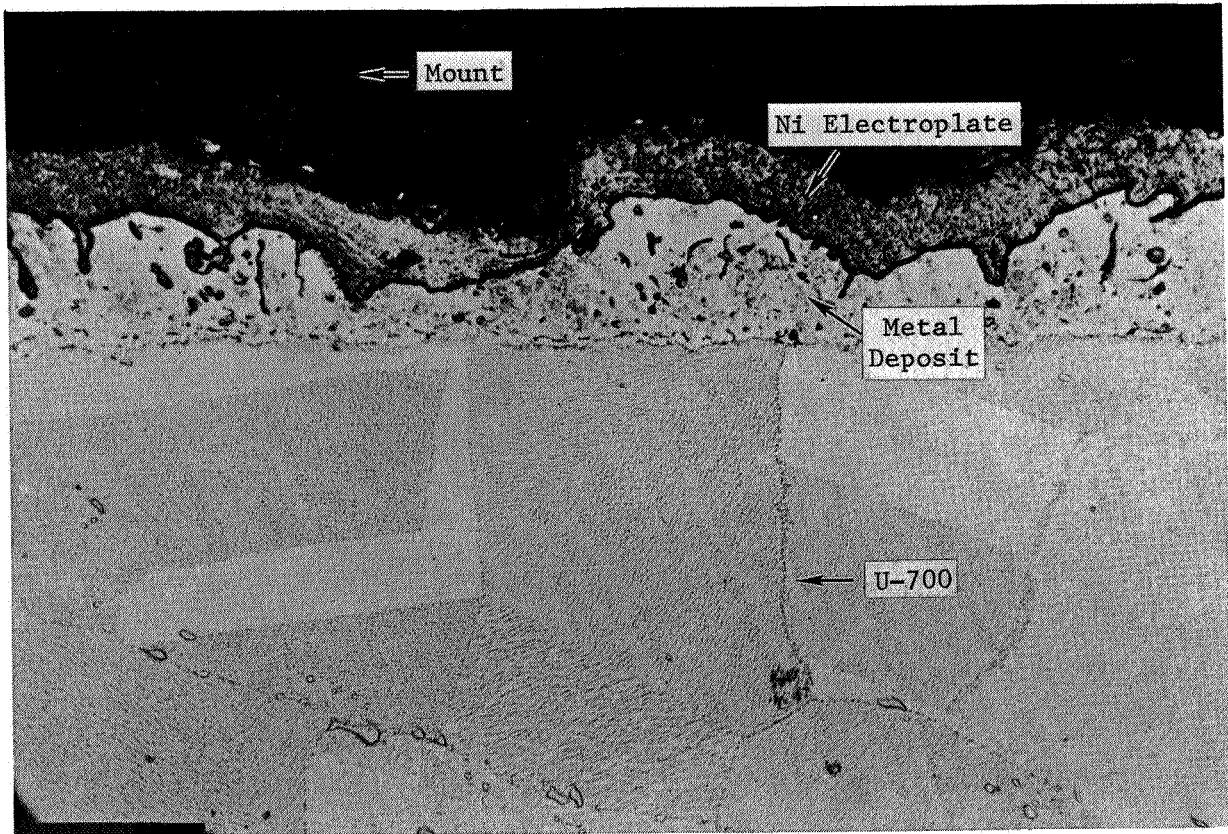
Figure 42. Metal Deposit on First Stage Blade Concave Surface After 35 Hour Turbine Checkout. (L171)

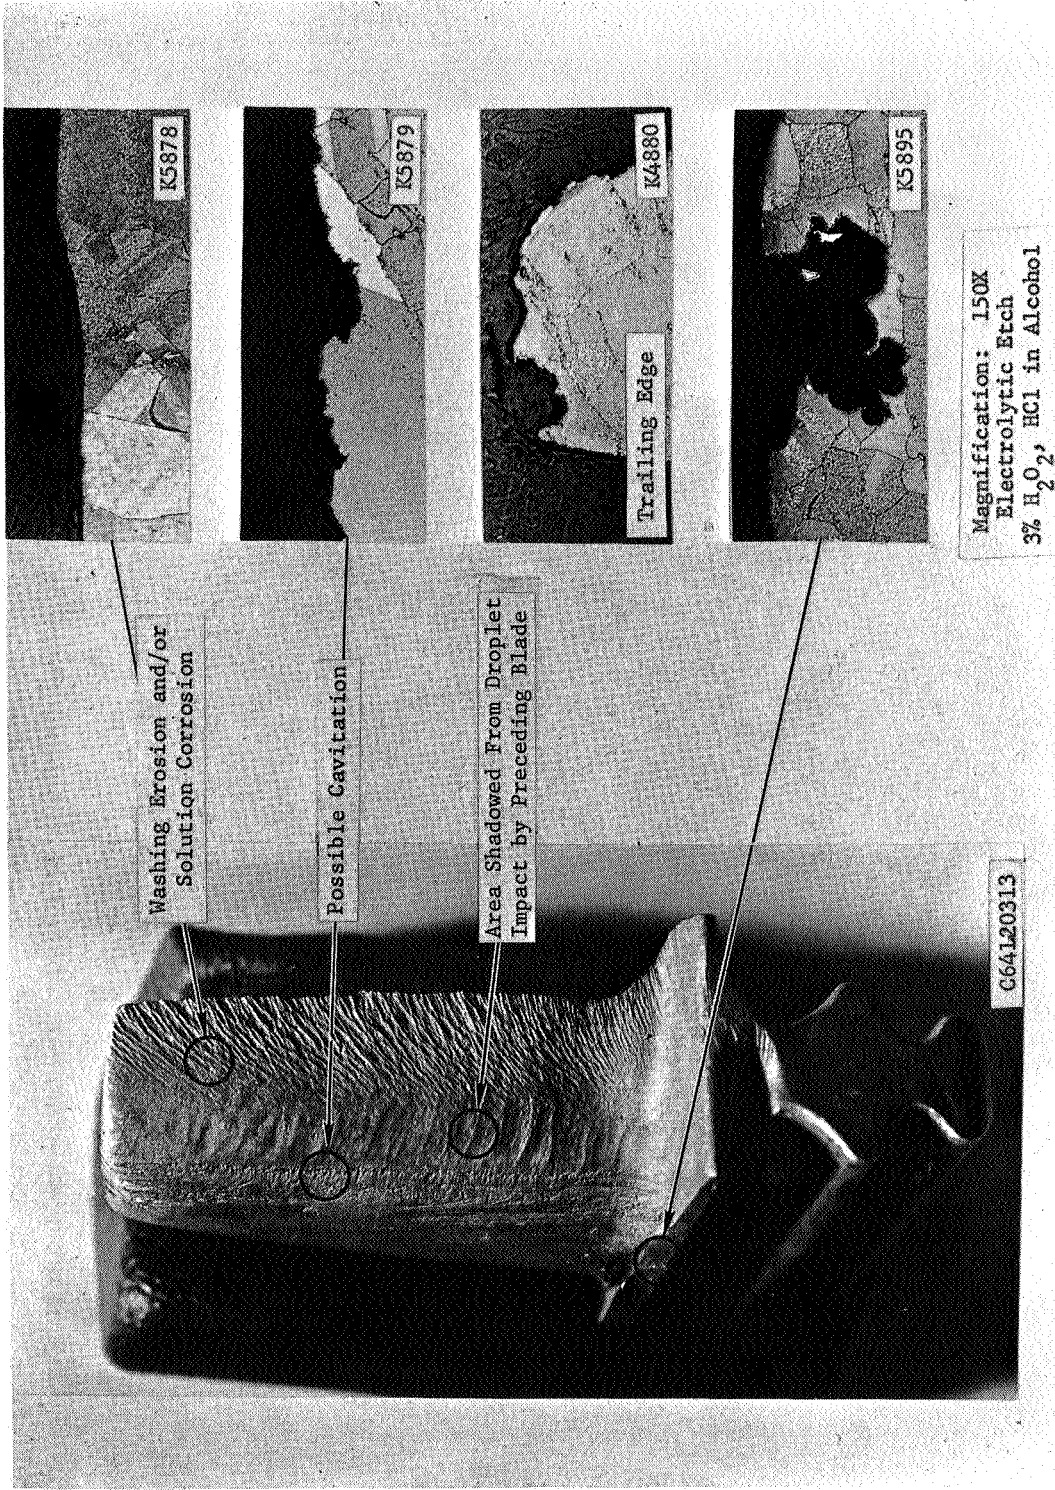
Figure 44. Photomicrographs Showing Nature of Metal Removal from Surface of First Stage Turbine Blade After 35-Hour Turbine Checkout.

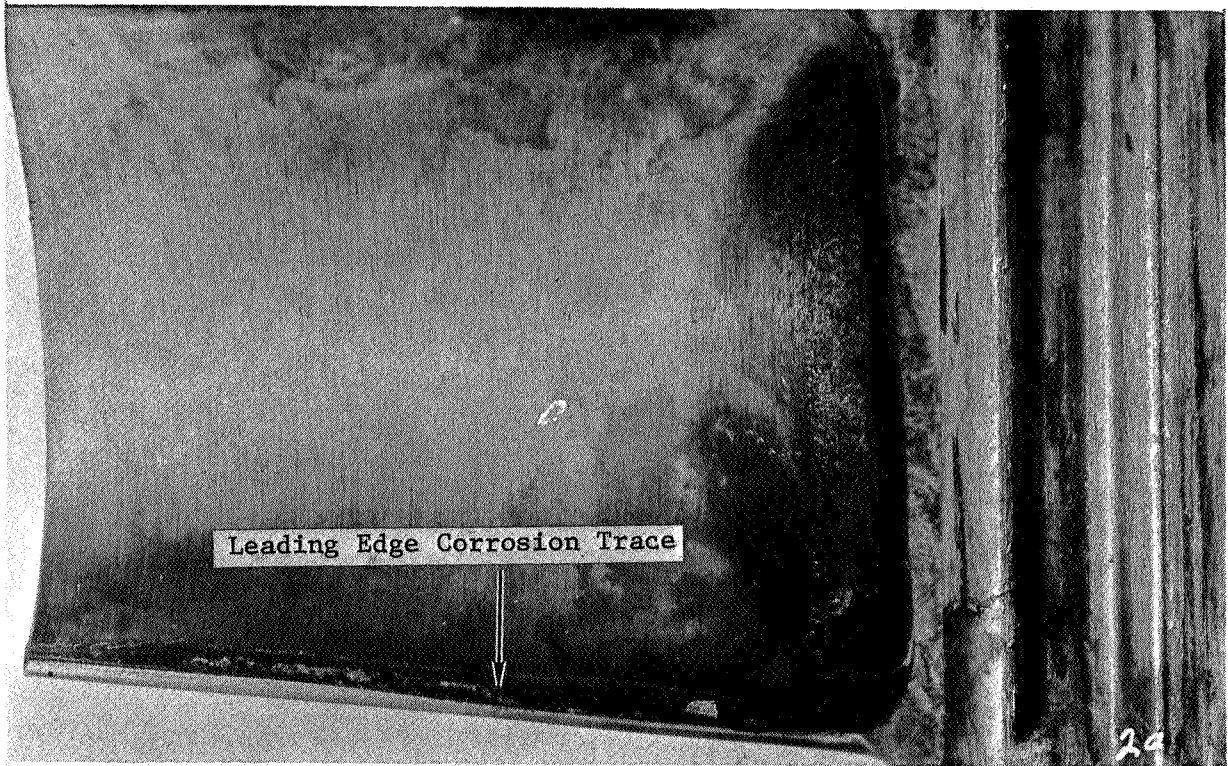
Figure 59. Concave Side of TZM Second Stage Turbine Blade After 2000-Hour Endurance Test. Note Leading Edge Corrosion. (C66011348)

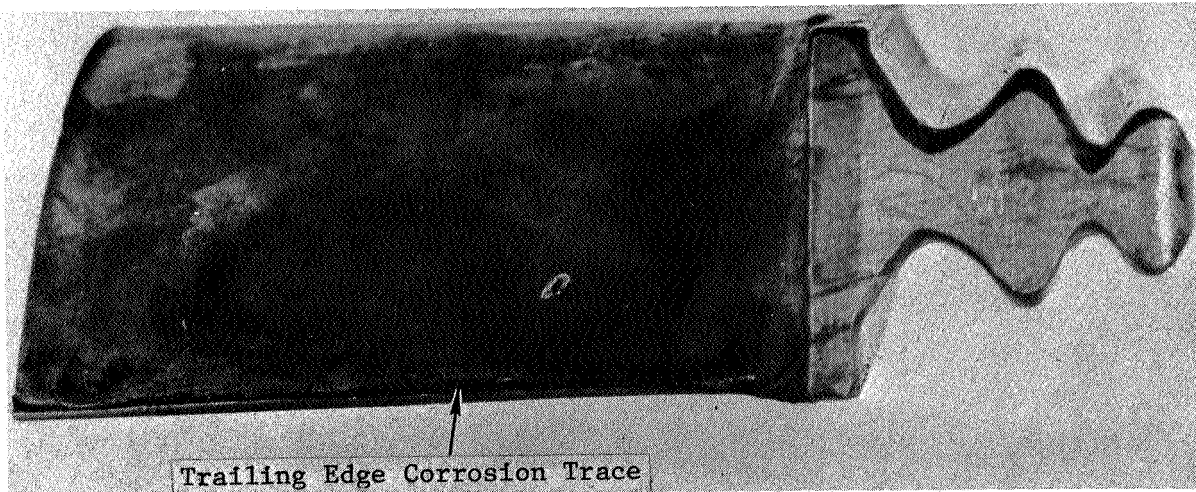
Figure 60. Trailing Edge of TZM Second Stage Turbine Blade After 2000-Hour Endurance Test. Note Corrosion at Trailing Edge.
(C66011328) Mag: 5X

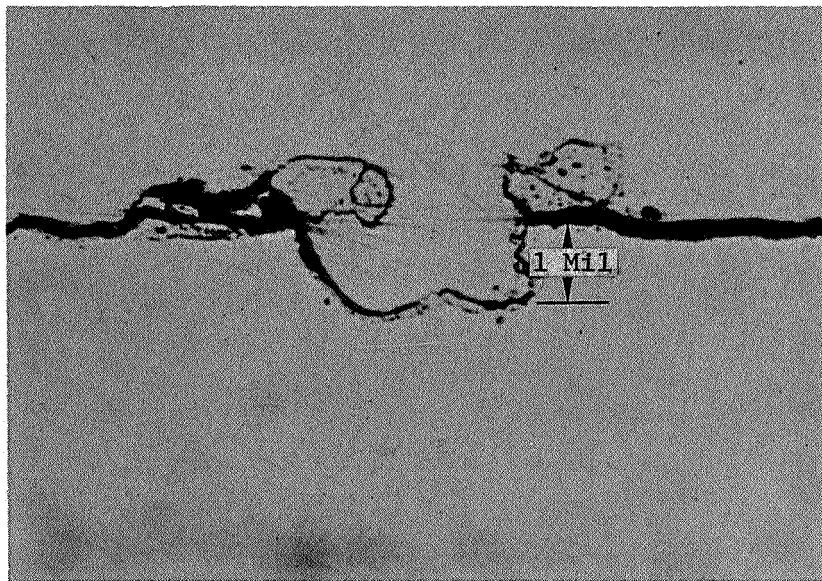
Figure 65. Convex Surface of TZM Second Stage Blade at Major Corrosion Area After 2000 Hour Test. (B320312)

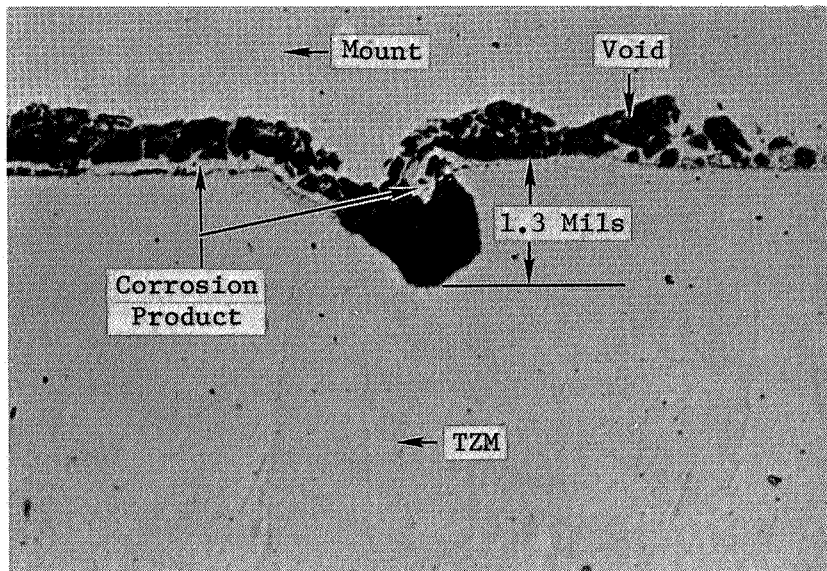
Figure 67. Tip of TZM Second Stage Turbine Blade at Major Corrosion Trace After 2000 Hour Test. (B320112)

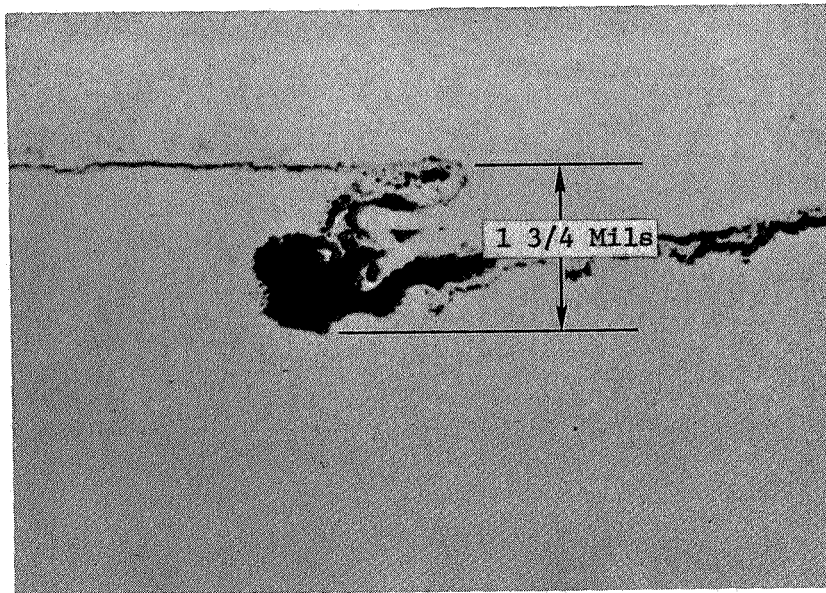
Figure 68. Tip of TZM Second Stage Turbine Blade at Major Corrosion Trace After 2000 Hour Test. (B320211)

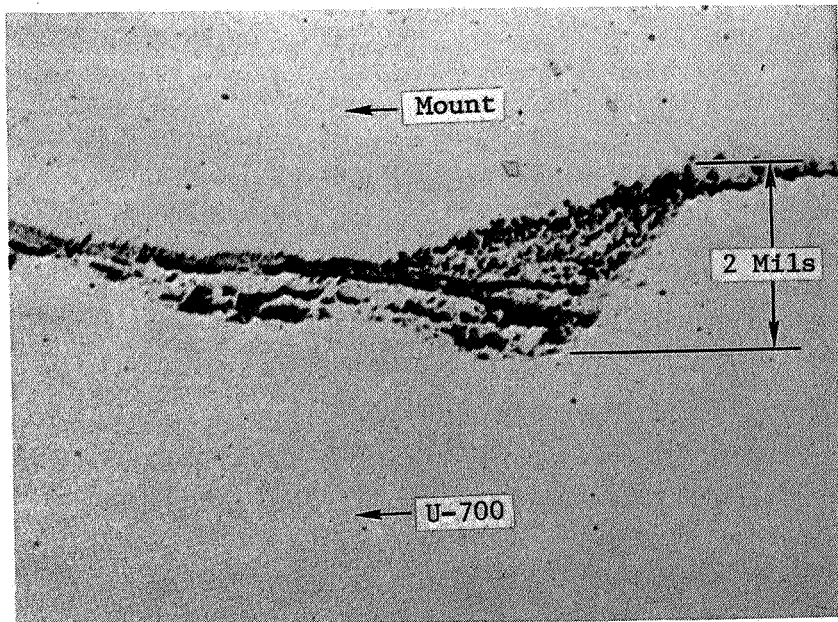
Figure 71. Corrosion Cavity at Concave Leading Edge of a First Stage U-700 Blade After 2000 Hour Endurance Test. (B321511)

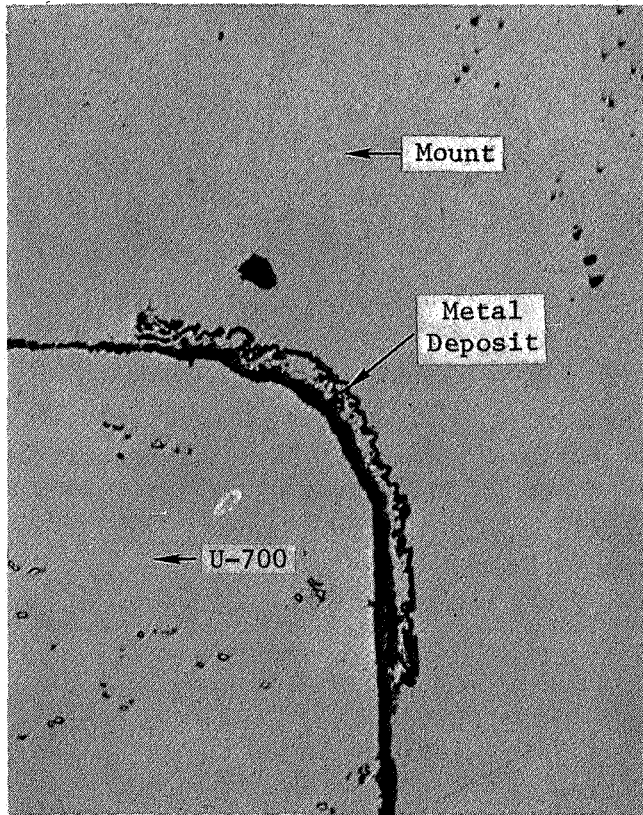
Figure 74. Surface Corrosion and Metal Deposit at Concave Tip of a U-700 First Stage Turbine Blade After 2000 Hour Endurance Test. (B322011)

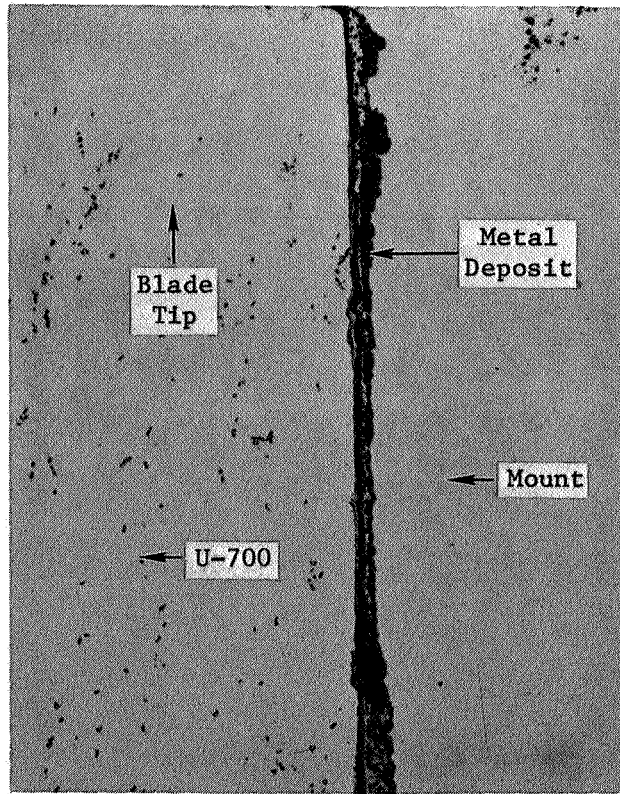
Figure 75. Light Surface Corrosion and Metal Deposit on Convex Tip of a First Stage U-700 Turbine Blade After 2000 Hour Test. (B322012)

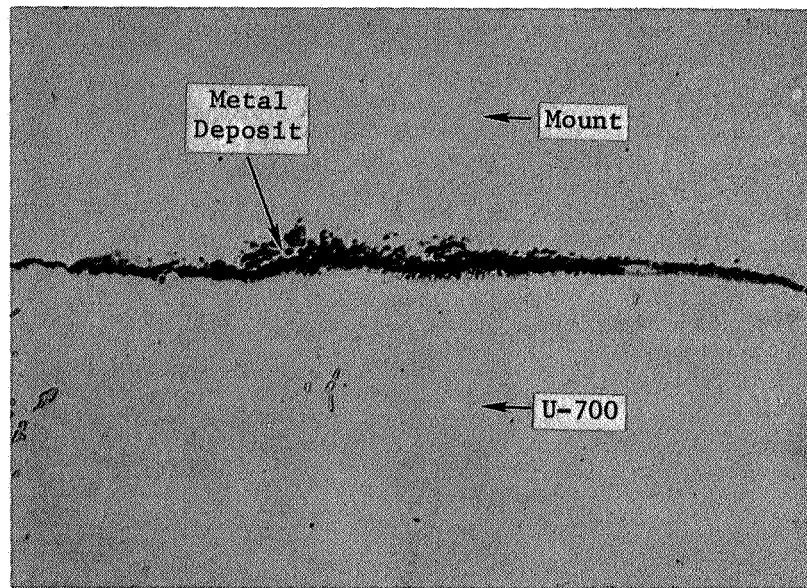
Figure 76. Corrosion and Metal Deposit on Convex Trailing Edge of a First Stage U-700 Turbine Blade After 2000 Hour Test. (B322114)

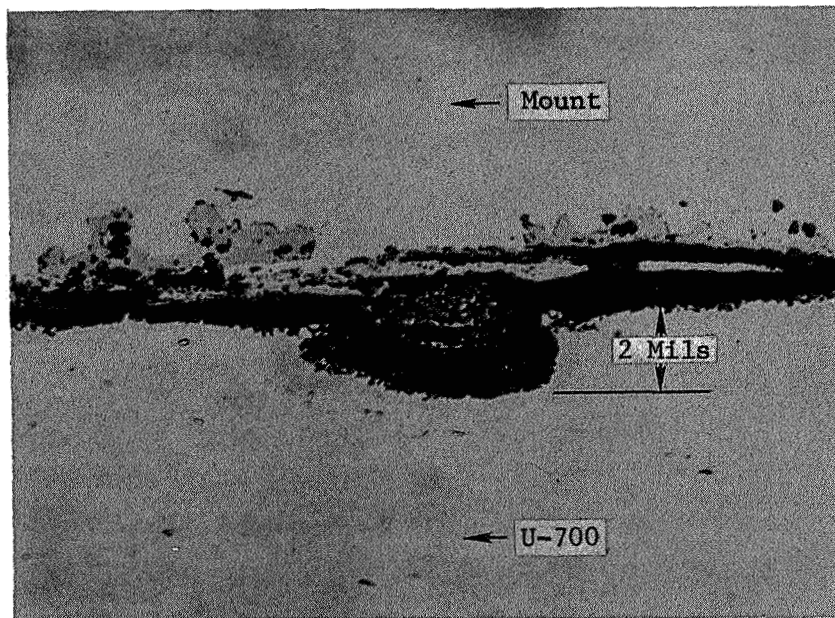
Figure 77. Corrosion Groove on Convex Airfoil Surface of a U-700 First Stage Turbine Blade After 2000 Hour Endurance Test. (B322013)

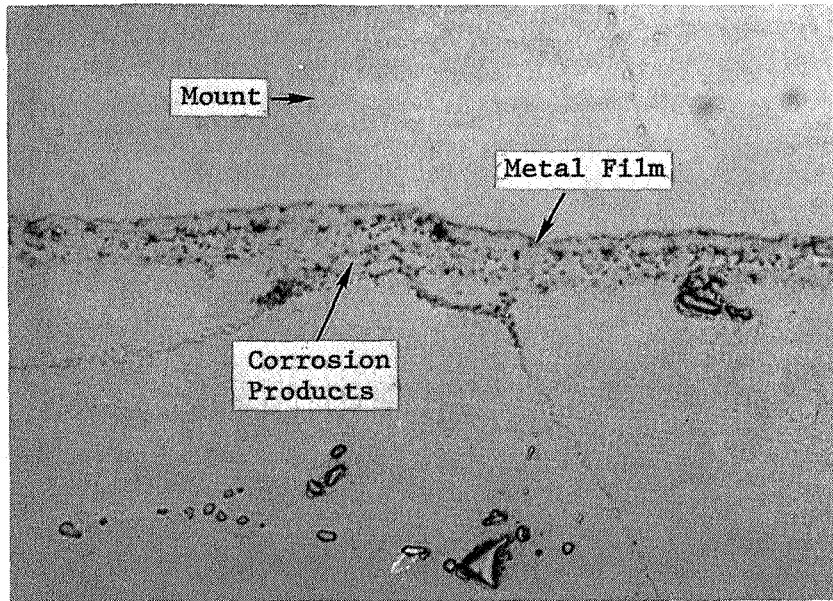
Figure 78. Metal Film Deposit Overlaying Corrosion Products on the Concave Tip Surface of a First Stage U-700 Turbine Blade After 2000 Hour Test (B320712)

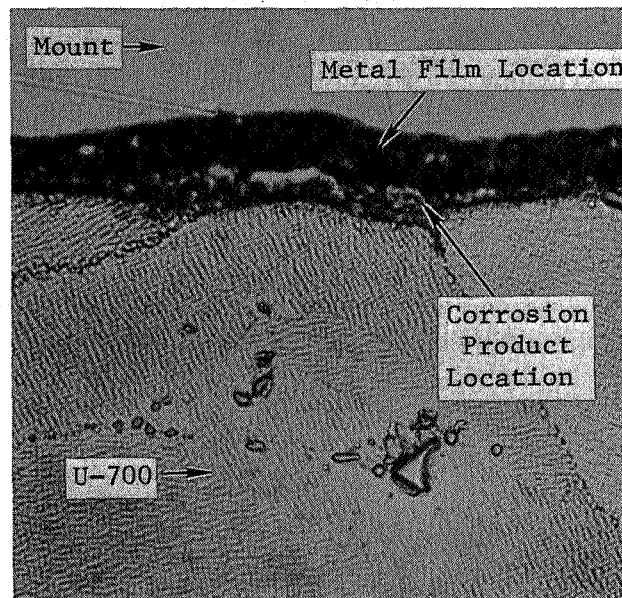
Figure 79. Metal Film Deposit Overlaying Corrosion Products on the Concave Tip Surface of a First Stage U-700 Turbine Blade After 2000 Hour Test. (B320713) Area Shown is that of Figure 78.

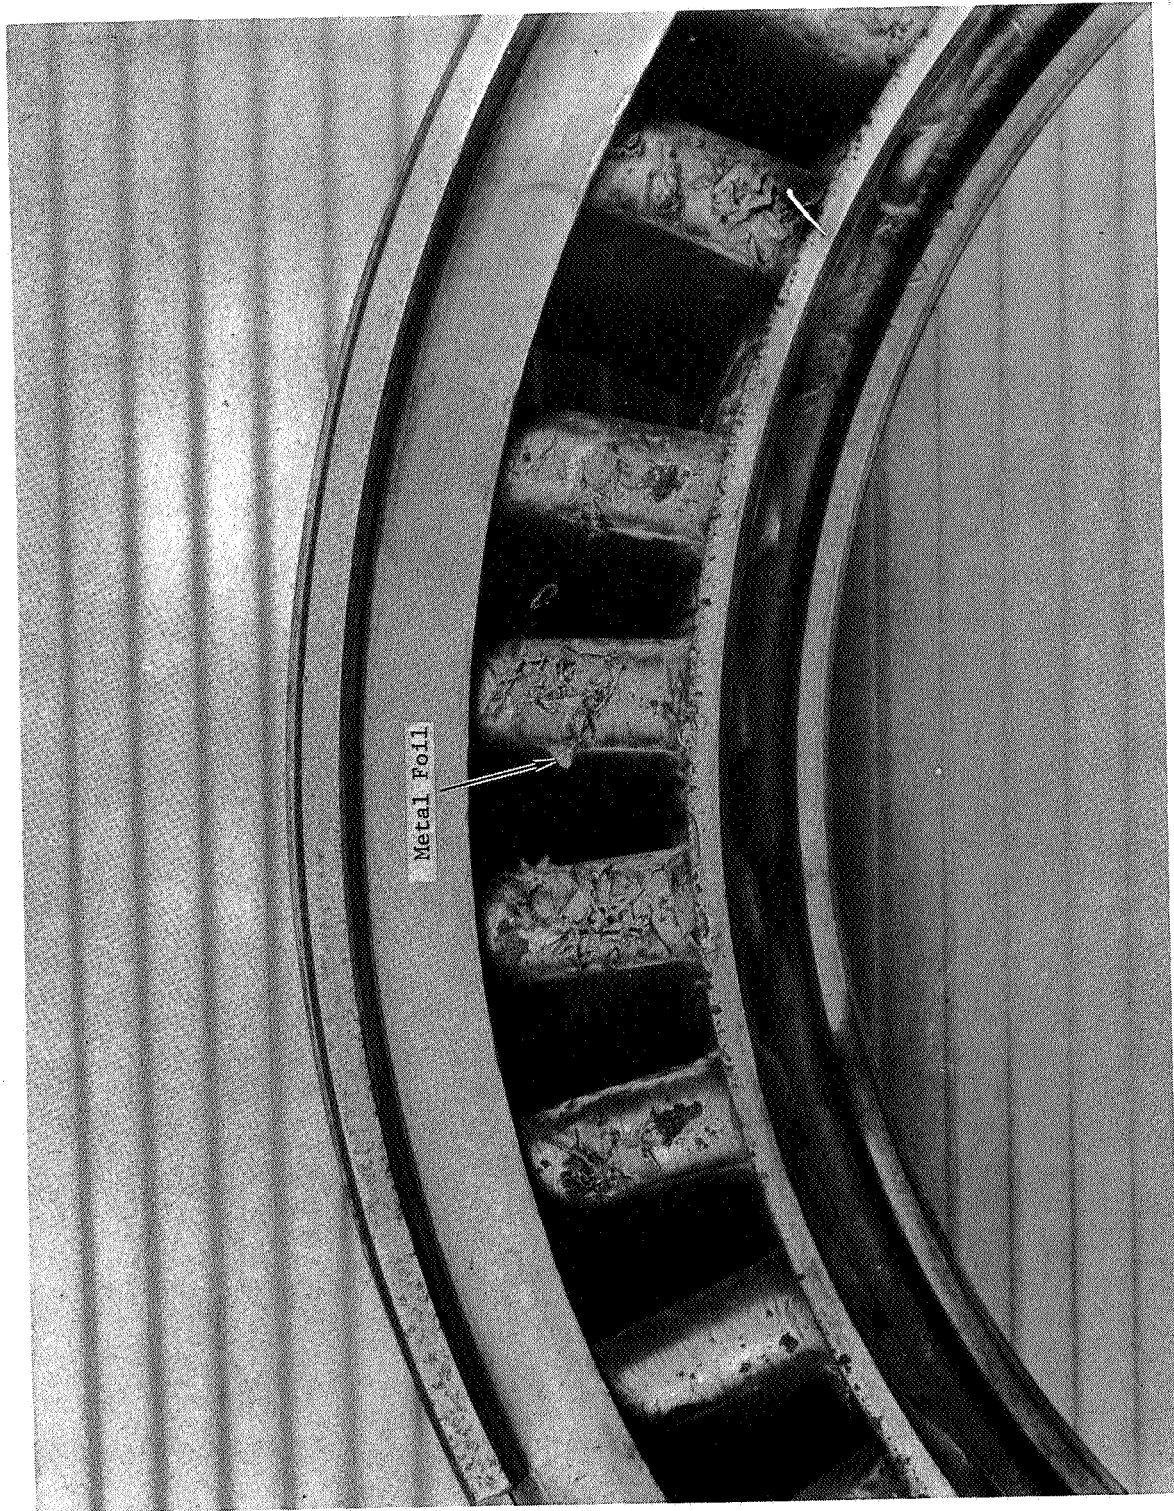
Figure 104. Metal Foil Deposits Impacted on the First Stage Turbine Nozzle Diaphragm After Performance Testing. (C65061516)

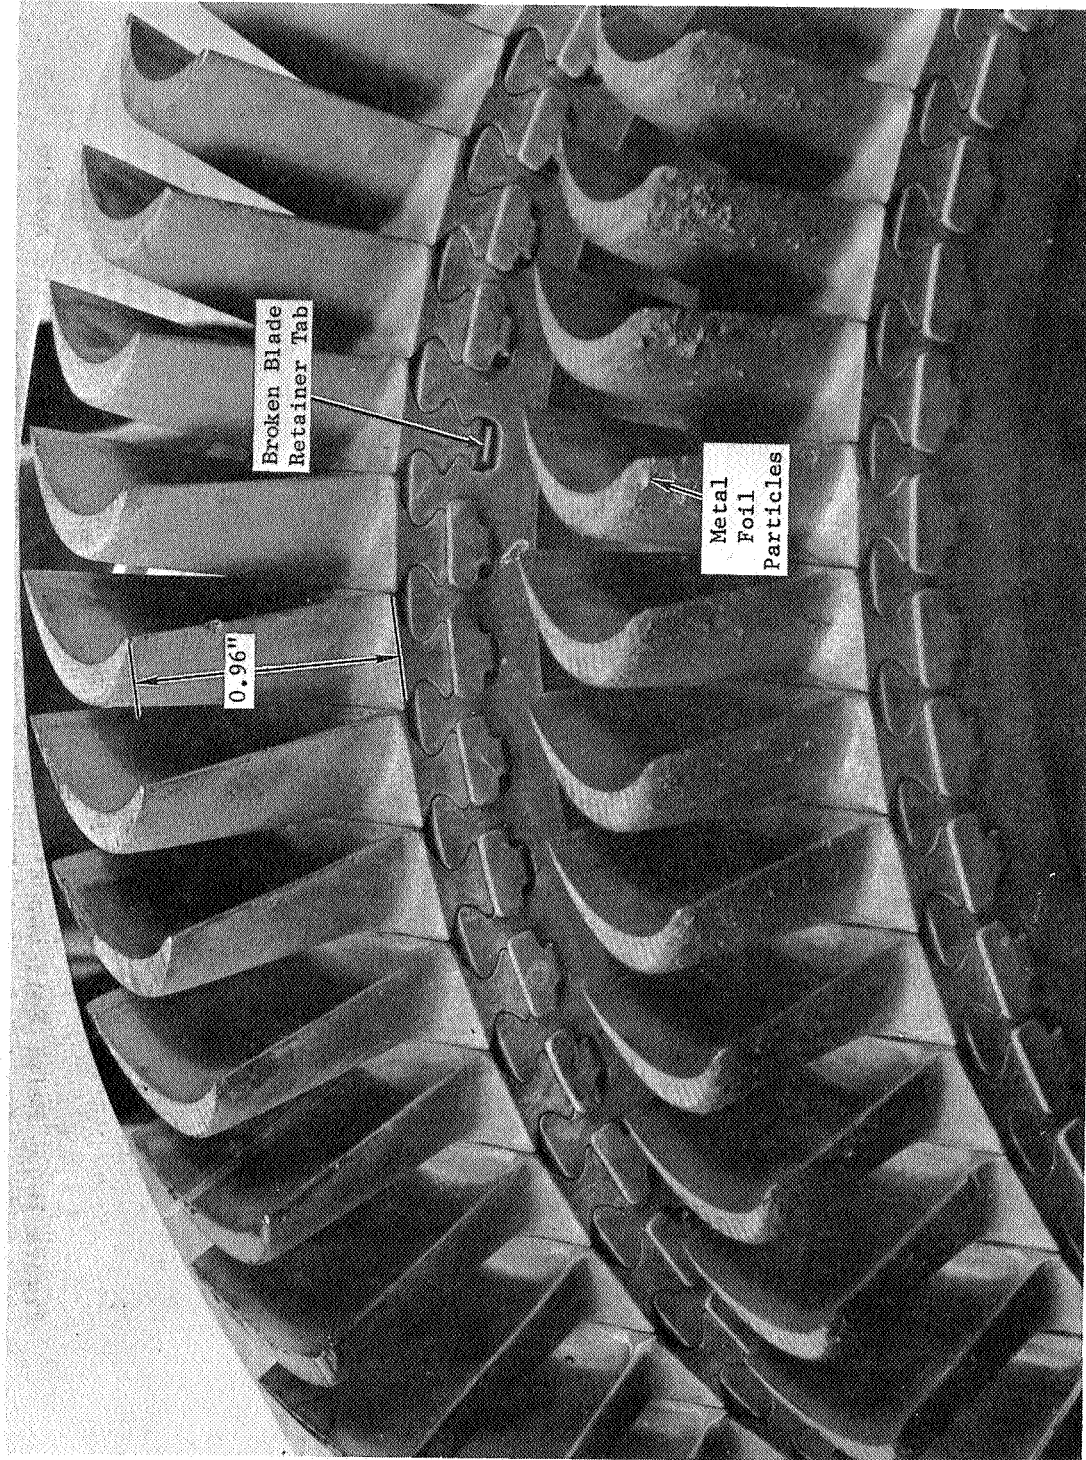
Figure 105. Close-up of Rotor Blades Showing Metal Foil Particles Impacted on First and Second Stage Blades. (C65060726)

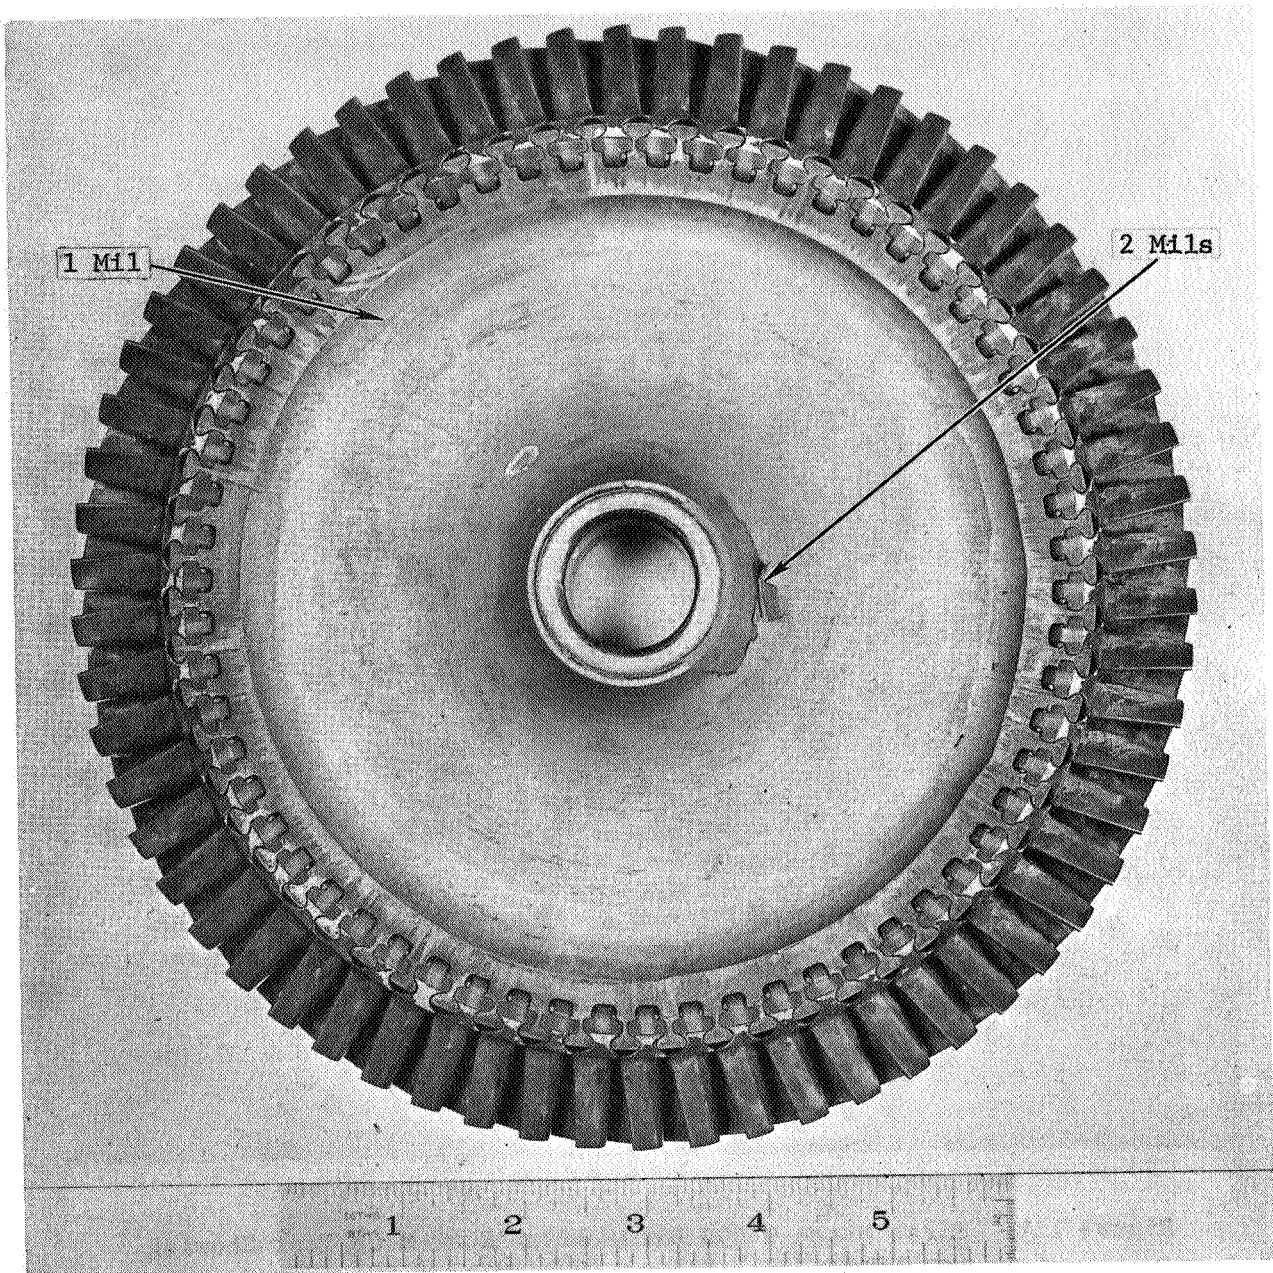
Figure 110. Forward Face of First Stage Turbine Wheel After 2000 Hour Endurance Test Showing Deposited Metal Film. (C65123043)

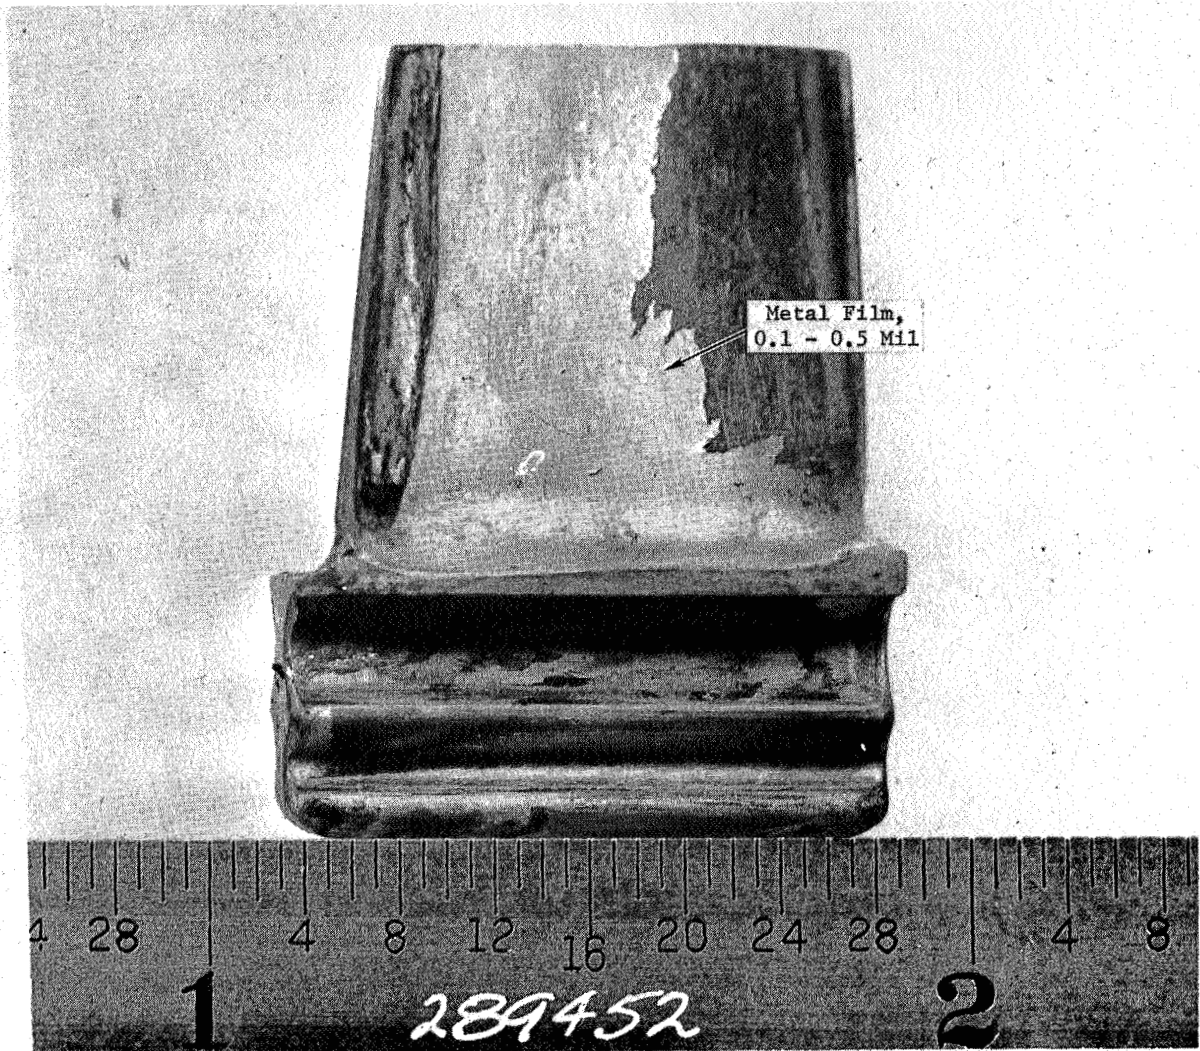
Figure 111. First Stage U-700 Blade After 2000 Hour Test Showing Deposited Metal Film. (289452)

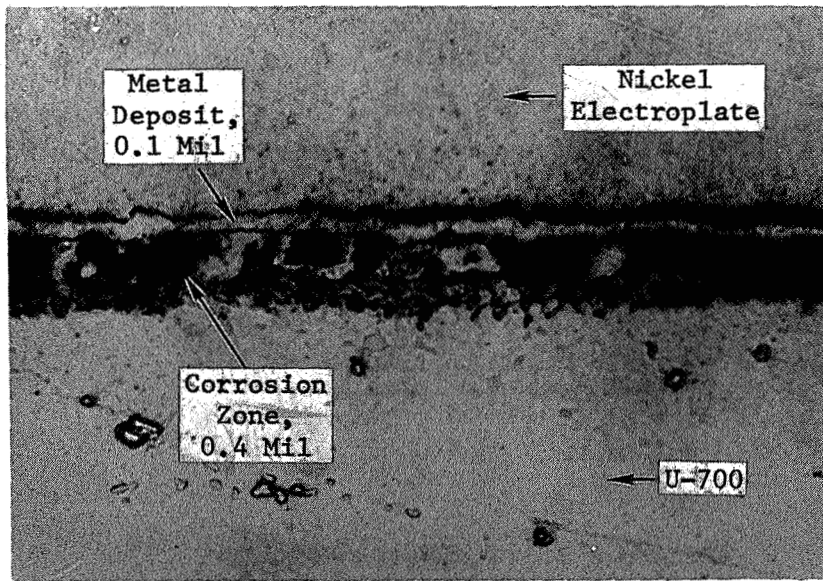
Figure 112. Concave Surface of First Stage U-700 Endurance Test Blade Near Leading Edge Showing Metallic Film Deposit and Underlying Corrosion. (B322112)

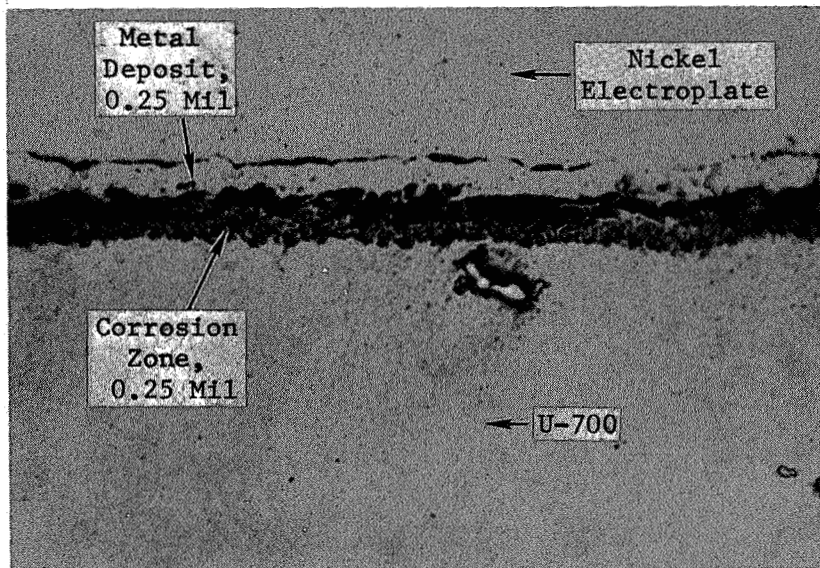
Figure 113. Convex Surface of First Stage U-700 Endurance Test Blade Near Leading Edge Showing Metallic Film Deposit and Underlying Corrosion. (B322113)
