GEMINI PROGRAM MISSION REPORT

GEMINI IV

JUNE 1965

NATIONAL AERONAUTICS AND SPACE ADMINISTRATION MANNED SPACECRAFT CENTER

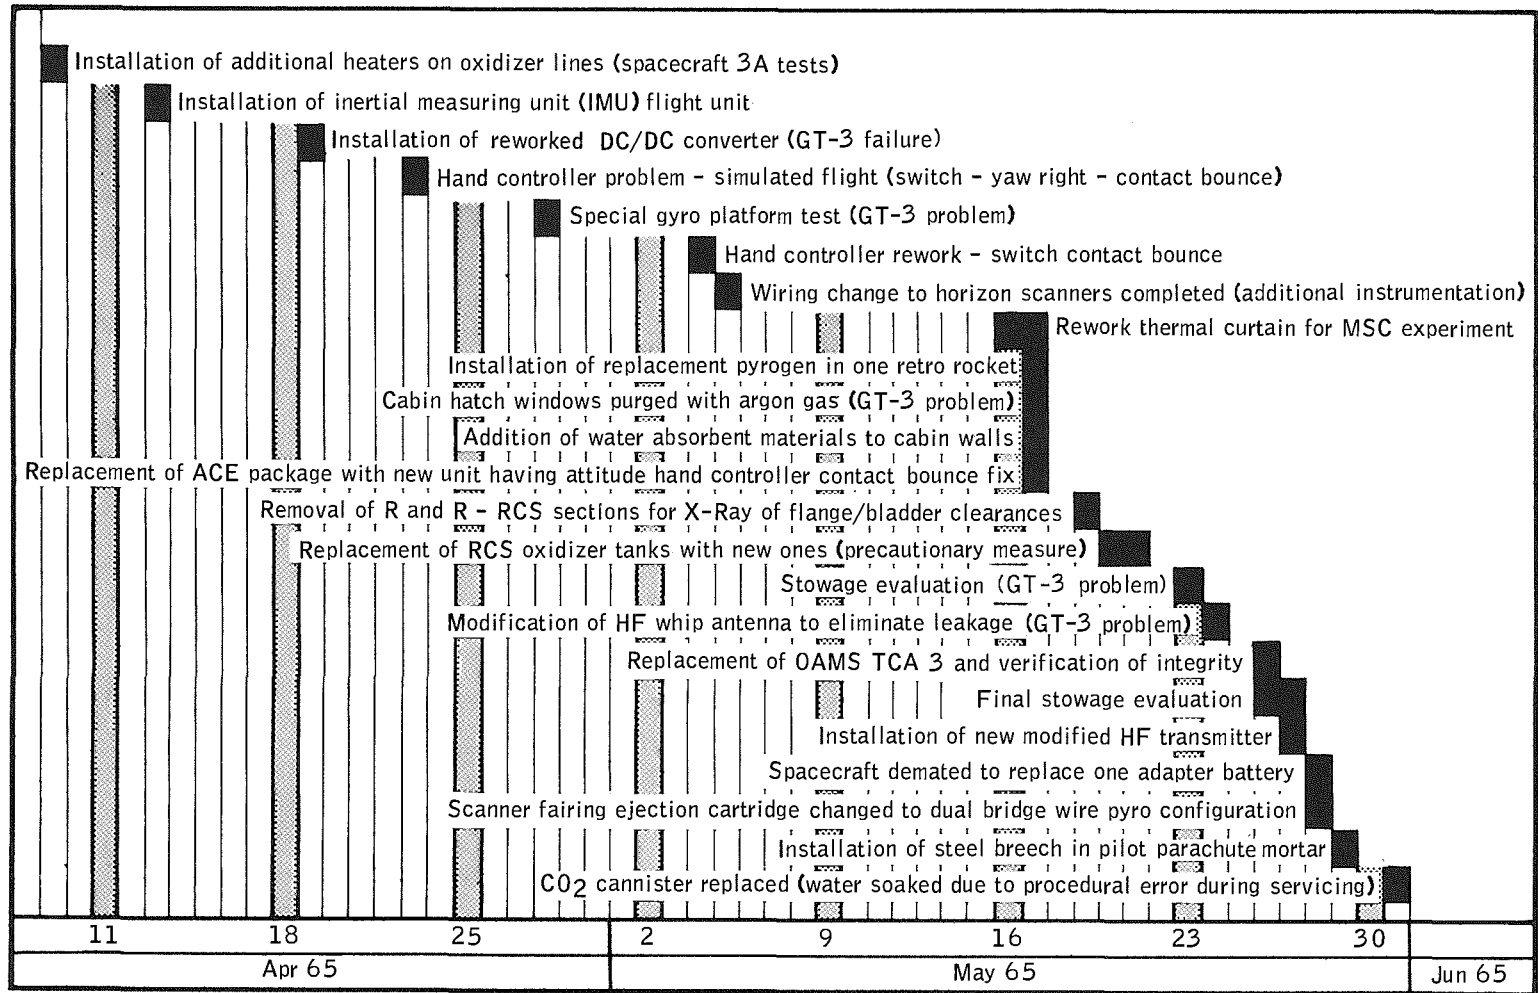
Figure 12-4.- Spacecraft 4 significant problem areas at Cape Kennedy.

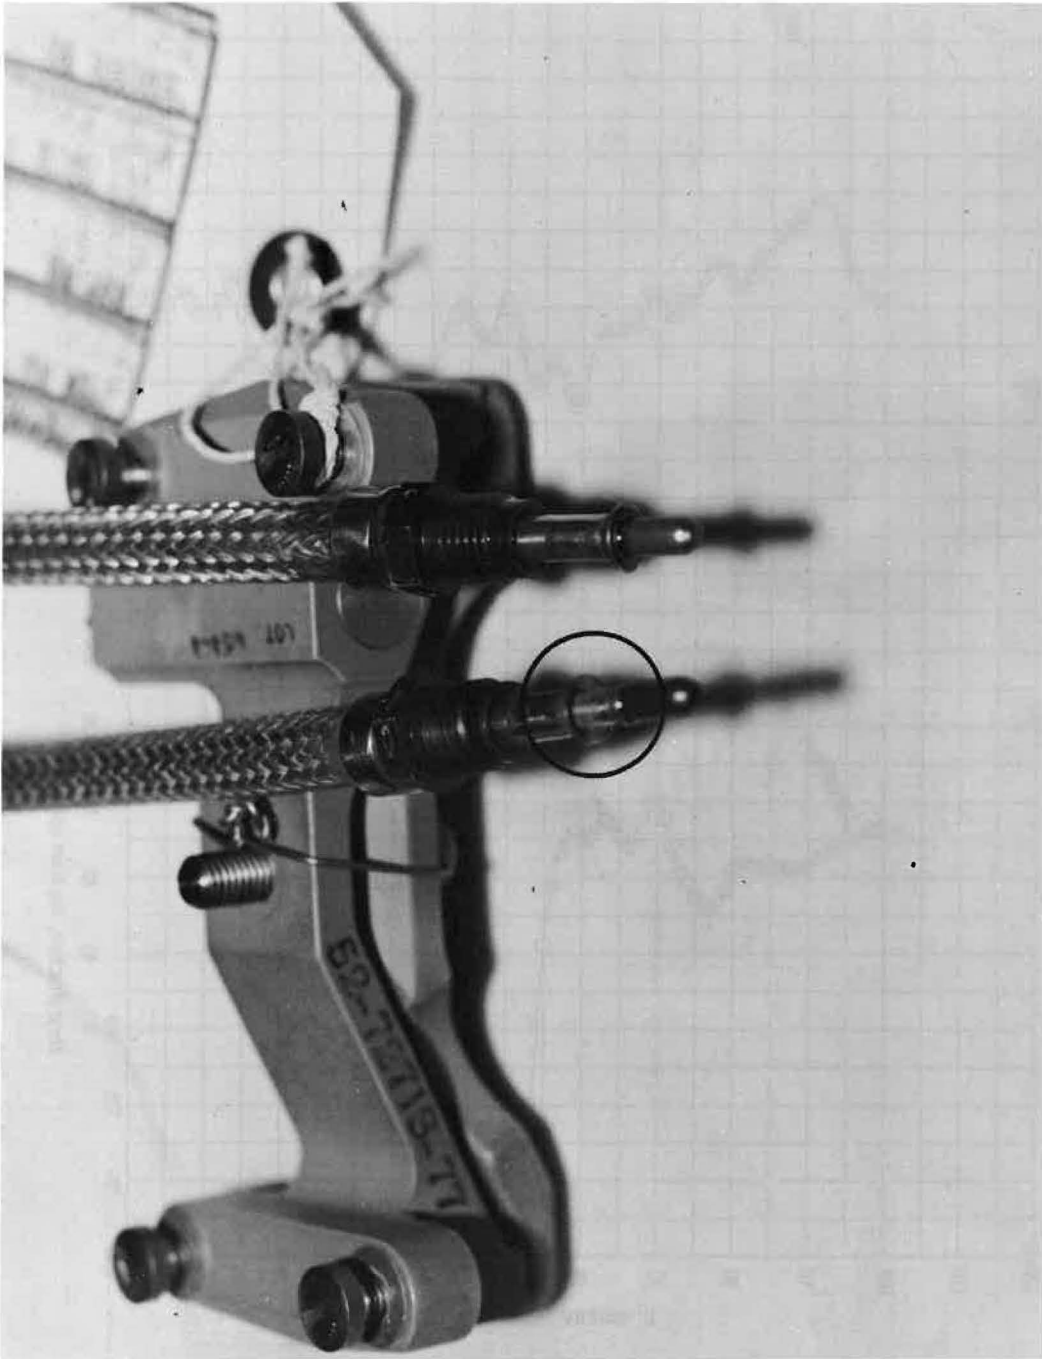
Figure 12-9. - Faulty escape system MDF interconnect.

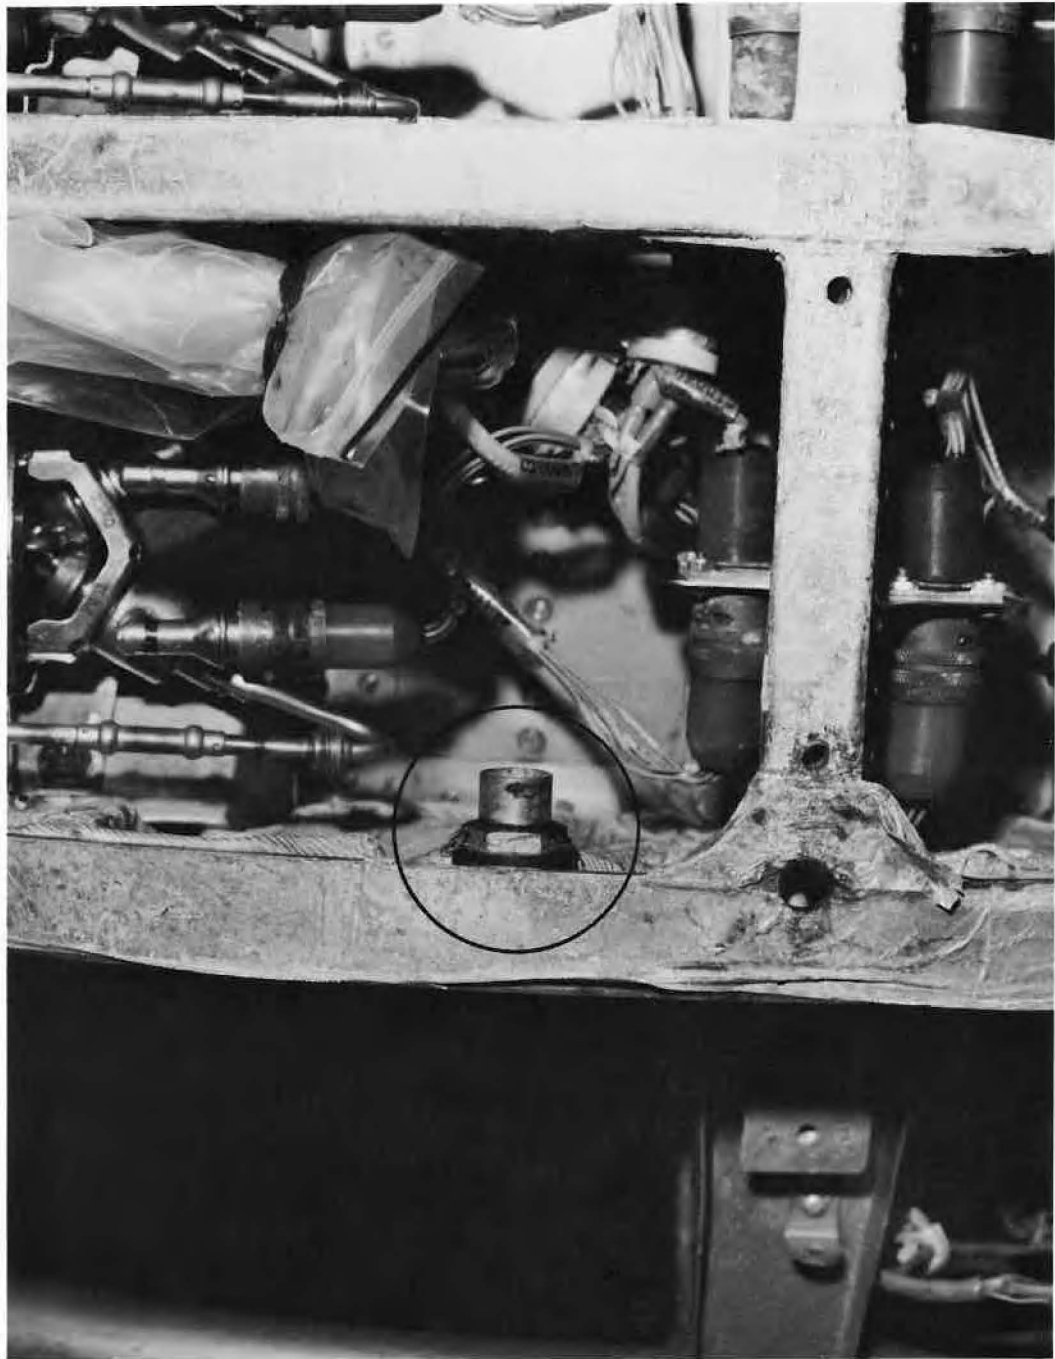
Figure 12-10 - Sheared connector to R and R separation igniter.
