29B
DOCUMENT NO. T5-6539-78 - END

TITLE *3* INVESTIGATION OF X-RAY INDICATIONS IN GOX LINE WELD *6*

MODEL NO. SAT V/S-IC CONTRACT NO. NAS8-5608 - 29ACV
25

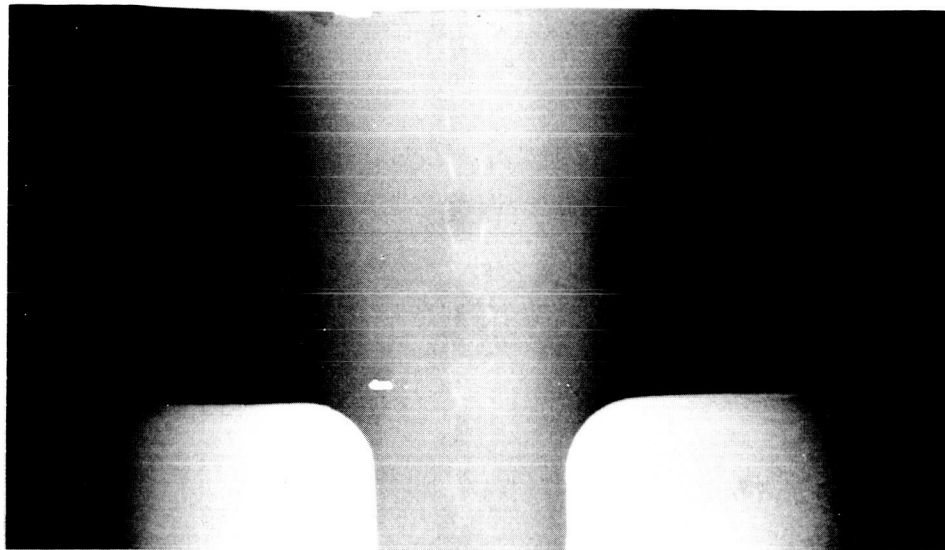
The 4-1/2" welded Inconel 718 tubing used in the GOX duct system of S-IC when x-rayed in the final heat treated condition, revealed numerous indications along the edges of the longitudinal weld, (Figure #1). These welds when x-rayed prior to planishing and solution heat treatment did not show these indications. These tubes have been produced in two production lots; (1) those, solution treated at the tube vendor's plant at $1750^{\circ} \pm 25^{\circ}\text{F}$ and subsequently at Lindberg in Los Angeles at $1950^{\circ}\text{F} (\pm 25^{\circ})$, have not shown these indications when x-rayed at the Michoud assembly facility, and (2) those, solution treated at the tube vendor's plant at $1950^{\circ}\text{F} \pm 25^{\circ}\text{F}$ only, showed these indications when x-rayed at Michoud assembly facility. Due to the criticality of the system it was decided to determine the nature and source of these indications and their effect on the reliability tubing.

Fig. # 1 X-Ray Positive Print of Showing
Defect Indications

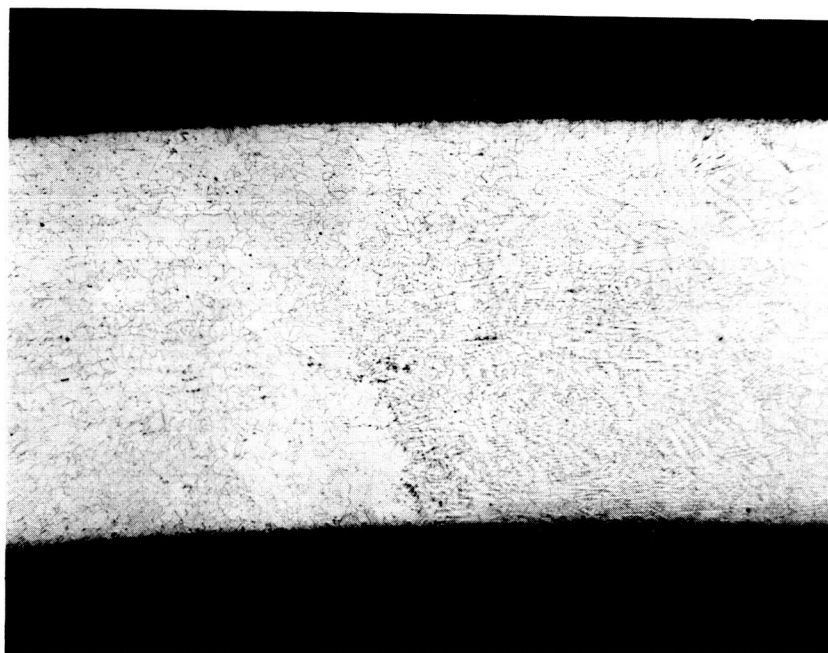
A section of tubing containing defects was delivered to the M&P Lab accompanied by x-rays of the longitudinal seam welds. "Worst areas" were removed and they in turn were x-rayed to accurately locate the defects. (Figure #1). Sections were cut exposing the cross sections of several defects and these were mounted and given a metallographic examination. This examination revealed an anomaly in the structure of the weld in the area of the weld fusion. (Fig. # 2, 3). These anomalies were located in the first 1/4 to 1/3 of the distance from the inside of the tubing.

Fig. # 2 Typical Tubing Cross Section in X-Ray
Defect Area

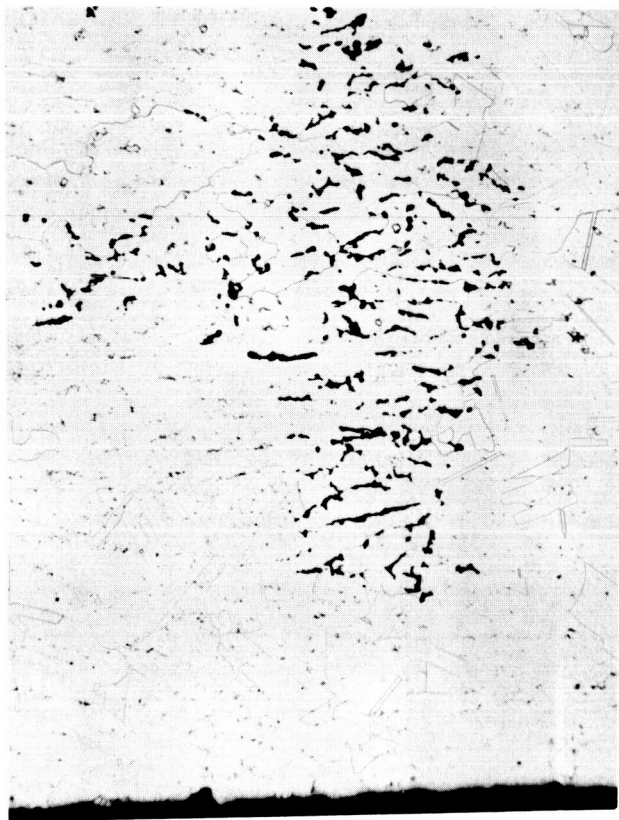
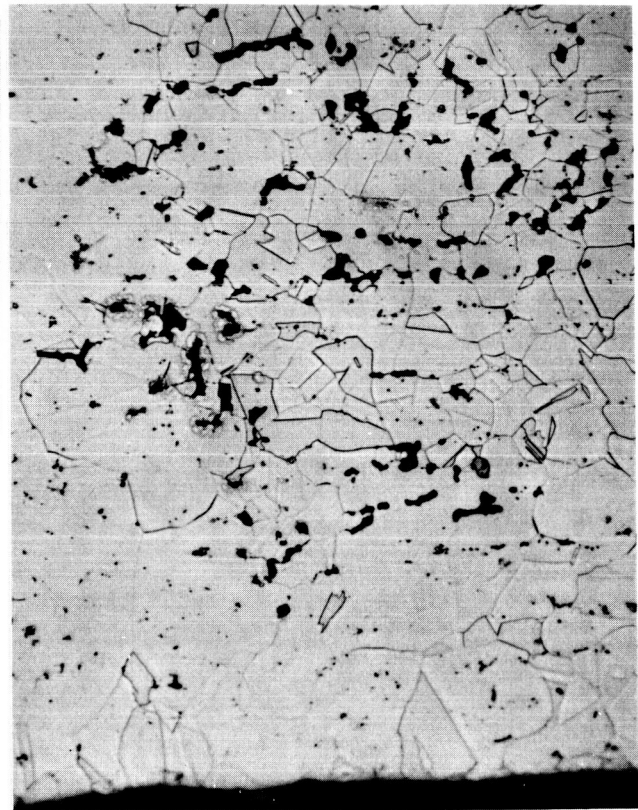
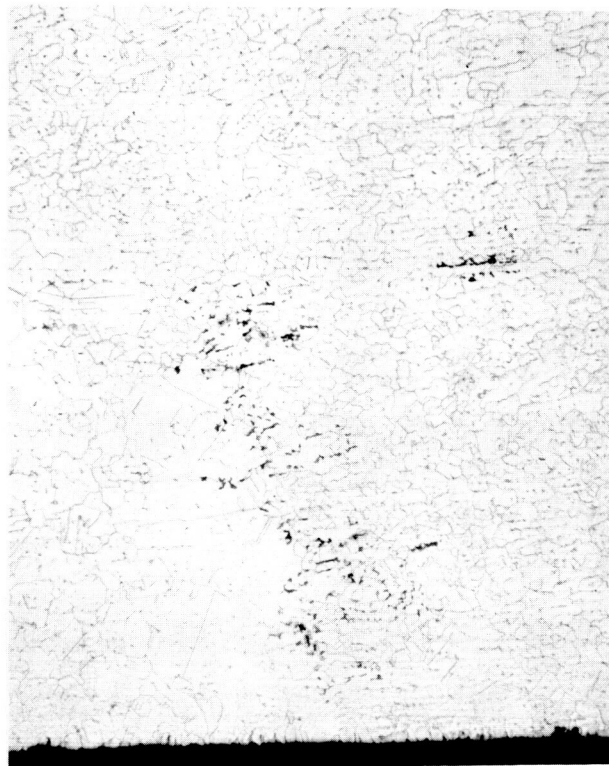
Fig. # 3 Higher Magnification of Figure # 2 Area

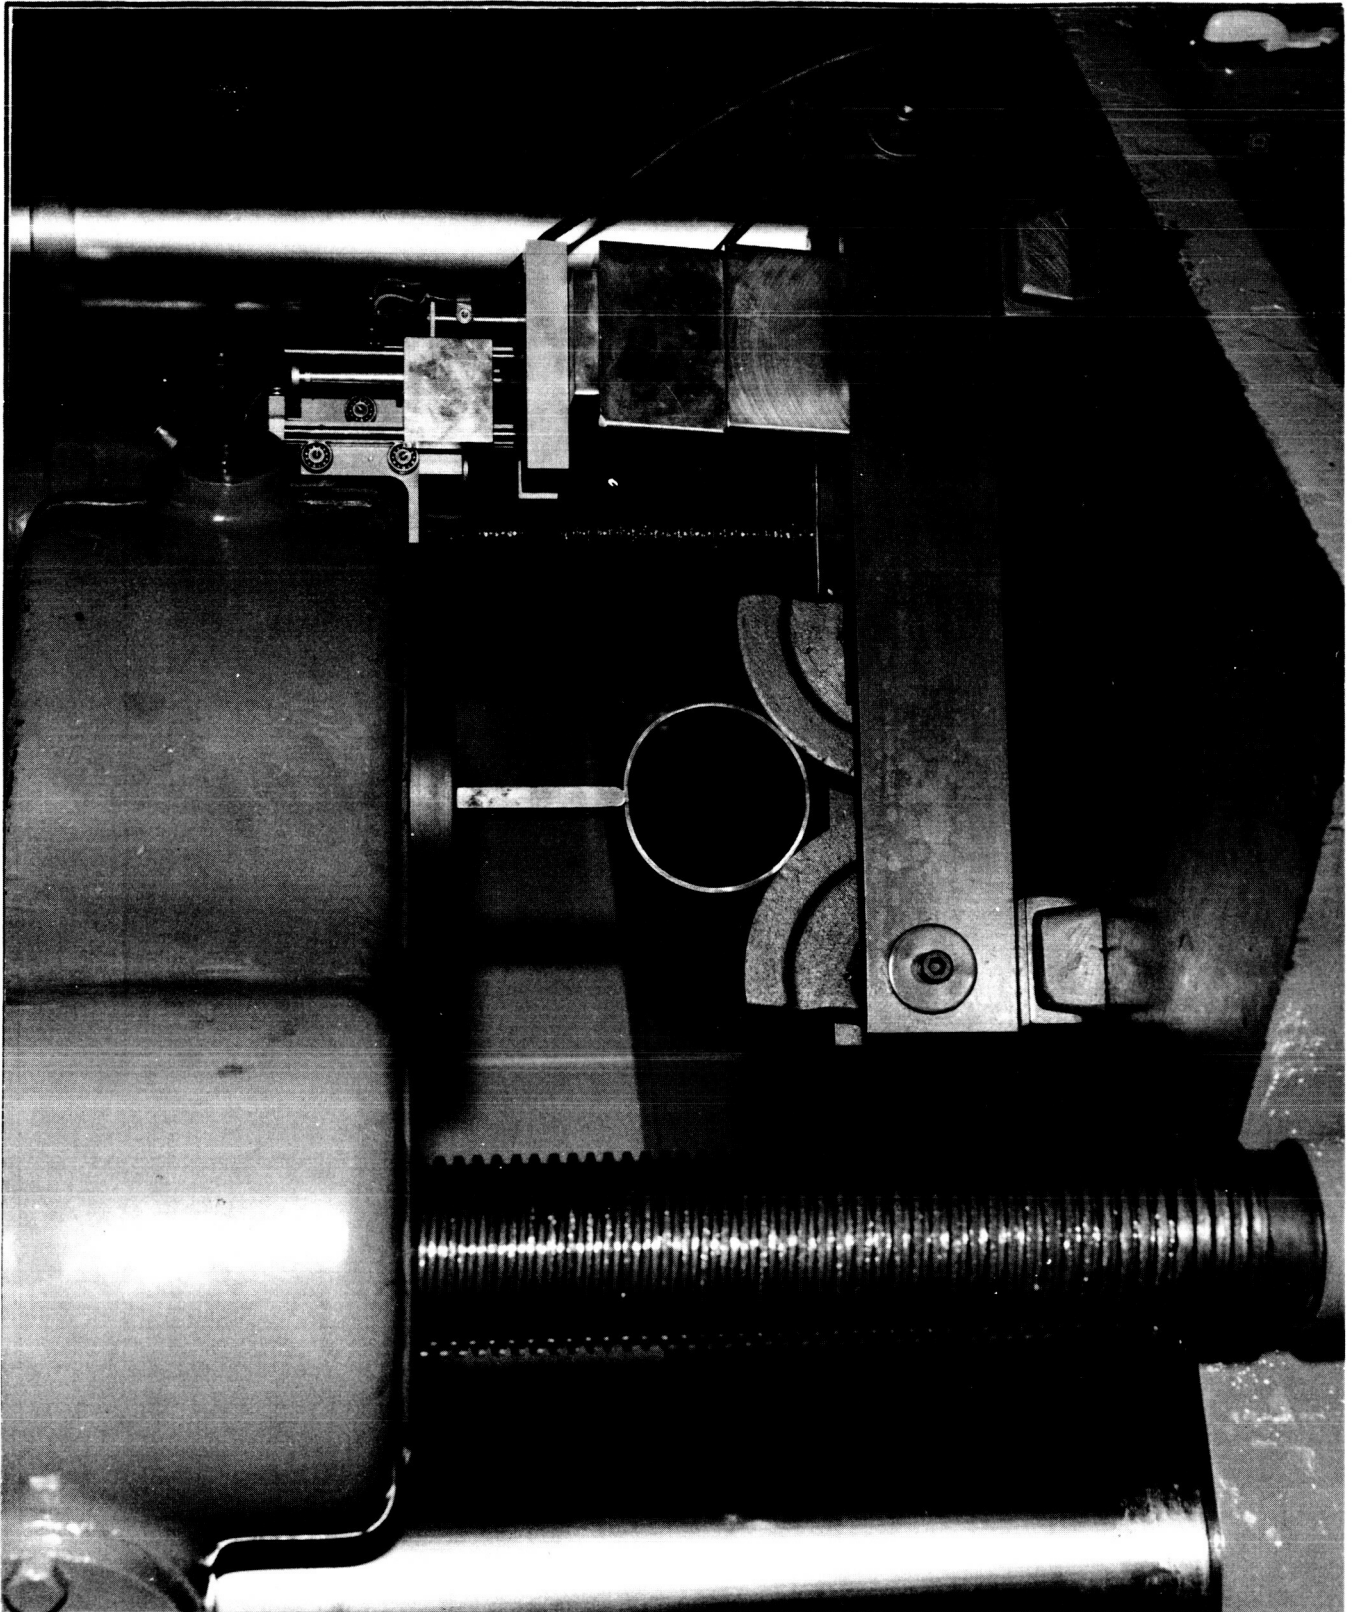
Fig. # 4 Test Set For Bending of Tube Ring Specimens

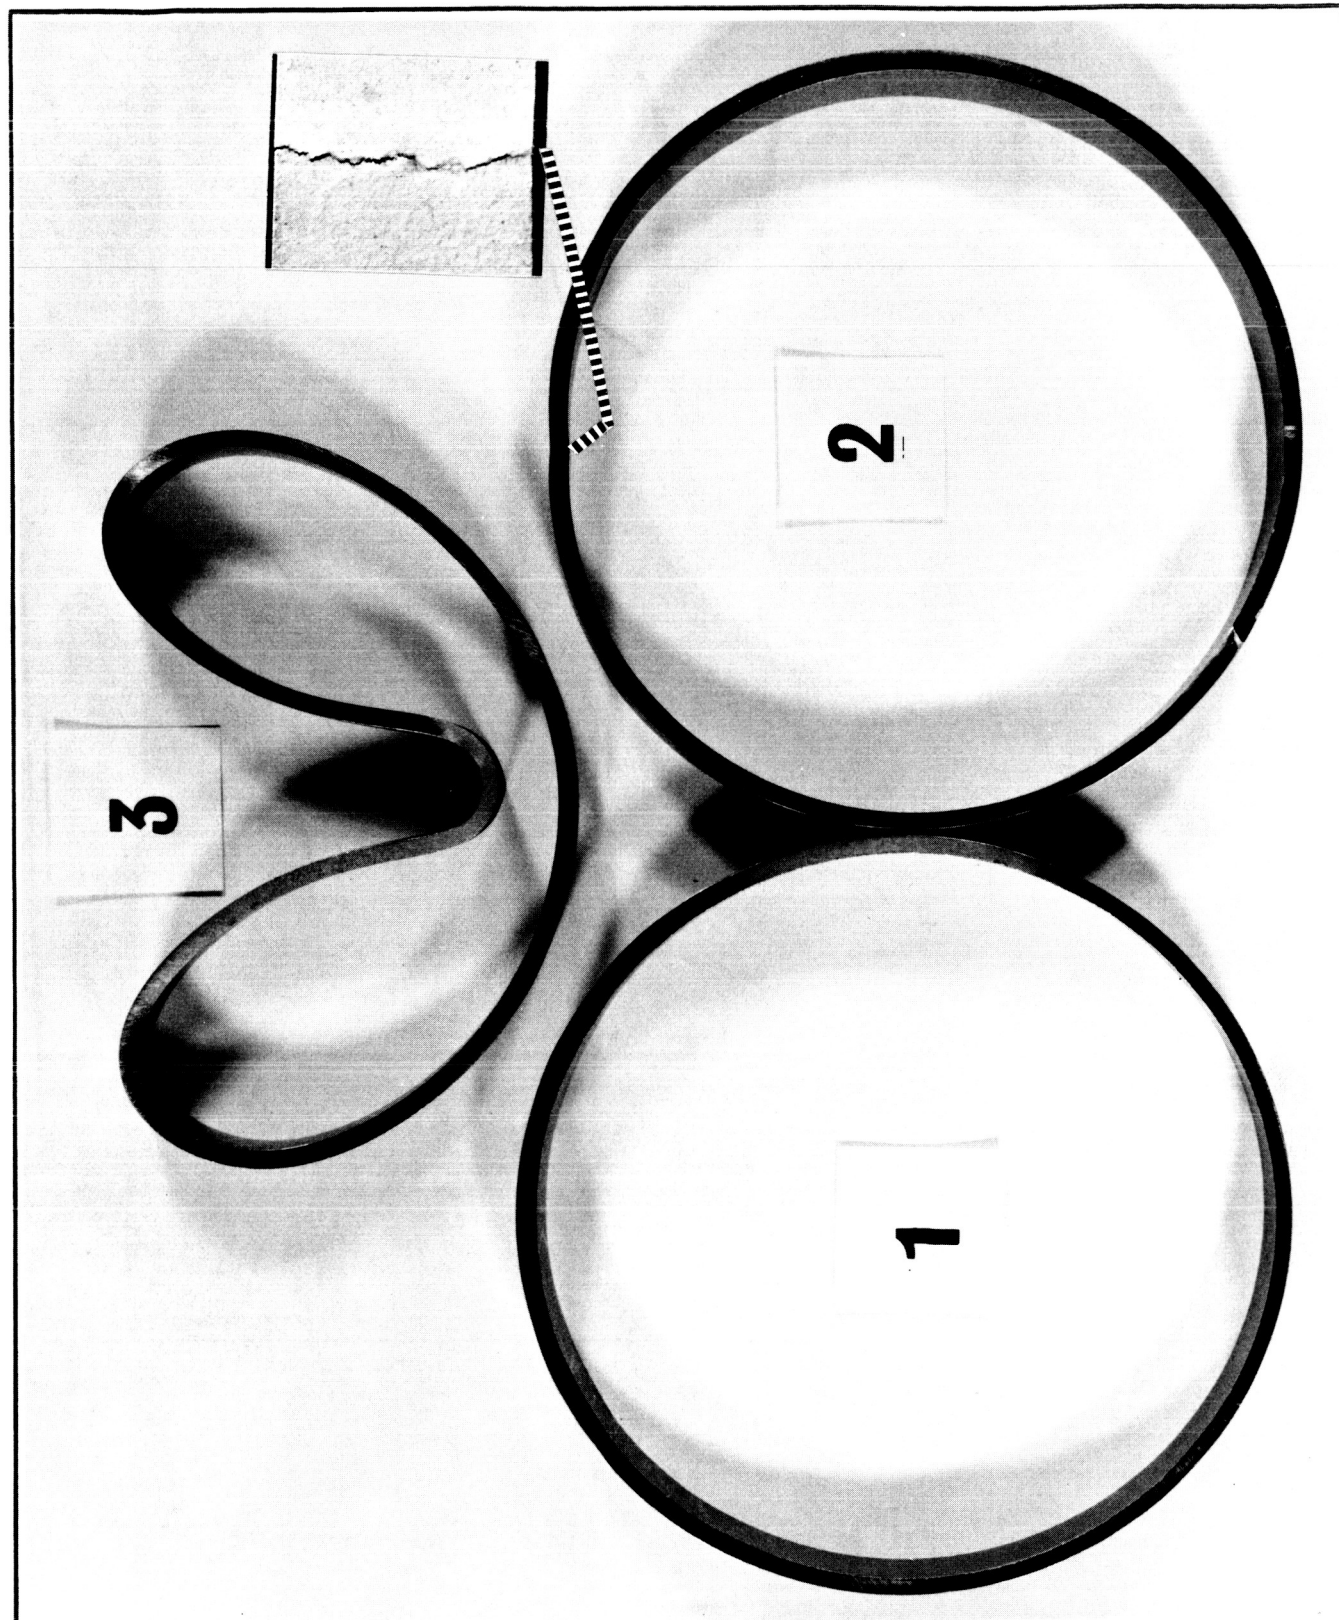
To determine the effect of these anomalies on the integrity of the tube, a part was obtained that showed one end free of indication and one end heavy with indications. Six 1/2" wide ring sections were removed from each end. (Each set of six representing defect containing and defect free material respectively). A bend test (across the weld) was performed on these rings. (See Figure #4 for test setup) the ring was set in a jig in a standard test machine and a penetrator with a 1/4" diameter head was placed against the weld center and the ring was compressed. The defect free rings were bent until the inside surfaces of the rings touched. No failure occurred. The rings containing defects were compressed 1/2" maximum when definite failure occurred, (See Figure #5).

Fig. # 5 #1 Untested Ring
 #2 Typical Defect Containing Ring with Crack Detail
 #3 Typical Defect Free Ring

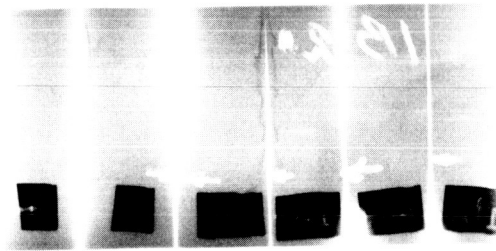
Boeing personnel (Project, M&P, Materiel, Manufacturing Development and Quality Control) then visited the tube vendor to observe tube production. X-rays were taken after welding, planishing, heat treating and sizing. The defects were first reproduced in the ends of the tubes that got excessively overheated during induction heating, (See Figure #6). This pointed to incipient melting as the cause of the defect. To confirm this condition, tubes were processed by the vendor at 1750°F, 1950°F, 2225°F and 2400°F. X-rays of these test tubes showed clear at 1750°F, minor indication at 1950°F (furnace used was improperly controlled and was probably not 1950°F in defect areas). Continuous defects at 2100°F, continuous and extremely heavy defects at 2225°F and tube melting at 2350°F and 2400°F. In order to confirm improper furnace control at 1950°F four tubes were sent to Los Angeles to be heat treated in a properly certified furnace at 1950°F. X-rays of these welds showed no defects in the four tubes.

Fig. # 6 X-ray Positive Print Showing Defects Reproduced
in Hot Ends of Tubing During Production

- 1) Heat treatment of welded Inconel # 718 tubes should be conducted in a certified furnace at a temperature not exceeding $1950^{\circ} \pm 25^{\circ}$.

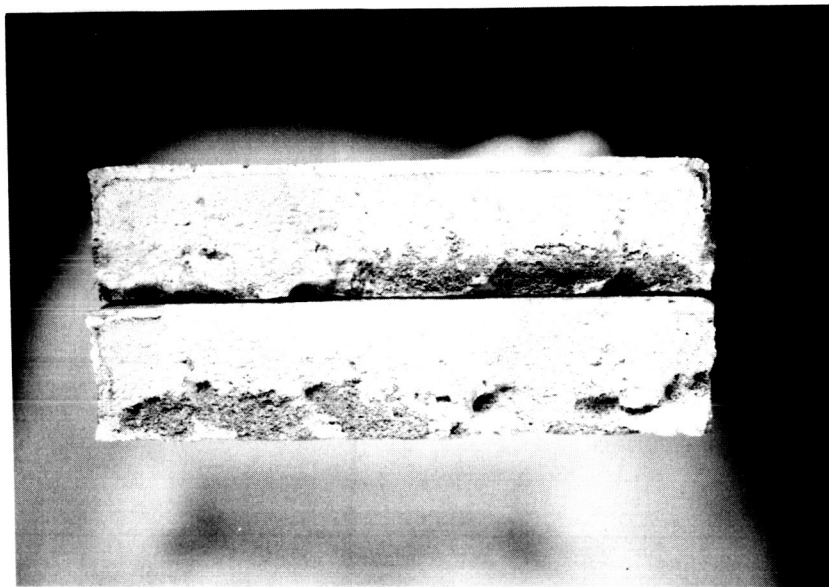
Fig. # 7 Fracture Face of Failed Ring 6X

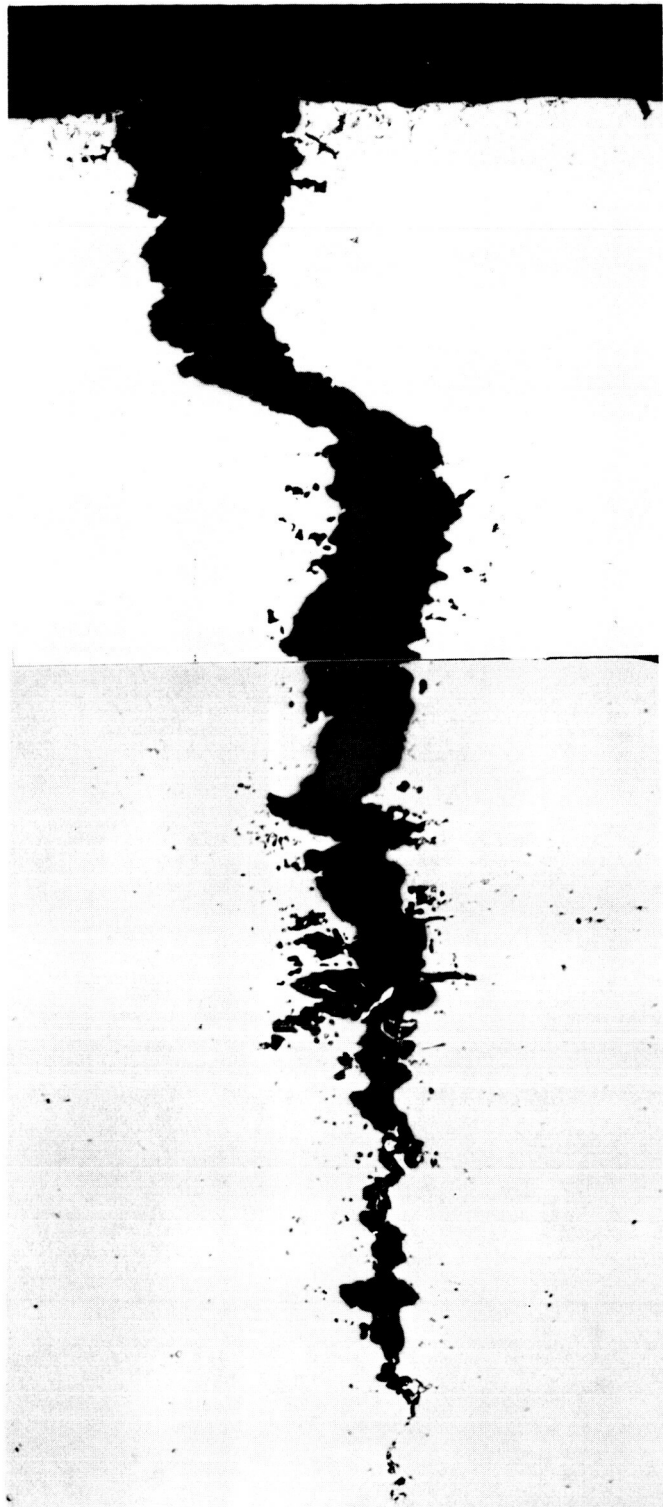
Fig. # 8 Metallographical Crossection of Failed Ring - Note Crack Propagates Through Defect Area
