THE **BOEING** COMPANY
AERO-SPACE DIVISION
LAUNCH SYSTEMS BRANCH

DOCUMENT NO. T5-6539-81

TITLE METALLURGICAL ANALYSIS OF, HANDLING TOOL, FORWARD BOOSTER

ASSEMBLY LIFTING EYE, H.T. 370-704^o-2-5.

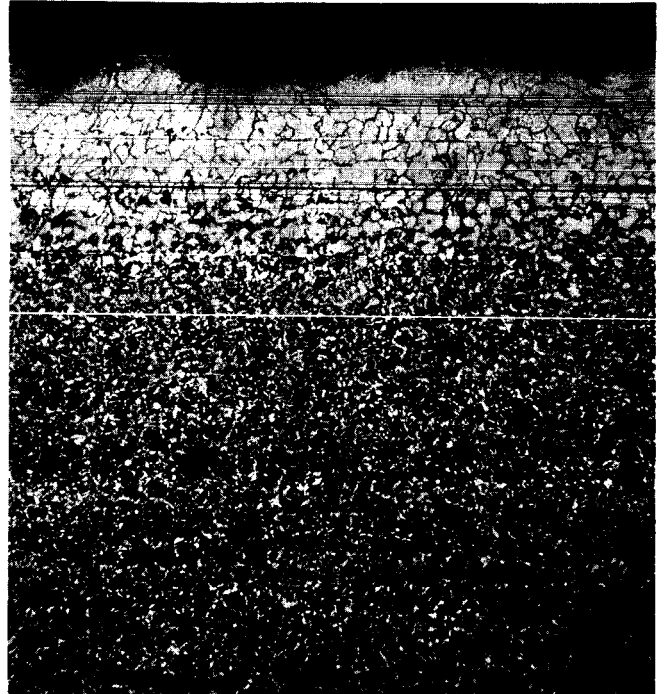
- 1) The general weakness of the 4130 plate due to surface laps and .010" depth of 100% decarburization is directly related to the surface cracking of the part.
- 2) The material was 90% below drawing strength requirements due to the inherent low hardenability of the 4130 steel plate.

The metallographic structure and a 500g DPH hardness survey (Figure #2) showed 100% decarburization .010" deep (Figure #1) on the top and bottom surface while the top surface showed partial decarburization another .012 to .015" deeper.

100X
Top Surface Cross Section
Note Depth of 100% Decarburization
And Partial Decarburization
