# SNAP-8 MATERIALS REPORT FOR JULY - DECEMBER 1965

SEMIANNUAL MATERIALS REPORT

By H. Derow and B. E. Farwell

February 1966

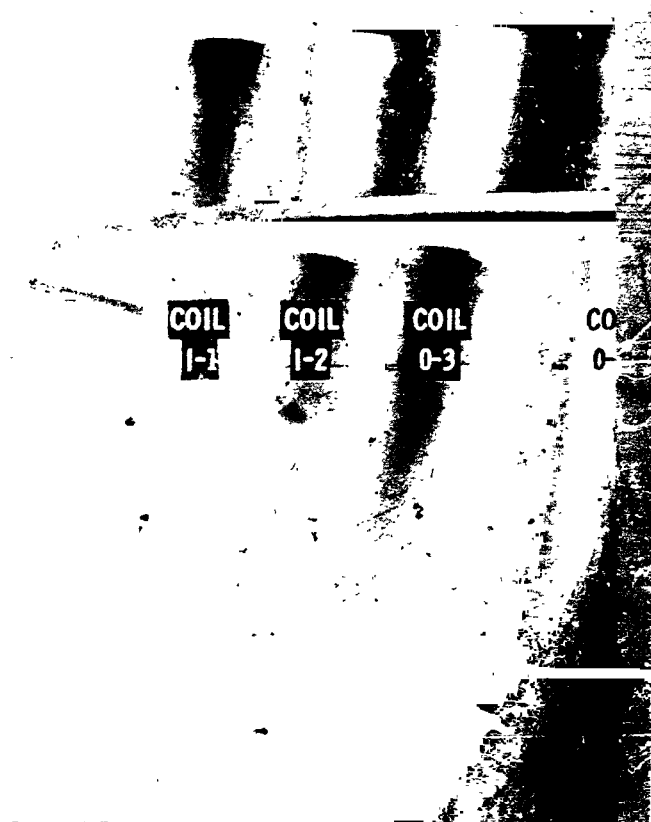
765-451

The cause of cracks near the end of the Hg inlet plug is obscure at present. The cause of cracks toward the Hg outlet end is apparently a pretest phenomenon, possibly resulting during tube manufacture. The cracks at a 5-1/2 in. radius tube bend at the Hg outlet manifold appear to have been caused by a pre-existing, excessively thin tube wall area resulting from tube ID-to-OD eccentricity produced during tube manufacture. This thin wall, combined with external surface decarburization and grain growth, 0.030 in. deep, produced circumferential expansion of the tube and enlargement of the tube diameter. Cracks in the tube wall resulted.

Hg TUBE SURFACE CRACKS AT 5 1/2 IN. R. BEN

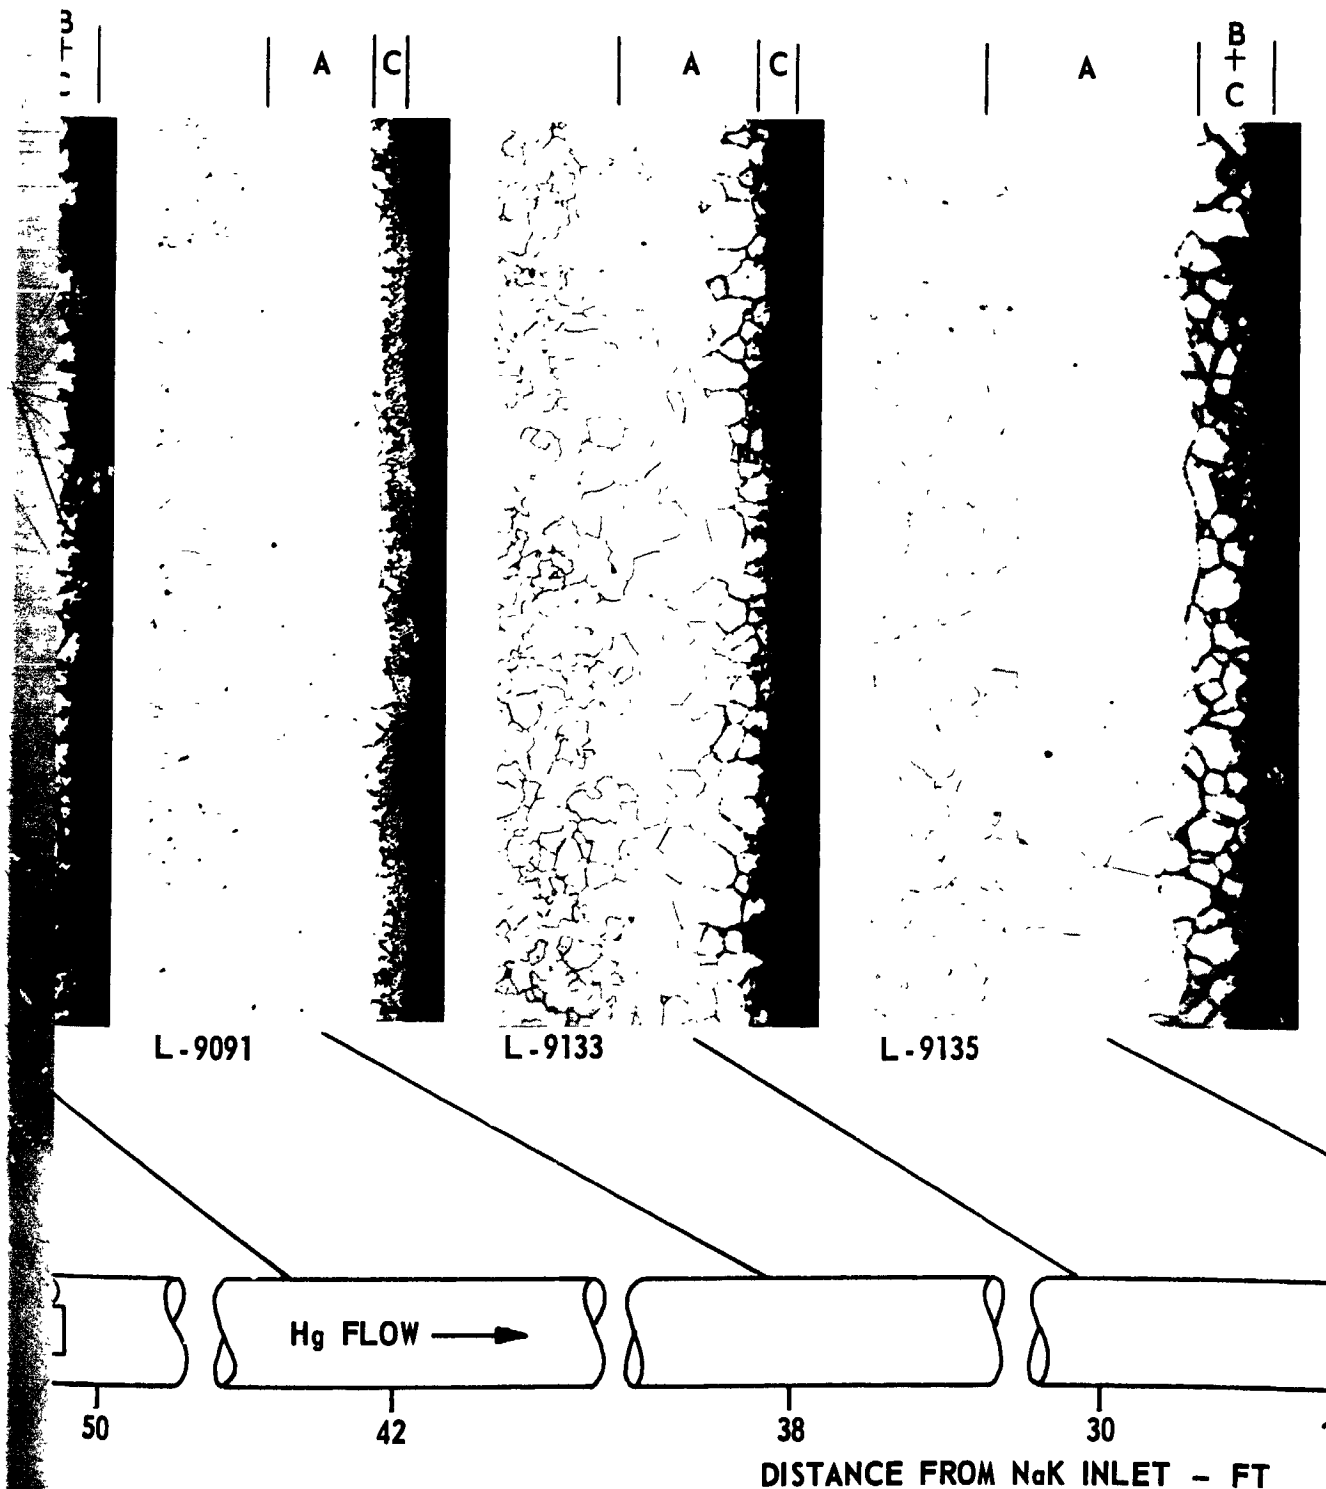
Microscopic examination of the NaK-exposed surface of the Hg containment tube revealed grain growth and concomitant decarburization (maximum approximately 0.030 in. deep), mass-transfer deposits (maximum approximately 0.002 in.), and tube cracking. The latter occurred at a 5-1/2 in. radius Hg tube bend at the Hg outlet manifold.

NaK-Exposed Surfaces of Hg Containment Coil No. O-4  
 After 2350 hr of NaK-Side Operation in RPL-2 (Vile:  
 All Areas Show Concomitant Decarburization and Grai.  
 The Former is Delineated at Higher Magnification.  
 Corrosion (Area B) and Mass-Transfer Deposits (Area  
 Present.

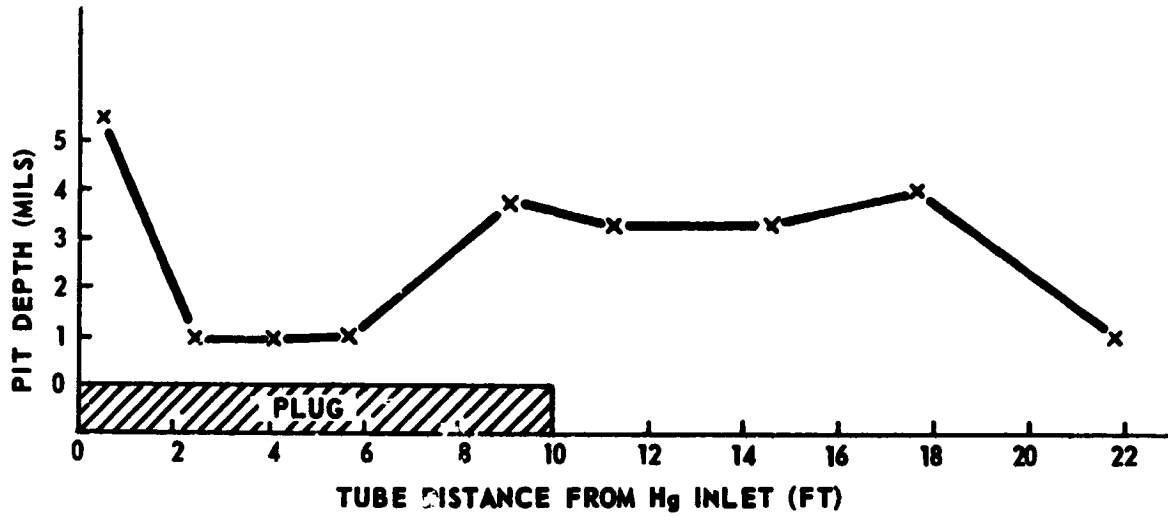
Figure 15

Macroscopic and microscopic examination of the Hg side of the tube revealed pitting (maximum depth, 0.0055 in.), mass-transfer (maximum height, 0.004 in.), unexplained surface decarburization toward the Hg outlet end, and surface cracking at various locations. The internal mild steel ribbon turbulator had collapsed during boiler operation, introducing possible flow discontinuities.

Distribution of Pit Depth of Mercury-Exposed Surface of Tube Coil  
No. 0-4 Removed from the -1 Boiler After 1415 hr of Operation in RPL-2

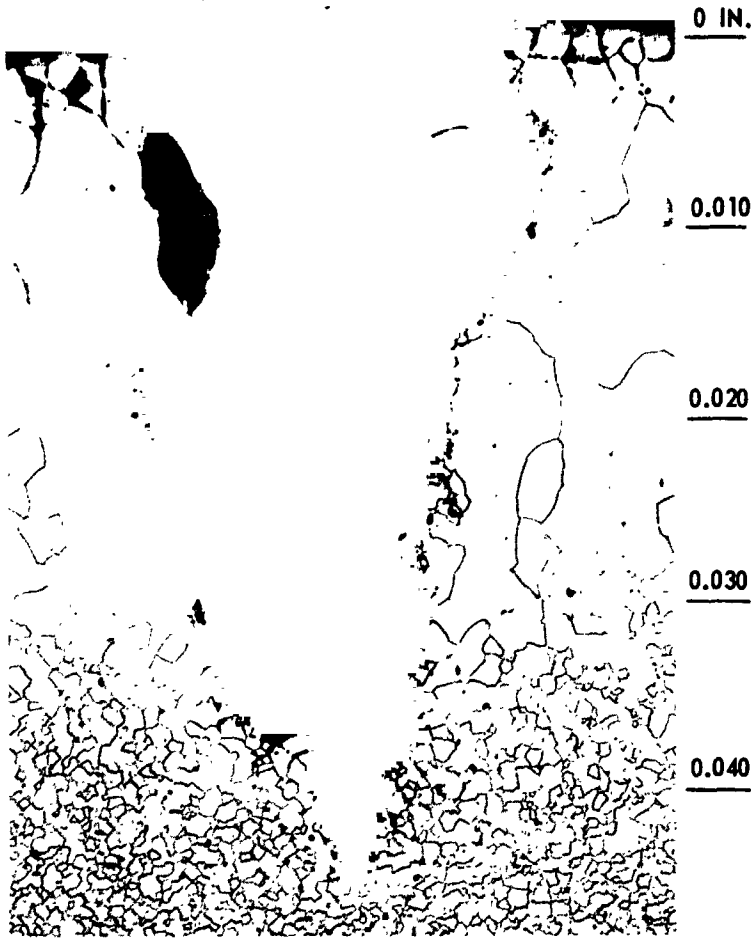
C. MAXIMUM EXTERNAL SURFACE (NaK SIDE) CRACK DEPTH AT SECTION A-A
