SATURN S-IB STAGE FINAL STATIC TEST REPORT

STAGE S-1B-4

SATURN S-1B STAGE
FINAL STATIC TEST REPORT
STAGE S-1B-4

FEBRUARY 25, 1966

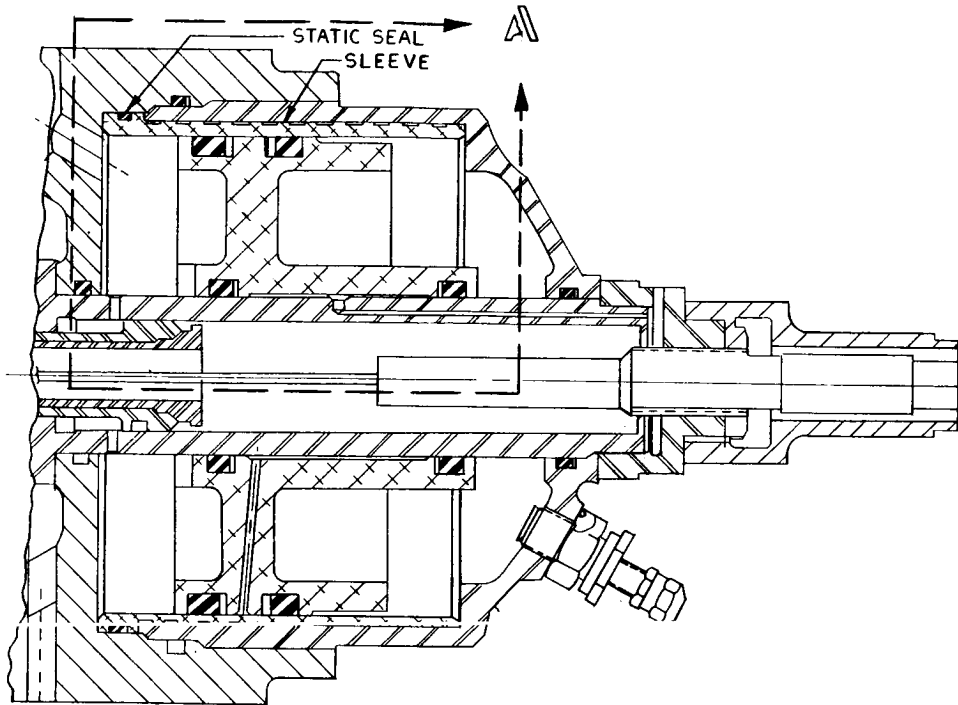
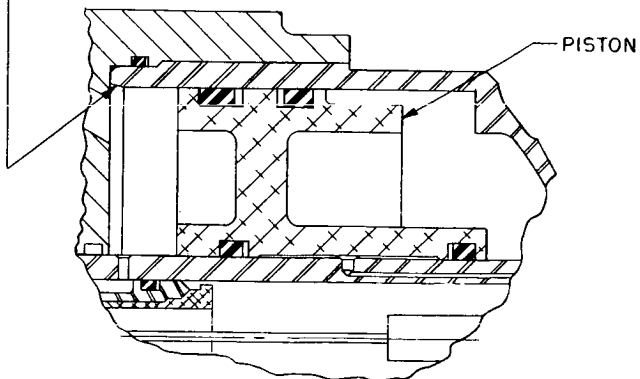
FIGURE 3-2
HYDRAULIC PACKAGE MODIFICATION

The problem experienced by the hydraulic package assembly (S/N 114) at engine 3 is believed to be identical to the problem experienced by S/N 140 hydraulic package assembly on engine 1 prior to test SA-32. Subsequent investigation at Michoud and at Cadillac Gage Company revealed that leakage had occurred past the static seal which is located between the accumulator sleeve and housing (see FIGURE 3-2). During these investigations, this type of leakage was duplicated on another hydraulic package assembly (S/N 116) by maintaining the package at 20°C for several hours and then precharging it rapidly (7 seconds) to 1,470 psig with GN₂. This leakage did not occur when this procedure was repeated with the precharge being applied slowly (several minutes). In light of this investigation, it is recommended that the accumulator sleeve be incorporated as an integral part of the housing, thus eliminating the static seal between the GN₂ and oil cavities (reference FIGURE 3-2) and that additional hydraulic system evaluation be conducted in an attempt to isolate causative malfunction factors.

The contamination in engines 1 and 3 hydraulic package assemblies (S/N 140 and 114, respectively) was found to be caused by the introduction of metallic particles to the system by the Vickers Auxiliary pump, by normal accumulator piston O-ring wear, and by MIL-I-8660 lubricant used when installing the accumulator piston into the sleeve. Because of the addition of metallic particles to the system by the Vickers auxiliary pumps an Engineering Order has been initiated to replace the Vickers pumps with Kellogg pumps on stages S-1B-9 and subsequent. If the effectivity of this Engineering Order cannot be changed to include earlier stages, an investigation of the result of such system contamination on performance and reliability should be instituted. Also, investigations should be conducted to determine if contamination caused by O-ring wear is detrimental to system operation, and to determine if the MIL-I-8660 lubricant can be eliminated by chamfering the accumulator housing (reference FIGURE 3-2).

CHAMFER TO BE LARGE ENOUGH SO THAT PISTON CAN BE INSTALLED
USING H-5606B RATHER THAN MIL-I-8660

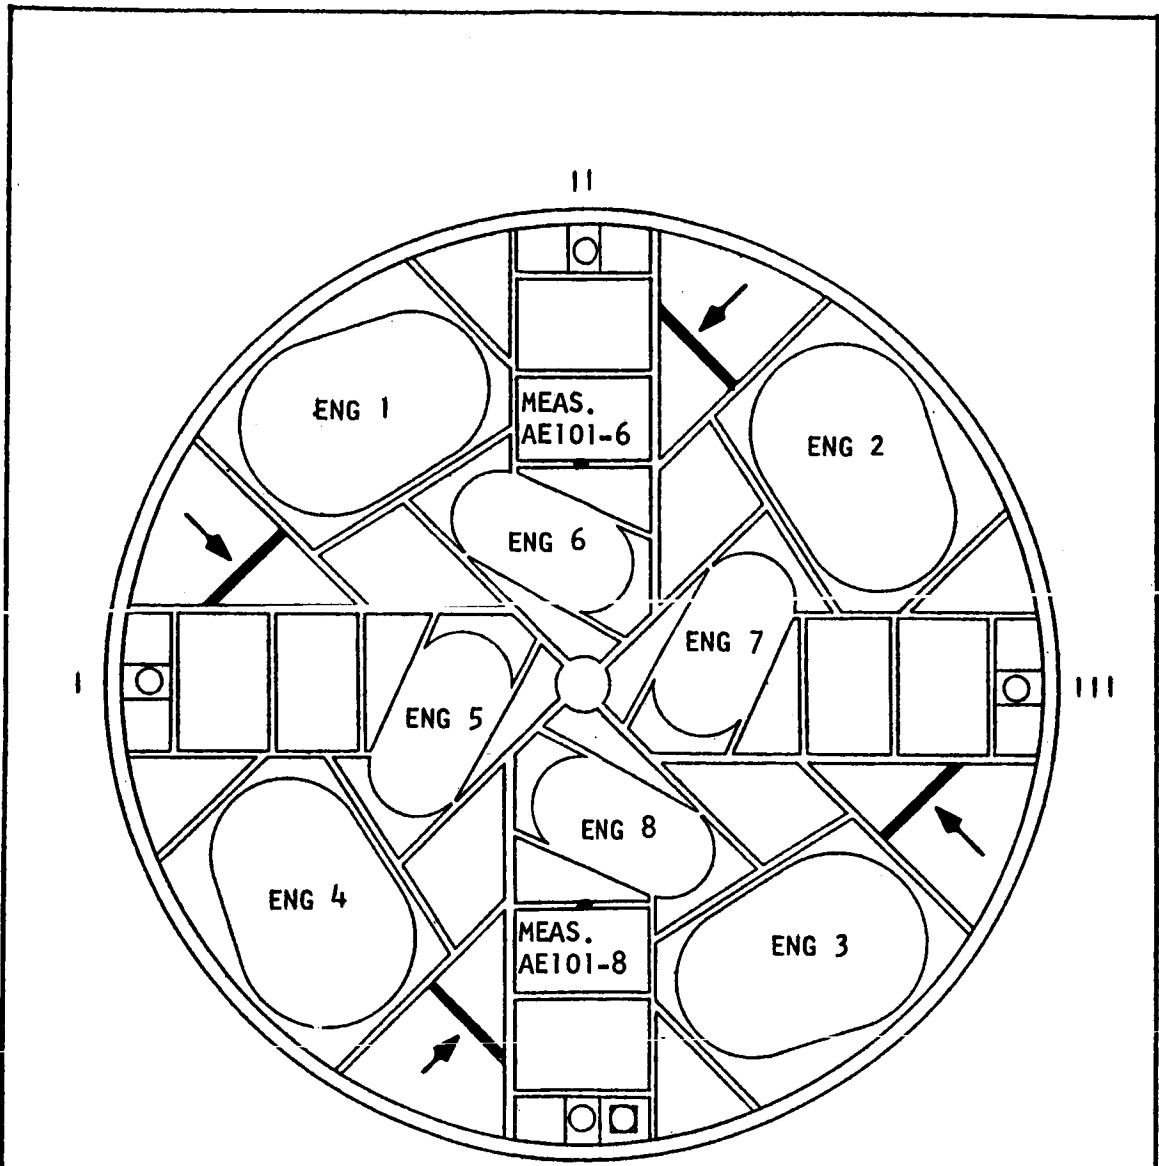
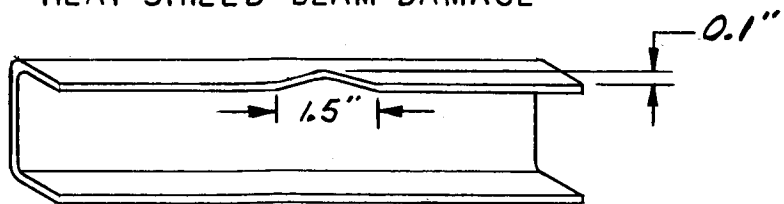
BEAM 60C30459-1
 MAXIMUM DISTORTION NOTED
 FIGURE 5-1

The heat shield support beams were instrumented to determine if excessive strains were present. There was no indication of damage following test SA-32. Boattail cameras, installed to determine the magnitude of heat shield beam movement, failed to give any useful data during test SA-32 due to failure of the camera light sources at ignition.

IV
 AFT LOOKING FORWARD
 HEAT SHIELD BEAM DAMAGE

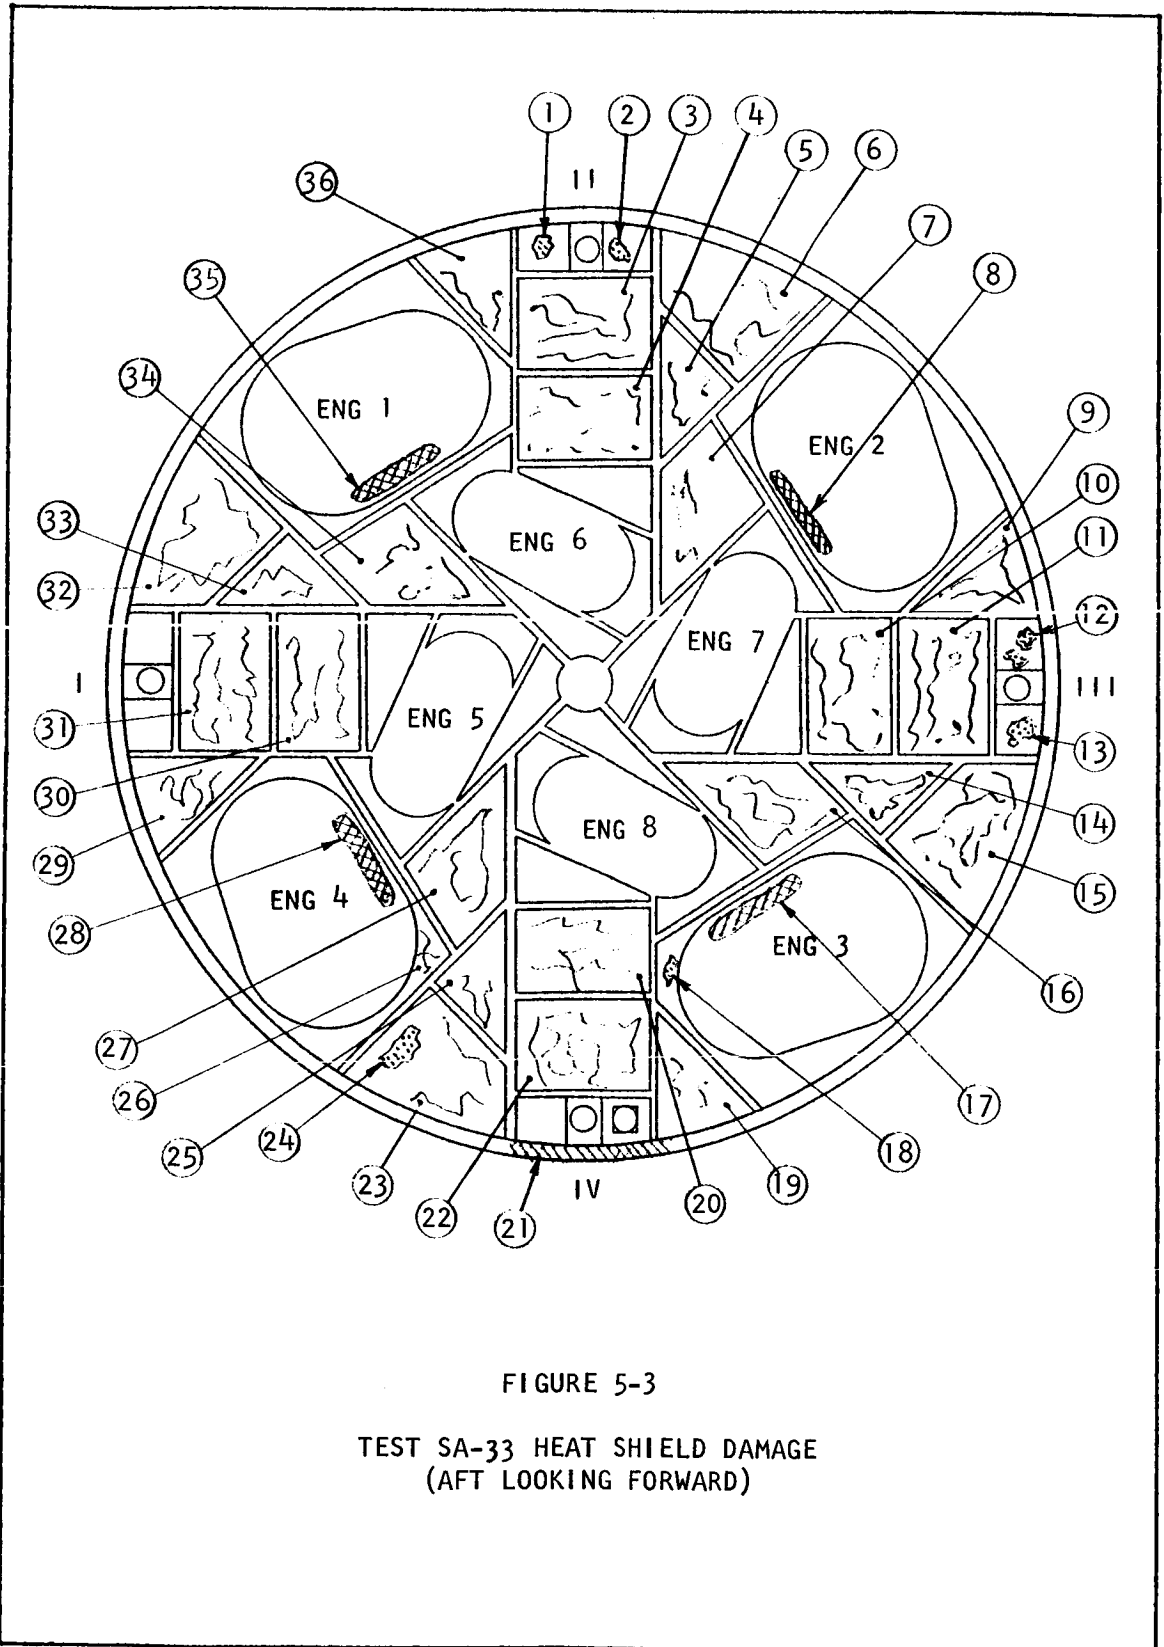
FIGURE 5-3

TEST SA-33 HEAT SHIELD DAMAGE
(AFT LOOKING FORWARD)
