SATURN S-IB STAGE

ASSEMBLY AND TEST REPORT

S-IB-1

SATURN
S-IB STAGE
ASSEMBLY AND TEST REPORT
S-IB-1

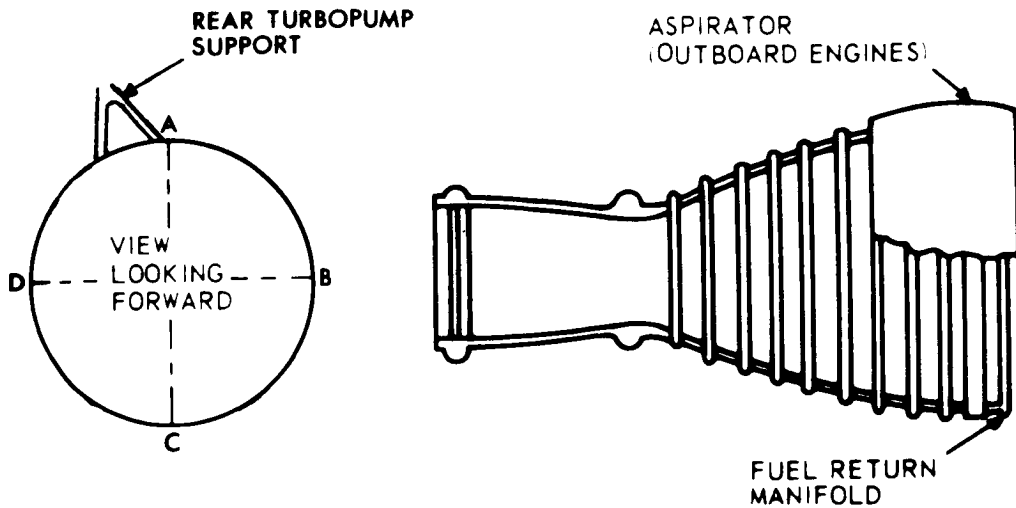
Figure 1-1. Thrust Chamber Tubing Damage Location Diagram

1.2.4.2 Thrust Chamber Damage Location. Table 1-4 contains the locations of damaged areas found during inspection, and as recorded on Defective Material Notices (DMN). The engine logbooks supplied with each engine should be consulted for locations of damage in addition to that listed in table 1-4. Figure 1-1 is a diagram of the thrust chambers and is used with table 1-4 for determining the exact location of damage.

Positions A, B, C, and D in figure 1-1 represent the location of drain ports in the fuel return manifold with position A referenced to the rear turbopump support. The Distance Forward column in table 1-4 provides the distance forward from the fuel return manifold to the internal area of damage on all engines and to the external area of damage on inboard engines. For location of external damage on outboard engines the distance forward is measured from the forward edge of the aspirator instead of the fuel return manifold. The Distance Around column in table 1-4 provides the distance from positions A, B, C, or D to the area of damage. To locate a damaged area using table 1-4 and figure 1-1 the following sequence must be used.

Pos.	Engine	Surface		Distance Forward (inches)	Distance Around (inches)	Remarks	Disposition (NASA)
		Int	Ext				
1	H-7046	X		3.20	3.25 off B to C	One dent 0.020 deep with sharp radius. Repaired. DMN M10604.	Accepted after repair
			X	3.00	14.5 off B to C	One dent 0.014 deep. DMN M10612-A	Use as is
2	H-7047	X		3.40	3.60 off C to D	One dent 0.012 deep. Repaired. DMN M10605, item 1	Accepted after repair
			X	2.30	9.90 off B to C	One dent 0.024 deep. Repaired. DMN M10605, item 2	Accepted after repair
3	H-7048	X		23.5	5.50 off A to B	One dent 0.025 deep. Repaired. DMN M10606	Accepted after repair
			X	4.00	3.75 off B to C	One dent 0.021 deep. Repaired. DMN M10609-A, item 1	Accepted after repair
			X	4.50	32.3 off B to C	One dent 0.014 deep. Repaired. DMN M10609-A, item 2	Accepted after repair
			X	2.88	5.00 off C to D	One dent 0.014 deep. Repaired. DMN M10609-A, item 3	Accepted after repair

Pos.	Engine Serial No.	Surface		Distance Forward (inches)	Distance Around (inches)	Remarks	Disposition (NASA)
		Int	Ext				
4	H-7049	X		66.5	1.65 off C to D	One dent 0.045 deep. Repaired. DMN M10607, item 1	Accepted after repair
		X		54.6	1.60 off C to D	One dent 0.021 deep. Repaired. DMN M10607, item 2	Accepted after repair
5	H-4044					No damage over tolerance was found	
6	H-4045		X	17.0	8.00 off D to C	One nick 0.034 deep. with sharp radius Repaired. DMN M07773-A	Accepted after repair
		X		63.0	2.25 off C to D	One dent 0.015 deep. DMN M10610-A, item 1	Use as is
		X		3.50	2.00 off C to D	One dent 0.017 deep. Repaired. DMN M10610-A, item 2	Accepted after repair
7	H-4052	X		19.0	3.50 off C to ?	One dent 0.038 deep. DMN M07530

Pos.	Engine Serial No.	Surface		Distance Forward (inches)	Distance Around (inches)	Remarks	Disposition (NASA)
		Int	Ext				
7	H-4052	X		71.0	13.0 off D to C 9.0 off C to D 11.0 off C to B	Erosion holes at forward end of tubes. Squawk K08360, items 18, 19, and 20	Accept
8	H-4047	X		62.0	1.50 off A to D	One dent 0.013 deep. DMN M10608-A, item 1	Use as is
		X		62.0	1.12 off A to D	One dent 0.016 deep. DMN M10608-A, item 2	Use as is
		X		4.75	On B	One dent 0.017 deep. Repaired. DMN M10608-A, item 3	Accepted after repair

All inspections for thrust chamber damage on engines were performed after static test of stage S-IB-1 and without removing engine combustion deposits. Undetected and unrecorded damage may be concealed by these deposits.
