SATURN STAGE S-1-8
FINAL STATIC TEST REPORT

by
J. K. Crawford
August 5, 1964

Chrysler Corporation Space Division
Huntsville, Alabama

This report describes the acceptance test firing of the Saturn flight stage S-1-8 conducted at the Static Test Tower East, Marshall Space Flight Center (MSFC), Huntsville, Alabama.

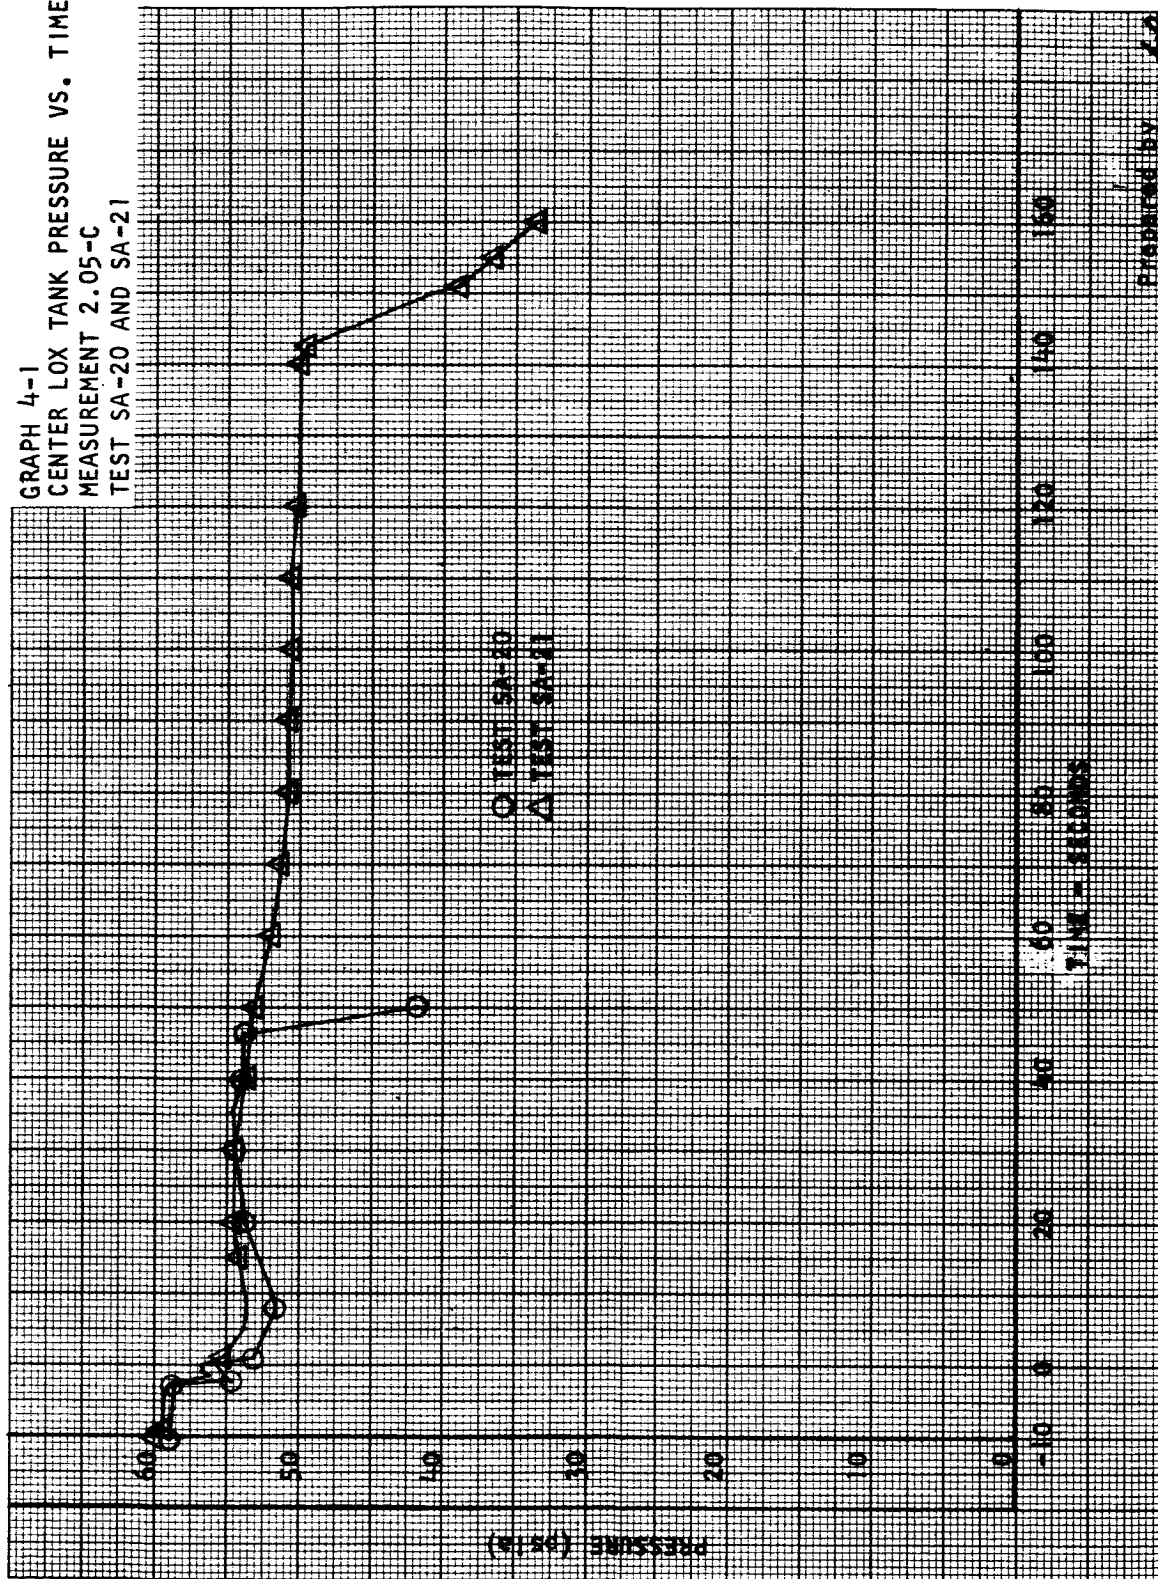
GRAPH 4-1
 CENTER LOX TANK PRESSURE VS. TIME
 MEASUREMENT 2.05-C
 TEST SA-20 AND SA-21

LOX tank pressure exceeded the specified limits of 50 ± 2.5 psia during tests SA-20 and SA-21 as it did during tests SA-18 and SA-19 of stage S-1-9. After test SA-20 ignition, LOX tank pressure decayed to 51.1 psia at X+9 seconds, then gradually increased and reached a maximum of 54 psia at X+30 seconds, after which time it slowly decayed to 52.7 psia at cutoff. Following ignition on test SA-21, LOX tank pressure dropped to 53.9 psia at X+9 seconds, then gradually increased to a maximum of 54.4 psia at X+28 seconds, after which time it slowly decayed to 49.9 psia at outboard engine cutoff signal. A plot of center LOX tank pressure (measurement 2.05-C) versus time for tests SA-20 and SA-21 is shown in GRAPH 4-1. Due to this recurring problem of LOX tank overpressurization, UCR CSD-S-00091 was written. This UCR recommends that further studies be initiated to determine whether the LOX-to-heat-exchanger orifices are too large, whether the closed stop setting on the GOX flow control valve (GFCV) is improper, or whether LOX tank overpressurization is caused by a combination of these factors. If this study indicates that the LOX pressurization system performance is satisfactory, it is recommended that the LOX system pressure specification be changed to comply with system performance. An additional factor to consider is that the GFCV did not go fully closed. This problem is discussed in the following paragraph.

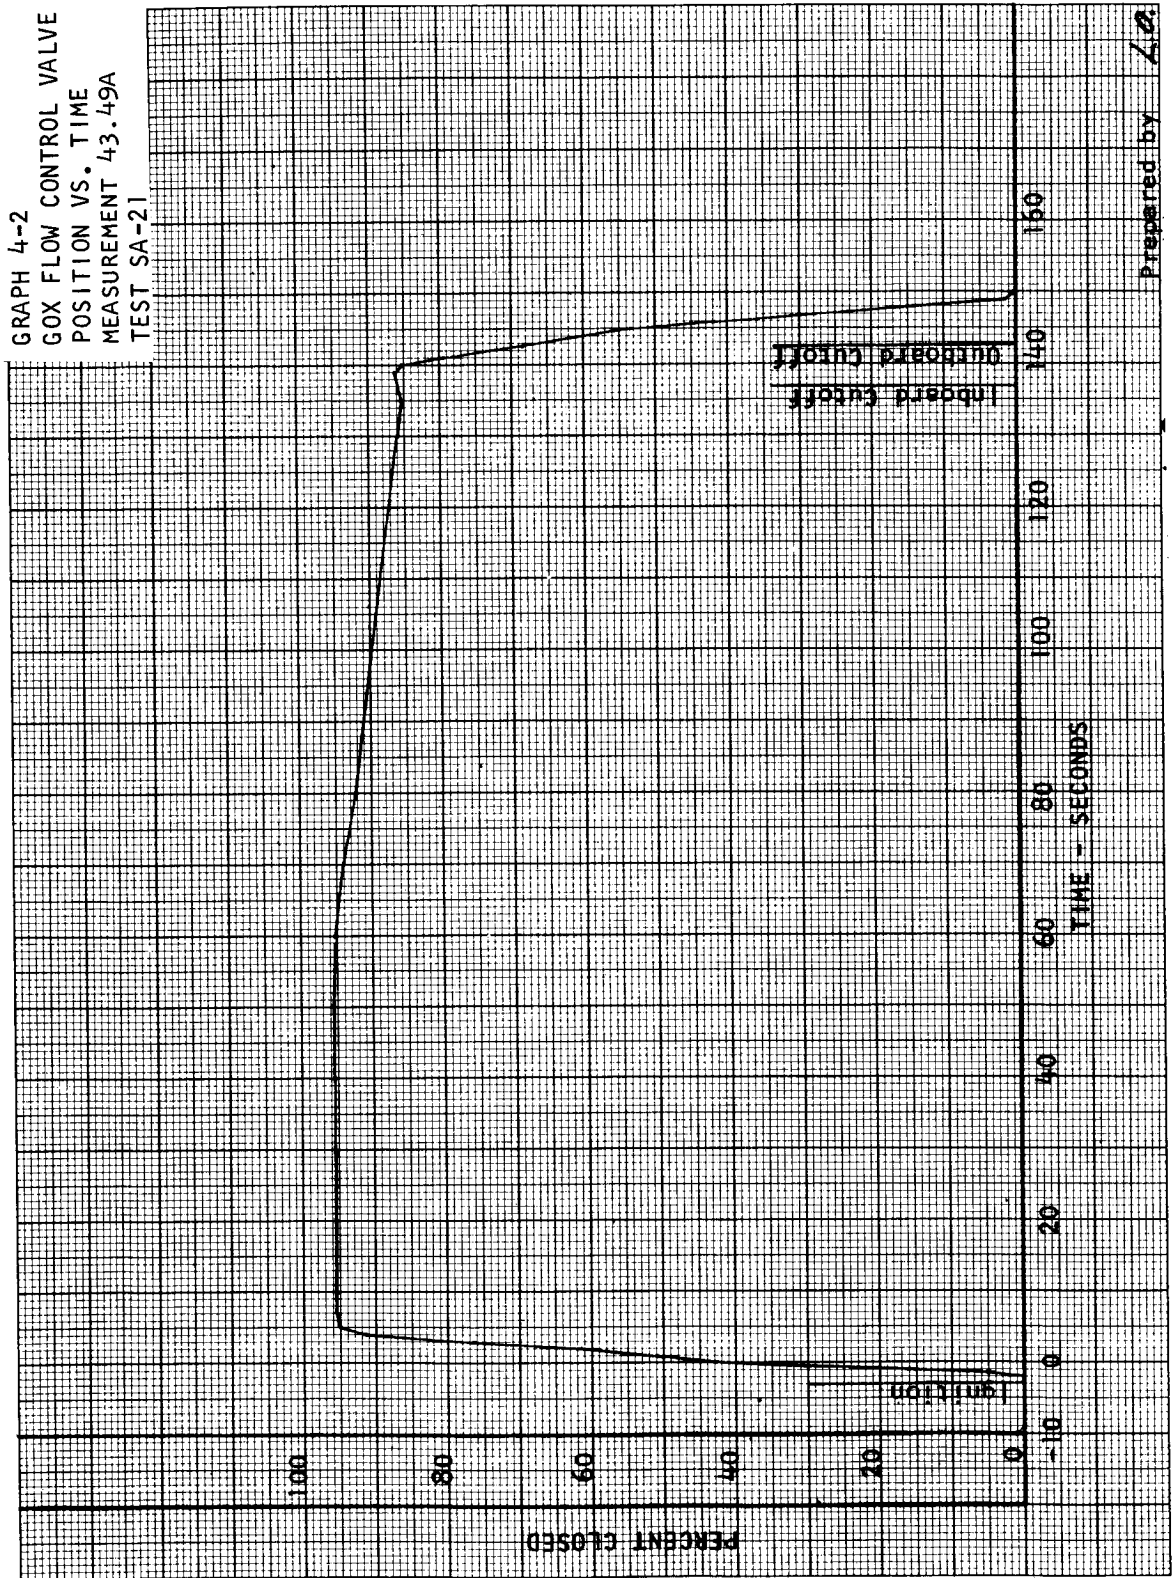
GRAPH 4-2
GOX FLOW CONTROL VALVE
POSITION VS. TIME
MEASUREMENT 43.49A
TEST SA-21

The GFCV position trace (measurement 43.49A) did not indicate that the GFCV reached the fully closed position during either test SA-20 or SA-21. The GFCV reached 98 percent closed and 96 percent closed during tests SA-20 and SA-21, respectively, and since the LOX tank pressure was above 52.5 psia, the GFCV should have been 100 percent closed (reference GRAPH 4-2). No cyclic movement of the GFCV gate was noted during either test. Similar indications of the GFCV not going fully closed were observed during the static tests for stages S-1-7 and S-1-9. During post-static checkout of both of these stages, the GFCV thrust bearings were inspected and found to be damaged. The indication of the GFCV not going fully closed tends to substantiate the theory that the thrust bearing of the valve is damaged. It was recommended in the Preliminary Static Test Reports for tests SA-20 and SA-21 that the GFCV on stage S-1-8 be inspected for thrust bearing damage during post-static
