CNLM-6031
QUARTERLY PROGRESS REPORT NO. 2
March 1, 1965 to July 2, 1965

INVESTIGATION OF CAVITATION DAMAGE OF A MECHANICAL
PUMP IMPELLER IN HIGH TEMPERATURE POTASSIUM

PRATT & WHITNEY AIRCRAFT DIVISION, UAC
CANEL - Middletown, Connecticut

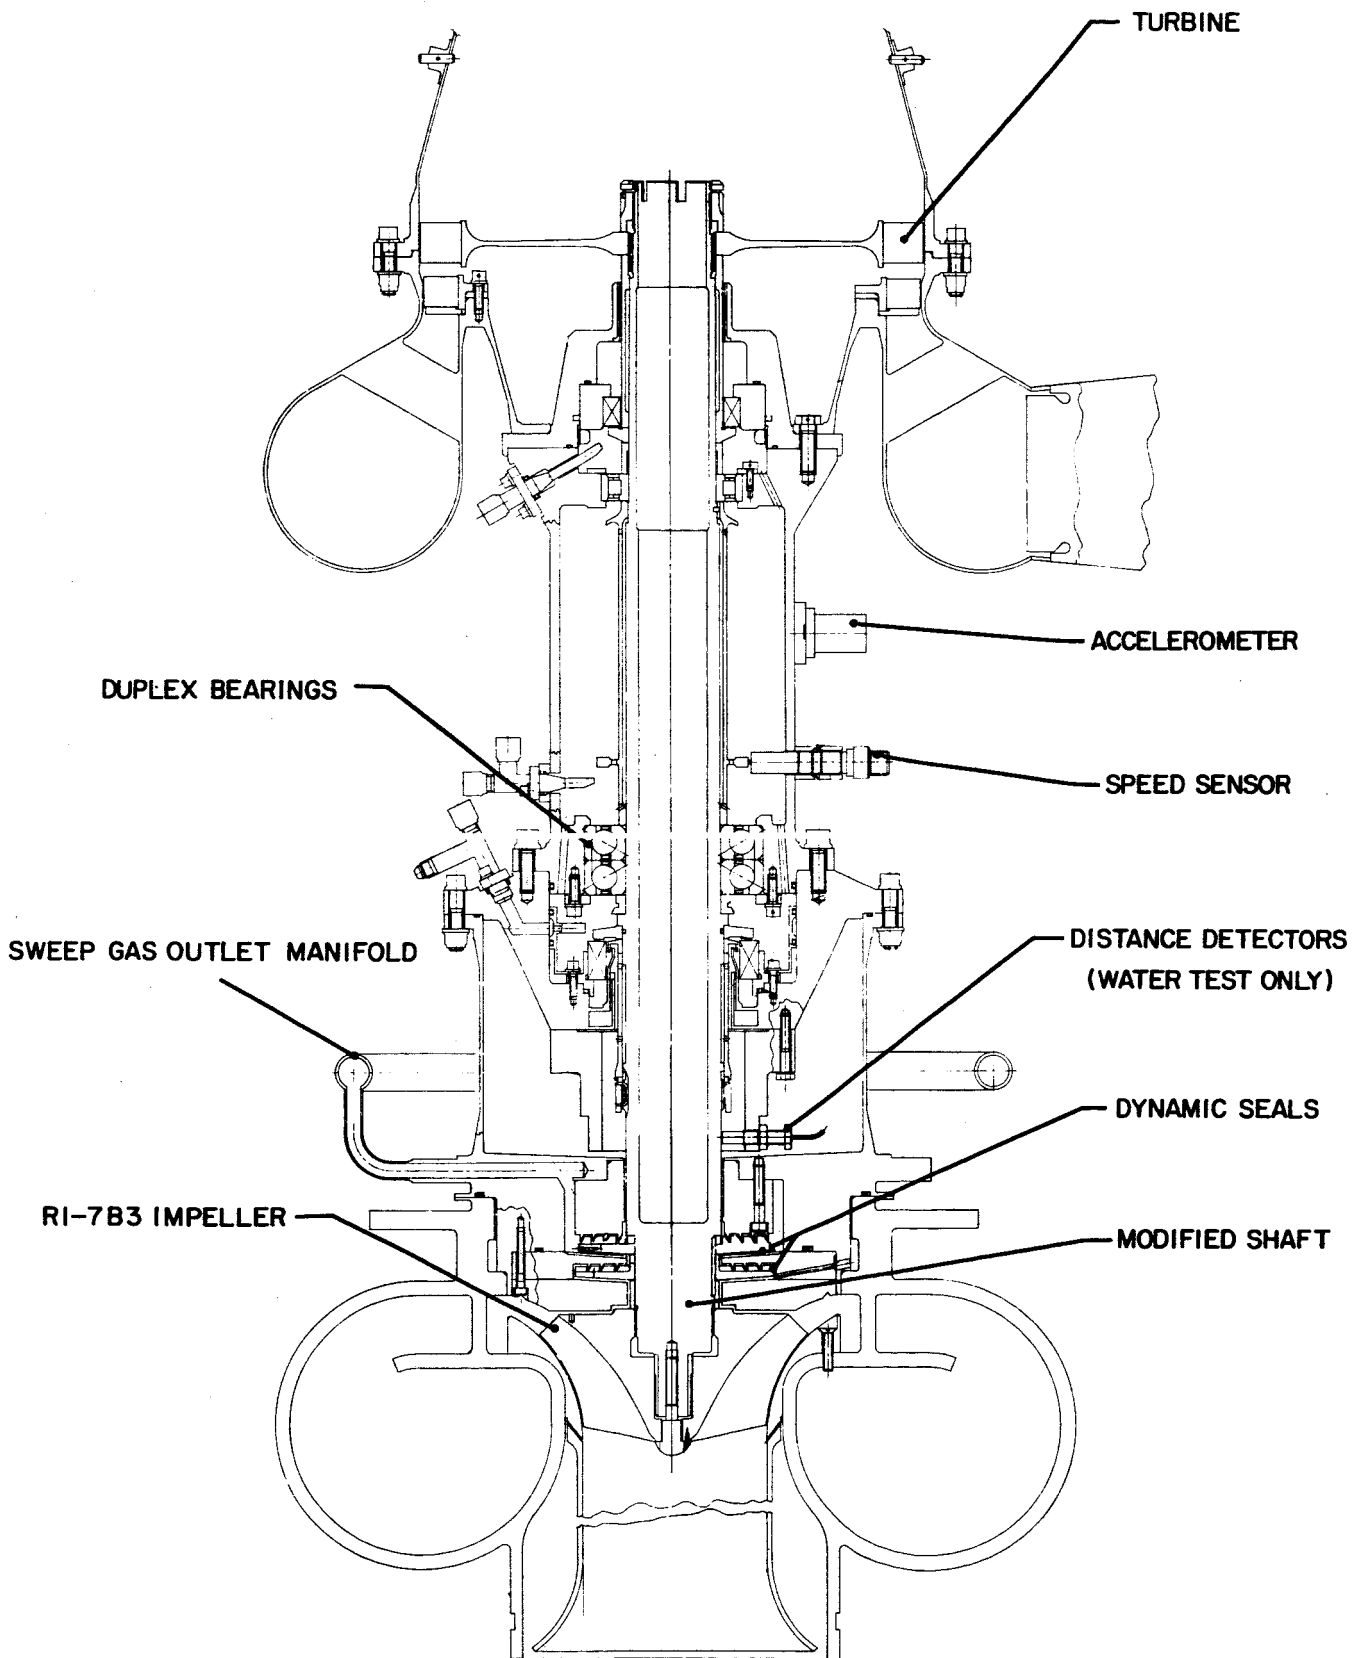
FIG 1

KP-1 TURBOPUMP DESIGN (FINAL)

Redesign of the turbopump shaft was considered necessary to strengthen the area most subject to high stress levels anticipated from radial forces on the impeller during operation in cavitation. The shaft to be used for this test was partially machined, and changes could be incorporated easily with no increase in costs or delay in time.

The specific changes to the shaft design are in the impeller attachment and dynamic seal area (see Fig. 1 and compare to Fig. 8 of Reference 1). The impeller end of the shaft was lengthened approximately two inches, and diameters in this area were increased. In place of an attachment bolt, as used in the earlier design, the shaft end was threaded and the impeller screwed on and locked by a small bolt. The increased diameter was carried through the dynamic seal area necessitating changes in the dimensions of these seals.

The instrumentation installed in the pump to detect dynamic shaft bending consists of four inductance type distance detectors placed 90 degrees apart (Fig. 1). The signal generated by the distance detectors sensing position of the rotating shaft was displayed on an oscilloscope and calibrated to give shaft movement in inches. Information on shaft displacement gained through this method was used to calculate the magnitude of the radial forces. It is presently considered that all causes of the rubbing contact of impeller and scroll experienced in the previous liquid metal test have been taken into account.

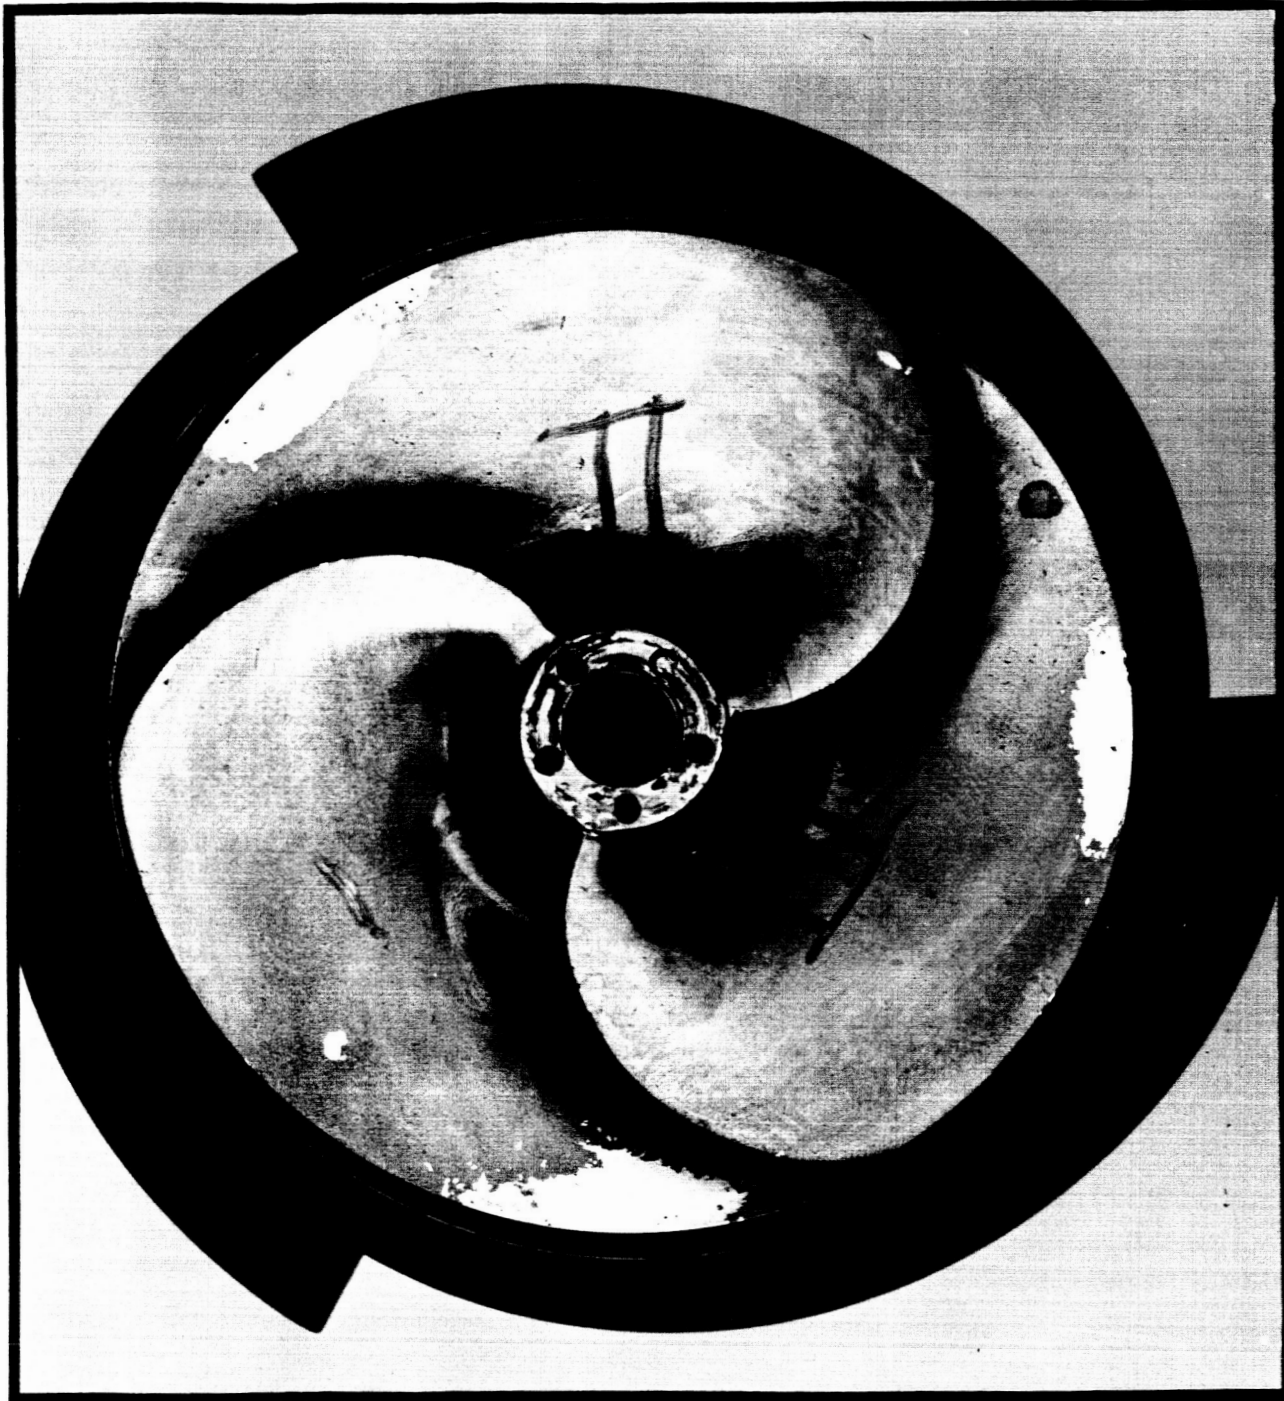
Photographs of the RI-7A3 and RI-7B3 impellers in cavitation at the same conditions and vane tip clearance are shown in Figures 4 and 5. The cavitation formations are identical. Figs. 6 and 7 show the paint removal patterns of the RI-7A3 and RI-7B3 impellers for the same conditions. The similarity of these patterns is quite evident.

RI-7A3 IMPELLER COATING DAMAGE PATTERNS AFTER 2 HOURS
AT AN NPSH OF 30 FEET AND 0.035-0.025 INCH
VANE TIP CLEARANCE (SUCTION SURFACES)

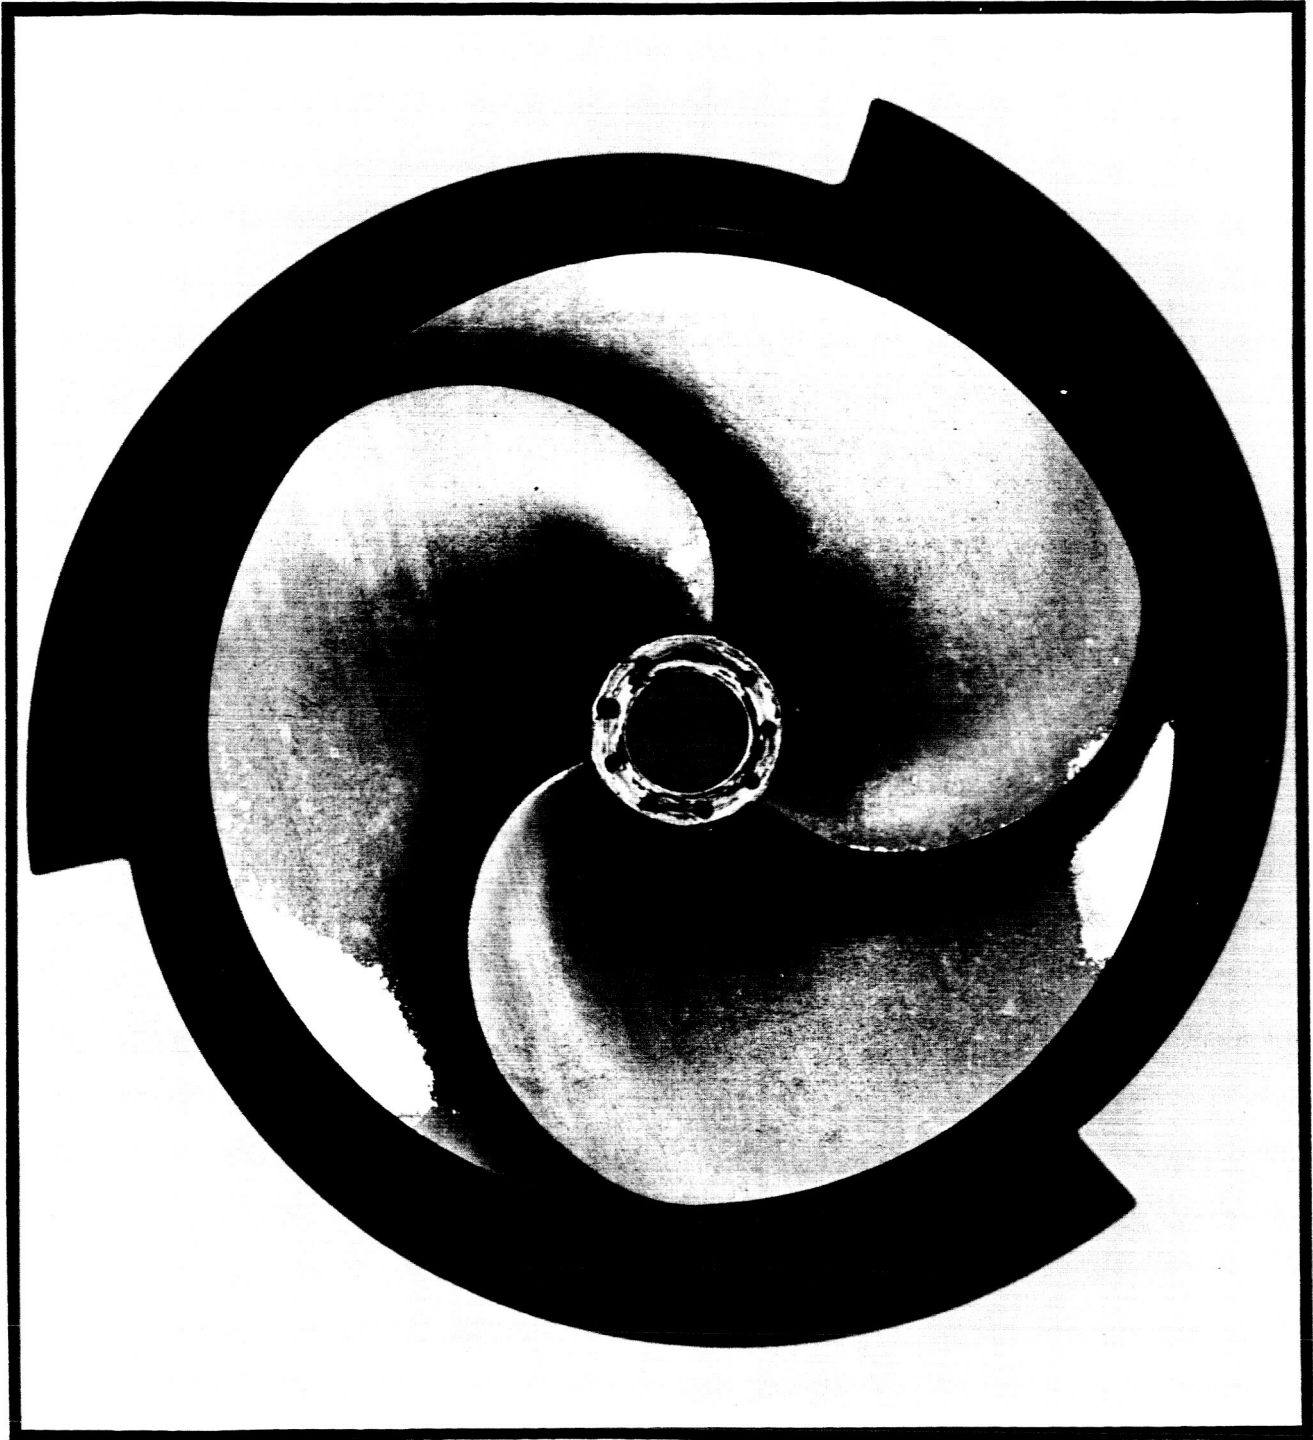
FIG 7

RI-7B3 IMPELLER COATING DAMAGE PATTERNS AFTER 2 HOURS
AT AN NPSH OF 30 FEET AND 0.035-0.025 INCH
VANE TIP CLEARANCE

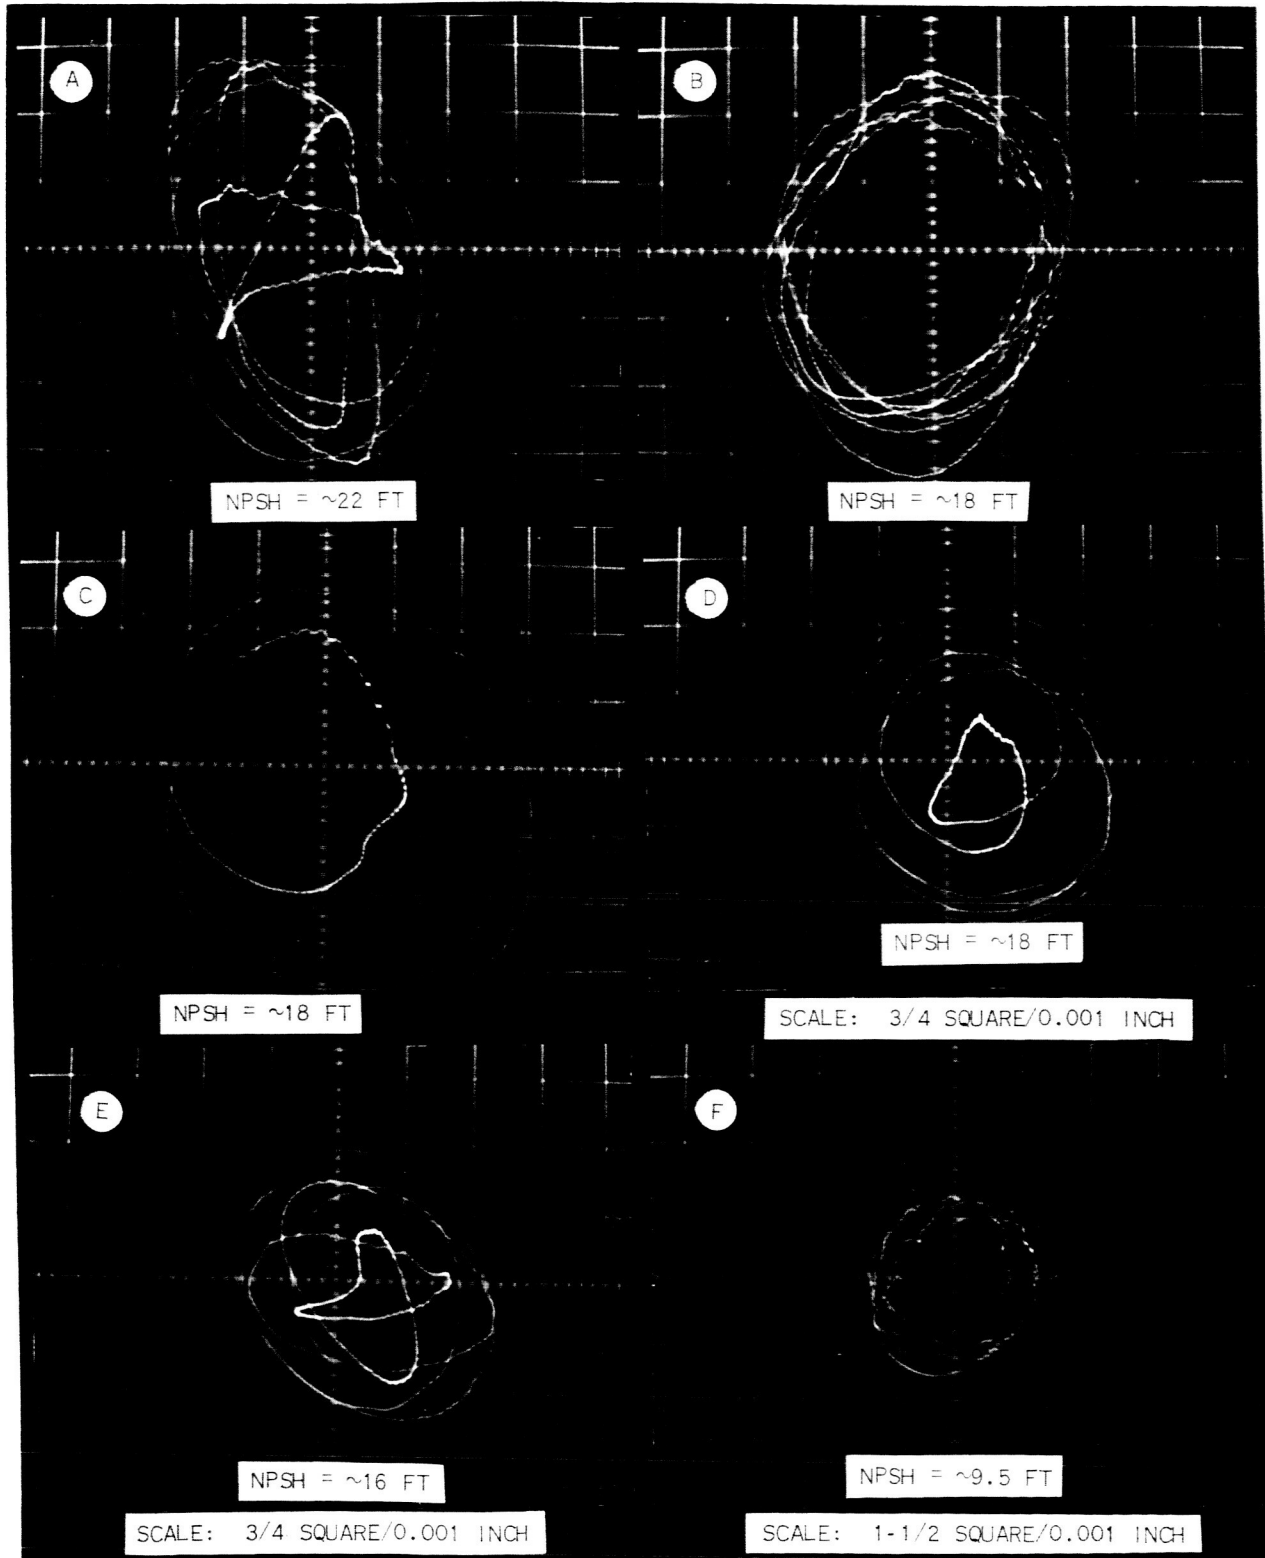
FIG 12

The oscilloscope traces of Fig. 12 show instabilities of the shaft position which are attributed to a relatively small, randomly applied hydraulic load at an NPSH value of 22 feet. When the NPSH value was decreased to 18 feet, oscillations occurred causing the trace to shift between Fig. 12B and Fig. 12C. These oscillations appeared to have approximately six seconds duration at each point. After about one minute, the trace stabilized to that of Fig. 12C and remained so for the duration of the time at this point. Fig. 12D is the same as Fig. 12C but with scale factor changed. Further decreases in NPSH values yielded the traces as shown in Figs. 12E and 12F.

Calculations based on the oscilloscope traces (and taking into account initial eccentricities and centrifugal forces due to imbalance) indicate radially applied hydraulic loads of about 150 pounds. Forces of this magnitude are quite capable of having caused the rubbing contact experienced during the liquid metal test described in Reference 3 (Final Report Under NASA Contract NAS3-2541).

OSCILLOSCOPE TRACES FROM DISTANCE DETECTORS

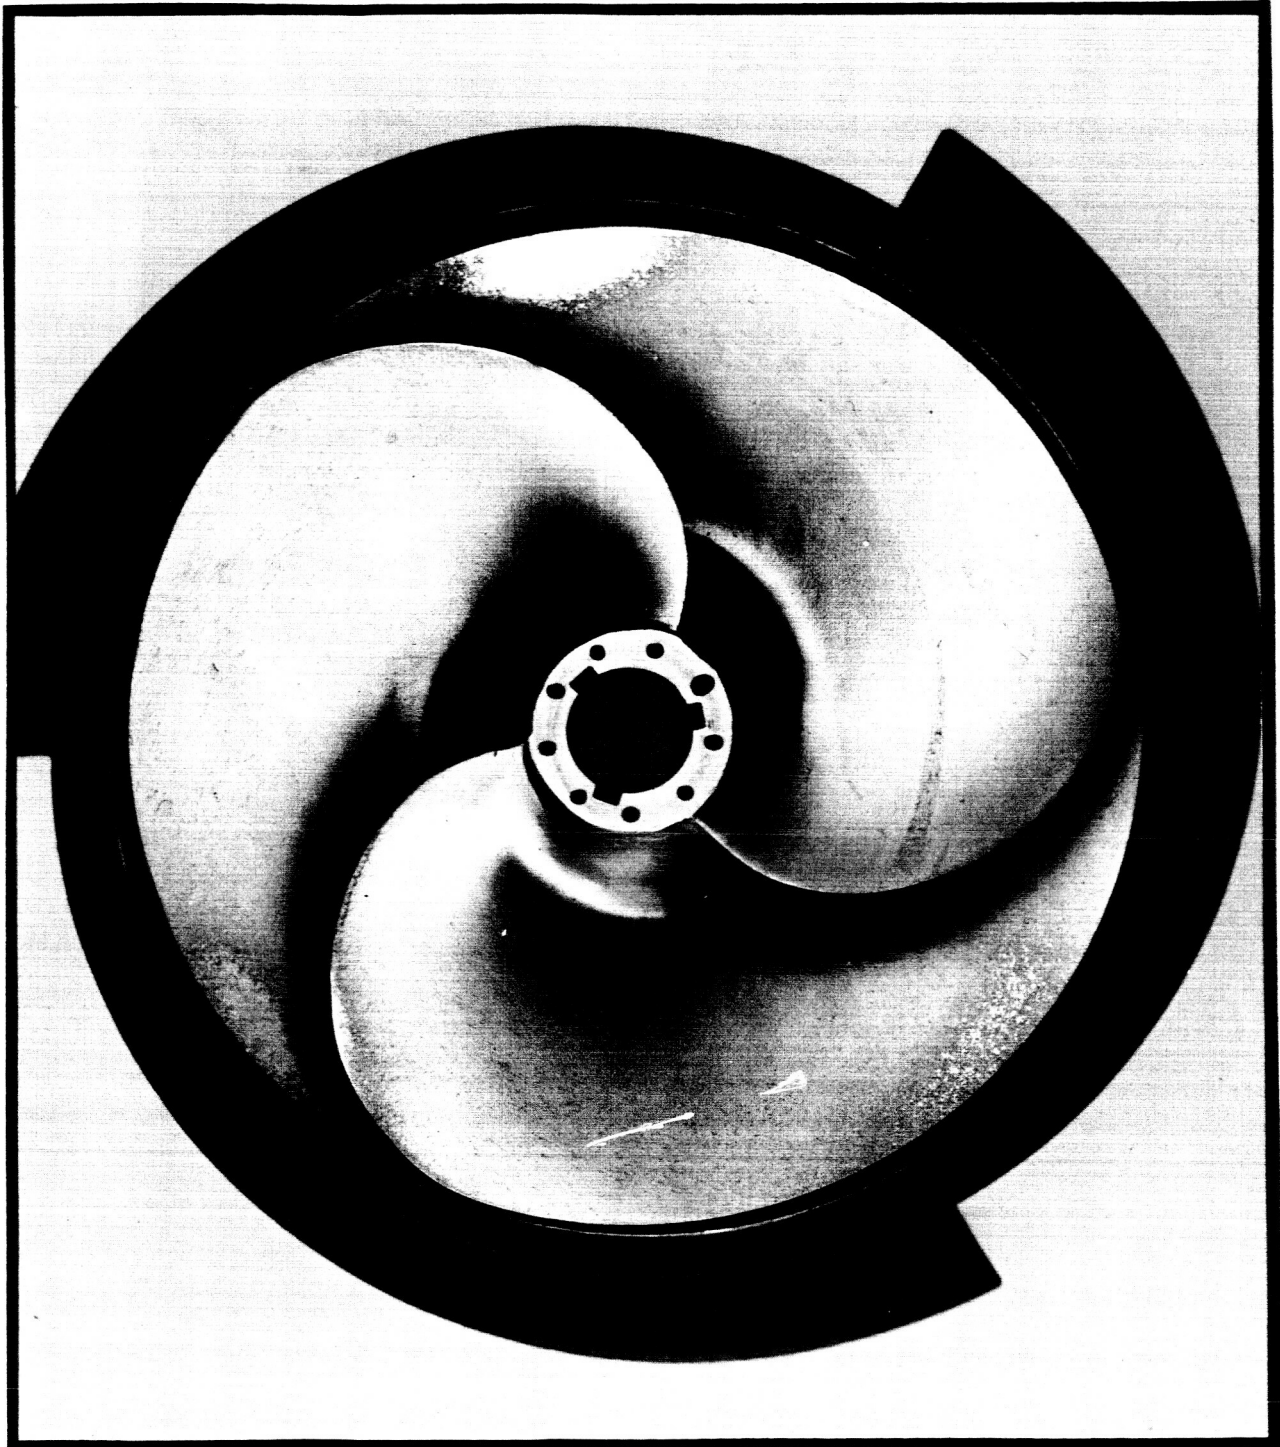
FIG 13

The KP-1 turbopump was removed from the test stand far enough to permit painting the impeller with gold colored acrylic lacquer. After the paint was thoroughly dry, the pump was reinstalled. Test conditions were set at a shaft speed of 6375 rpm, flow rate of 700 gpm and an NPSH value of 30 feet. After a two hour run at these conditions, the pump was removed and the impeller examined for paint removal patterns. These patterns, shown in Figs. 13 and 14, are very similar to those of the RI-7A3 impeller under the same conditions in the Impeller Water Test Stand (Reference 1, Figs. 57 and 58). It is concluded from this test that the cavitation pattern in the turbopump is slightly less intense than the impeller test but located in the same areas.

PAINT REMOVAL PATTERNS ON IMPELLER INLET
