OPERATION OF A FORCED CIRCULATION, HAYNES ALLOY NO. 25, MERCURY LOOP TO STUDY CORROSION PRODUCT SEPARATION TECHNIQUES

by David B. Cooper

Prepared under Contract No. NAS 5-462 by
THOMPSON RAMO WOOLDRIDGE, INC.
Cleveland, Ohio
for

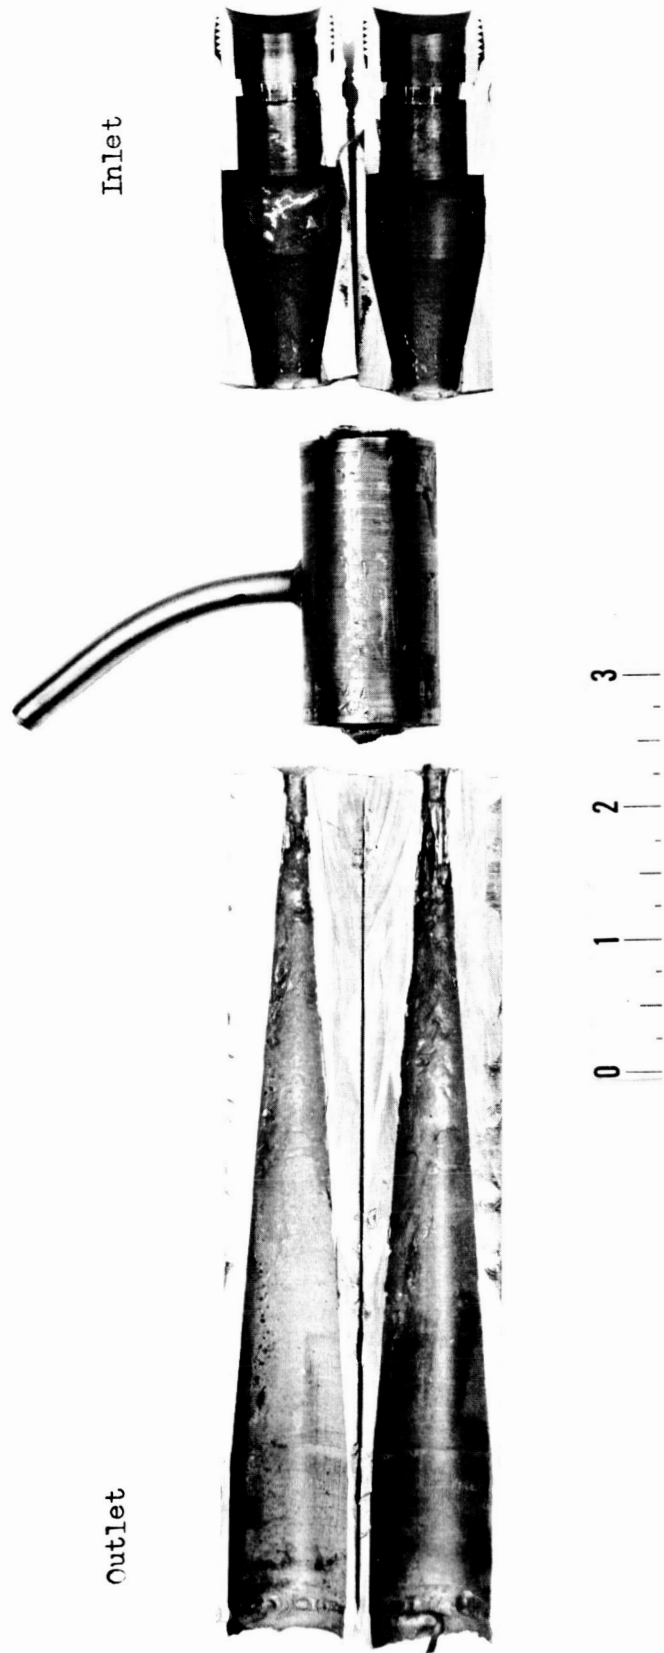
Figure 11. Deposition in Venturi.

As shown in Figures 11 and 12, the Venturi was found to contain an amalgam which was located on the outlet side in the vicinity of the orifice. The pre-heater (Sections 10, 11, and 12) also contained an amalgam, as shown in Figure 13. Photographs of the boiler are shown in Figure 14. As seen here, the boiler inlet contained a small quantity of a dark deposit while the mid-section and outlet again contained an amalgam. The amalgam extended into the superheater inlet, as shown in Figure 15. From this point on, as the mercury was dried and superheated, the quantity of deposit decreased until the superheater outlet was reached, where an amalgam was again present. The vapor corrosion product separator outlet tube and the superheater mid-section were essentially free of deposit, Figure 15.

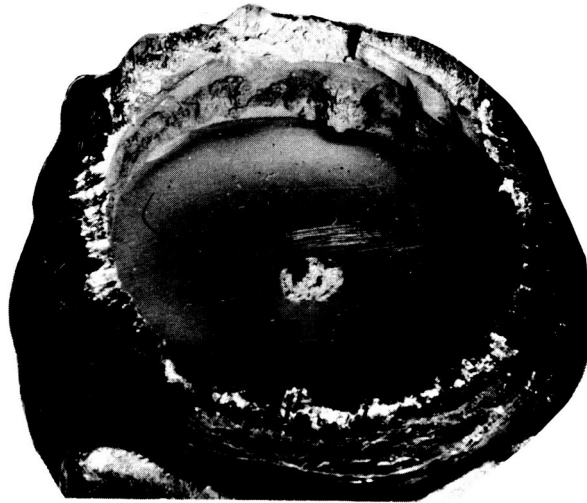
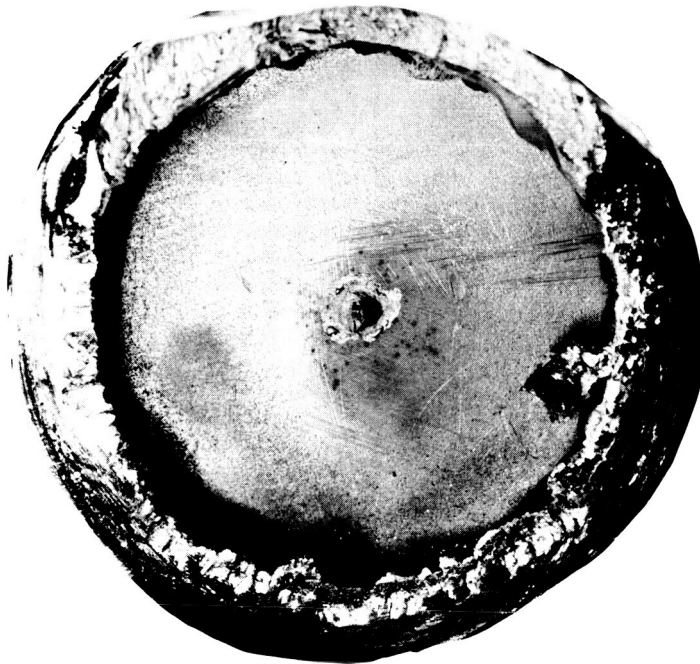
Figure 16. Deposit Found in Loop Orifice.

A hard deposit was found in the orifice and is shown in Figure 16. The deposit contained essentially no mercury and was blocking approximately 99.2 percent of the flow passage. The presence of this deposit accounts for the decrease in flow rate in the system during the final hours of operation. However, it is believed that the majority of this deposit was formed during the shut-down operation, since the change in flow rate did not reflect essentially complete blockage.

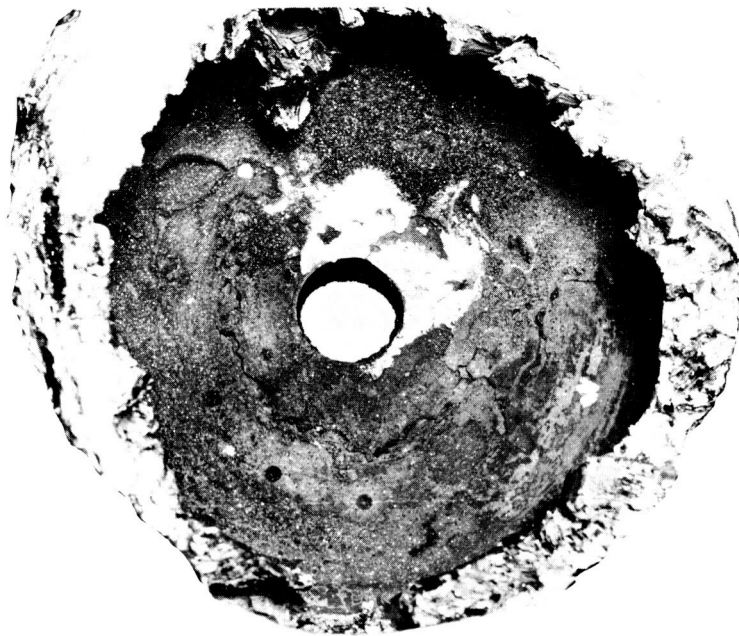
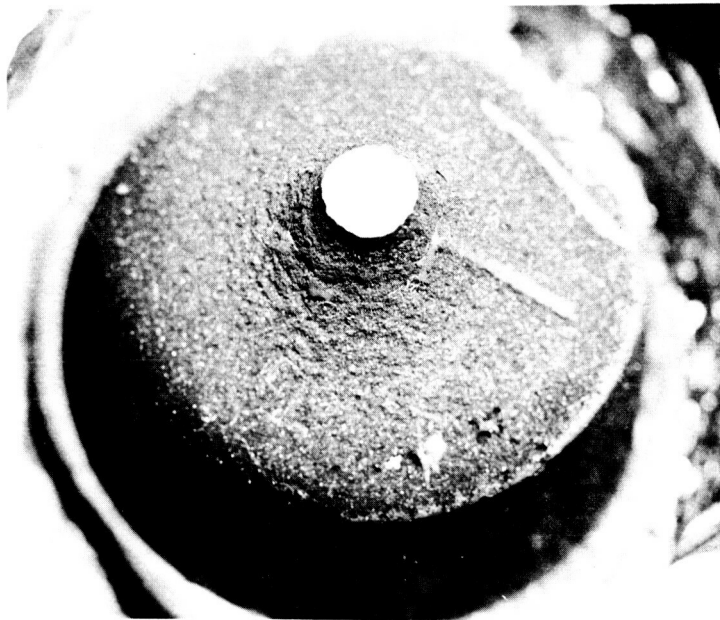
Figure 17. Deposit Found in Loop Nozzle.

The nozzle was also observed to contain a deposit, as shown in Figure 17. Although there was a small amount of deposition on the inlet side, the majority of the deposit was found on the outlet.

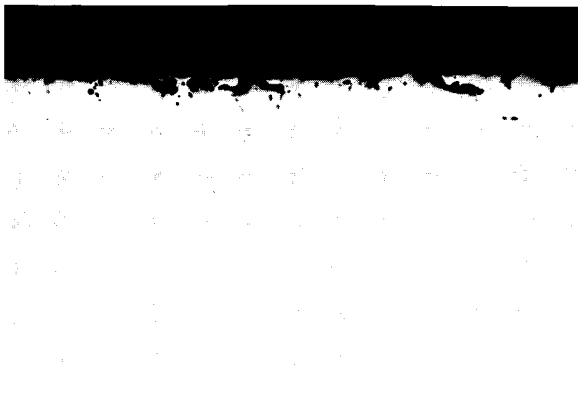
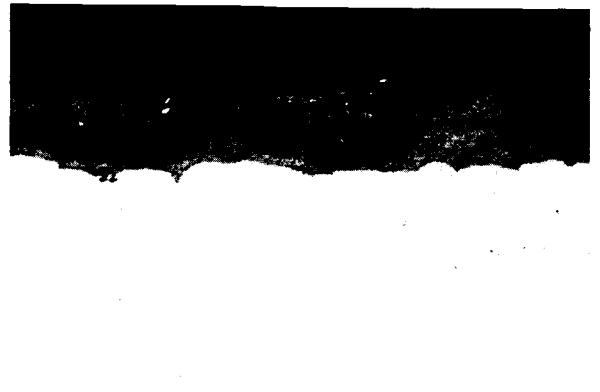
a) Section 12, TC 2 Pre-Heater Inlet (Crevice Attack)

b) Section 10, TC 6 Pre-Heater Outlet (Layer Attack)

Corrosion in the horizontal pre-heater inlet section of the loop was manifested as crevice attack up to 1.85 mils deep. A typical photomicrograph is shown in Figure 20a. The average wall temperature at this section was measured at 838°F. Swirl wire attack was less severe, 0.55 mils, Figure 23a and Table 3. The attack was similar to the container wall attack (i.e., crevice type).

The pre-heater outlet section suffered the most serious attack observed in the loop (see Figure 20b), and was as great as 10 mils in the 1106°F region, Table 2. Attack was of the leached zone type. Swirl wire attack was again considerably less severe (2.8 mils) than the corresponding wall attack and is represented by Figure 23b.

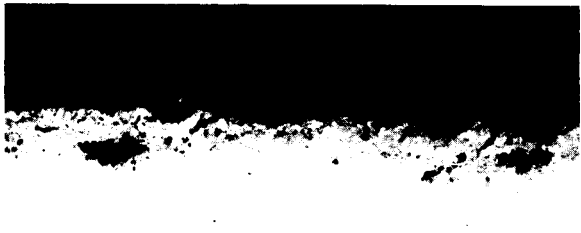
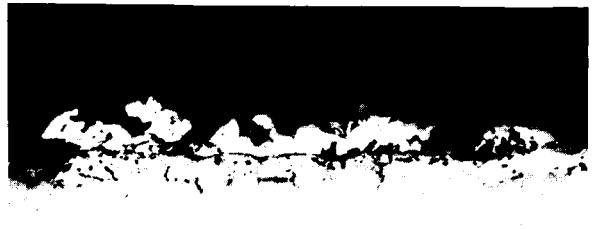
c) Section 8, TC 8 Boiler Inlet (Layer Attack)

d) Section 7, TC 9 Boiler Mid-Section (Deposition and Layer and Intergranular Attack)

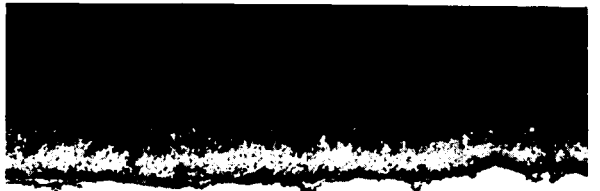
e) Section 7, TC 10 Boiler Mid-Section (Layer Attack)

f) Section 6, TC 12 Boiler Outlet (Layer Attack)

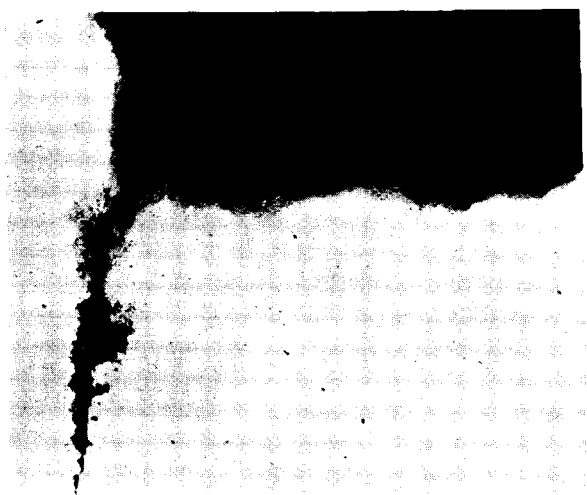
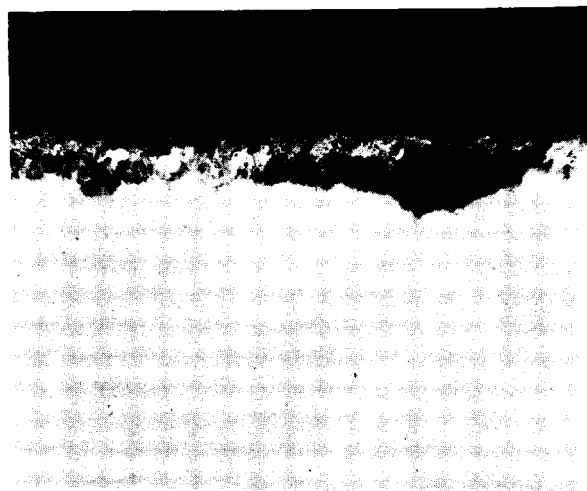
a) Section 5, TC 14
Weld; Superheater Inlet
(Layer Attack)

b) Section 5, TC 14
Superheater Inlet
(Layer Attack)

Haynes alloy No. 25 fusion welds appeared to be unattacked in all cases except in the vapor section (No. 5) of the boiler. Corrosion was present at the weld and in the crack, Figure 21a. Corrosion was manifested as a depleted layer.

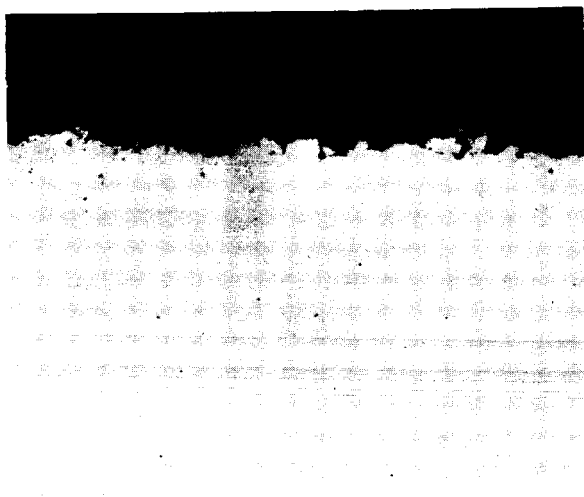
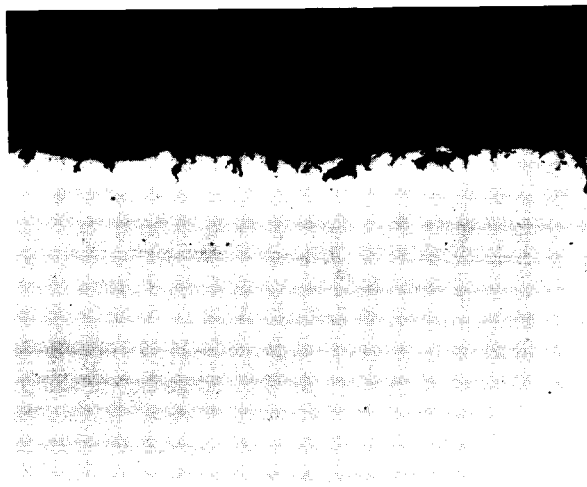
c) Section 5, TC 17
Superheater Inlet
(Crevice Attack)

d) Vapor Corrosion Product
Separator Filter Tube
(Crevice and Intergranular Attack)

The vapor corrosion product separator was attacked to a depth of 1.9 mils in the 1130°F temperature zone. Corrosion was manifested as both intergranular and leached layer attack (see Figure 21d). Attack diminished to 1.1 mils penetration in the superheater mid-section as vapor quality improved, Figure 22a. Corrosion was of the crevice type. In the last quarter of the superheater (outlet), a substantial deposit was observed, Figure 22b. The maximum thickness of this deposit was seven mils. Swirl wire attack in the vapor portion of the loop generally was of the intergranular type and varied between 0.3 and 1.35 mils, Figures 23e and 24b and Table 3. Only the Haynes alloy No. 25 swirl wire in the vapor region contained cracks as contrasted to the lack of cracking in the liquid-contacted sections, Figure 24. The swirl wire was cold-worked as a result of swirl forming.

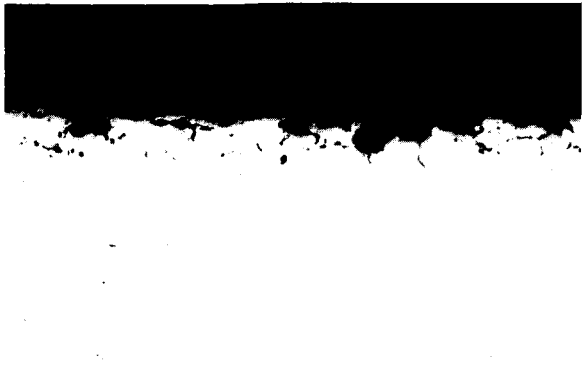
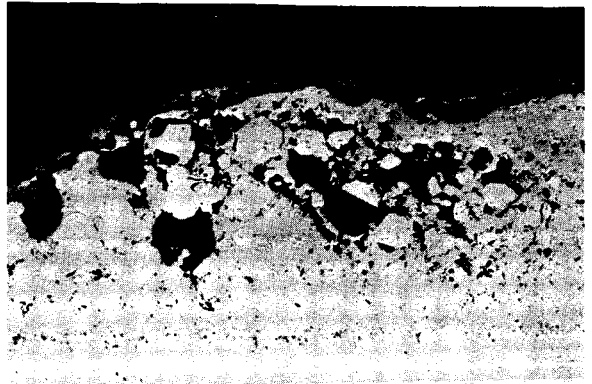
a) Section 2, TC 25
Superheater Mid-Section
(Crevice Attack)

b) Section 1, TC 27
Superheater Outlet
(Deposition)

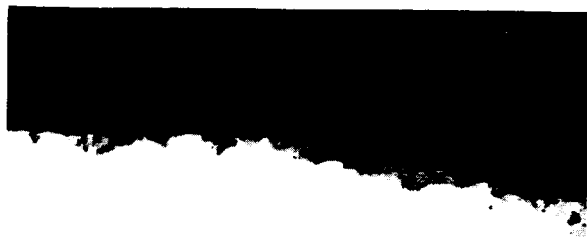
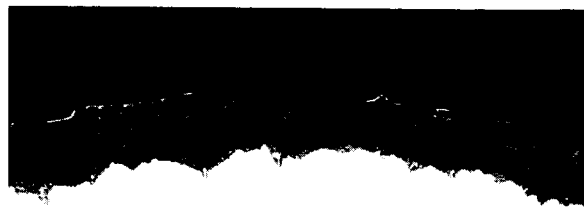
a) Section 12
Pre-Heater Inlet
(Crevice and Layer Attack)

b) Section 11
Pre-Heater Mid-Section
(Layer Attack)

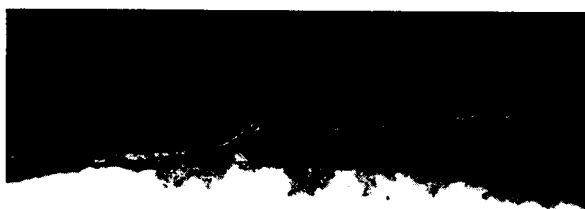
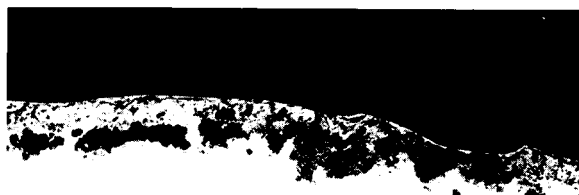
c) Section 8
Boiler Inlet
(Layer Attack)

d) Section 7
Boiler Mid-Section
(Layer and Intergranular Attack)

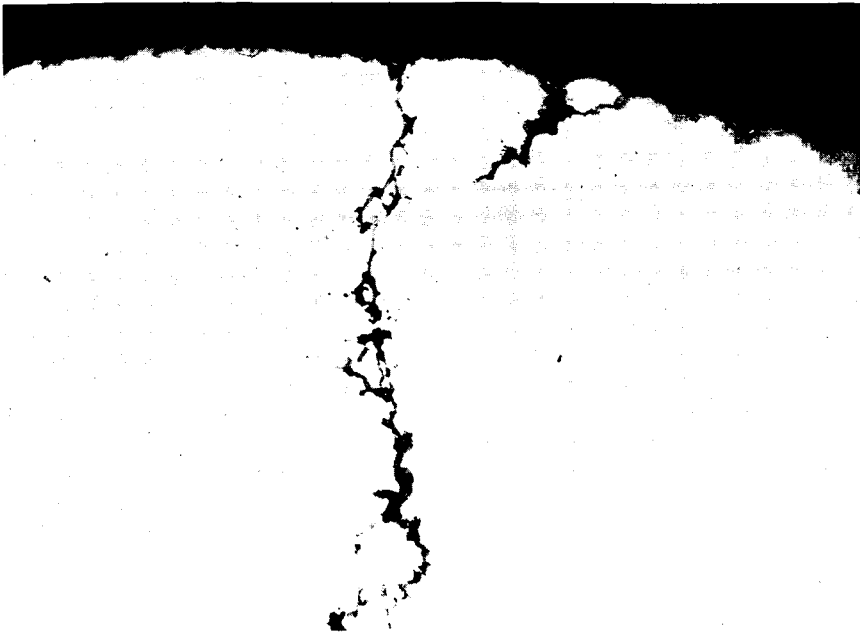
a) Section 6
Boiler Outlet
(Cracking and Layer
and Crevice Attack)

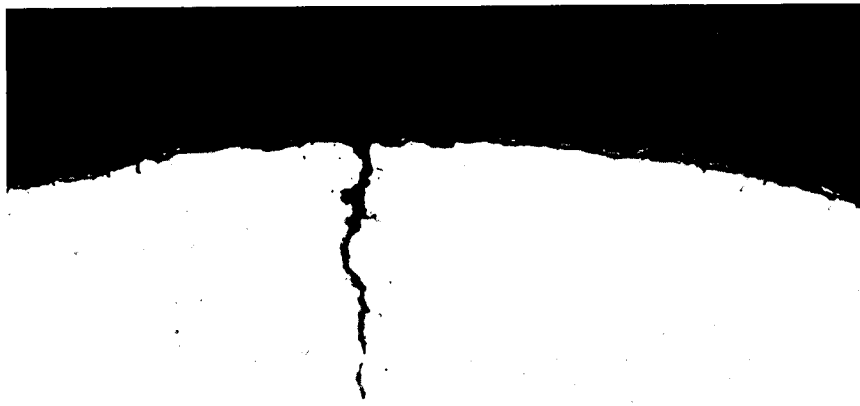
b) Section 2
Superheater Mid-Section
(Cracking and Intergranular Attack)

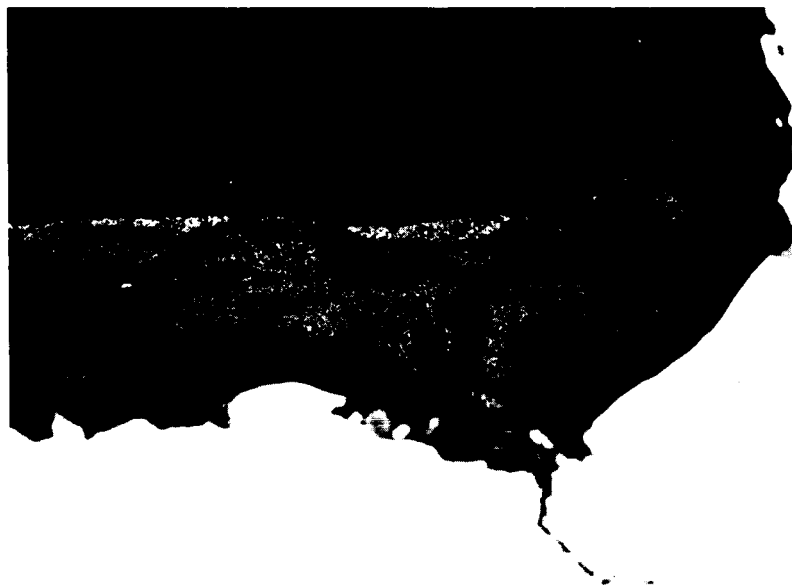
b) At Tube-Orifice Plate Junction

Figure 26. Cross-Section of Orifice on Inlet Side Showing Intergranular Attack Near Orifice Opening and a Leached Layer and Cracking at the Orifice Plate-Tube Junction. Magnification: 250X, Unetched.

Orifice corrosion was greatest on the inlet side near the wall and measured 7.3 mils in depth, Figure 25. Cracking was also observed at the orifice plate-tube wall junction, Figure 26b. Corrosion up to 1.1 mils in depth was also present on the orifice opening, Figure 26a. The corrosion was manifested as both layer and intergranular attack. The outlet side of the orifice contained deposits which adhered to the orifice wall. The attack was undoubtedly a result of mercury vapor condensation on the orifice plate, since immersion thermocouples recorded 796 and 867°F as the respective inlet and outlet temperatures. The severity of the attack could also be a result of erosive action by the condensing mercury vapor, which is not readily separable from corrosive attack.

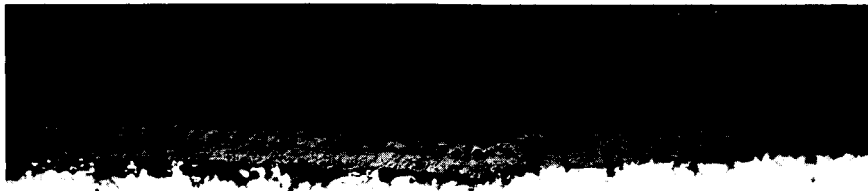
a) Inlet Side Oxidation

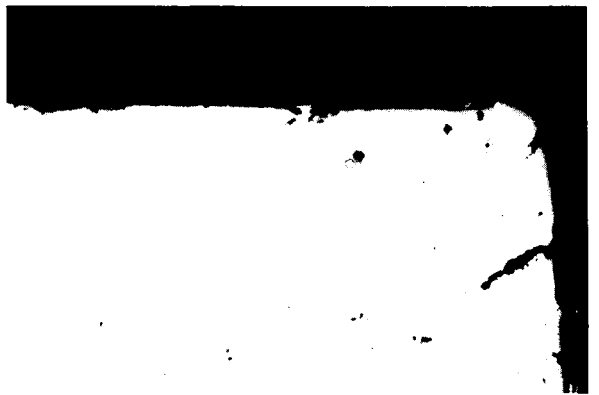
d) No. 3 Nivco 10
(Deposition and
Intergranular Attack)

Corrosion was observed on three specimens, namely Nos. 1, 3, and 4 (Table 4). Corrosion on the PH15-7Mo in condition RH 950 (sample No. 4) was manifested as a leached layer less than one mil deep, Figure 28f. Corrosion on the Nivco 10 was manifested as crevice attack on specimen No. 3 and as intergranular penetrations up to 2.5 mils in depth on specimen Nos. 1 and 3, Figures 28a, 28c, and 28d. Deposits of corrosion products were also evident on Nivco 10 specimen No. 3, Figure 28d.

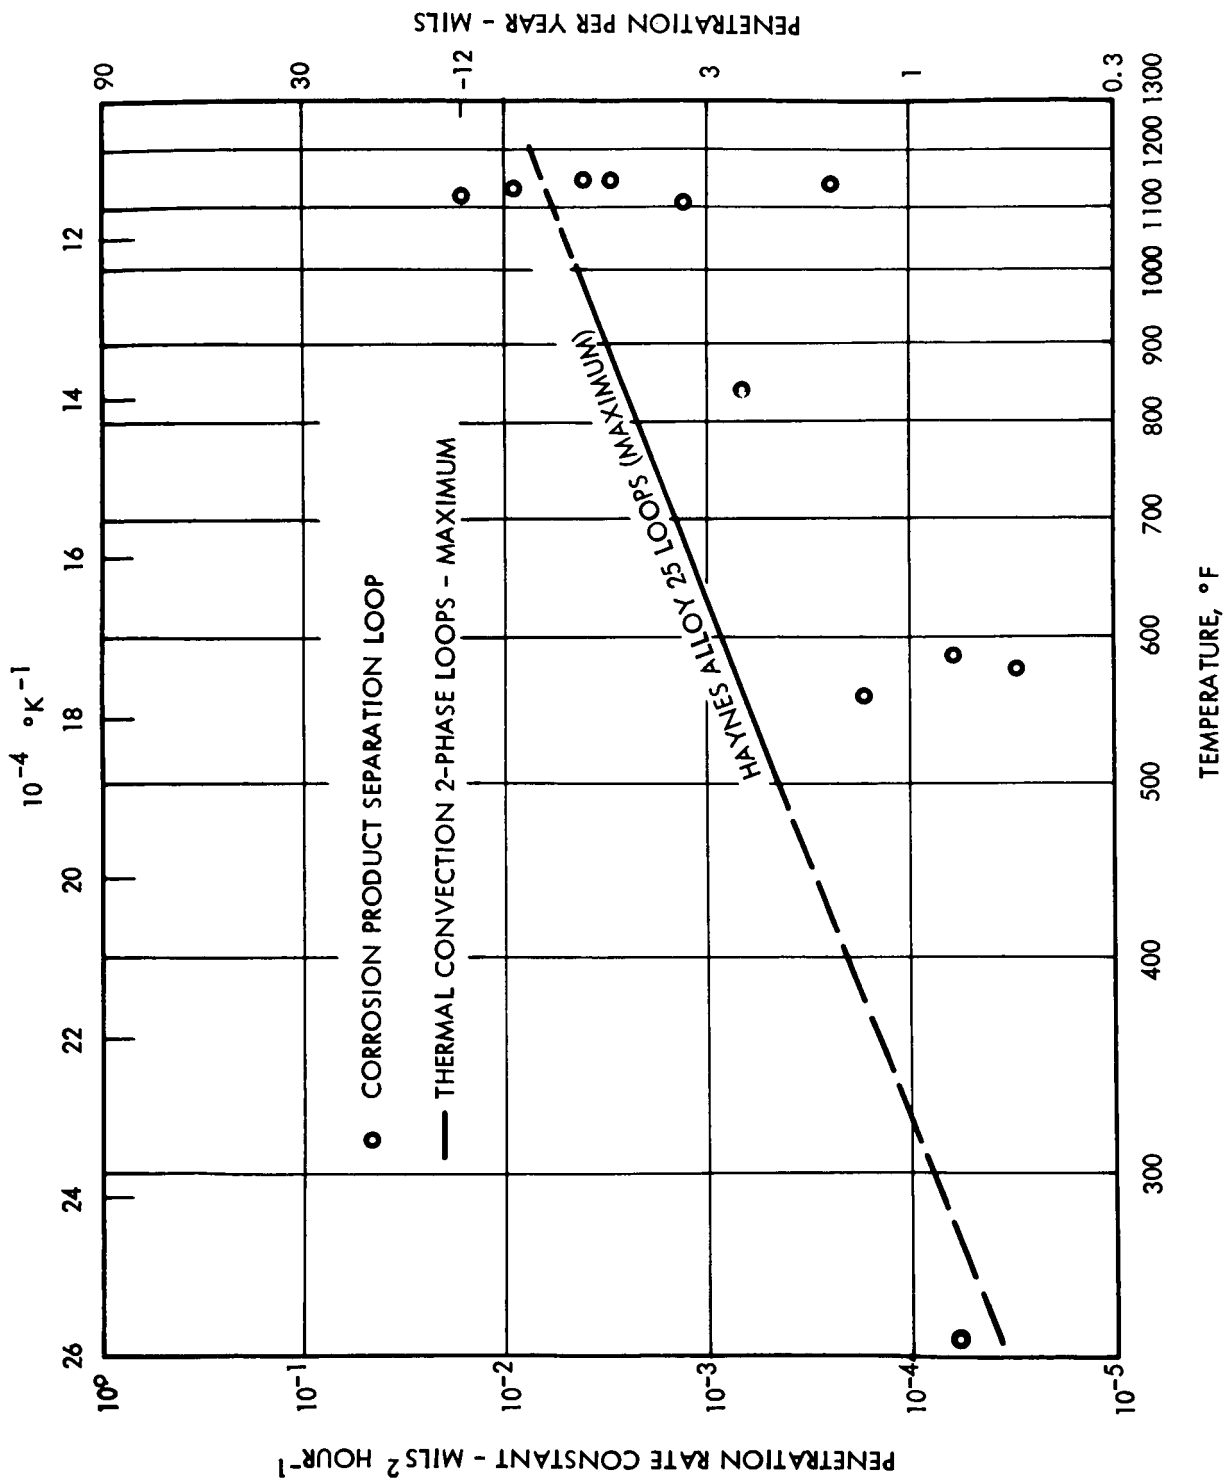
FIGURE 30. COMPARISON OF HAYNES ALLOY NO. 25 MERCURY PENETRATION FROM CORROSION PRODUCT SEPARATION LOOP WITH THERMAL CONVECTION, TWO-PHASE LOOPS (4).

Corrosion for the Haynes alloy No. 25 forced circulation corrosion loop was compared with maximum penetration data obtained from thermal convection two-phase loops (4). Although the mercury mass flow rate was on the order of 10 to 40 pounds per hour greater in this forced circulation loop than in the natural circulation loops, the data compare favorably, as shown in Figure 30. The majority of the points fall below the maximum penetration observed for two-phase thermal convection mercury loops. The points which lie above this curve are the two isolated penetrations observed in the pre-heater outlet (10 mils at 1106°F) and the superheater inlet (7 mils at 1118°F).
