P&WA CNLM-6028  
QUARTERLY PROGRESS REPORT NO. 1  
December 7, 1964 to February 28, 1965

INVESTIGATION OF CAVITATION DAMAGE OF A MECHANICAL  
PUMP IMPELLER IN HIGH TEMPERATURE POTASSIUM

CONTRACT NAS3-6468

PRATT & WHITNEY AIRCRAFT DIVISION, UAC  
CANEL - Middletown, Connecticut

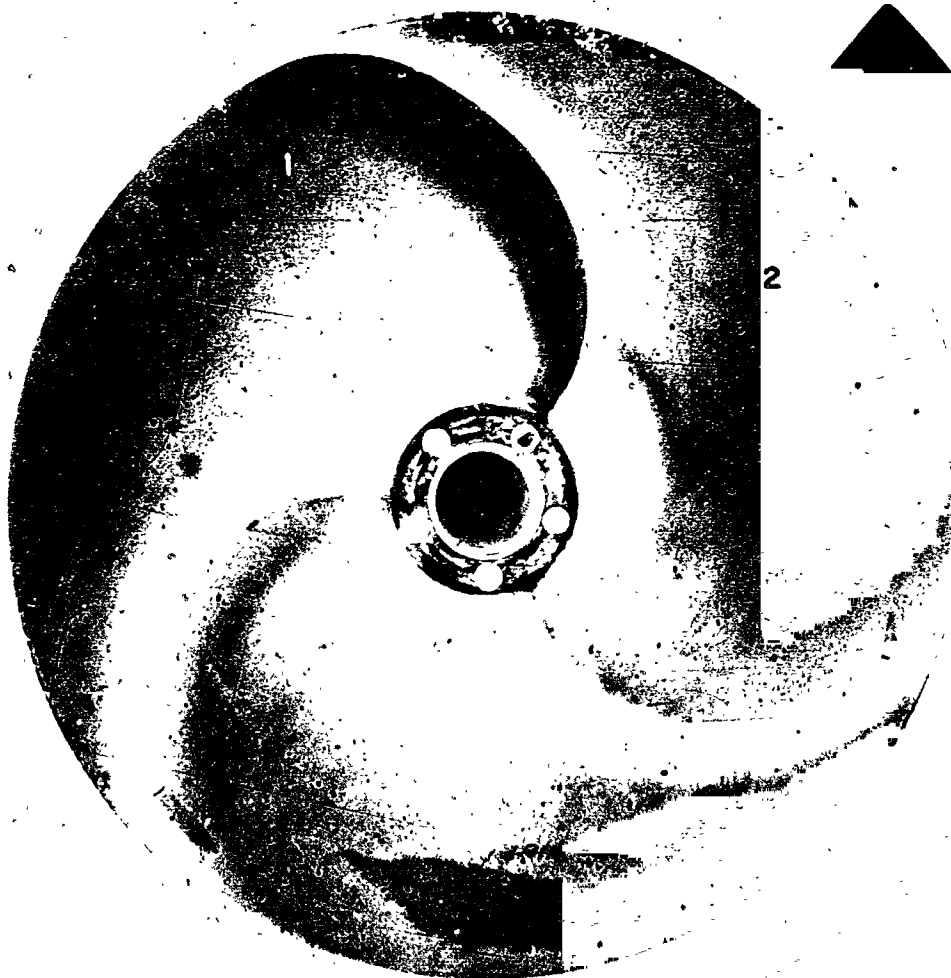
FIG 15

COATING DAMAGE PATTERNS AFTER 2 HOURS AT AN NPSH OF 18 FEET AND 0.015  
INCH VANE TIP CLEARANCE (PRESSURE SURFACE)

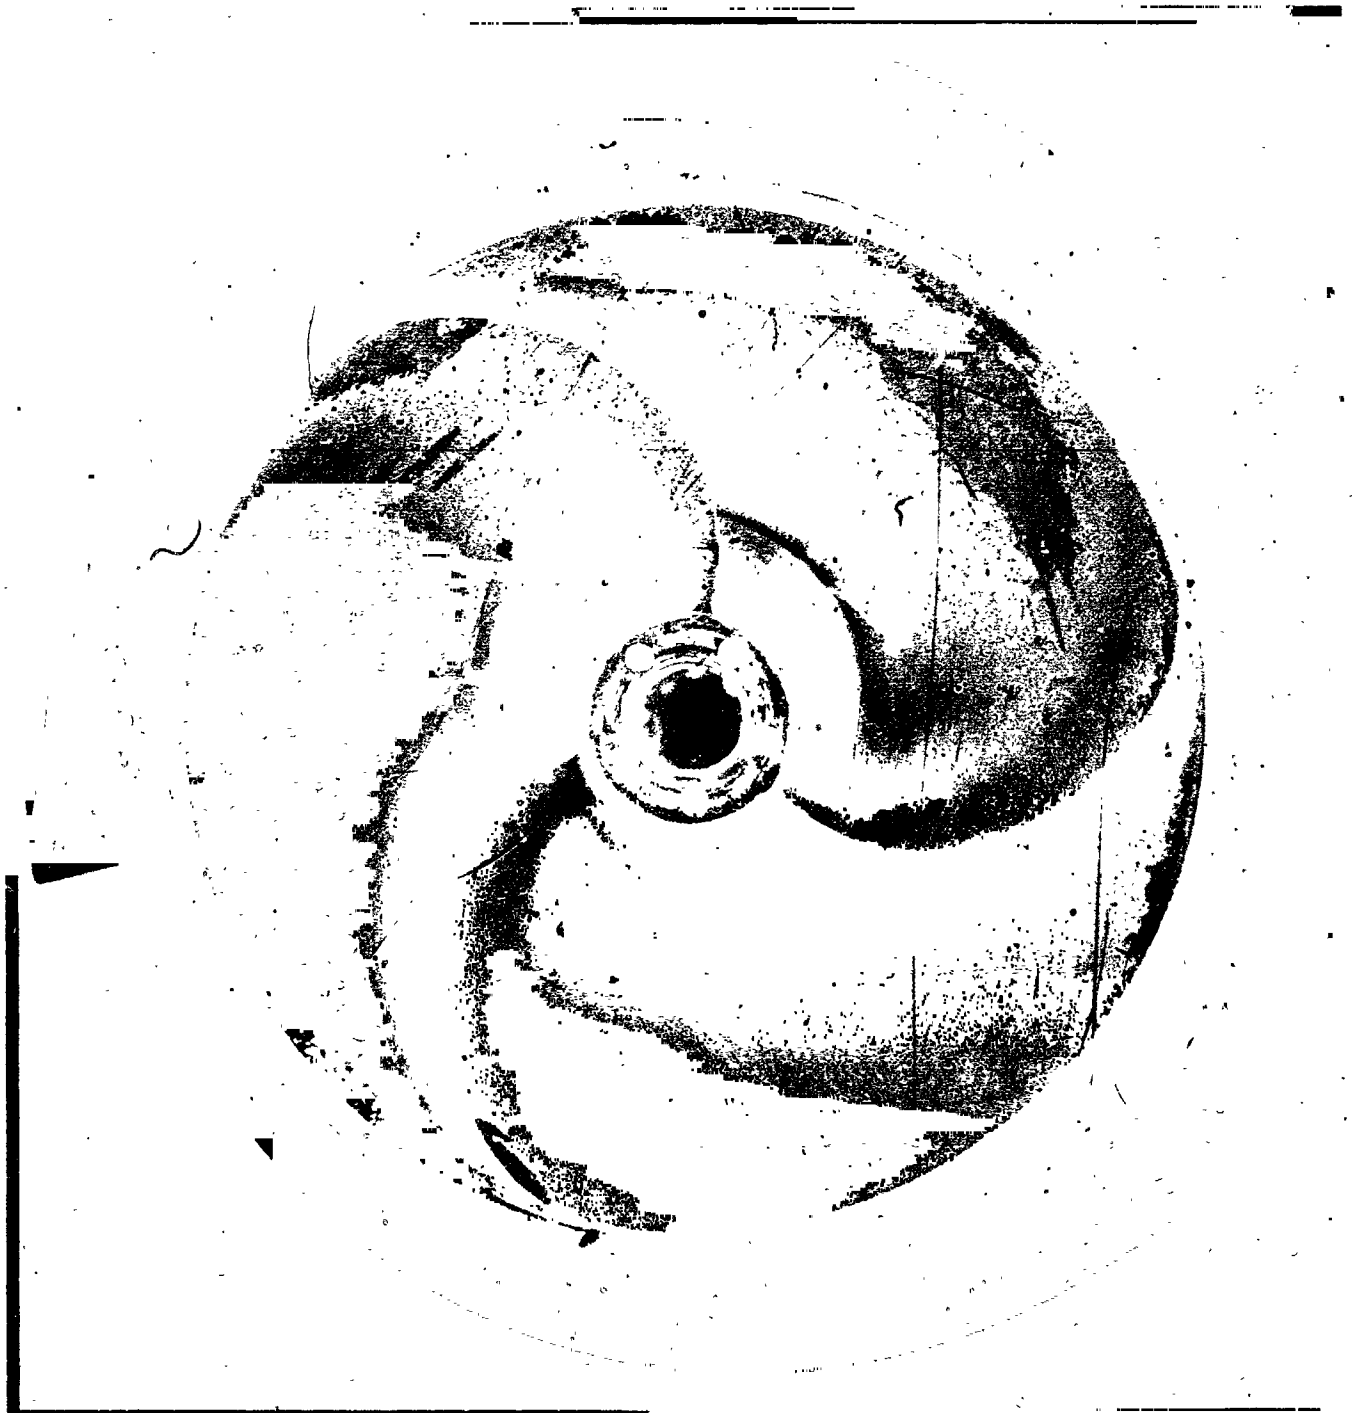
FIG 17

CAVITATION ON THE RI-7A3 IMPELLER AT AN NPSH OF 30 FEET  
AND 0.015 INCH VANE TIP CLEARANCE

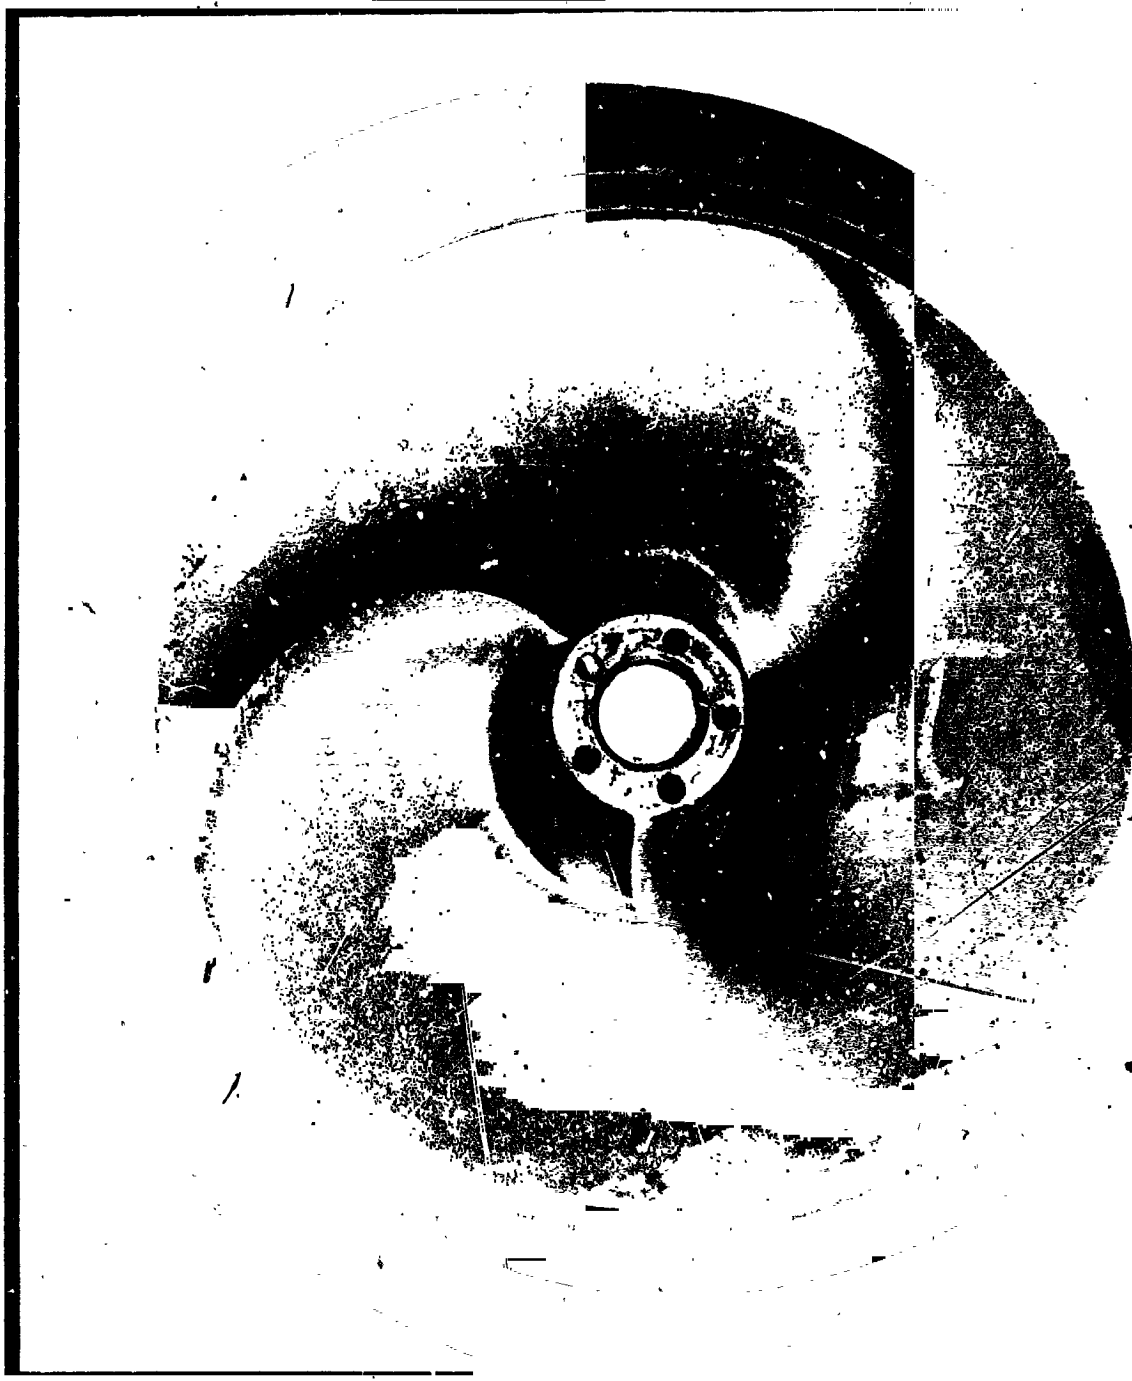
COATING DAMAGE PATTERNS AFTER 2 HOURS AT AN NPSH OF 30 FEET AND  
0.015 INCH VANE TIP CLEARANCE (PRESSURE SURFACE)
