NASA CR-225

## OPERATION OF A HAYNES ALLOY NO. 25 FORCED CIRCULATION LOOP TO STUDY THE EFFECTS OF HYDROGEN IN A SIMULATED SUNFLOWER SYSTEM

by *R. C. Schulze and D. B. Cooper*

Prepared under Contract No. NAS 5-462 by  
THOMPSON RAMO WOOLDRIDGE, INC.  
Cleveland, Ohio

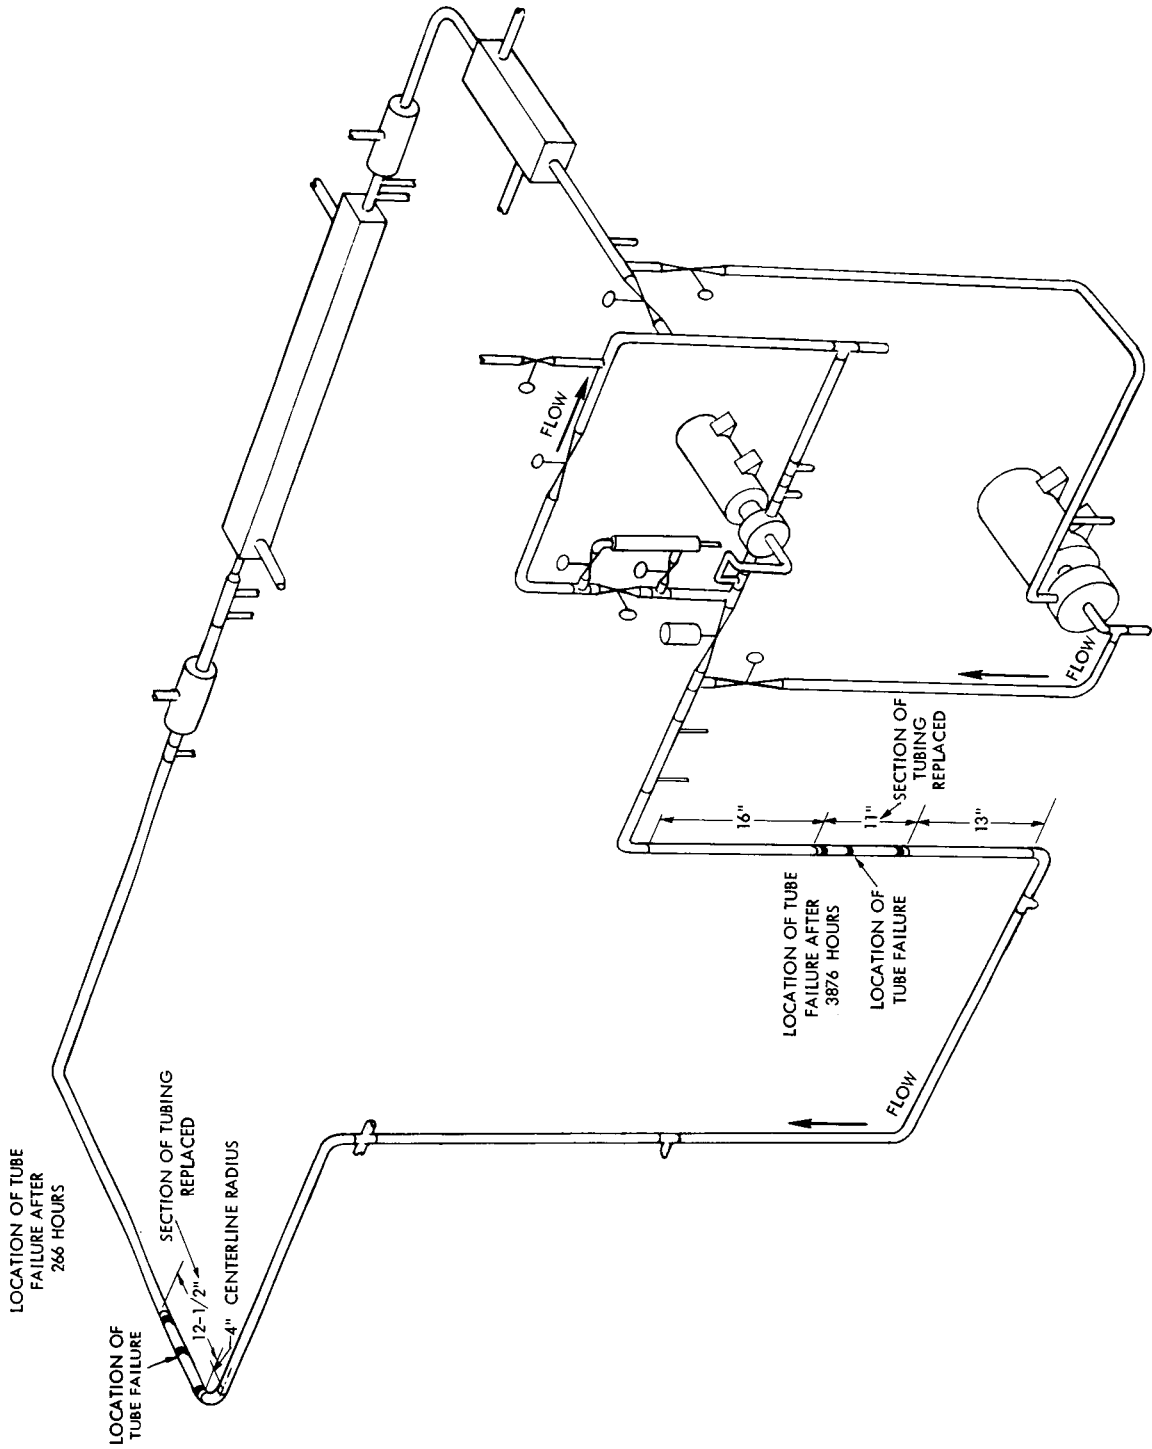
FIGURE 11 ISOMETRIC SKETCH OF THE LOOP SHOWING THE LOCATIONS OF THE TUBE FAILURES WHICH OCCURRED AFTER 266 AND 3876 HOURS

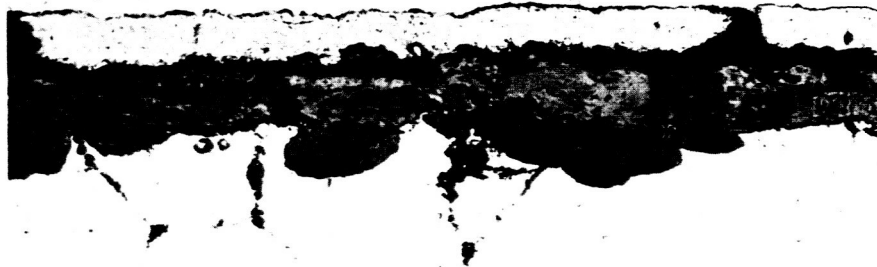
Figure 31. Appearance of Corrosive Attack Found on the I.D. Surface of the Specimen Removed from the Weld in the Lower Part of the Boiler Inlet (Section No. 11, Weld).

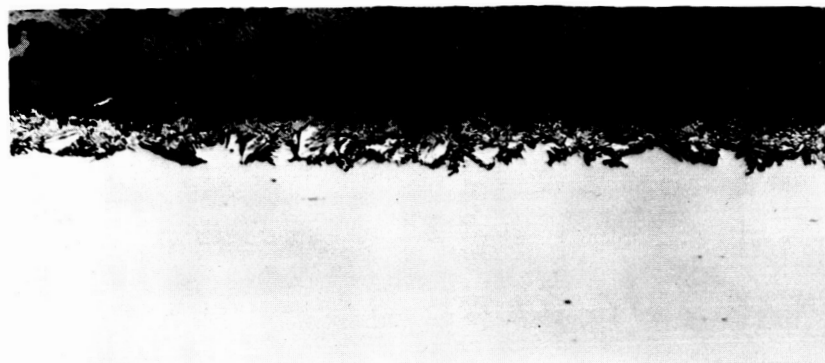
Figure 34. I.D. Surface of Specimen Removed from the Lower Part of the Boiler Outlet (Section No. 15, Thermocouple No. 10).

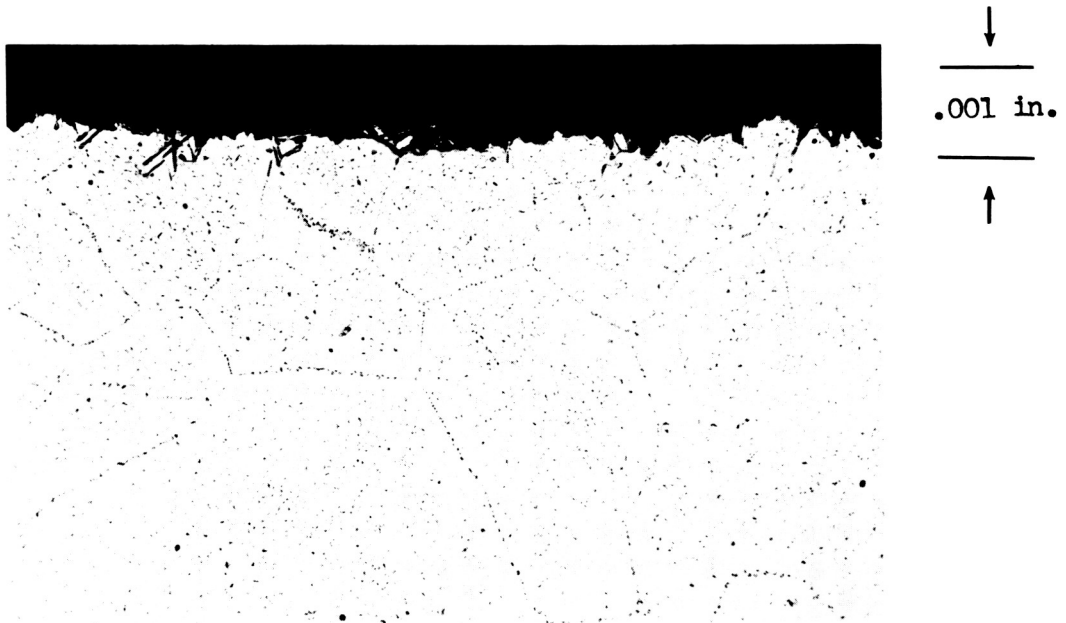
Figure 37. I.D. Surface of Specimen Removed from the Outlet Region  
of the Superheater (Section No. 26A, Thermocouple No. 24).

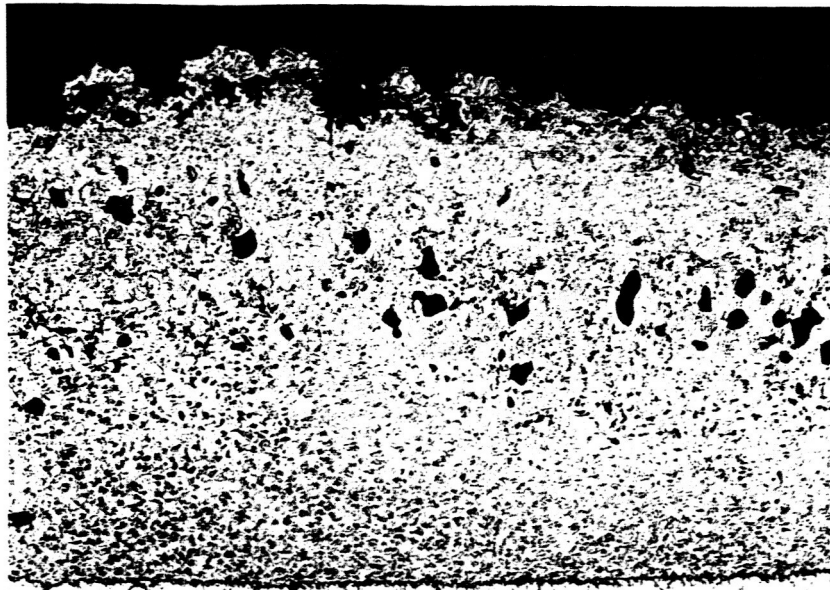
Figure 38. Appearance of Deposit Found on the I.D. Surface of the Specimen Removed from the Superheater Inlet (Section 20, Thermocouple No. SH 1).

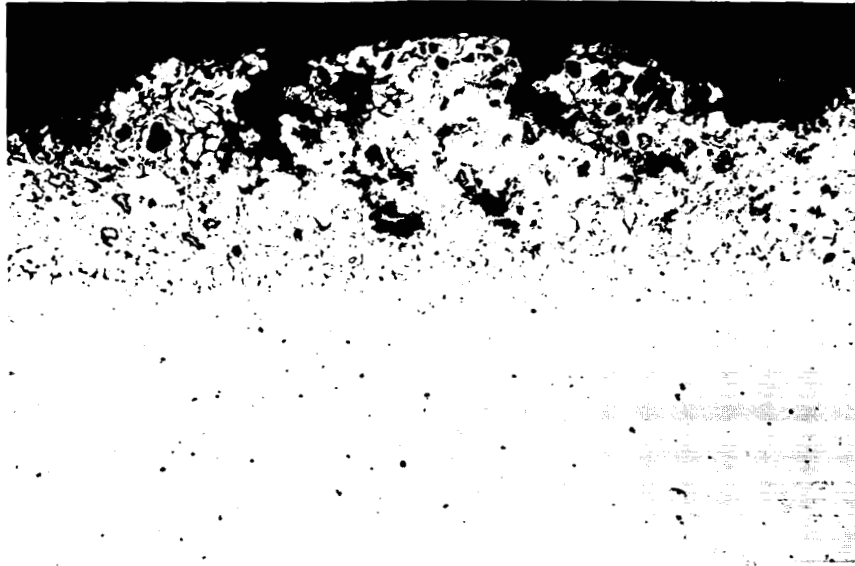
Figure 41. Appearance of Deposit Found Along the I.D. Surface of the Specimen Removed from the Middle Region of the Superheater (Section No. 22, Thermocouple No. 22).

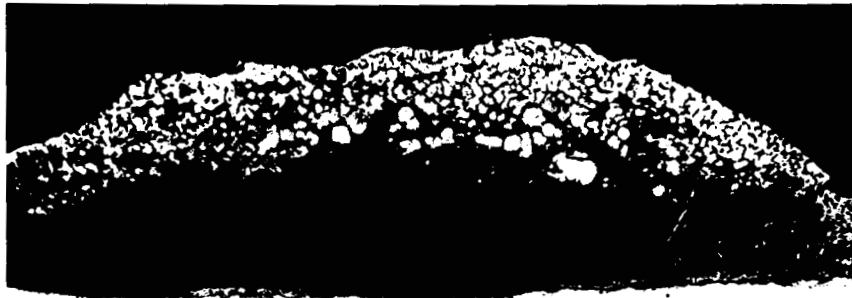
Figure 42. Appearance of Deposit Found on the I.D. Surface Near the Weld Area of the Specimen Removed from the Outlet Region of the Superheater (Section No. 25, Weld).

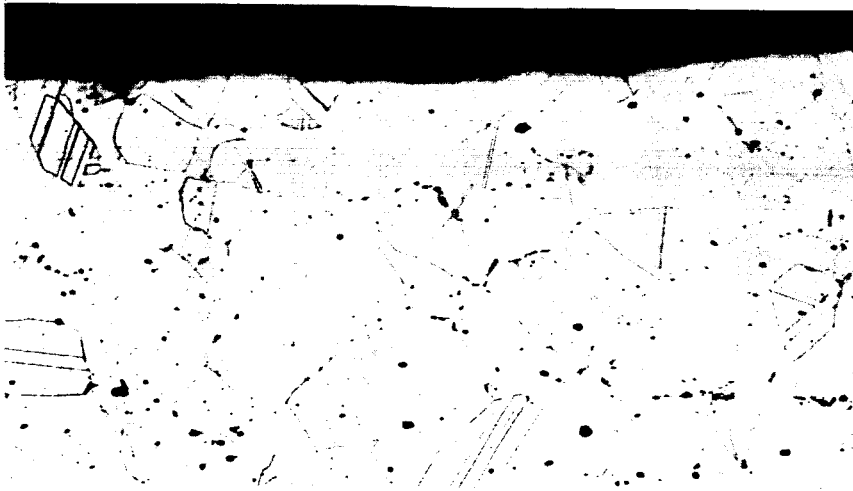
Figure 43. Appearance of the I.D. Surface of the Specimen Removed From the Condenser (Section No. 29, Thermocouple No. 35).

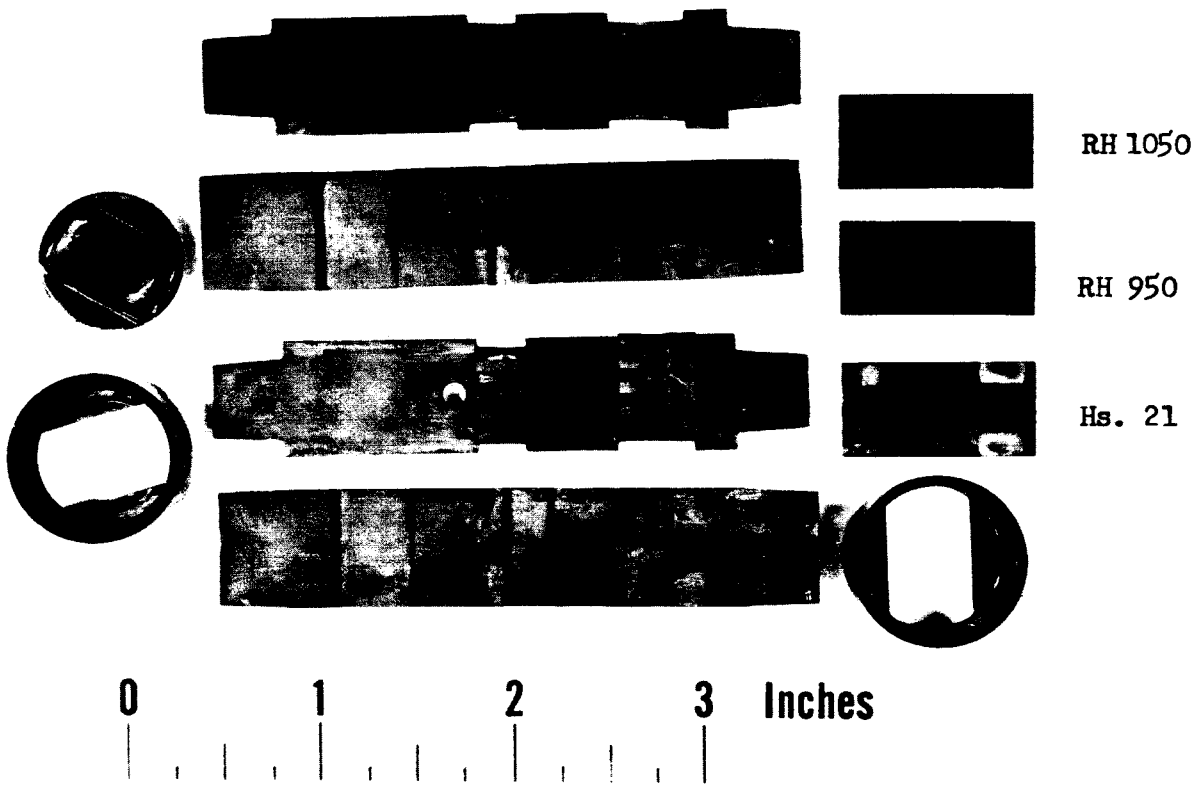
Figure 50. Appearance of Orifice and Specimen Holder Assembly After Test. Actual size.

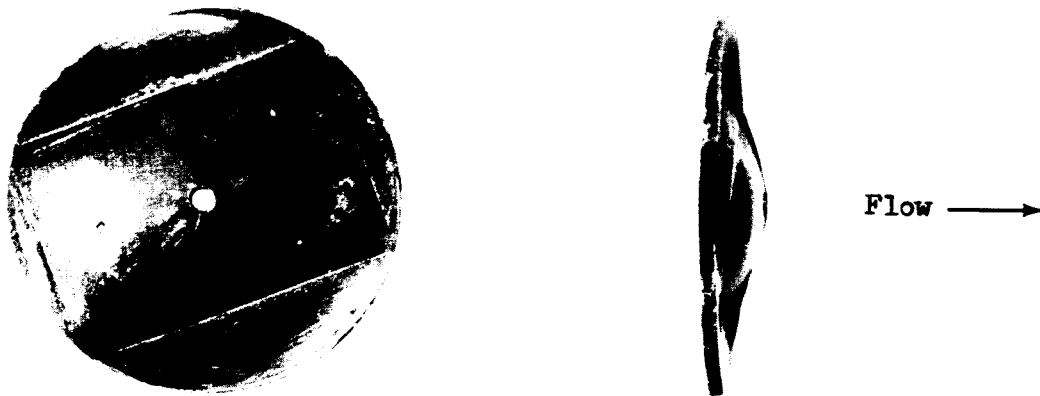
Figure 51. Macrograph of the Orifice Plate Showing the Amount of Distortion Incurred. Mag. 2.6X

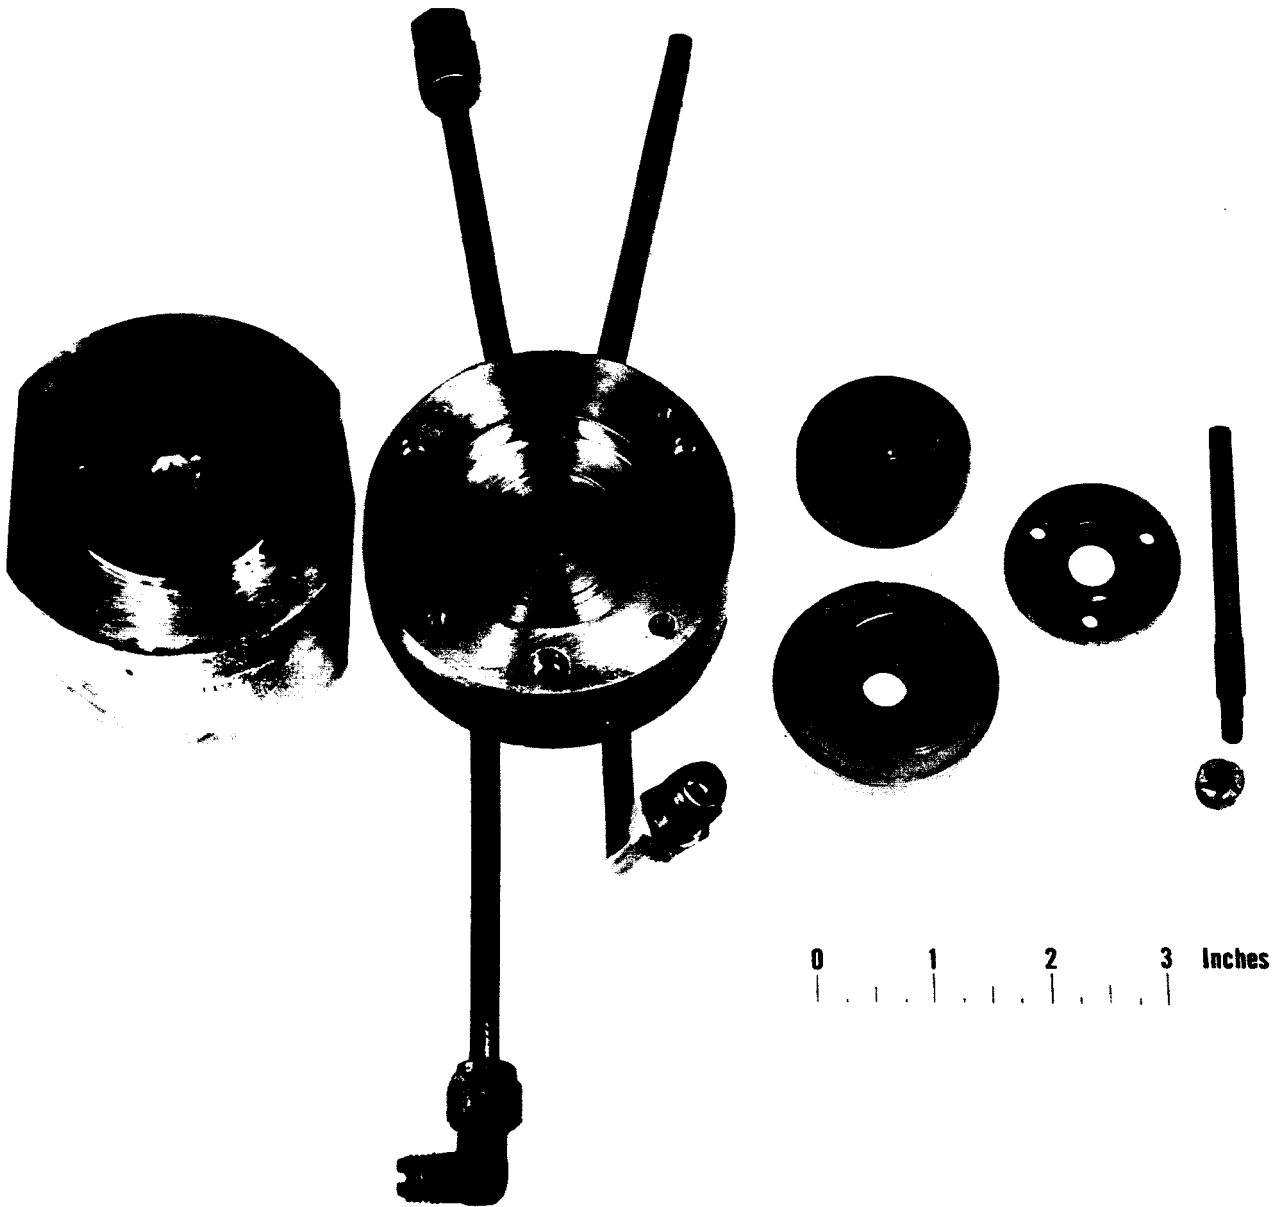
The centrifugal pump was operated for approximately 1000 hours, during these tests. The only area of the pump that was damaged during test was the volute tongue where an erosive action had occurred.

Figure 55. Condition of Centrifugal Pump Components After Test.  
Size of components reduced to three-quarters original size.
