**COUPLING CREDIBLE FAILURE MODES AND OWNER OPTIONS TO INTERVENE**

**Stephen R. Locke**  
Principal Consultant, Rotating Machinery  
DuPont  
Old Hickory, TN, USA

In this paper, a user's and an OEM's views are presented of the most common coupling failure modes with examples showing details in the final stages of deterioration and identifies options to enable owners to intervene in sufficient time to prevent catastrophic failure.

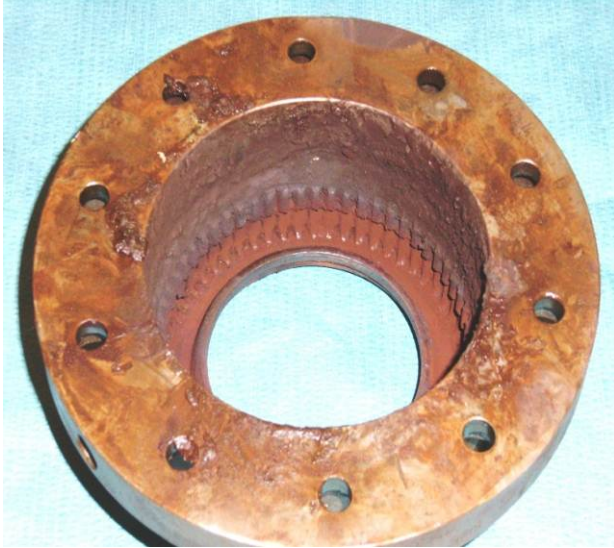
The typical failure mode of gear couplings is that the teeth wear away from improper lubrication and/or excessive misalignment until there is excessive backlash and tooth tip clearance leading to high vibration, or they become so thin they can no longer support the torque and roll over, an example which is a hub spinning inside a sleeve (Figure 2).

*Figure 2. Excessively Worn Gear Teeth*

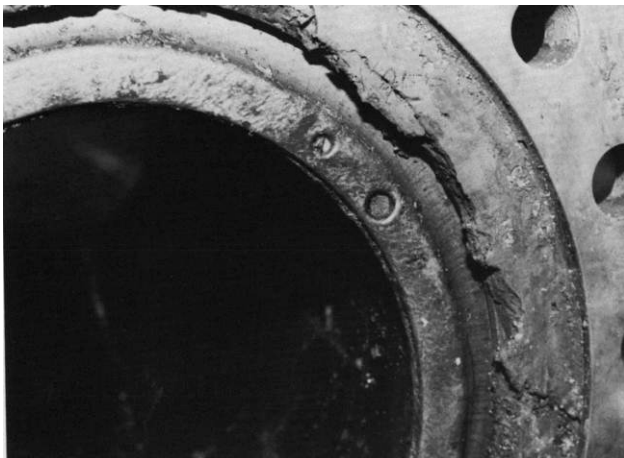
In one scenario, the additives and impurities present in the lubricant are separated and retained in the coupling due to centrifugal forces, creating sludge. As the quantity of sludge increases over time, it can impair axial float, corrode the teeth thereby accelerating their wear rate, or reduce the circulation of the lubricant. In extreme cases, sludge can even lock-up the coupling and prevent the movement necessary to accommodate misalignment in (Figure 3) per Calistrat and Webb (1972).

*Figure 3. Sludge Lock up In Gear Coupling. (Calistrat)*

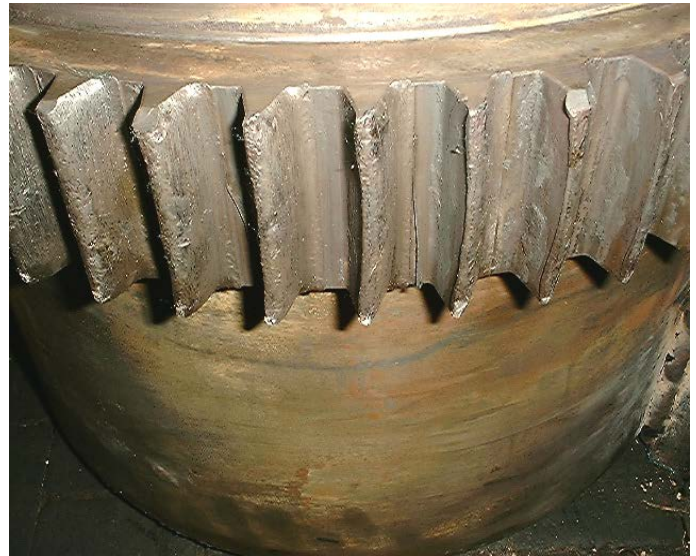
In addition to lubrication, excessive misalignment causes failures due to an increased bending stress towards the end of the gear teeth, or end loading (Figure 4).

*Figure 4. Gear Teeth Worn From Excessive Misalignment*

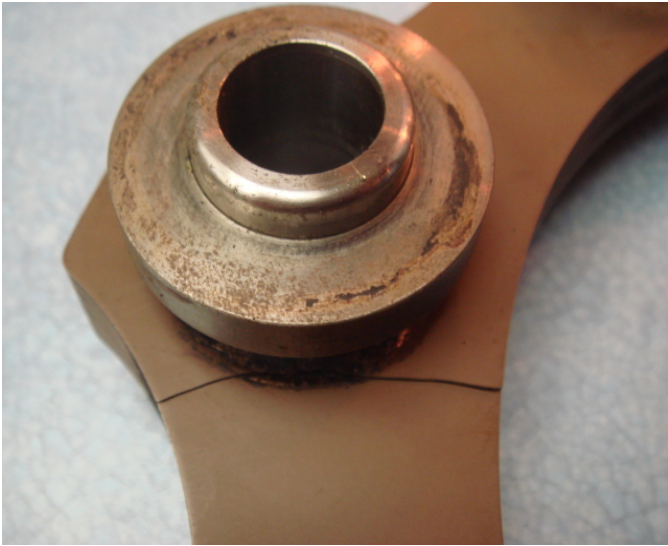
The most common failures for disc couplings are caused by either excess misalignment or a torque overload. Excessive angular misalignment applies an alternating stress to the disc packs and which can eventually lead to a failure due to bending fatigue. One of the benefits of multiple disc pack couplings is multiplicity since the outer discs experience the highest stress from angular misalignment and they are the first to break (Figure 5).

Figure 5. Disc Excessive Angular Misalignment Crack

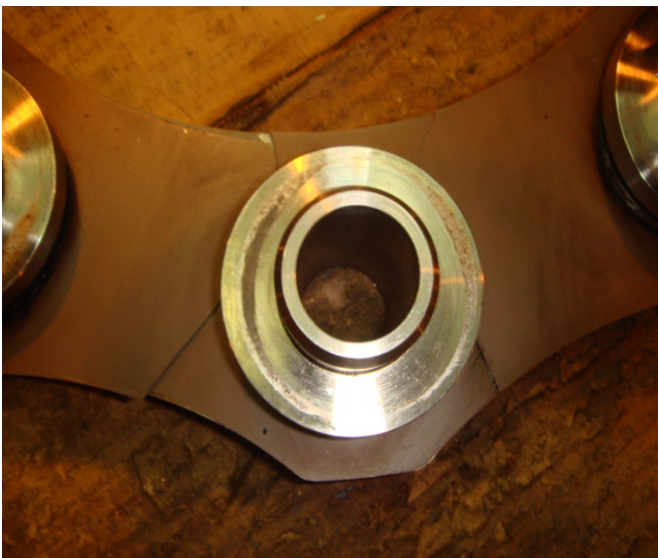
If one or a few outer discs break the load redistributed among the inner discs, each disc will subsequently carry a higher torque load but a lesser stress due to misalignment. As the disc pack unravels from the outer discs inward, increased unbalance will cause higher machine vibrations, and the machinery can be safely shut down. Excessive axial with angular misalignment produces a tensile stress in both the compression and tension links of the disc pack, and bending fractures are likely to occur on both sides of the bolt hole (Figure 6).

Figure 6. Excessive Angular Misalignment And Axial Movement Cracks

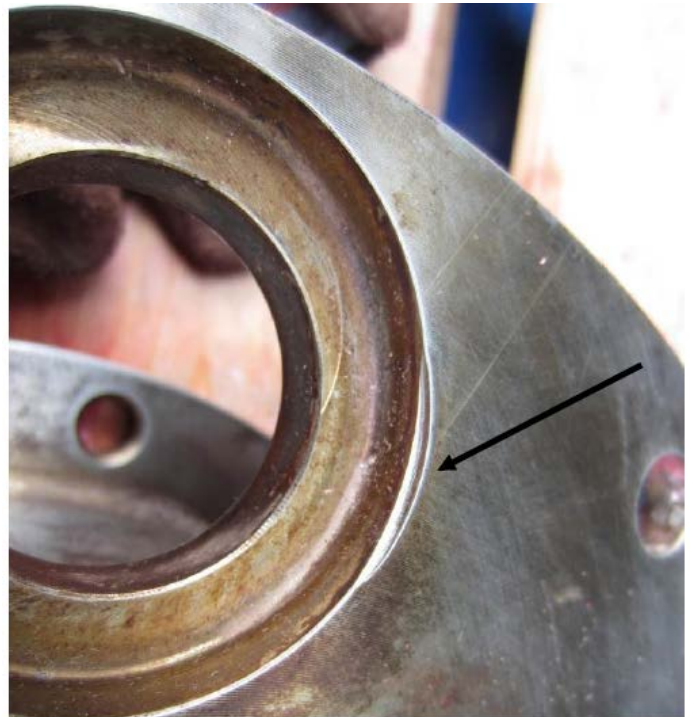
The other major cause of disc coupling failure is due to a torque overload. In the event of a torque overload – caused by a compressor ingesting a liquid slug, or a generator fault, etc., – the disc pack will yield. Distortion of the bushings, bent bolts and contact between the bushing and the disc pack flange may also be evident upon further inspection (Figure 7).

Figure 7. Torque Overload Bushing Indentation in Disc Pack Flange

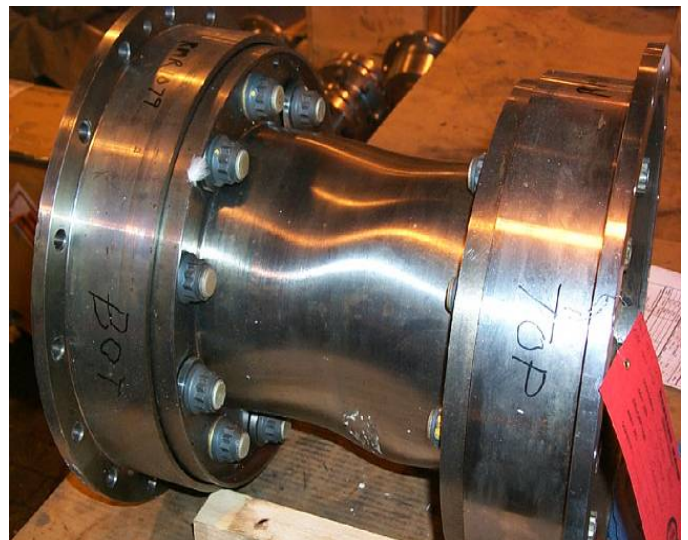
If the load is large enough, fractures in the disc pack can occur at the links or at the bolt holes. However, though yielded, the disc pack coupling will stay together, and typically cause high vibration from unbalance, unless the load is so high and monstrous that the whole coupling fails at various places catastrophically. More commonly, again, parts will yield but not break from potentially high over torques (Figure 8).

Figure 8. "Twisted Sister" Yielded (Buckled) Spacer From Over Torque

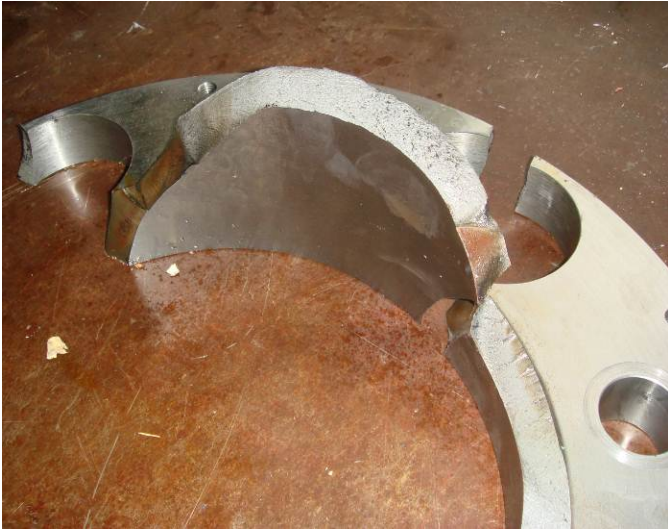
oscillations can also occur with applications with reciprocating engines or pumps that have torque pulses from an engine firing cylinders or reciprocating pump action. Moderate oscillations may cause fatigue failures (either high or low cycle) at either the bolt holes accompanied by considerable fretting, or in adjacent tension and compression links. High magnitude torque fluctuations can result in bidirectional elongation of the disc pack at the bolt hole as well as serious fatigue failure to other coupling components if they are not designed for the torsional load (Figure 9), Corcoran, et al. (2010).

Figure 9. Excessive Torsional Oscillation Fatigue Failure in Spacer

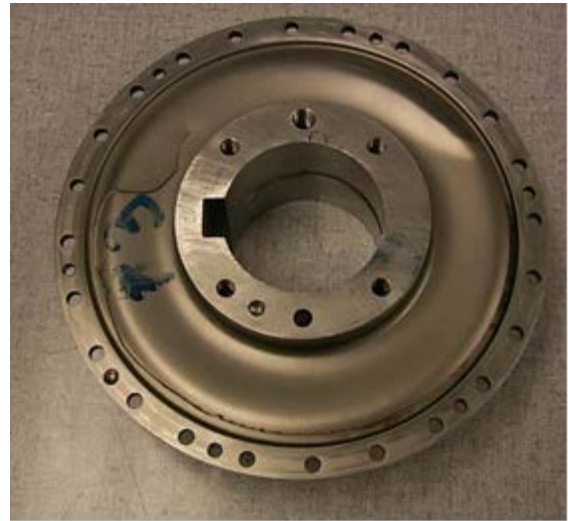
Angular misalignment causes an alternating stress in the web of the diaphragm as it bends back and forth with each revolution. Failures occur due to bending fatigue and start with a crack in the flexible element. Axial misalignment stretches the diaphragm, resulting in an additional continuous stress (Figure 10).

Figure 10. Excessive Angular Misalignment and Axial Movement Diaphragm Failure

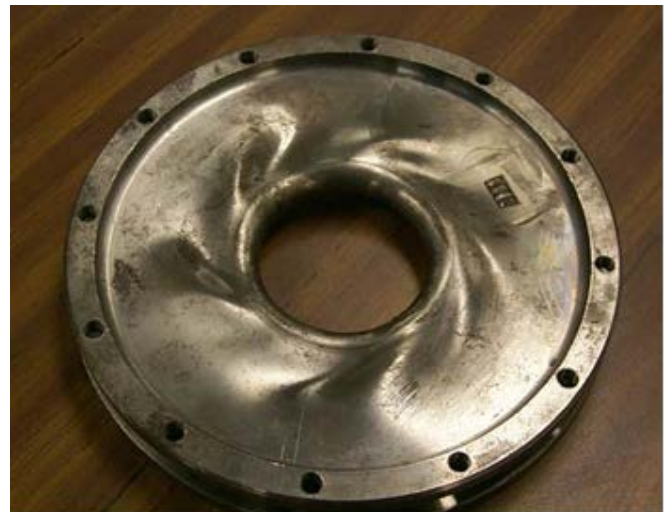
Torque overloads cause distortion of the diaphragm and can cause a rippling effect in the web (Figure 11).

Figure 11. Diaphragm Torque Overload

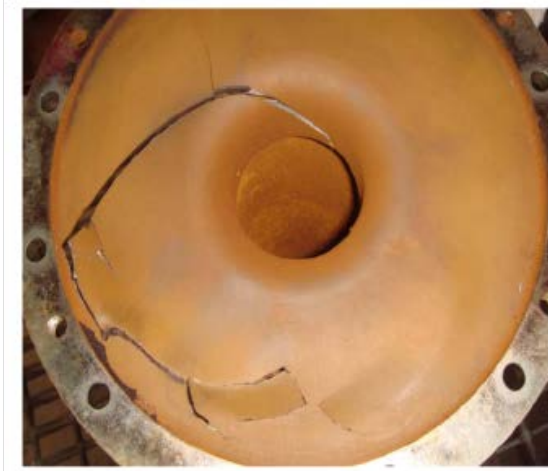
In addition, excessive torsional oscillations can cause a fatigue crack at a 45 degree angle to rotation. (Figure 12)

Figure 12. Excessive Torsional Oscillation Failure

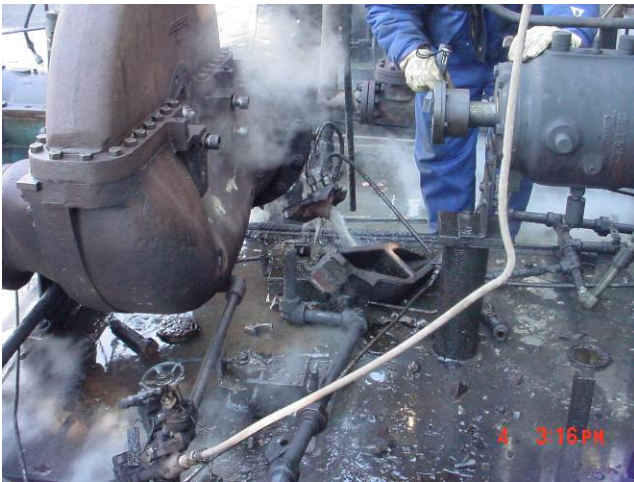
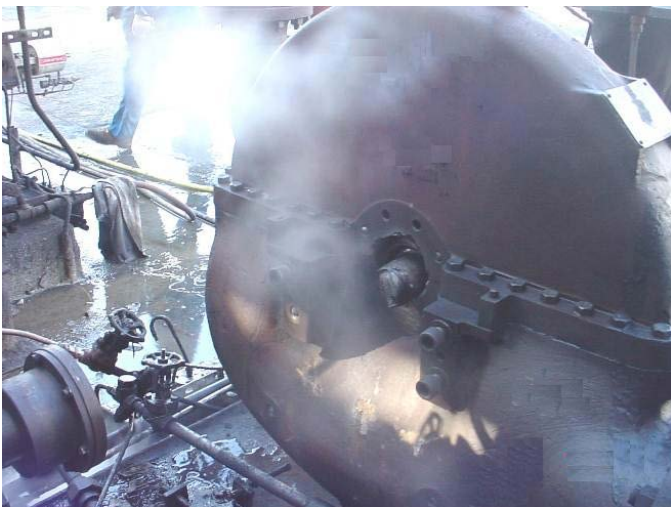
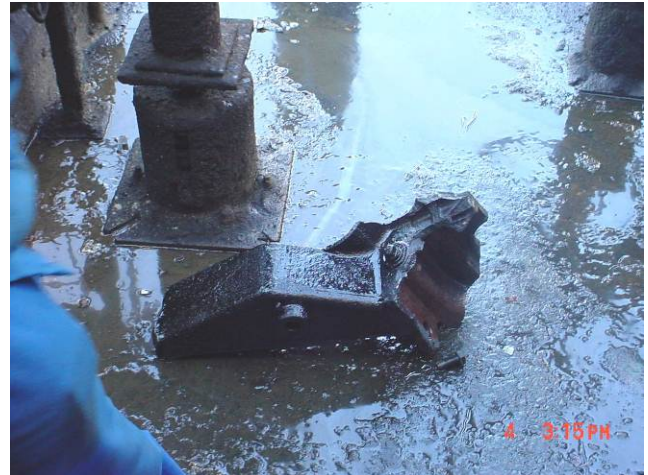
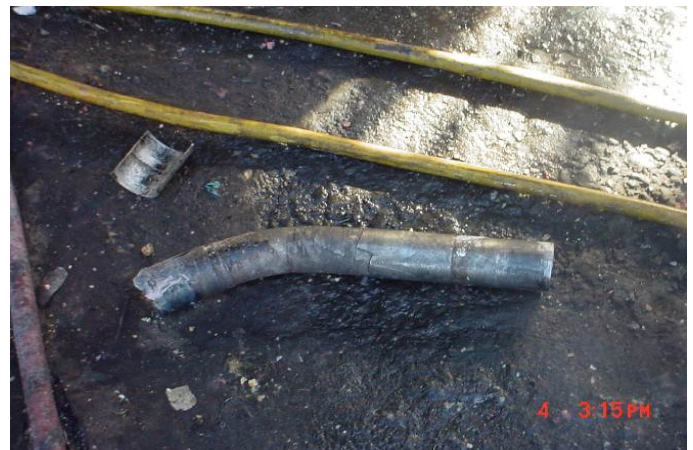
A disc coupling failed on a 600 HP, 1800 RPM steam turbine-driven centrifugal pump. The failure resulted in ejection of the coupling spacer in spite of it being an anti-flail design. When the coupling failed the turbine speed increased from 1800 to 3100 due to a failure of the governor and trip systems. When the coupling speed increased, the coupling spacer was ejected from the machine. No personnel were injured, but the turbine was damaged beyond repair (Figures 13, 14, 15, and 16).

Figure 13. Damaged Turbine

Figure 14. Turbine Minus Bearing Bracket and Seal Housing

Figure 15. Section of Pedestal Support

Figure 16. Section of Turbine Shaft

The coupling bolts failed because of incorrect application (under sizing) and misalignment. Once the coupling bolts failed at the pump end of the spacer, the spacer assembly became eccentric, causing severe vibration and friction contact between the spacer which was still rotating and the pump end coupling hub which was stationary due to the broken bolts. At the same time, the turbine speed increased due to failure of the governor and over speed trip system, which increased the vibration due to the spacer eccentricity. Within seconds, the coupling spacer was ejected because the anti-flail extension on the spacer assembly was overheated and deformed from friction due to contact with the non-rotating pump end coupling hub. The disc pack at the turbine end of the spacer failed from low cycle fatigue, as the eccentric spacer stressed the discs far beyond the design limits. The disc pack at the pump end of the spacer failed from impact with stationary objects while rotating during the failure (Figure 17).

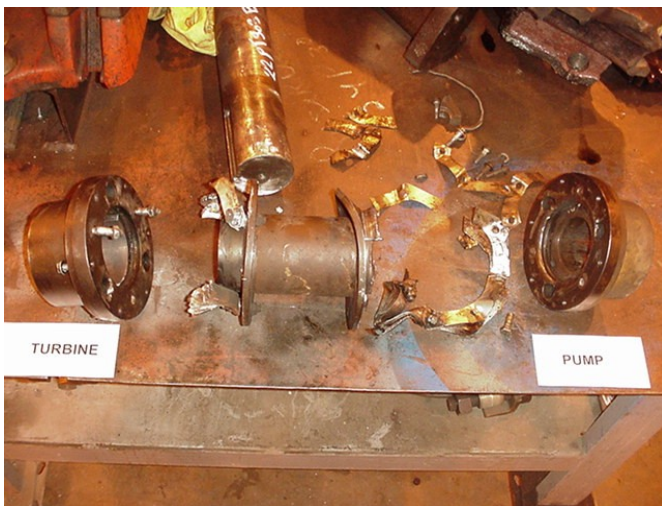
Figure 17. Failed Coupling Components

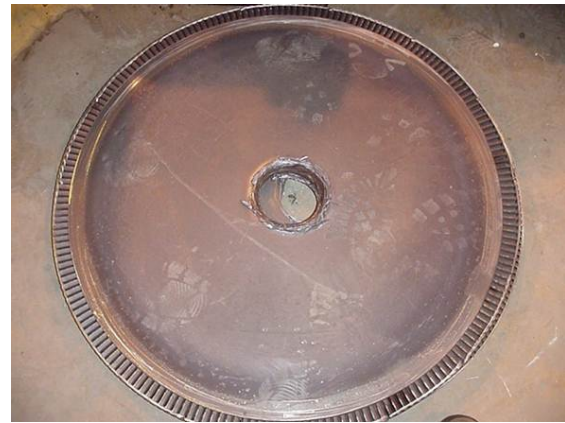
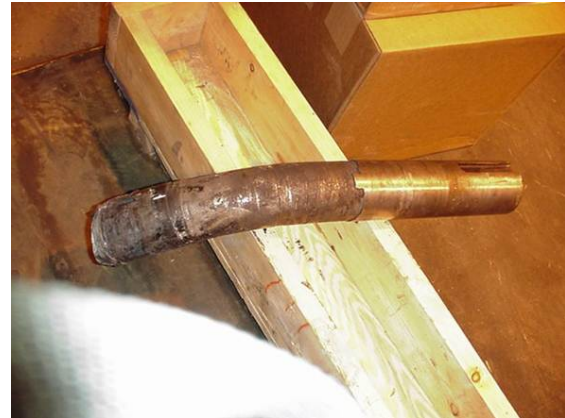
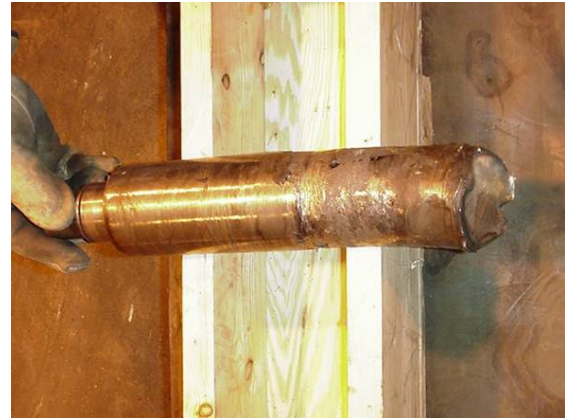
The turbine shaft was pulled through the turbine wheels (Figure 18) approximately 8-10 inches and the turbine shaft broke at the axial location of the second stage turbine wheel (which was the turbine wheel location after the shaft had pulled through the wheels). The turbine shaft was also bent approximately 30 degrees, with the bend starting approximately inboard of the outboard radial bearing. (Figures 19 and 20) The bend and break of the turbine shaft were a result of the large eccentric mass and unbalance caused by the eccentric coupling spacer. It is unusual to generate enough force to pull a turbine shaft through the substantial interference fit of the turbine wheels to the shaft, but perhaps the wheel fits were released during the over speed of the turbine rotor.

Figure 18. Turbine Disc with Damage at Bore

Figure 19. Bent Turbine Shaft Segment

Figure 20. Opposite End of Failed Turbine Shaft

The turbine inboard bearing housing and pedestal support essentially disintegrated during the failure. This housing and pedestal assembly is made of cast iron. The damage to the bearing housing was most likely caused by forces from the bent shaft and possible impact from the rotating shaft and flying parts. Although the pieces of the housing were so badly damaged as to make reconstruction of damage progression impossible, there is some indication that the bearing saddle broke off inside the housing from overload. The broken inboard turbine bearing housing caused the turbine to fall towards the pump, which caused the governor and trip valve assembly to break away from the turbine casing.

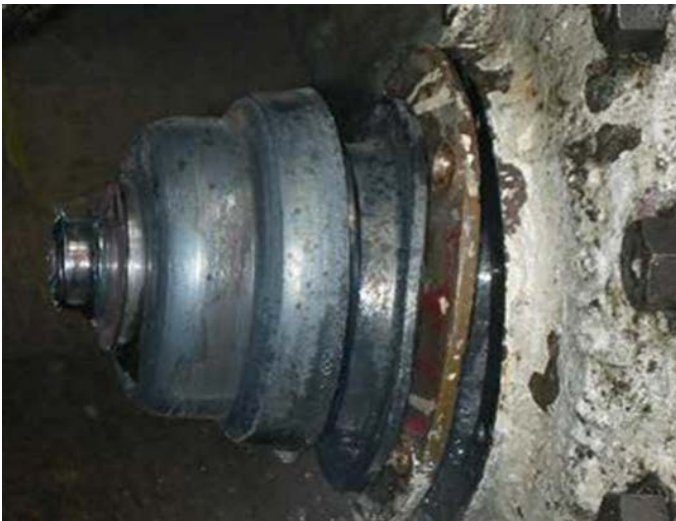
In this first failure, the coupling teeth had worn thin enough to strip. Then, and without the benefit of high vibration interlock protection, the motor continued to run as friction severely overheated the hub and spool teeth as shown in Figures 22 and 23.

Figure 22. Friction heated coupling hub, teeth are gone!

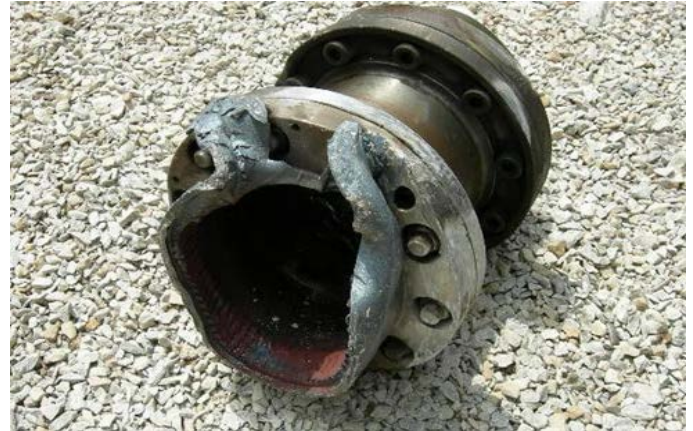
Figure 16 shows the spool ring gear not only stripped the teeth, the combination of rapid heating and unbalance forces permanently swelled the diameter where the teeth had been. Forces were high enough to bend the compressor shaft slightly and damage the compressor bearings.

Figure 23. Friction heated coupling spool.

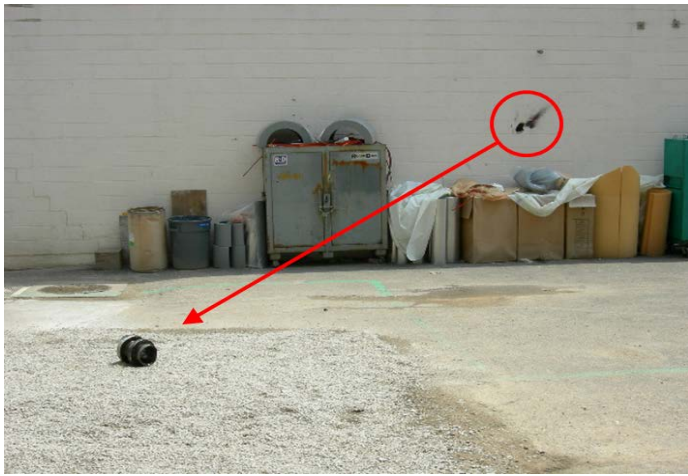
Lack of vibration interlock protection and loss of control of shaft alignment left the plant vulnerable with no way to effectively mitigate loss of lubricant to the coupling teeth.

Figure 24. Ejected spool impact and final location.

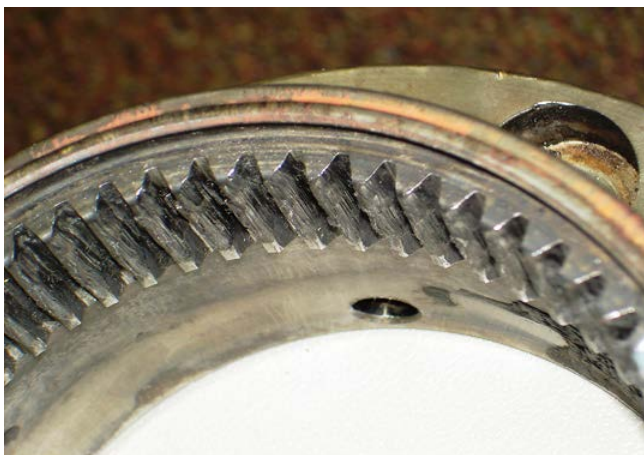
After a full year of operation, a plant engineer had made a habit of inspecting the machine for grease leaks or other signs of distress. Just a few hours after his inspection, the coupling failed again, but this time vibration interlocks safely shut the machine down prior to stripping the coupling teeth (Figure 25).

Figure 25. Heavy tooth scoring from loss of lubrication.

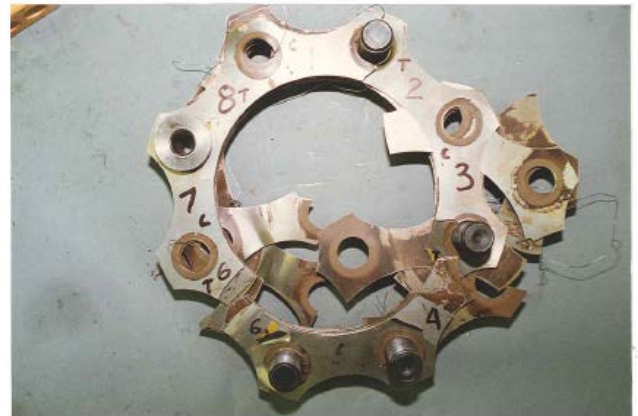
When it finally was, cracks were noticed in the discs. When a detailed inspection at the factory took place, it was noticed that discs in the pack had failed progressively from outer pack to inner, indicating an excessive misalignment condition. As found, all the discs on the turbine end had failed (Figure 26), as had many on the compressor end.

Figure 26. Failed Turbine End Discs

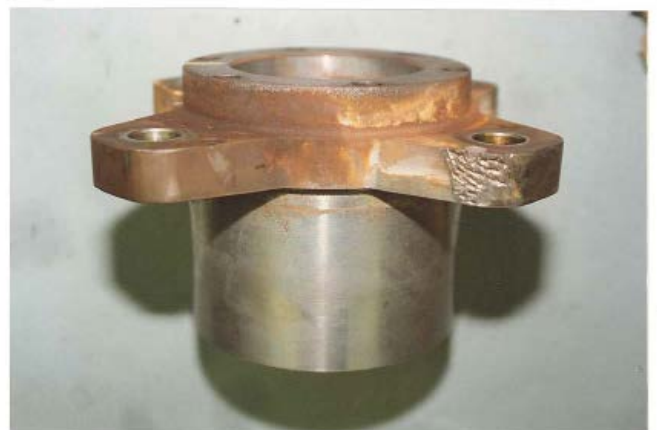
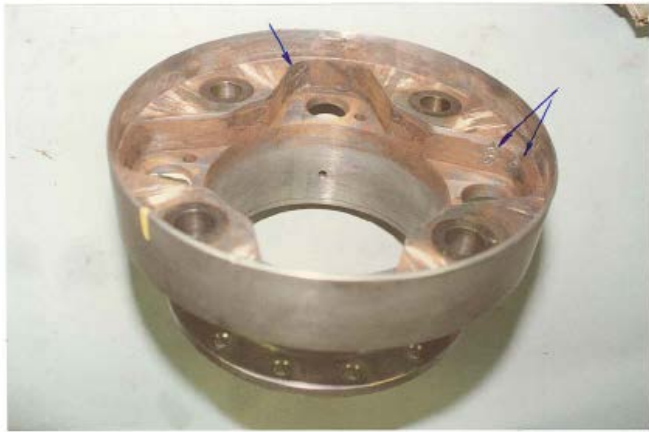
Moreover, the coupling was running on the interlock feature (Figures 27 and 28) on the turbine end! The train had run at 3.5 – 4.5 mils for 2 months and 2 restarts after bearings had been replaced, but no one suspected a coupling failure.

Figure 27. Interlock Engagement Wear on Hub

Figure 28. Interlock Engagement Wear on Sleeve

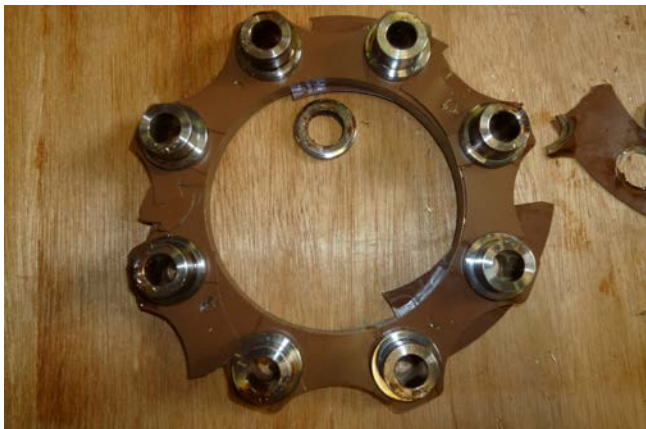
After two identical gas turbine upgrade procedures on an offshore platform, where the turbines were driving centrifugal compressors for gas injection service, the couplings on both trains failed from excessive angular misalignment (Figure 30).

Figure 30. Disc Angular Misalignment Failure

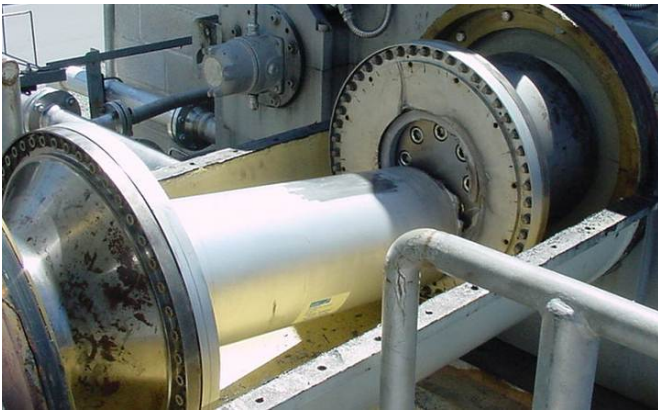
The motor to gearbox diaphragm coupling on a 12,000 HP compressor train failed from fatigue due to incomplete fusion of a friction weld, which acted as a stress raiser. Very high nominal stress was present on the piece, as shown by the small fatigue area and the large final-fracture region. This friction weld was used in the coupling between the low alloy carbon steel spacer tube and the precipitation-hardened martensitic stainless steel diaphragm on the gearbox end.

Figure 32. Coupling Assembly after Failure

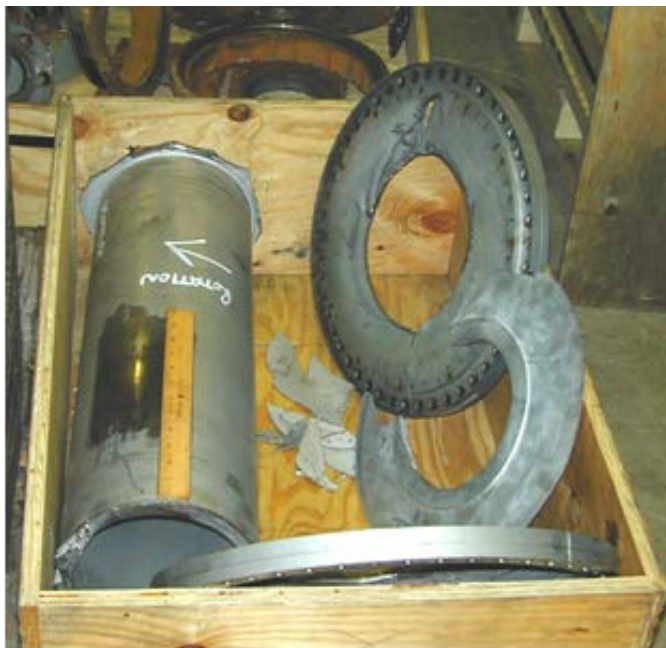
The coupling spacer tube is friction welded to the diaphragms as part of the normal manufacturing process. Both ends of the spacer tube had broken from both diaphragms and both diaphragms had shattered (Figure 33).

Figure 33. Components from Coupling Spacer

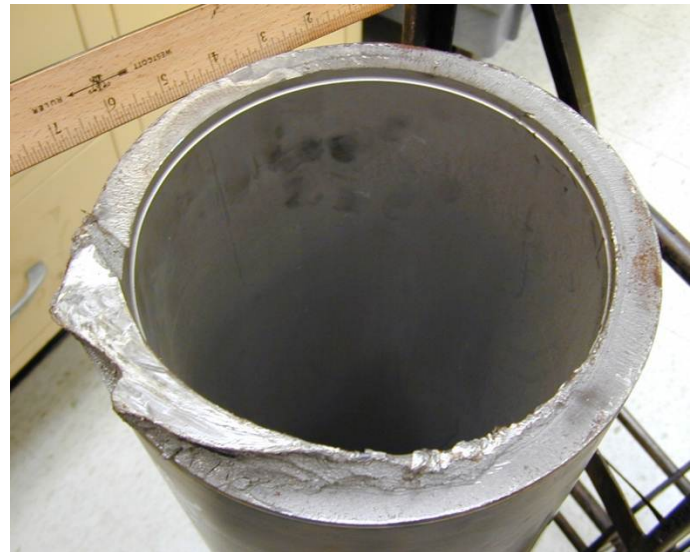
suspected initiation point was on the spacer tube (Figure 34). This face retained more failure features (less smeared) than the matching areas on the diaphragm and was used for further evaluation. Visual examination showed that the majority of the fracture, about 90%, was the final-fracture region, indicating a highly stressed weld joint.

Figure 34. End of Spacer Tube; Failure Initiation Site is at 10 O'clock Position on the ID

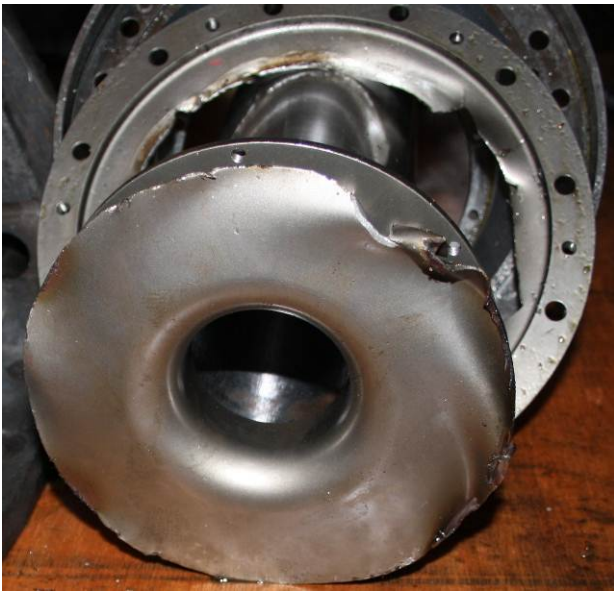
Vibration monitors tripped at 75 microns, when apparently the coupling diaphragms were ripped completely around circumferentially and the now free center section was completely loose from the rest of the coupling. (Figure 35)

Figure 35. Angular Misalignment Failure

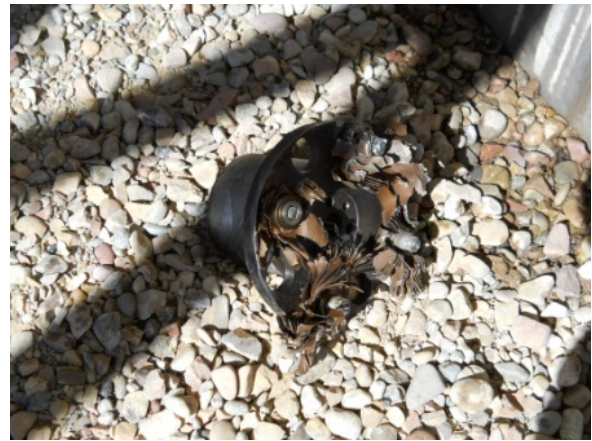
In a Gas Turbine / Gearbox / Compressor application the coupling between the turbine and gearbox failed catastrophically and parts were ejected through the coupling guard and through a wall to outside the building. (Figure 37).

Figure 37. Hub with Disc Pack Ejection

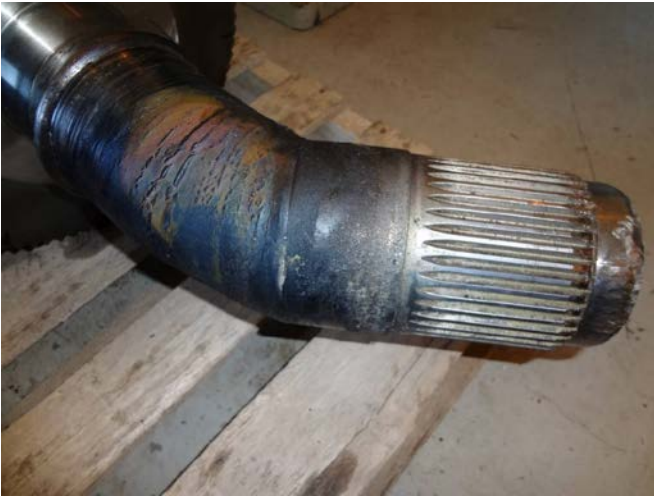
Figure 39. Bent Shaft from Heat

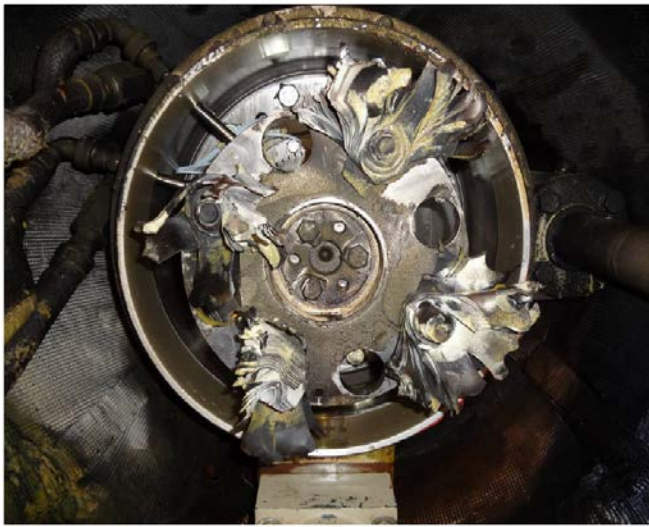
Figure 40. Disc Packs Ripped from Tremendous Forces

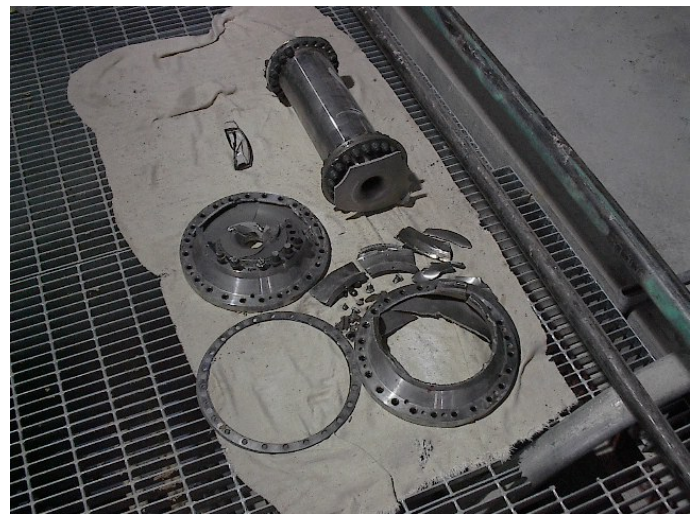
Figure 42. Ejected Parts when Anti-Flail did Not Work

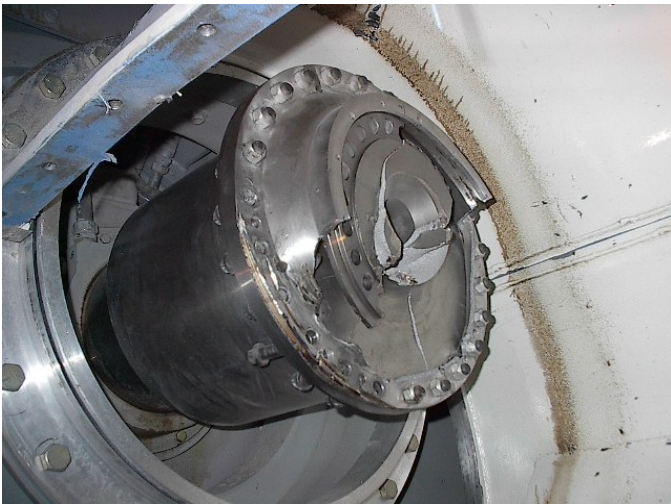
Figure 43. Broken Anti-Flail Guard

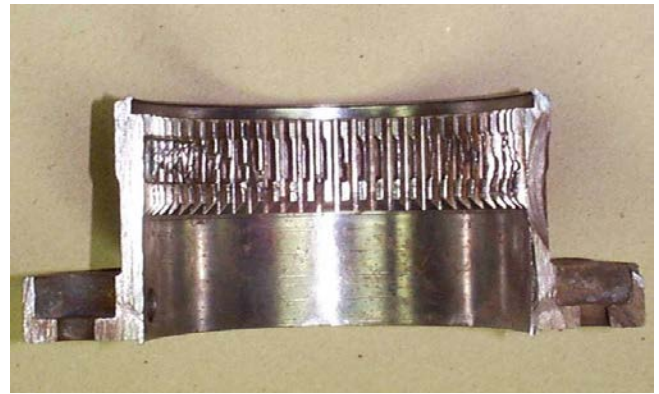
Figure 45. Coupling half, sectioned for easier viewing.

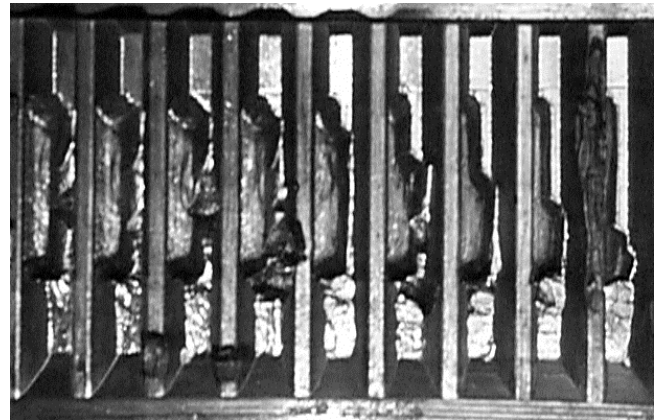
Figure 46. Tooth Damage Close Up.

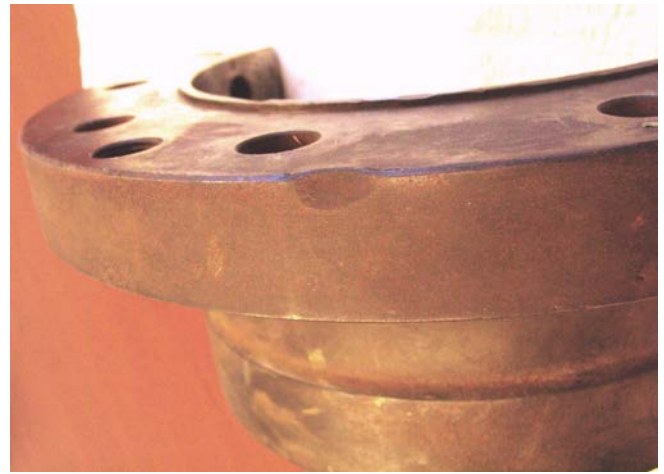
Figure 48. Dimple prevented sealing, allowed grease to leak

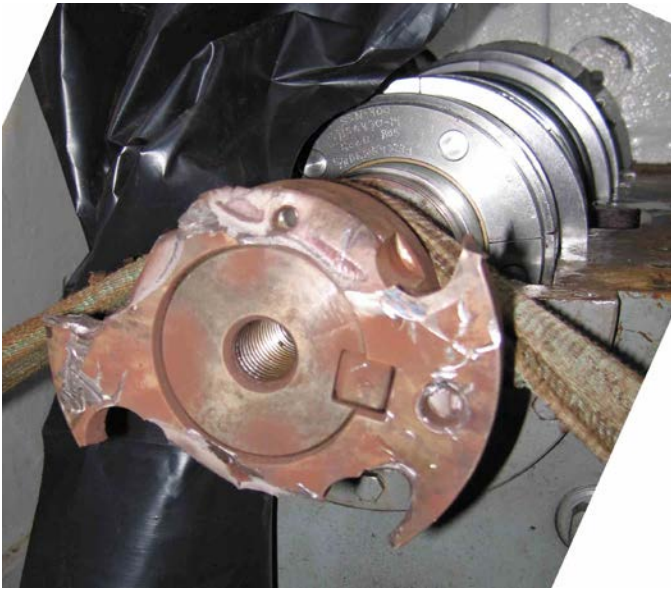
Figure 49. Compressor hub, fractured with worn bolt holes.

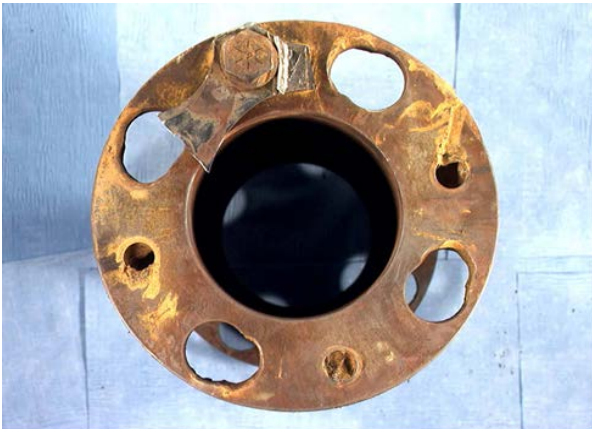
Figure 50. Oblong bolt holes in spool hub on compressor side.

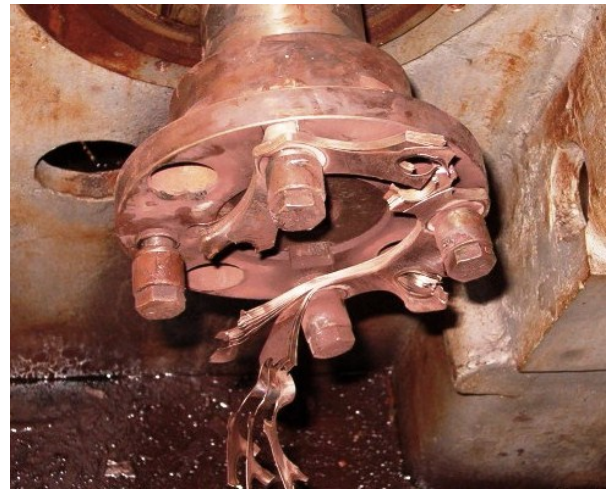
Figure 52. Turbine hub disc pack sudden fracture.

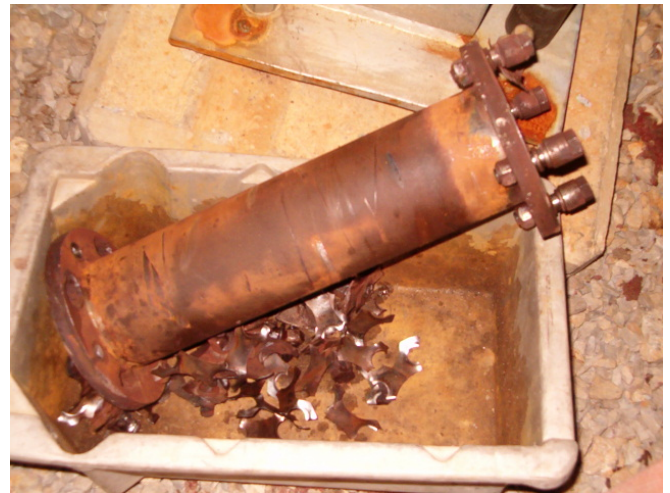
Figure 53. Coupling spool piece which ejected from the machine.

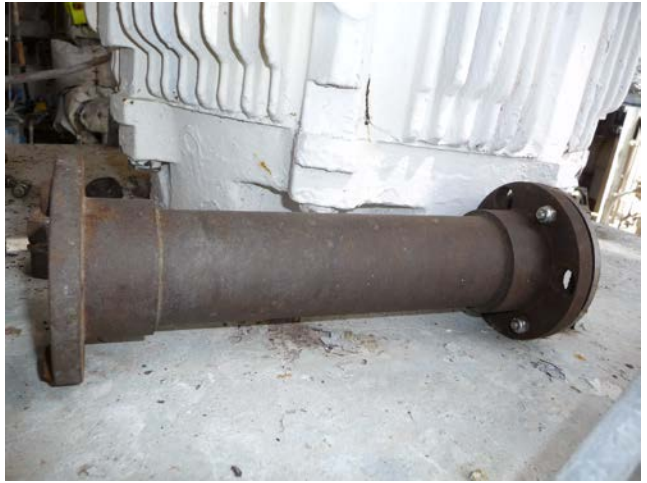
*Figure 55. Disc pack spool piece was ejected on start up.*

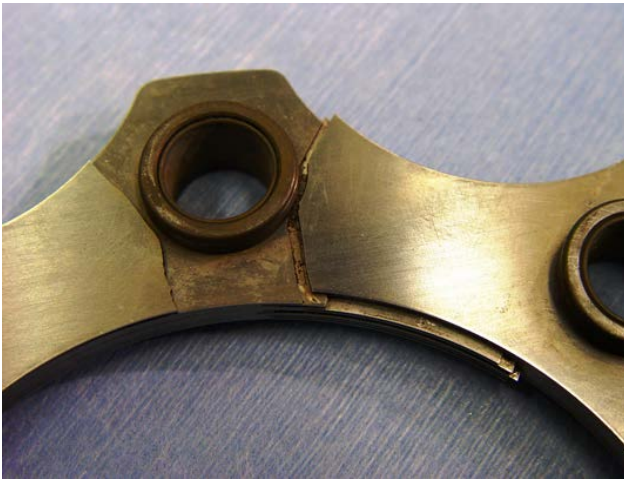
Figure 58. Failing disc pack with missing shards found by an alert operating crew!

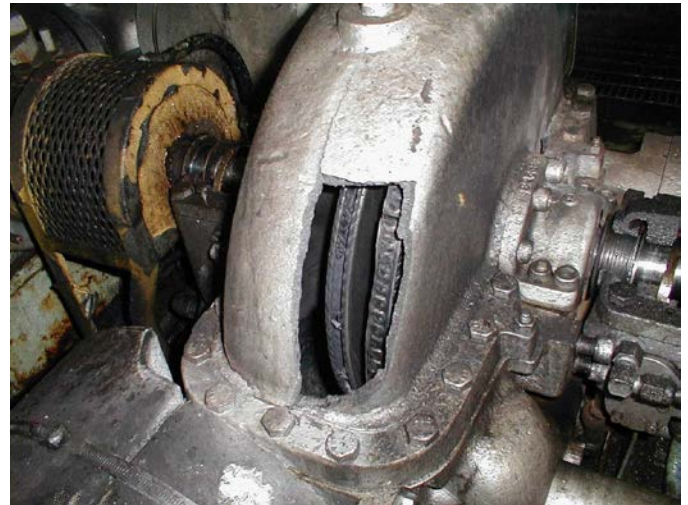
Figure 59. Turbine ran away after gear coupling failed

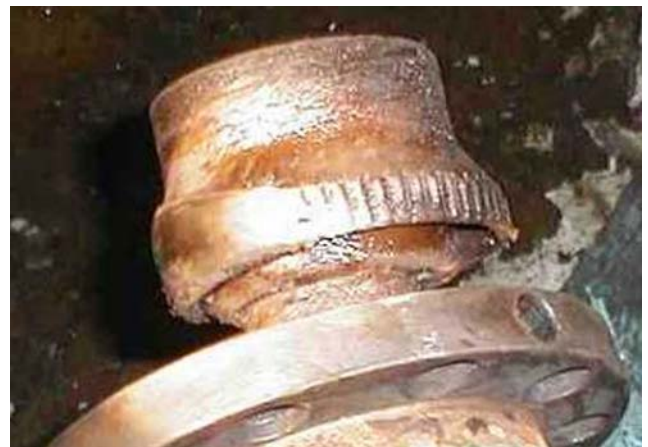
Figure 60. Heavy wear due to grease being displaced by water.

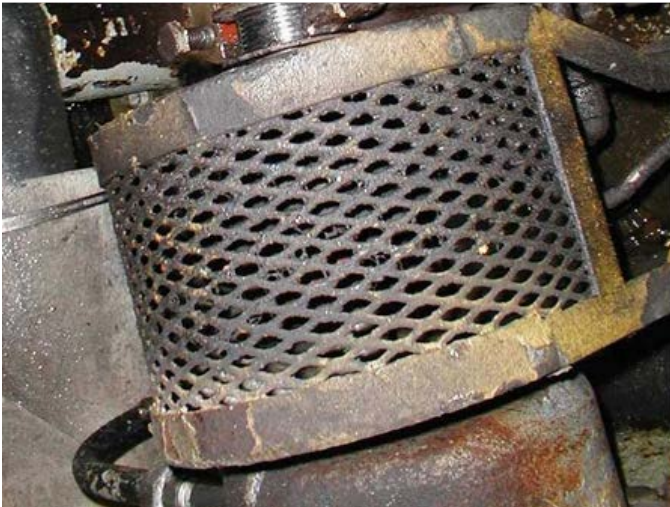
Figure 61. Grease displaced by water collects on guard made visible by an expanded metal guard. Solid guards hide leakage.

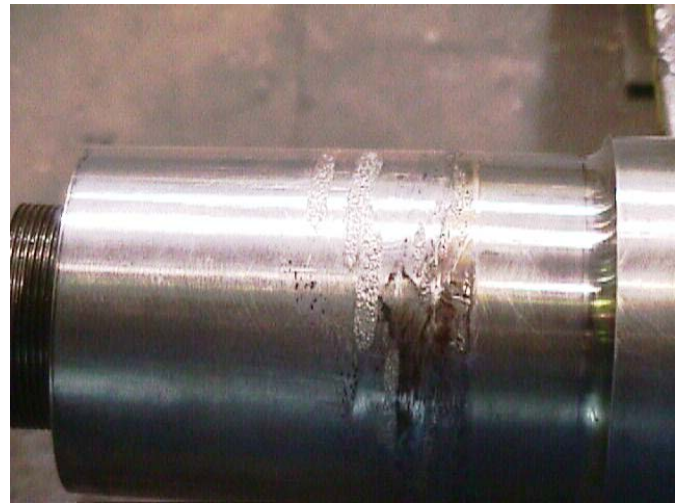
Figure 69. Shaft fretting from improper hub fit

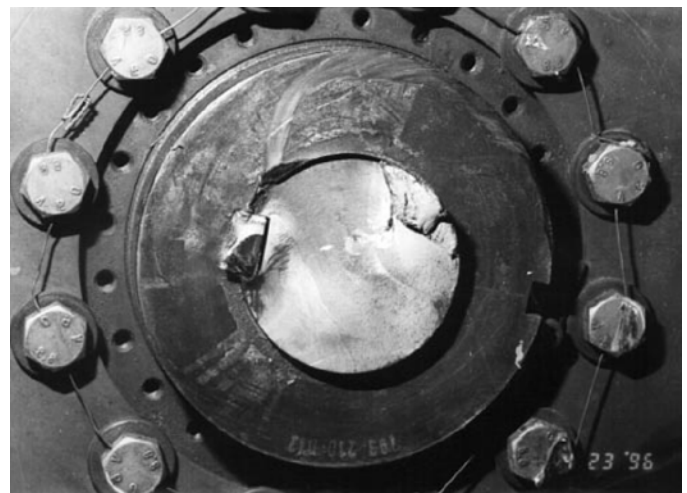
Figure 70. Shaft failure from improper hub fit

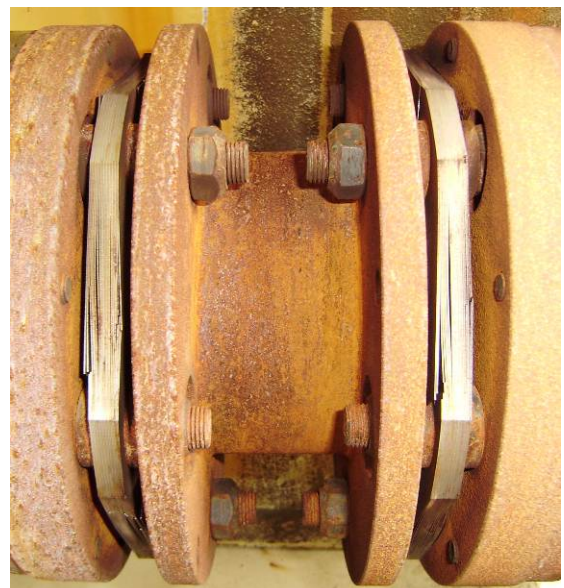
Figure 74. Disc Breakage from Angular and Parallel Misalignment

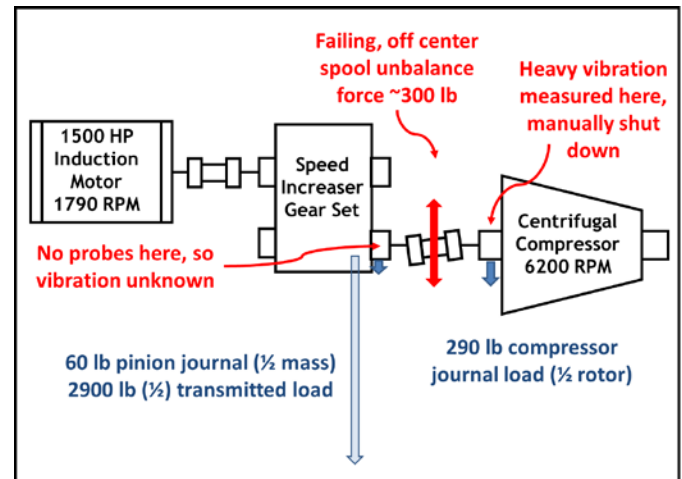
Figure 76. Case 9 compressor gear coupling damaged mesh on pinion side, picked up on compressor vibration

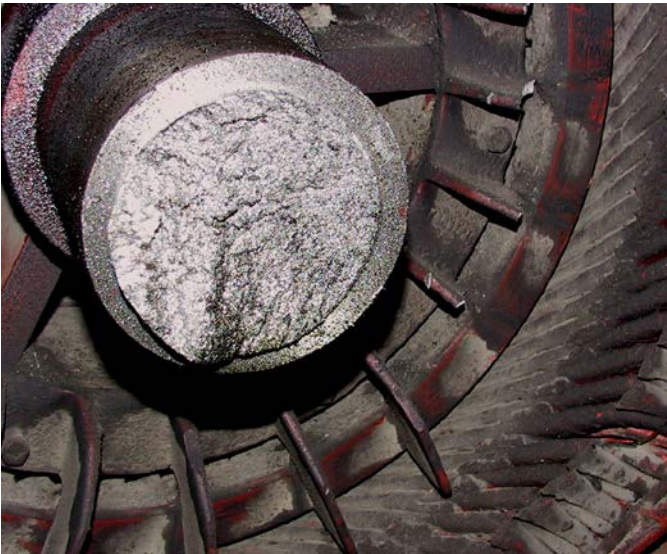
Figure 82. Close up of fractured motor shaft
