## Corrosion of Aluminium Alloy in White Mangrove Wood Ash Solution

C.A. Loto.

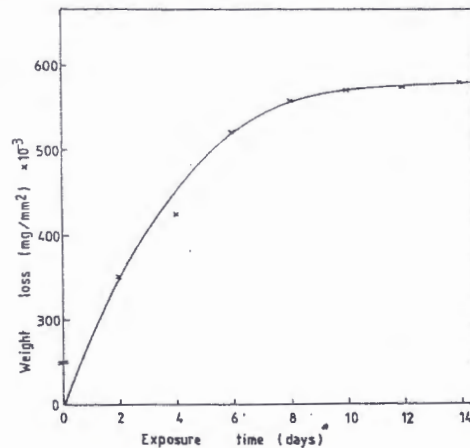
**Figure 1.** Variation of exposure time with weight loss for the aluminium alloy test specimen immersed in white mangrove wood ash solution.

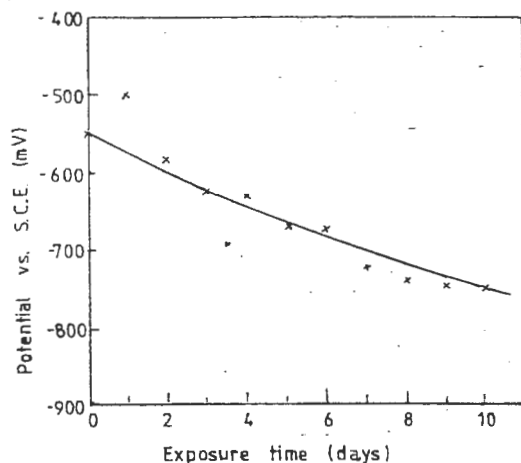
Figure 2. Variation of potential with time (in days) for the aluminium alloy specimens immersed in white mangrove wood ash solution

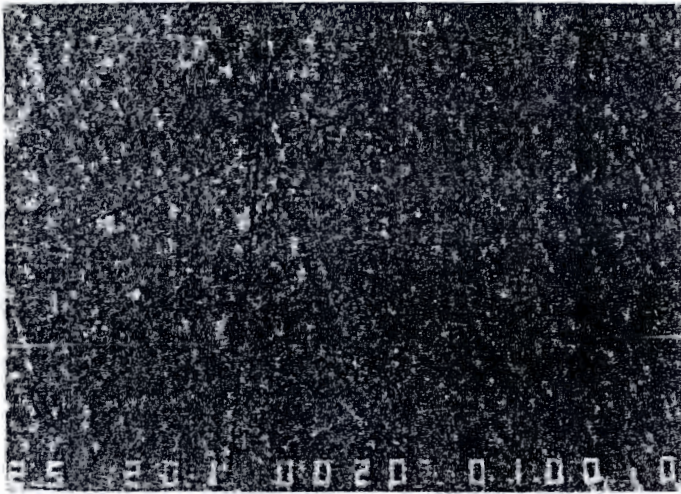
Figure 3. S.E.M. micrograph of the test aluminium alloy's surface before immersion in test environment.

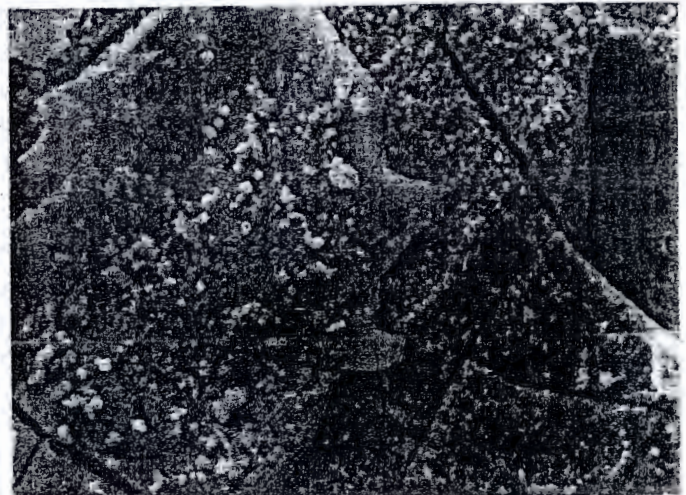
Figure 4. S.E.M. micrograph of the test aluminium alloy's surface after immersion in test environment showing hard brittle corrosion deposits and oxide layers.

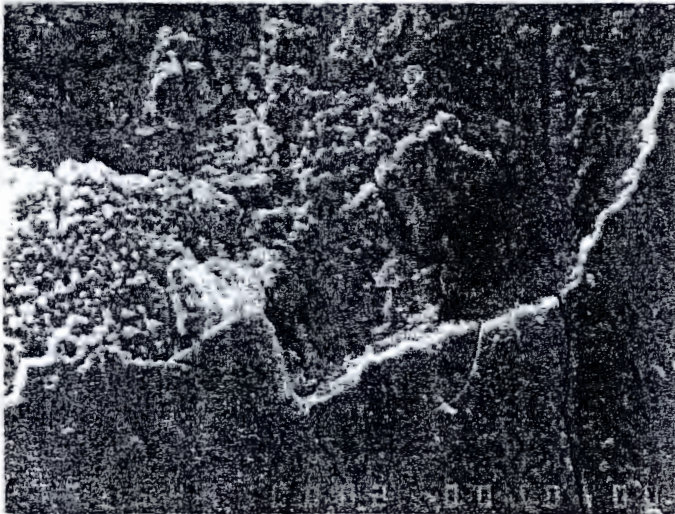
Figure 5. Surface of the test aluminium alloy after immersion showing further corrosion deposits and cracked oxide layers.

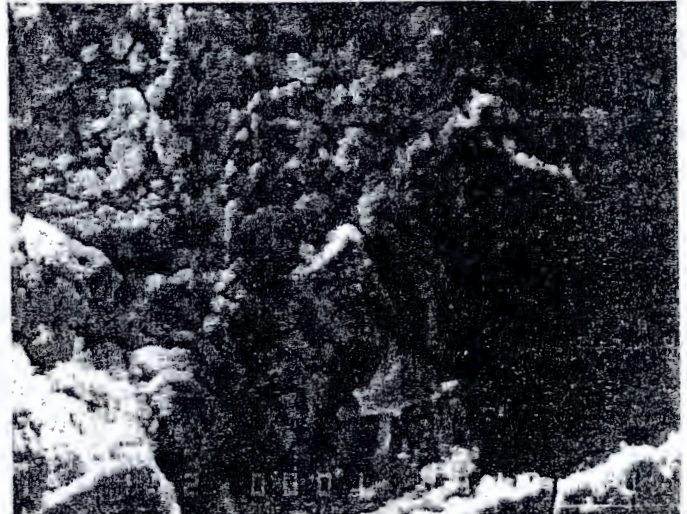
Figure 6. Surface of the test aluminium alloy after immersion showing further corrosion deposits and cracked oxide layers as in Fig. 5, but at higher magnification.

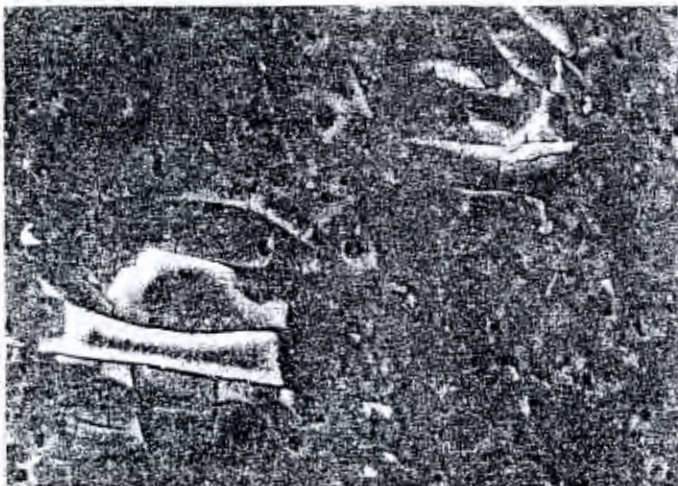
Figure 7. S.E.M. micrograph of the test aluminium alloy surface after immersion showing extensive pitting of the specimen's surface located underneath the corrosion deposits.

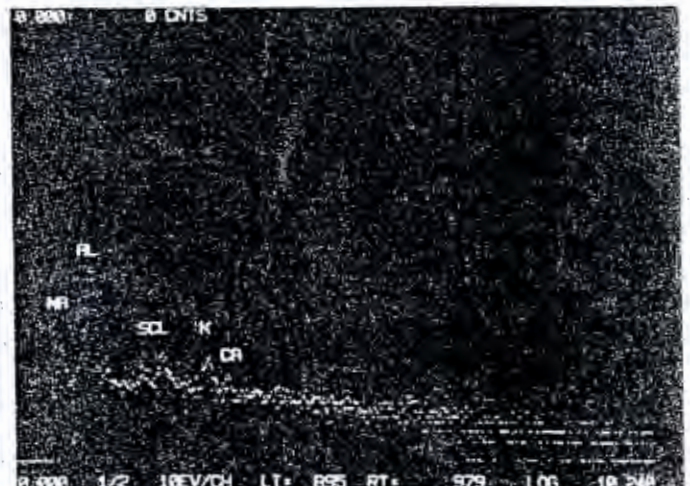
Figure 8. S.E.M./E.D.S analysis of the corrosion deposit on the test aluminium alloy surface after immersion in the mangrove wood ash solution.

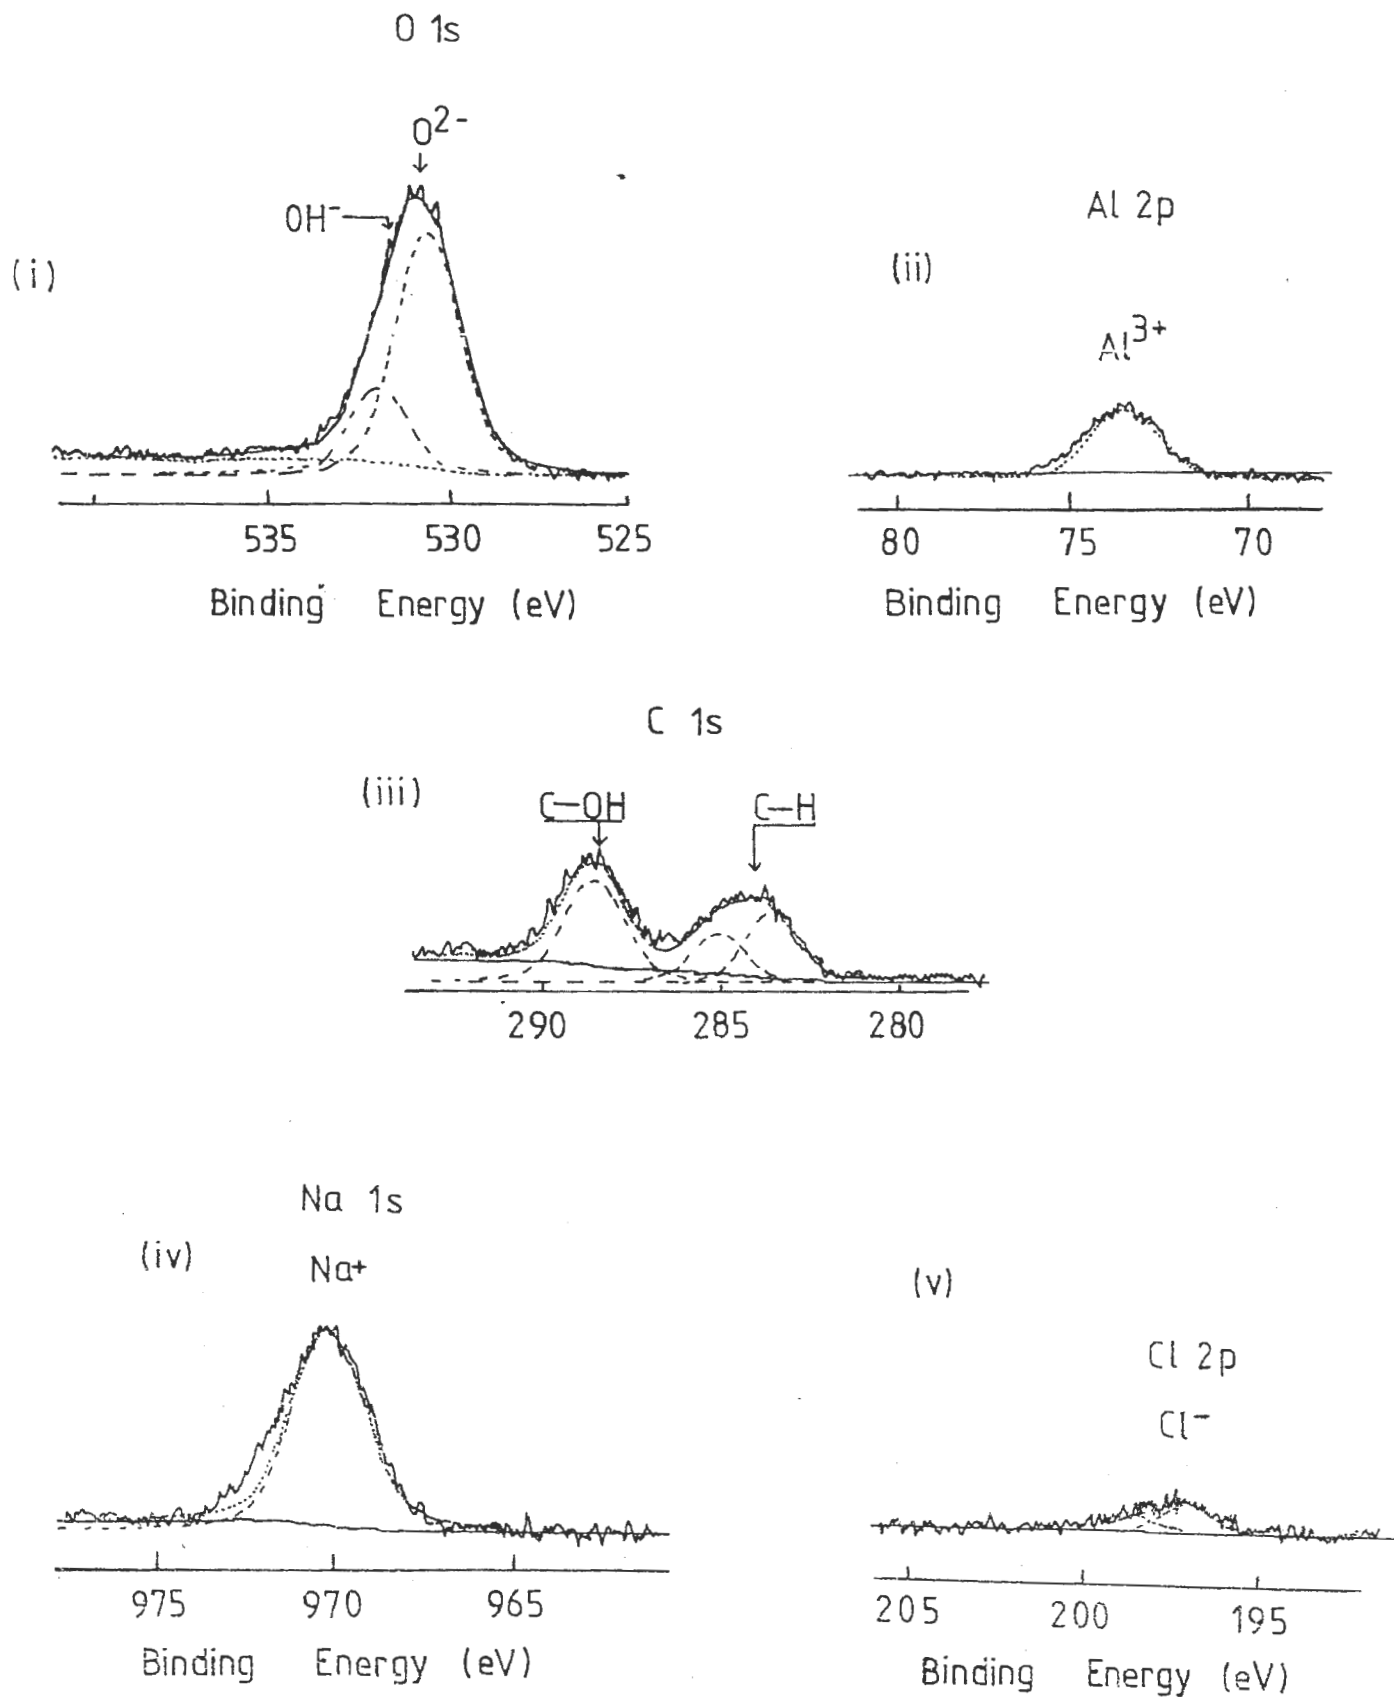
Figure 9. ESCA spectra of the corrosion deposit recorded after corrosion test from aluminium alloy test specimen exposed to white mangrove wood ash solution for 14 days at ambient temperature
