Habitat assessment and ecological restoration design for an unnamed tributary of Stone Dam Creek, Conway, Arkansas

Undergraduate Research Articles

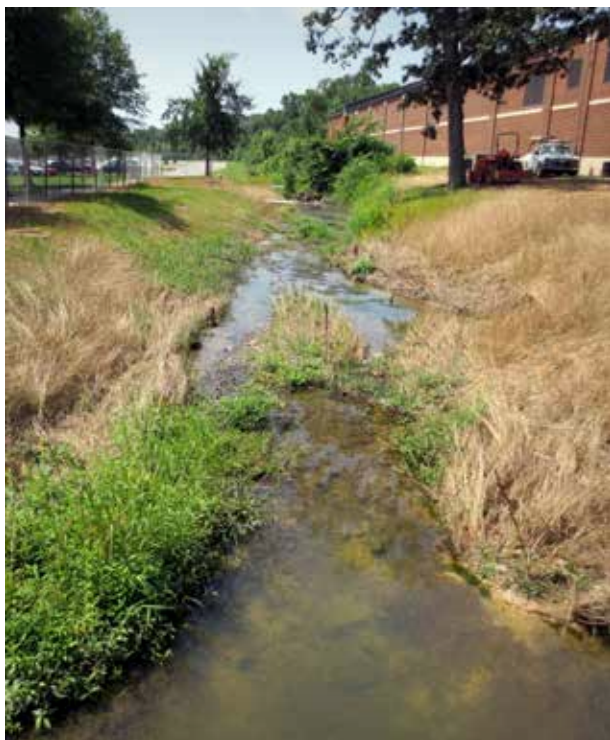
Study Area. The unnamed tributary leads into Stone Dam Creek on the UCA campus in Conway, Ark. It is part of the 109.04 km² Little Creek–Palarm Creek watershed, which is 35.5% urban cover and home to three major universities (ANRC, 2006). The tributary is highly channelized, and runs underground until it surfaces between a large parking lot and the UCA's Health, Physical Education, and Recreation (HPER) building (Fig. 1),

Fig. 1. Downstream view of the unnamed tributary of Stone Dam Creek on the University of Central Arkansas campus, Conway, Ark. University of Central Arkansas Health, Physical Education, and Recreation building shown on the right, with a large parking lot to the left.
