# X-ray microtomography analysis of the damage micromechanisms in 3D woven composites under low-velocity impact

R. Seltzer<sup>a</sup>, C. González<sup>a,b</sup>, R. Muñoz<sup>a</sup>, J. Llorca<sup>a,b,\*</sup>, T. Blanco-Varela<sup>c</sup>

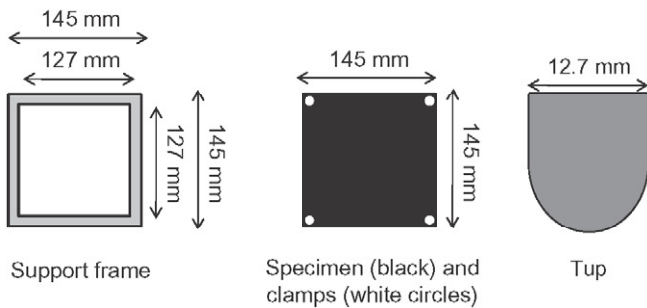
**Fig. 2.** Scheme of drop weight clamping system and tup geometries.

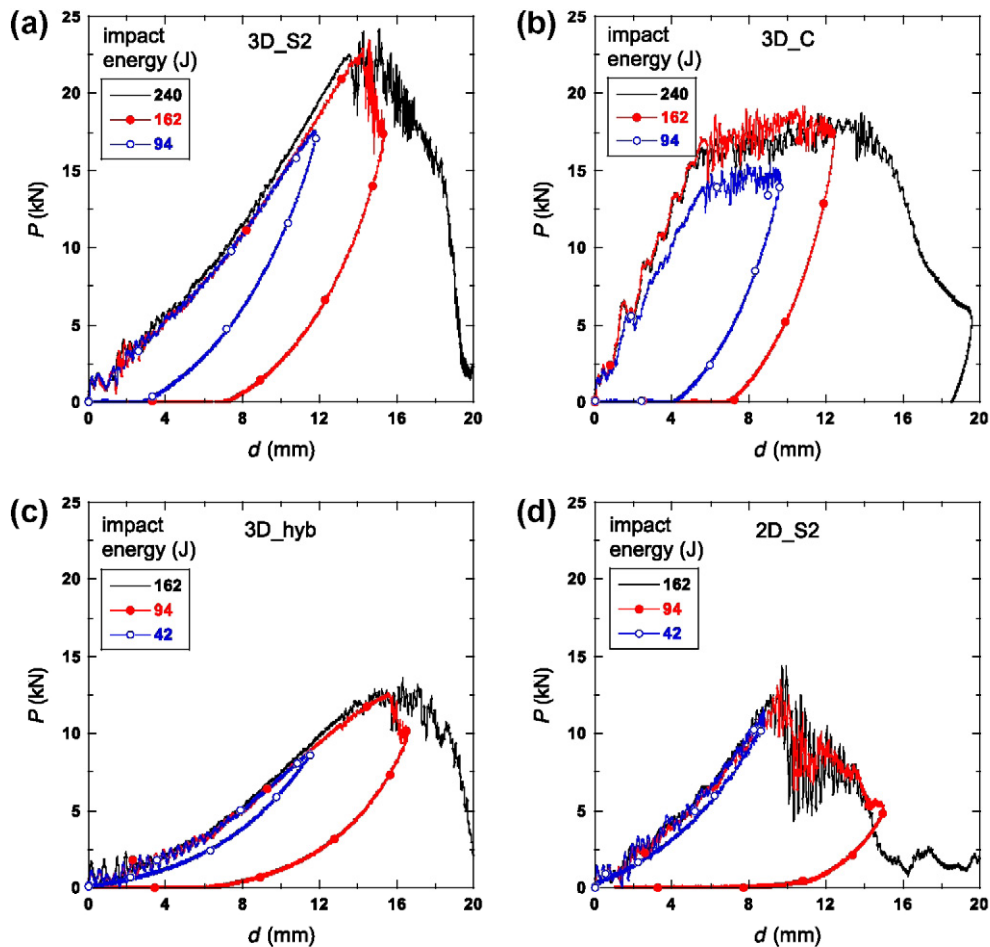
**Fig. 3.** Representative  $P$ - $d$  curves from the low-velocity impact tests. (a) 3D\_S2 composite. (b) 3D\_C composite. (c) 3D\_hyb composite. (d) 2D\_S2 composite. (For interpretation of the references to color in this figure legend, the reader is referred to the web version of this article.)

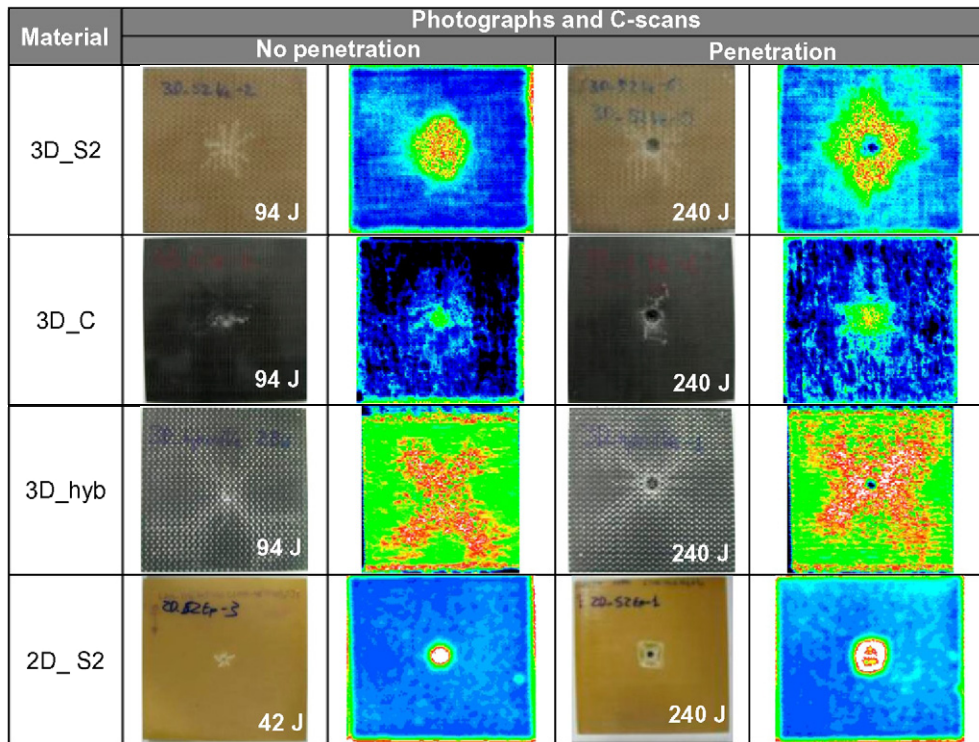
**Fig. 5.** Photographs of the back face and C-scans of the composite plates after impact. Results for two different impact energies are shown for each material, corresponding to no penetration and full penetration. The color scale is related to the depth of the first crack. The white-red regions stand for the cracks further away from the scanned surface, while undamaged regions are shown in black-navy blue. (For interpretation of the references to color in this figure legend, the reader is referred to the web version of this article.)

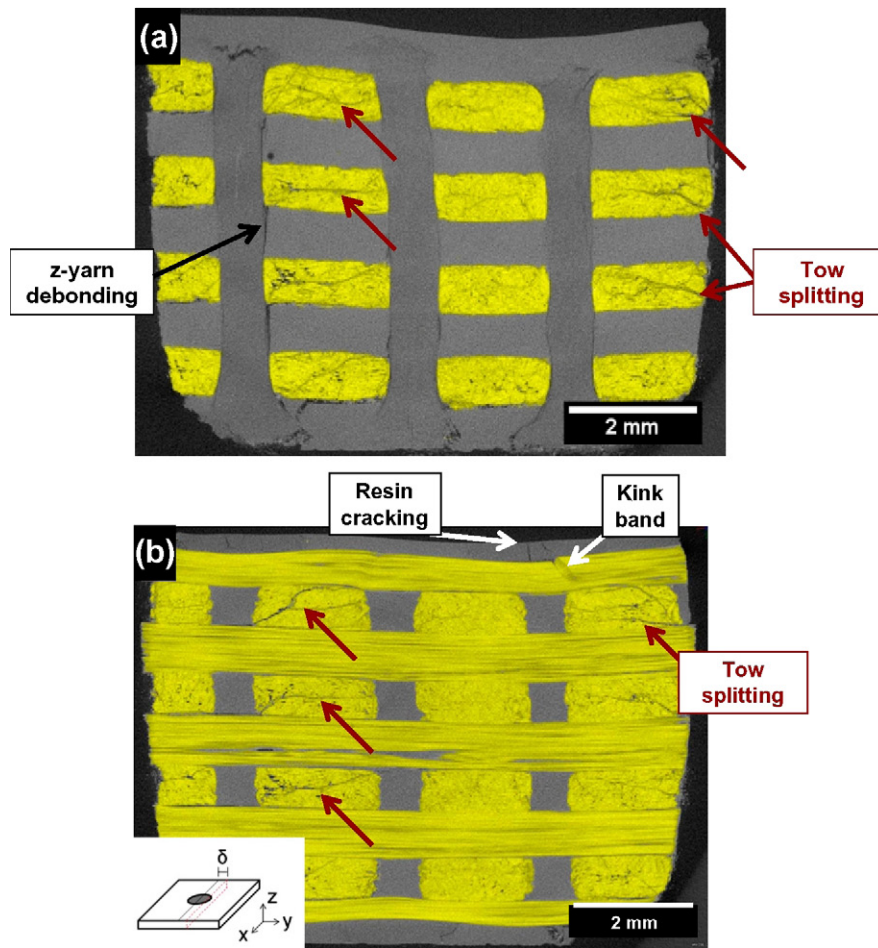
**Fig. 6.** Tomographic cross-sections (perpendicular to the  $y$  axis) of the 3D\_S2 composite impacted with 94 J. (a) Cross-section below the impact center. (b) Cross section at  $\delta = 1.7$  mm from the impact center. PE z-yarns and resin are grey, while S2-glass fibers are yellow. Arrows with different colors indicate different failure micromechanisms. (For interpretation of the references to color in this figure legend, the reader is referred to the web version of this article.)

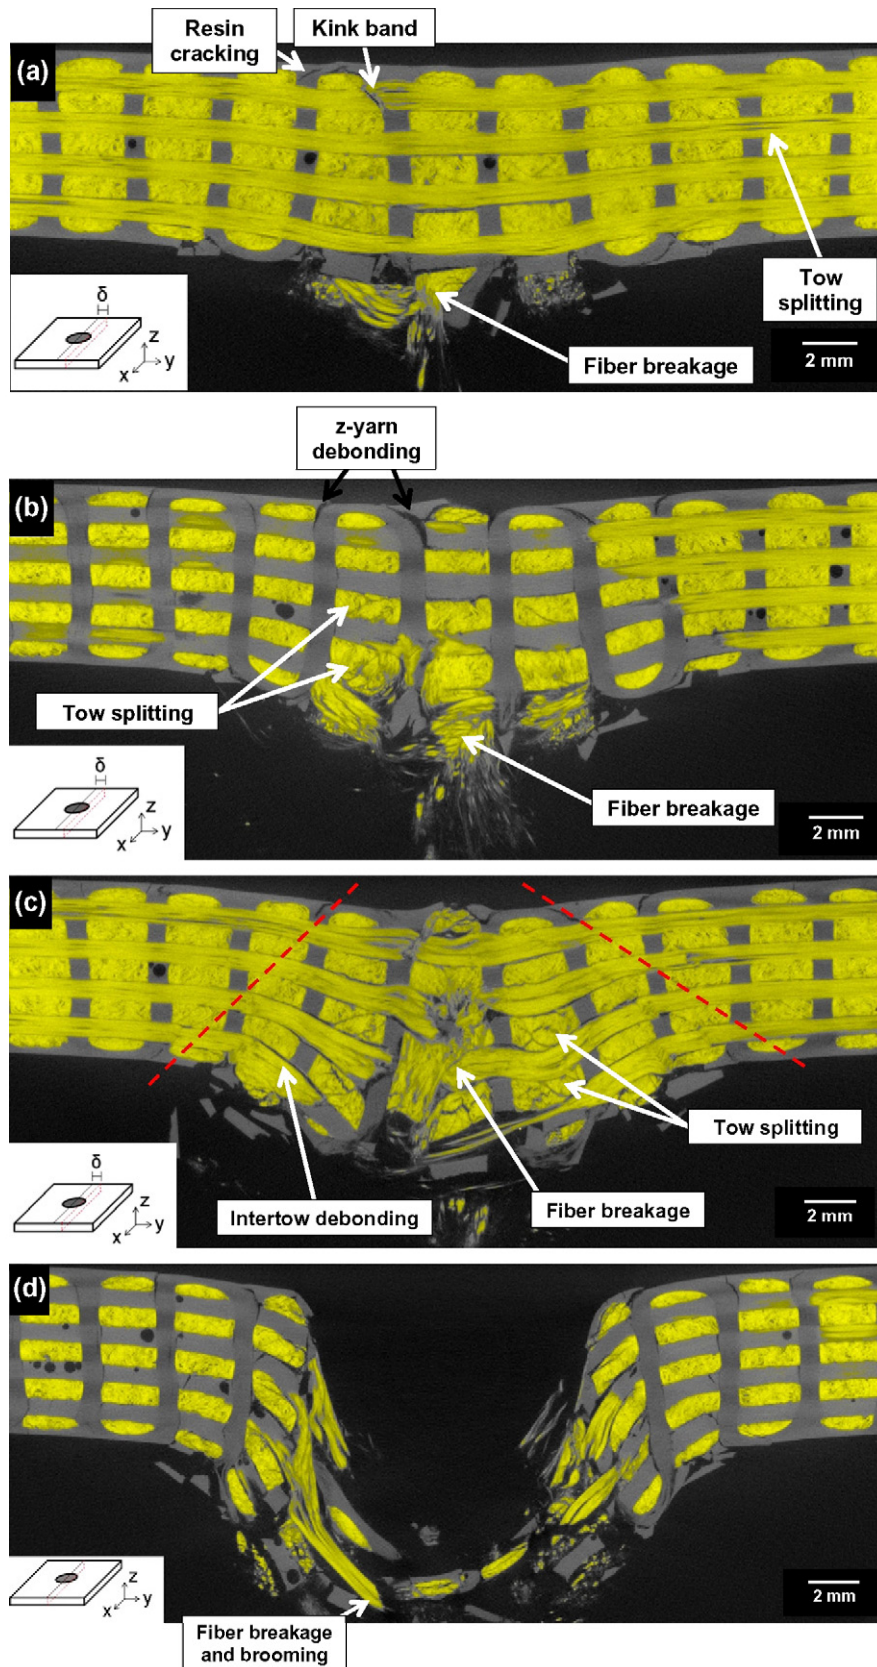
**Fig. 7.** Tomographic cross-sections (perpendicular to the y axis) of the 3D\_S2 composite impacted with 240 J. (a) Cross section at  $\delta = 5.9$  mm from the impact center. (b) Cross section at  $\delta = 5.5$  mm from the impact center. (c) Cross section at  $\delta = 4.2$  mm from the impact center. (d) Cross-section below the impact center. PE z-yarns and resin are grey, while S2-glass fibers are yellow. Black regions are matrix voids. Arrows indicate different failure micromechanisms. (For interpretation of the references to color in this figure legend, the reader is referred to the web version of this article.)

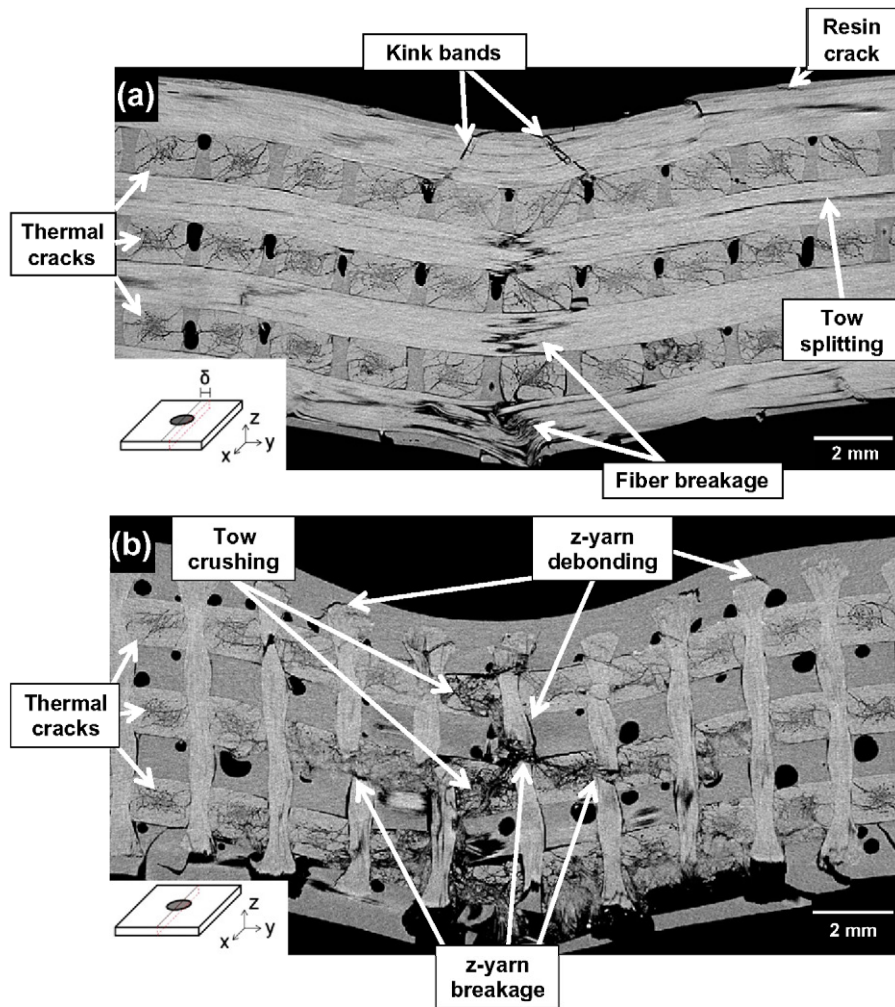
**Fig. 8.** Tomographic cross-sections (perpendicular to the  $y$  axis) of the 3D\_C composite impacted with 94 J. (a) Cross section at  $\delta = 3.2$  mm from the impact center. (b) Cross section below the impact center. Carbon fibers (fiber tows and z-yarns) appear in light grey while the resin is grey. Black regions are matrix voids. Arrows indicate different failure micromechanisms. (For interpretation of the references to color in this figure legend, the reader is referred to the web version of this article.)

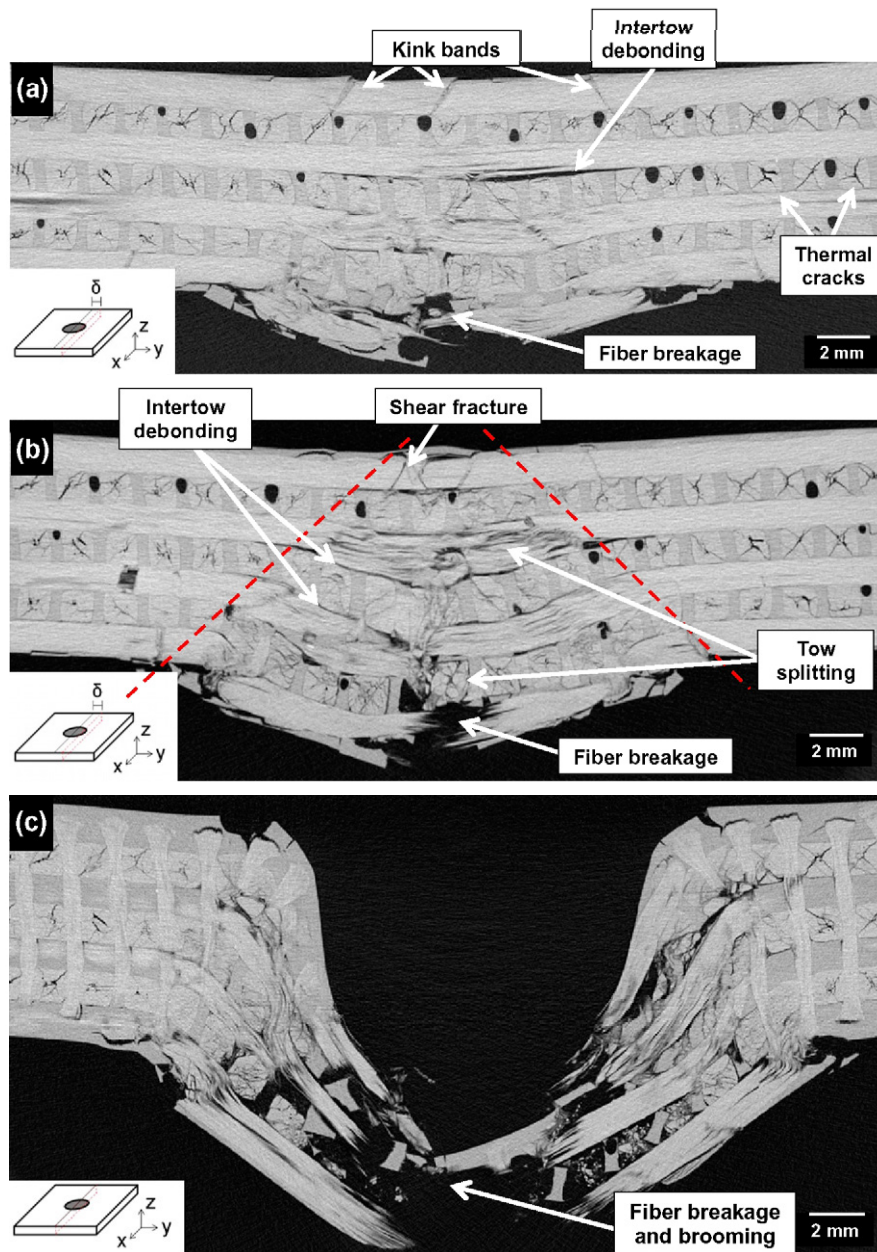
**Fig. 9.** Tomographic cross-sections (perpendicular to the  $y$  axis) of the 3D\_C composite impacted with 240 J. (a) Cross section at  $\delta = 7.6$  mm from the impact center. (b) Cross section at  $\delta = 6.2$  mm from the impact center. (c) Cross-section below the impact center. carbon fibers (fiber tows and z-yarns) appear in light grey while the resin is grey. Arrows indicate different failure micromechanisms. (For interpretation of the references to color in this figure legend, the reader is referred to the web version of this article.)

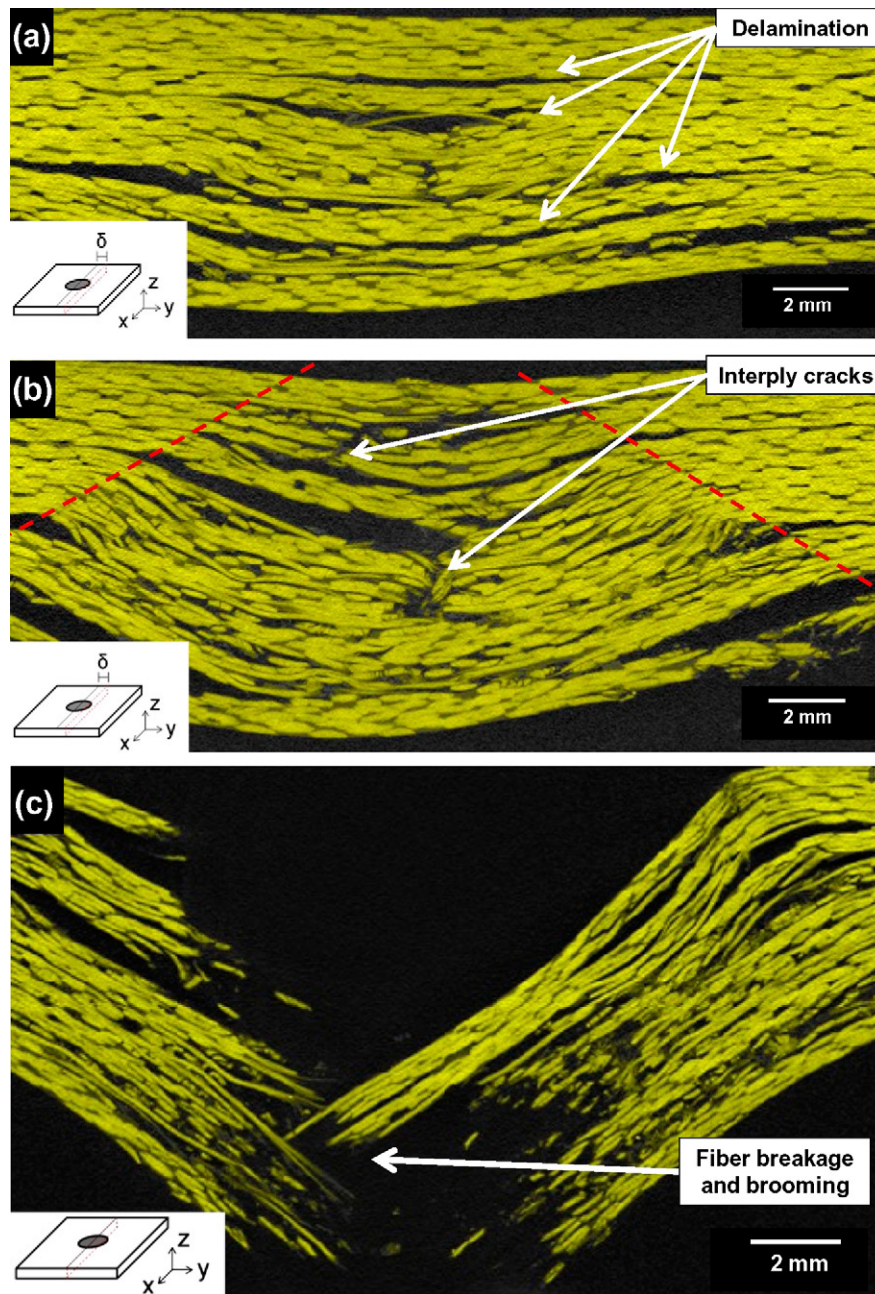
**Fig. 10.** Tomographic cross-sections (perpendicular to the  $y$  axis) of the 2D\_S2 laminate impacted with 240 J. (a) Cross section at  $\delta = 7.8$  mm from the impact center. (b) Cross section at  $\delta = 5.8$  mm from the impact center. (c) Cross-section below the impact center. Glass fibers appear in yellow. Arrows indicate different damage mechanisms. (For interpretation of the references to color in this figure legend, the reader is referred to the web version of this article.)
