Epithermal Neutron Beam Interference with Cardiac Pacemakers

Keywords: Neutron activation, pacemaker, MCNP, SERA

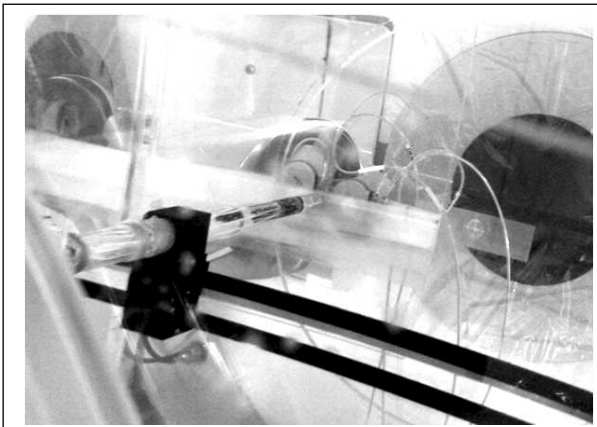
Figure 1. Exradin Mg(Ar) ionization chamber, activation foils and the pacemakers inside the water phantom placed at 10 cm distance from the 14 cm circular FiR 1 beam aperture.

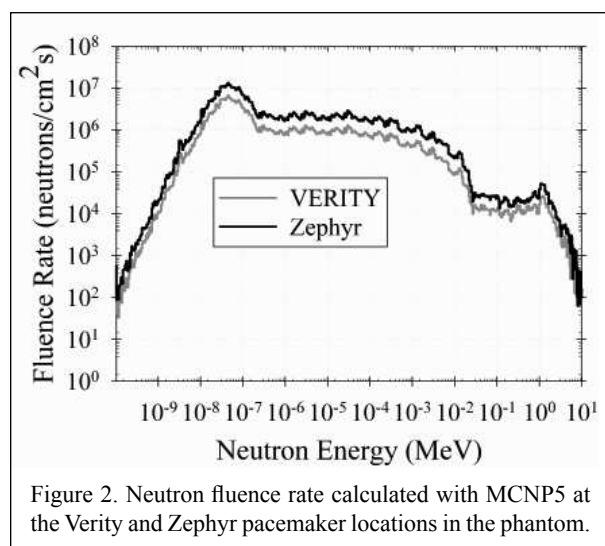
Figure 2. Neutron fluence rate calculated with MCNP5 at the Verity and Zephyr pacemaker locations in the phantom.
