RAPID RESERVOIR SEDIMENTATION OF FOUR HISTORIC THIN ARCH DAMS IN AUSTRALIA

by H. CHANSON¹ and P. JAMES²

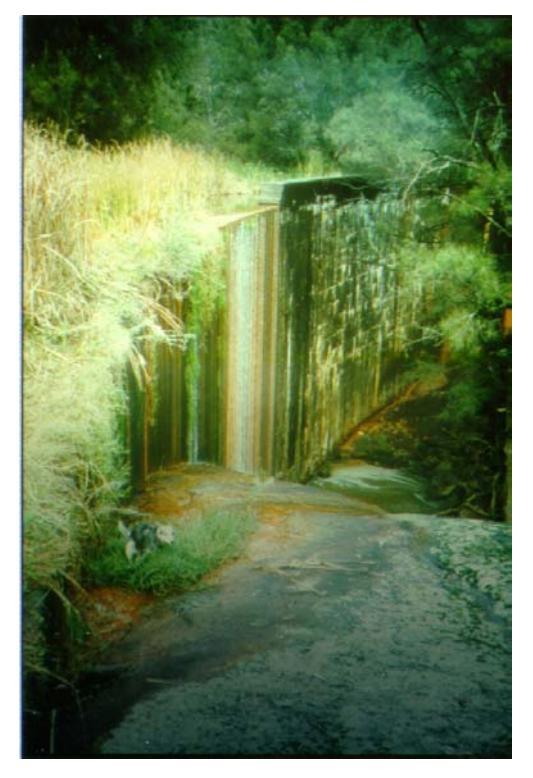
Figure 2 - Moore Creek dam (1898)

Between 1898 and 1911, the reservoir was filled with $85,000 \text{ m}^3$ of sediment. Observations recorded at the time suggested that most siltation took place during the floods of February 1908 and January 1910. In 1924 the reservoir ceased completely to supply water because it was fully silted. The dam is still standing today and listed in ICOLD (1984).

(B) Downstream vertical wall. View from the right bank. Photograph taken on 14 June 1997 (by H. CHANSON)

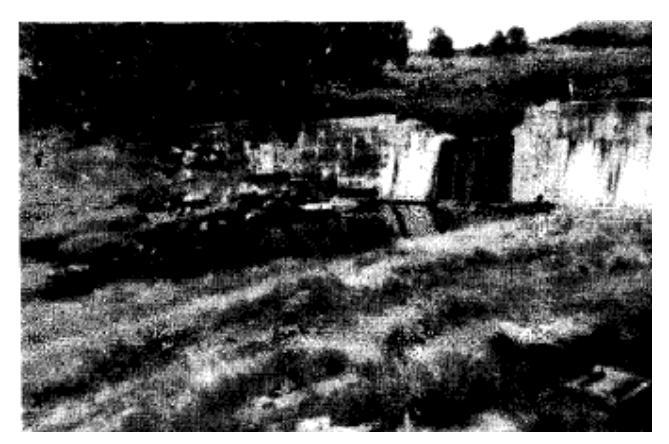
Figure 3 - Gap weir (1902)

The reservoir became fully-silted by 1924. It was abandoned and replaced by available water supply from Quipolly Creek and later from the Quipolly dam⁵. Since 1924, the dam wall was blasted twice to facilitate the passage of flood flow and to limit upstream flooding. Interestingly, the reservoir is located downstream of a long flat flood plain (slope < 0.2 degrees, streamwise length > 6 km). The river, cutting through into the reservoir sediment, highlights the silty material caught by the weir, suggesting a siltation process by suspended-load.

(A) View from downstream. Photograph taken in the 1960s by N. BEDFORD. The dam opening is smaller than in Figure 3(B).

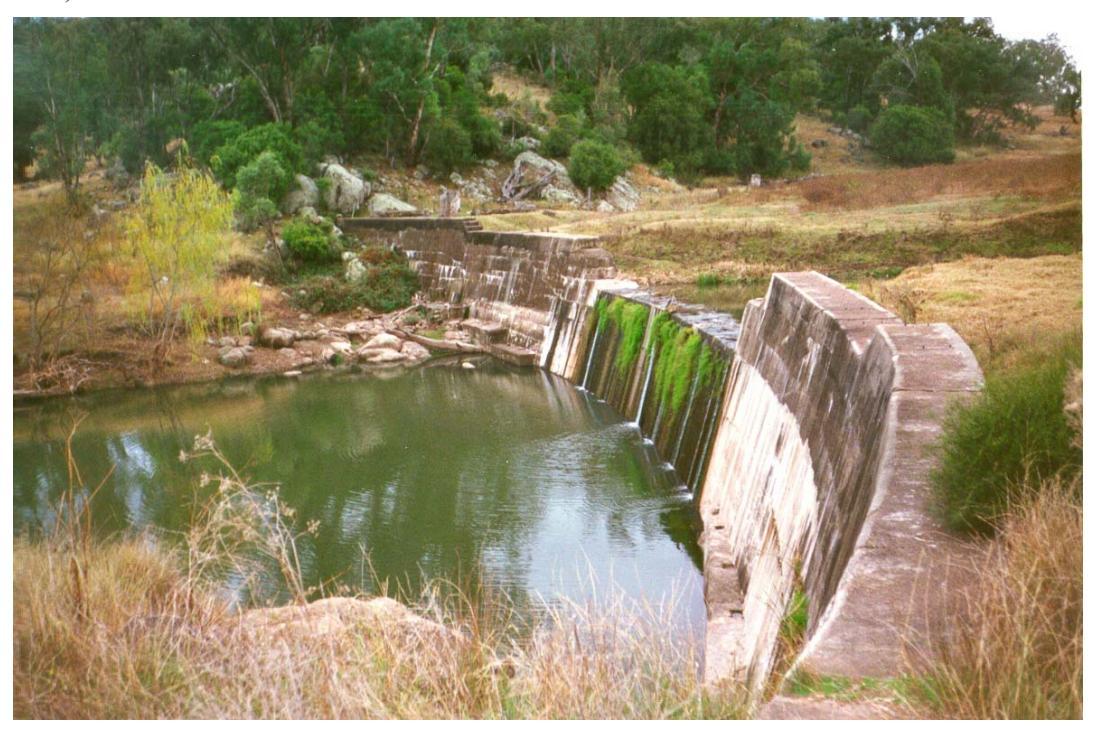
The Gap weir was built without a bottom outlet and thus it could not be scoured. Note, further, that the spillway capacity (35 to 40 m^3/s) was small compared to the Moore Creek and Korrumbyn Creek dams, which both have a smaller catchment.

(B) View from the left bank. The creek flows from the right to the left. Photograph taken on 13 June 1997 (by H. CHANSON)

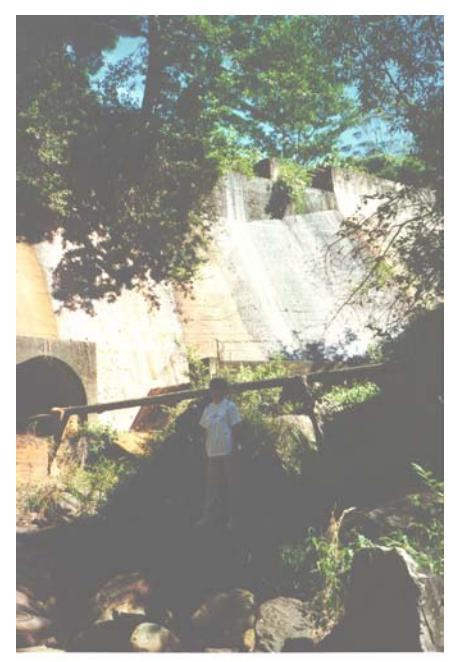
Figure 4 - Korrumbyn Creek dam (1918)

The dam was rapidly abandoned because a log jammed the scour pipe entrance during a flood. It could not be removed and the reservoir silted up very quickly by bed-load. Further, during dry periods, the water level used to drop, the water would turn green and foul as it warmed up, making it unfit for use. The dam still stands today, the reservoir being occupied by an overgrown tropical forest (Fig. 4).

(B) View from downstream. Note the bottom outlet system on the left and the pipe to Murwillumbah. Photograph taken on 25 April 1997 by H. CHANSON.

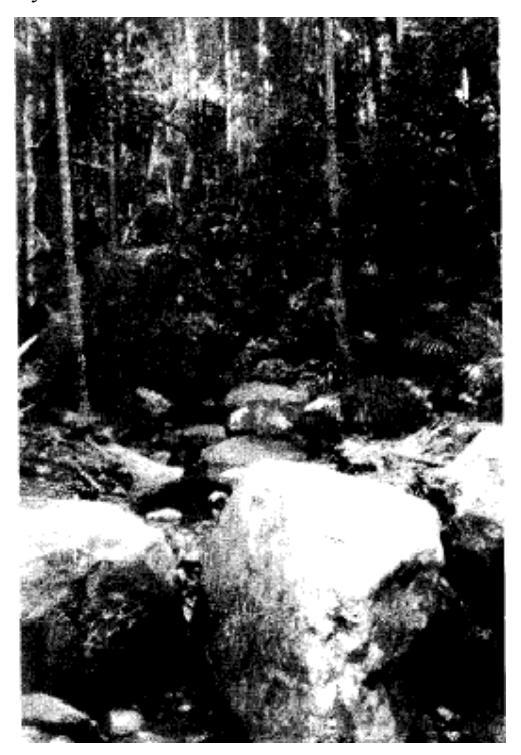
Figure 4 - Korrumbyn Creek dam (1918)

(C) View of Korrumbyn Creek 1.5 km upstream of the dam wall, looking upstream. Note the coarse sediment material. Photograph taken on 25 April 1997 by H. CHANSON.

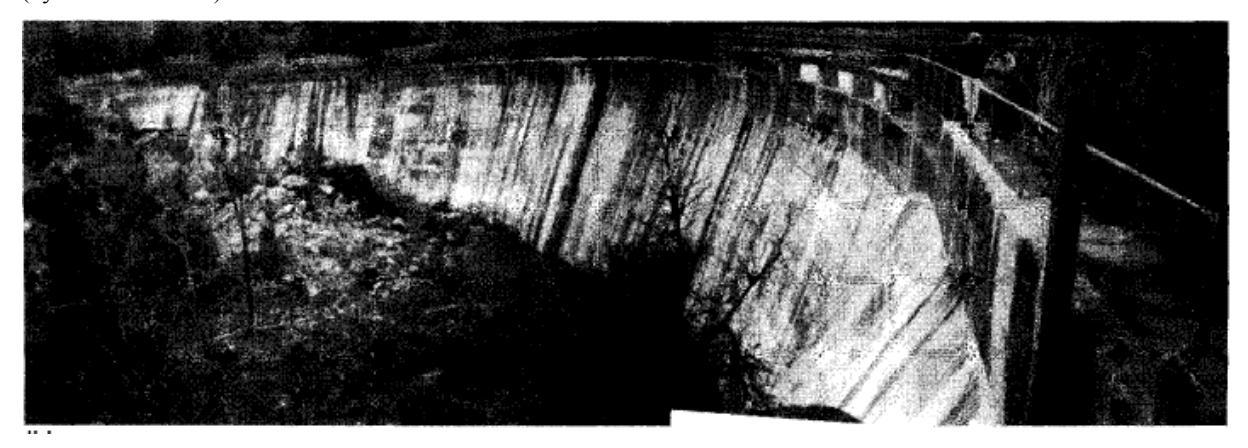
Figure 5 - Quipolly dam (1932)

Between 1932 and 1941, 130,000 m³ of sediment had accumulated (15% of initial reservoir capacity). In 1943 the siltation volume amounted to 290,000 m³ (34% of initial capacity). By 1952, more than half of the initial storage had been lost. The reservoir was abandoned in 1955 at the completion of a new dam (Quipolly dam No. 2), built 3 km downstream, and the reservoir is fully silted today. Although the dam is 'officially' useless, it acts, in fact, as a sediment trap to prevent or reduce the sedimentation of the new Quipolly dam.

(B) View from the left bank. Note the outlet system at the downstream wall bottom. Photograph taken on 13 June 1997(by H. CHANSON)
