Advantages of using raw materials in ancient and recent buildings

In the context of sustainable building construction an early XX century Portuguese watermill building is used in this research work as a study case to show how a roof leaking may lead to a progressive building collapse.

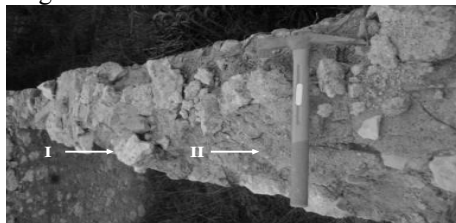
Fig. 4.1. Detail of the structural stone masonries walls

Since this region is sparse in stones, the structural stone masonries walls (exterior and interior) had been built up using irregular and small sized limestone pieces (Fig. 4.1, detail I) agglutinated by a structural mortar (Fig. 4.1, detail II). The average thickness of these walls is 0.40 m.

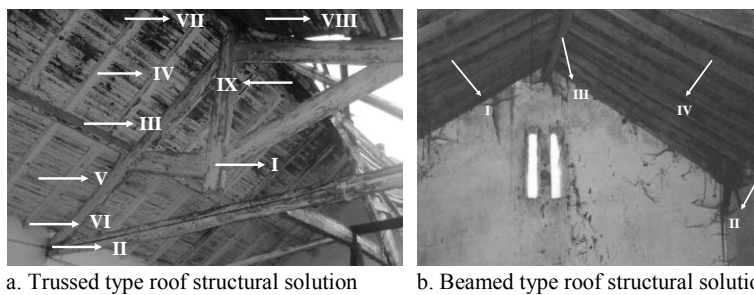
Fig. 5.1. Roof structural systems

The roof timber structural solution comprises two types. In the grind stone and the command rooms (Fig. 5.1-a) it was adopted trusses (Fig. 5.1-a, detail I) directly supported on the limestone based masonries walls (Fig. 5.1-a, detail II), these trusses support beams (Fig. 5.1-a, detail III) which are supporting the purling (Fig. 5.1-a, detail IV). On the purling there are timber boards (Fig. 5.1-a, detail V) supporting the ceramic tiles.

The other type of roof timber structural solution was only applied in the storage room, Fig. 5.1-b, which includes timber beams (Fig 5.1-b. detail I) which were

structures supported on the limestone based masonry walls (Fig. 5.1-b, detail II) and a central timber beam (Fig. 5.1-b, detail III). On these timber beams there were timber boards (Fig. 5.1-b, detail IV) supporting the ceramic tiles.
