DOUBLE CORROSION PROTECTION OF LONG SOIL NAILS AT DEEP BAY LINK – A CASE HISTORY

Nick Koor¹ & Anson Cheung²

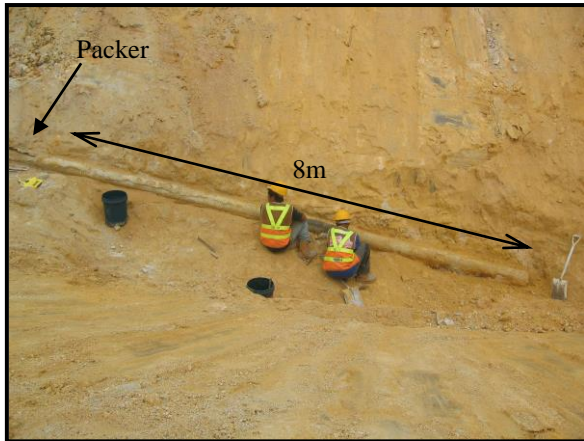
Once tested, three of the longest nails were carefully excavated (Plate 2) to allow close inspection of the nail and to facilitate sampling. Samples were also taken from the exposed grouted sections and saw cut (Plate 3). Several observations were made:

being exposed

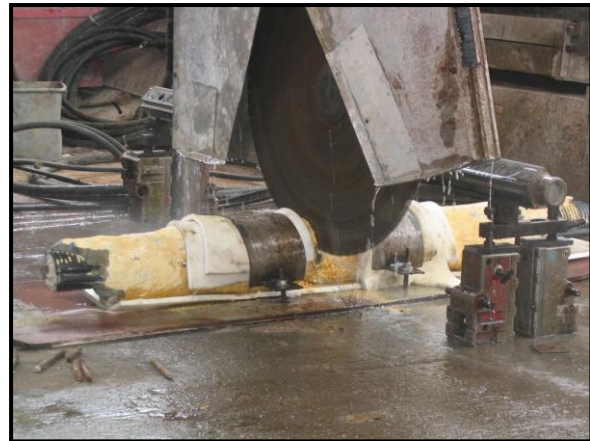
Plate 2 - Preliminary soil nail being saw cut

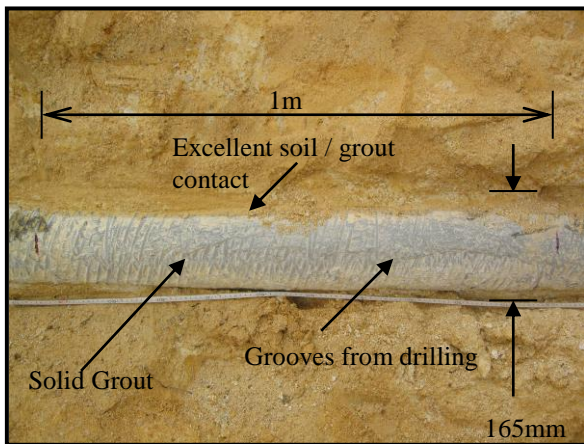
- (1) The grout was continuous over the bond length (Plate 4) with no signs of voids apart from close to the packer.
- (2) Some grout escaped past the external packer (up to 2 m) which generally formed a coating around the drillhole surface with a void between the grout and the sheath.
- (3) Nail PT6 showed signs of crown collapse in the drillhole. The grout within the over-break contained inclusions of soil.
- (4) The grouted diameter measured on nail PT6 ranged from 165 to 180 mm.
- (5) The grout over the bonded length had excellent contact with the ground (Plate 4).
- (6) The nails deviated from the design inclination of 10° to the horizontal by up to 10° for the 30 m long nail PT8.

Plate 4 - Exposed preliminary soil nail

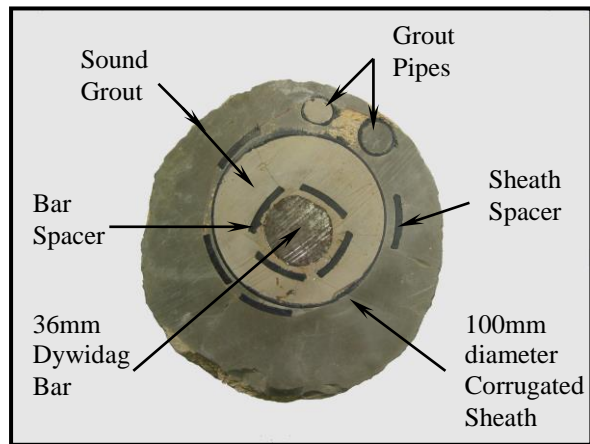
- (7) The saw cut sections revealed continuous sound grout in both the internal and external annuli (Plate 5).
- (8) The corrugated sheath tended to float during the grouting of the outside annulus however the steel bar remained central (Plate 5).

Plate 5 - Section through grouted preliminary soil nail

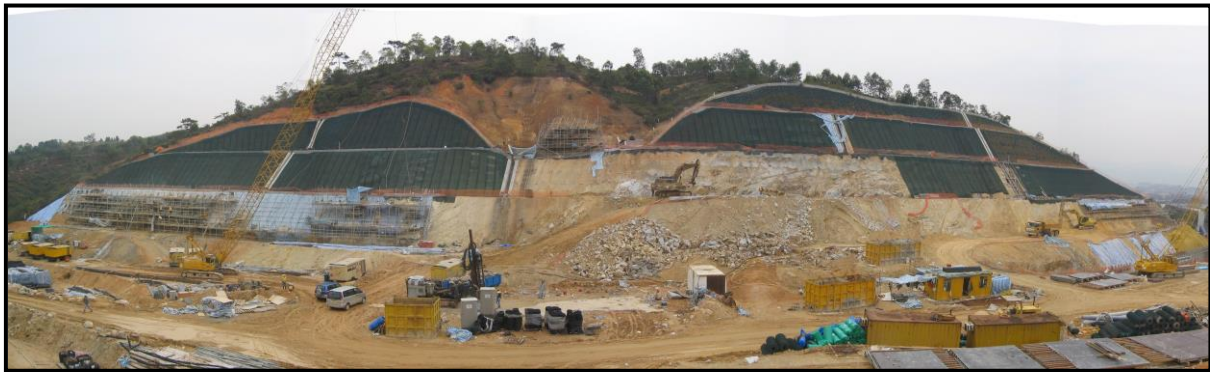
At the time of writing approximately 430 nails with double corrosion protection between 24 and 28 m long have been successfully installed at Deep Bay Link (Plate 6). Initial difficulties were experienced using standard Hong Kong soil nail grouting equipment. The Contractor was not able to fully grout these long nails and there was leakage from the outside annulus into the central annulus. The Contractor has modified his grouting procedure by using slightly larger diameter grout pipes (increased ID from 13 to 17mm), utilizing a pressure grout pump (HD Engineering Ltd GP60) and simultaneously grouting both annuli. On average each 28 m long nail takes about 3 hours to drill in saprolite, 15 to 20 minutes to install the

Plate 6 - General view of 40m high cut slope at northern end of Deep Bay Link during soil nail installation (March 2005)
