# Attoyac Bayou Recreational Use Attainability Analysis

**Attoyac Bayou  
Recreational Use Attainability Analysis**

**Texas State Soil and Water Conservation Board  
Project # 09-10**

**October 2012**

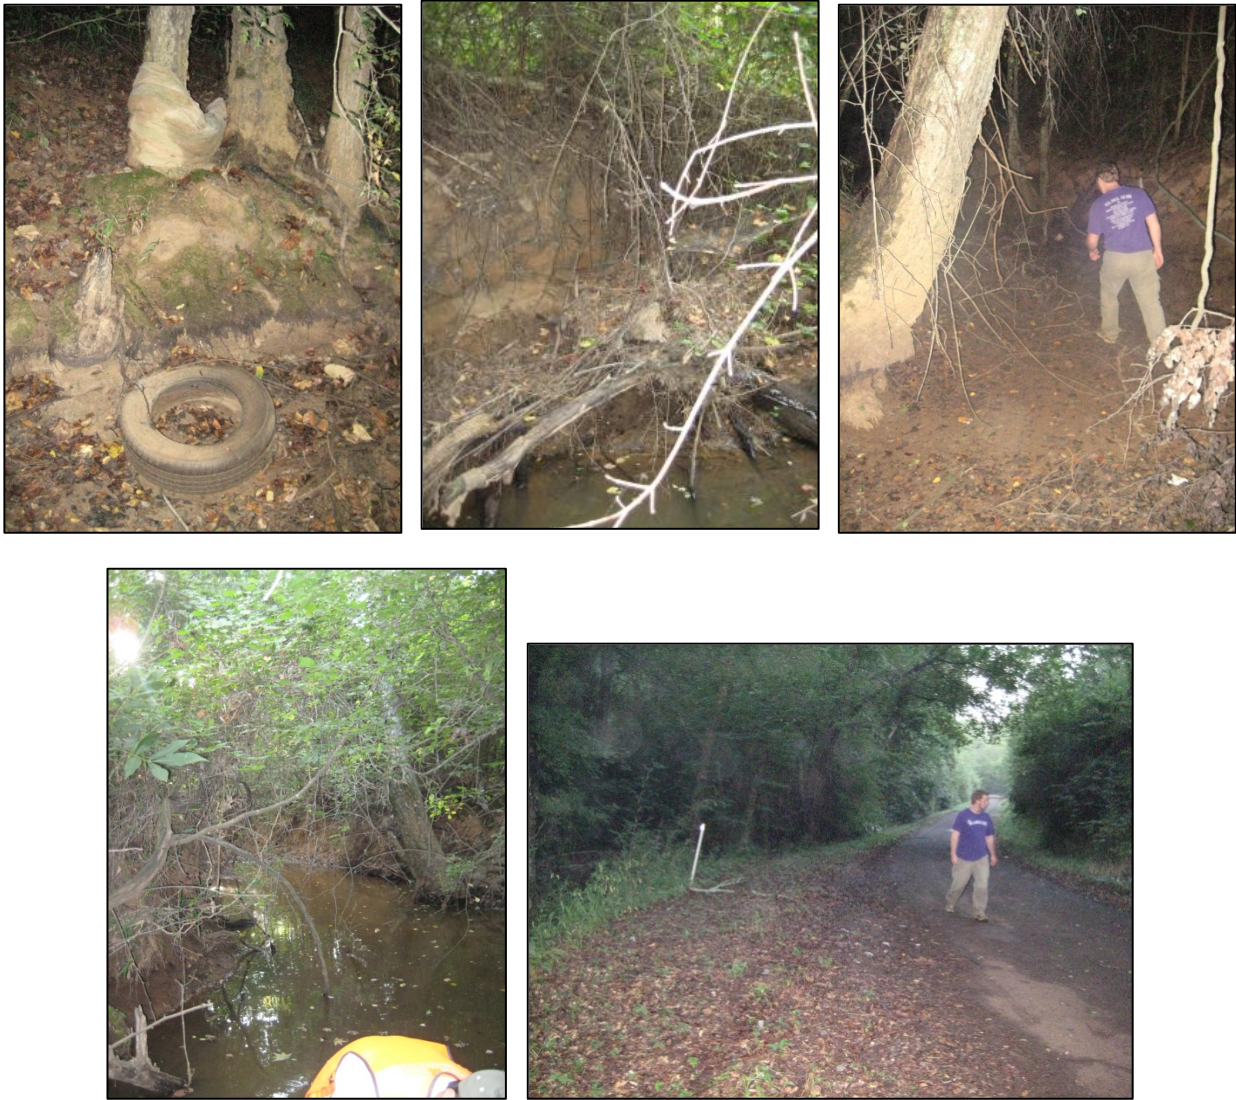
**Photogroup 4-3** Attoyac 3 depicting bank access and general bank appearance. All individuals featured are SFASU and CES staff. Top left: Large channel litter against left bank, August 2012; Top center: 150-m transect, left bank, July 2012; Top right: 30-m transect, downstream, August 2012; Bottom left: 150-m transect, upstream, July 2012; Bottom right: Stream access point from CR 3181.

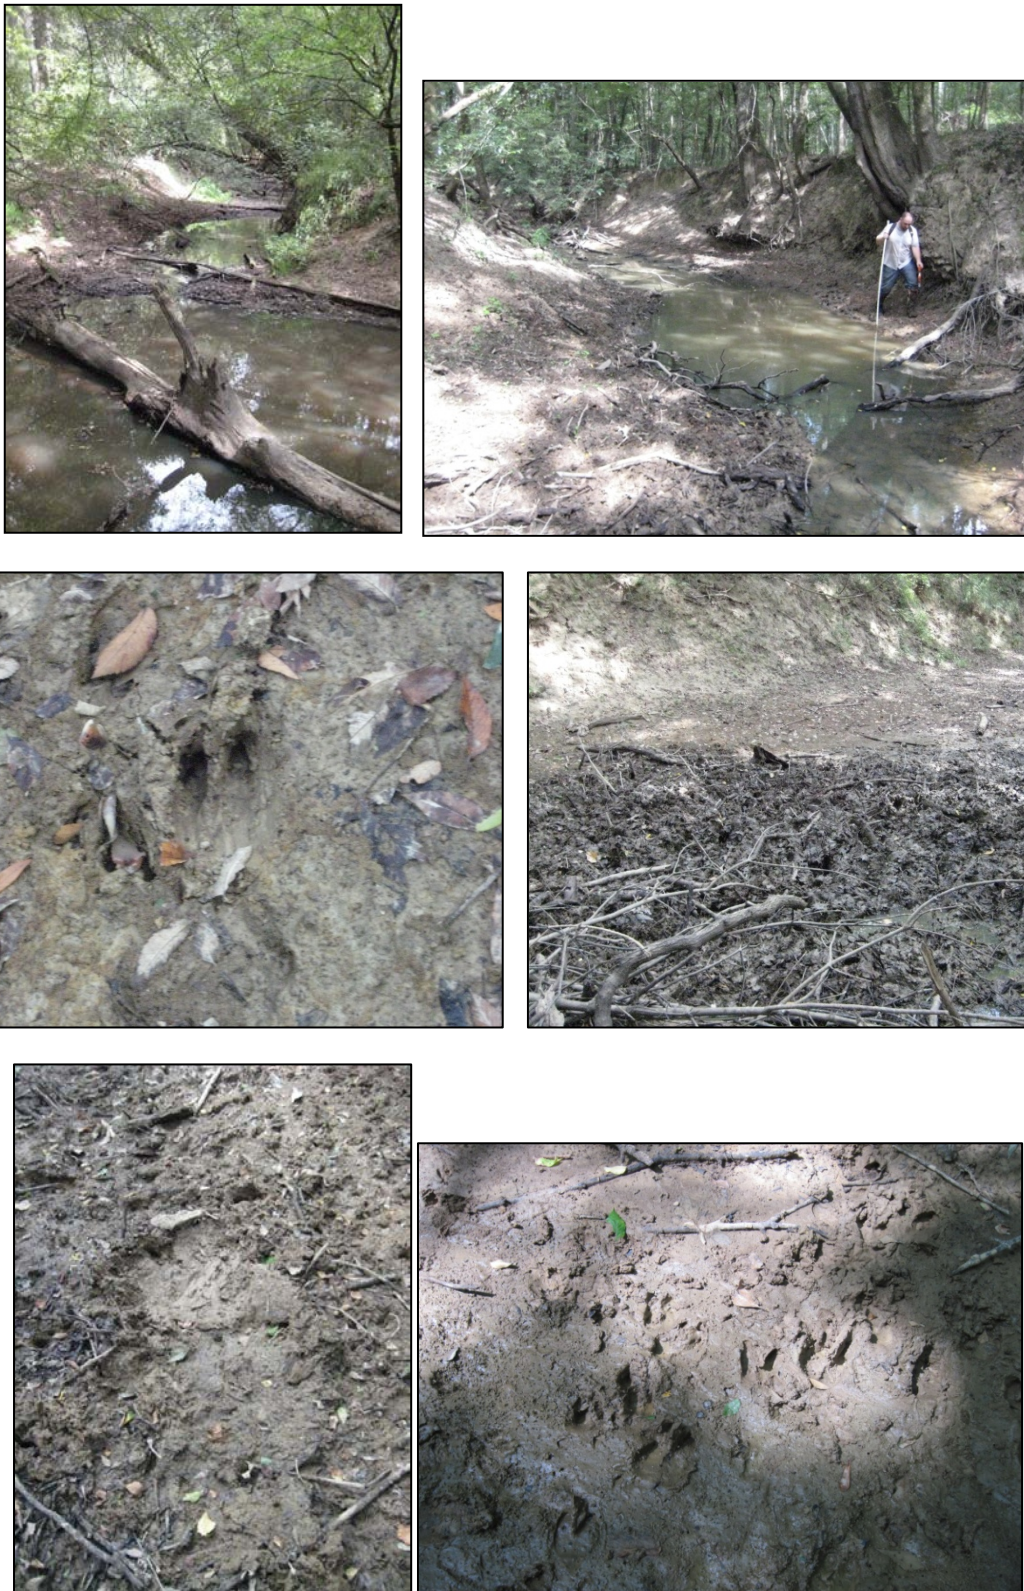
**Photogroup 4-9** Attoyac 9 depicting general water surface appearance and potential sources of contamination. All individuals featured are SFASU and CES staff. Top left: Large woody debris, August 2012; Top right: 150-m, downstream, August 2012; Middle left: Feral hog track, August 2012; Middle right: Feral hog use; Bottom left: Feral hog wallow, August 2012; Bottom right: Feral hog tracks, August 2012.

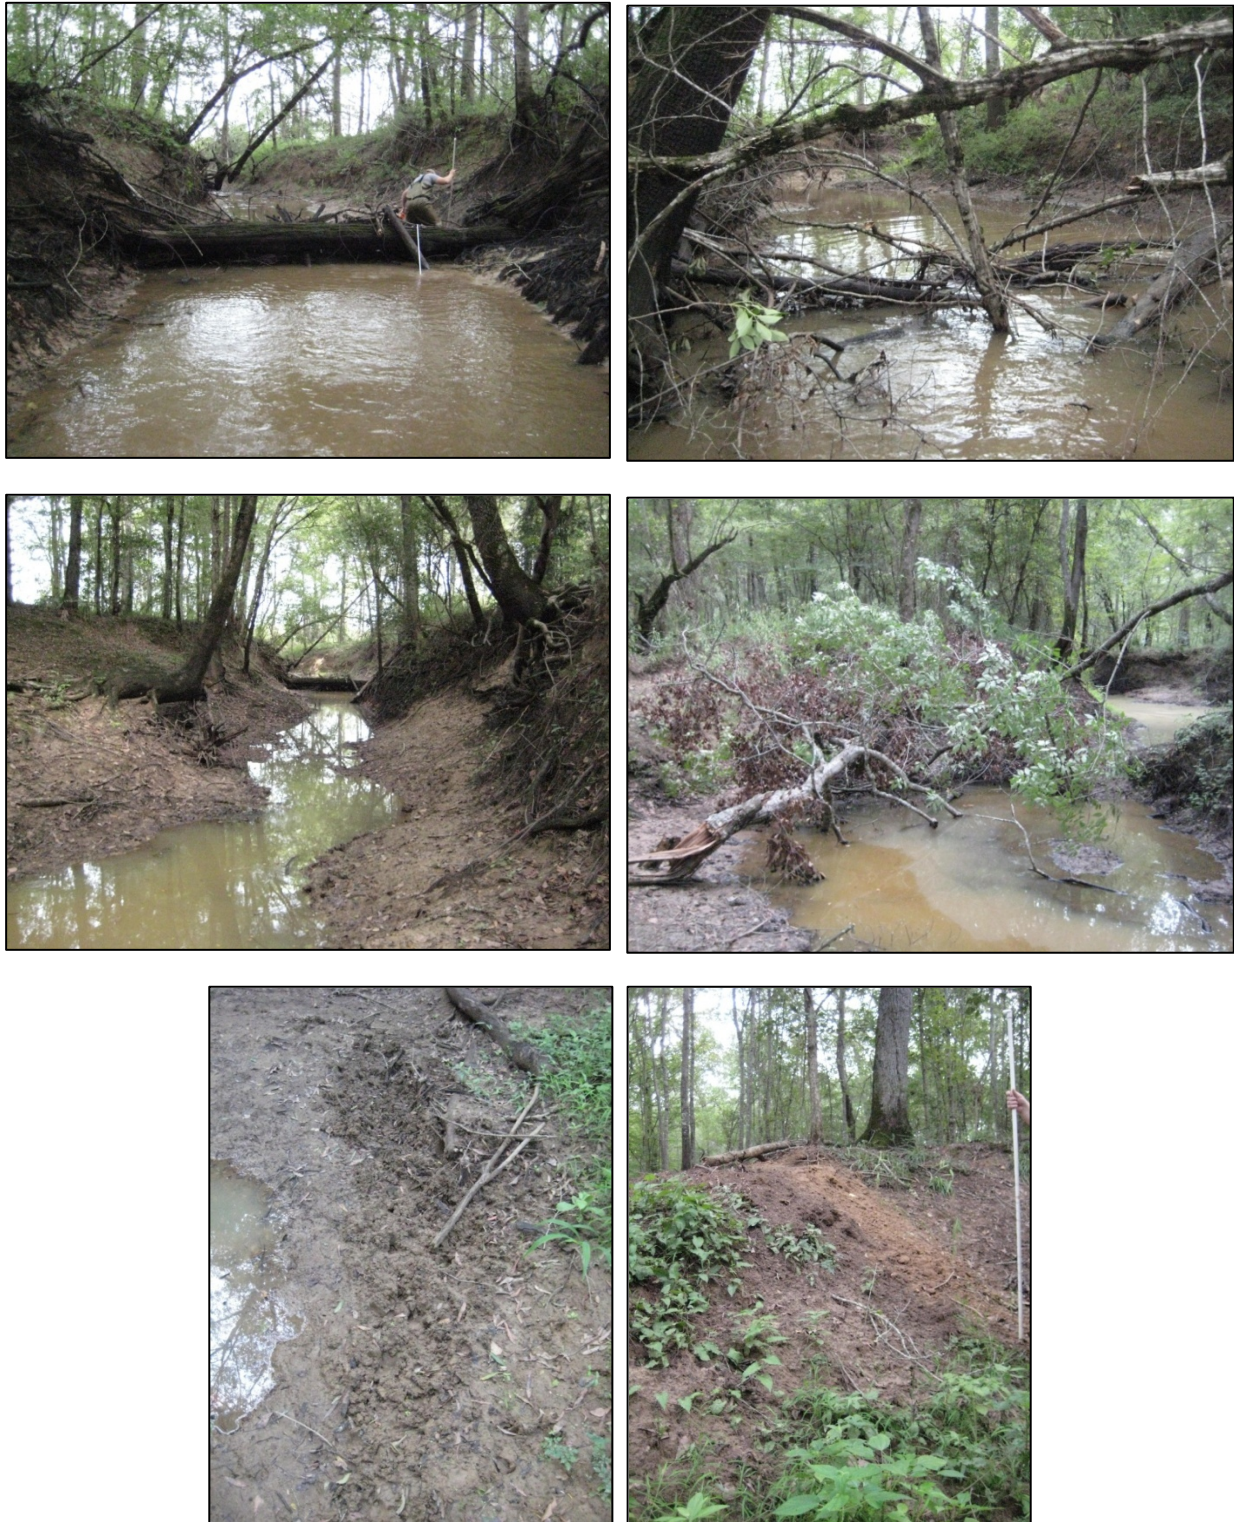
**Photogroup 4-12** Attoyac 13 depicting water surface appearance and potential sources of contamination. Top left: Large woody debris, July 2012; Top right: 300-m, upstream, July 2012; Middle left: 300-m, upstream, August 2012; Middle right: Woody debris, August 2012; Bottom left: Feral hog use, August 2012; Bottom right: Feral hog use, August 2012.

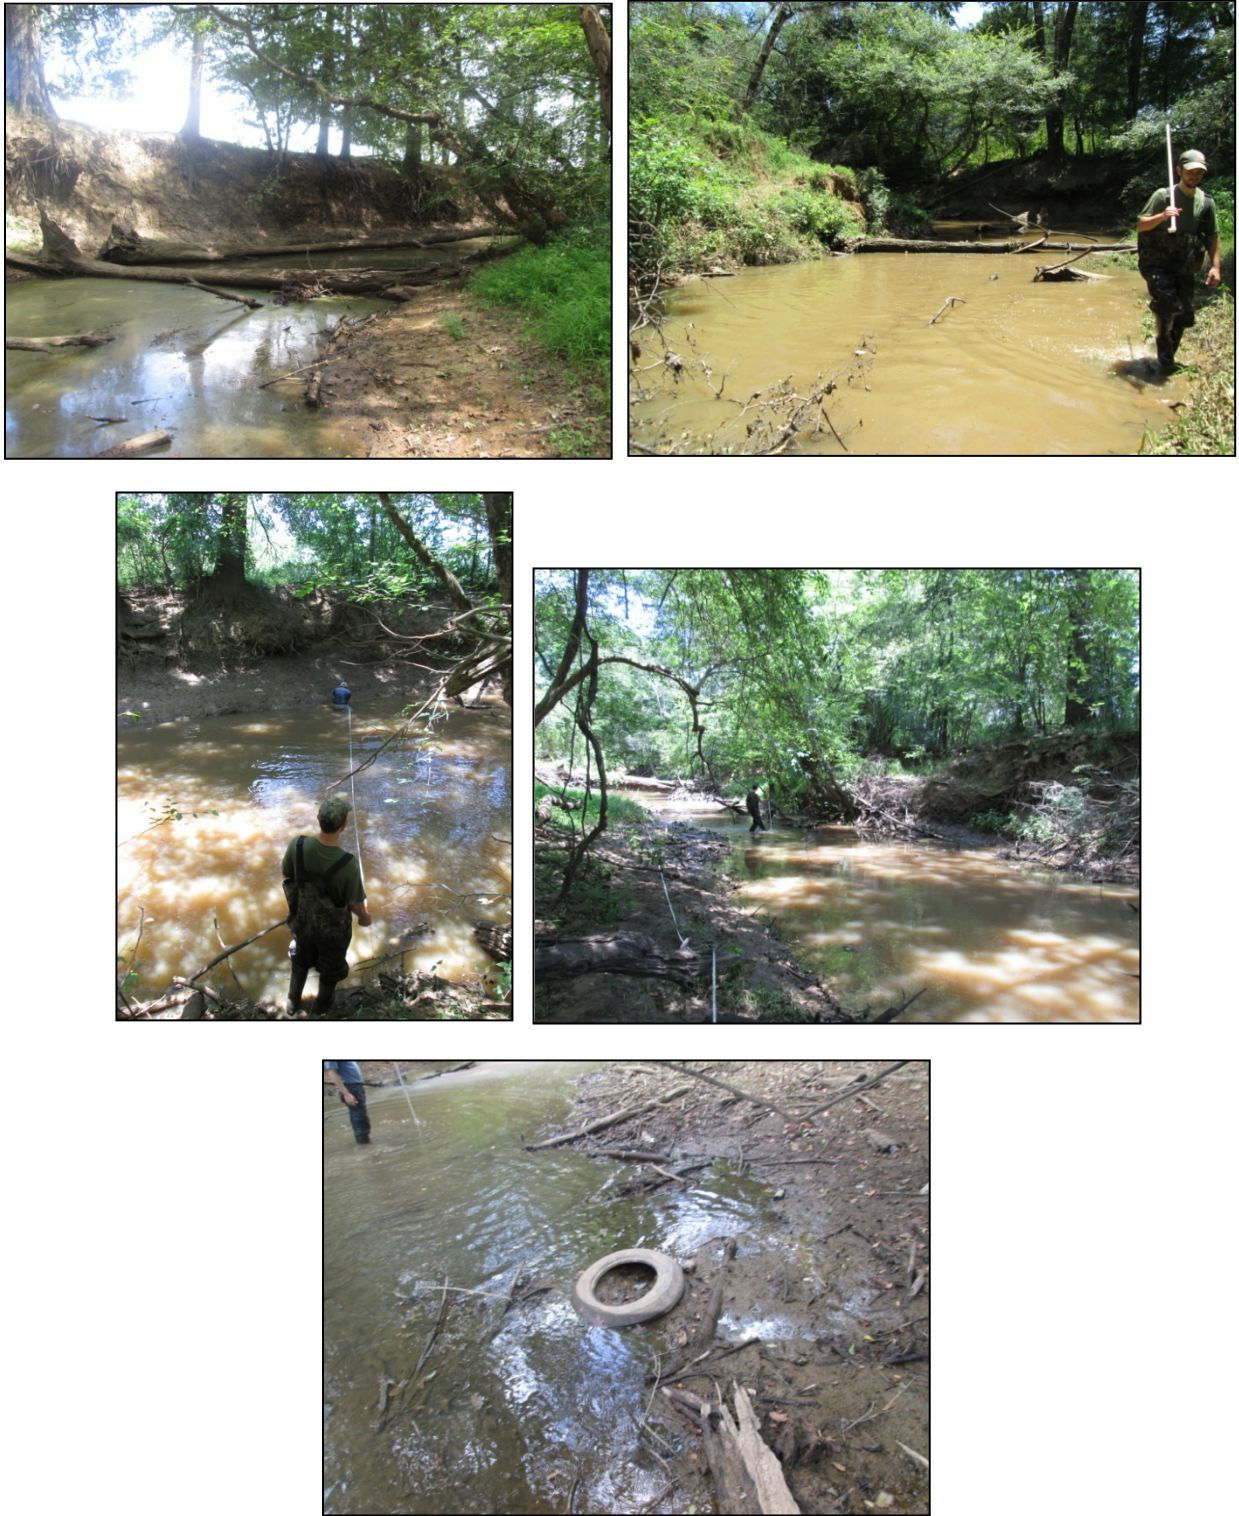
**Photogroup 4-14** Attoyac 15 depicting water surface characteristics. All individuals featured are SFASU and CES staff. Top left: 300-m transect, upstream, August 2012; Top right: 300-m, downstream, July 2012; Middle left: Stream width measurement, July 2012; Middle right: 150-m transect, upstream, July 2012; Bottom: Channel litter (tire), August 2012.

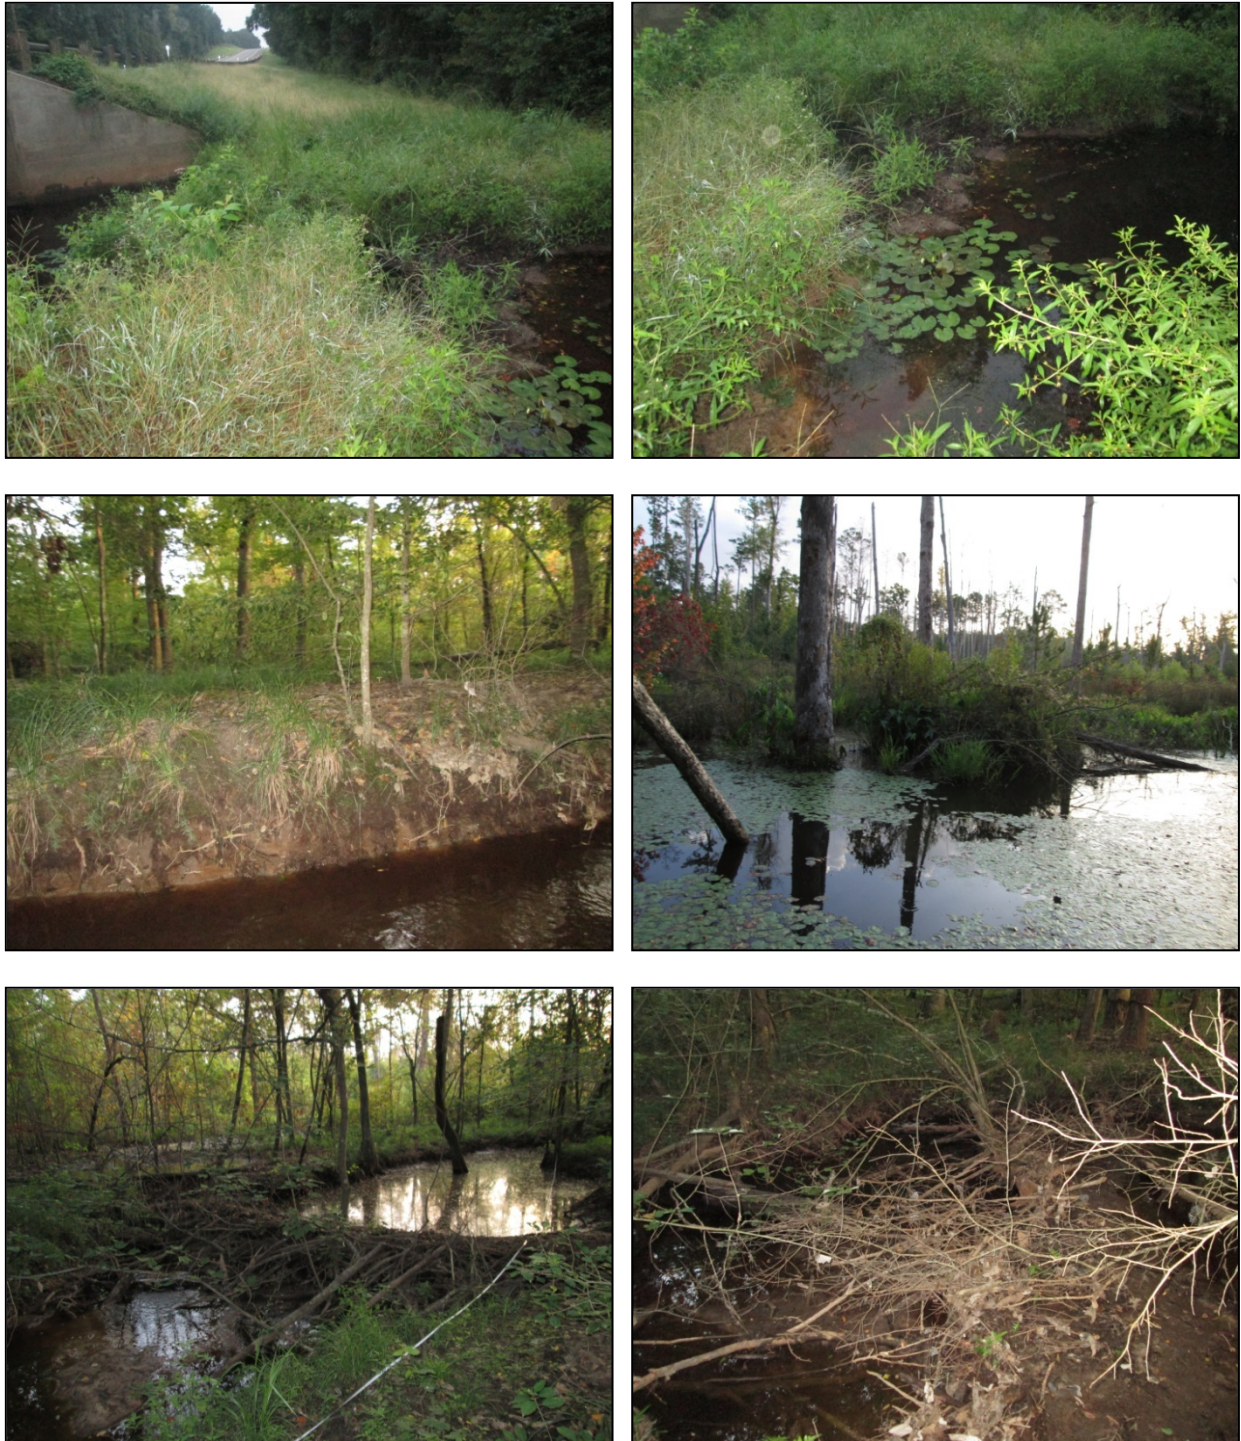
**Photogroup 4-18** Big Iron Ore 1 depicting general bank appearance and water surface characteristics. 0-m transect, Highway 96 access point; Top right: 0-m transect, left bank, August 2012; Middle left: 150-m transect, left bank, July 2012; Middle right: 300-m transect, right bank, July 2012; Bottom left: Beaver dam; Bottom right: Woody debris.

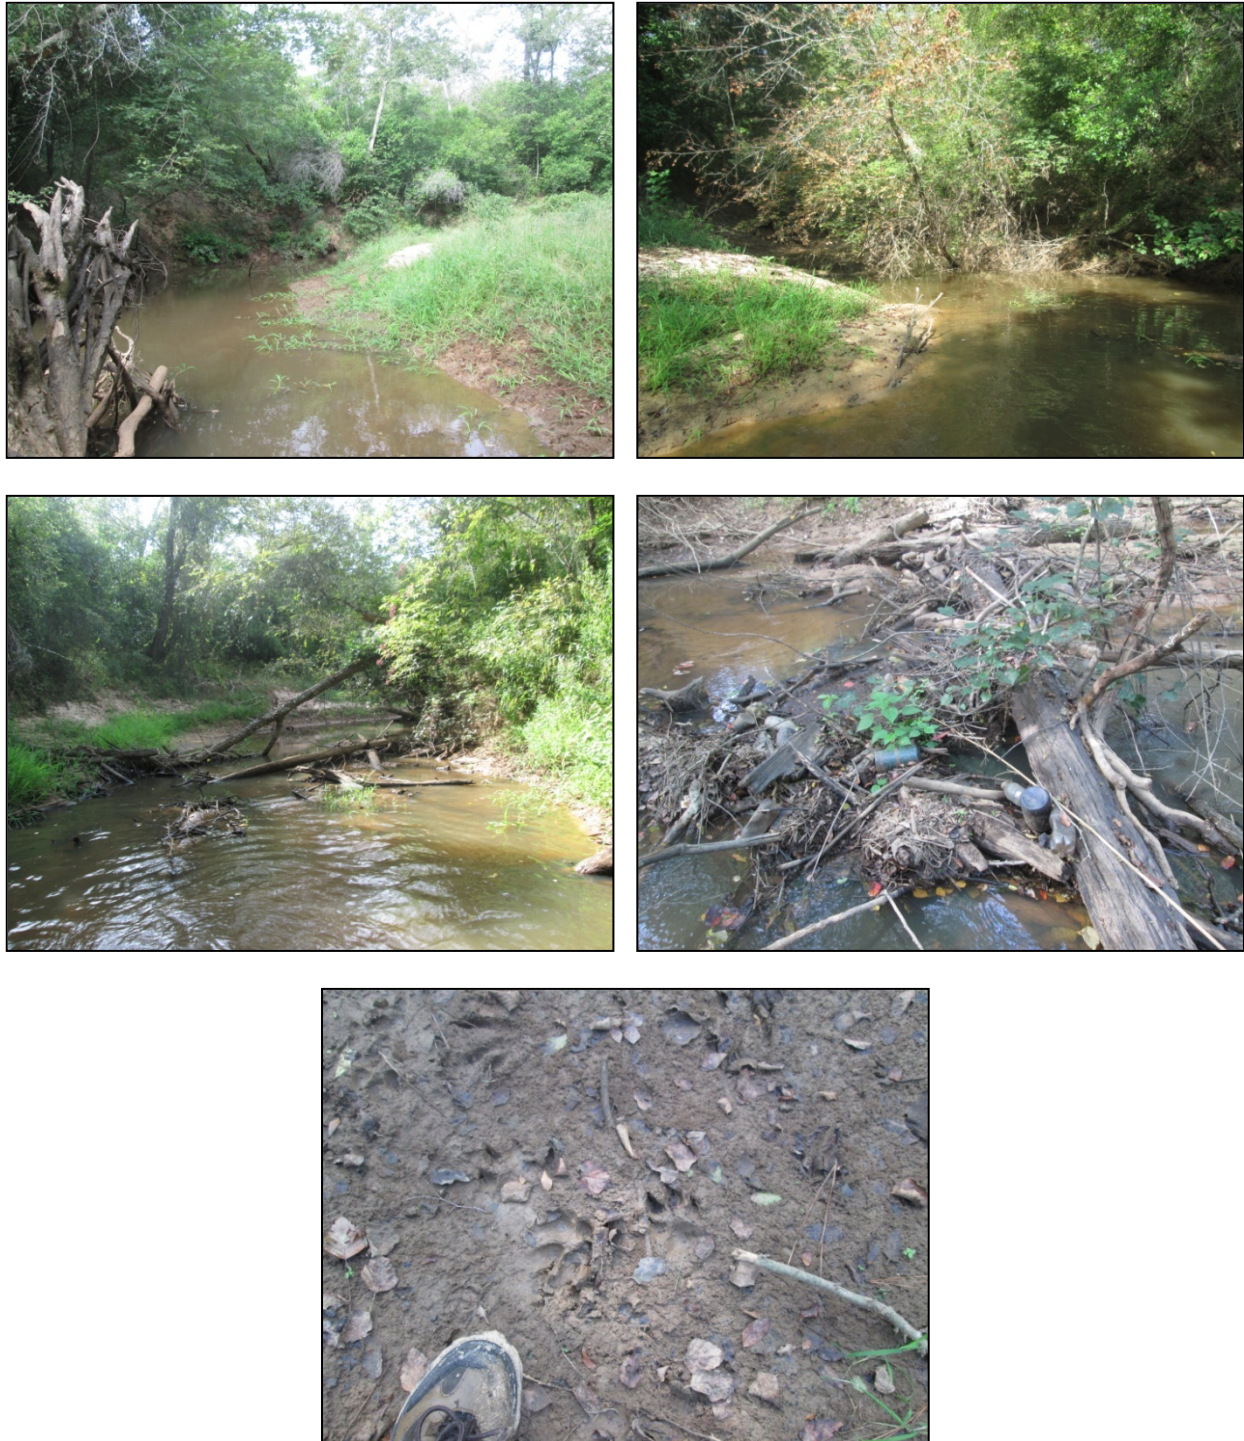
**Photogroup 4-21** Big Iron Ore 4 depicting water surface characteristics. Top left: 150-m transect, upstream, August 2012; Top right: 300-m transect, downstream, August 2012; Middle left: 300-m transect, upstream, August 2012; Middle right: Log jam with small channel litter; Bottom: Coyote tracks along stream bank.

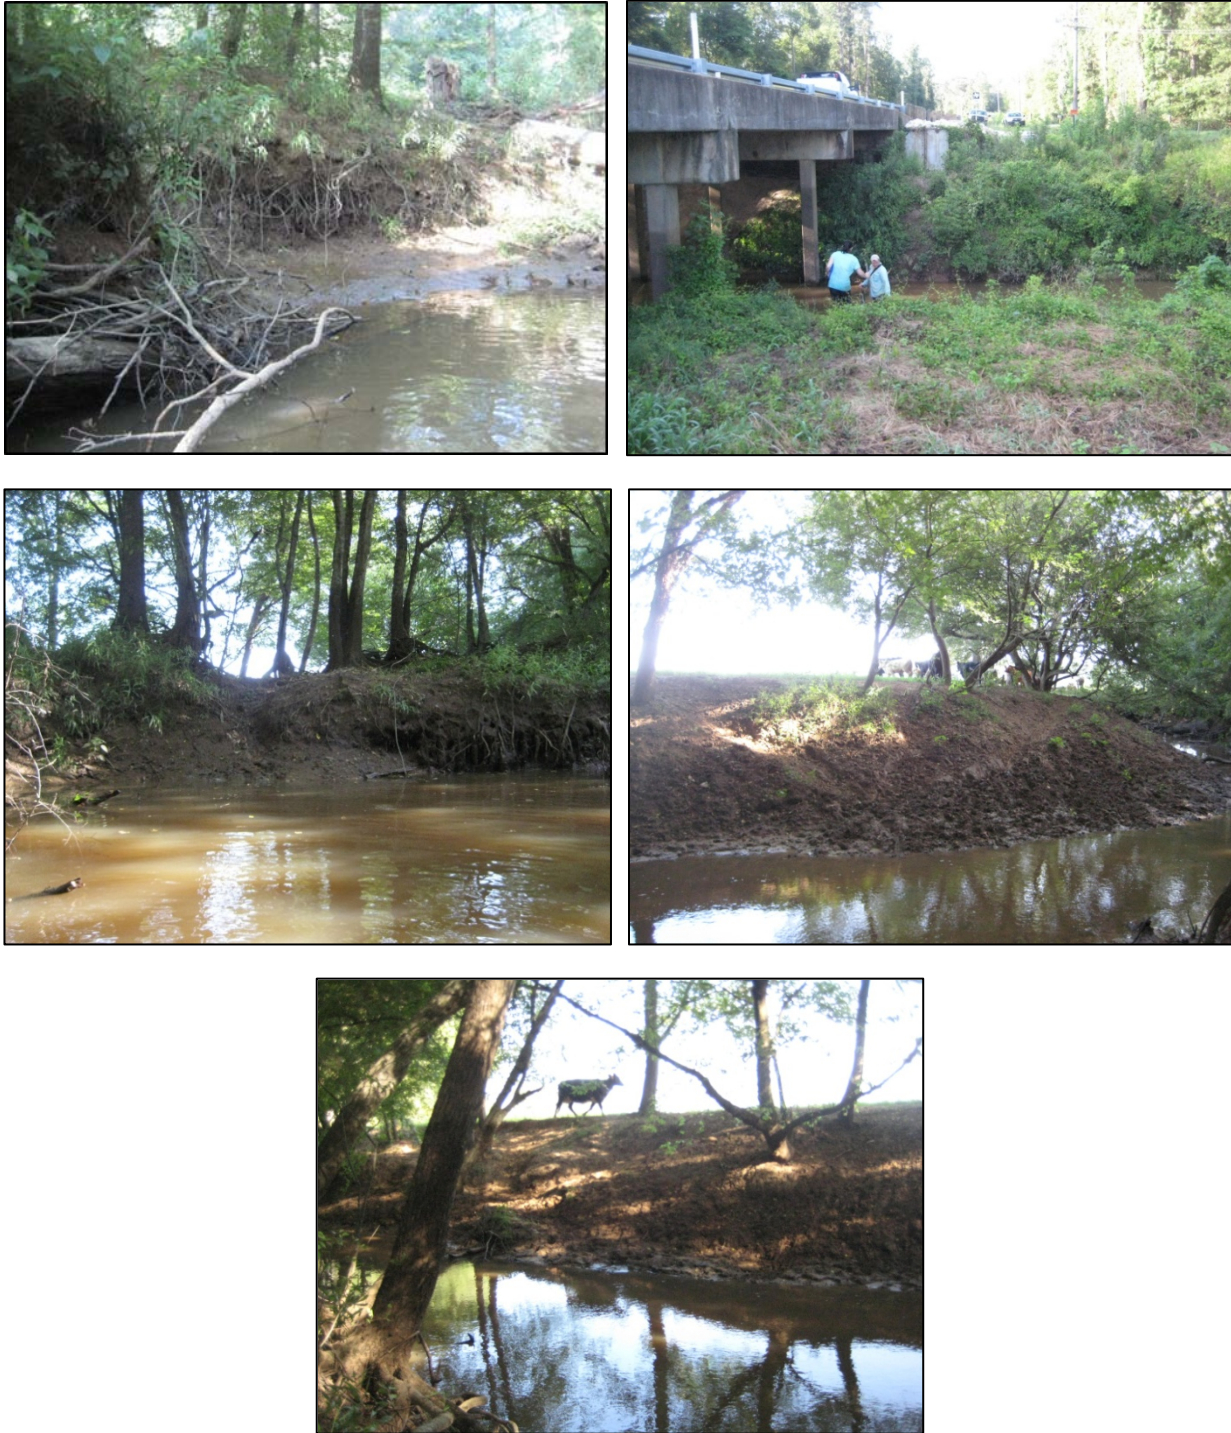
**Photogroup 4-30** Naconiche 11 depicting bank access and general bank appearance with livestock access. All individuals featured are SFASU and CES staff. Top left: 30-m transect, left bank, July 2012; Top right: 0-m transect, FM 95 crossing/access point, July 2012; Middle left: 300-m transect, left bank, July 2012; Middle right: Livestock and livestock bank use, July 2012; Bottom: Livestock use, July 2012.

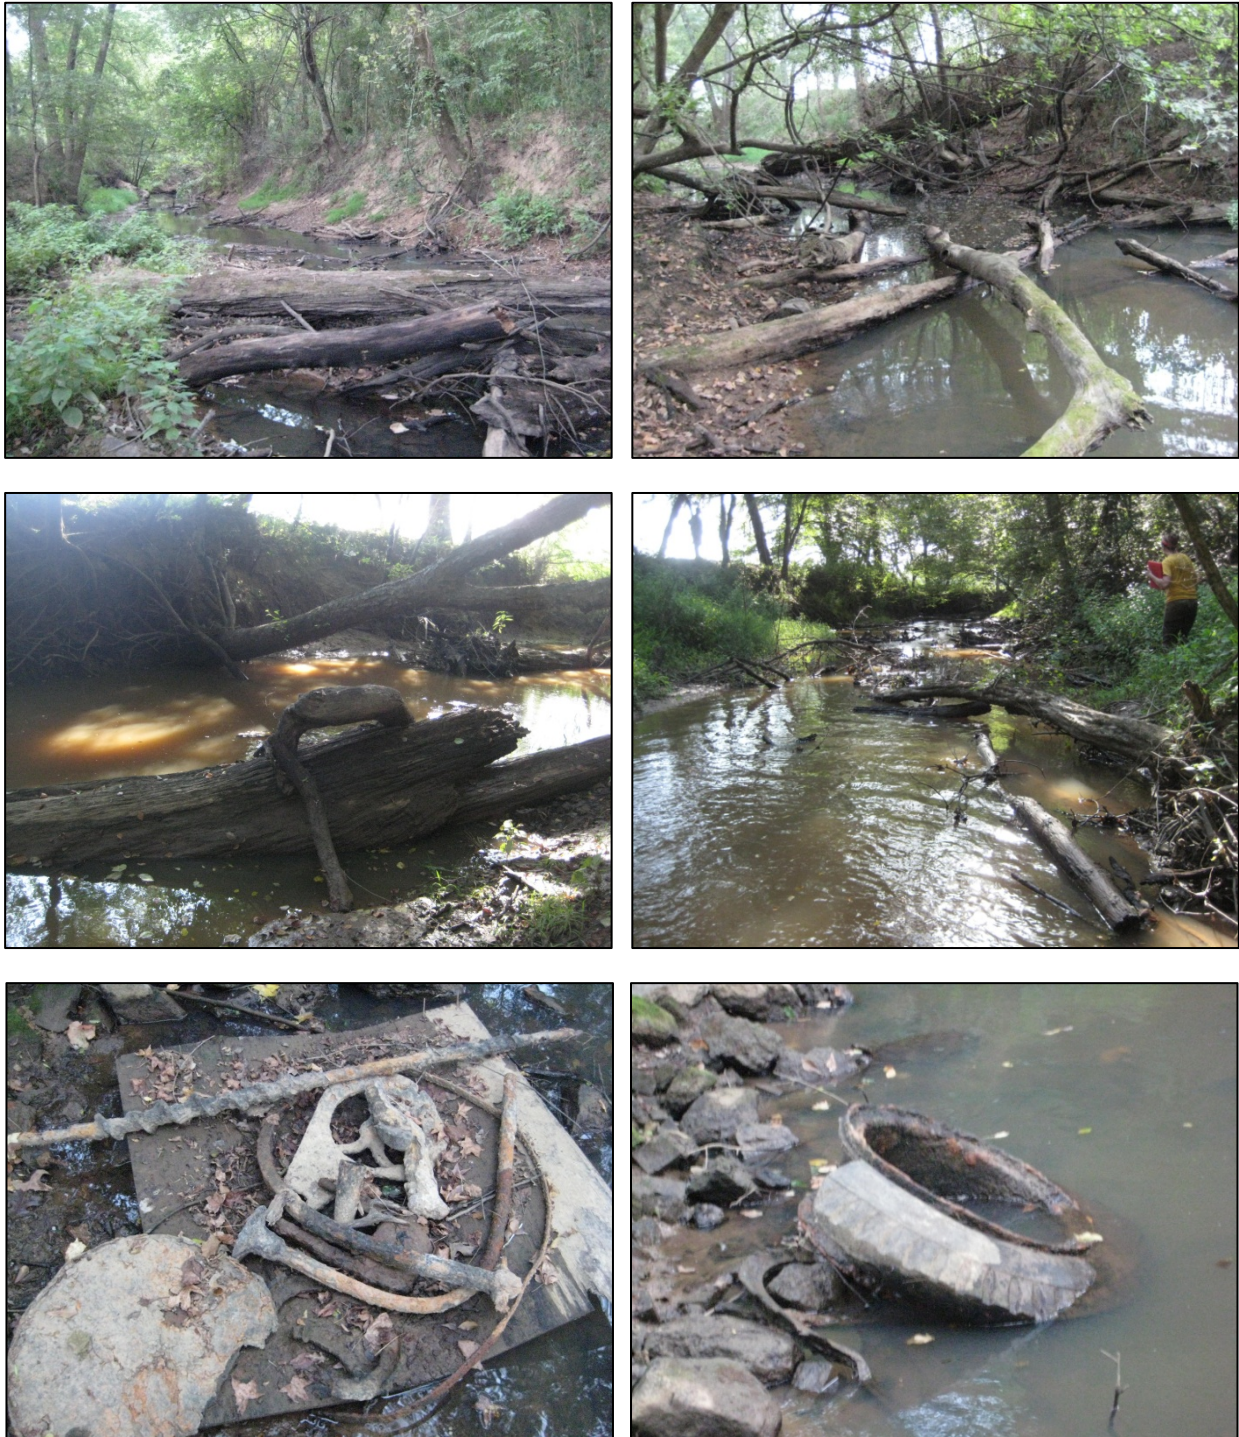
**Photogroup 4-30** Naconiche 11 depicting water surface characteristics. All individuals featured are SFASU and CES staff. Top left: 150-m transect, downstream, August 2012; Top right: Large woody debris across/within channel, August 2012; Middle left: Large woody debris, July 2012; Middle right: Large woody debris, July 2012; Bottom left: Large channel litter (various metal objects), August 2012; Bottom right: Large channel litter (tire with metal rim), August 2012.

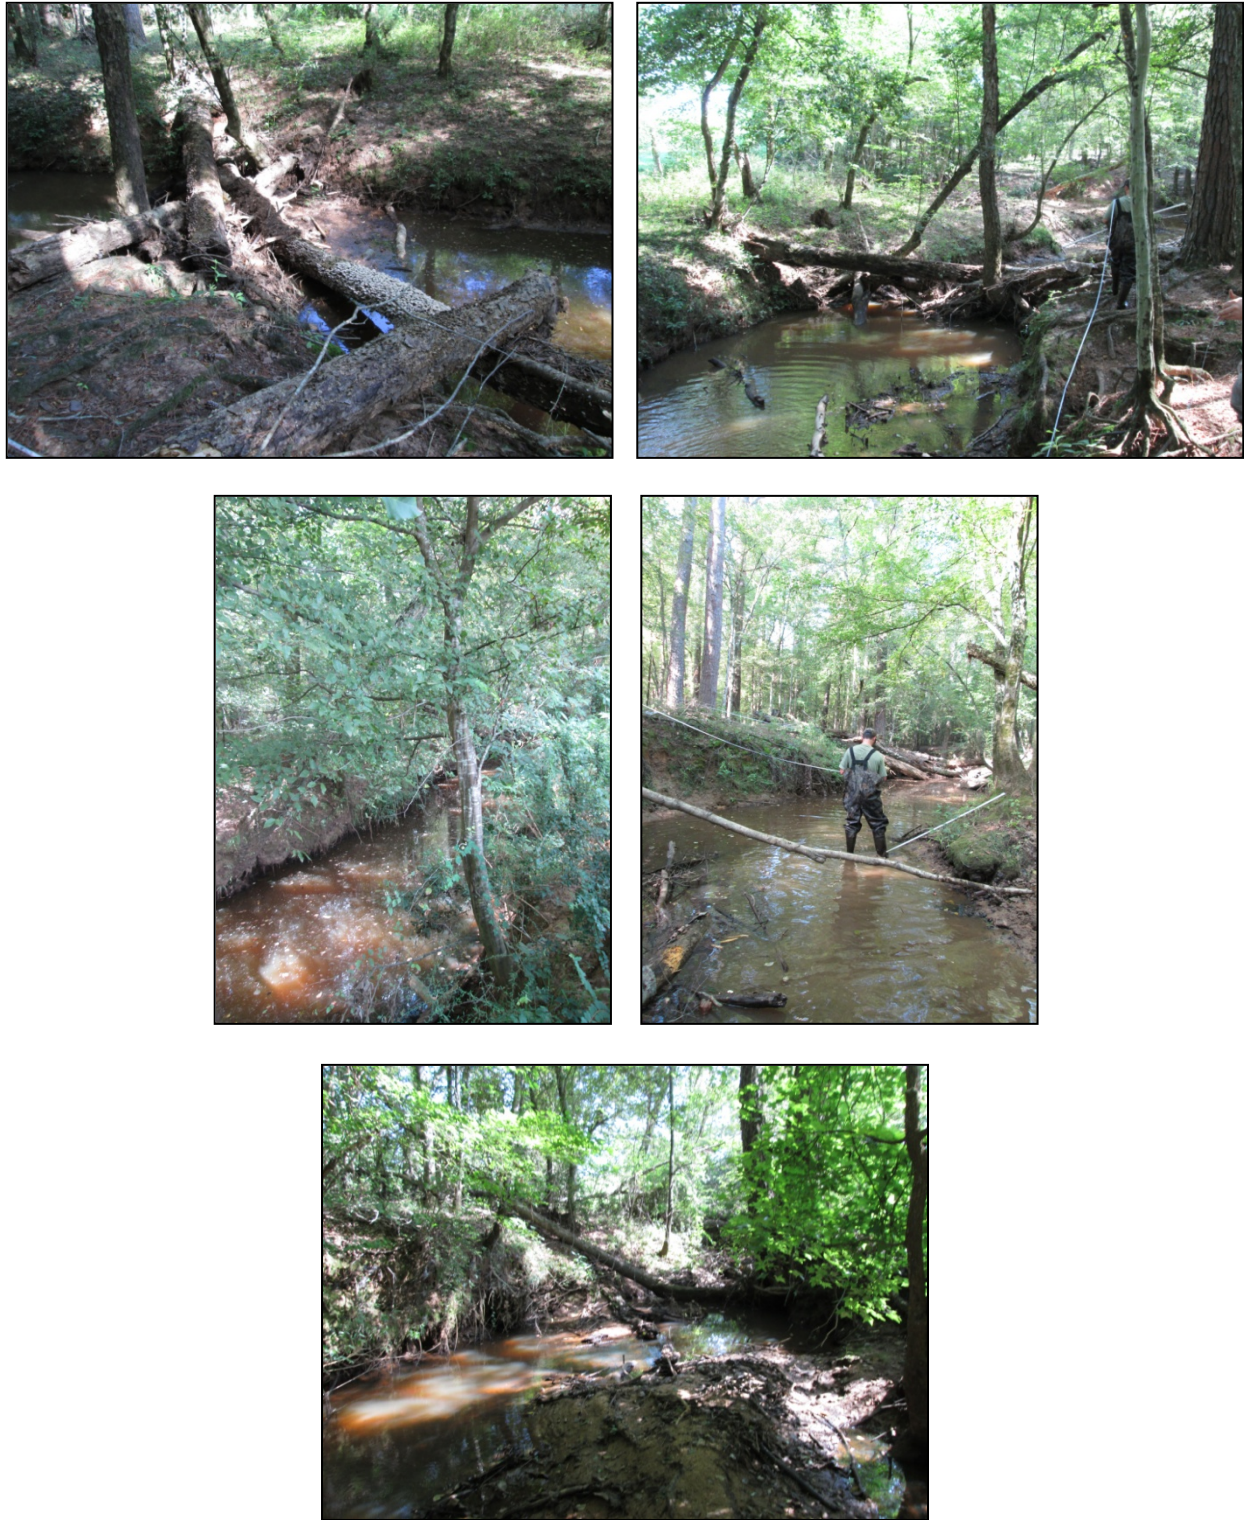
**Photogroup 4-32** Terrapin 2 depicting water surface characteristics. All individuals featured are SFASU and CES staff. Top left: Logjam with foam, July 2012; Top right: Logjam within channel, July 2012; Middle left: 150-m transect, upstream, August 2012; Middle right: 150-m transect, downstream, July 2012; Bottom: 300-m transect, upstream, July 2012.

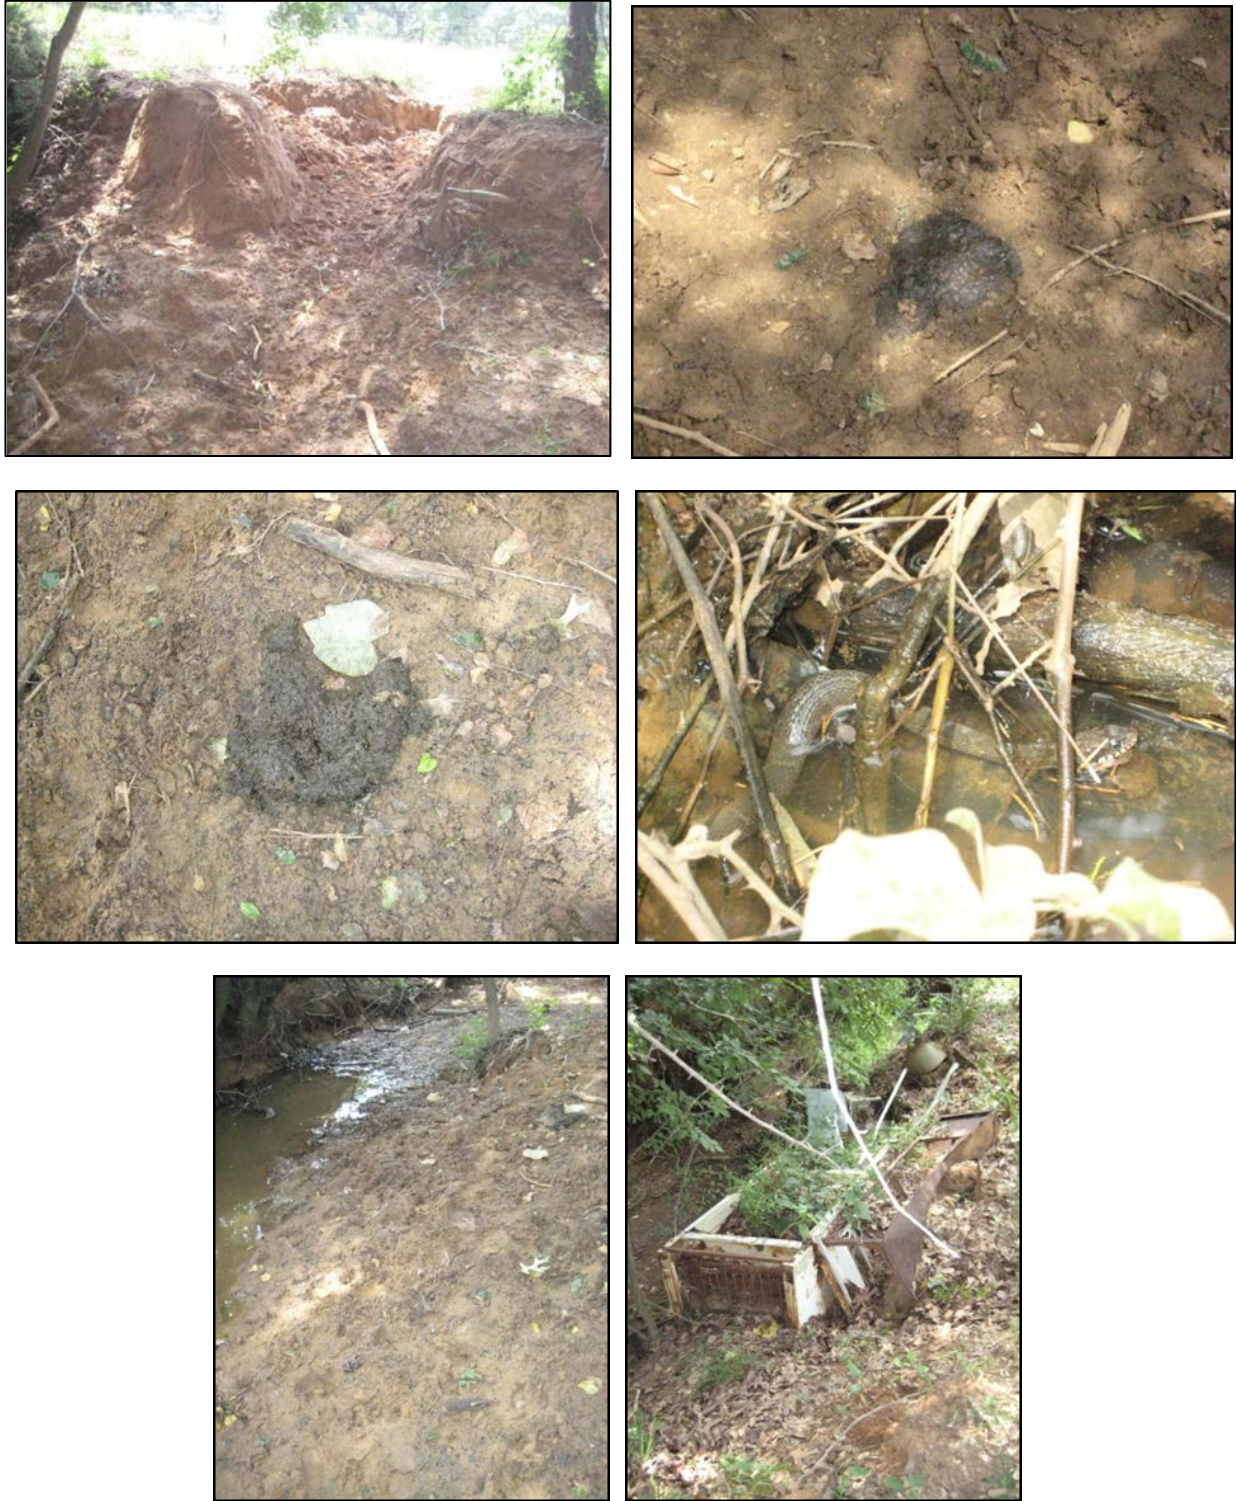
**Photogroup 4-35** Waffelow 1 depicting water surface characteristics and potential sources of contamination. Top left: Livestock access point, July 2012; Top right: Livestock fecal in portion of dry stream channel, July 2012; Middle left: Livestock fecal on bank, July 2012; Middle right: Water snake at CR 1878 access point, July 2012; Bottom left: Livestock bank use, July 2012; Bottom right: Large bank litter (refrigerator), July 2012.
