ASIA TURBOMACHINERY & PUMP SYMPOSIUM MARCH 2018 | SUNTEC SINGAPORE

Case Study on resolving high vibration issue of a centrifugal compressor at an offshore platform

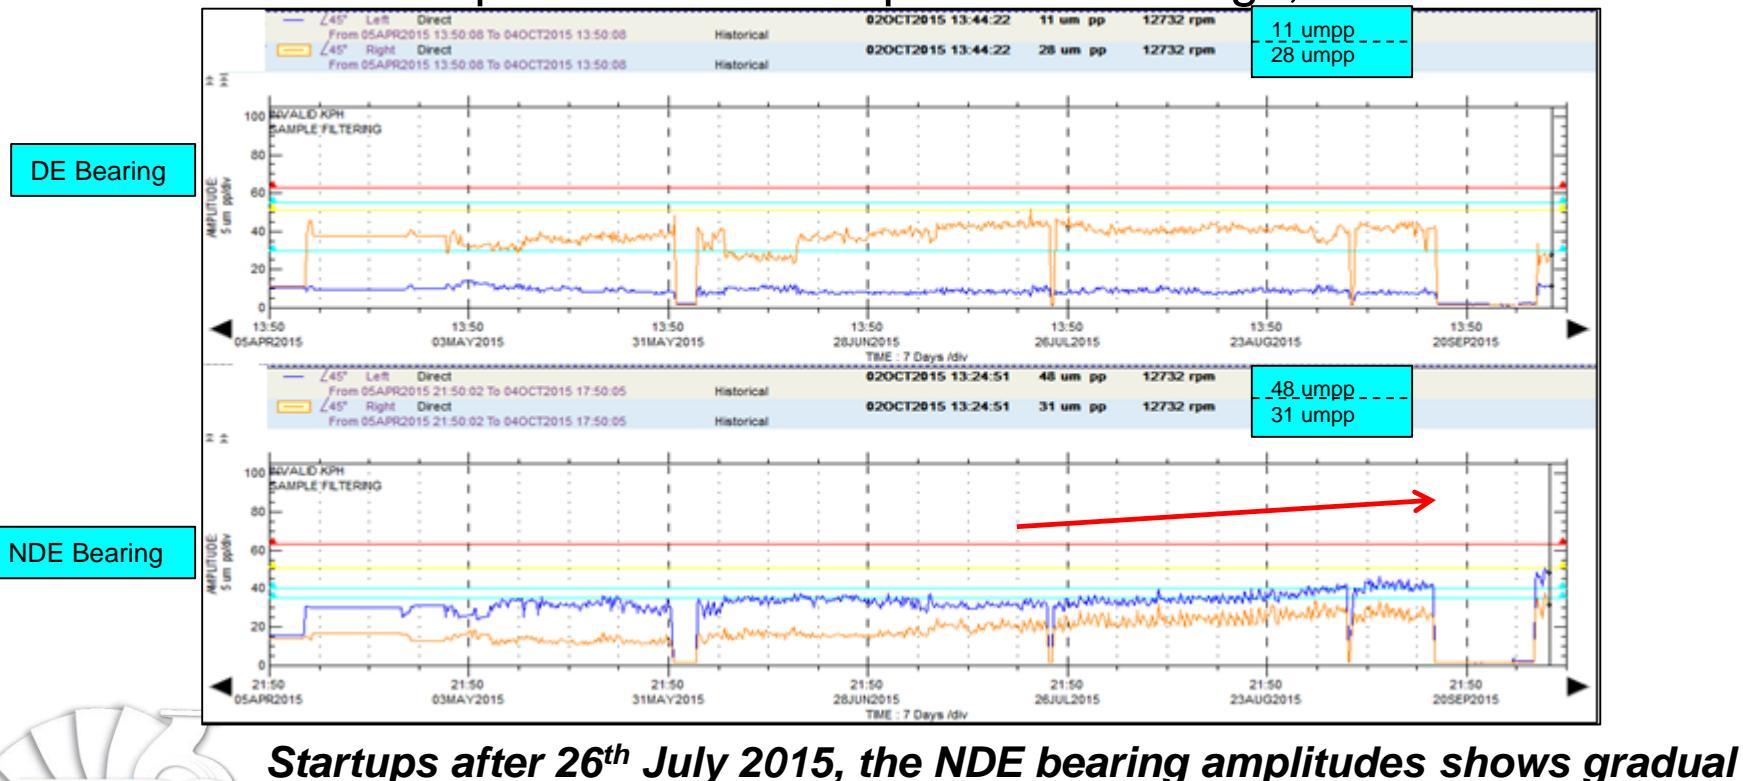
Shaft Vibration Amplitudes- LP Compressor Bearings, Oct 2015

rise approaching alarm levels (51 μmpp)

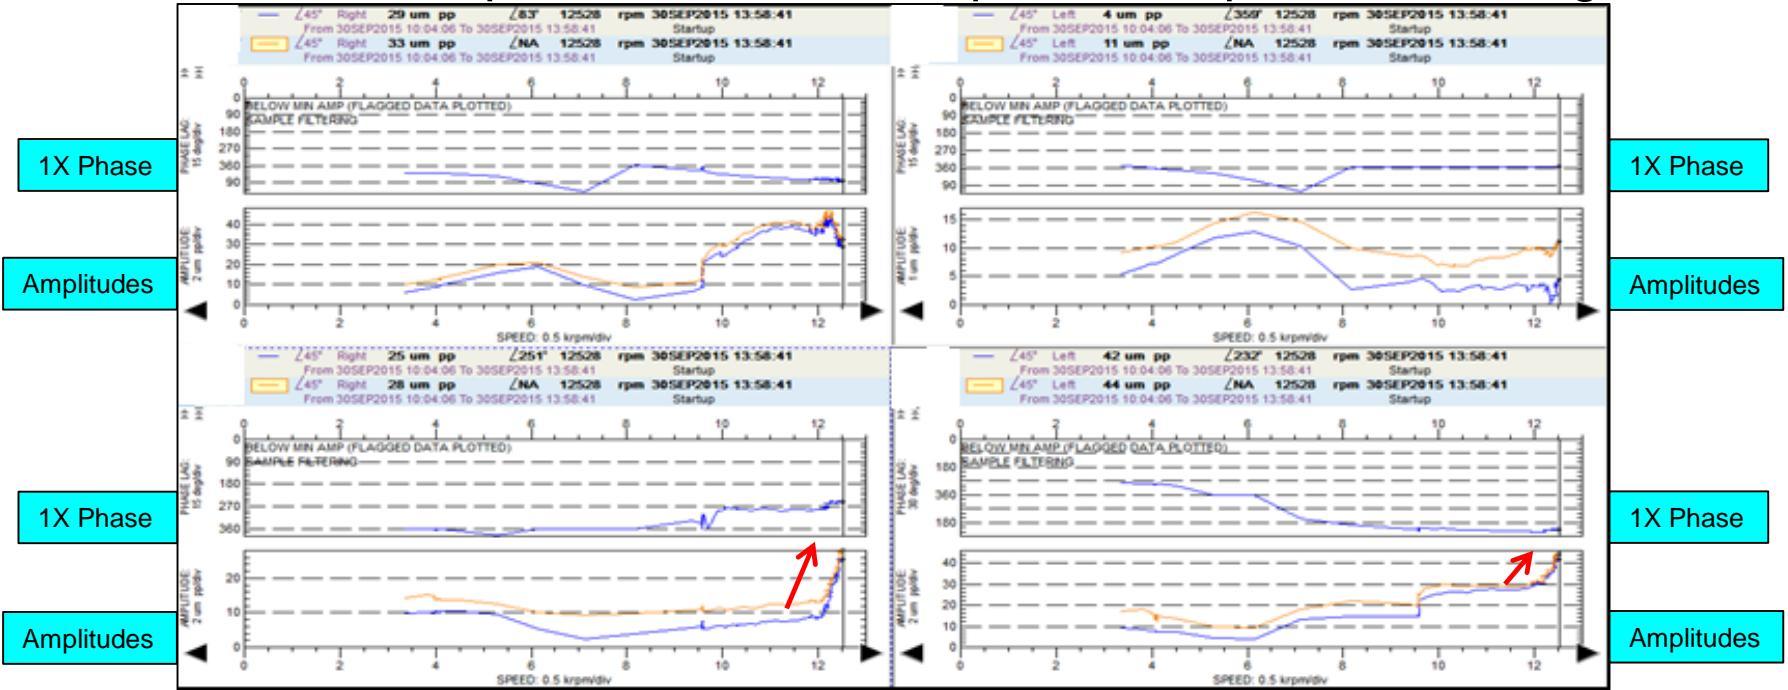
Bode Plots- 30th September 2015 Startup- LP Compressor Bearings

Startup shows steep rise in amplitudes at NDE bearing, especially above 12000 rpm. DE bearing Vibrations reduces with rise in speed/load.

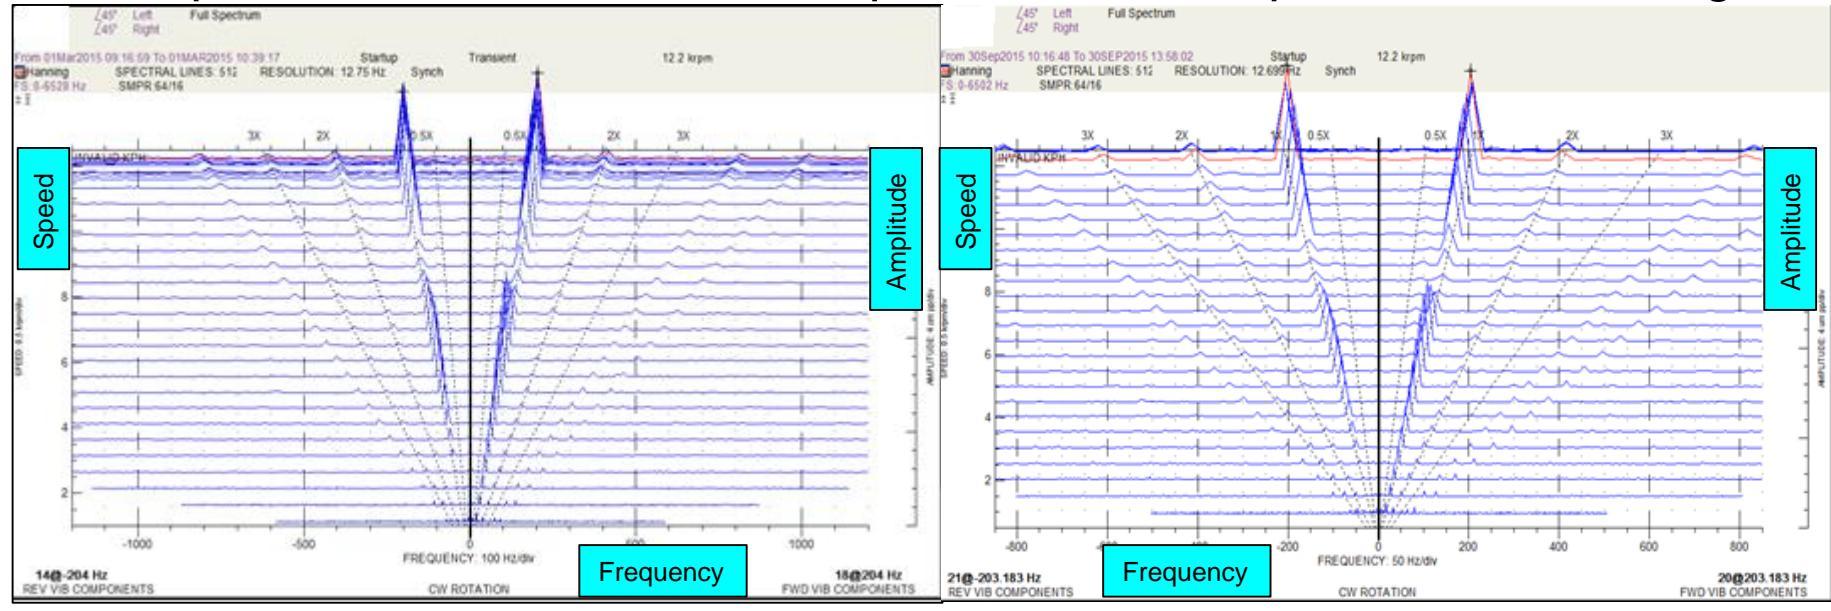
Full Spectrum Cascade Plots Comparison- LP Compressor DE Bearing

Rise in reverse 1X component indicative of increased DE pre-load forces.

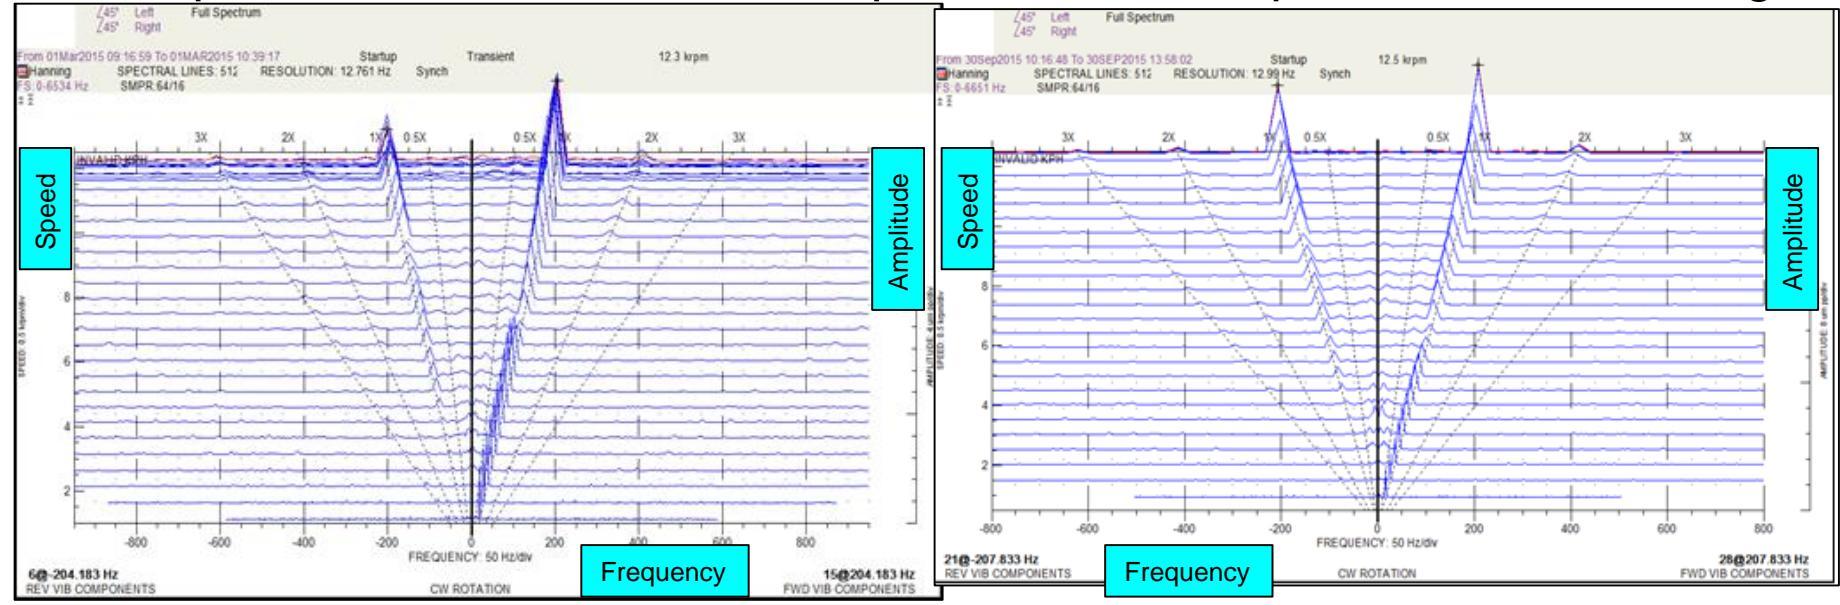
Full Spectrum Cascade Plots Comparison- LP Compressor NDE Bearing

Rise in reverse 1X component indicative of increased NDE pre-load forces.

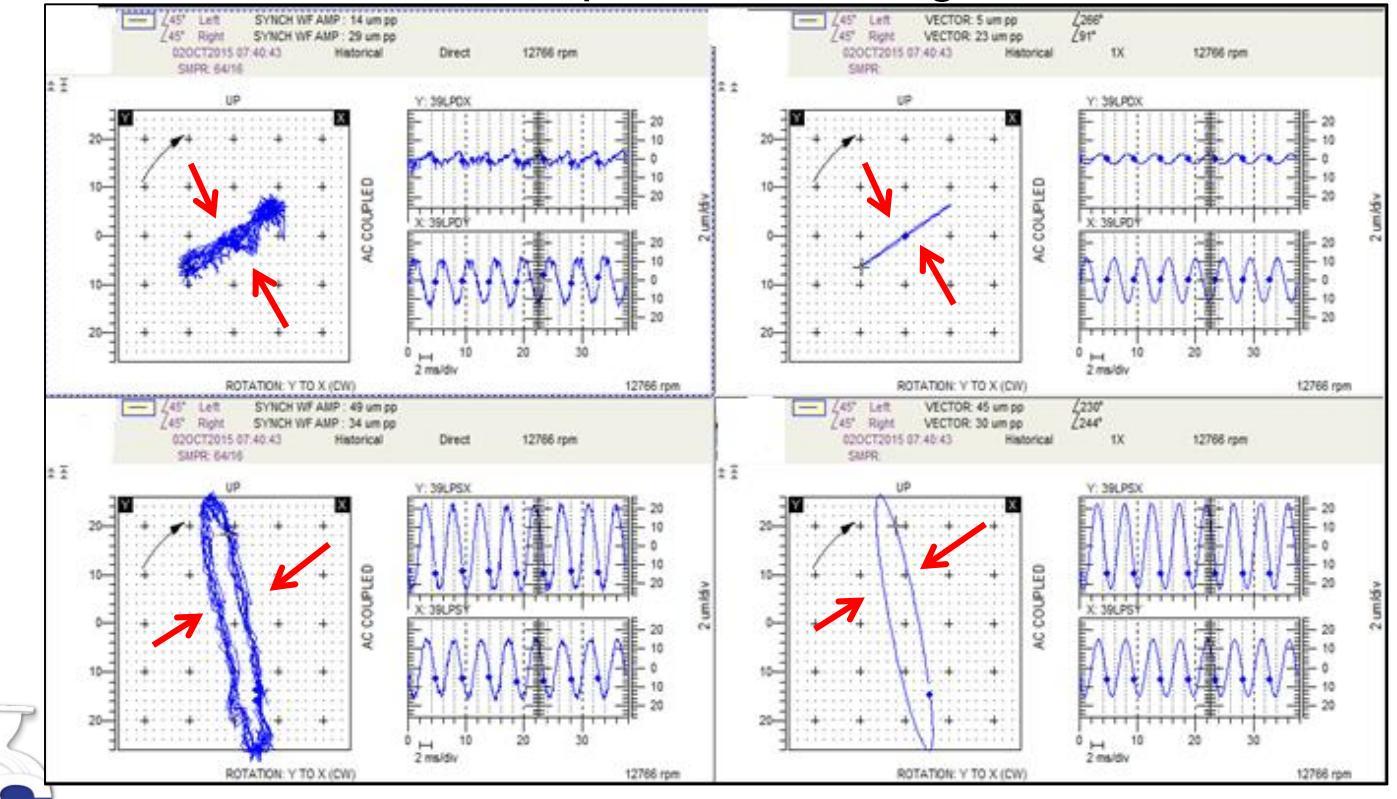
Direct / 1X Orbit Plots: LP Compressor Bearings

Highly elliptical orbit observed, with higher amplitudes at NDE Bearing

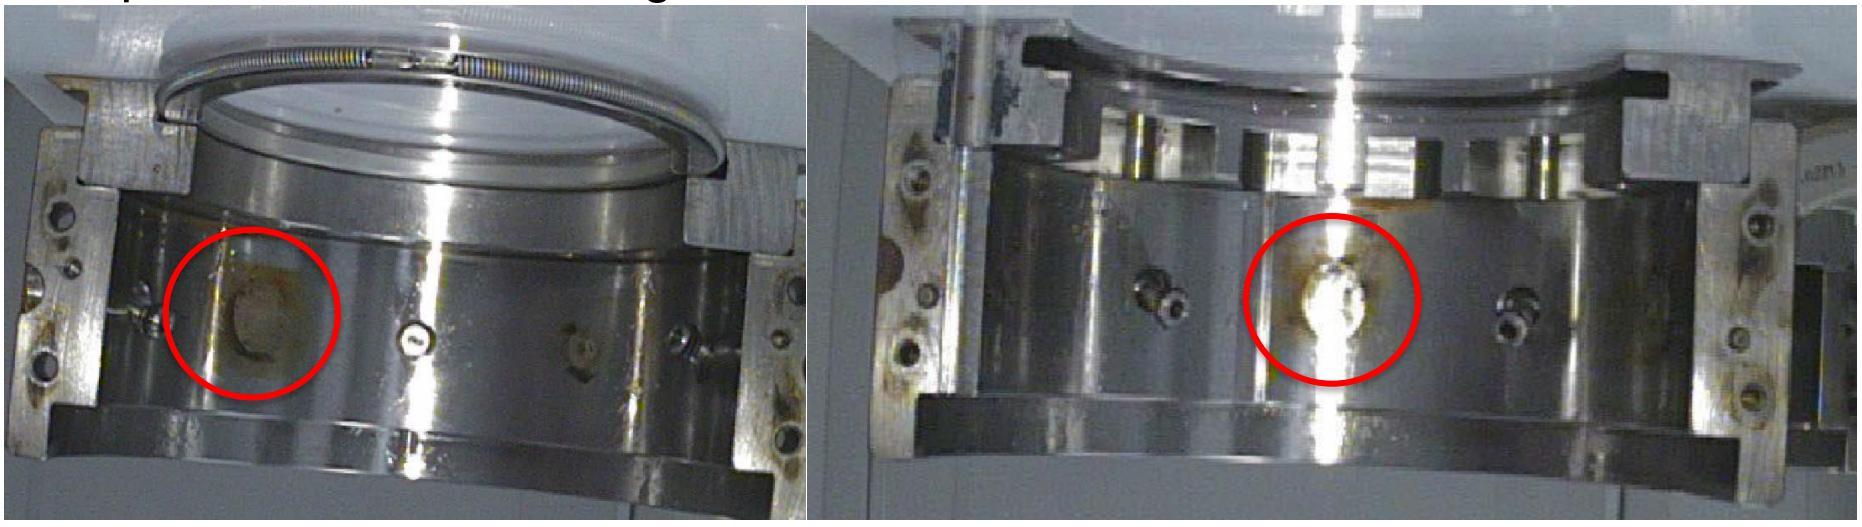
Evidence of hot spots observed on the bearing pads which might be due to pre-load on the bearing.

- Coupling Pre-stretch between LP & HP compressor was found to be 1.72 mm compared to the recommended 1.32 mm.
- The bearings pads were observed with minor carbon deposits which might be due to burned oil in the pads.

- Coupling pre-stretch between LP & HP compressor was found 1.72 mm against recommended 1.32 mm. Hence a shim of 0.4 mm was added.
- LP Compressor NDE bearing was replaced with new one with clearances maintained at 203 μm . Alignment of the machine train was done as per design values.

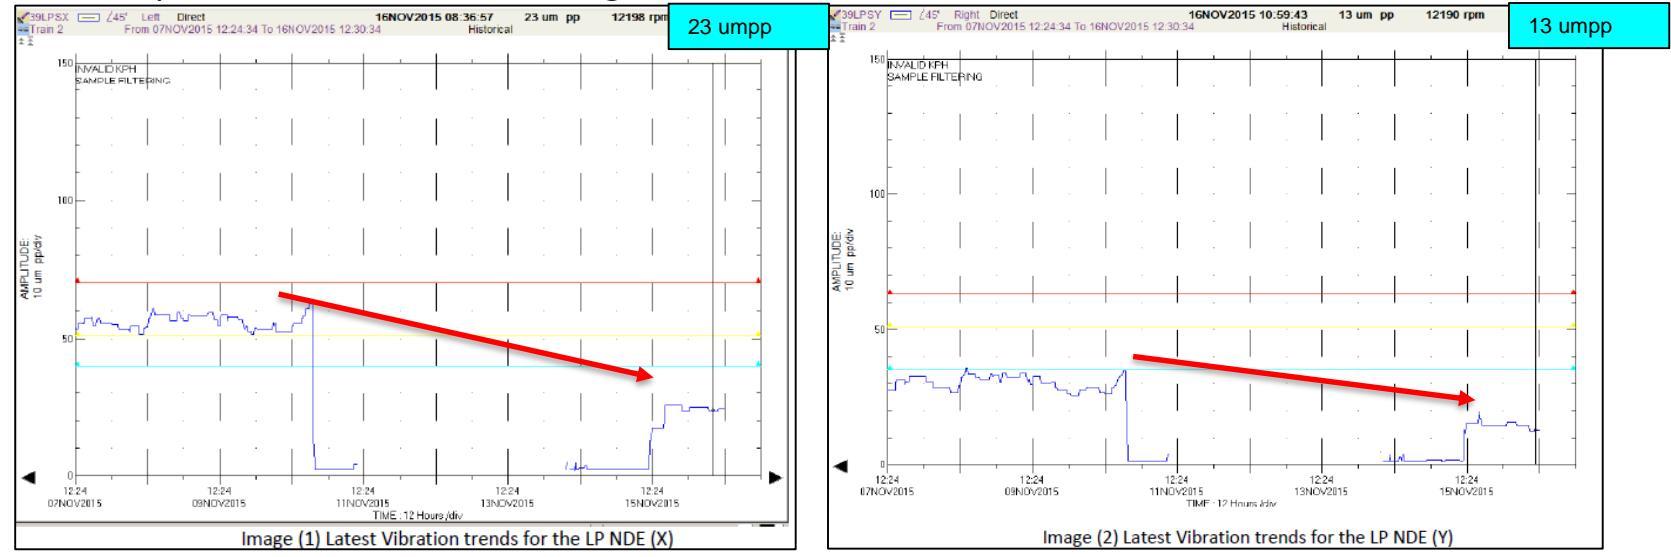
LP Compressor NDE Bearing Vibration:

Considerable improvement in LP compressor NDE bearing vibration amplitudes observed.
