CASE REPORT

Double left ventricular pacing following accidental malpositioning of the right ventricular electrode during implantation of a cardiac resynchronization therapy device

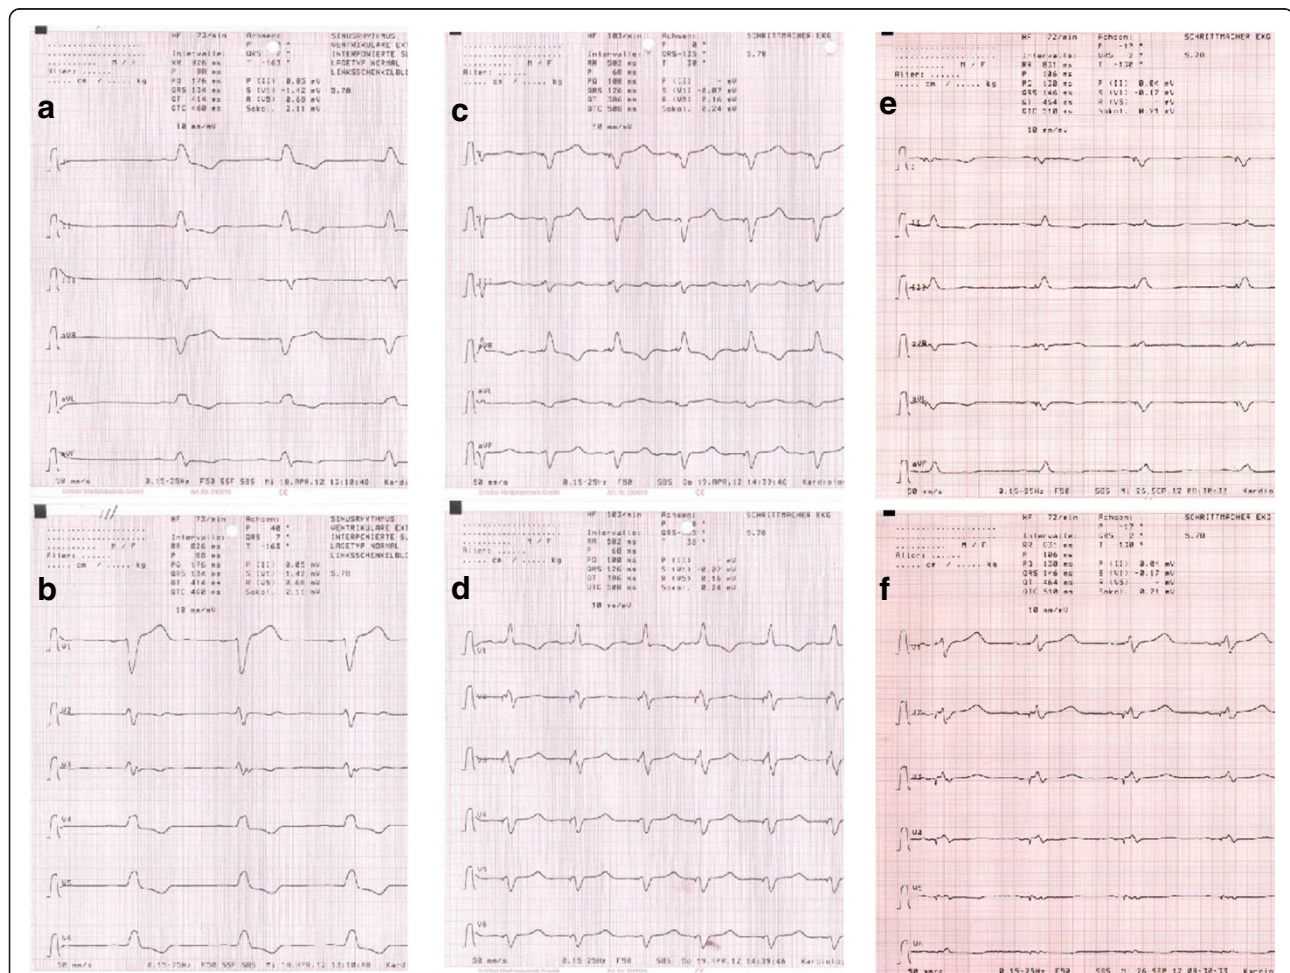
A 75-year-old caucasian male patient with a diagnosis of dilative cardiomyopathy (echocardiographic biplane ejection fraction (EF) 23%) had sinus rhythm with left LBBB ECG (Figure 1a-b) (QRS with 136 ms) and a profound dyssynergic contraction profile. There was a history of Diabetes Typ II, hypertension and mild renal insufficiency (serum creatinine 1.63 mg/dl). Significant coronary artery disease had been excluded by angiography. Currently, he suffered from New York Heart Association (NYHA) III heart failure status and was admitted for implantation of a CRT – implantable cardioverter defibrillator (ICD). The operative procedure was unremarkable, although some difficulties advancing the right electrode into the right ventricle were reported. Chest X-ray after implantation (Figure 2a-b) excluded pneumothorax and electrodes appeared well placed. The patient was discharged one day after the procedure when the pacing ECG showed a

narrowed QRS complex (Figure 1c-d) with optimal values of all three electrodes (Table 1).

Figure 1 ECC recordings before CRT implantation showed a wide QRS due to LBBB (1 a-b); after CRT implantation simultaneous stimulation of the presumed RV electrode misplaced in the left ventricle and the CS electrode resulted in a narrow QRS and positive R-waves in V1 (1 c-d); after revision of the RV lead simultaneous stimulation in the RV and the CS (1 e-f). Although the ECGs before and after revision show differences, the principle finding of a narrow QRS and a positive R-Wave in V1 is present in both recordings.

In patients with right ventricular apical pacing post-procedure ECG is diagnostic in most patients revealing a RBBB with positive deflection in lead V1 and a negative deflection in lead I. Typically, RV pacing results in a LBBB with negative deflection in V1 and positive in I. This finding has a good sensitivity for malposition or perforation of the RV electrode [11]. However, patients with RBBB configurations after transvenous RV pacing require careful evaluation. In some cases, "safe" RBBB patterns may occur in epicardial pacing, septal pacing, and even in right apical pacing [11,12]. In CRT paced patients, ECG signs are not helpful because biventricular pacing (RV and LV lead simultaneously) usually results in an expected RBBB ECG pattern. An RV lead inadvertently placed in the LV may be identified by single testing under 12 lead ECG control, which is uncommon during routine postoperative follow-up. The frequency of LV misplacement in the CRT population remains unknown and is possibly underdiagnosed.

right heart without a sheath. A new electrode was advanced and fixed at the base of the right ventricle. Postprocedure chest x-ray (Figure 2c-d), ECG (Figure 1e-f), and measurements (Table 1) all documented good results. This time a postprocedure echocardiogram showed an intact mitral valve, persistent good left performance, and the RV electrode within the right heart.

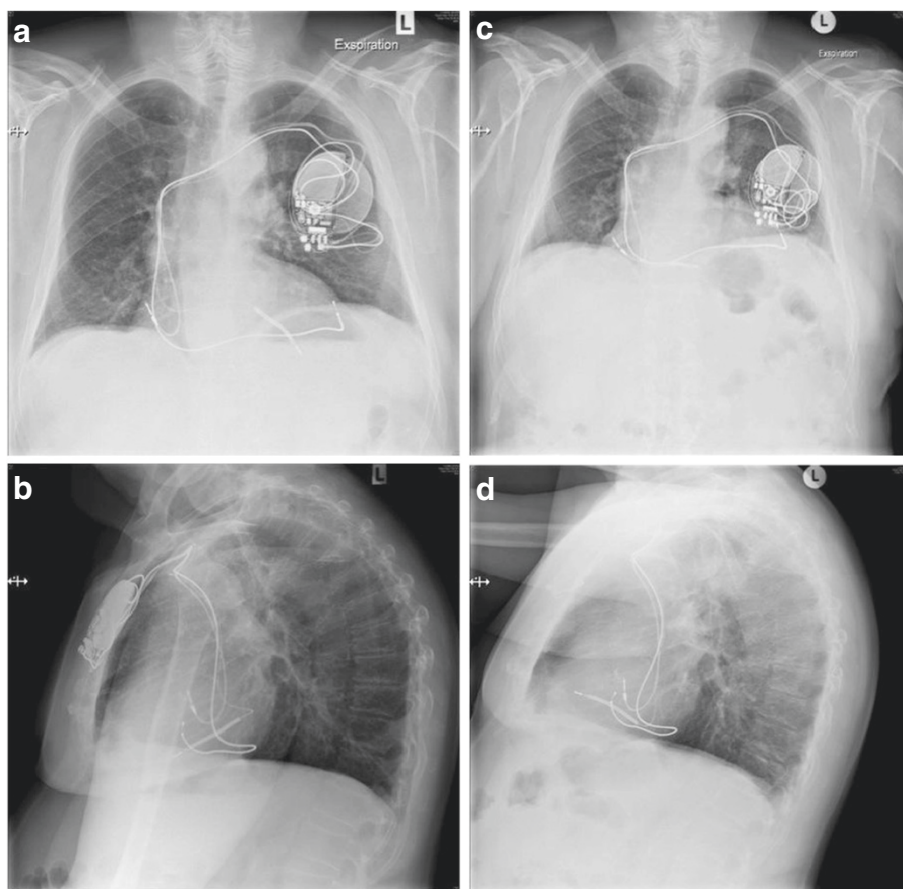
Figure 2 Chest x-ray in the anterior and lateral view after the original CRT-ICD implantation (2 a-b) and after revision of the ICD lead (2 c-d). Atrial and CS electrodes remained unchanged. During revision the malplaced ICD electrode was removed and replaced in the RV. The chest x-ray after first implant was graded normal by routine judgement. In retrospective, the curve at the atrial level and the posterior orientation of the ICD lead may indicate passage of the foramen ovale and misplacement in the LV.

RV malplacement may be detected by postero-anterior and lateral chest radiographs in particular if the tip shows a posterior orientation [4,6,9]. However, diagnosis of RV malpositioning requires a high degree of suspicion [10]. In the present case, routine examination of chest x-ray (2a-b) was judged normal. By careful retrospective analysis, however, the RV lead curve is unusual and needs further investigation. In the present case, diagnosis of malplacement was made by transthoracic echocardiography 4 weeks after the implantation. Instead of transesophageal echocardiography, chest CT scan would be an alternative diagnostic possibility [10].

After studying the literature and informing the patient about possible consequences a revision procedure was performed. The RV electrode was easily removed from the left ventricle but could not be safely placed in the

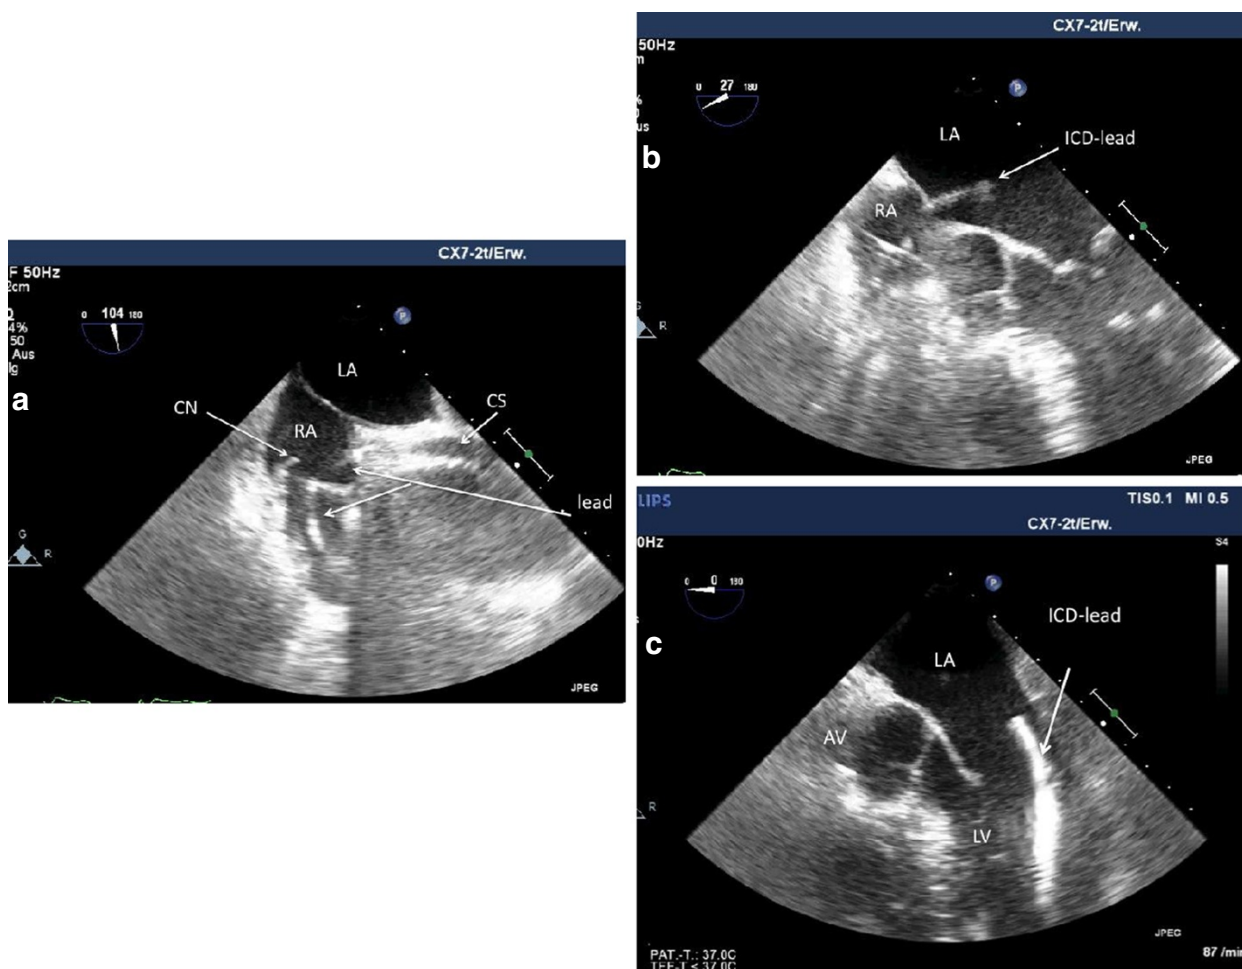
One month later on follow-up, the patient reported a marked improvement of his exercise capacity (NYHA II). Electrode values remained stable. An unscheduled echocardiogram (Philips iE33) revealed a marked reduction of left ventricular dimensions with an improved mono-plane ejection fraction (51%). However, through the mitral valve leaflets a thick electrode proceeded into the apex of the left ventricle. An additional transesophageal echocardiographic examination demonstrated the coronary sinus (CS) electrode in place (Figure 3a) but a malposition of the RV electrode passing the patent foramen ovale (PFO) via an Eustachian valve into the left ventricle (3 b-d).

Figure 3 Transesophageal echocardiographic recordings after the original implantation procedure. The LV electrode (lead) is placed in the coronary sinus (CS), Chiari's network (CN) present in the right atrium (RA) (**3 a**); the ICD electrode (ICD lead) passes the atrial septum via the foramen ovale (**3 b**) into the left atrium (LA) and ventricular (LV) apex (**3 c**).
