Are Britain's Higher Education Institutions Prepared for Prosecution in September 2005 Due to Their Lack of Disabled Access? Emily Godson & Graham Farrell Department of Social Sciences Loughborough University

Key Words: disabled access, higher education, SENDA

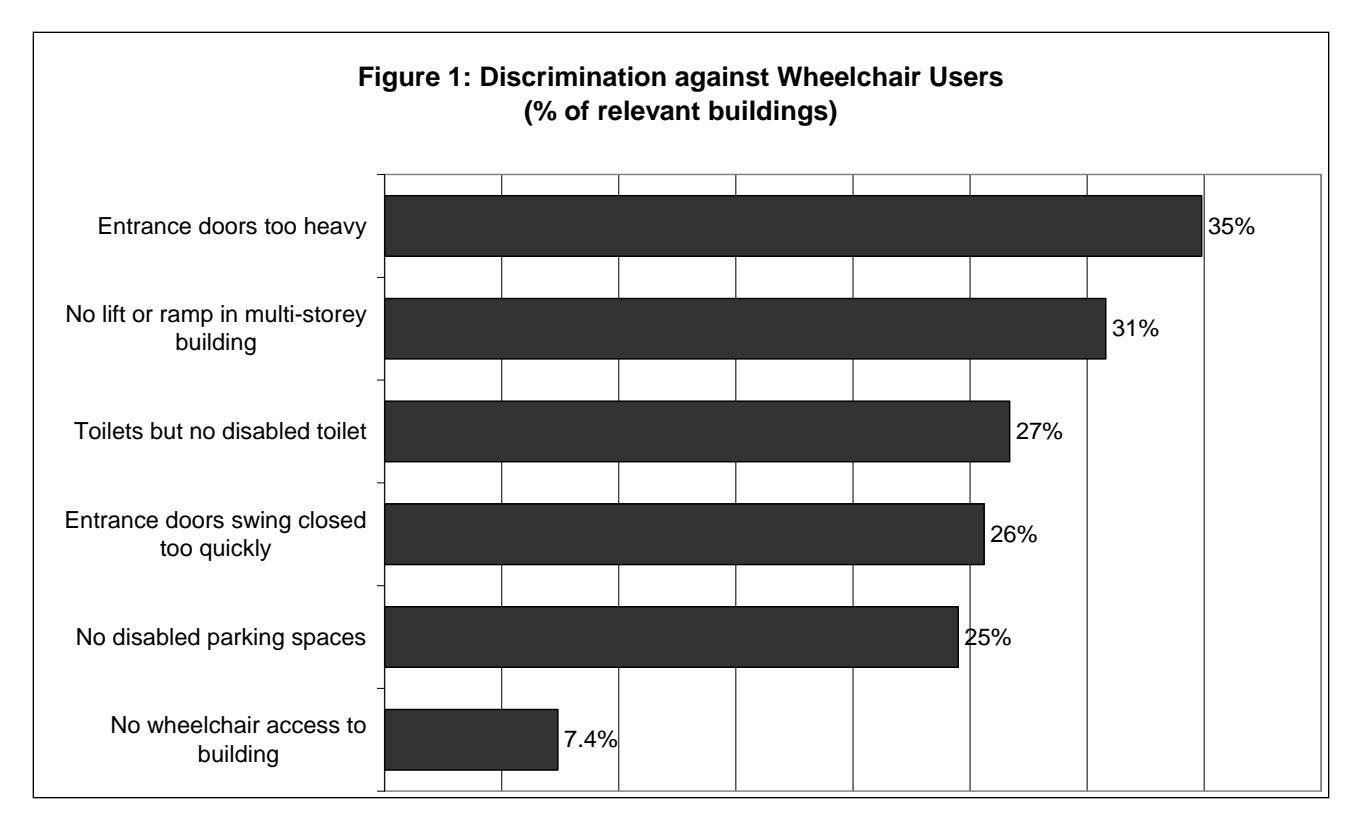
Key findings of the audit relating to discrimination against wheelchair-users are summarised in Figure 1 and Table 1. Table 1 contains more information than is discussed in the text. Key findings relating to discrimination against persons with sensory impairment are shown in Figure 2. The number of relevant buildings or entrances is given in the table and figures. Forty-nine buildings were surveyed, five of which had two main entrances for a total of fifty-four main entrances.

Four of the fifty-four main entrances (7.4%) surveyed did not allow independent access by a wheelchair. Although this is arguably the most blatant exclusionary practice, other indicators suggest exclusion is more widespread. Many buildings did not have access ramps, and well over a third of main access doors were either too heavy or too speedy for wheelchair-users, thus presenting difficulties and requiring, at best, a belittling request for assistance. One interviewee observed:

Since almost a third of multi-storey buildings did not have a lift or ramp to non-ground floors, wheelchair-users were effectively excluded from these buildings. A quarter of on-campus car parks did not have disabled spaces, while others suggest tokenism due to either the absence of additional space for wheelchair manoeuvres (46% of car parks with disabled spaces) and/or a prohibitively long distance between the disabled space and the relevant building (41%). One interviewee complemented a particular building, although it is the implied exclusion from others that is arguably most apparent:

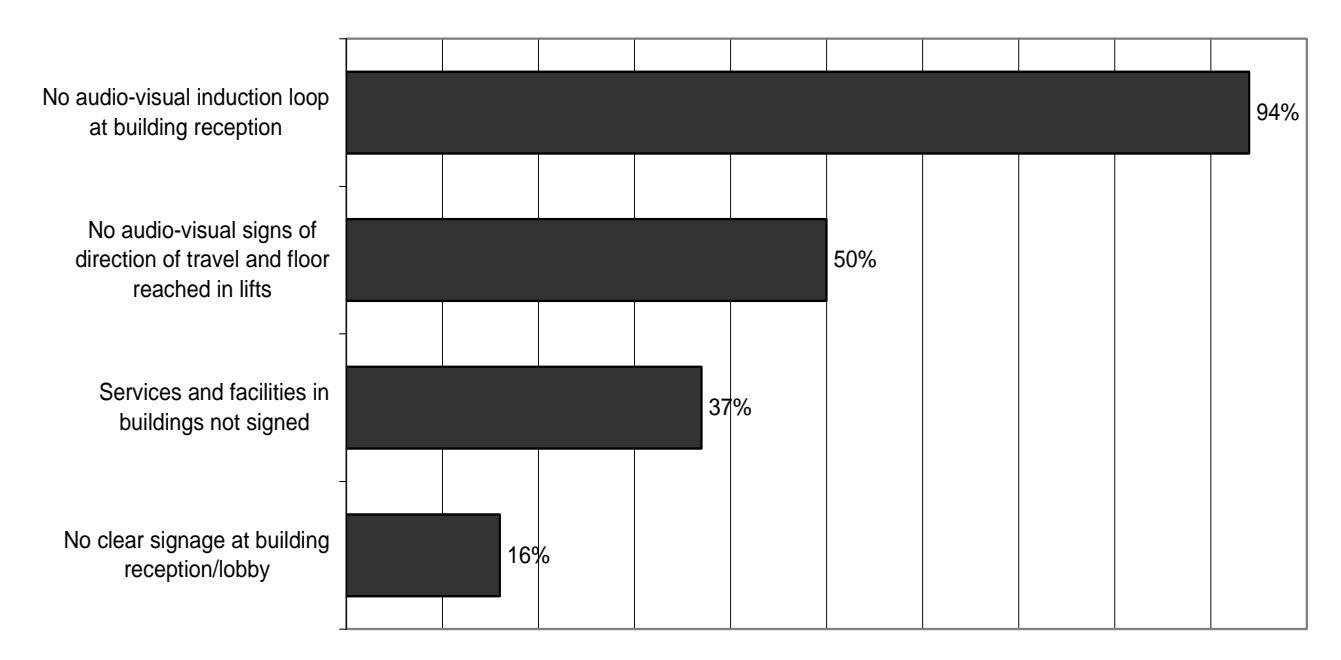
Figure 2: Discrimination against Sensory Impairment (% of Relevant Buildings)

Key findings relating to discrimination against the sensory impaired are shown in Figure 2. Hardly any campus buildings had an induction loop in reception, though the presence in some instances indicates that there was institutional knowledge of this facility. However, with only half of buildings exhibiting directional signs, and over a third failing to sign their services and facilities, there was a clear suggestion of discrimination against persons with hearing impairments. In some instances, even where it was clear that some effort had been made to improve access, it had not succeeded:
