Structural behaviour of pultruded fibre composites guardrail system under horizontal loading

Allan Manalo¹ and Mac Pac²

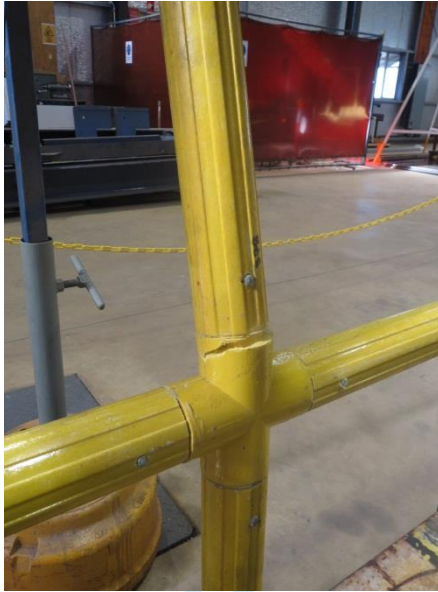
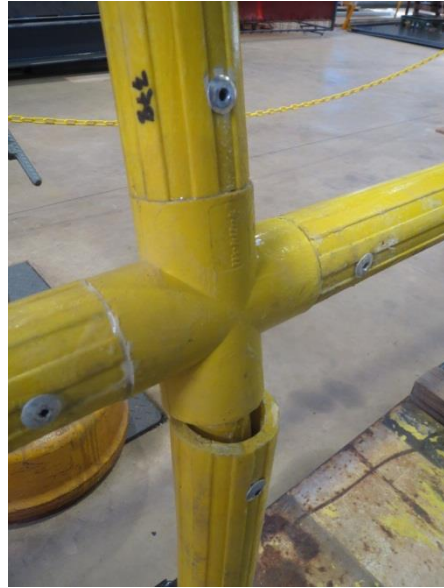
The load and deflection behaviour of the composite guardrails mounted at the top of the beam and loaded to the middle post is shown in Figure 8. A linear load deflection curve was observed in all specimens at the initial application of the load. For specimens GTP-PE and GTP-RE, a slight decrease in the load was observed due to the initiation of epoxy debonding and sliding of the guardrail members. A significant drop in the load was then observed for both specimens due to the failure in the 4-way tee joint at the middle post. Failure in the 4-way tee joint (Figures 9a

1
2
3 and 9b) occurred at a load of 19.18 kN and 19.31 kN in specimens GTP-PE and GTP-RE,
4
5 respectively. The high deflection after the initial failure is explained by the failure of the 4-way
6
7 tee joint which separates the top portion of the post, thus reducing the force absorbed by the
8
9 post. However, the guardrail system continued to carry load as the load was transferred to the top
10
11 guardrail members but with a significant amount of deflection at the top post due to the
12
13 progression of failure in the 4-way tee joint. Final failure occurred due to significant damaged on
14
15 the 4-way tee joint combined with sliding failure on the 3-way tee joint at the top of the post.
16
17

(a) GTP-PE

(b) GTP-RE

Figure 9: Failure behaviour of top mounted guardrail loaded to post

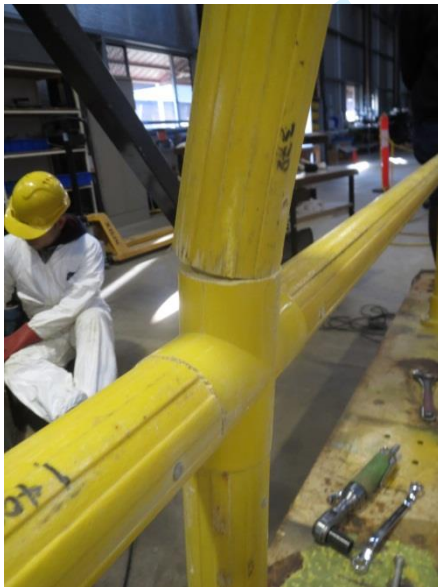
(c) GTP-P

18
19 For specimens GTP-P and GTP-R, the absence of epoxy adhesive resulted in the joint
20
21 connectors to rotate and reduced the overall stiffness of the guardrail system. This is expected as
22
23 the connection between the joints and the GFRP tubes is not fully tight allowing the tube to
24
25 rotate and lose stiffness resulting in large deformation. For specimens without epoxy adhesive,
26
27 the continuous splitting of the GFRP tube also contributed to the large amount of deflection
28
29 observed. The failure in specimen GTP-P occurred due to sliding of the polypin at an applied
30
31 load of 12.96 kN as shown in Figure 9c. The initial failure of guardrail connected with polypin
32
33 occurred at a displacement of around 170 mm. This failure of the polypin resulted in a reduction
34
35 in the applied load but the specimen continued to carry load and deflected more as the load was
36
37 transferred to the top guardrail members. On the other hand, specimen GTP-R failed due to

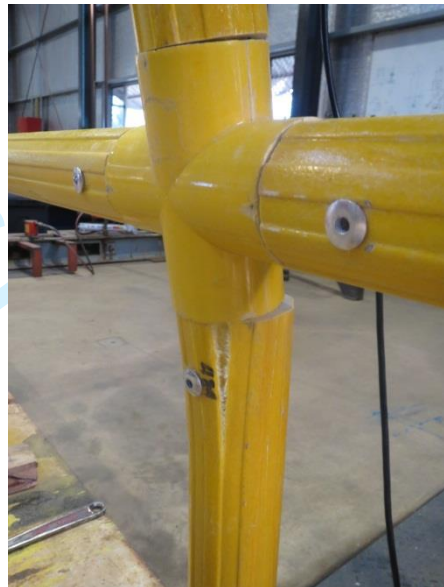
38
39 failure of the GFRP tube at the bottom post (Figure 9d) at an applied load of 16.77 kN. During
40
41 the spread of the damage, sliding of the 3-way tee joint under the loading nose was observed in
42
43 all specimens at final failure.
44
45
46
47

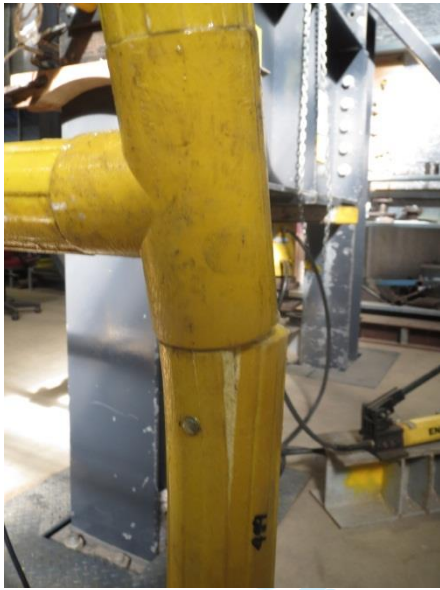
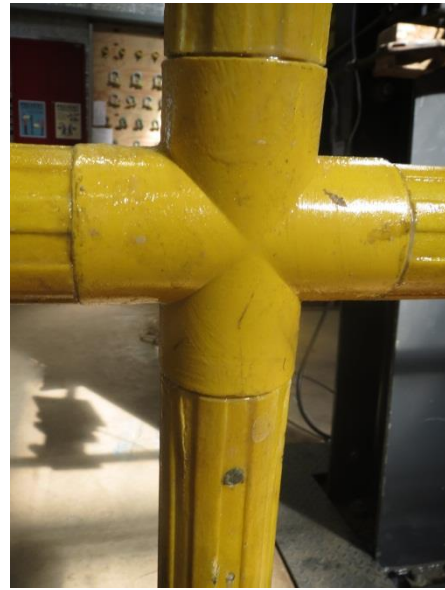
1
2
3 and GTM-RE, initial failure occurred due to failure at the 3-way tee joint at the side post
4 (Figures 11a and 11b) at an applied load of 13.7 and 10.3 kN, respectively. Eventhough failure
5 of the 3-way tee joint occurred, the guardrail system still carry load as indicated by the increase
6 in the load capacity as shown in the load-displacement curve. This is due to the load transferred
7 to the guardrail member and post. Final failure of specimens GTM-PE and RE is due to the
8 failure of the GFRP tube at the bottom portion of the middle post as shown in Figures 11b and
9
10
11
12
13
14
15
16
17
18
19

(a) Failure of FRP profile (side post)

(b) Failure of FRP profile (middle post)

Figure 11: Failure behaviour of specimen GTM-PE

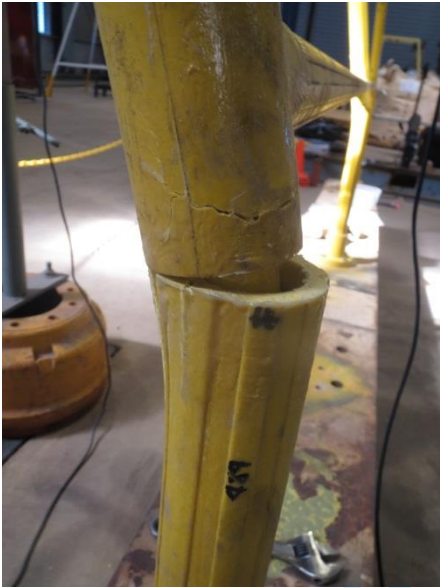
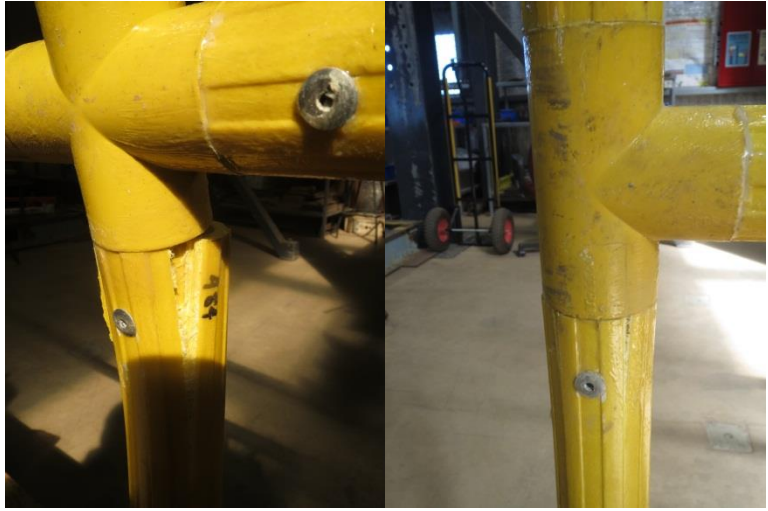
(a) Failure of joint (side post)

(b) Failure of FRP profile (middle and end posts)

Figure 12: Failure behaviour of specimen HTM-RE

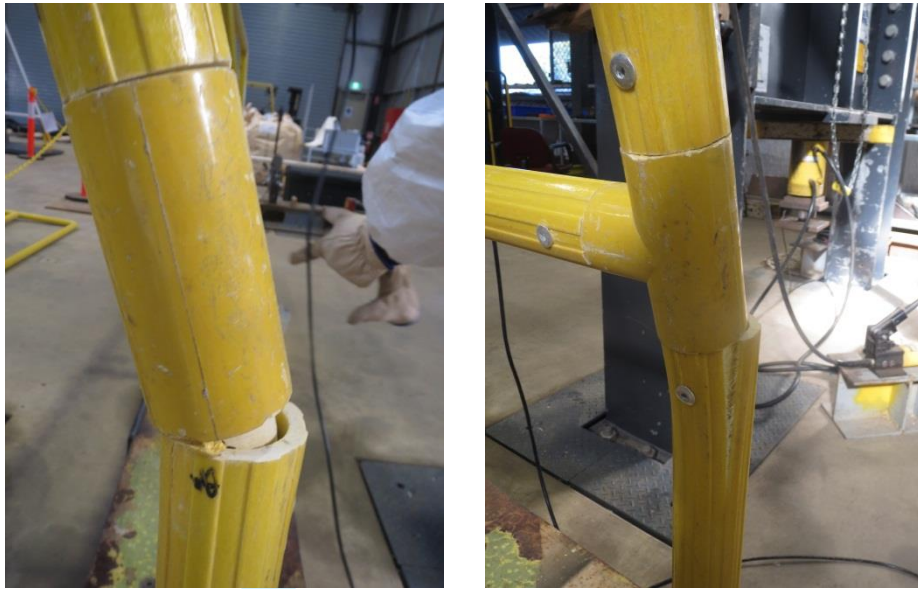
20 For guardrails without epoxy at the joints, specimens GTM-P and GTM-R, the failure
21 was initiated at 3-way tee joint at the side post (Figure 13) at an applied load of around 13.2 kN.
22 Both specimens continued to carry load with more deformation and finally failed due to the pull-
23 out of the polypin for specimen GTM-P and splitting shear failure of the GFRP tube for
24 specimen GTM-R at the middle post. In specimen GTM-R, the failure of the GFRP tube
25 occurred as only the randomly oriented strand glass mats provide the strength in the transverse
26 direction of the guardrail. However, it can be also seen that the composite guardrail fails
27 progressively with the application of load. The splitting of the tubes occurs without the rupture
28 of the unidirectional glass fibres which preserved some of the strength capacity of the guardrail
29 system. With the continuous application of the load, the splitting and tearing of the composite

30 guardrail progresses resulting in large deformation and total failure of the guardrail system.
31
32
33
34
35
36
37
38
39
40
41
42

(a) GTM-P

(b) GTM-R

Figure 13: Failure behaviour of specimen GTM

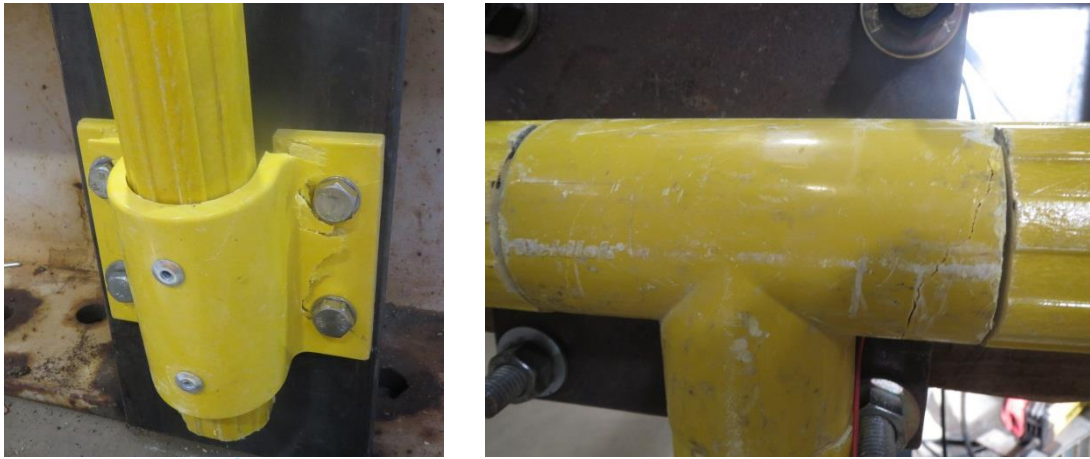
1
2
3 All specimens failed due to the failure of the side-mounted plate at the bottom of the
4 middle post as shown in Figure 15a. Except for specimen HSP-RE, failure of the side-mounted
5 plate occurred at a deflection of around 140 mm. However, it can be observed that after a
6 deflection of 140 mm there is a decrease in the stiffness in specimen GSP-RE which indicates
7 that the failure initiated in the guardrails system. The failure of the side mounted connector result
8 in the guardrail losing functionality as indicated by the significant drop in the load. After this
9 point, all specimens showed some resistance to carry load but with significant amount of
10 deflection until the sliding failure of the 3-way tee joint connecting the two guardrail bays at the
11 top post was observed as shown in Figure 15b.
12
13
14
15
16
17
18
19
20
21
22
23

(a) Failure of the side mount plate (b) Failure of 3-way tee at the top post

Figure 15: Failure behaviour of specimen GSP

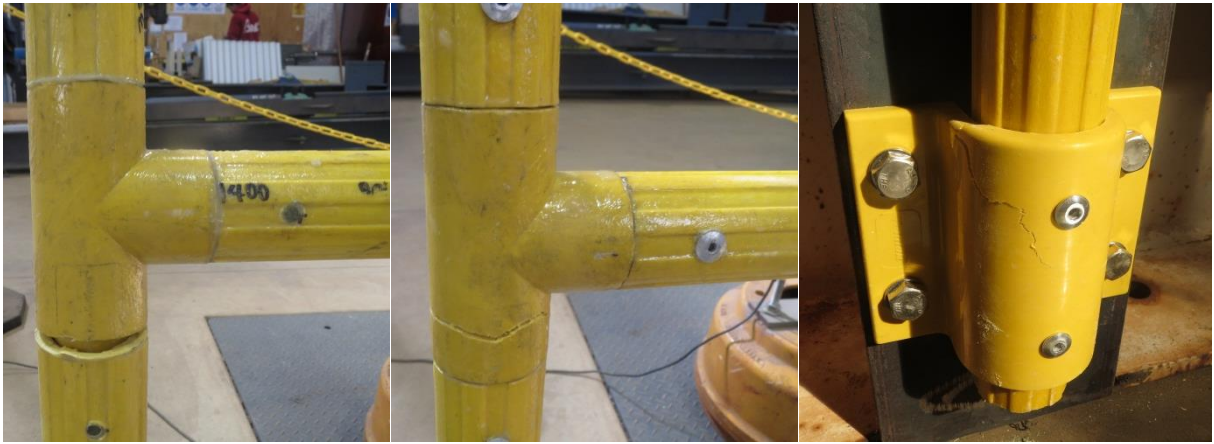
40 Specimens GSM-PE and GSM-RE showed very similar behaviour. Both of them
41 exhibited the same load-deflection behaviour and resisted a maximum applied load of around
42 14.7 kN when the first failure was observed. Similarly, the failure occurred at a deflection of
43 around 150 mm due to the failure of the 3-way tee joint at the side post as shown in Figure 17a.
44 A drop in the load was then observed after this failure but the guardrail continued to carry load.
45 After failure of the 3-way tee joint, the horizontal guardrail member transferred the load to the
46 middle post which results in the failure of the side mounted plate as shown in Figure 17b.
47
48
49
50
51
52
53
54

(a) Failure of 3-way tee (GSM-PE, left and GSM-RE, right) (b) Failure of side mount plate

Figure 17: Failure behaviour of specimens GSM-RE and GSM-PE

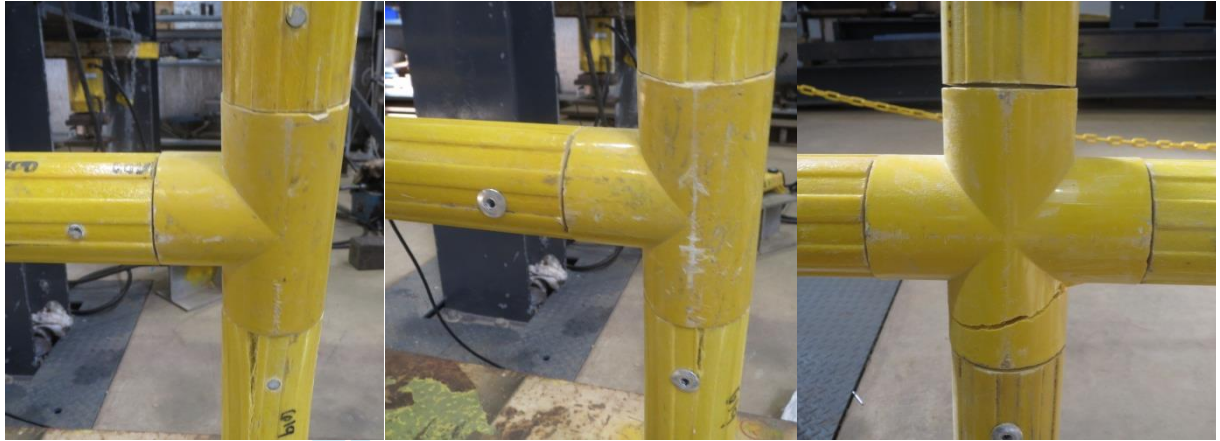
55 The specimen GSM-R and GSM-P failed at an applied load of almost 13.5 kN when
56 failure of the GFRP tube at the 3-way tee joint at the side post occurred as shown in Figure 18a.
57
58
59
60

1
2
3 After the initial failure, the load was transferred to the nearby post (middle post) through the
4 horizontal guardrail member which resulted to the failure of the 4-way tee joint as shown in
5 Figure 18b. This result shows that for joints without epoxy, failure occurs mostly at the joints as
6 there is no continuity of the system and the load is not transferred effectively to the base plate
7 connector.
8
9

(a) Failure of the GFRP tube at side post

(b) Failure of 4-way tee joint

Figure 18: Failure behaviour of specimen GSM-P and GSM-R
