October 2017

# Evaluating the Vulnerability of Boston's Inner Harbor Designated Port Areas to Sea Level Rise and Coastal Storms

An Interactive Qualifying Project Report Submitted to the Faculty of the WORCESTER POLYTECHNIC INSTITUTE in partial fulfillment of the requirements for the

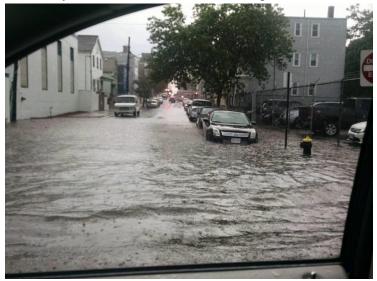
Channel Fish Co. is located in the East Boston DPA, with direct access to the waterfront along Chelsea Creek. The East Boston area has been prone to serious erosion along the coast, and is located within the boundaries of the PFZ with regards to 5 feet SLR, shown in Figure 7 above. The representative stated that his business has been prone to flooding in the past, with an example of this flooding shown below in Figure 8. In regards to flooding on this property, the representative said "It's been pretty severe at times: the most recent occurrence on Aug. 2, the standing water was about a foot tall. It's also gotten into our basement in the past."

Figure 8: Flooding Within East Boston August 2, 2017 From: Margaret Farmer

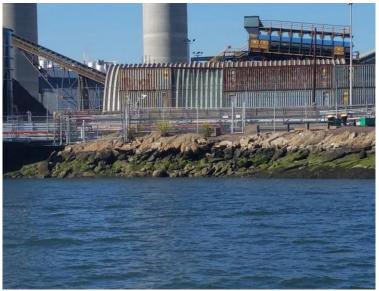
Figure 9: Riprap located at Prolerized

During our water taxi tour, we were unable to visit all of the parcels from our sample due to limited time and travel restrictions. We were able to look at some SLR preventative infrastructure near some of the sites. Figure 9 shows riprap located on Prolerized. It can be seen that the high water mark on the rocks is more than halfway up the structure. We were not able to gain the exact measurements of the height of the rip rap, but we can safely estimate there is less than 5 feet of riprap above the high water mark. This is concerning due to the fact that 5 feet of SLR is expected by 2100, and if coastal storms hit the area, they will most likely experience more than 5 feet of coastal storm surge, resulting in the Prolerized site being flooded. Similar flooding would be experienced at the Eastern Salt site under the same future conditions. As seen in Figure 10, the Eastern Salt parcel has bulkheads. However, the high water mark is also located less than 5 feet from the top of the structure. The quality of SLR prevention infrastructure on these sites demonstrates the exposure to SLR and coastal storms, adding to the vulnerability of these working port areas.
