Spring 2010

Digital Image Correlation application to structural health monitoring

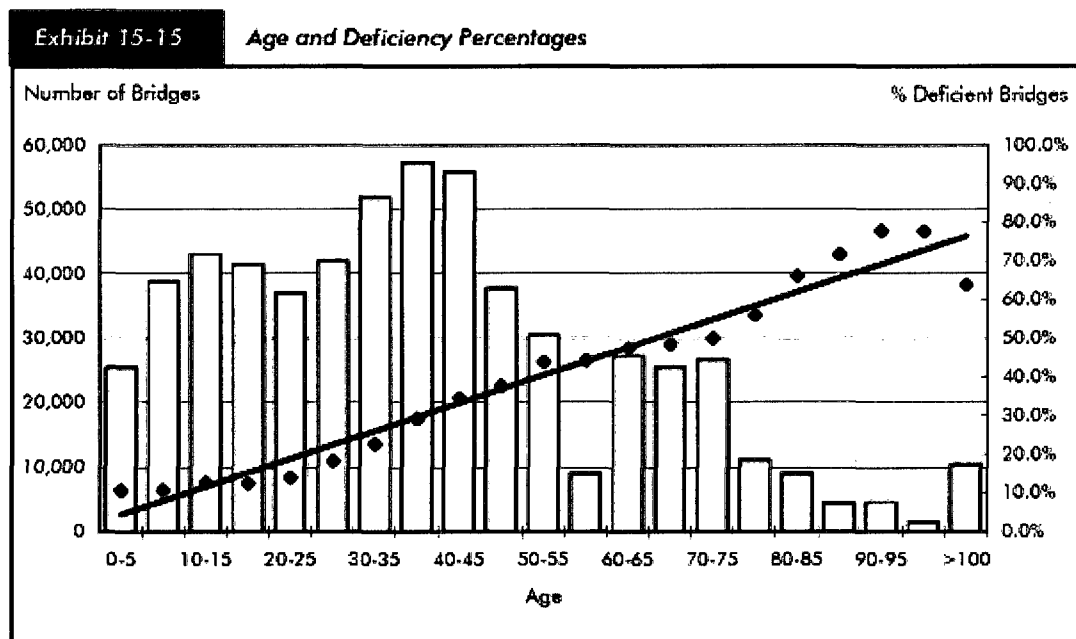
Source: National Bridge Inventory.

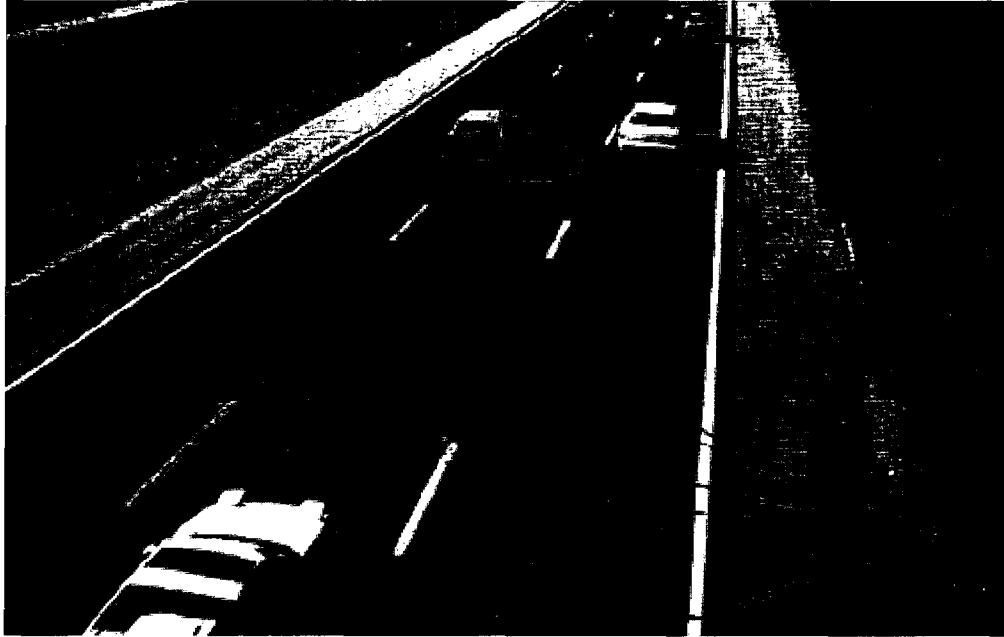
Figure 1-8: Loop detectors (FHWA, 2006)

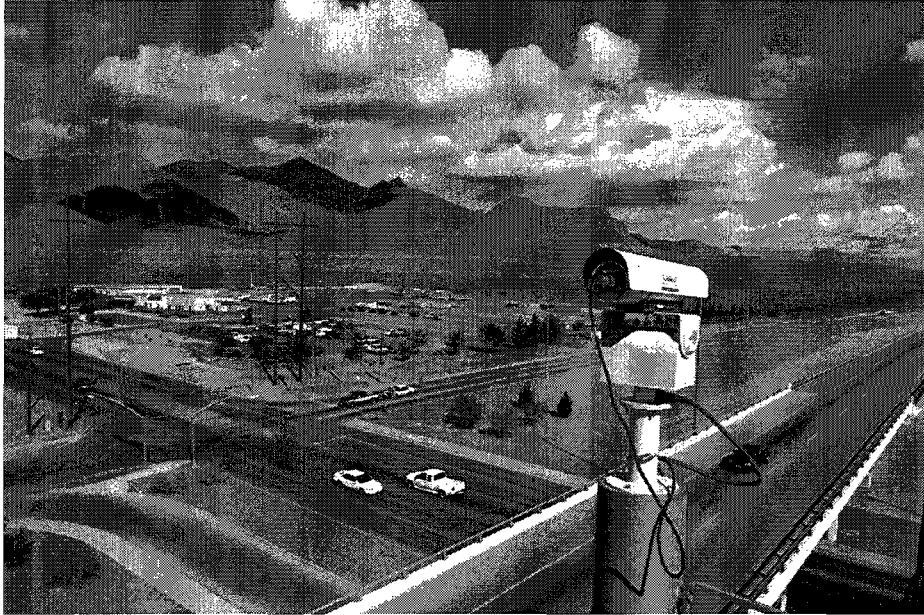
Figure 1-9: Traffic camera monitor (A&M University, 2004)

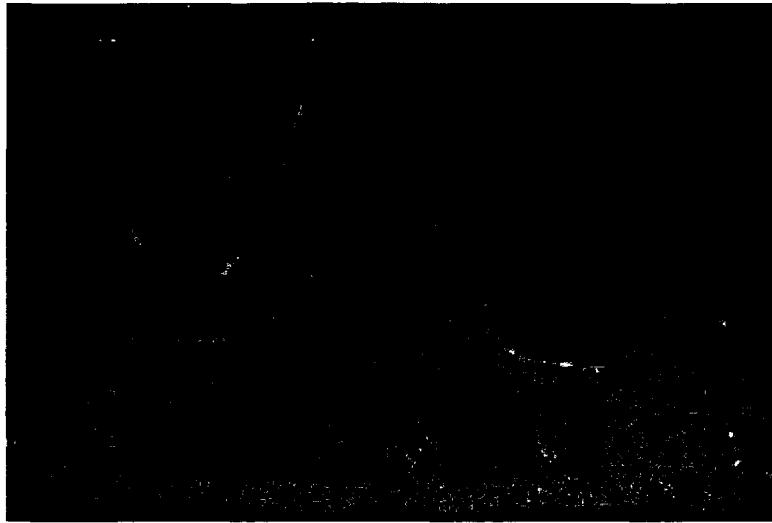
Figure 3-2: Strain in a gear tooth (CSib, 2009)

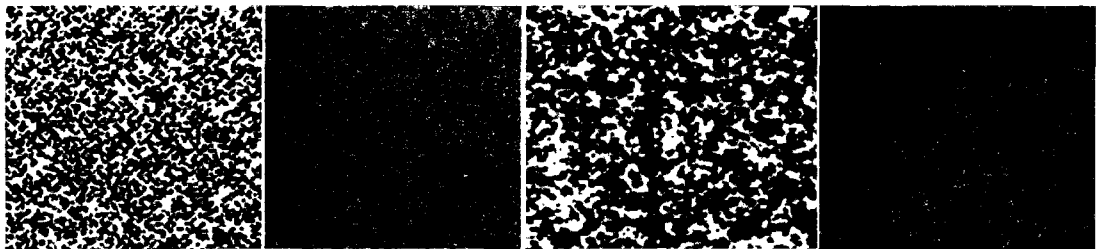
Figure 3-12: Examples of acceptable speckle patterns (CSI, 2007)

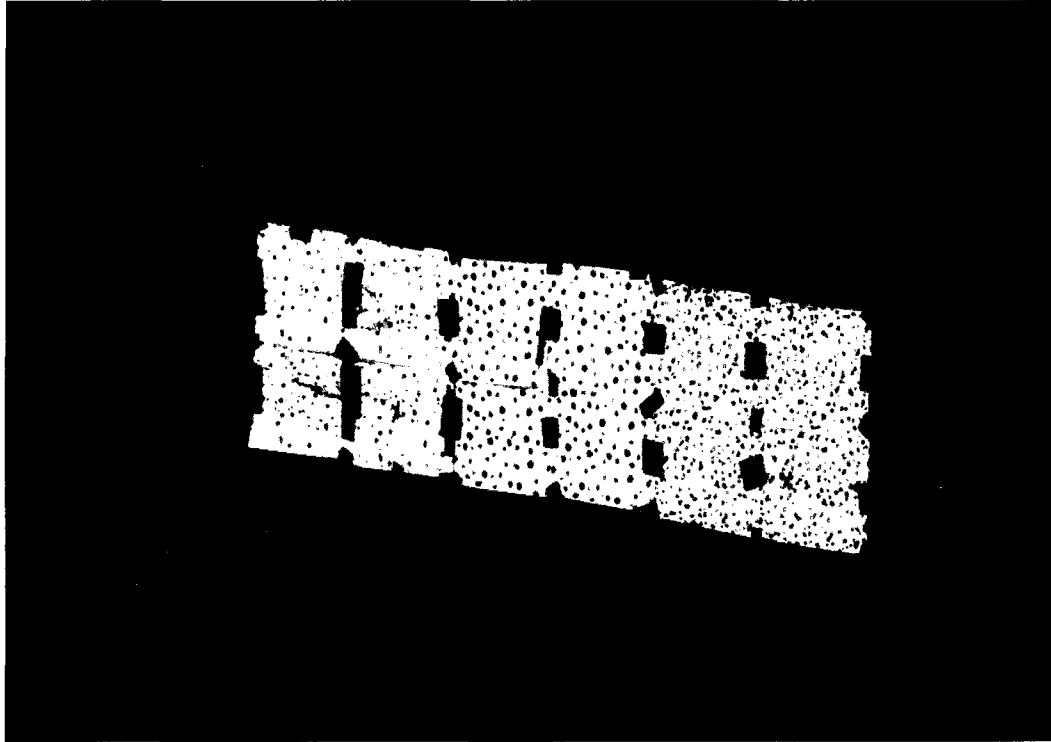
Figure 3-13: Paper speckle pattern on bridge girder in Tiverton, Rhode Island

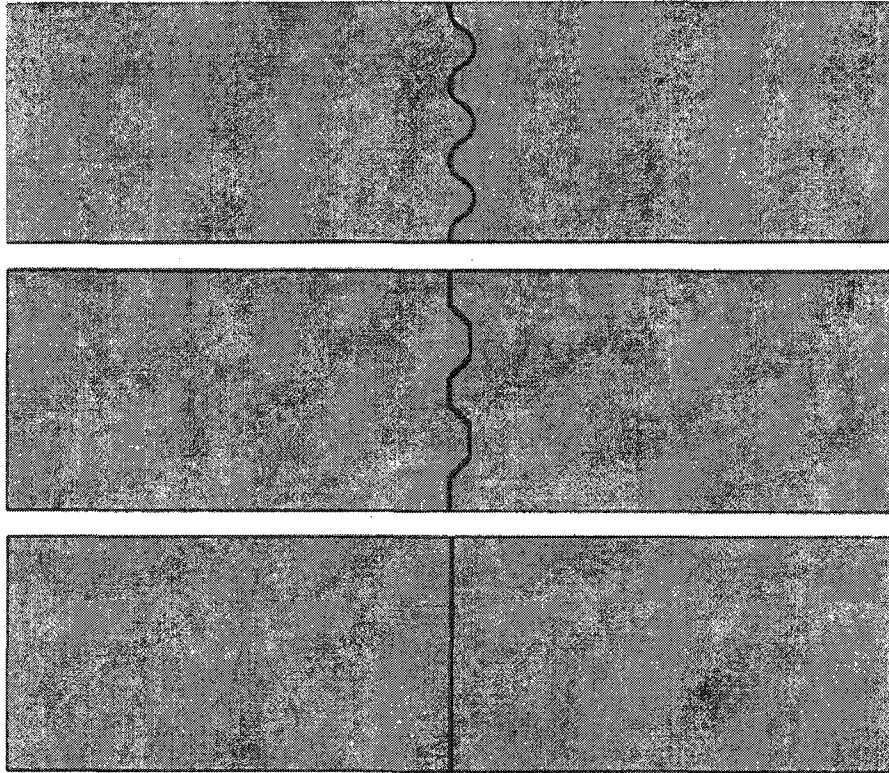
Figure 4-4: Examples of precast bridge deck panel connections (Robert, 2009)

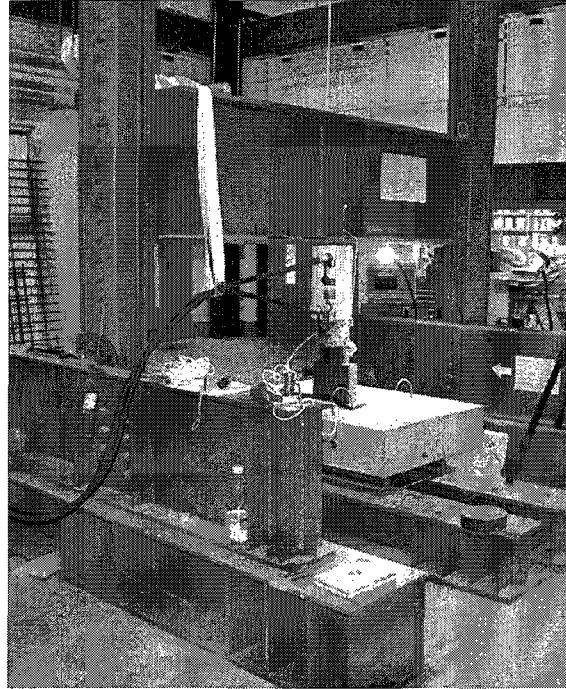
Figure 4-5: UNH loading frame

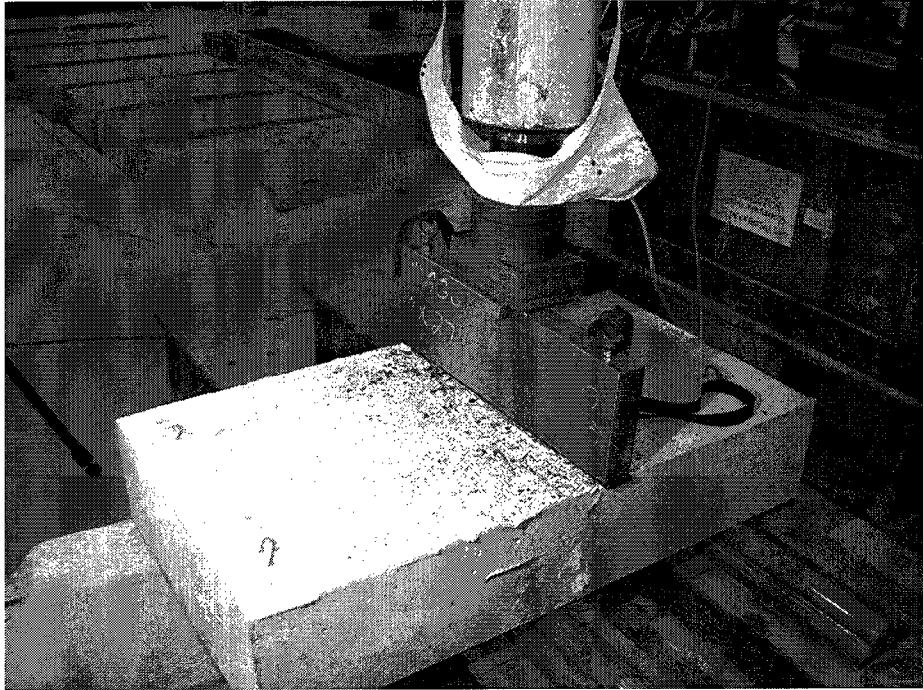
Figure 4-6: Slab test loading setup

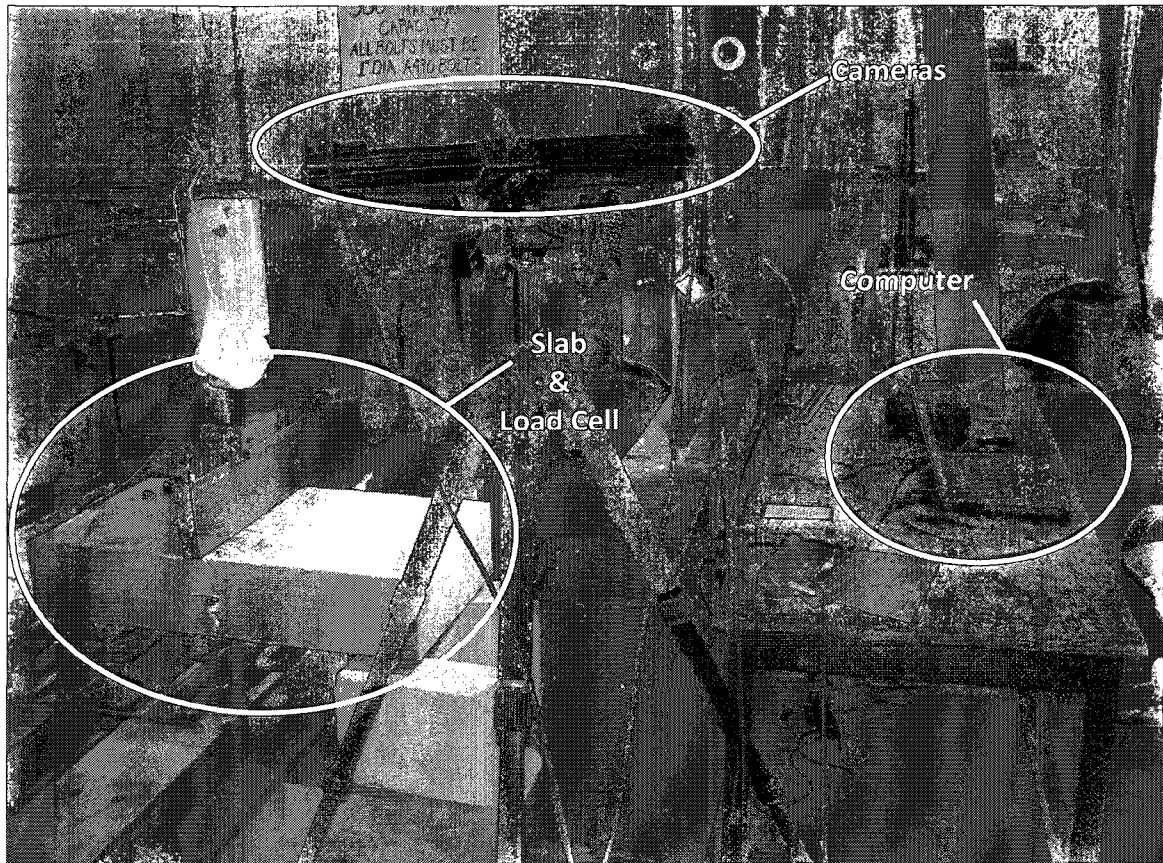
Figure 4-7: Slab test DIC setup with cameras, loaded slab, and computer

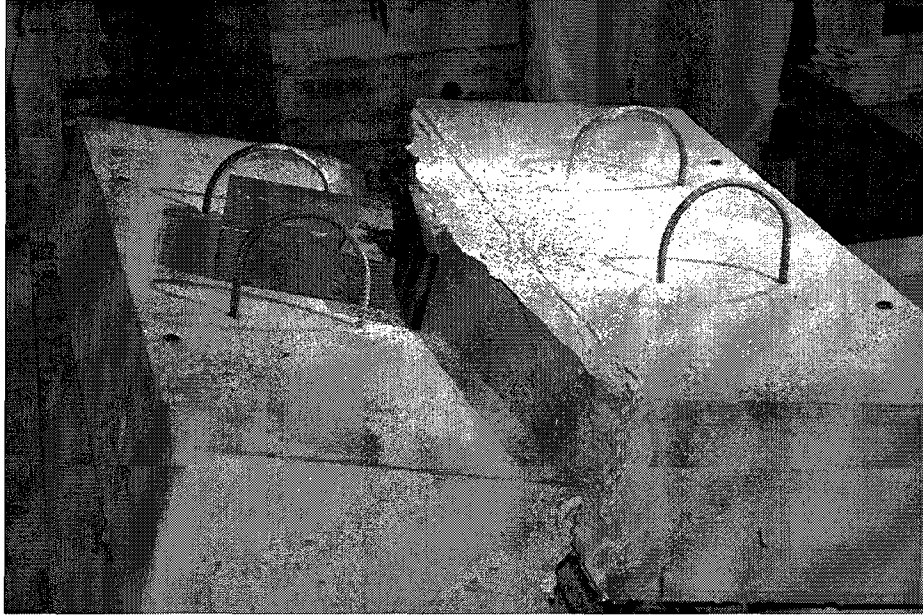
Figure 4-8: Slab after failure

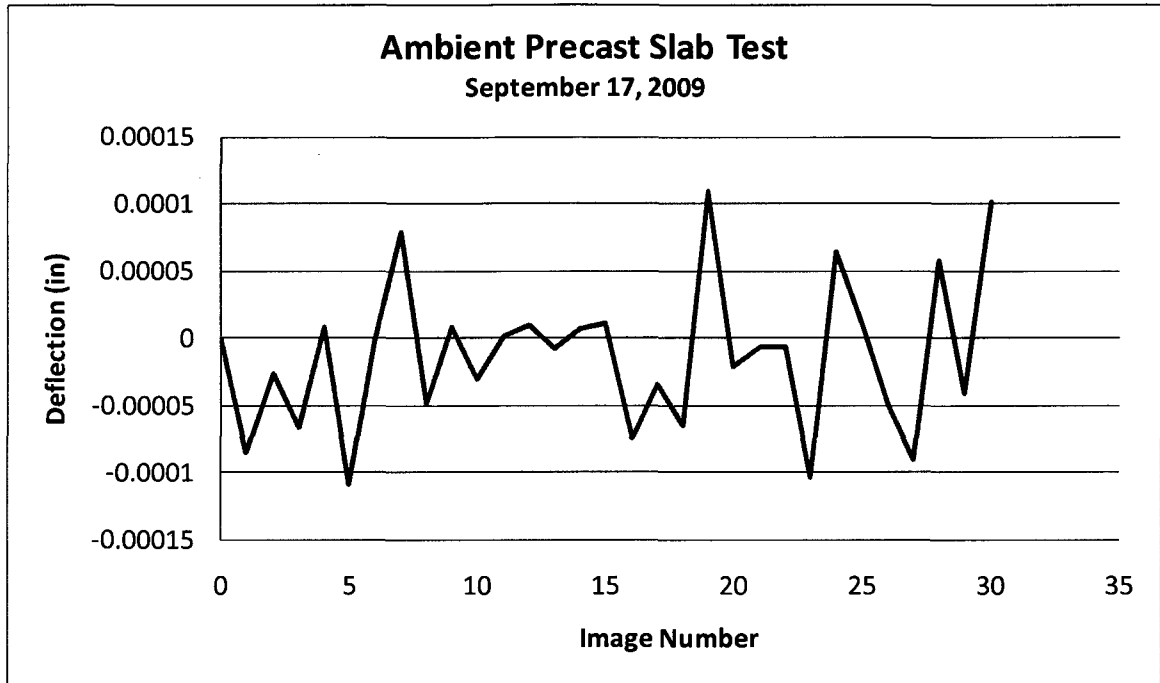
Figure 4-9: Precast Slab test ambient data

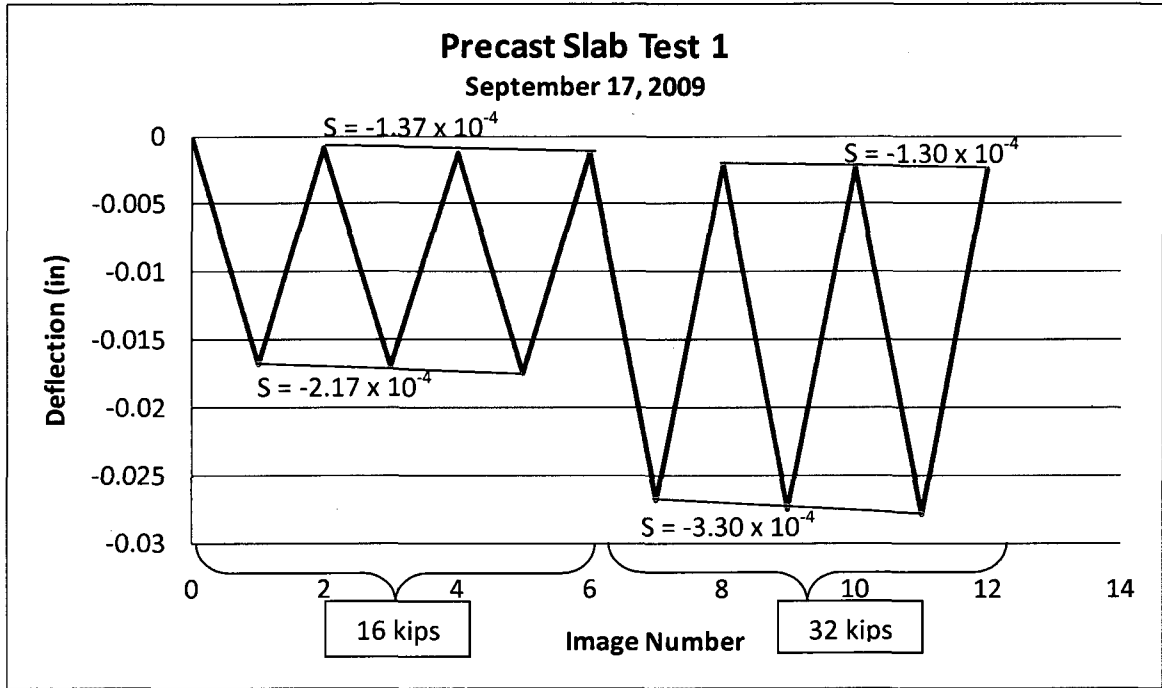
Figure 4-10: Precast slab Test 1

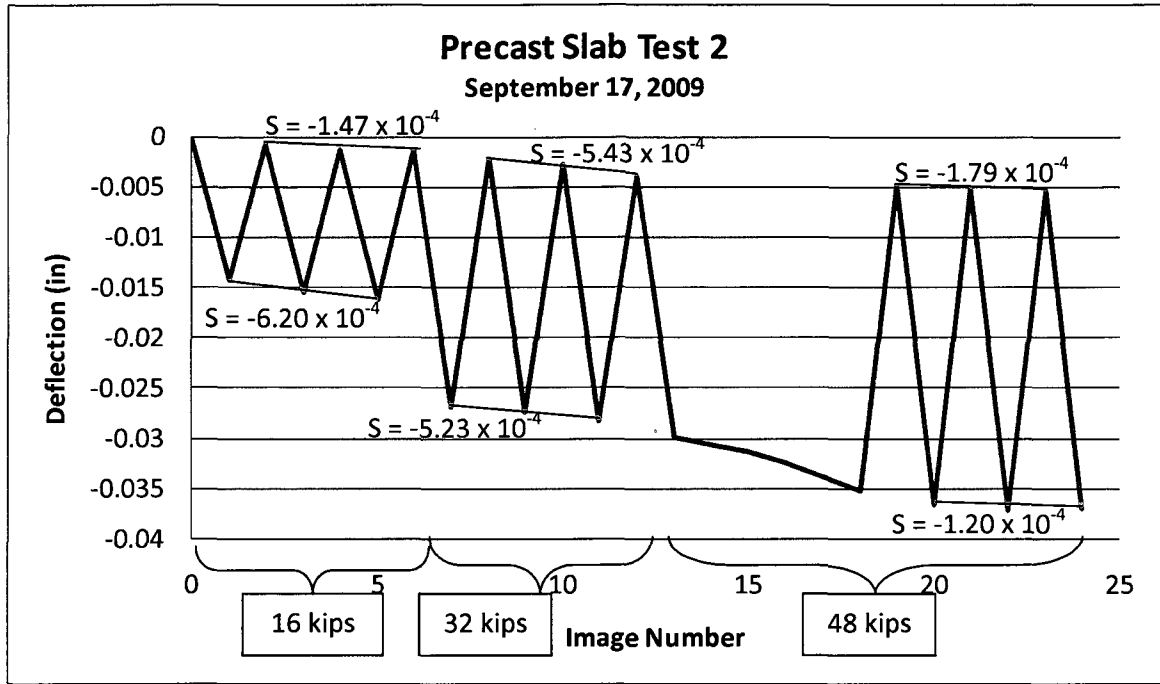
Figure 4-11: Precast slab Test 2

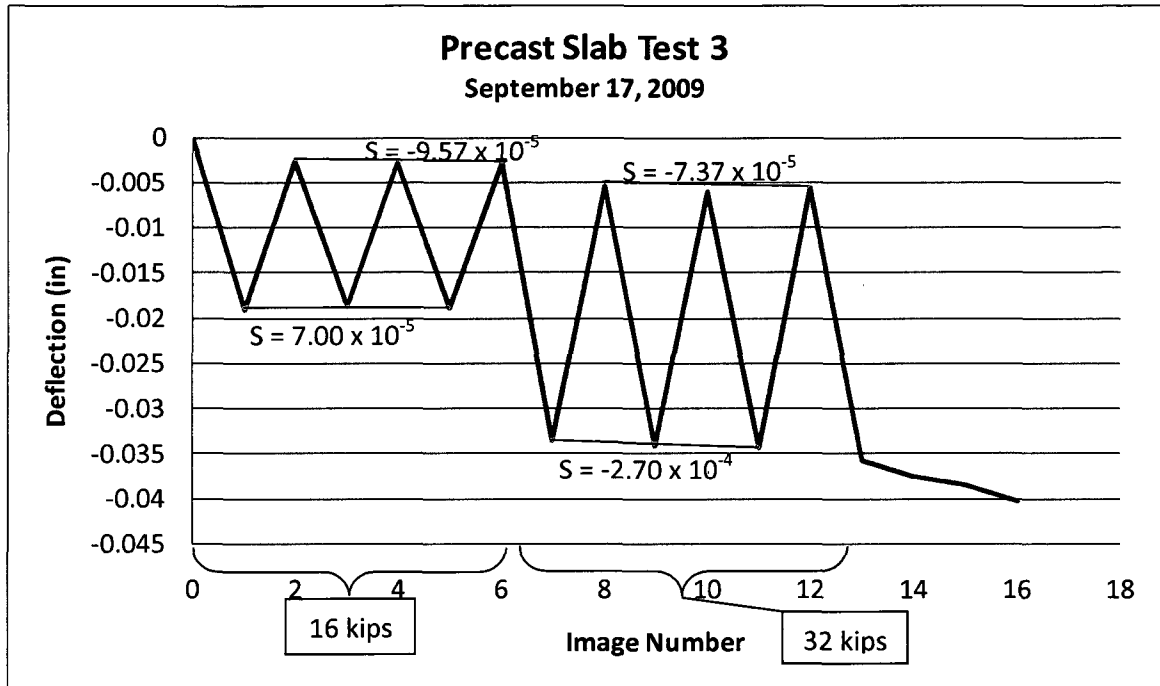
Figure 4-12: Precast slab Test 3

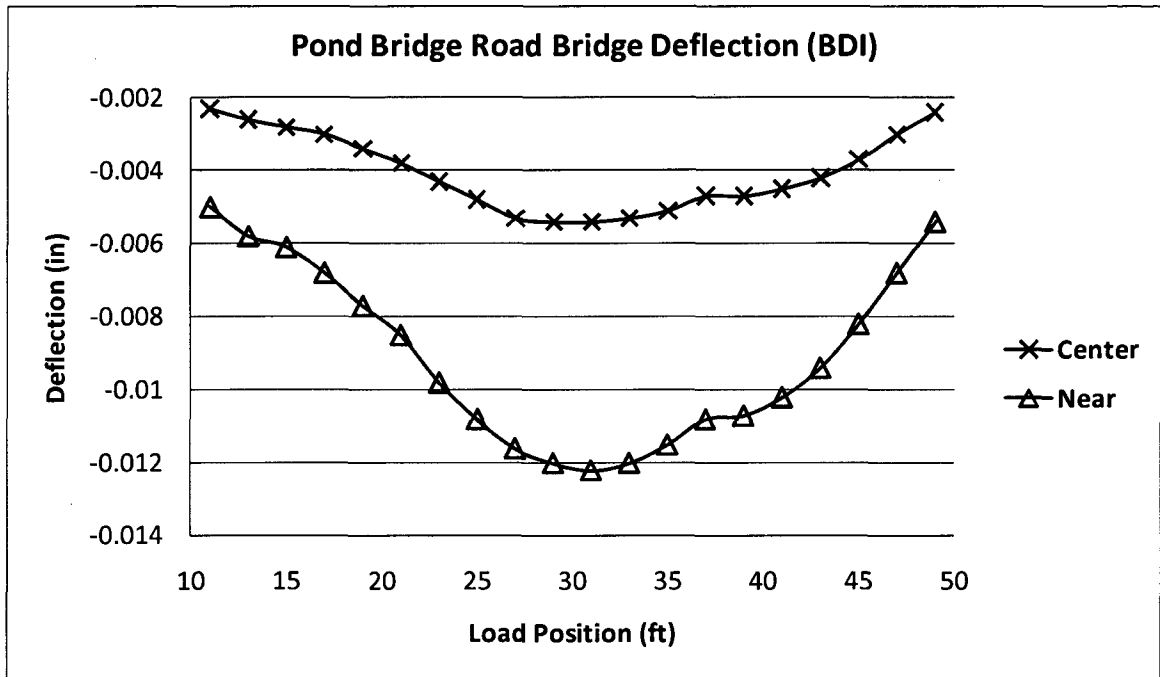
Figure 4-27: BDI data for two load truck locations at Pond Bridge Road Bridge

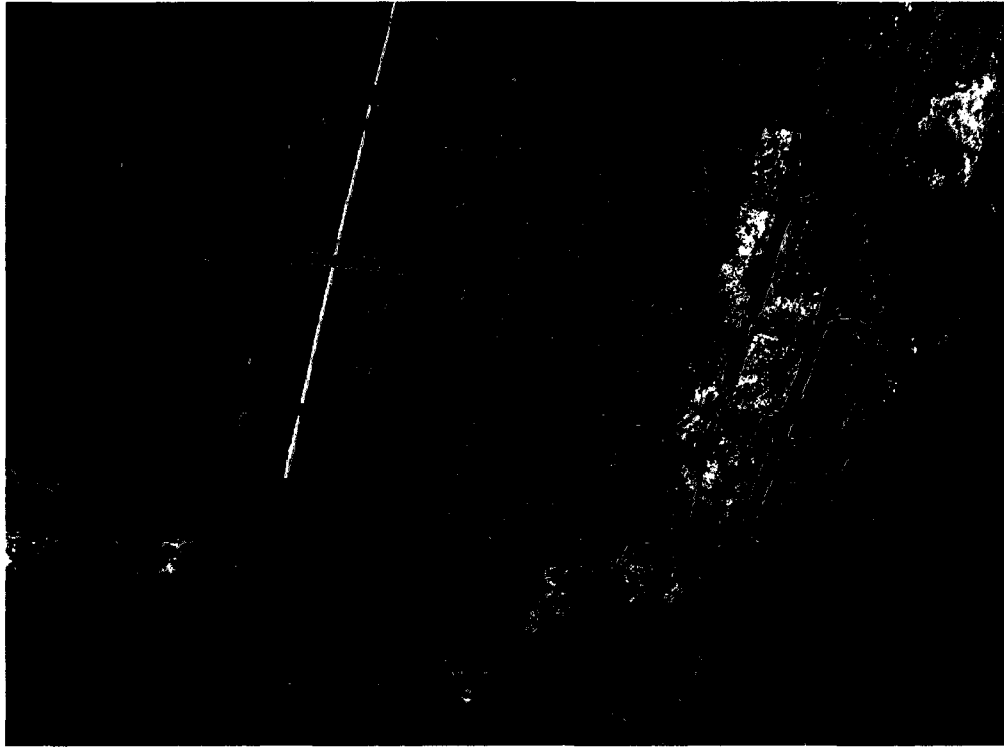
Figure 5-1: Deck spall at Vernon Avenue Bridge (MHD, 2007)

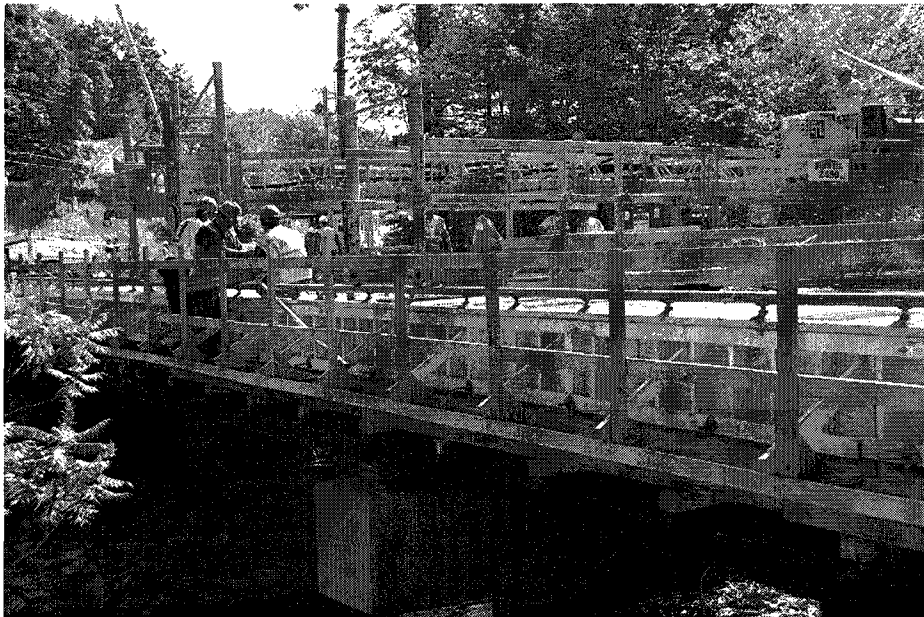
Figure 5-5: Concrete deck pour and heavy equipment operation

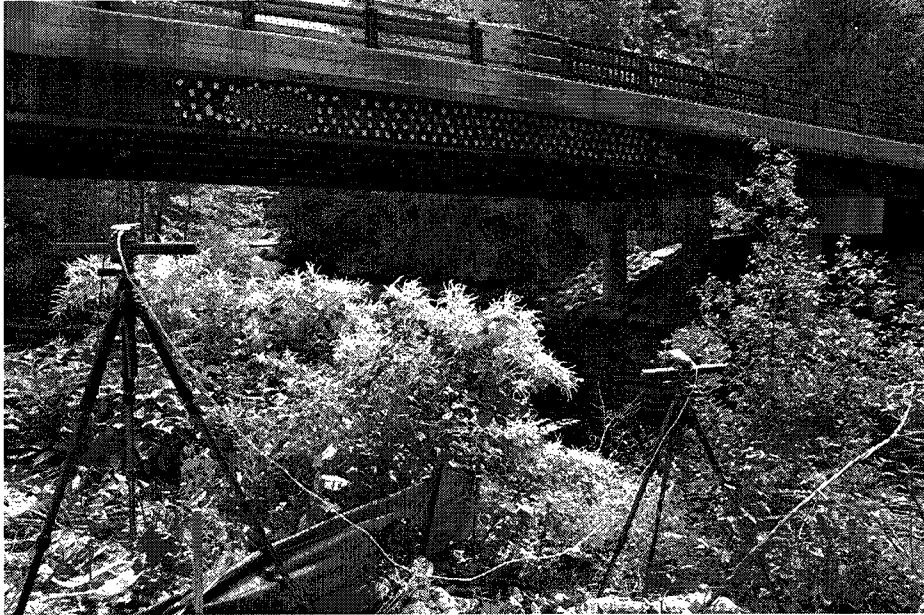
Figure 5-7: Middle span DIC setup

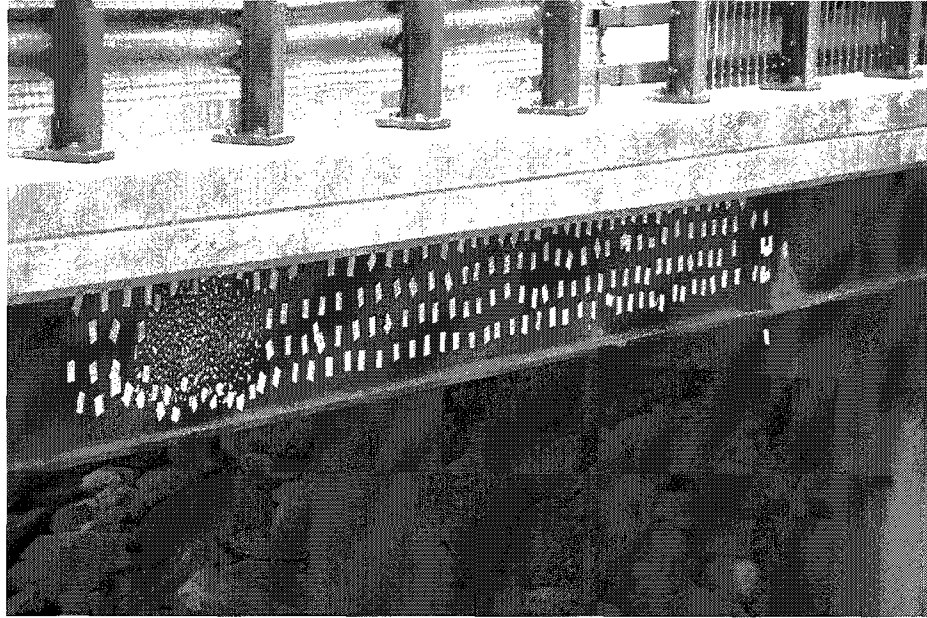
Figure 5-8: Updated speckle pattern at middle span

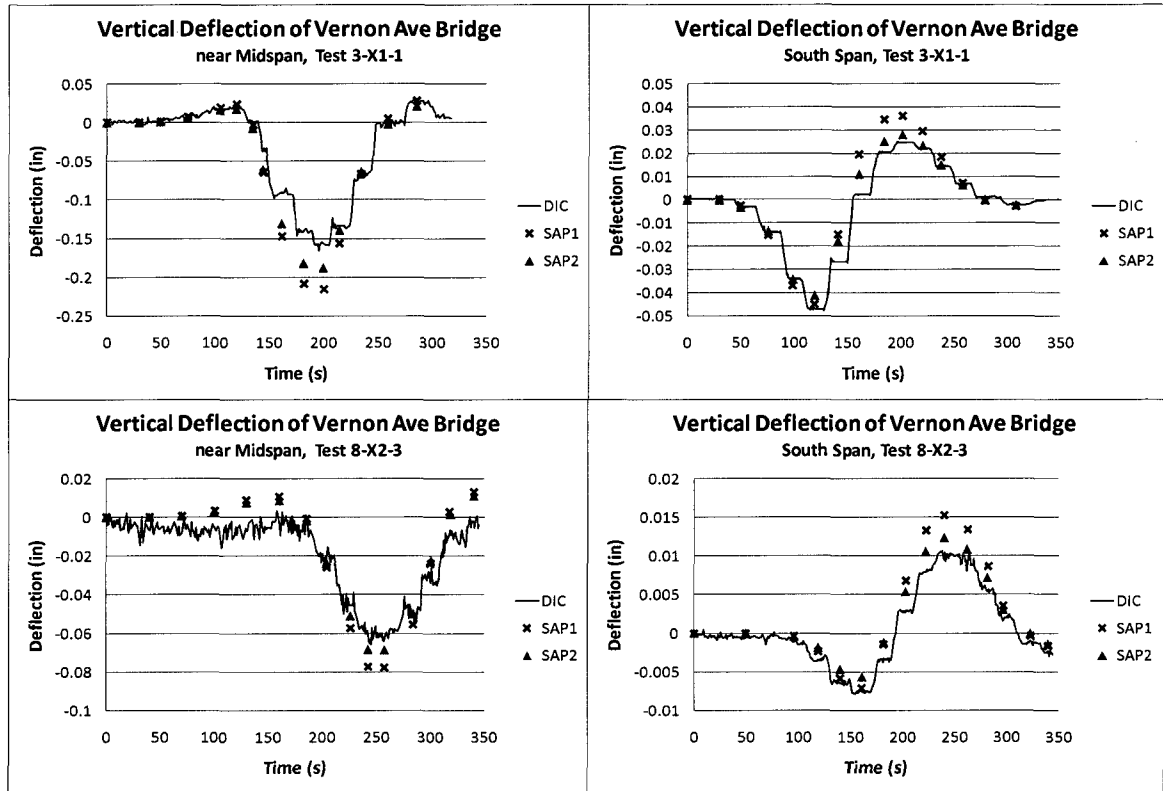
Figure 5-19: SAP2000 model deflection data versus DIC data from Vernon Ave Load Test

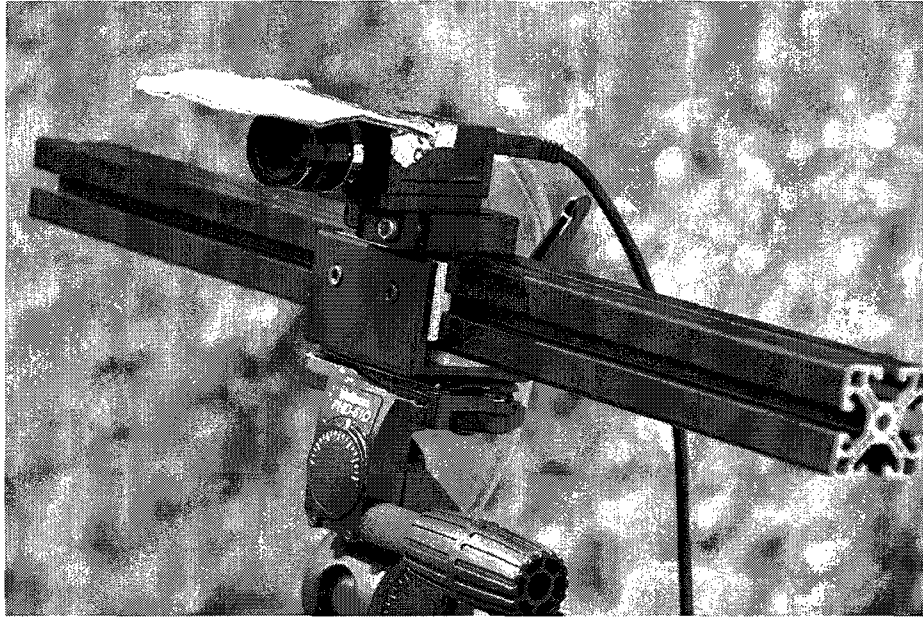
Figure 5-20: DIC camera with visor

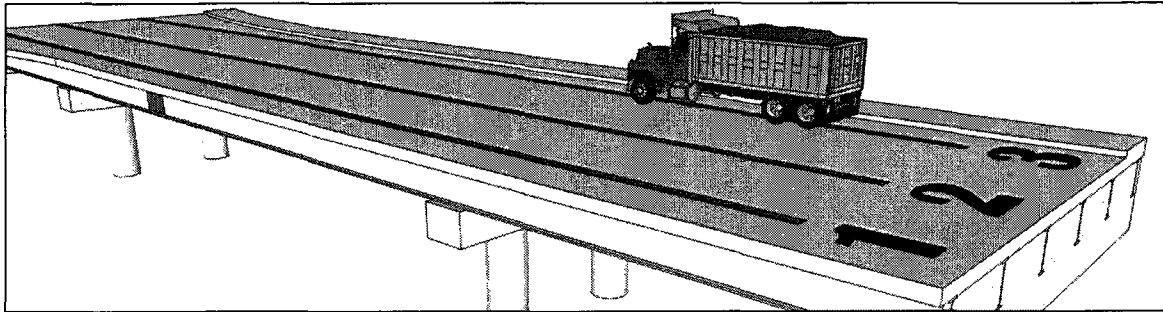
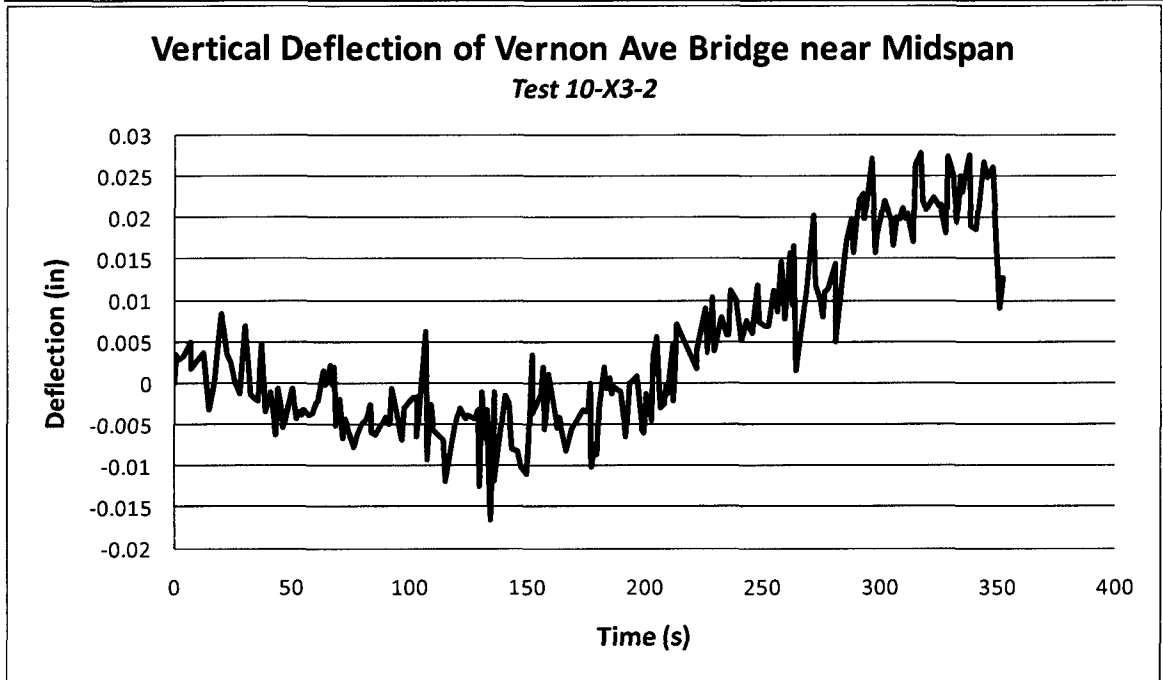
Figure 5-23: Trending of Vernon Avenue data near midspan-Test 10-X3-2

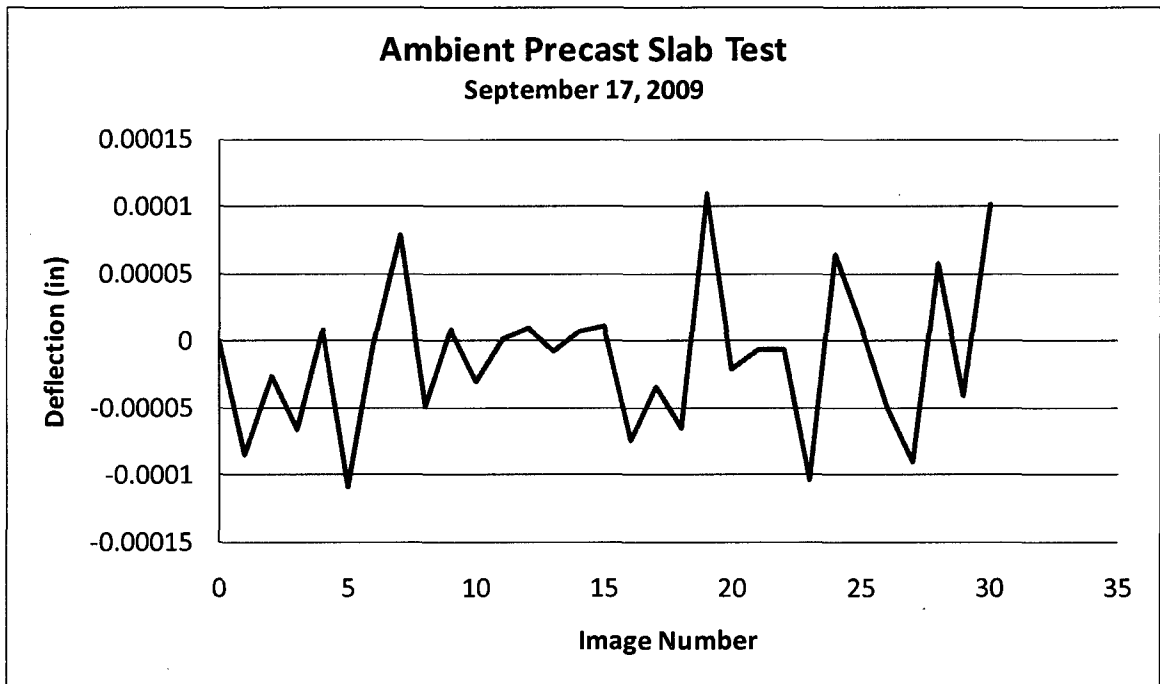
Three tests were conducted on precast concrete slabs to determine their maximum allowable service for a rapid bridge deck replacement system. The DIC system was used to collect deflection data.

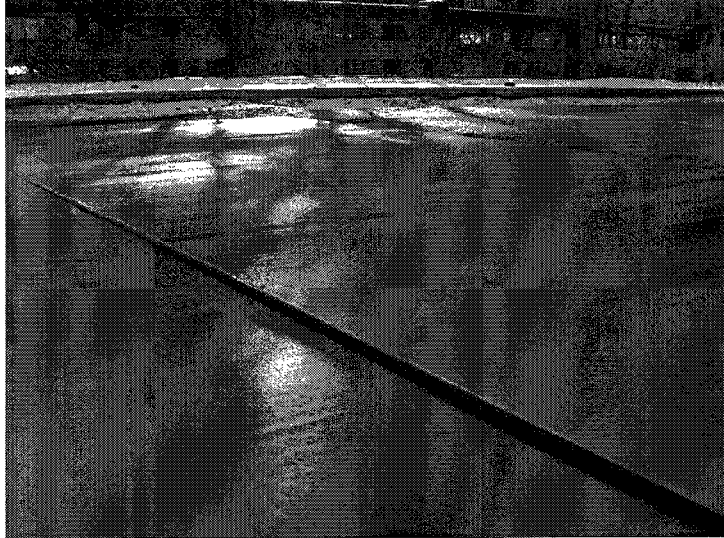
Photo 1: Connection welds are broken between steel plates. Plate #2 sags, creating a 1" lip between Plates #1 & #2.

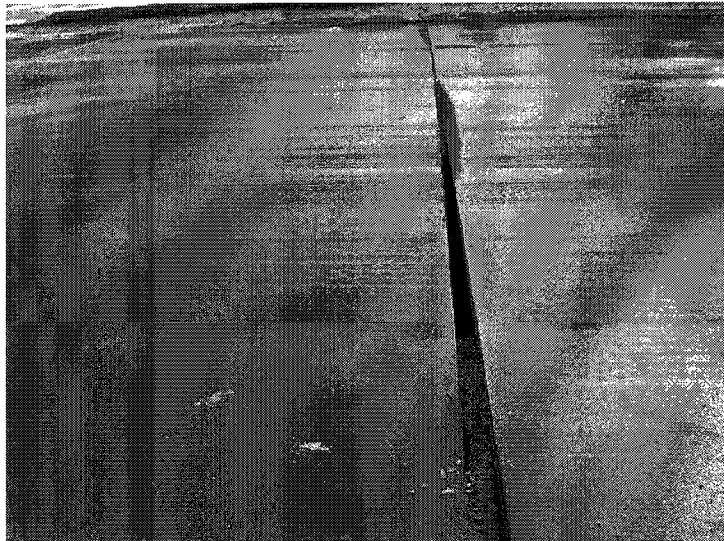
Photo 2: Looking east, welds between steel plates have failed; a 1.5" gap is present between Plates #2 & #3.

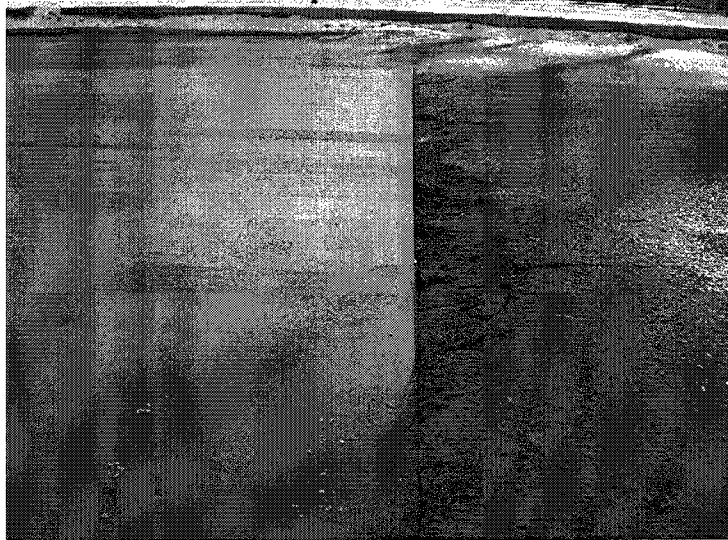
Photo 3: Looking east; Wearing surface has broken up & is pot-holed at the end of the steel plate above Span 1.

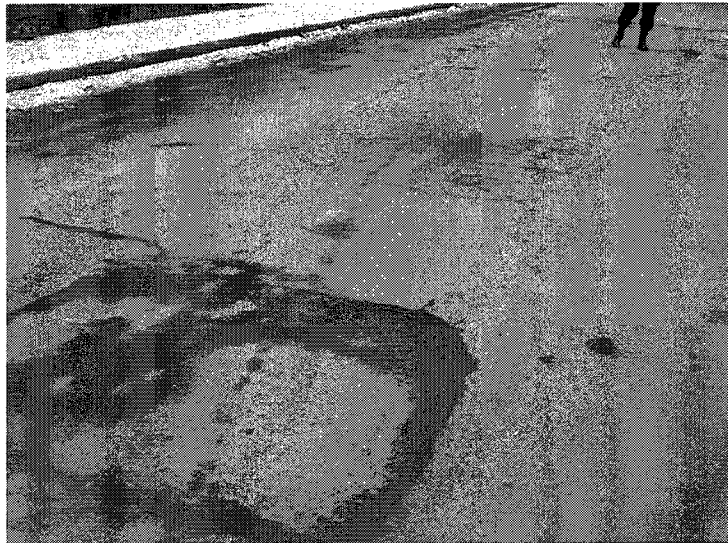
Photo 4: Wearing surface above Span 3 has areas of full depth repairs; Other areas are heavily cracked.

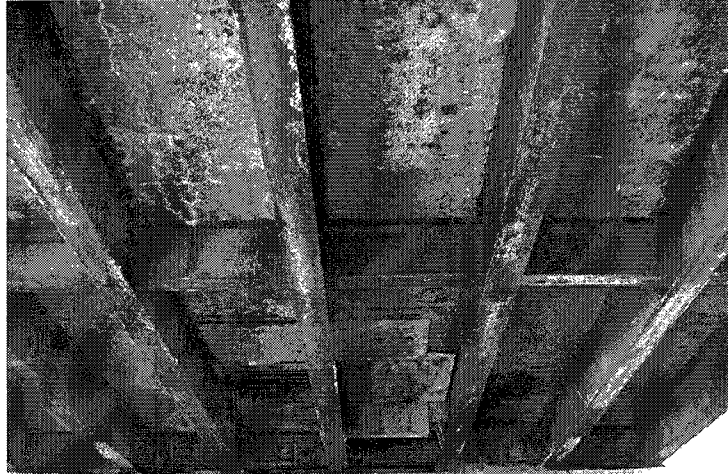
Photo 5: Span 2, looking south; Note the heavy cracking with efflorescence & severe spalls, some with timber repair forms.

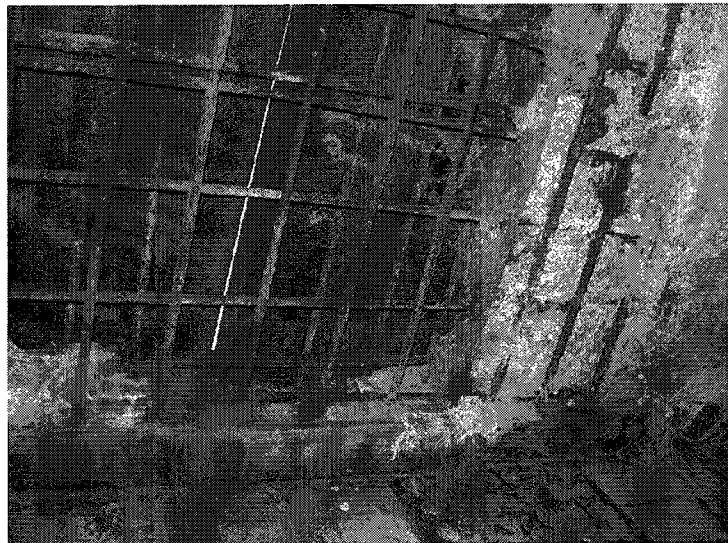
Photo 6: Span 2, Close-up of typical full depth spall adjacent to Pier #1.

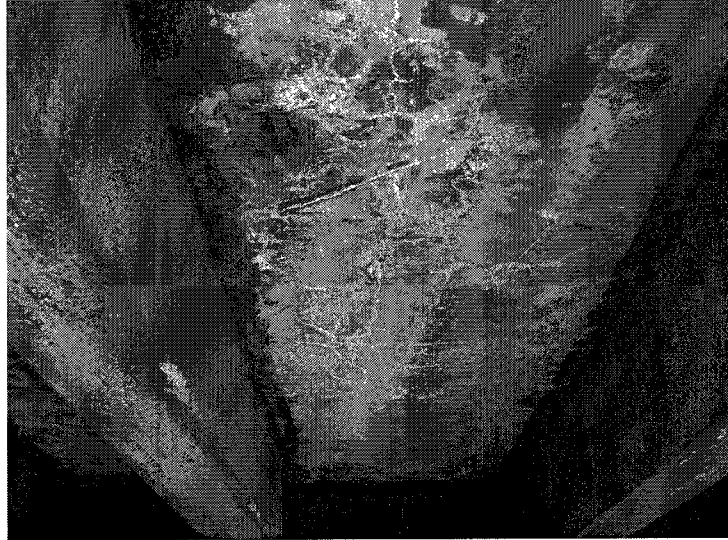
Photo 7: Span 1, Bay #5; Cracking in deck soffit is heavy. This section is directly below the southernmost steel plate on the deck surface.

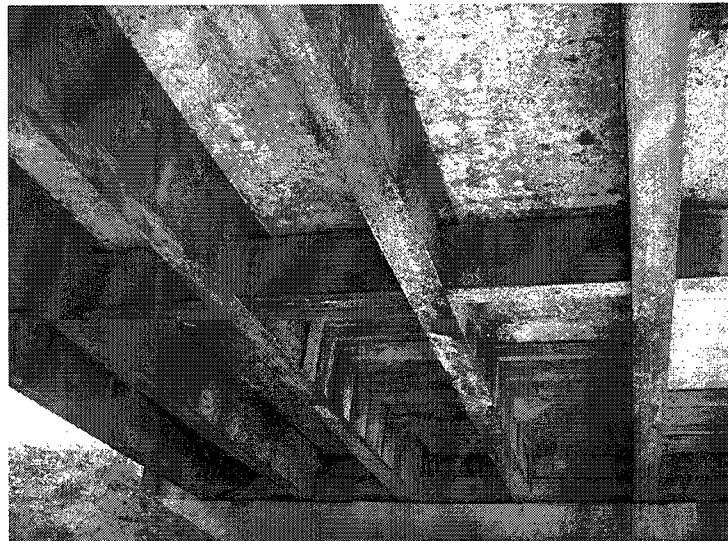
Photo 8: Span 3; Timber repair forms remain in place at north end of Bays #3, #4, & #5.

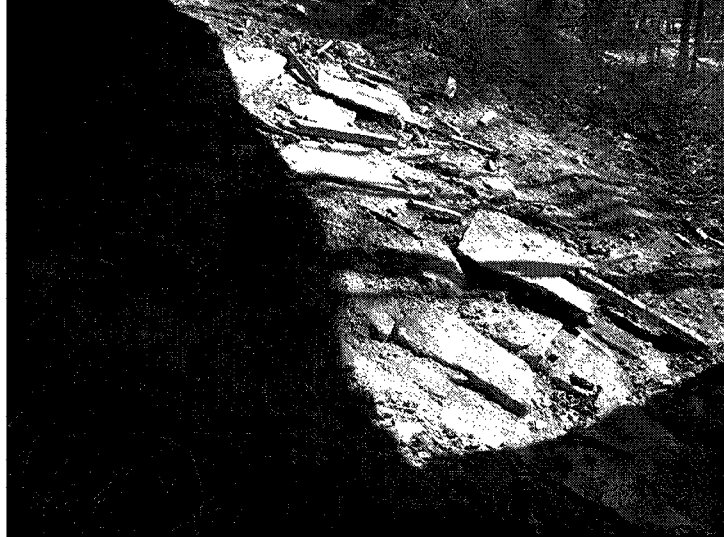
Photo 9: Several of the timber repair forms have fallen to the embankment below Span 3.

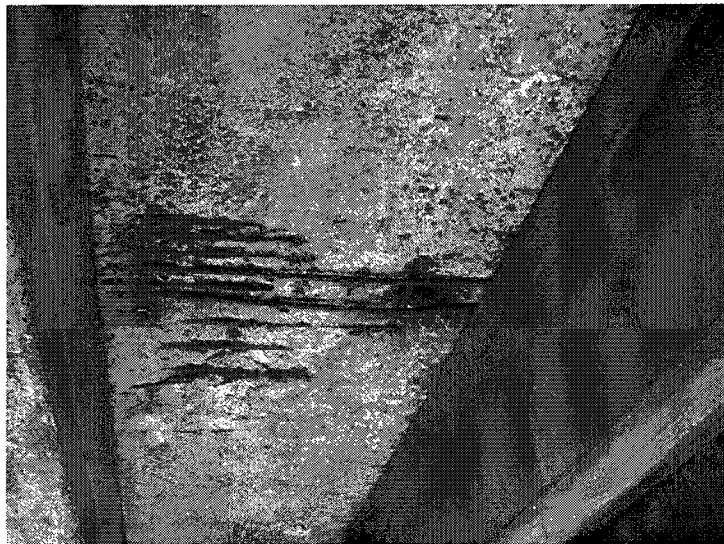
Photo 10: Span 3, Bay #5; Spalled area with corroded rebar extends full width of the bay.

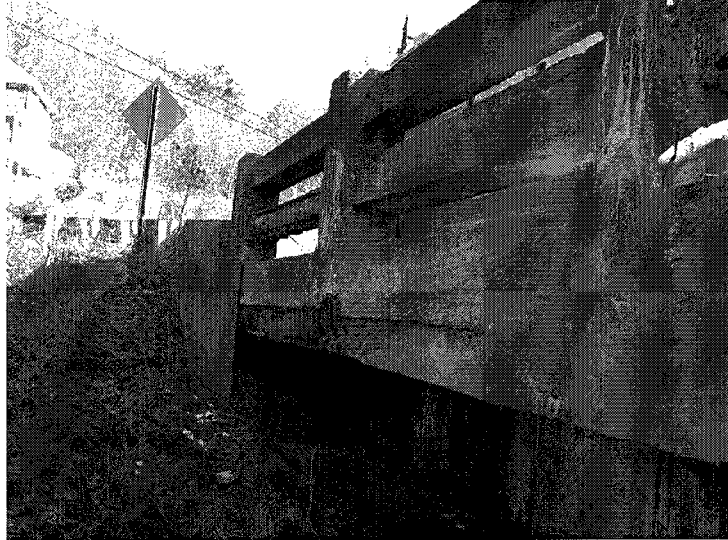
Photo 11: West Parapet @ northerly end; Note the spalled condition below the horizontal construction cold joint.

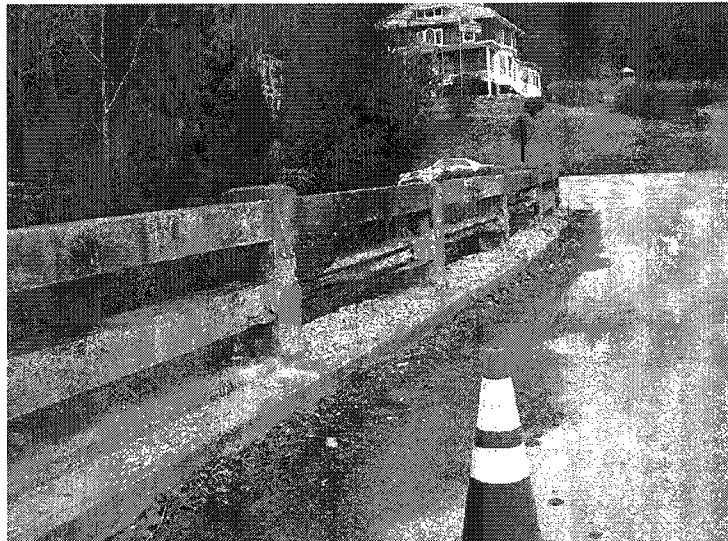
Photo 12: Heavy deterioration of concrete horizontals is typical for approximately 25% of the bridge rail system.

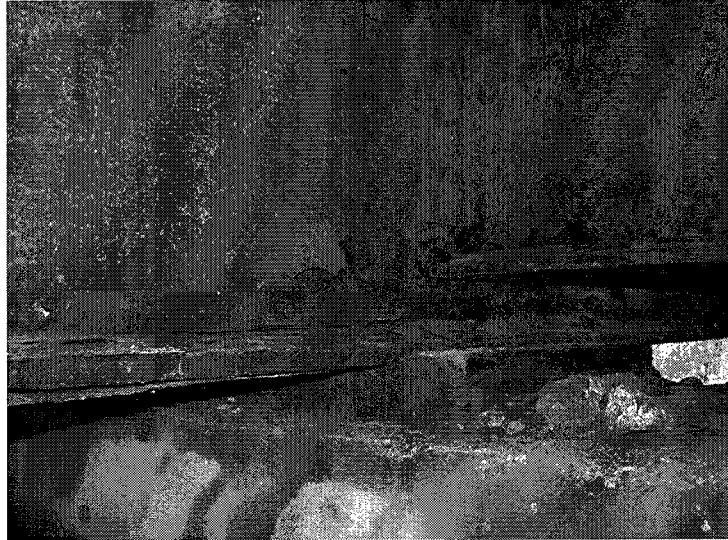
Photo 13: Span 1, Typical heavy corrosion of beam & bearing above Pier #1.

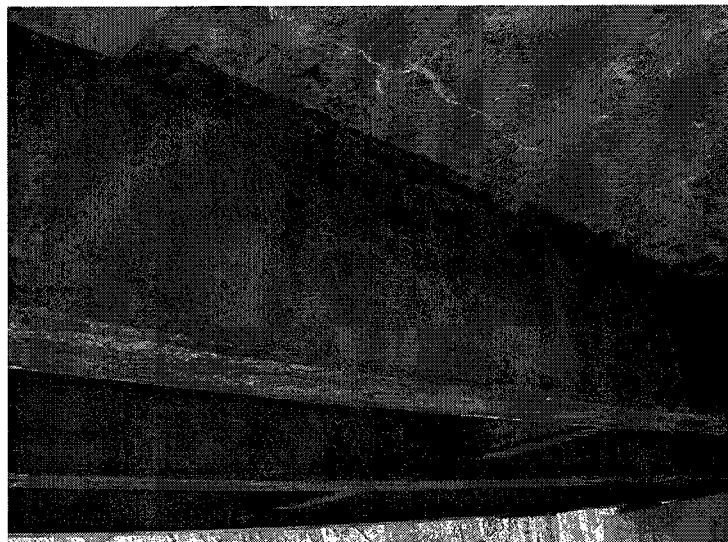
Photo 14: Span 2; Typical corrosion of beams.

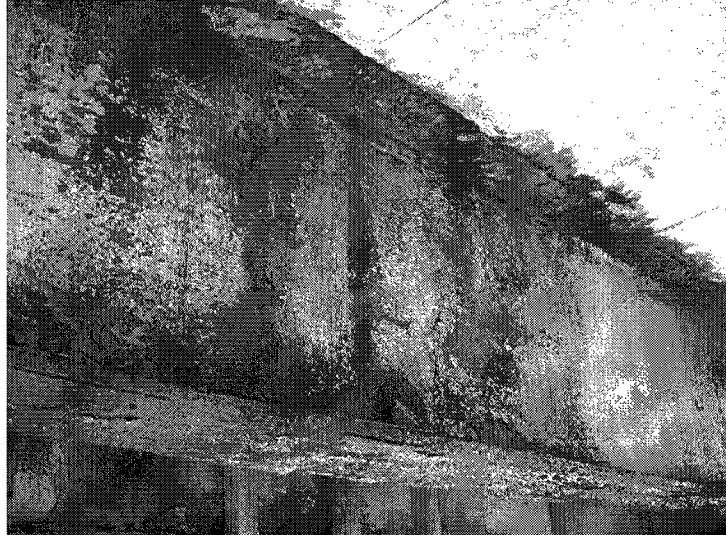
Photo 15: Span 3, Beam #4 near mid-span. Upper & lower flanges have layered rust with measurable section loss. Web has flaking rust.
