Spring 2010

Digital Image Correlation application to structural health monitoring

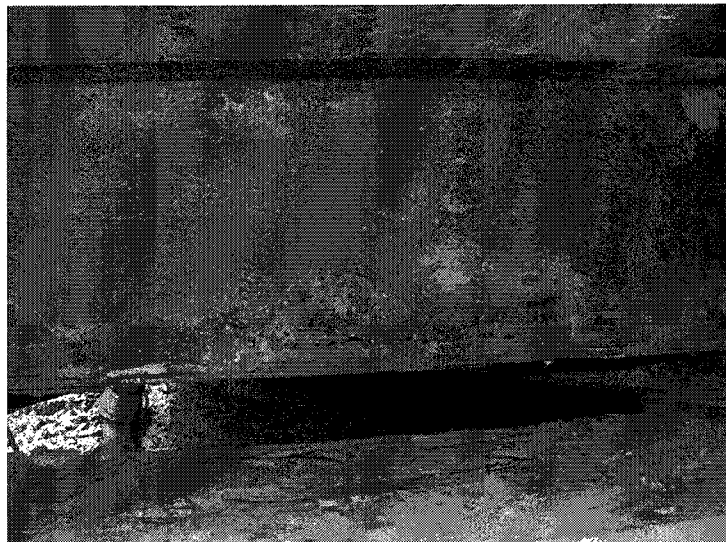
Photo 16: Bay #6 above Pier #1; Note the severe rust & section loss holes along lower web of diaphragm.

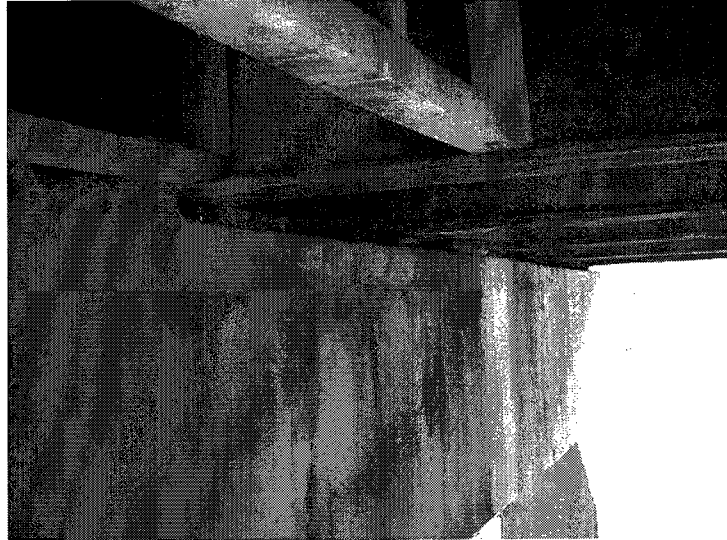
Photo 17: Pier Cap #1, south face; Rust stains exist below horizontal cracks.

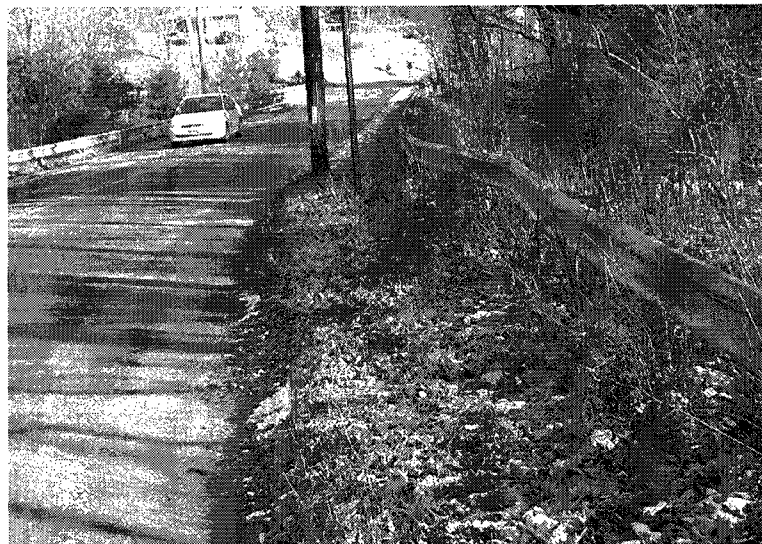
Photo 18: Guardrail at southeast corner has some minor collision damage.
