HALF-BEAD WELD REPAIRS FOR
IN-SERVICE APPLICATIONS*

P. P. Holz, Sr. Development Engineer
Oak Ridge National Laboratory
Oak Ridge, Tennessee 37830

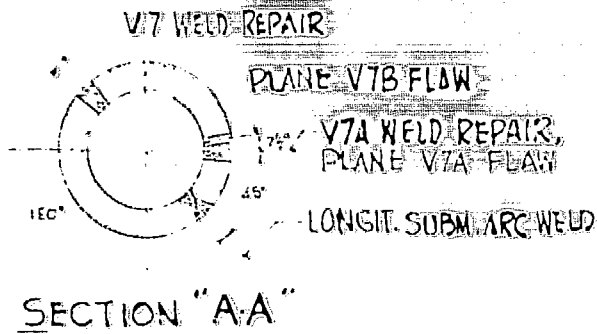
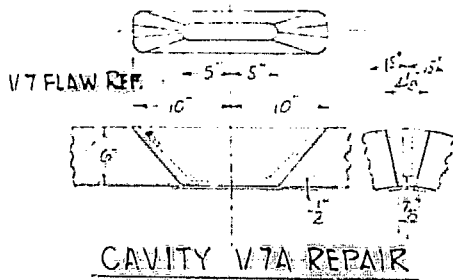
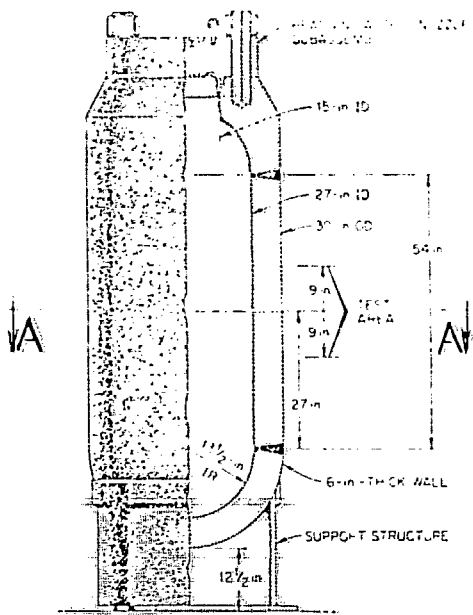
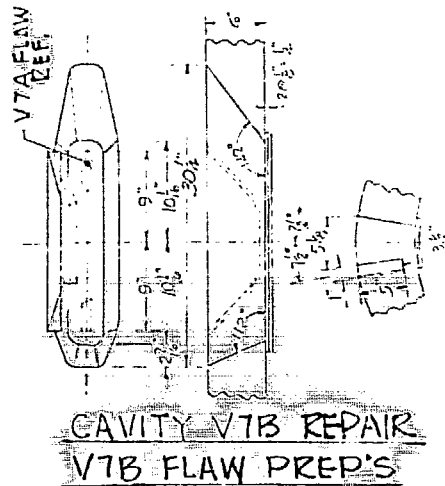
FIG. 1 INTERMEDIATE TEST VESSEL 7

The general features of the 99-cm (39-in.) outside diam, 15.2-cm (6-in.) wall thickness \times 254-cm (100-in.) overall length vessel are shown along with the various weld repair and flawing details in Fig. 1. More detailed design and procurement activities for achieving the foregoing objectives are covered in Ref. 5 and 6. The assembled vessel weighs about 18,300 lbs. Vessel weight less head is approximately 16,400 lbs. Vessels consist of ASTM A508 class 2 forgings for the hemispherical head, the cover closure, and the cover flange and of either A508 class 2 forging or rolled ASTM A533, grade B, class 1 low alloy plate for the cylindrical test sections, the latter being used for vessel V-7. The two prolongations used in conjunction with the two vessel repairs were cut from two vessel cylindrical sections, and were manufactured and heat treated concurrently. Except for vessel V-6, the cylindrical shell courses each contained one longitudinal seam weld. These welds and the two circumferential seam welds joining the head and flange ends were welds made with submerged-arc EB013 NM filler rod. The fabrication sequence consisted of welding, preliminary weld seam ultrasonic inspection, weld repair, conventional post-weld heat treatment, intermediate weld seam ultrasonic inspection, radiography, hydrostatic testing, final weld seam ultrasonic inspection, magnetic particle inspection, and leak testing.

preparation. Flaw location, shape and dimensions are shown in Fig. 1. The vessel was heated to 91°C (196°F) and pressurized hydraulically until leakage through the below flaw ligament terminated the test at a peak pressure of 147 MPa (21,350 psi), a failure pressure equaling 2.2 times design pressure. The vessel, as expected, did not burst. Upon depressurization, the rupture ligament closed so as to maintain static pressure without leakage at about 129 MPa (18,700 psi). The test demonstrated leak without break, at a loading for which the inside surface of the vessel was about to yield, and at a test temperature higher than the Charpy upper-shelf temperature which was chosen to provide toughness in the specimen similar to that in a operating reactor vessel. More complete details of the V-7 test are covered in Ref. 2.

A through-wall wedge piece, approximately 114-mm wide \times 527-mm long (4 1/2-in. \times 20 3/4-in.) containing the V-7A flaw was removed from the vessel by air-arc gouging for detailed study of crack propagation. Both ends of the wedge cutout cavity were gouge-tapered at 112° (head end) and 142° (dome end) included angles for a 768-mm-long (30 1/4-in.) vessel top surface cavity opening. Cavity sides were cut on radial surface planes. Thereafter, an additional 6 to 8 mm (1/4 to 5/16 in.) of material was removed by grinding or milling along and adjacent to the cutout's boundary surfaces to eliminate flame induced carburization and heat-affected zones. Machine milling was selected along the radial plane surfaces of the longitudinal cavity edges to establish accurate reference planes for flawing within the center portion of the heat-affected zone of the vessel V-7A weld repair for the V-7B test. The main objective for the V-7B test was to demonstrate the structural integrity in the upper shelf temperature range of a vessel containing a large flaw in the heat-affected zone of an inservice repair weld. The preweld repair cavity is shown in Fig. 1.

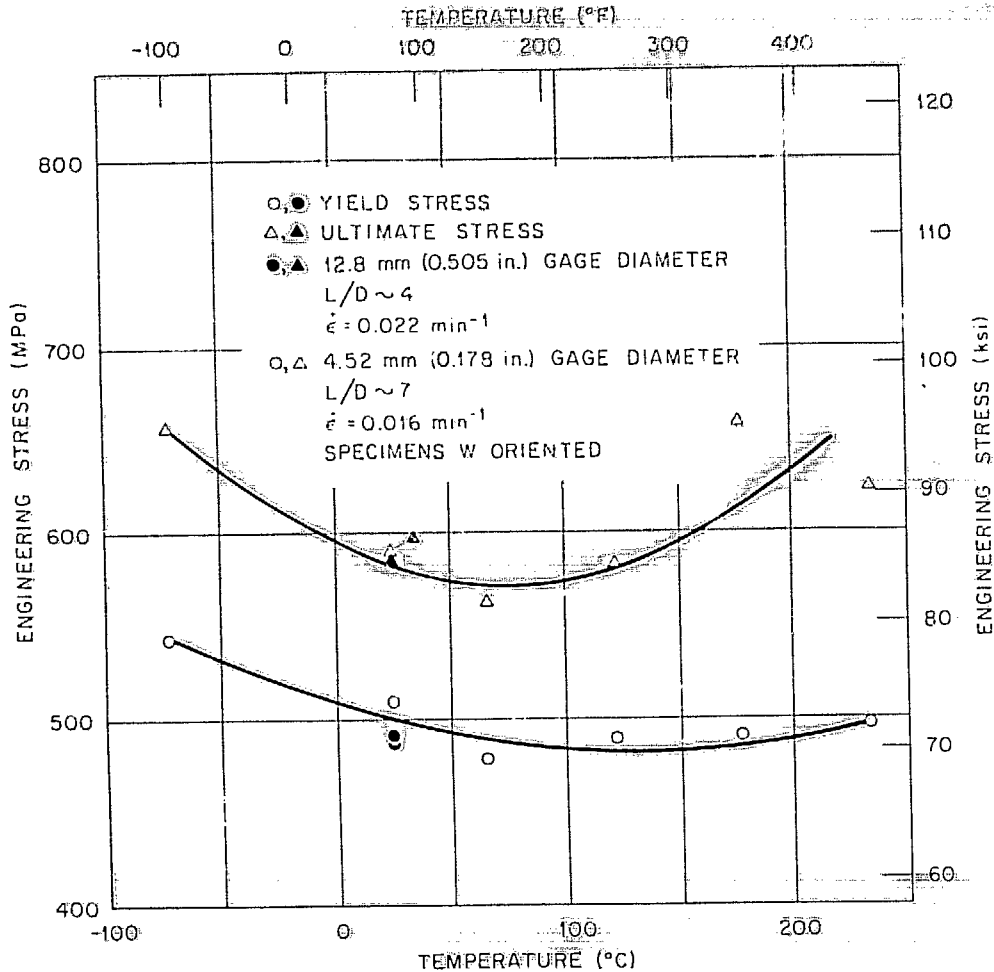
V-7A test plate (weldment W-1 repair weld material) tensile test results, for the W orientation (axis perpendicular to the welding direction and parallel to the plate surface) and for the temperature range from -73 to 177°C (-100 to 350°F), are shown in Fig. 2. Charpy V-notch specimens, with the notches located at the weld centerline, were tested in the WL orientation (axis as in the tensile specimen, crack propagating in the weld direction). Charpy V-notch impact properties are given in Fig. 3. Precracked Charpy specimens of the same orientation were also tested statically with the results shown in Fig. 4. The fracture toughness and hardness data proved to be very similar to the results from the V-7B repair, hence these are discussed in Section 4 of this report. Detailed accounts of the V-7A repair characterization studies are given in Chapter 3 of Ref. 3.

Fig. 2. Variation of tensile properties with temperature for half-bead test weldment W-1 in weld metal.

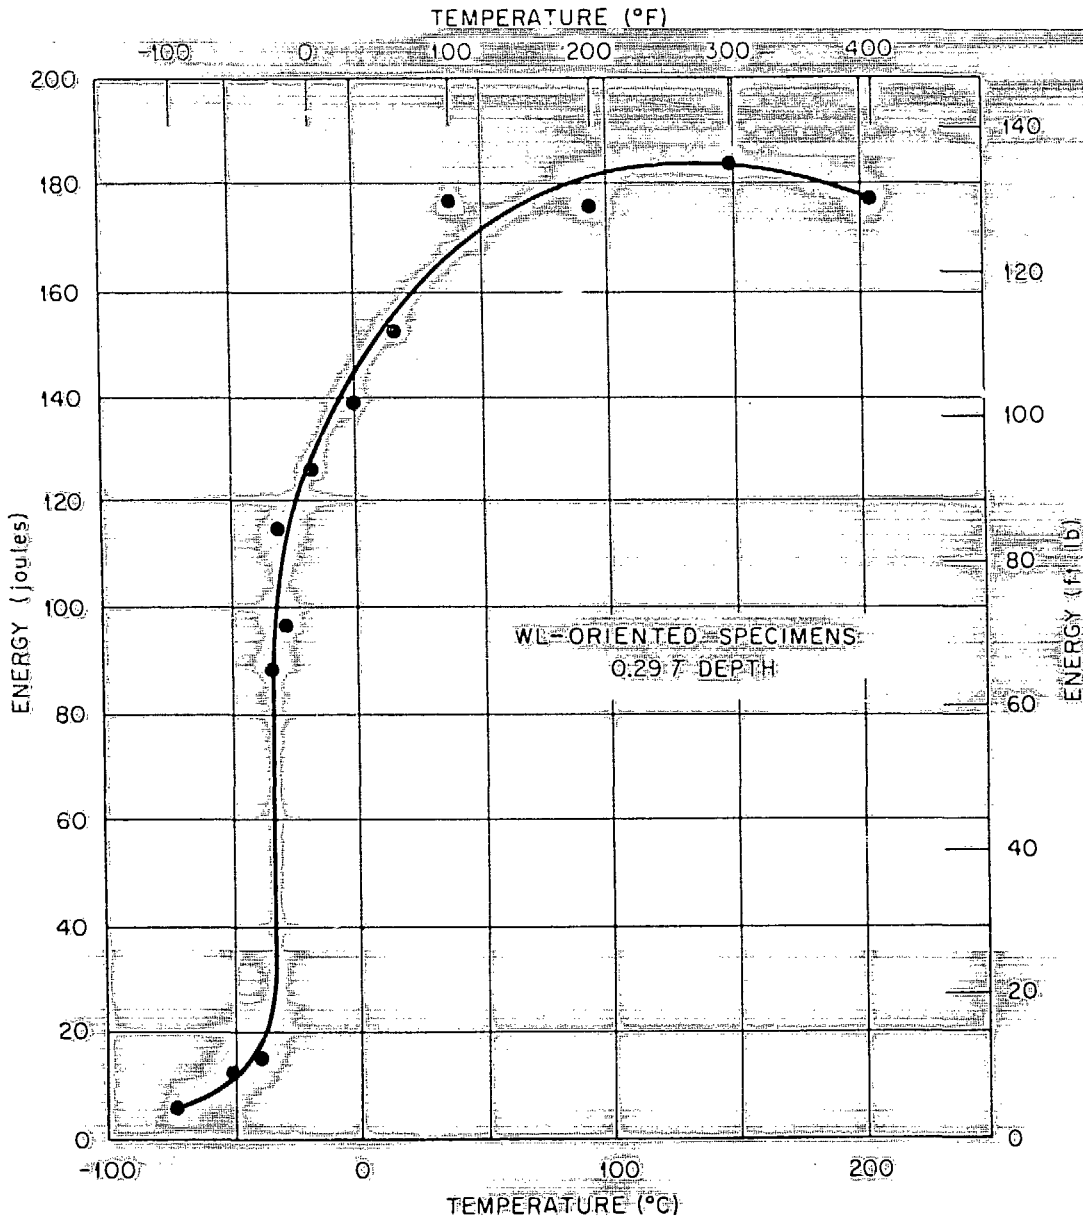
Fig. 3. Variation of Charpy V impact energy with temperature for half-bead test weldment W-1 in weld metal.

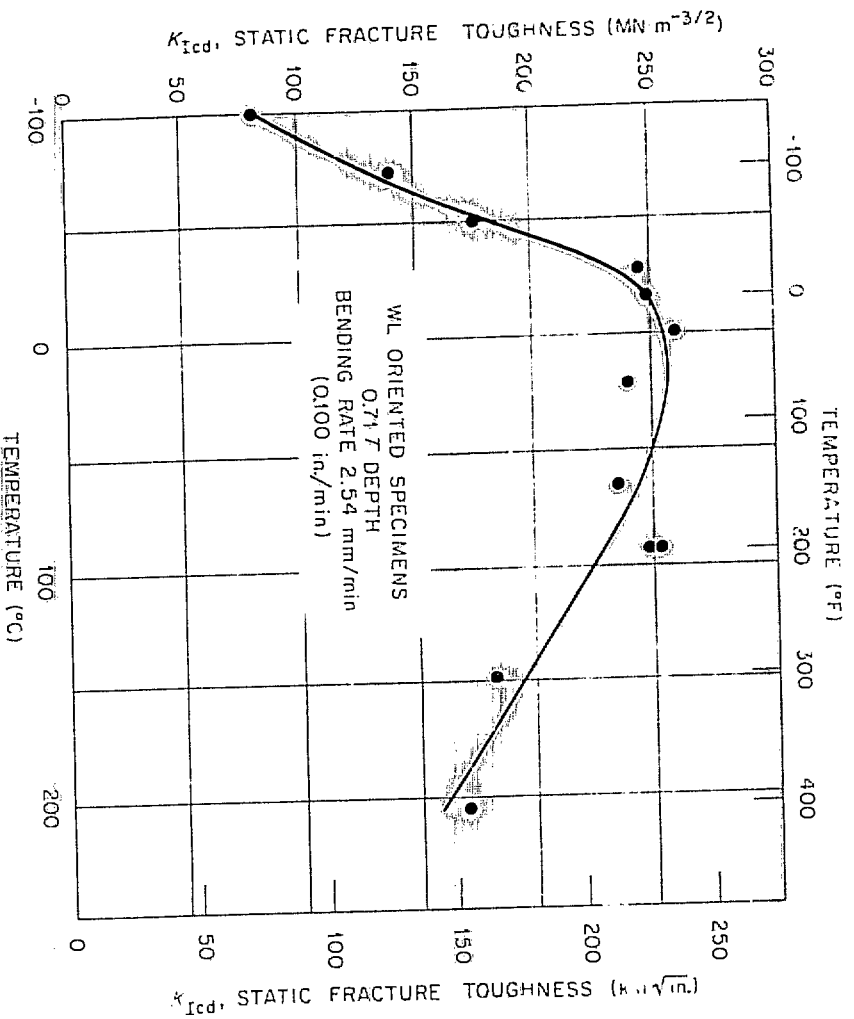
Fig. 4. Variation of fracture toughness with temperature as determined from slow bend tests of precracked Charpy specimens from half-bead test weldment W-1 in weld metal.

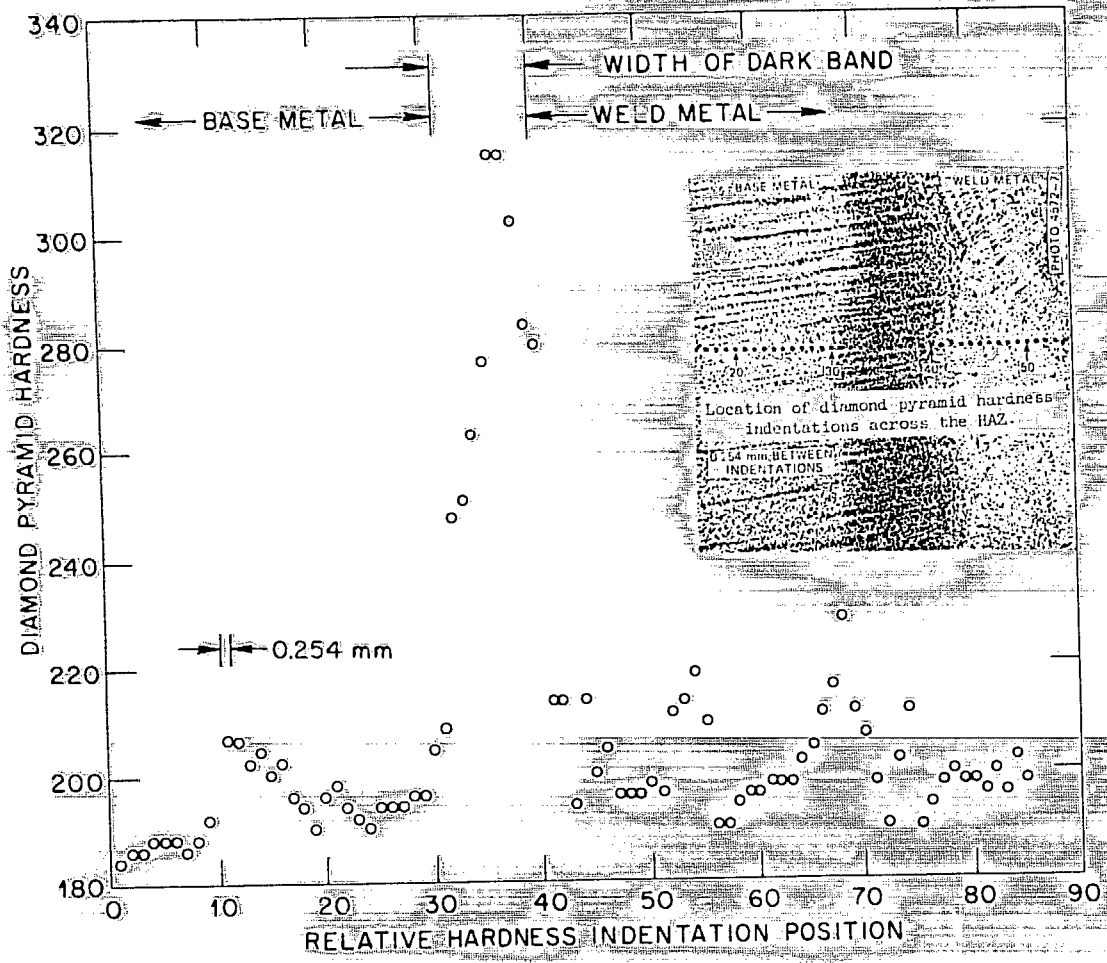
Hardness investigations. A typical microhardness traverse taken across the base metal-repair weld HAZ of the V-7B prototype half-bead repair weld in the V-8 prolongation is shown in Fig. 5, which indicates that the highest hardness values occur in the dark etched 2.29-mm (0.090-in.) wide region which is the heat affected zone. The highest DPH value, 314 (R 31.6), occurs twice with a distance of 0.254 mm (0.010 in.). This is in agreement with hardness data obtained from three traverses across a similar HAZ in the V-7A prototype weld in the V-9 prolongation.

Fig. 5. Hardness traverse of the heat-affected zone and adjacent areas of a cross-section of the V-7B prototype shielded-metal-arc half-bead weld repair in the V-8 prolongation. (Insert - location of diamond pyramid hardness indentations across the HAZ.)
