Developing Improved Bridge Parapet Designs

DEVELOPING IMPROVED BRIDGE PARAPET DESIGNS

DEVELOPING IMPROVED BRIDGE PARAPET DESIGNS LAUREN A. HEDGES ABSTRACT

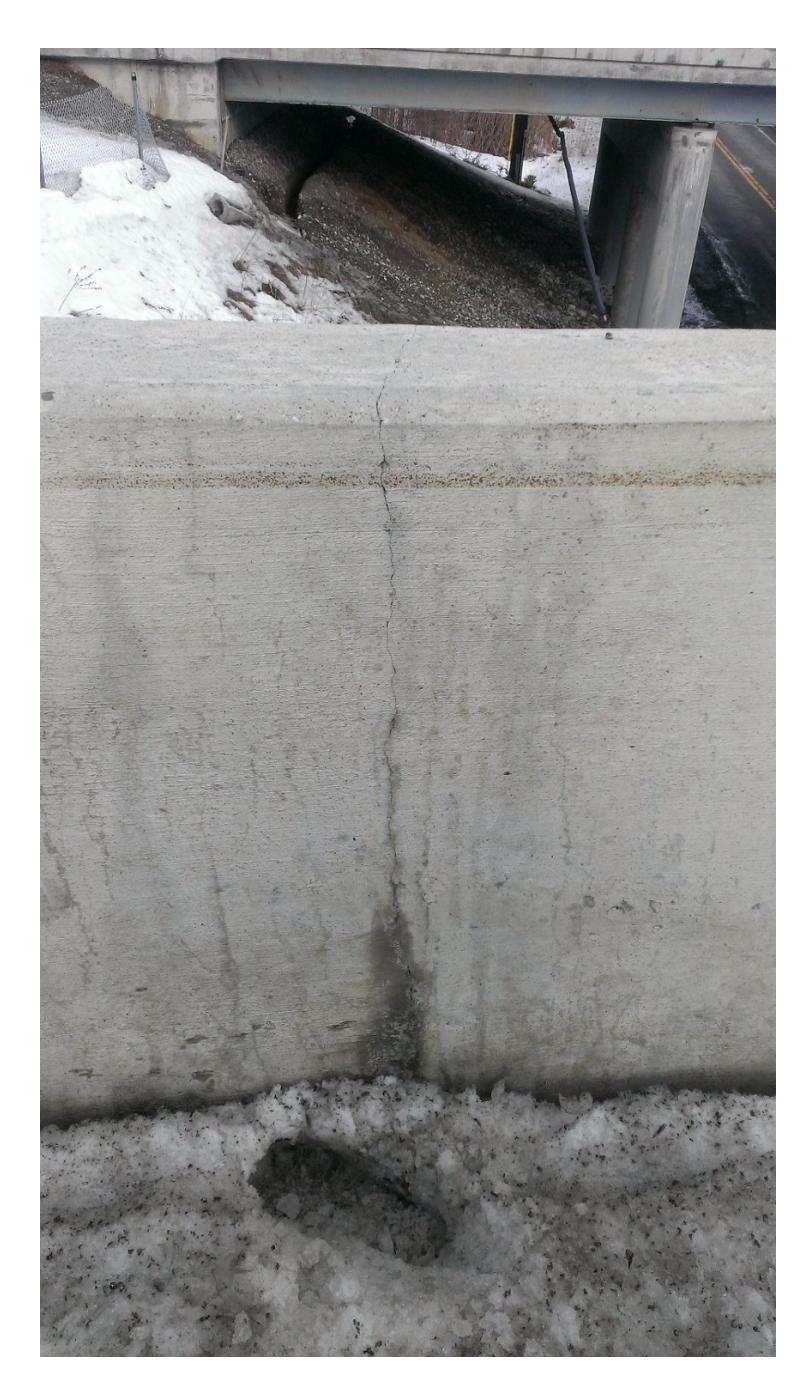
District 12 in ODOT is not the only district to have experienced problems with parapet cracking. Additional information was collected from ODOT District 8, which is located in the Southwest portion of Ohio. According to Brandon Collett, P.E. and structures planning engineer for District 8, many bridge parapets located in their district also suffer from prominent vertical cracking (Brandon Collett, P.E., personal communication, October 21, 2013). An example of the vertical cracking seen in these districts can be seen in Figure 2.

Figure 2: Vertical Parapet Cracking (Photo Provided by Lauren Hedges)

Many of the older bridges with these cracks were seen upon were constructed through the use of slip forming. Slip forming is the construction of a parapet with the use of pulling or lifting a form while concrete is placed. The machine moves at a slow but steady pace, placing concrete with a low slump into the shape of the parapet, over the set rebar. This practice is currently not allowed for use on parapets constructed in District 12 and a few other districts within ODOT, but new construction specifications will allow the use of slip forming in the coming year.

District 8 has also shown concern for their older bridges that received a joint cut that passes entirely through the parapet. A through joint allows for an air gap between segments of the parapet. The parapets that received this type of joint cut have also been subjected to severe cracking near the joints. The final observation from District 8 is that bridges with large spans see the most and worst type of cracking.

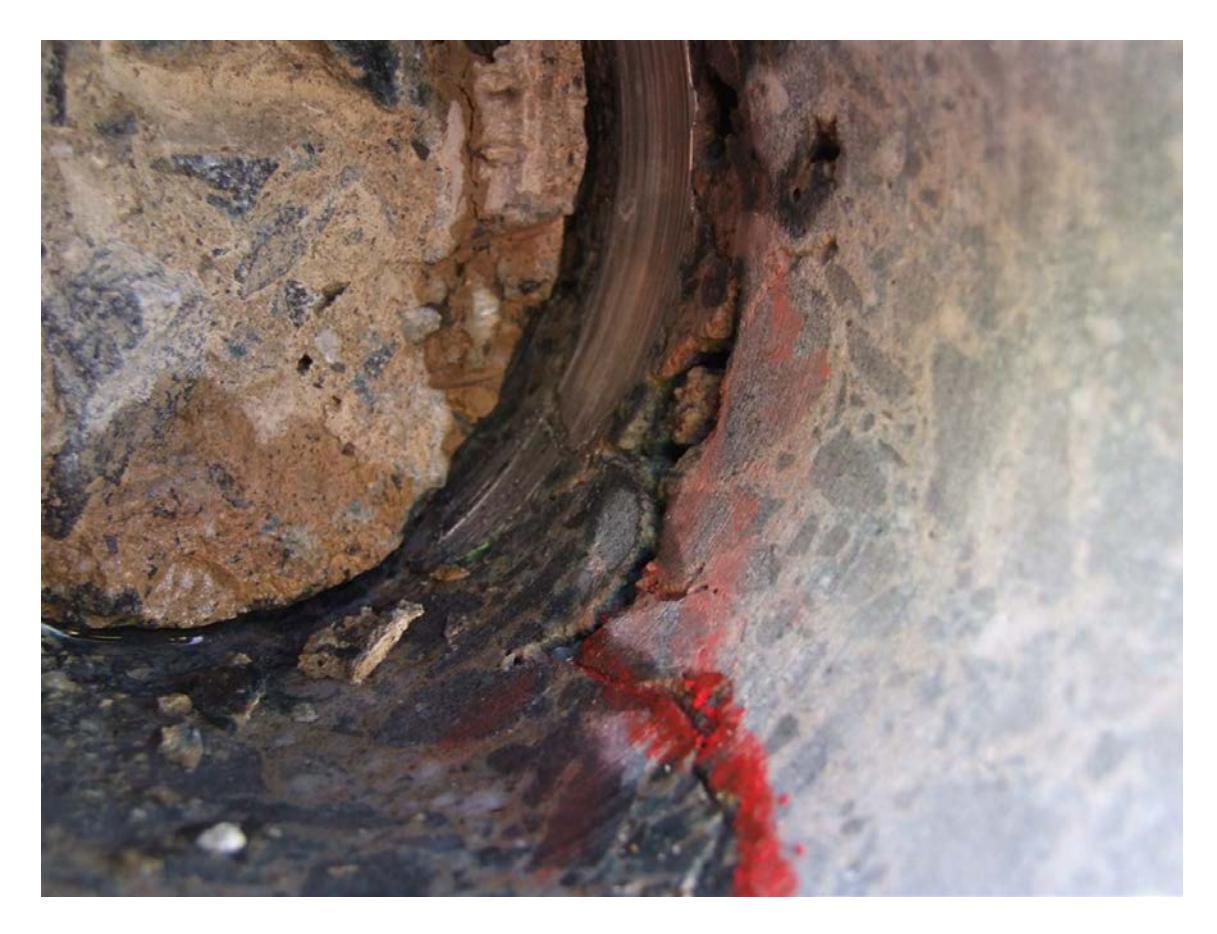
The parapets were also subject to vertical cracks as wide as 0.05 inches (1 mm). Two core samples were taken at the location of where the cracks can be seen. For both cores, concrete voids were present around the vertical rebar, as seen in Figure 3 below. Because the parapets were constructed using the slip forming method, it is thought that the voids may have occurred due to the low slump and poor vibration methods not allowing the concrete to flow around to the underside of the vertical rebar (Saraf, 2013).

Figure 3: I-95 Parapet Concrete Void (Photo Provided by Fawaz K. Saraf, P.E.)

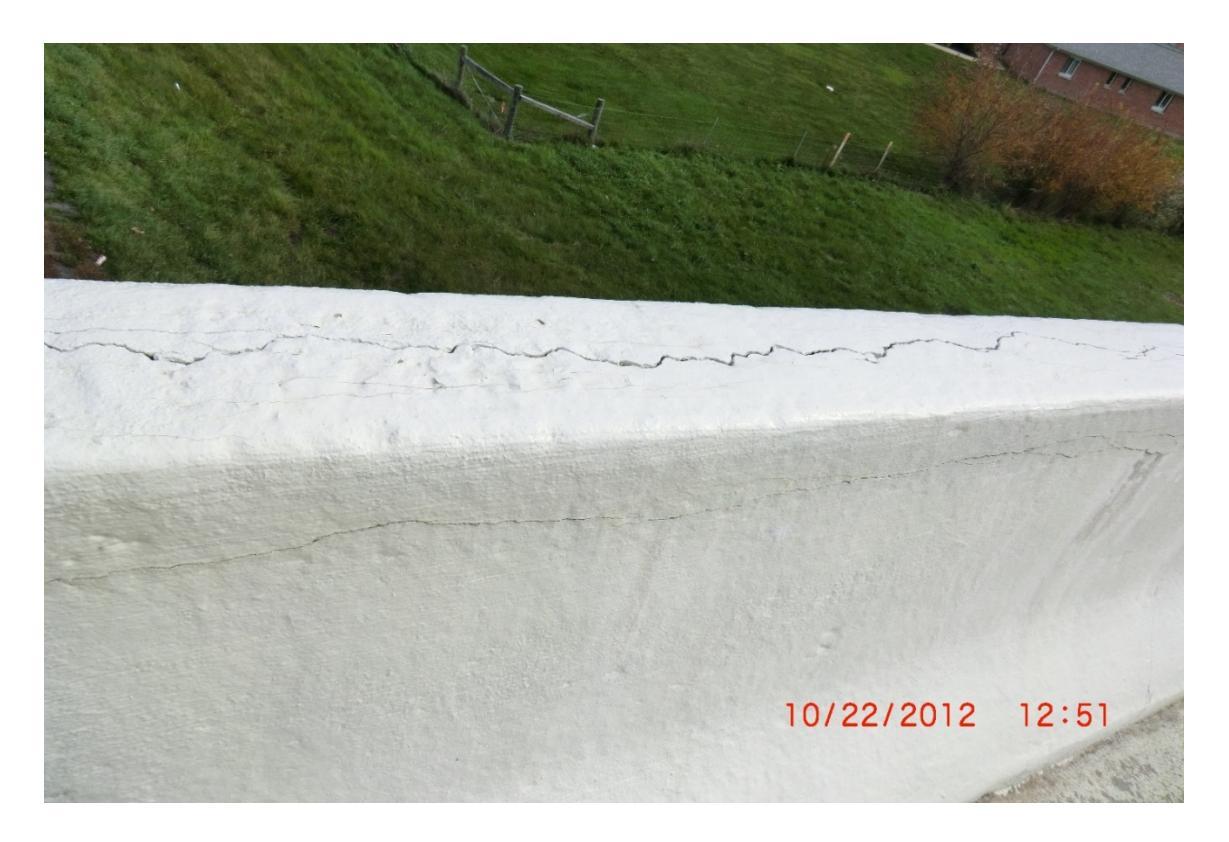
Although it is not considered premature, the replacement of the parapets will need to be done before the bridge deck needs to be repaired. An official estimate for this work has not yet been calculated, but Rod Maas, PE in District 1 has a rough estimate of \$225,000 (Rod Maas, personal communication, March 4, 2014). This is roughly \$363 per linear foot of parapet (\$1,190/m). A photograph of the cracking seen in this parapet can be seen in Figure 23.

Figure 23: Bridge Number ALL-75-1836 Cracking (Photo Provided by Rod Maas)

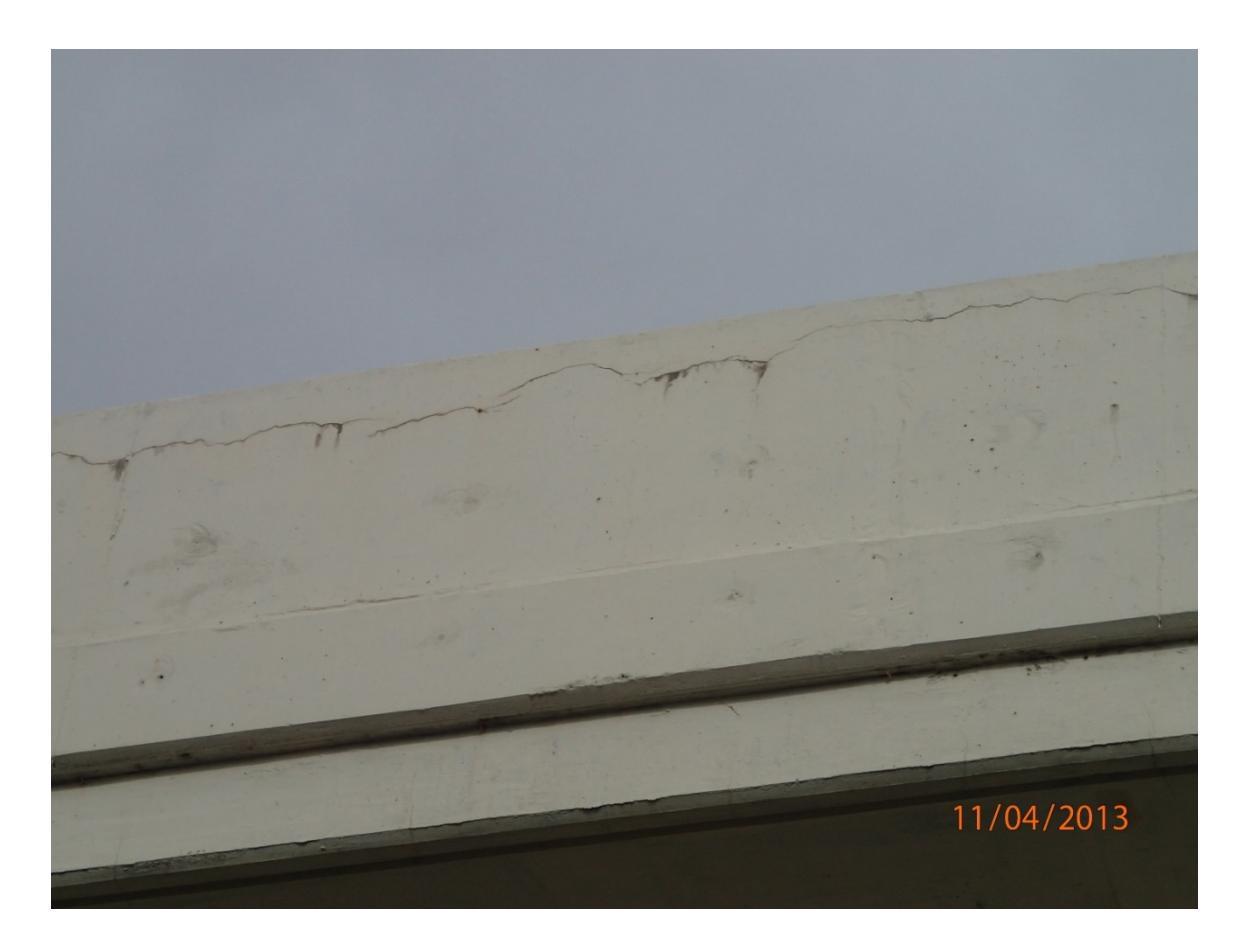
An official estimate for the work needed has not yet been calculated, but Rod Maas, PE in District 1 has a rough estimate of \$150,000 (Rod Maas, personal communication, March 4, 2014). This is roughly \$428 per linear foot of parapet (\$1,400/m). A photograph of the cracking seen on this parapet can be seen in Figure 24.

Figure 24: Bridge Number ALL-696-0086 Cracking (Photo Provided by Rod Maas)

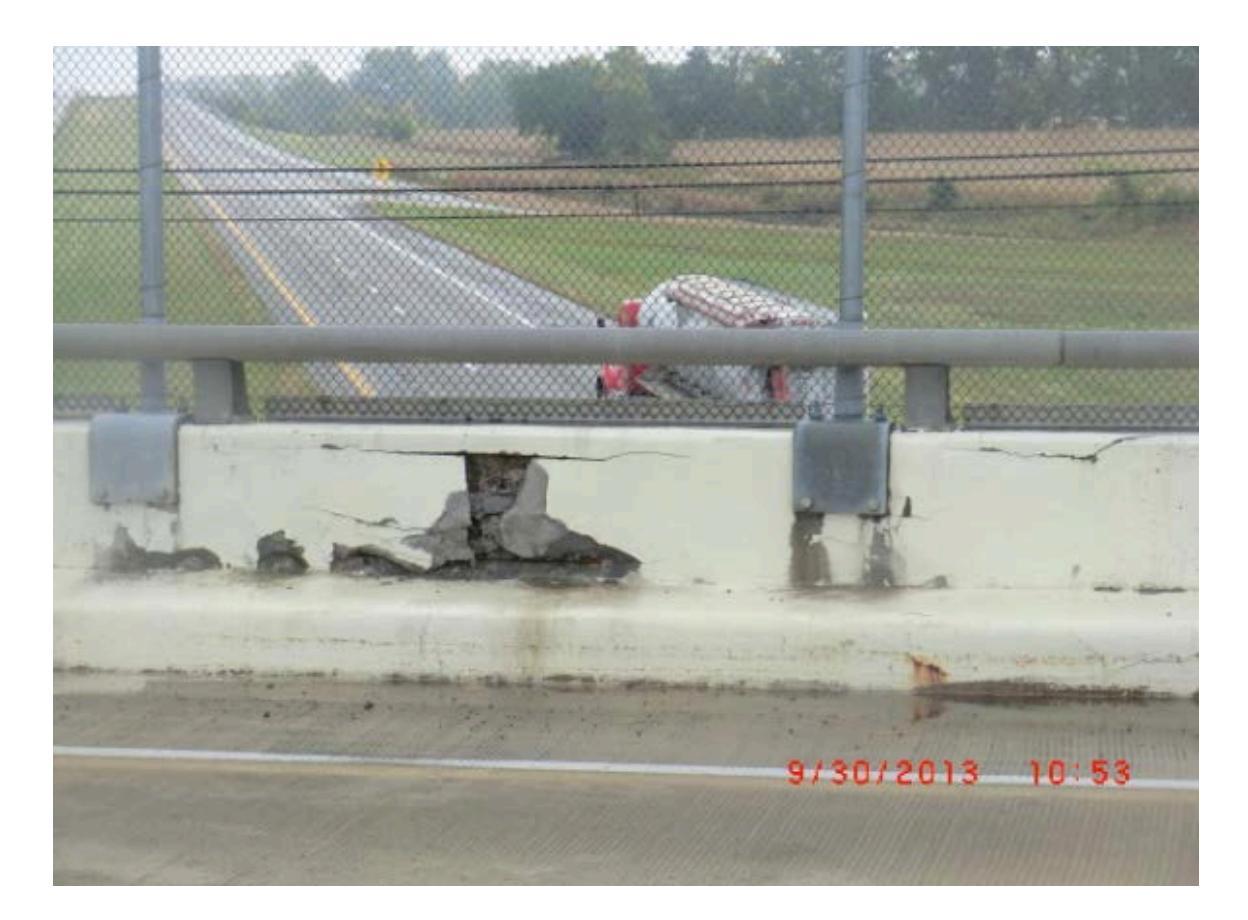
Since 2009, the parapets have begun to deteriorate again and will need more patching done. The patch work is planned for the spring construction season of 2014. A photograph of the parapet can be seen in Figure 25.

Figure 25: Bridge Number ALL-65-1322 Cracking (Photo Provided by Steve

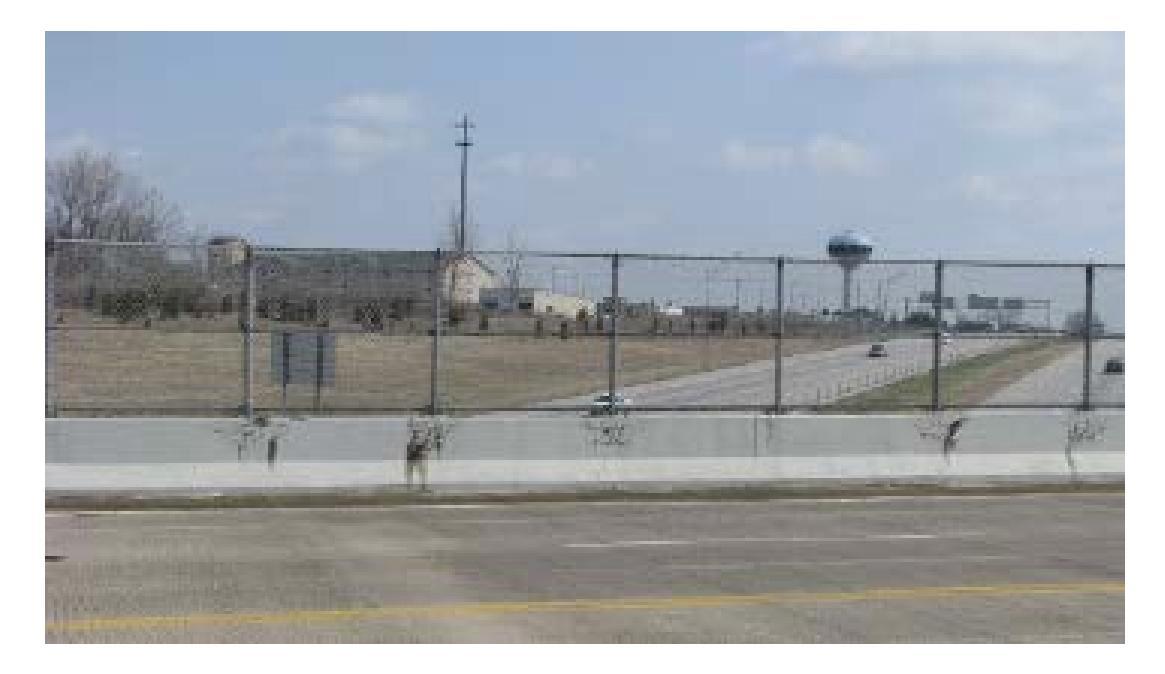
Figure 26: Bridge Number GRE-675-0895 Cracking (Photo Provided by Brandon Collett,

The total cost of repairs to the two parapets was \$218,852. This cost included the repair of the transition sections and purchase and installation of new VPF. The cost is approximately \$420 per linear foot of parapet (\$1,380/m).

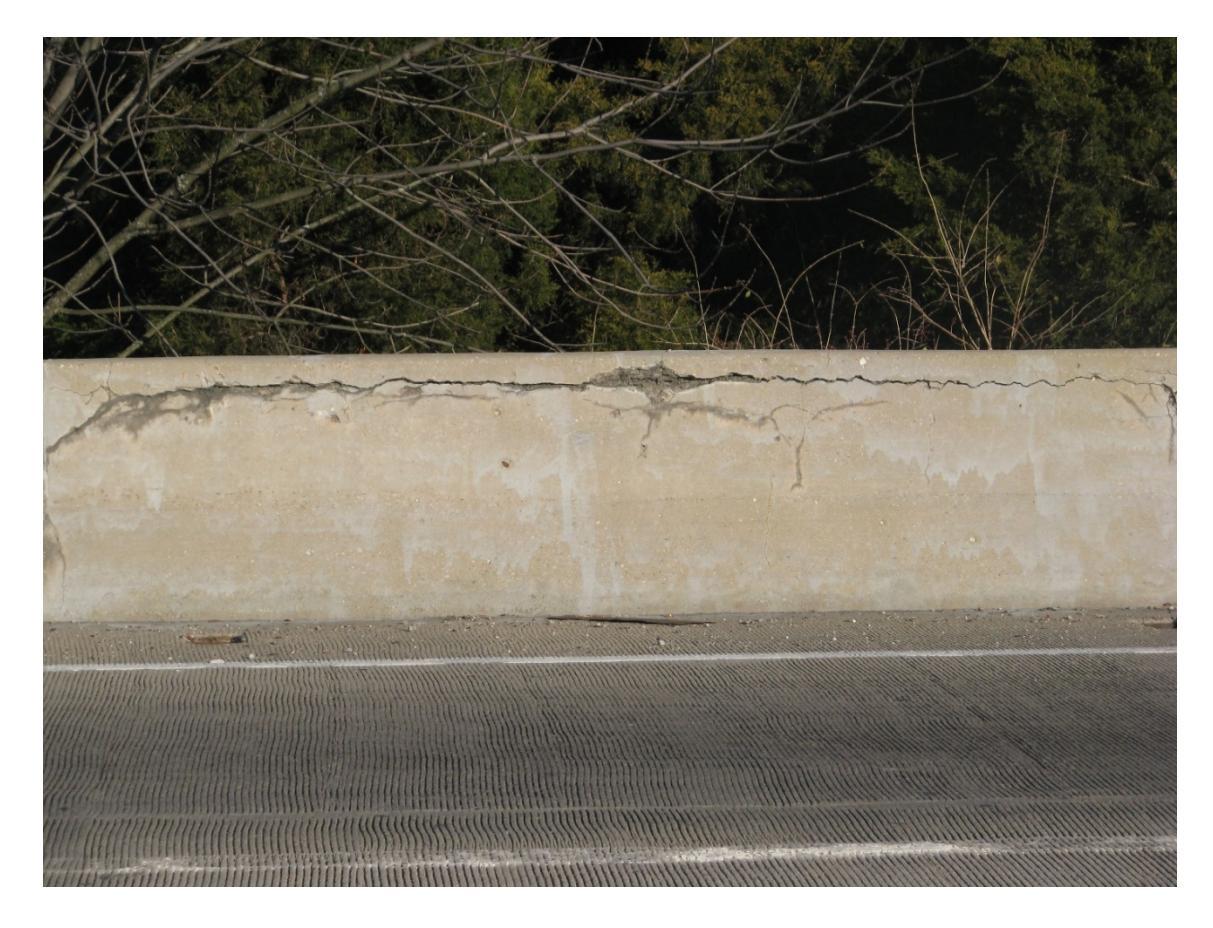
Figure 27: Bridge Number HAM-74-1116L Cracking (Photo Provided by Brandon Collett, PE)

The top foot and a half of the selected sections needed to be repaired. Other work that was performed at the same time included barrier replacement and zone painting. The total cost of these repairs was \$17,000, which is \$60 per linear foot of parapet (\$200/m).

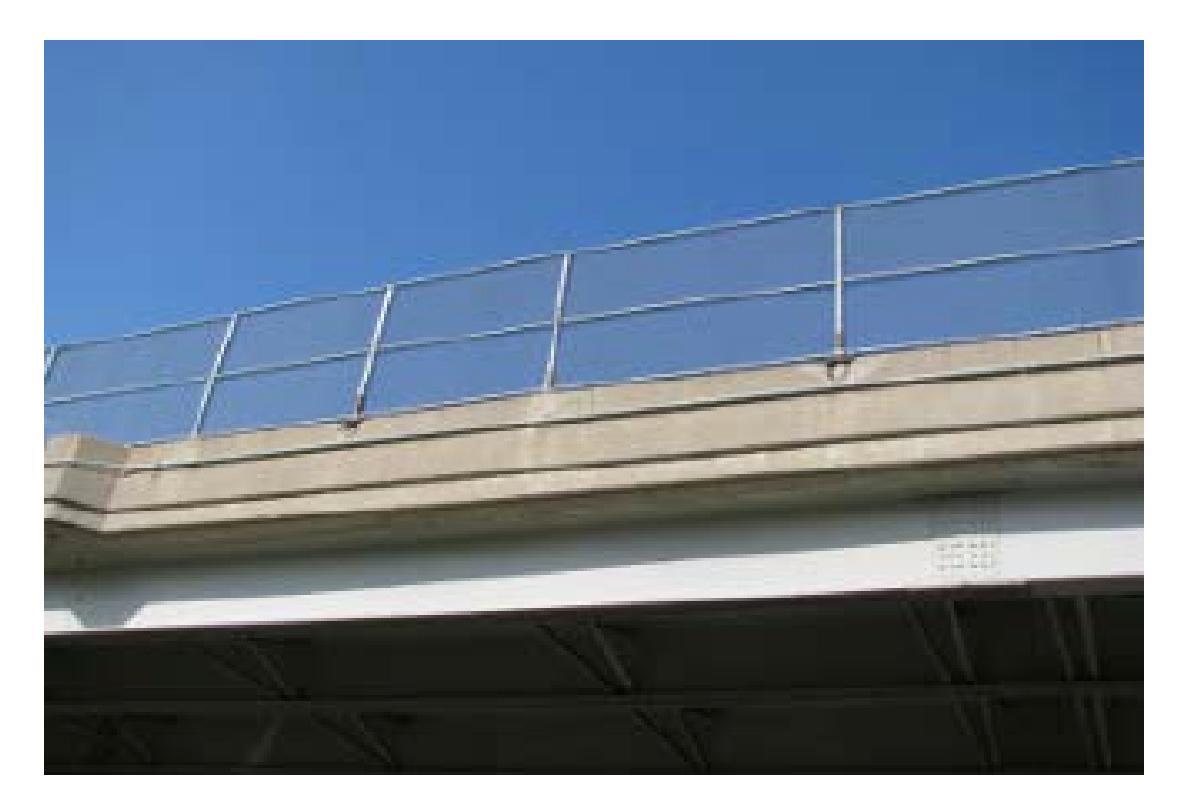
This bridge repair occurred in Greene County. The bridge is an overpass on North Fairfield Road that crosses over I-675 and has a total length of 277 feet (84 m). Due to extensive concrete deterioration and cracking caused by VPF, multiple patches were needed along the length of the parapet. A photograph of the deterioration can be seen in Figure 28. The total cost of these patches was \$13,600, which is \$50 per linear foot of parapet (\$910/m).

Figure 28: Bridge Number GRE-675-1034 Cracking (Photo Provided by Brandon Collett, PE)

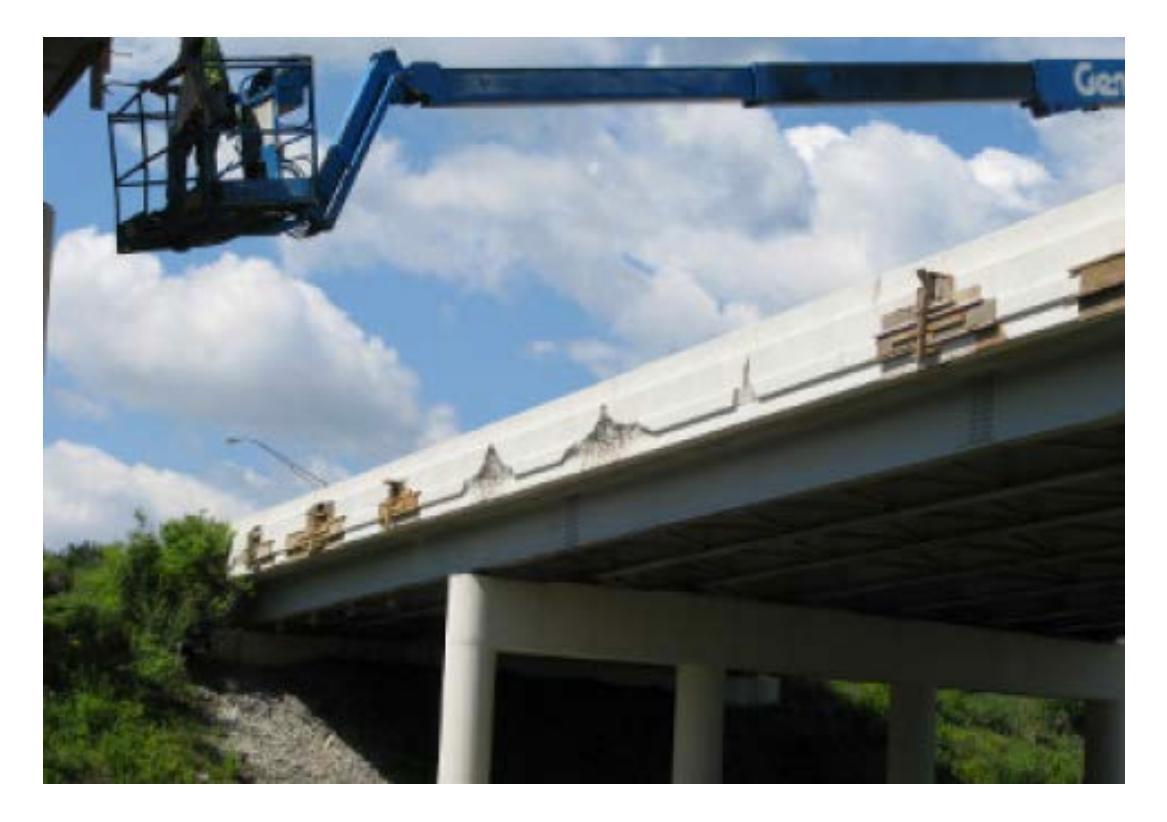
Figure 29: Bridge Number GRE-42-0789 (Photo Provided by Brandon Collett, PE)

This bridge parapet repair occurred in Greene County and has a total length of 244 feet (74 m). The cost of repairs included in this project included the removal of loose concrete from the parapets, various deep patches, and applying an epoxy sealer. A photograph of the cracking and repairs being done can be seen in Figure 29. The total cost of these patches was \$117,000, which is \$240 per linear foot of parapet (\$790/m).

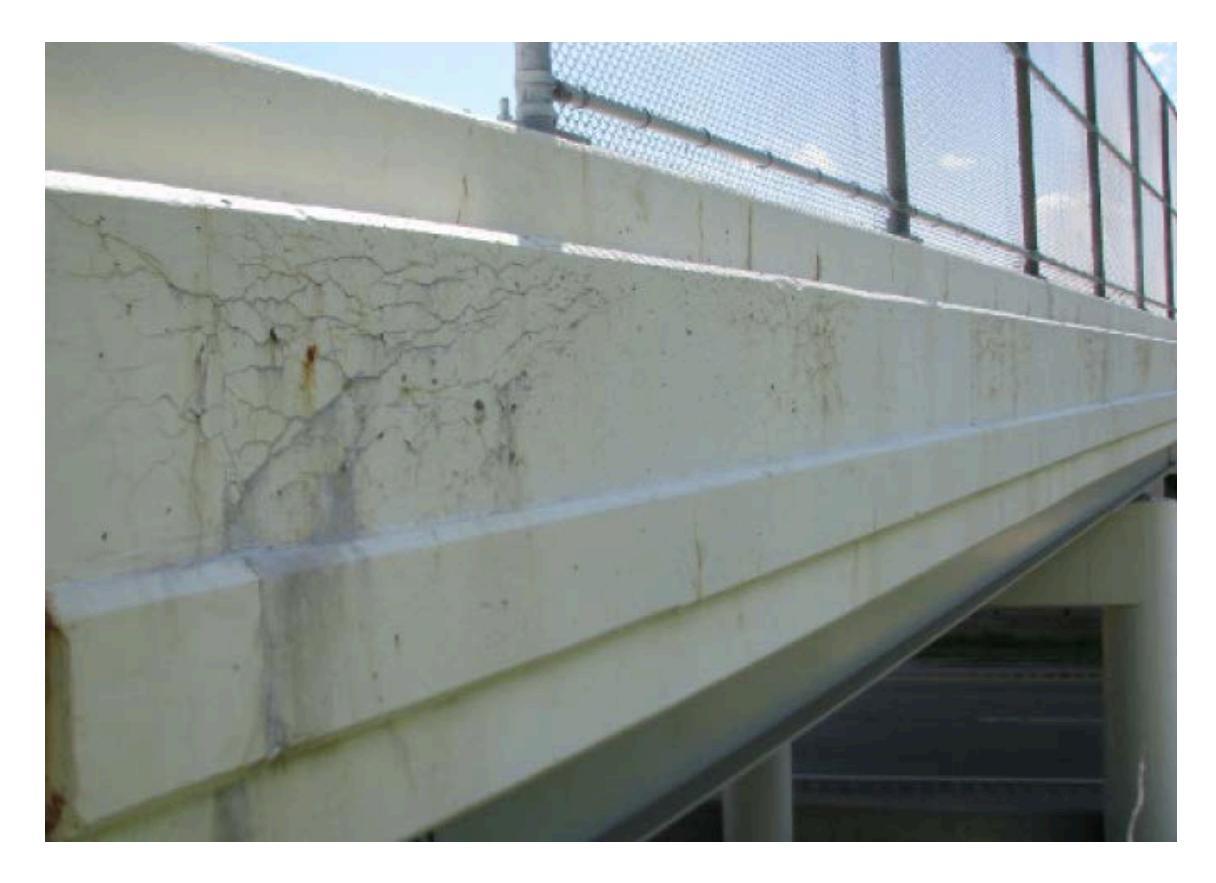
This bridge parapet repair will occur in Greene County with a total length of 277 feet (84 m). The repairs needed for this bridge not only include the replacement of the parapet, but also an overlay of the bridge deck and possible replacement of the VPF. A photograph of the cracking can be seen in Figure 30. The estimated total cost of these repairs is \$200,000, which is \$361 per linear foot of parapet (\$1180/m).

Figure 30: Bridge Number GRE-380-0671 Cracking (Photo Provided by Brandon Collett,
