Pendulum Testing as a Means of Assessing the Crash Performance of Longitudinal Barrier with Minor Damage

Gabauer, Doug; Kusano, Kristofer D.; Marzougui, Dhafer; Opiela, Kenneth; Hargrave, Martin; and Gabler, Hampton C.. "Pendulum Testing as a Means of Assessing the Crash Performance of Longitudinal Barrier with Minor Damage." *International Journal of Impact Engineering* (2010) : 1121-1137.

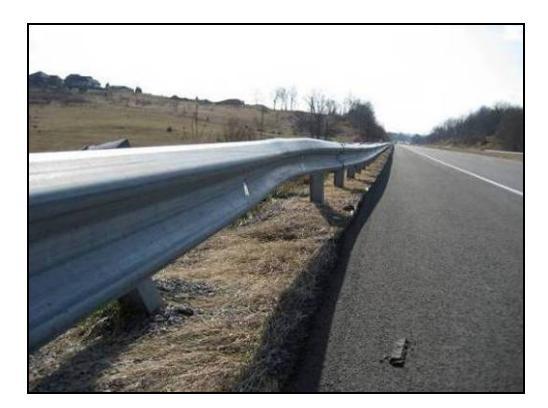
Fig. 1. Minor damage to a strong post w-beam barrier on a major state route.

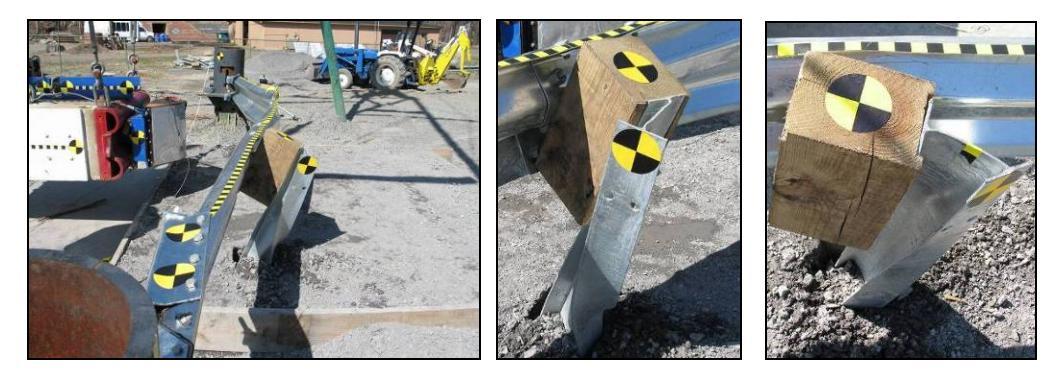
In test 03-2, the undamaged barrier contained the pendulum mass impacting at 30.1 km/hr (18.7 mph). The maximum dynamic deflection of the test section was 658 mm (25.9 inches) at 131 ms after the initial impact. The maximum static crush at the center of the w-beam was 356 mm (14.0 inches). The overall damage and individual post damage is shown in Fig. 6. The post at the splice location (center in Fig. 6) experienced more torsion than the non-splice post and had some minor cracking at the flange. The post at the splice location also remained connected to the rail while the post bolt at the non-splice location pulled through the slot in the rail. There were no failures in the anchor cables in this test and there was no visible separation of the cable from the swaged portion of the anchor cable assembly. At the splice location, there was approximately 19 mm (0.75 inches) of relative movement between the two w-beam rail

sections. No tears were evident in the guardrail and no bolt failure was observed. The left portion of Fig. 7 shows time sequential snapshots of test 03-2 obtained from the high speed camera positioned overhead. Fig. 8 (a) and Fig. 9 (a) show the measured pendulum acceleration and barrier center deflection for all three undamaged barrier baseline tests, respectively. The force on the pendulum mass as a function of barrier center deflection for these tests is shown in Fig. 10 (a).

Fig. 6. Test 03-2: Overall damage (right) and post damage at splice (center) and non-splice location (right)

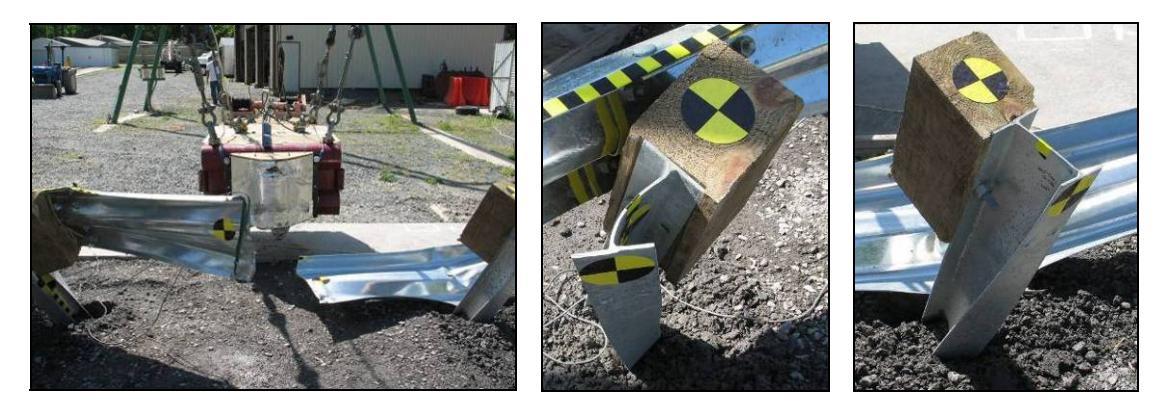
In test 03-5, the barrier section with a 102 mm (4 inch) vertical tear was unable to contain the pendulum mass impacting at 32.0 km/hr (19.9 mph). A vertical tear developed from the bottom tip of the induced vertical tear and continued (approximately straight downward) through the entire w-beam cross section resulting in a complete transection of the w-beam at the impact location. The deflection of the rail was 651 mm (25.6 inches) at 90 ms after initial impact, which was just prior to penetration of the w-beam section. At 118 ms after initial impact, the w-beam was completely transected.

Fig. 11. Test 03-5: Overall damage (left) and post damage at splice (center) and non-splice location (right)

The overall damage and the post damage due to impact are shown in Fig. 11. Compared to undamaged rail, the posts experienced less torsion and did not fracture. The post-rail bolt pulled out of the rail at the non-splice location. At the splice location the post-rail connection remained intact despite large deformation of the bolt. There was 6 to 13 mm (0.25 to 0.50 inches) of relative movement between the two w-beams at the splice location. Other than at the damage location, there were no other tears evident in the beam. Also, there was no relative movement between the cable and swage of any anchor cable assembly. The right portion of Fig.

- <u>Vertical Tear Damage</u>: W-beam rupture was observed in both 32.2 km/hr (20 mph) tests. While the induced tear at the impact location was roughly one third of the w-beam cross section, it is likely that any rail tear could cause a stress concentrator sufficient to cause rail rupture. In our testing, this was demonstrated by a third test; a 13 mm (0.5 inch) tear propagated to the midpoint of the w-beam cross section. In full-scale crash testing, a small tear at the bottom of the rail (caused by contact with the post during the test) was linked to rail rupture in a full-scale test conducted to develop the improved TL-3 version of the weak post w-beam barrier [16]. Based on this information, our recommendation is that vertical rail tears significantly affect the structural adequacy of the barrier and should be repaired.

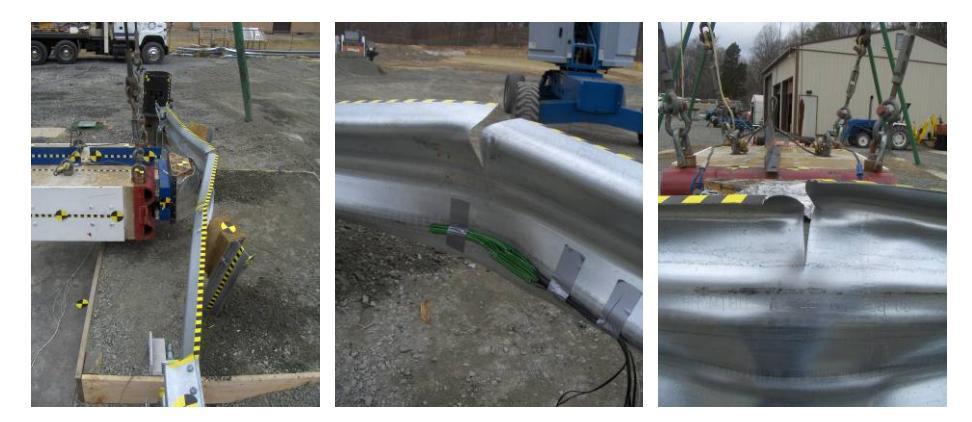
For the 13 mm (0.5 inch) vertical tear damage in test 08-2, the barrier was able to contain the pendulum mass with a maximum deflection of 723 mm (28.5 inches). A vertical tear developed from the bottom tip of the induced vertical tear, at 13 mm (0.5 inches) from the wbeam edge, and continued (roughly straight downward) through approximately half of the wbeam cross section. The overall damage and close-up views of the tear propagation are shown in Fig. 12. Fig. 8 (b) and Fig. 9 (b) show the measured pendulum acceleration and barrier center deflection for all three vertical tear tests, respectively. The force on the pendulum mass as a function of barrier center deflection for the vertical tear tests are shown in Fig. 10 (b).

Fig. 12. Test 08-2: Overall damage (left) and detail views of the additional tearing caused by the pendulum impact (center and right)

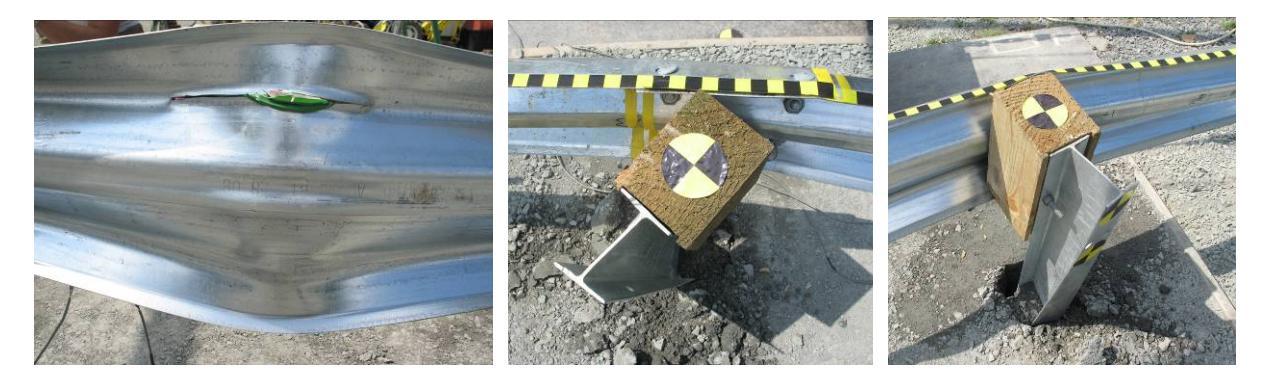
The horizontal tear damaged barrier in test 07-3 contained the pendulum mass impacting at 26.8 km/hr (16.7 mph). The maximum dynamic deflection of the test section was 618 mm (24.3 inches) at 134 ms after the initial impact, computed from the pendulum acceleration data. The maximum static crush at the center of the w-beam was 406 mm (16.0 inches). The damage at the impact location and individual post damages are shown in Fig. 13. Both post-rail connections remained intact and there was 16 mm (0.63 inches) of relative movement between the two w-beams at the splice location. The left portion of Fig. 14 shows time sequential snapshots of test 07-3 obtained from the high speed camera positioned overhead. Fig. 8 (c) and Fig. 9 (c) show the measured pendulum acceleration and barrier center deflection, respectively, for both horizontal tear tests conducted. The force on the pendulum mass as a function of barrier center deflection for the vertical tear tests are shown in Fig. 10 (c).

Fig. 13. Test 07-3: Detail view of impact location (left) and post damage at splice (center) and non-splice location (right)

In the 28.2 km/hr (17.5 mph) test, the damaged barrier was able to contain the impacting pendulum mass. Based on this information, our recommendation is that horizontal tears less than 306 mm (12 inches) in length and 13 mm (0.5 inches) in width do not significantly alter the performance of the barrier. Given the splice failure observed in the higher speed test, this damage should be repaired with a medium priority.

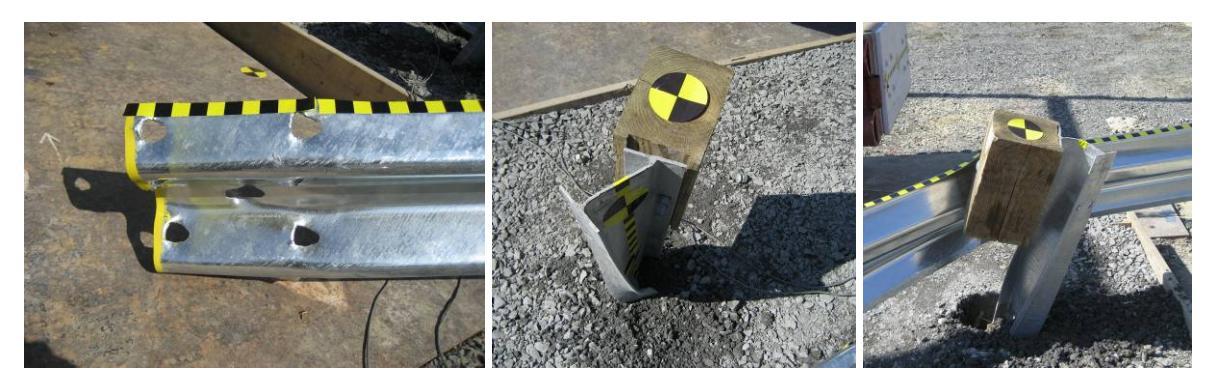
In test 02-1, the horizontal tear damaged barrier (overhead sequence not shown) was unable to contain the pendulum mass impacting at 32.0 km/hr (19.9 mph). The deflection of the rail was 738 mm (29.1 inches) at 102 ms after the initial impact, which was just prior to penetration of the w-beam section. The barrier section failed at the splice due to the splice bolts pulling through holes in the rail with none of the individual splice bolts fracturing. At both the splice and non-splice location, the post bolt pulled through the rail element. The splice failure and post damage is shown in Fig. 15.

Fig. 15. Test 02-1: Detail view of splice failure (left) and post damage at splice (center) and non-splice location (right)

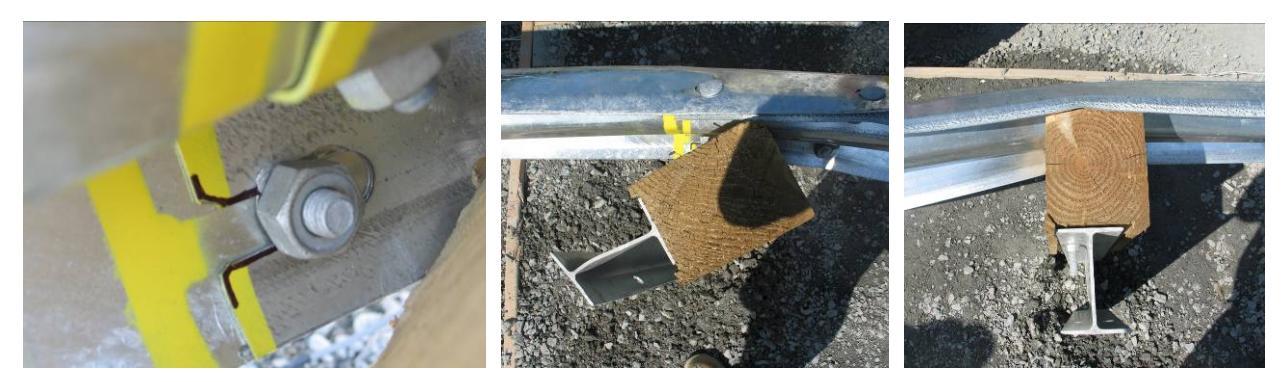
In test 07-4, the splice damaged barrier contained the pendulum mass impacting at 26.8 km/hr (16.7 mph). The maximum dynamic deflection of the test section was 610 mm (24 inches) at 135 ms after the initial impact. Both post-rail connections remained intact and no serious splice separation was observed in the splice damage created prior to the impact. There was approximately 13 mm (0.5 inches) of relative movement between the two w-beams at the splice location. A detailed view of the splice damage and the individual post damage is shown in Fig. 16. The right portion of Fig. 14 shows time sequential snapshots of the test obtained from the overhead camera. Fig. 8 (d) and Fig. 9 (d) show the measured pendulum acceleration and barrier center deflection, respectively, for this test. The force on the pendulum mass as a function of barrier center deflection for the splice damage test is shown in Fig. 10 (d).

Fig. 16. Test 07-4: Detail view of splice bolt damage after test (left) and post damage at splice (center) and nonsplice location (right)

- <u>Splice Damage</u>: Splice damage was simulated such that one of the eight bolts in the splice connection had lost all available bearing capacity. In a 28.2 km/hr (17.5 mph) test, this barrier was able to contain the impacting pendulum mass with performance indistinguishable from the undamaged barrier section. Full-scale crash testing as well as the splice failures observed in the pendulum tests suggests the splice is a weak point in guardrail system. In light of this, our recommendation is that splice damage, where at least one bolt has compromised bearing capacity, be repaired with a medium priority.

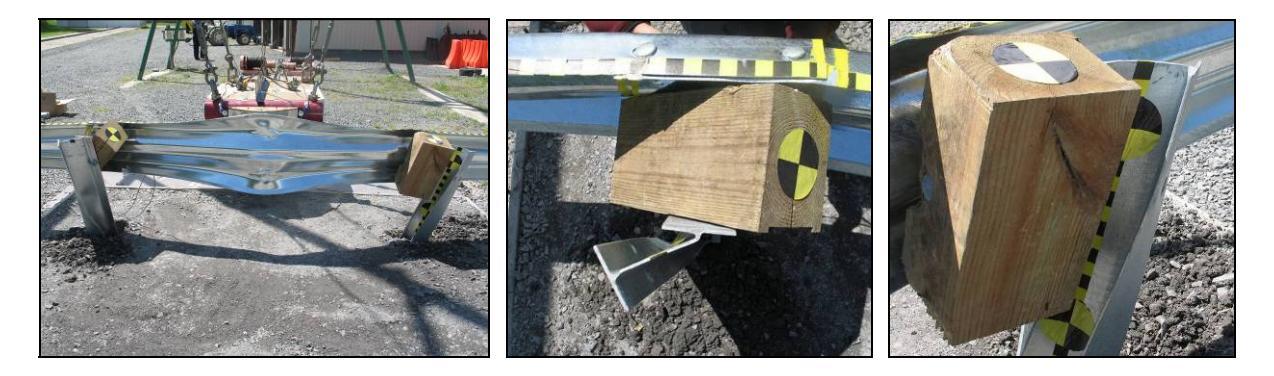
In test 03-8, the twisted blockout damaged barrier contained the pendulum mass impacting at 30.4 km/hr (18.9 mph). The maximum dynamic deflection was 684 mm (26.9 inches) at 134 ms after the initial impact. The maximum static crush at the center of the w-beam was 356 mm (14 inches). The overall damage and the post damage due to impact are shown in Fig. 17. The left portion of Fig. 18 shows time sequential snapshots of test 03-8 obtained from the overhead high speed camera.

The posts experienced similar damage to that in previous tests that contained the pendulum. The post at the splice location experienced more torsion than the non-splice post and had some minor cracking at the flange. The post at the splice remained connected to the rail while the post-rail bolt at the non-splice location pulled out of the slot in the rail. There were no failures in the anchor cables in this test and there was no separation of the cable from the swage portion of the anchor cable assembly. Splice separation was similar to previous tests, approximately 19 mm (0.75 inches) of relative motion between the w-beam sections. No tears developed in the guardrail and no bolts failed. The analogous 3-cable test (no photos shown), test 02-2, also contained the pendulum mass with very similar impact performance. Fig. 8 (e) and Fig. 9 (e) show the measured pendulum acceleration and barrier center deflection,

Fig. 17. Test 03-8: Overall damage (left) and post damage at splice (center) and non-splice location (right)

- <u>Twisted Blockout Damage</u>: The performance of the barrier section with this damage was indistinguishable from that of the undamaged barrier section in two higher speed tests conducted suggesting that this damage mode has little effect on the structural adequacy of the barrier. Based on this information, our recommendation is that twisted blockout damage does not significantly alter the structural performance of the barrier and, as a result, is a low priority repair.

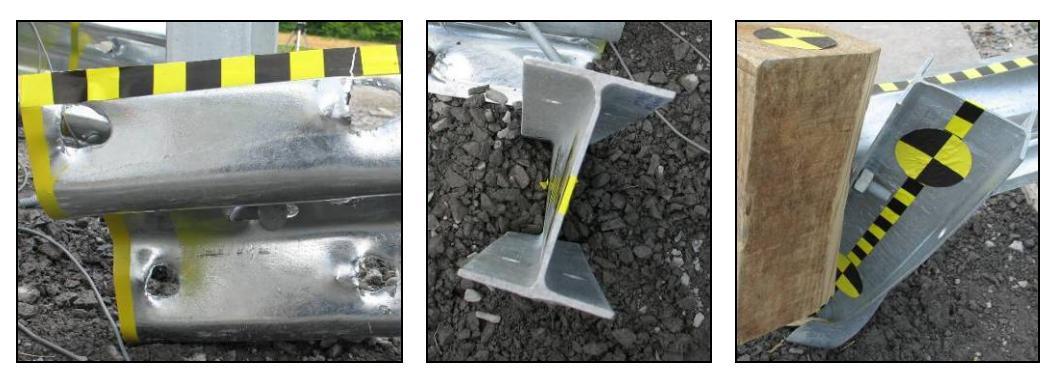
For the missing blockout damage, two 2-cable tests were performed. In the first test (test 03-7), the barrier was unable to contain the pendulum mass impacting at 30.5 km/hr (19.0 mph). The barrier section failed at the splice due to the splice bolts pulling through holes in the rail with none of the individual splice bolts fracturing. This failure was similar to that observed in test 02-1 with the horizontal tear damaged section. The deflection of the rail was approximately 691 mm (27.2 inches) at 106 ms after the initial impact, which was just prior to penetration of the w-beam. At 116 ms, the splice was completely separated.

The deformation of the posts was less than in the undamaged section test, as there was almost no torsion experienced by the post at the splice location. There was no visible cracking of either post. As with most previous tests, the post-rail bolt pulled through the w-beam rail at the non-splice location. The post-rail bolt at the non-splice location experienced large bending

deformation while the bolt at the splice location fractured in the threaded region. Fig. 19 shows the post damage and the splice failure. No tear developed and none of the bolts failed, but rather the bolt holes deformed enough to allow the two sections to separate. The right portion of Fig. 18 shows time sequential snapshots of the test 03-7 obtained from the overhead high speed camera.

Fig. 19. Test 03-7: splice failure (left) and post damage at splice (center) and non-splice location (right)

in test 01-4. The washers would allow additional tension to develop in the rail, ultimately leading to a rail tear as opposed to the bolt pullout splice failure observed in the other test. The lower speed test resulted in performance indistinguishable from the undamaged barrier. Our recommendation is that a missing blockout, especially at the splice, should be repaired with a medium priority based on the marginal performance of the barrier at the higher impact speed.

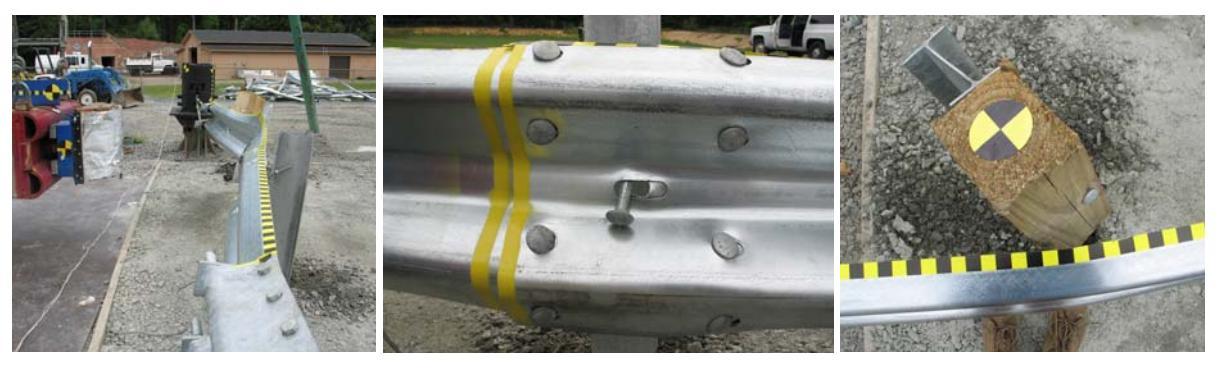
In the second test (overhead sequence not shown), the barrier was able to contain the pendulum mass impacting at 26.7 km/hr (16.6 mph). The deflection of the rail was approximately 633 mm (24.9 inches) at 132 ms after the initial impact. Damage that the barrier section sustained in Test 07-5 is shown below in Fig. 20.

Fig. 20. Test 07-5: overall damage (left), detail view of damage at splice (center) and post damage at non-splice location (right)

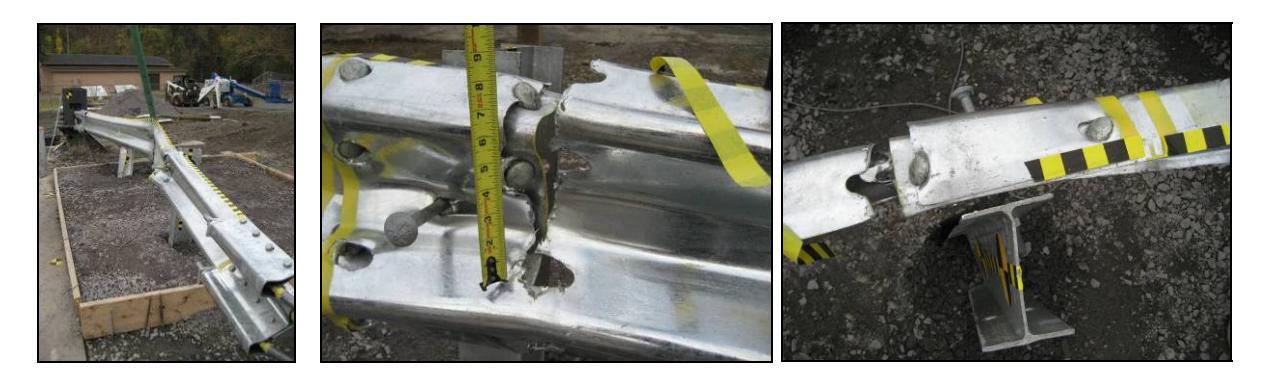
In test 01-4, the barrier had a different impact performance. The barrier section contained the pendulum mass impacting at 31.5 km/hr (19.6 mph). The maximum dynamic deflection of the rail was 719 mm (28.3 inches) at 126 ms after the initial impact. The asymmetry caused by

the missing blockout resulted in a significant twisting of the pendulum (approximately 6 degrees) in the horizontal plane. The vertical tear that developed at the splice location was 229 mm (9 inches) in length, approximately two-thirds of the total w-beam cross section, and along the line of the splice bolts. A close-up of the tear is shown in the center image in Fig. 21. Fig. 8 (f) and Fig. 9 (f) show the measured pendulum acceleration and barrier center deflection, respectively, for the missing blockout tests conducted. The force on the pendulum mass as a function of barrier center deflection for the missing blockout tests are shown in Fig. 10 (f).

Fig. 21. Test 01-4: overall damage (left), rail tear at splice (center), and post damage at splice location (right)
