# A Conservation Study of the Naulakha Pavilion at Lahore Fort, Pakistan

Noor Jehan Sadiq  
*University of Pennsylvania*

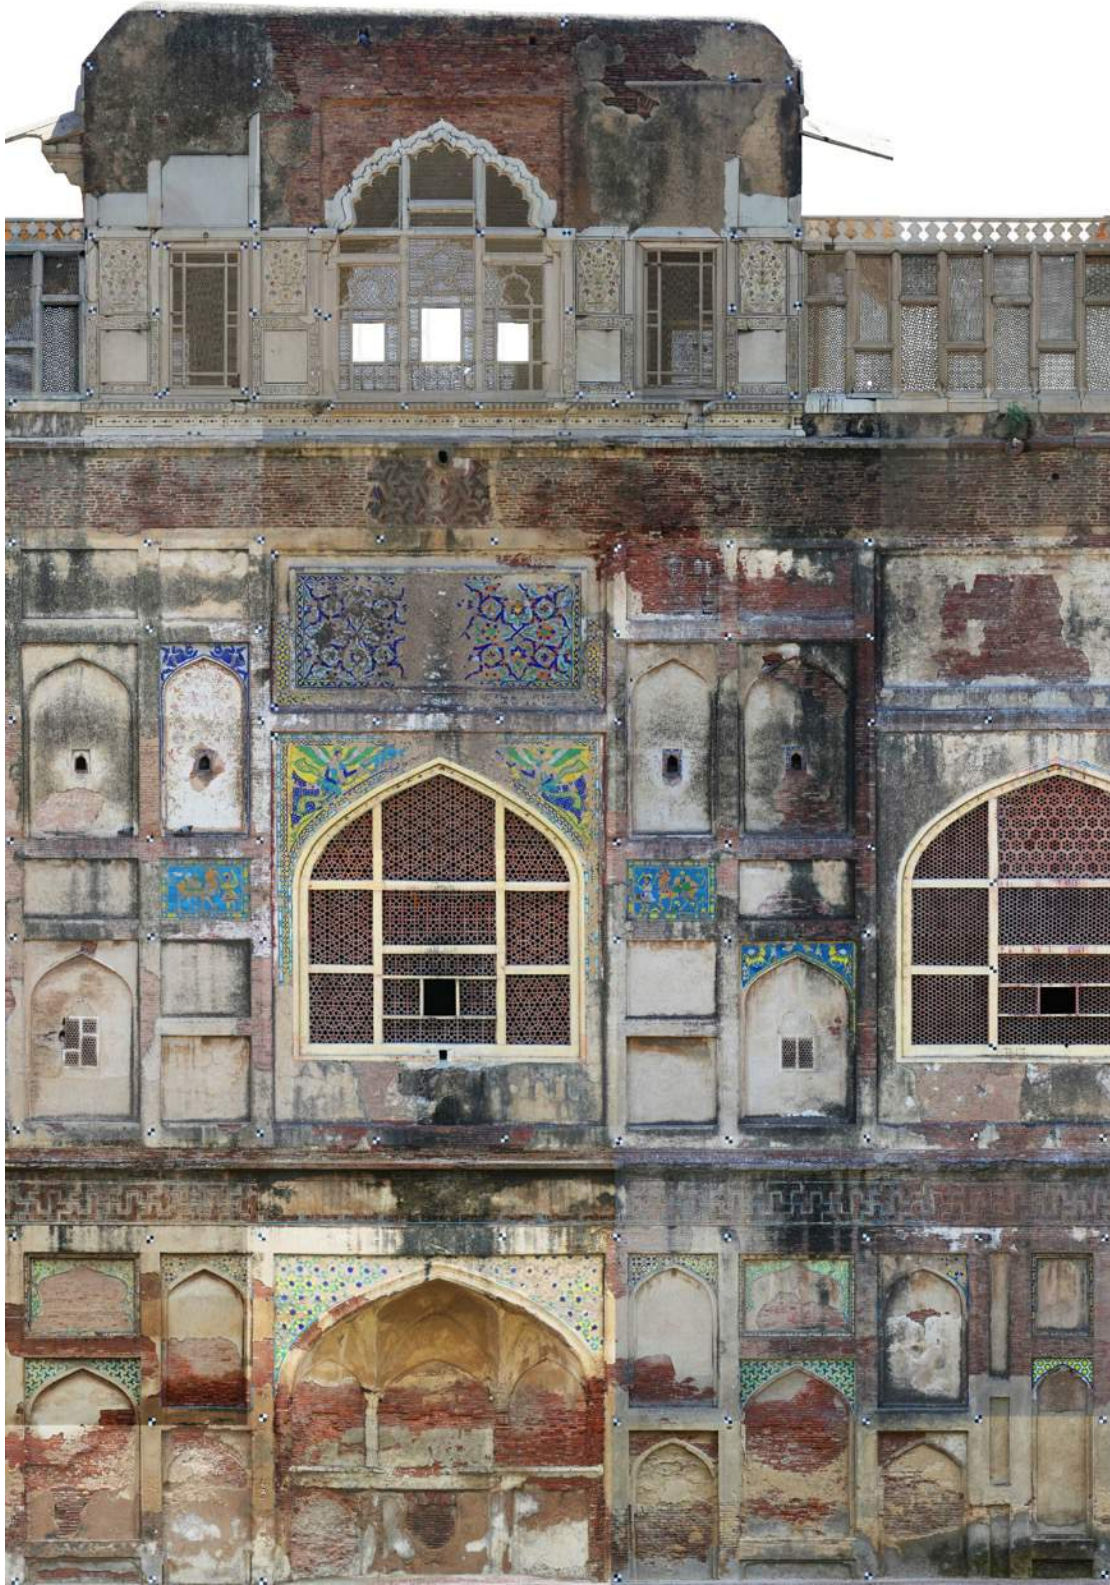
Figure 1: The decorative surfaces of the Picture Wall, Lahore Fort. These include, *kasbi kari* (glazed tilework), *naqqashi* (frescos), *taza kari* (brick imitation), and marble panels with *parbin kari* (*pietra dura*) that are part of the upper story Naulakha Pavilion.

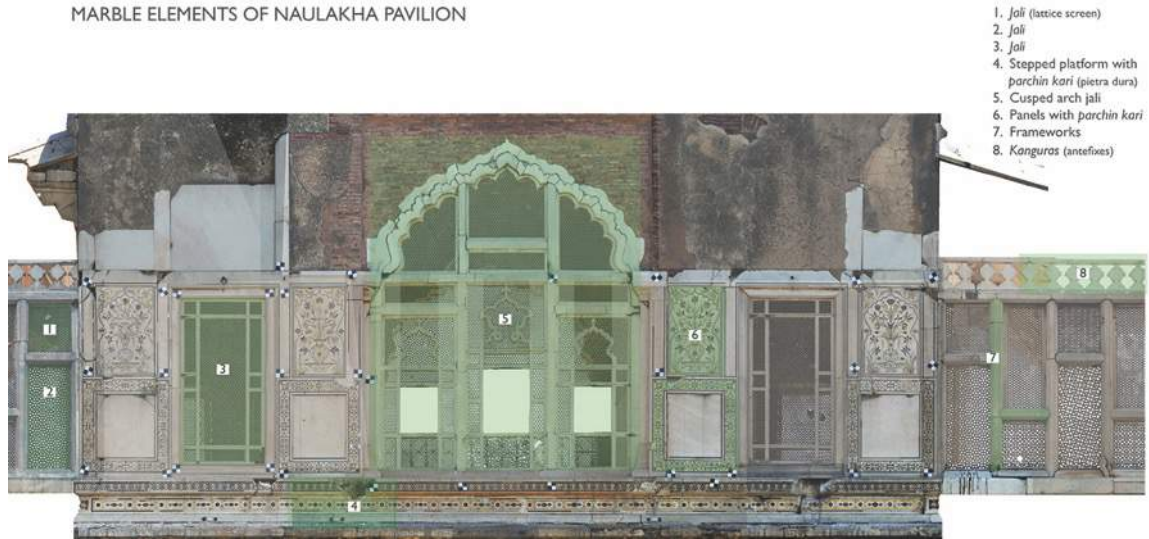
Figure 2: Marble elements of the Naulakha Pavilion. 1, 2, & 3- jalis (lattice screens); 4- stepped platform; 5- cusped arch jali; 6- panels with parchin kari (pietra dura); 7- frameworks; 8- kanguras (antefixes).

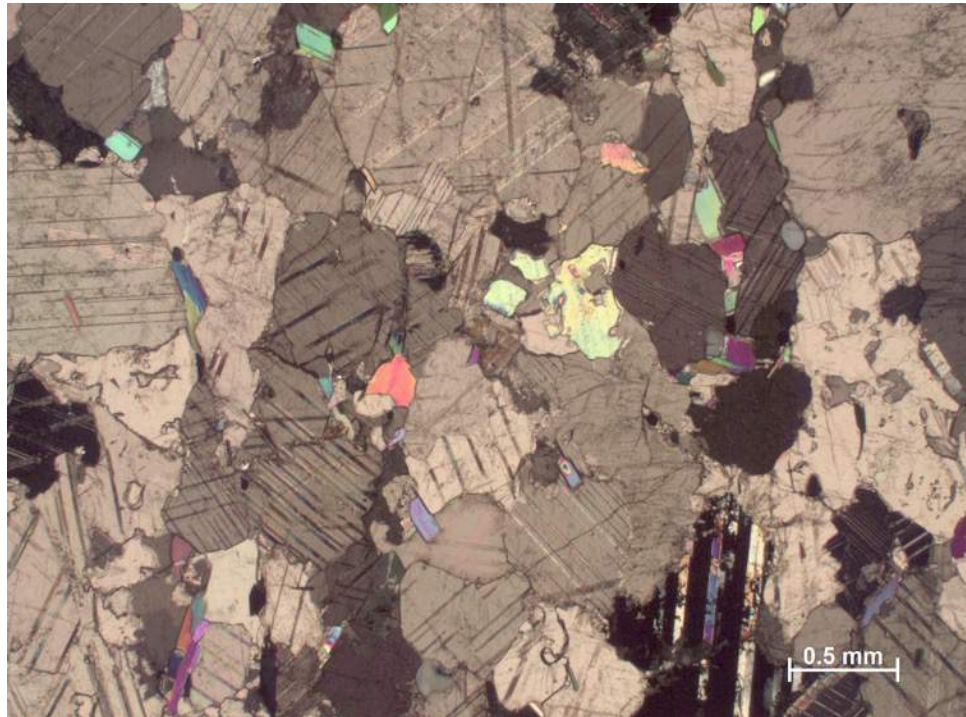
*Figure 12: Thin section micrograph under polarized light microscope for sample PW8. Magnification: 25X. Showing calcite grains with rhombohedral cleavage and lamellar twinning. Accessory muscovite can be seen in clusters and as calcite inclusions.*

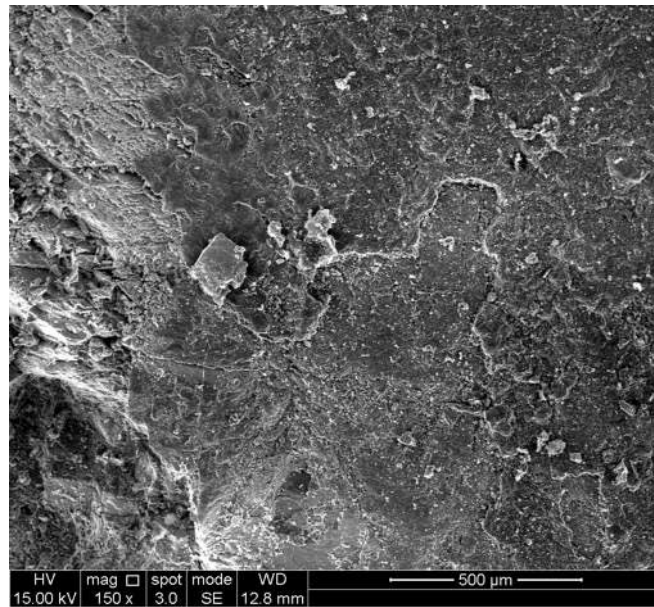
Figure 16: SEM micrograph of deteriorated marble sample PW9. Magnification: 150X. Showing a variety of cracking patterns, and the presence of a surface film covering the crystalline structure.

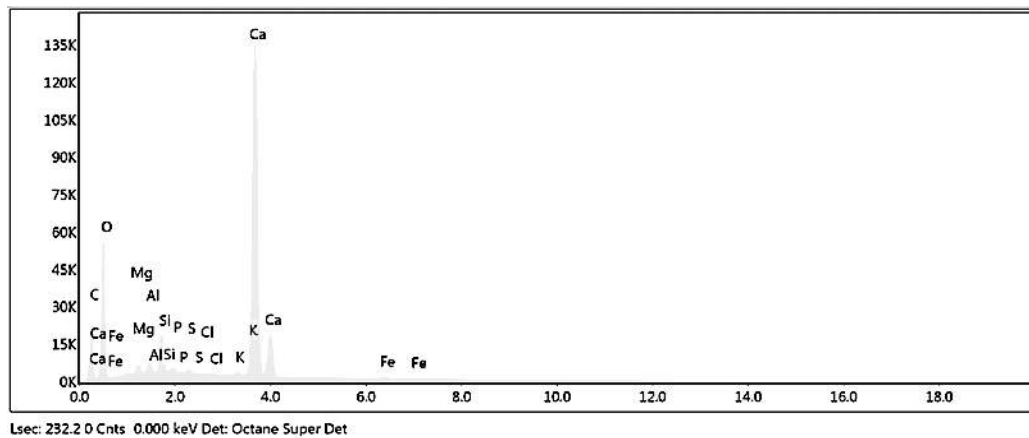
Figure 17: EDS chart of marble sample PW9. Revealing an almost pure carbonate composition, with low amounts of all elements but Ca.

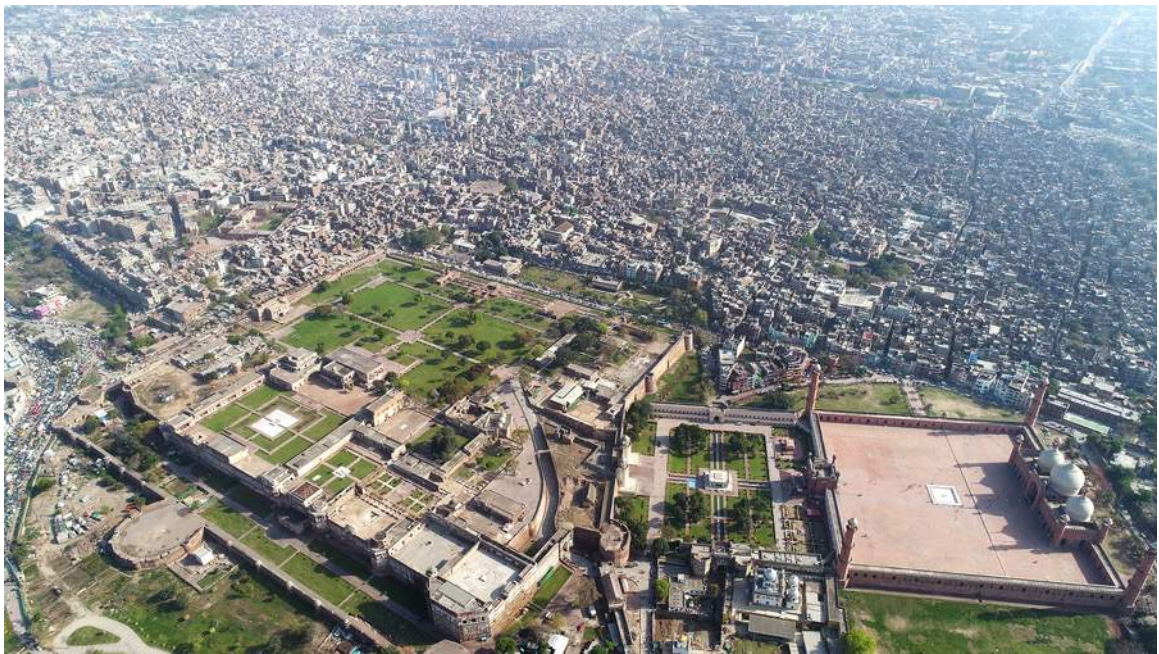
*Figure 18: Lahore Fort complex in relation to the surrounding urban fabric. (Data Source: AKCS-P).*

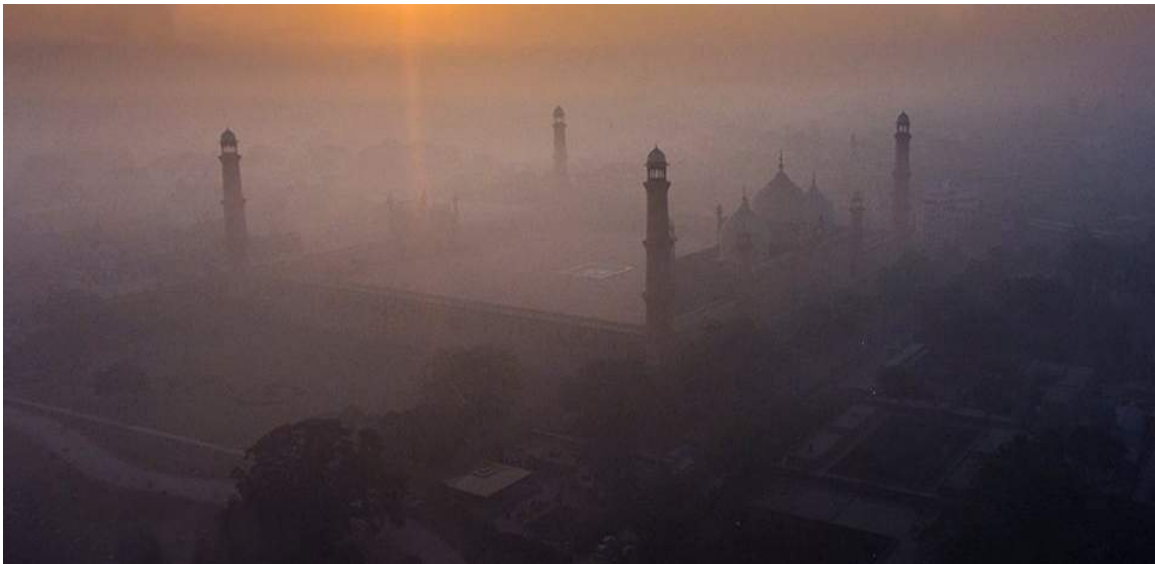
*Figure 19: View of the Lahore city enveloped by a shroud of toxic smog. (Data Source: Yasir Naseer).*

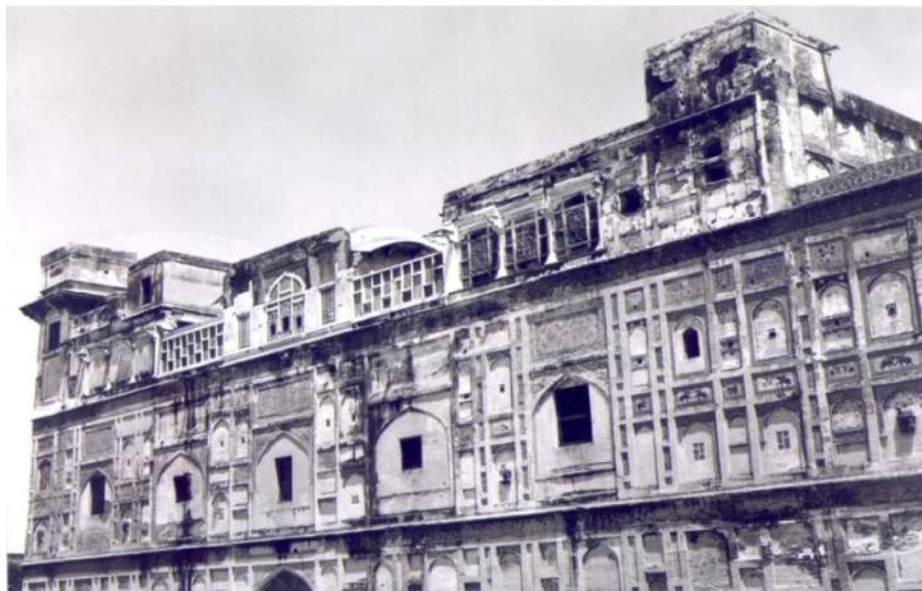
Figure 20: Historical photograph of the western façade of Naulakha (ca. 1900). Showing the missing western *chajja* (eave) in relation to the rest of the roof.

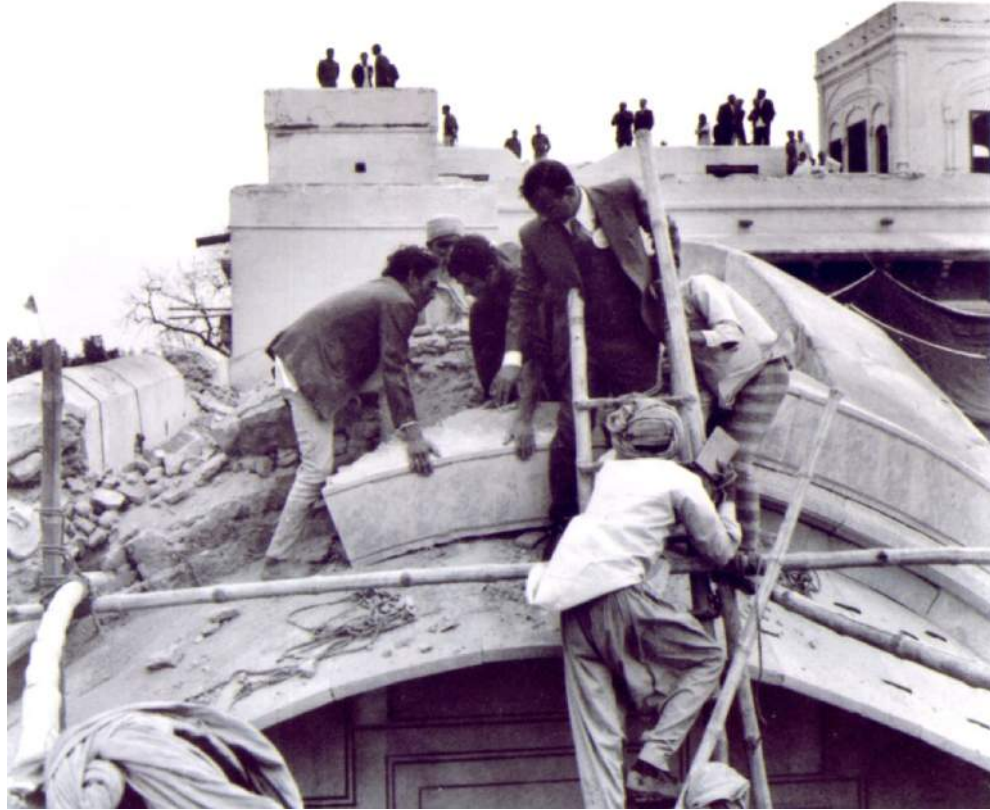
Figure 21: Historical photograph showing restoration of Naulakha's parapet wall (ca. 1970).

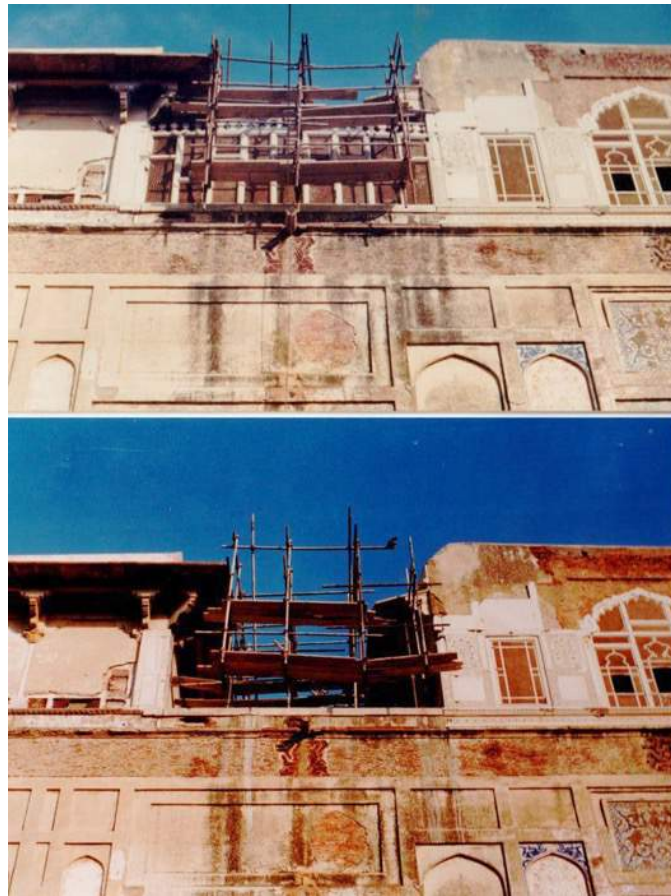
*Figure 22: Repair by disassembly of the marble jalis (2000).*

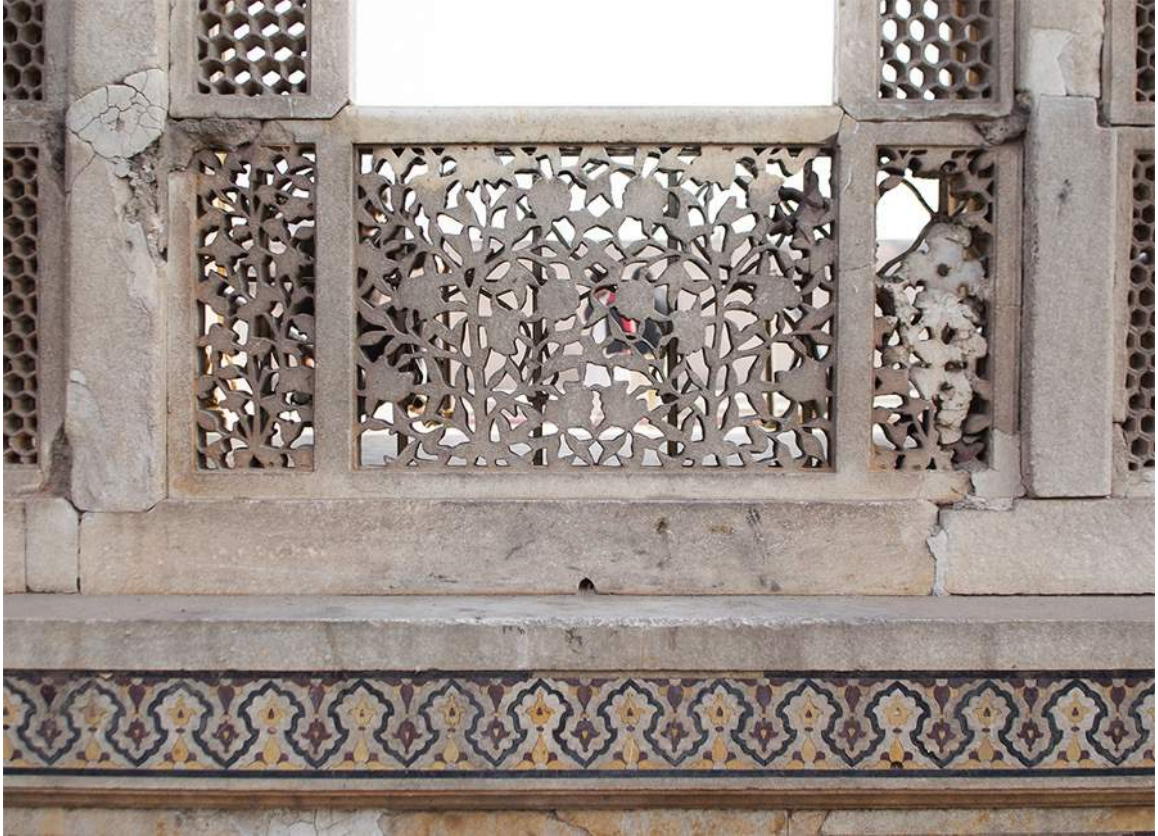
Figure 23: Atmospheric soiling on the central jali of the Naulakha Pavilion.

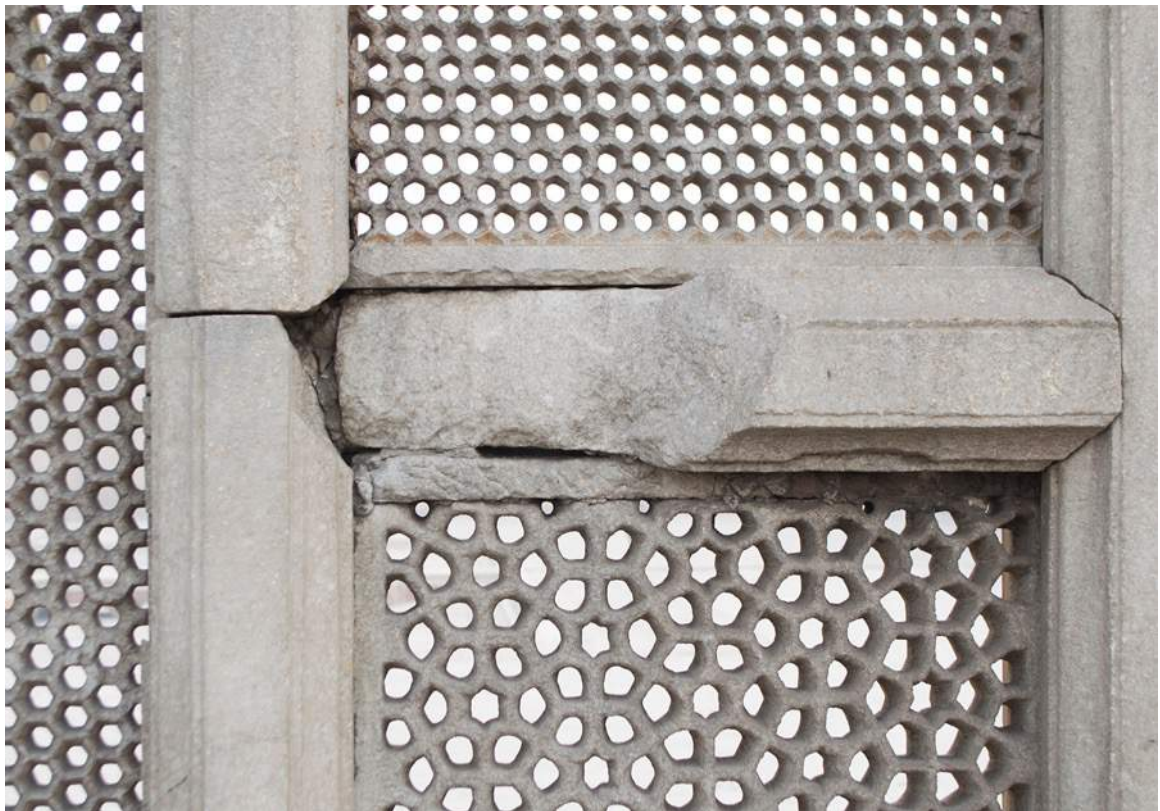
*Figure 24: Open joints in the supporting frameworks of the jalīs. Mostly seen as a result of mortar deterioration and spalling.*

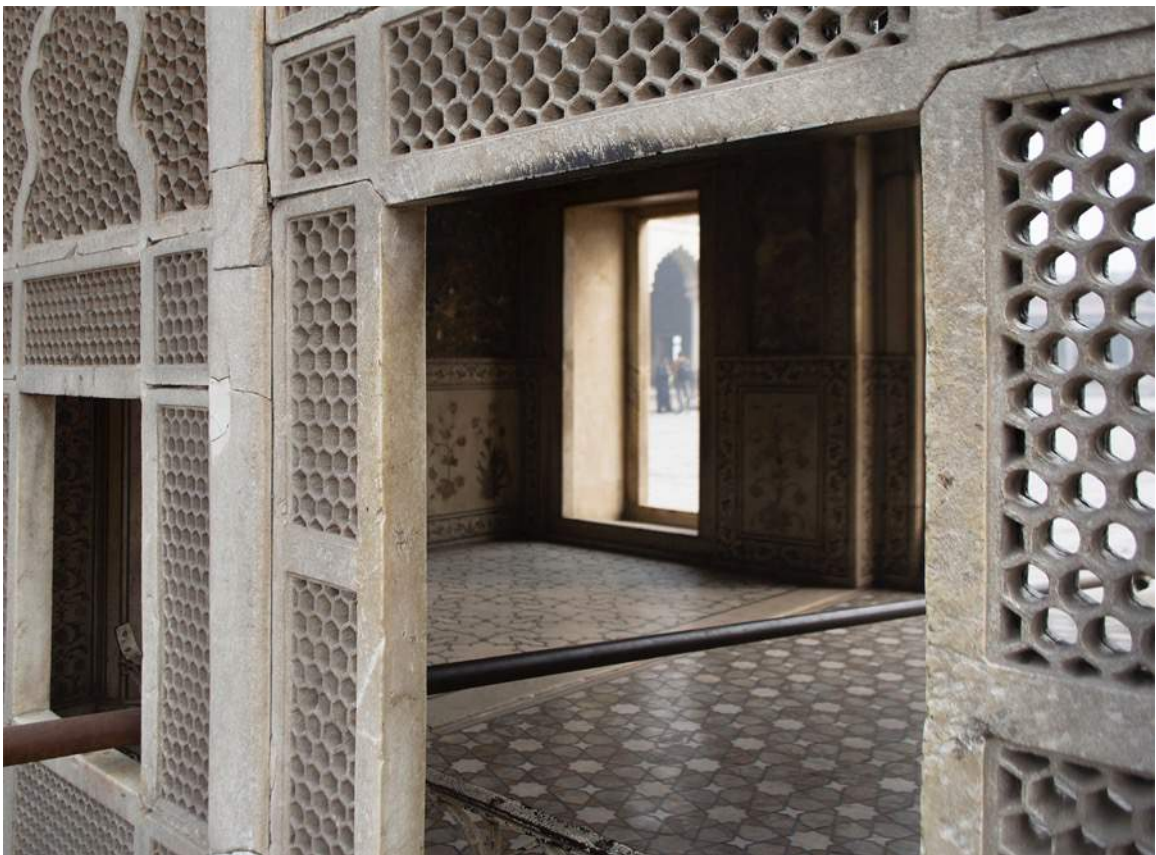
*Figure 25: Gypsum related black crust seen on the underside of the central jali.*

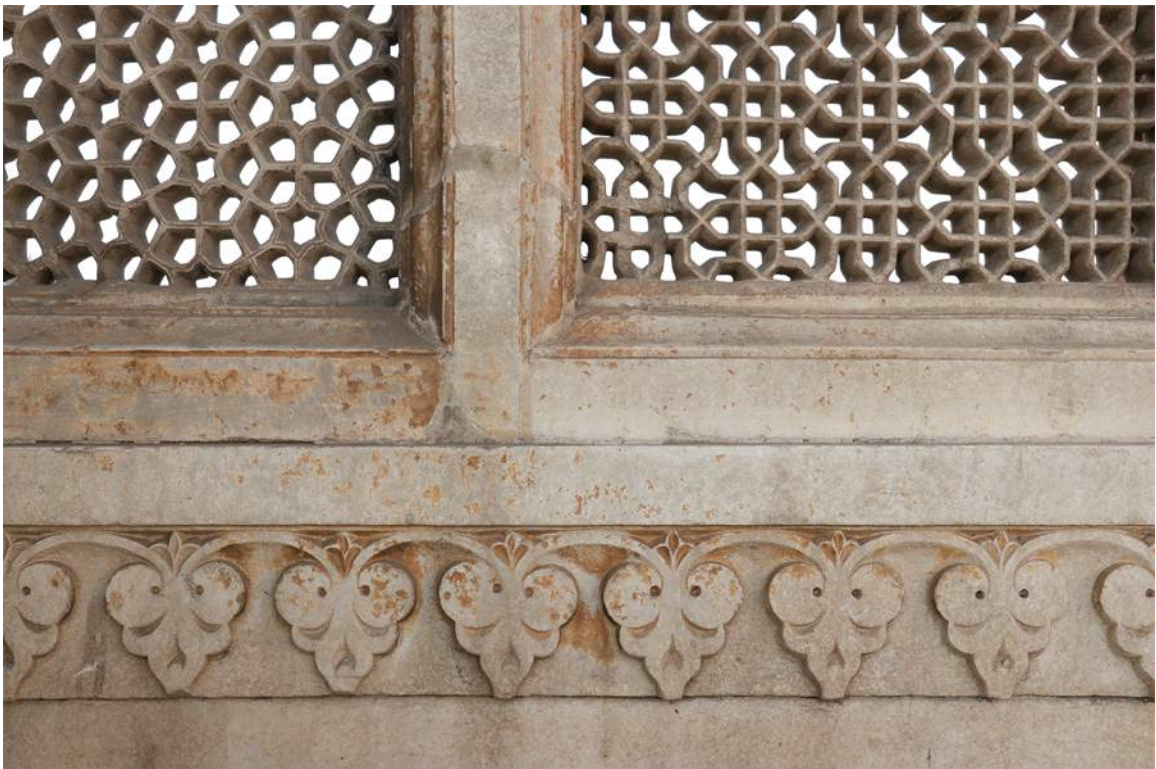
*Figure 26: Silica-based yellow surface film on the stone. Accumulating primarily within the carved details.*

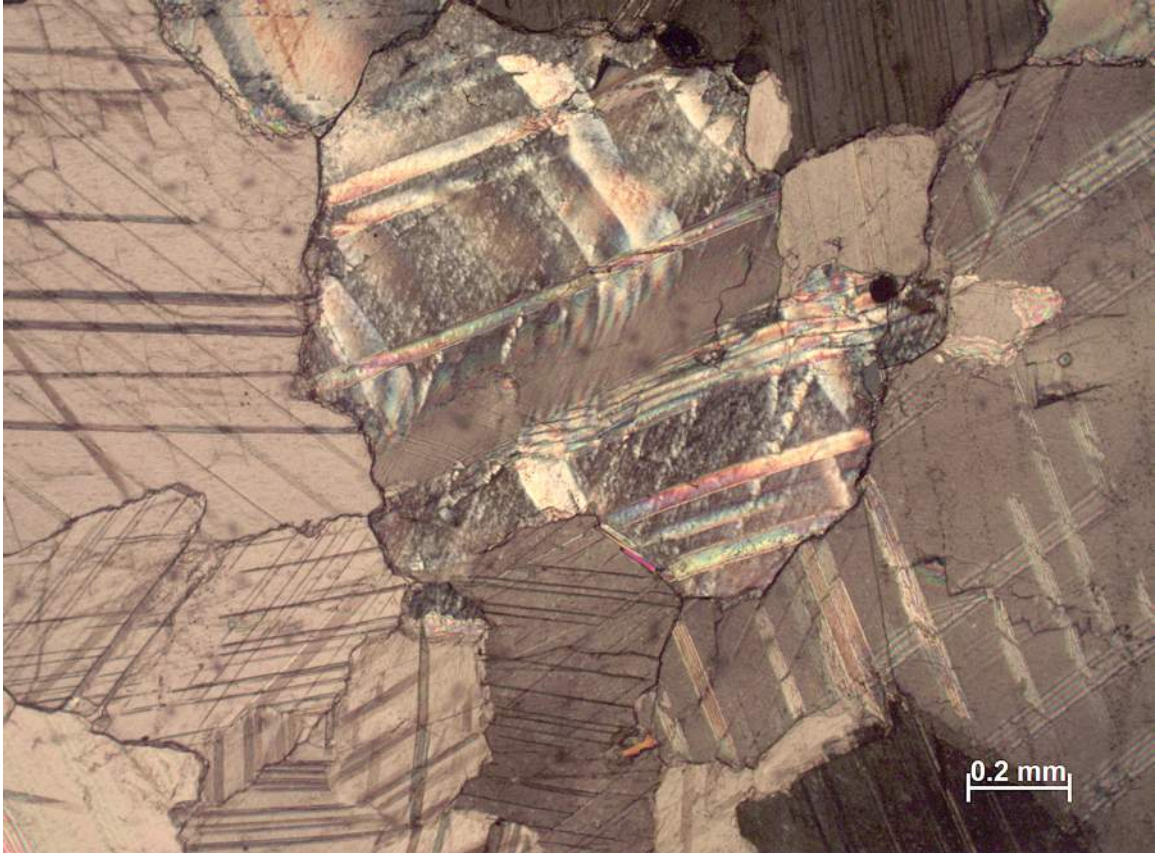
*Figure 29: Thin section micrograph under polarized light microscope for sample PW8 with grains under stress. Magnification: 50X. Displaying the polysynthetic twin deformation and microcracking of calcite minerals around grain boundaries.*

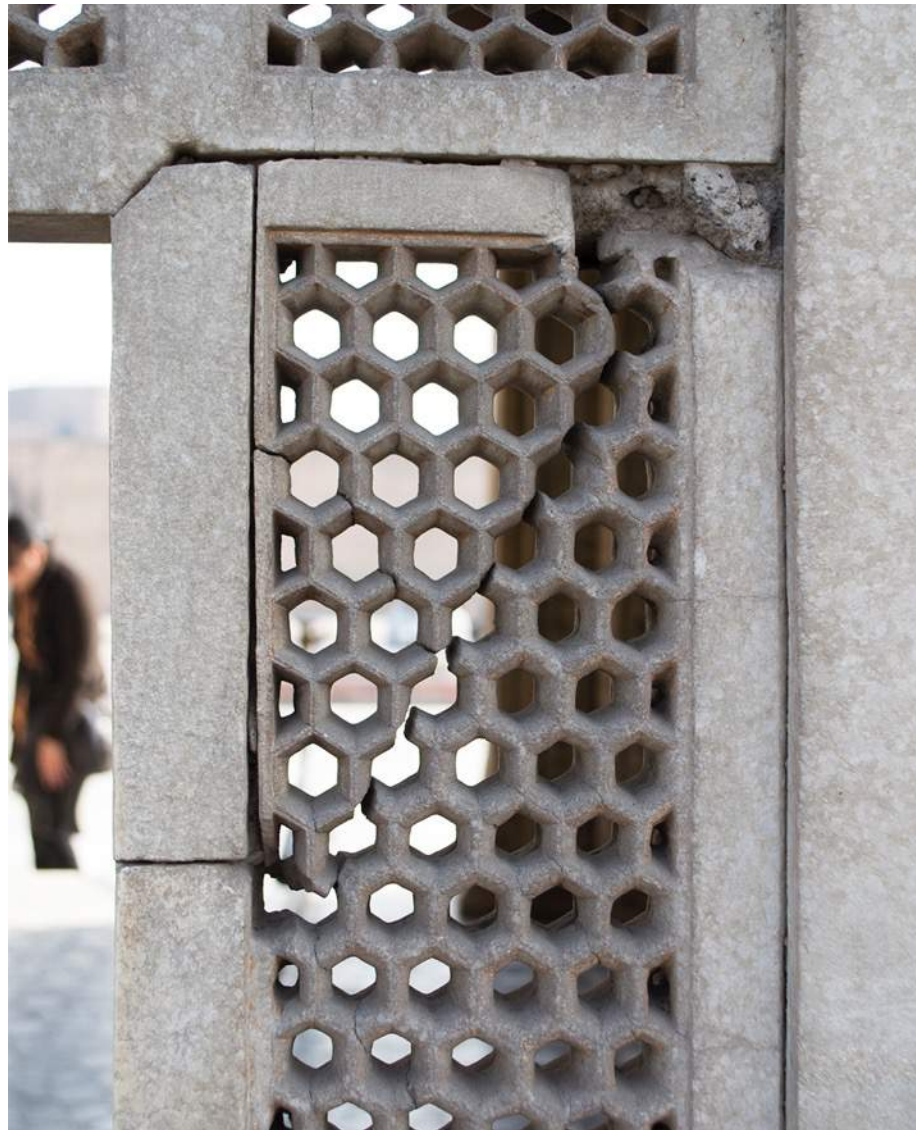
*Figure 30: The varied forms of cracking within the marble elements. Showcasing a fractured part of the jali in relation to the surrounding microcracking.*

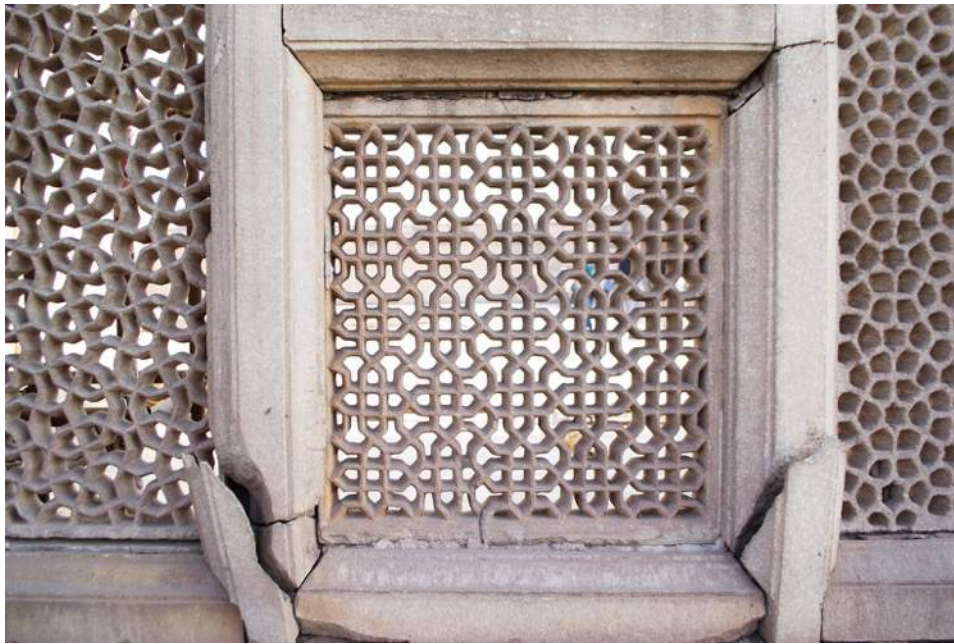
*Figure 31: Spalling of the marble frameworks as a response to their corroded pinning system.*

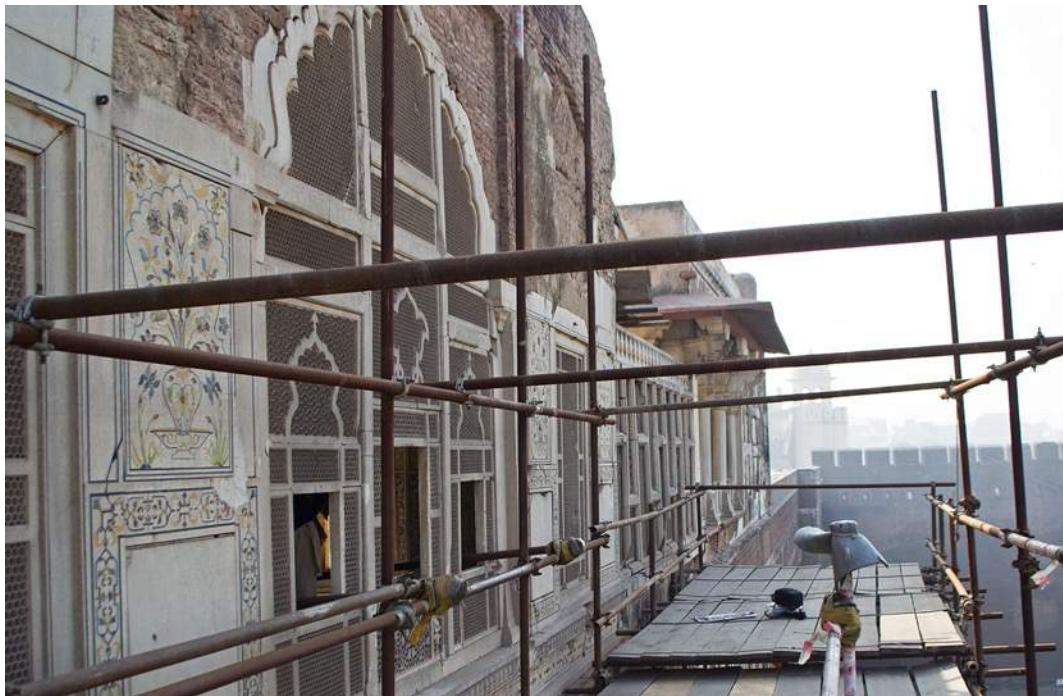
*Figure 32: Convex deformation of the central cusped arch jali.*

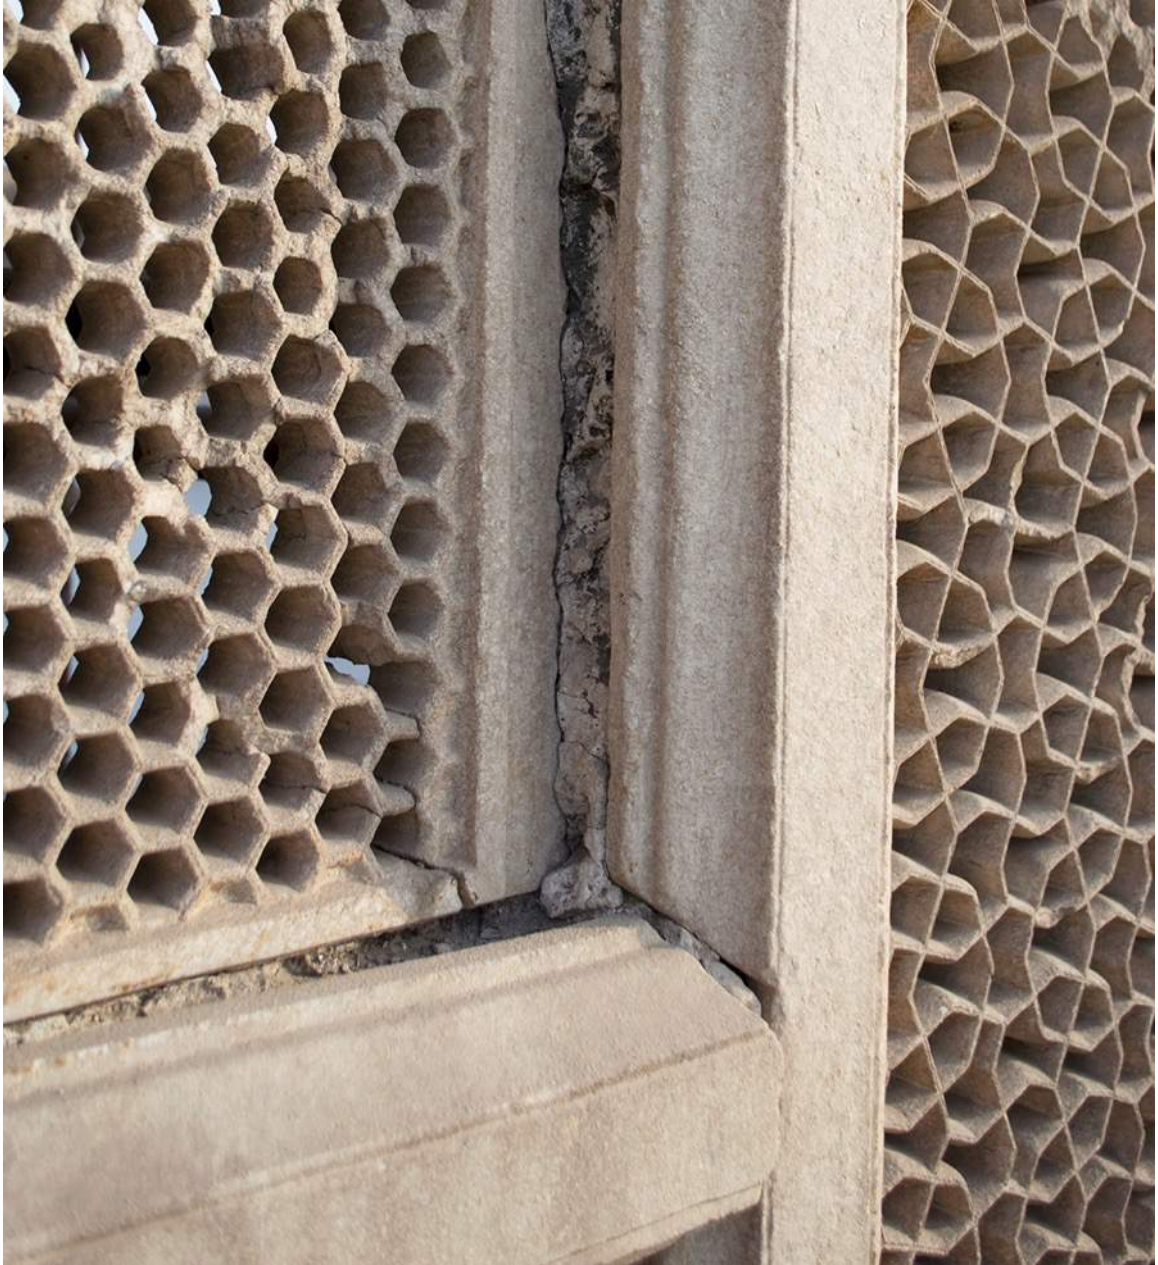
*Figure 33: Displacement of the marble jali as it tilts along the façade due to thermal movement.*

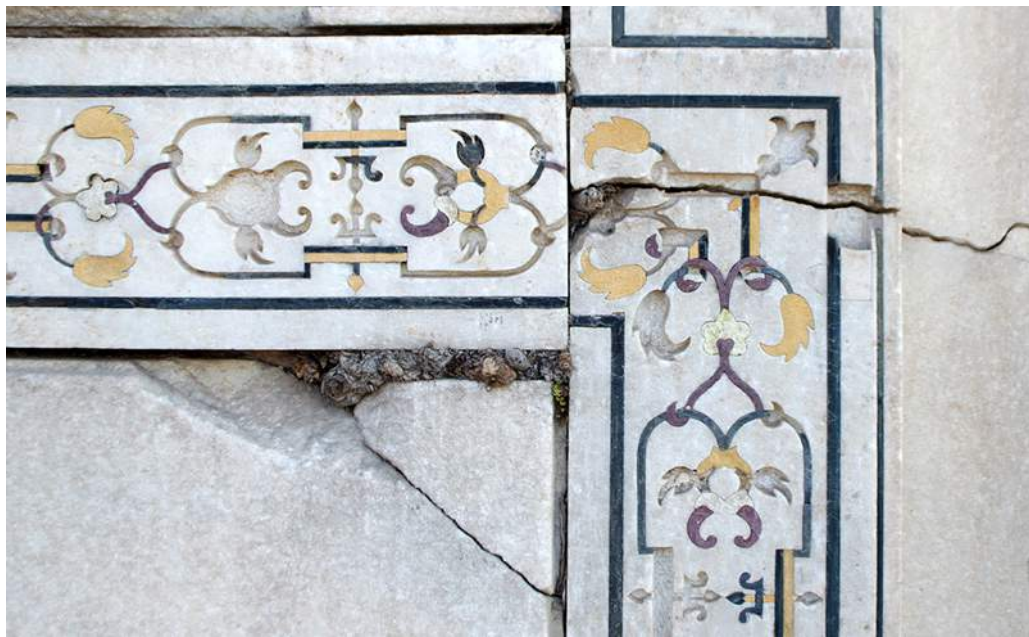
Figure 36: The growth of macroflora around the parchin kari (pietra dura) panel. Displaying resultant fracturing of the stone.

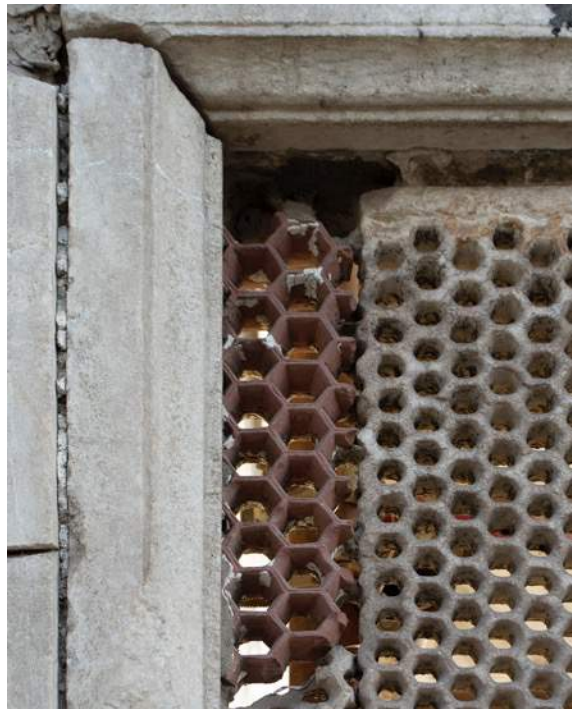
Figure 37: Dutchman repair of the marble jali with terracotta.

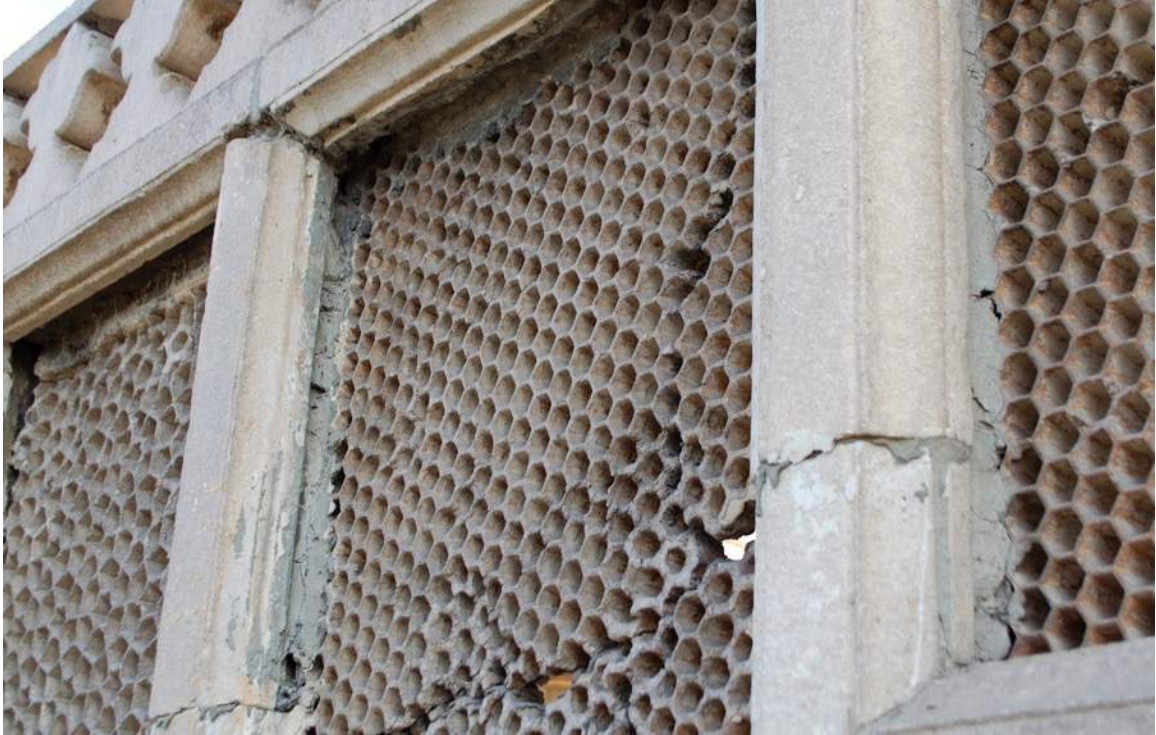
Figure 38: Incompatible cementitious mortar used for resetting the *jalis* and their frameworks (2000).

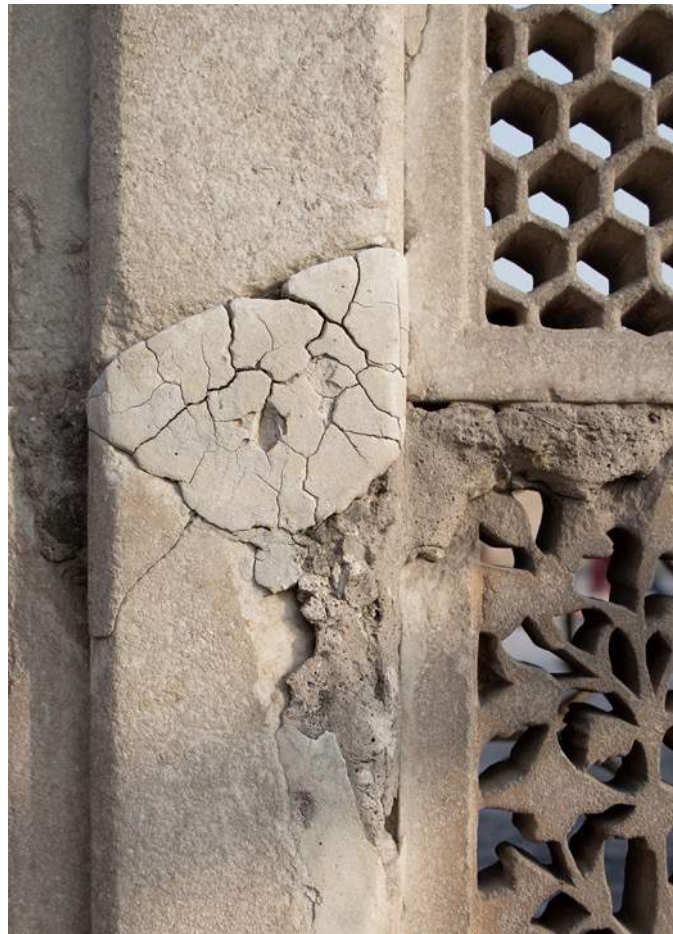
*Figure 39: Incompatible marble-dust fill repairs showing extensive network cracking.*

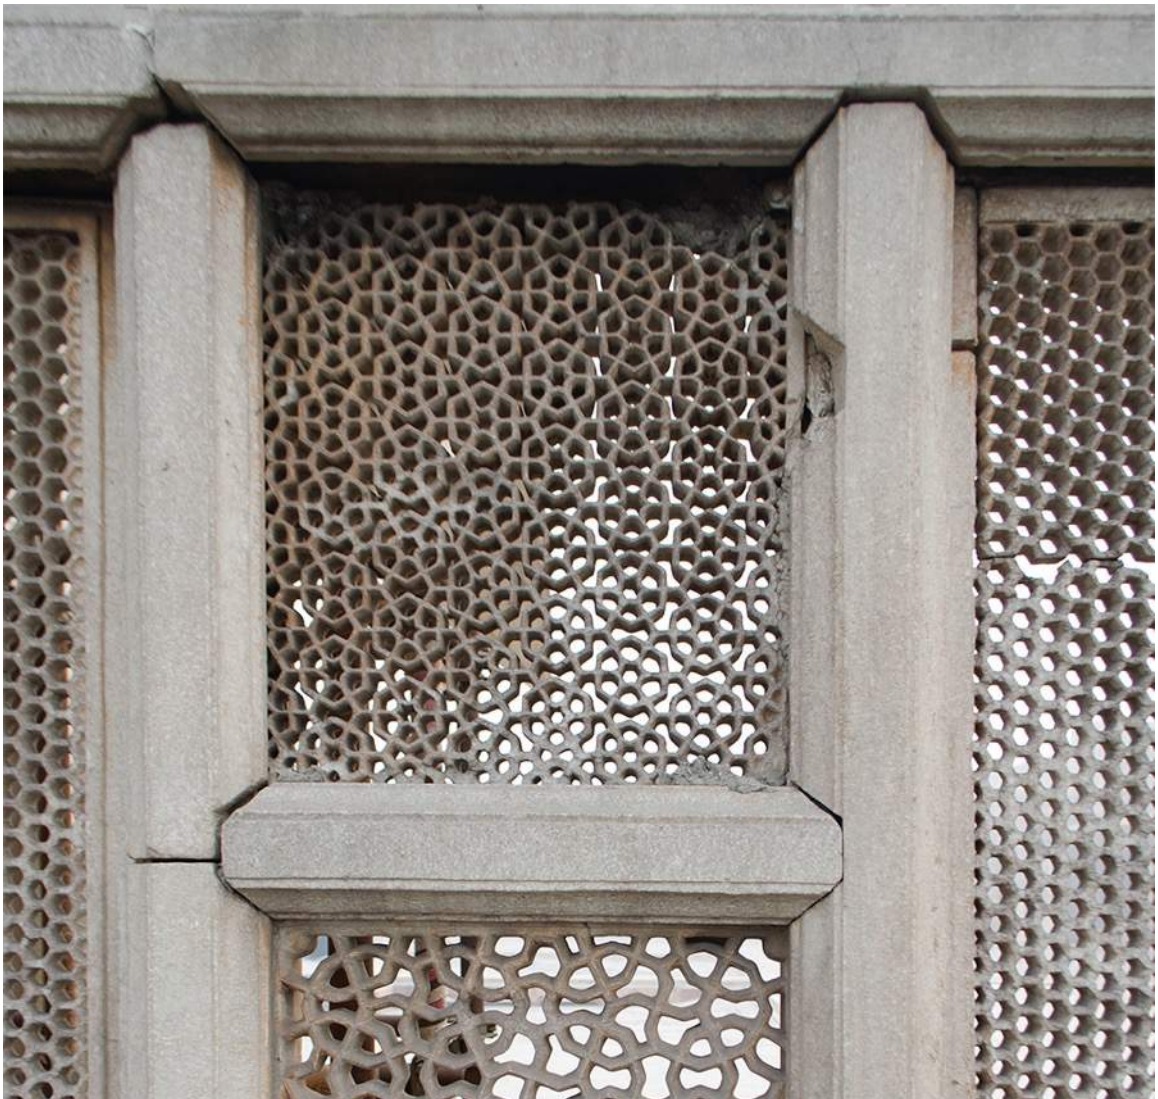
*Figure 40: Inaccurate placement of the marble elements during reassembly. The interlocking joint of the framework on the upper right side does not cohere with the rest of the elements, and therefore is seen without any counterpart which consequently skews the interpretation of the original design.*

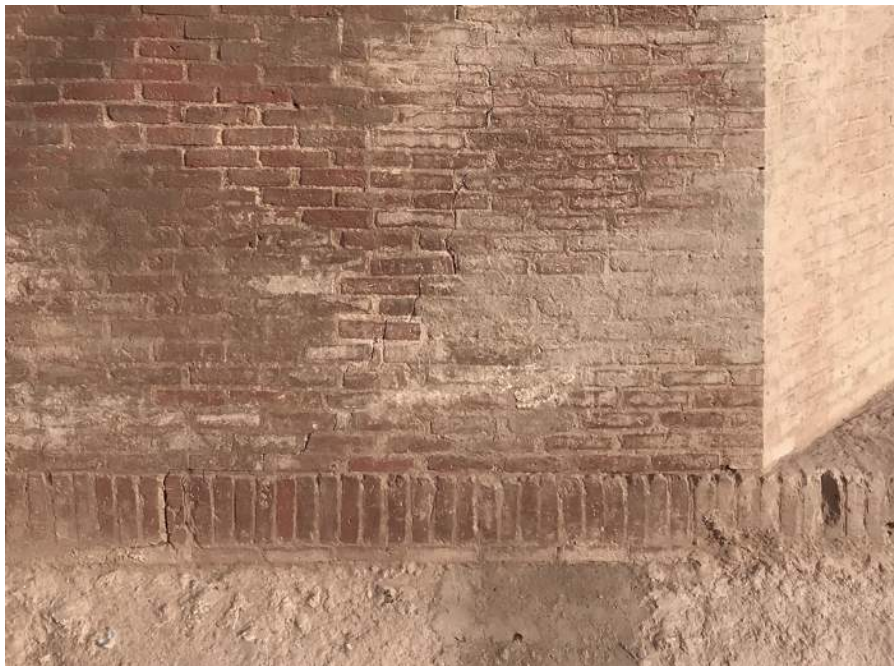
*Figure 41: Structural cracks beginning at ground level as seen on the Picture Wall.*

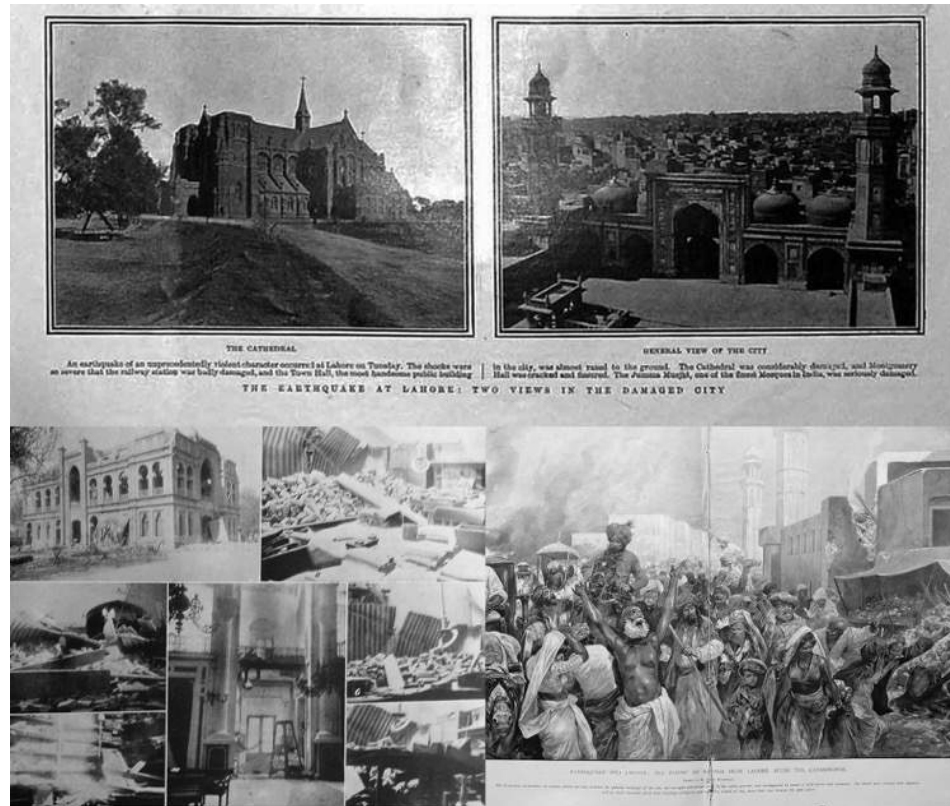
Figure 42: Illustrations of the Earthquake that hit Lahore in April 1905. Published in *The London News*, England.

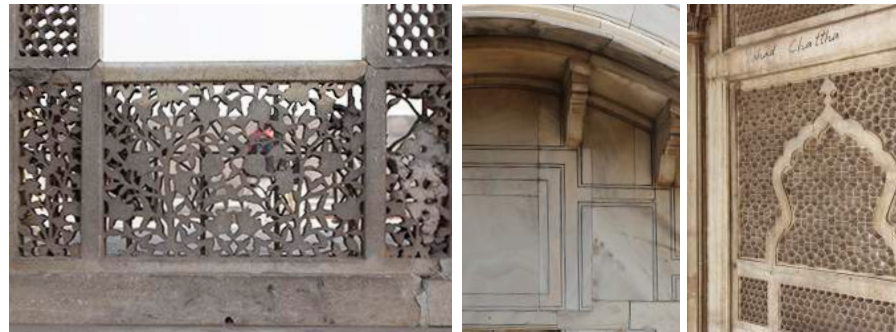
Darkening of the stone by a thin layer of atmospheric pollutants and/or particles transported by rain and runoff water. Found in areas that cannot be easily washed away by rain.

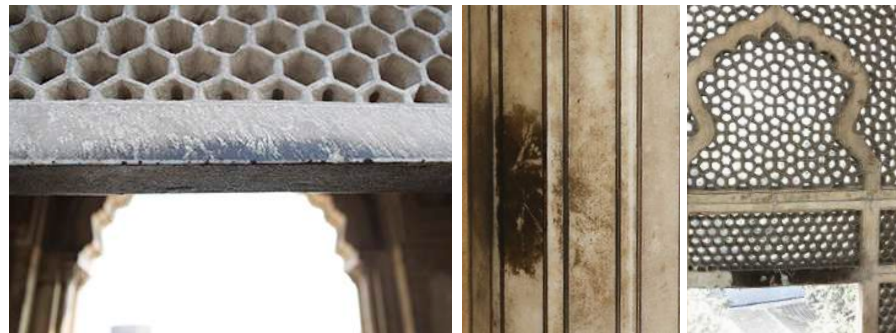
Encrustation of calcium sulphate (gypsum) as rainwater combines with atmospheric particulates such as carbon, giving the surface its black color. Usually adheres firmly to the substrate.

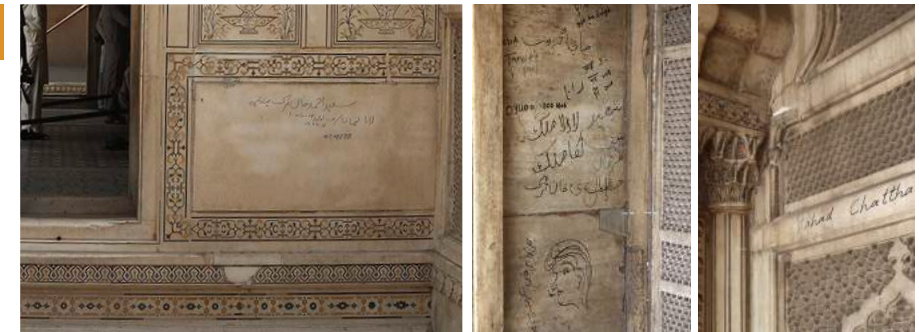
Engraving, scratching or using ink on stone surfaces as an act of vandalism. Found mostly in more easily accessible interior spaces of the pavilion.
