# A Conservation Study of the Naulakha Pavilion at Lahore Fort, Pakistan

Noor Jehan Sadiq  
*University of Pennsylvania*

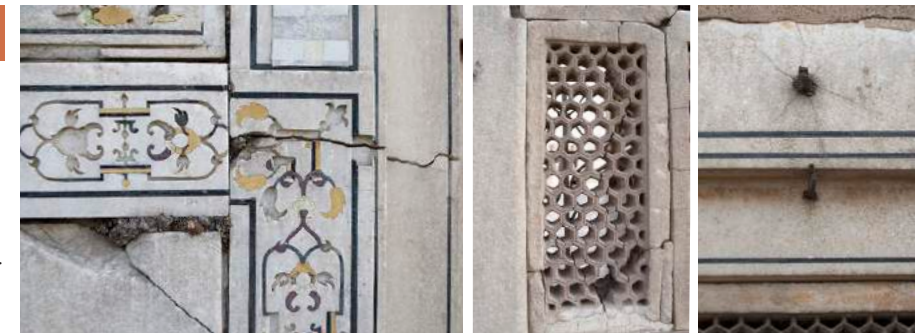
Fissures of varying length, depth and orientation likely associated with displacement, spalling, and dimensional loss. Includes fractures (> 3.2 mm), moderate cracks (1.6 to 3.2 mm), hairline and star cracks (< 0.1 mm) caused by corroding iron.

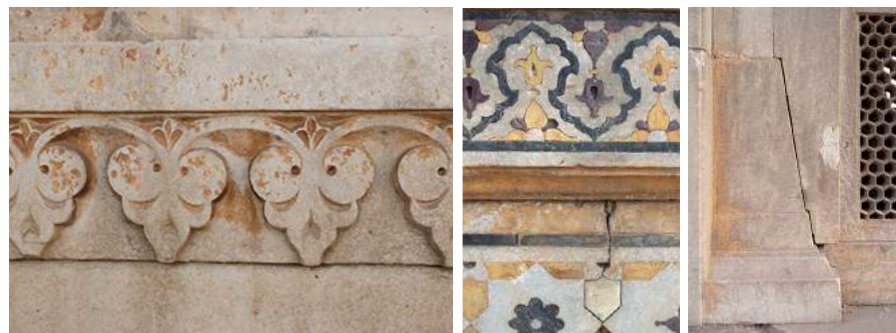
Formation of a thin ochre-to-brown surface alteration layer enriched with silicates, gypsum, and other accessory minerals. Found in areas protected from rain water intrusion.

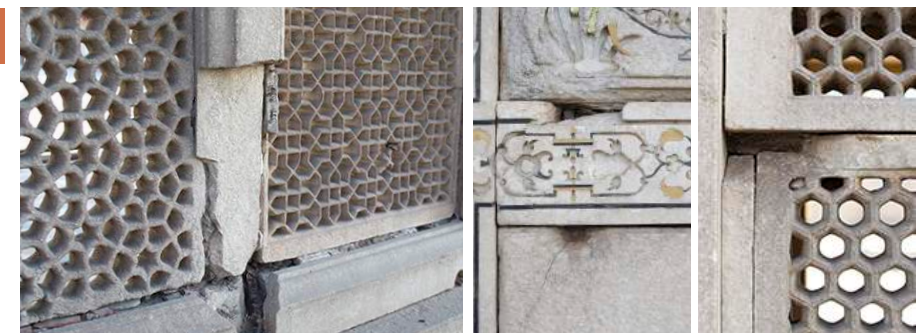
Localized loss of marble due to internal pressure through volumetric expansion induced by the corrosion of the ferrous anchorage. Typically preceded by star-shaped fractures.

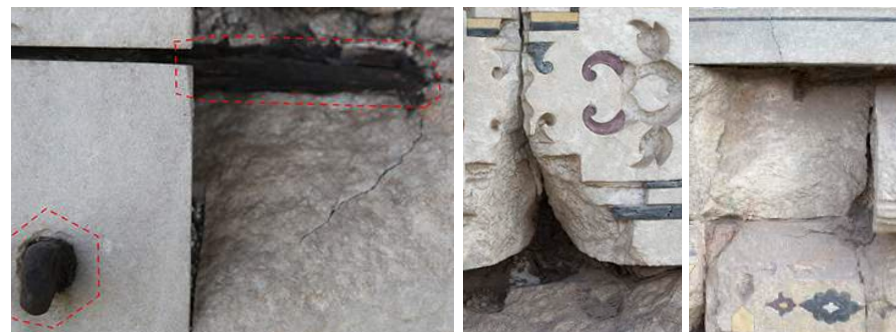
Localized change of the stone color due to metallic staining resulting from the oxidation of ferrous anchorage embedded in the marble slabs.

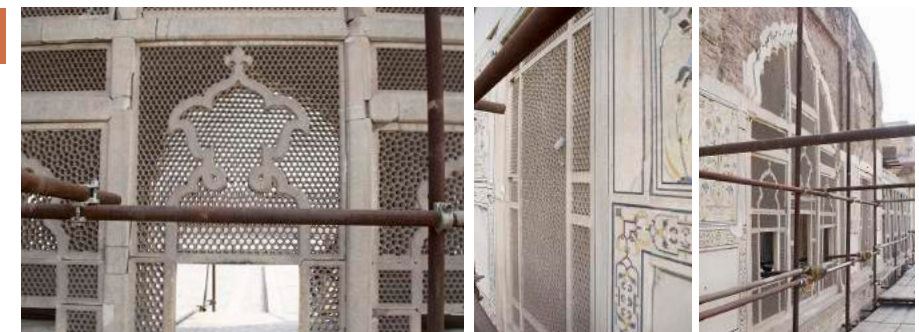
## Appendix C: Conditions Drawings

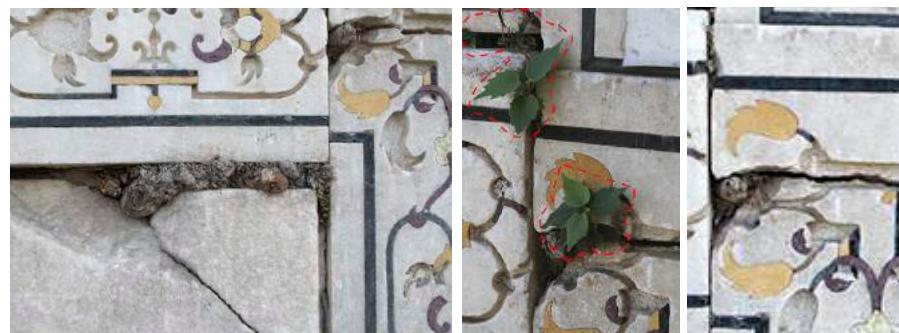
Direct vegetal growth on and in stone work, showing roots and leaves. Usually associated with open joints and areas containing sufficient moisture to sustain plant life.

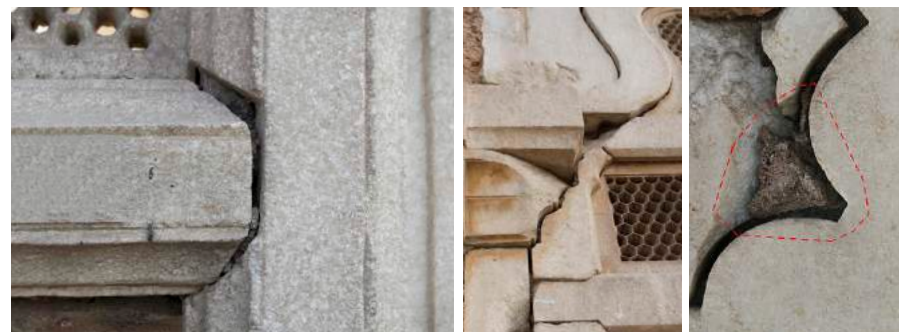
Stone joints that show partial or complete loss of mortar, typically associated with erosion and moisture penetration inside and outside of the structure.

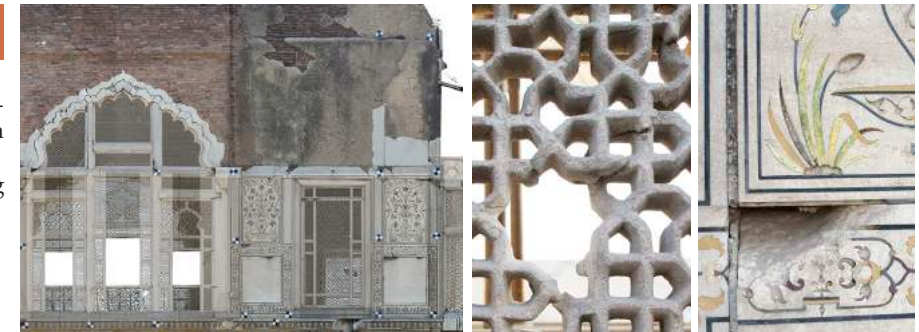
Localized loss in stone > 2 square inches in area. Typically caused in association with excessive disaggregation, spalling and cracking of stone.

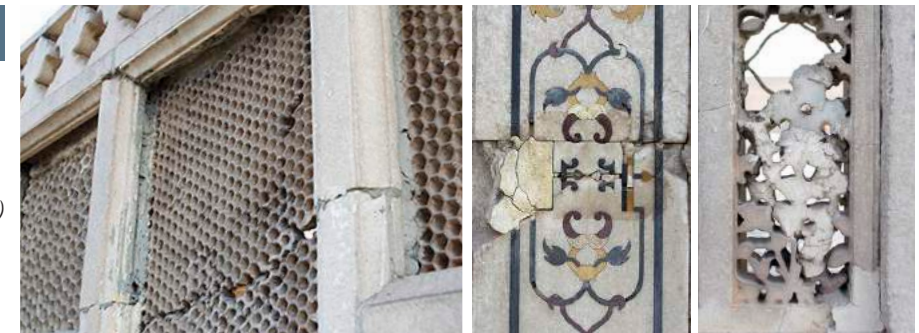
Repair work including composite repairs and cement fills primarily visible around the *jalis*. Along with recent resin based treatments (*Paraloid B-72*) used as a surface repair of cracks and losses.

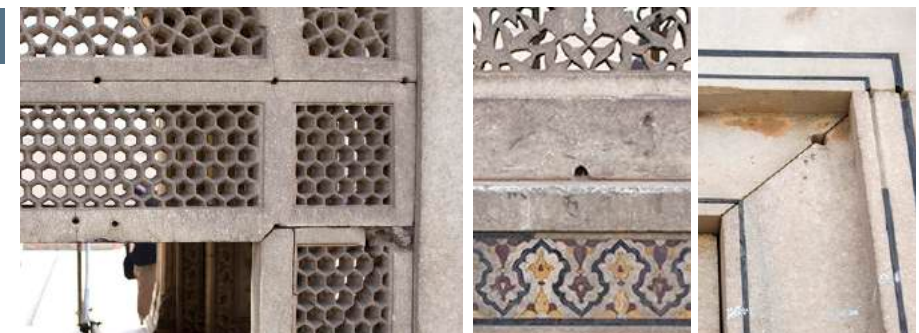
Loss of stone material due to impact damage during disassembly of the structure for repair work. There are clear signs of an impact tool used to pull out the marble slabs.

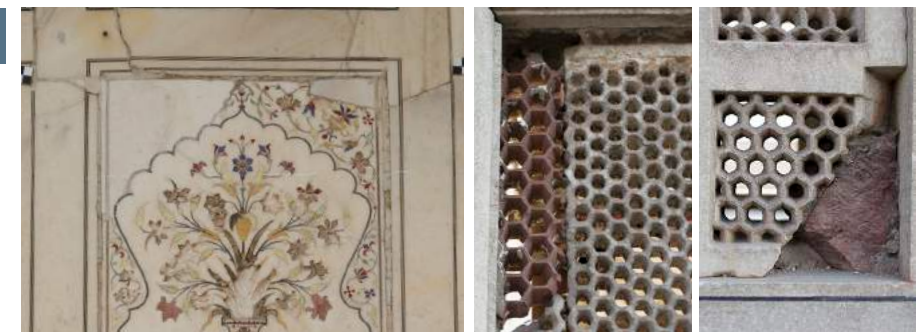
Previous repairs using an entirely new and different type of white marble and in some cases includes partial replacement of marble *jalis* with terra cotta.

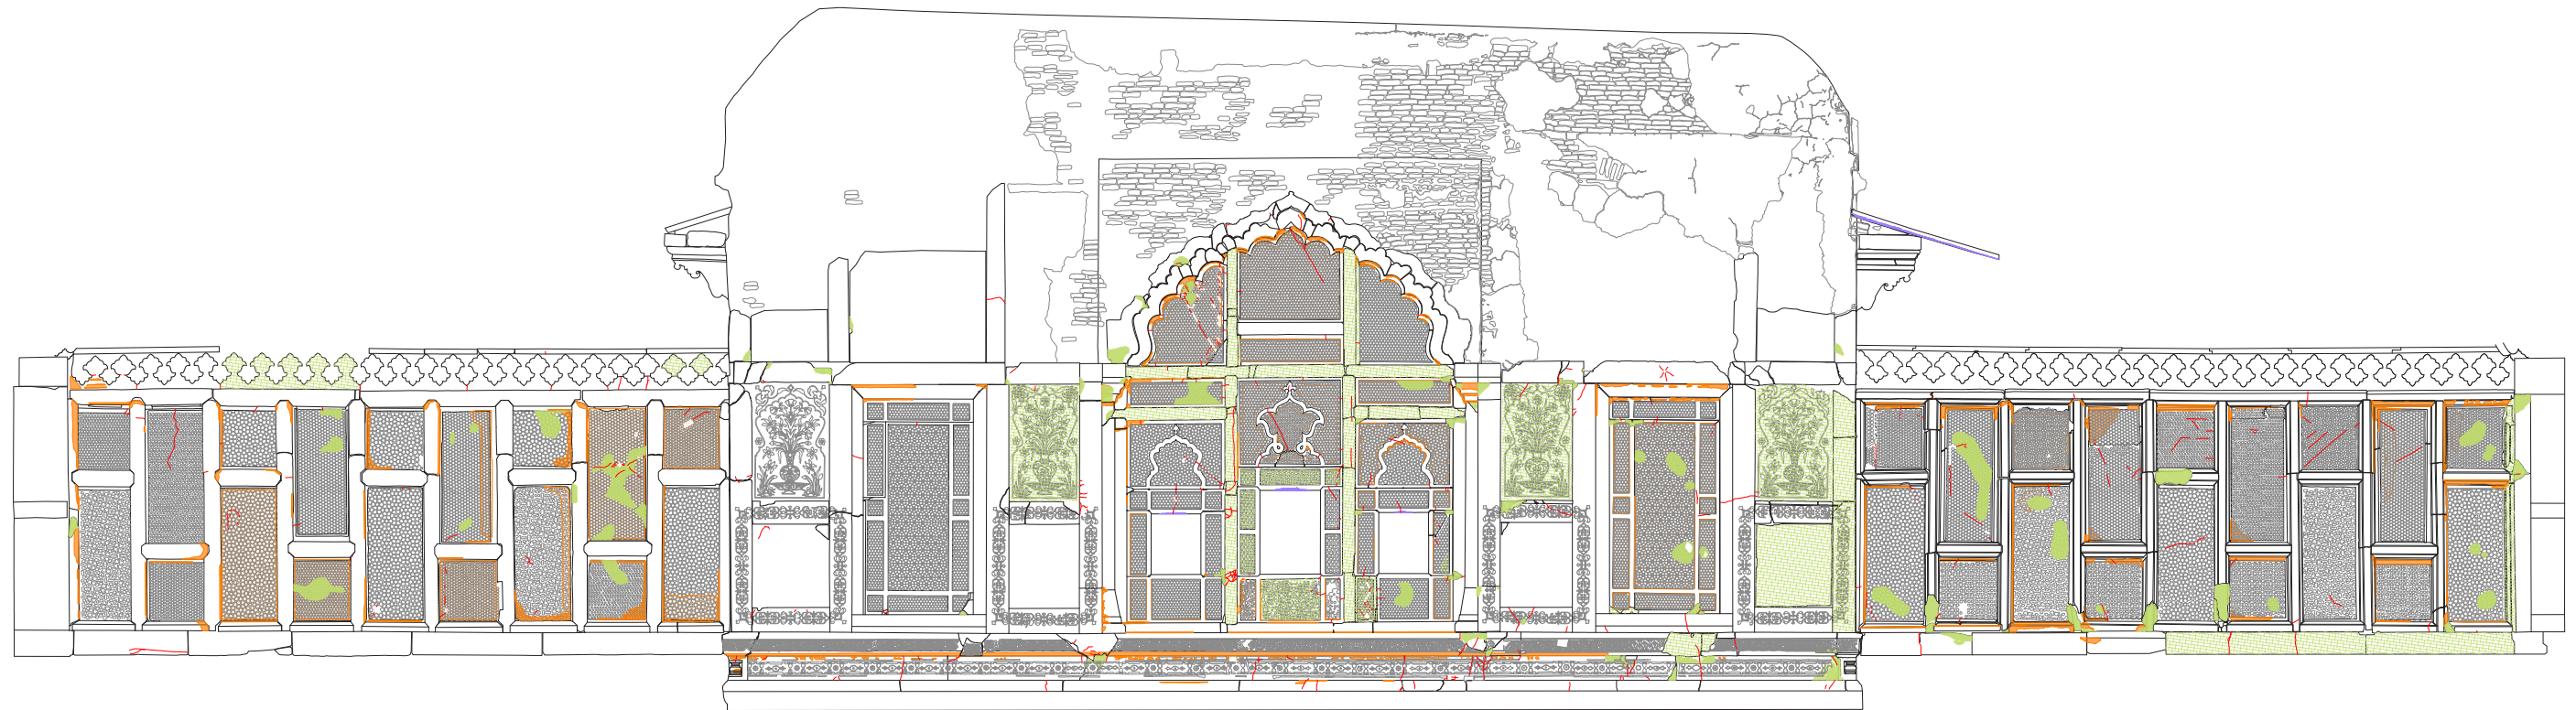
Appendix C: Conditions Drawings

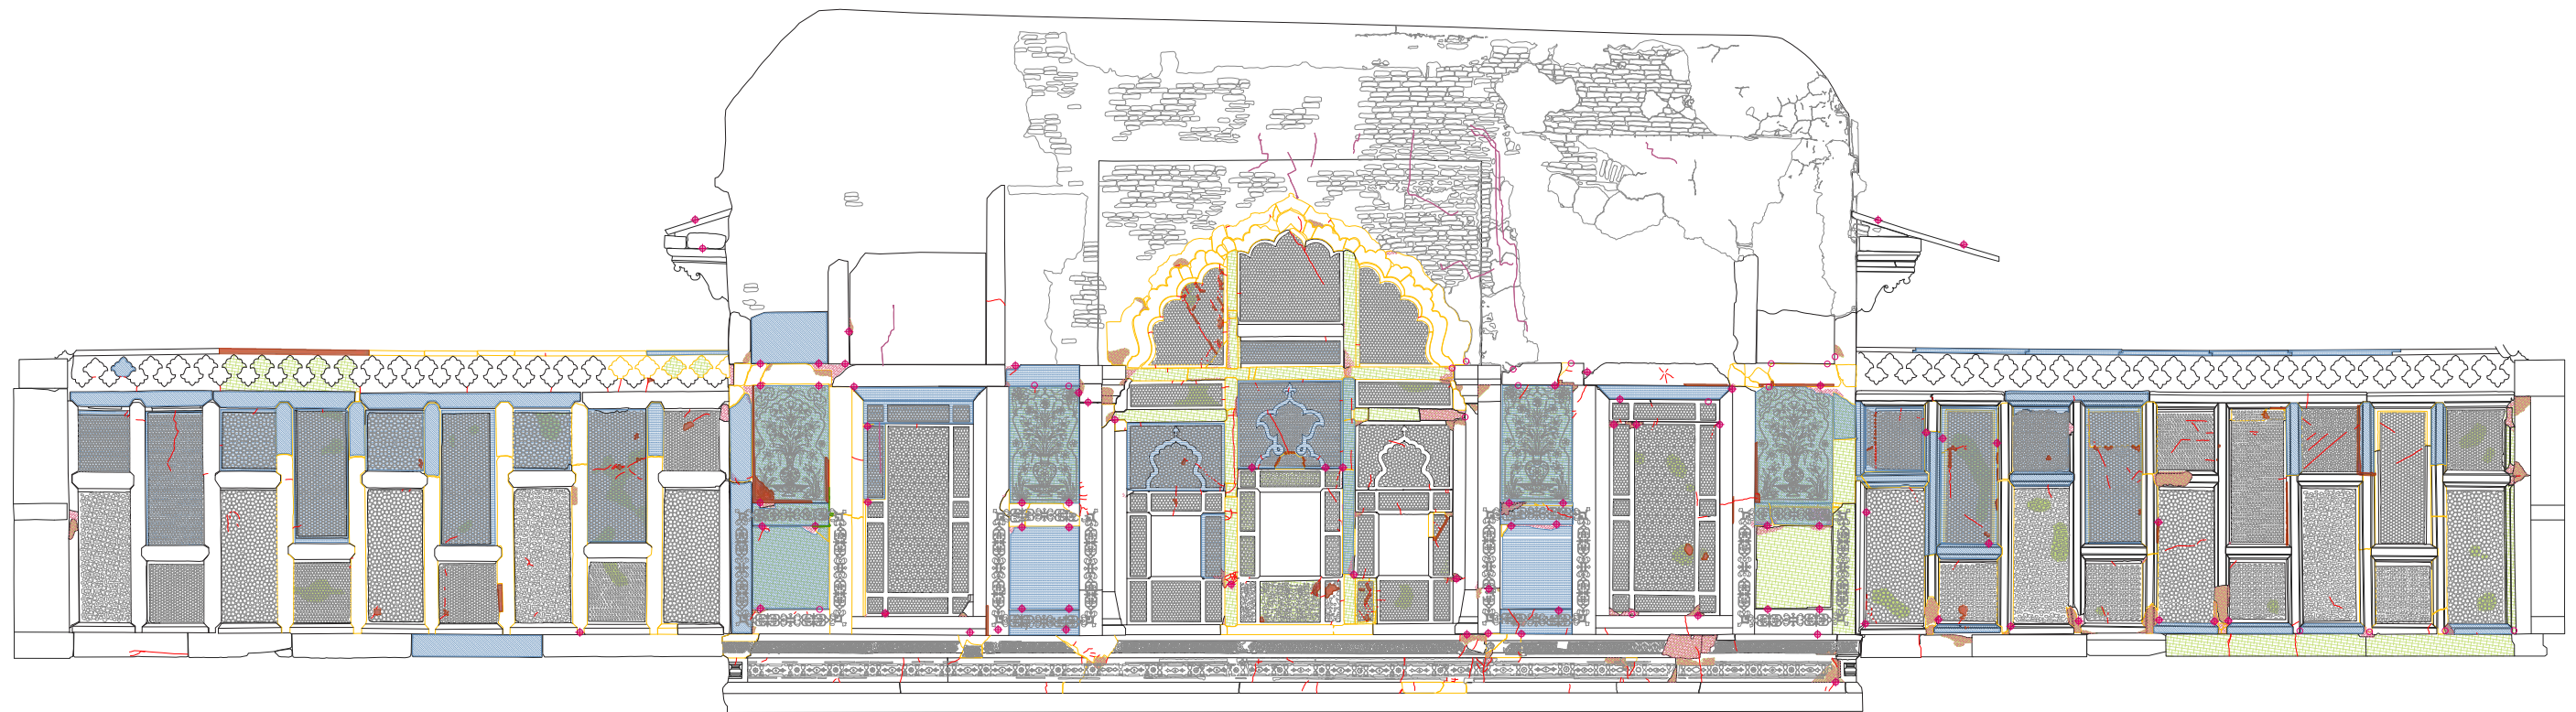
Appendix C: Conditions Drawings

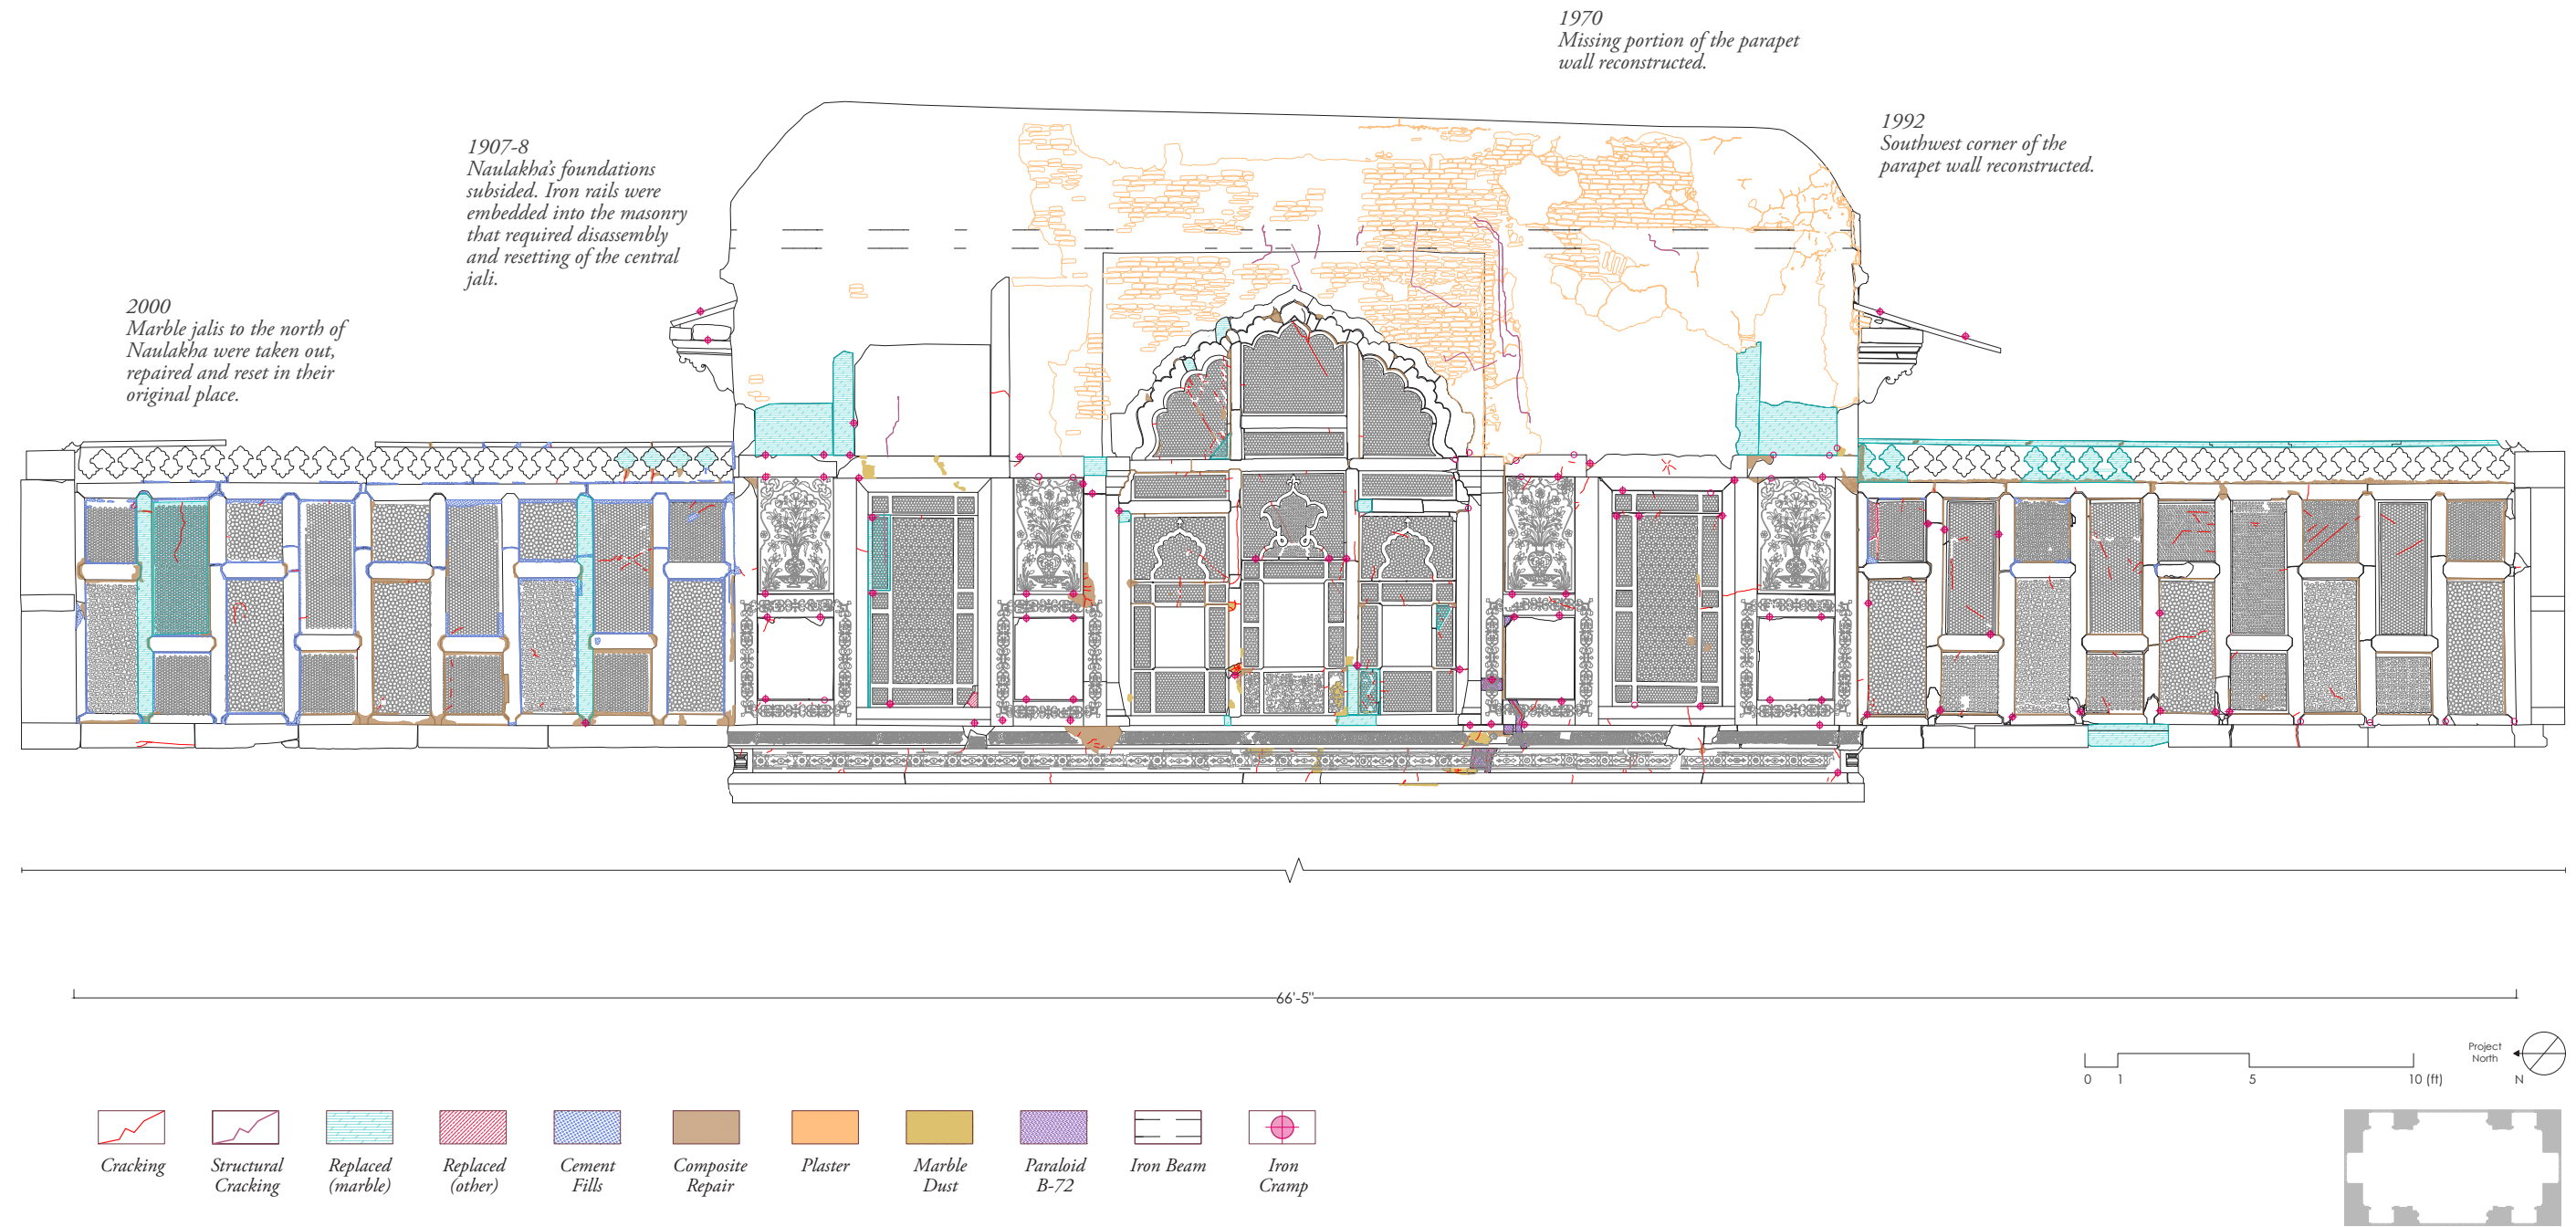
UNIVERSITY OF PENNSYLVANIA School of Design	NAULAKHA PAVILION & Adjacent Marble Screens	LAHORE FORT Lahore, Pakistan	REPAIRS & REPLACEMENTS Western Elevation	DATA SOURCE: Aga Khan Trust for Culture	DRAWN BY: Noor J. Sadiq	SCALE: 3/16" = 1'-0"	SHEET NO: C3	DATE: May 3, 2018
--	--	---------------------------------	---	--	----------------------------	-------------------------	-----------------	----------------------

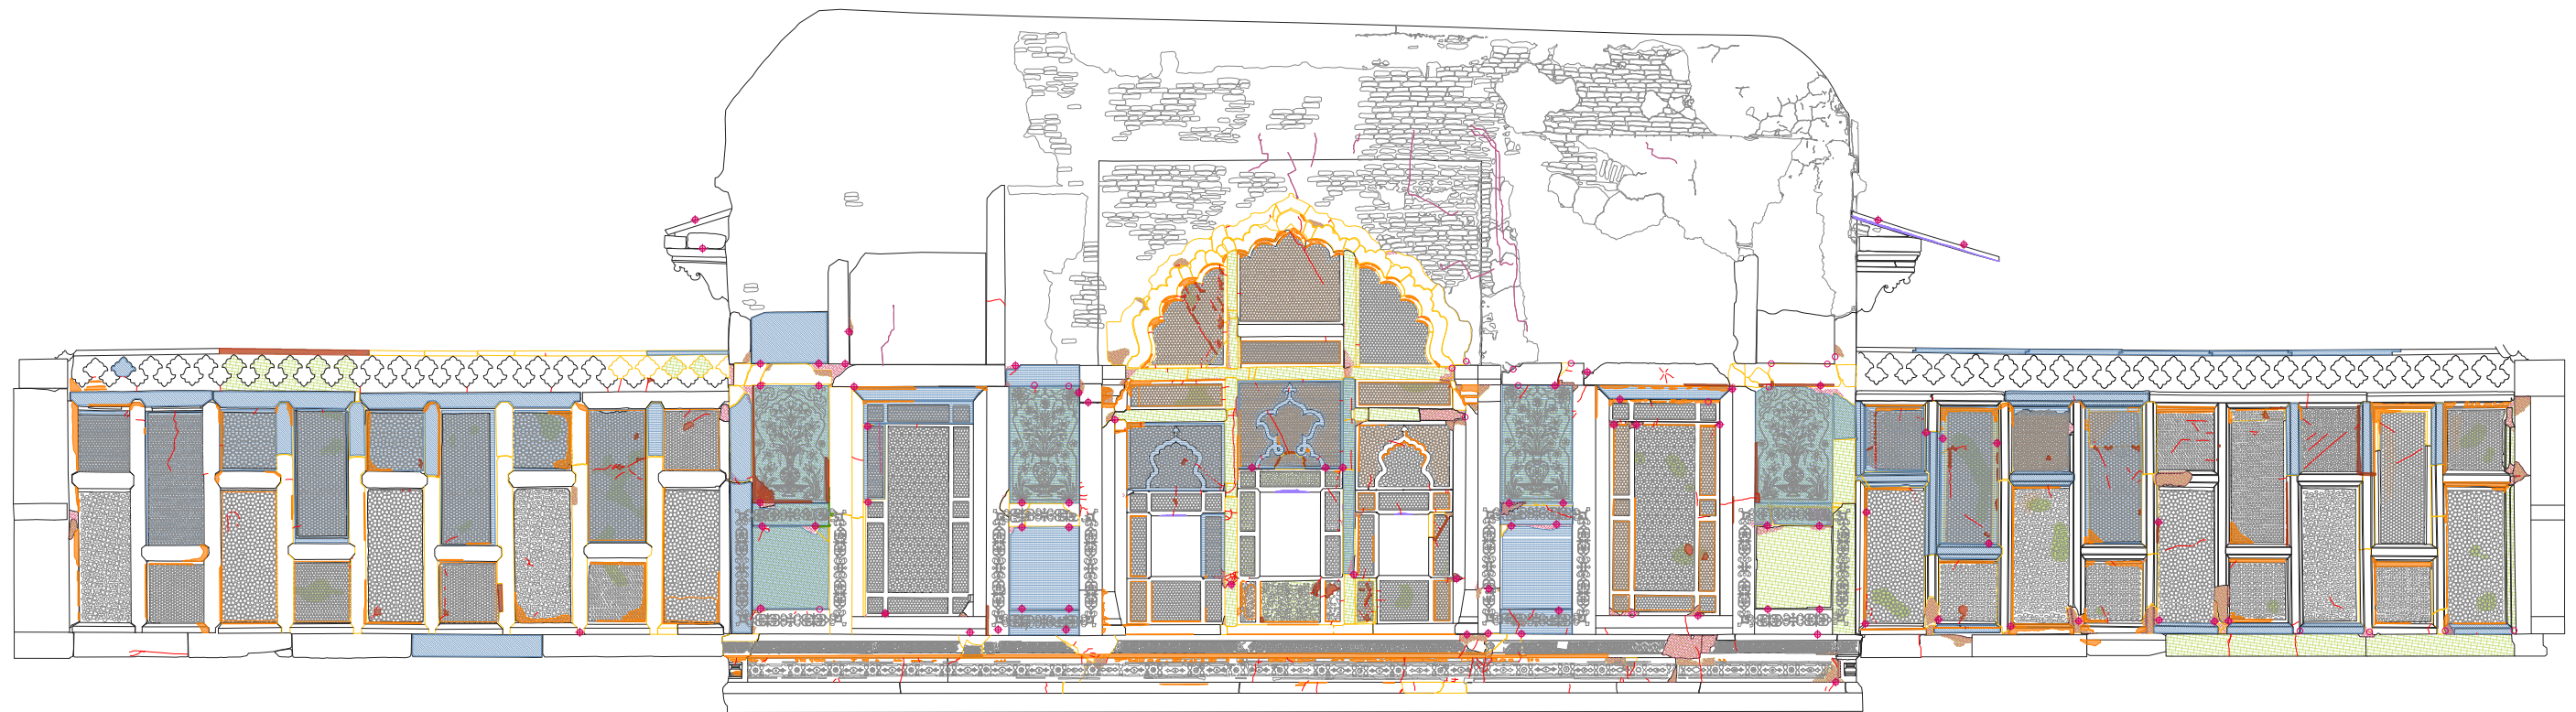
Appendix C: Conditions Drawings

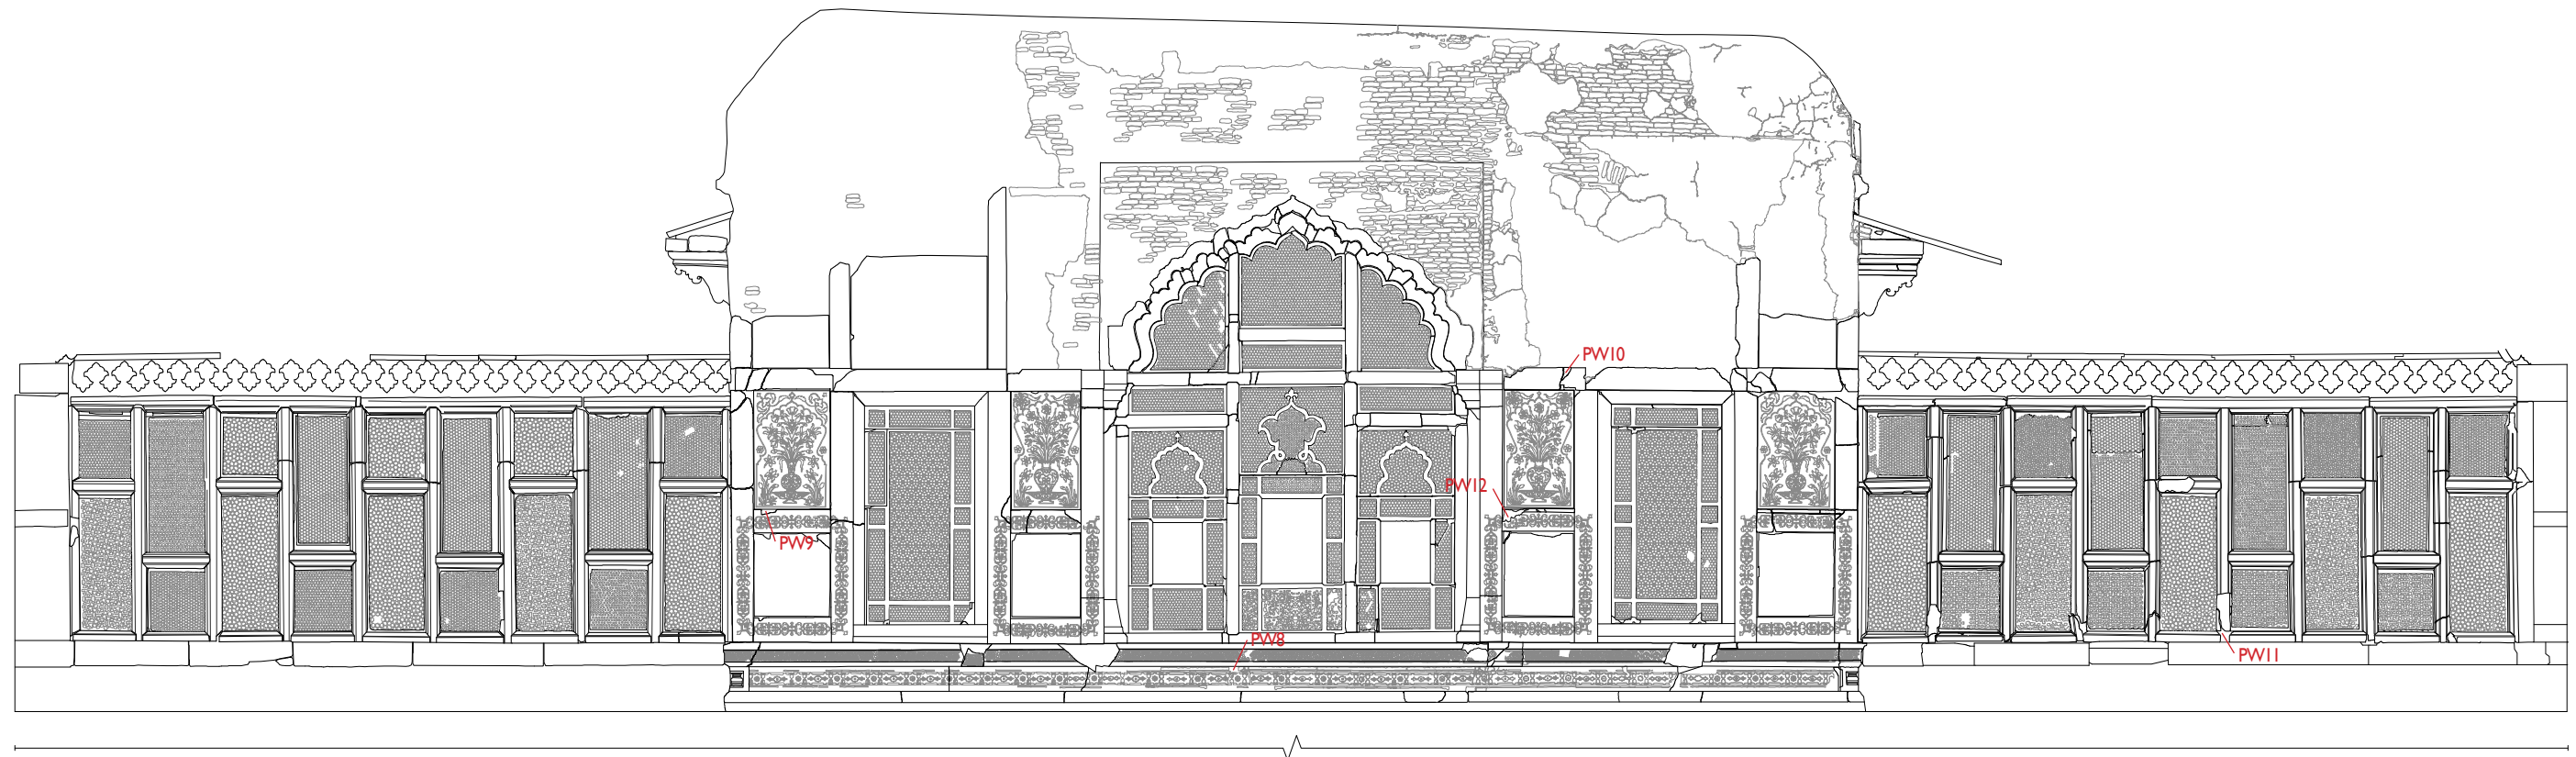
*\*Locations and identification numbers of samples taken from the western facade in 2017.*
