Battams, G., & Barton, J. (2016). Data-rich characterisation of damage propagation in composite materials. *Composites Part A: Applied Science and Manufacturing*, 91(Part 2), 420-435.

Peer reviewed version

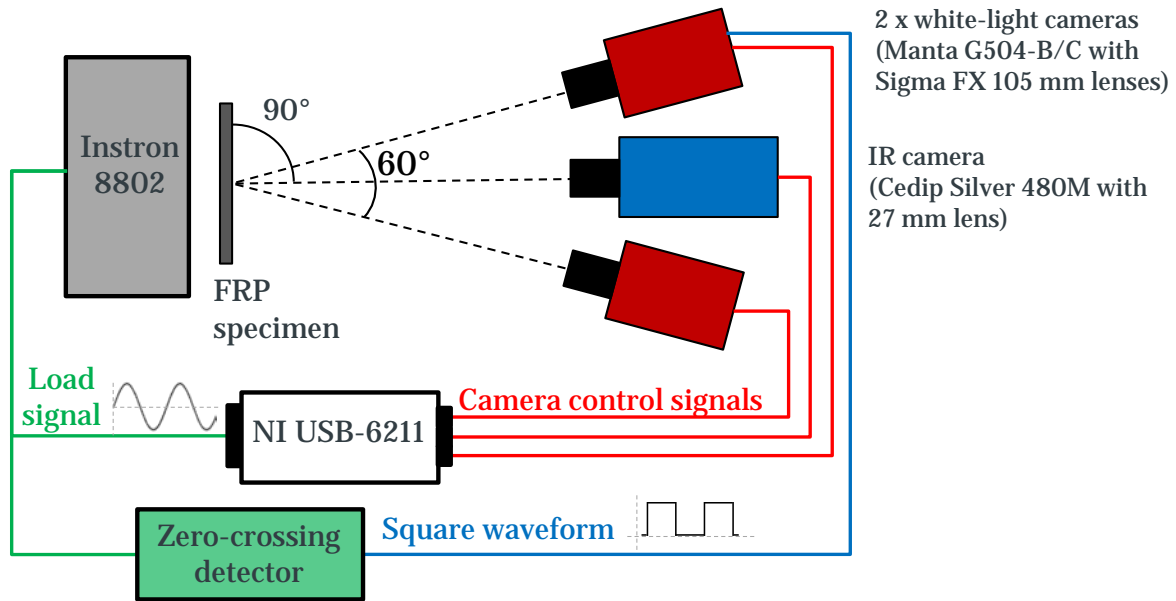
Figure 1: Equipment overview

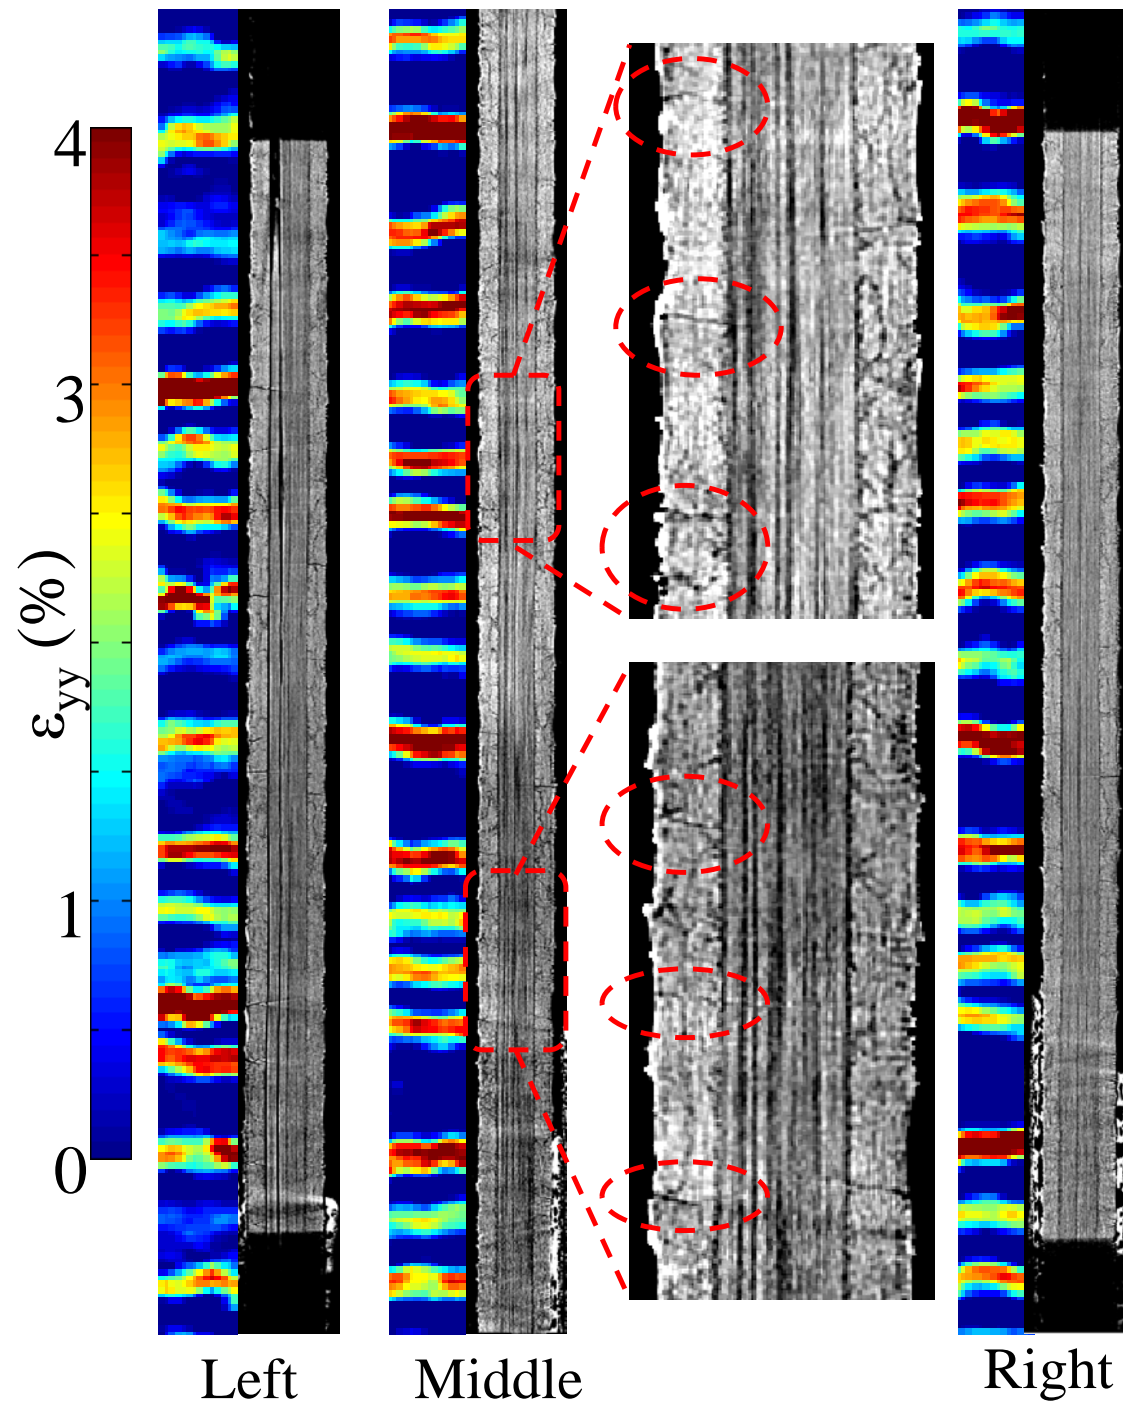
Figure 16: Comparison of DIC longitudinal strain data and vertical (longitudinal) X-ray CT cross sectional images of a fatigued CFRP specimen. A zoomed view of the middle section of the specimen shows the surface cracks in the 90° ply correspond with the regions of high longitudinal strain shown by the DIC.

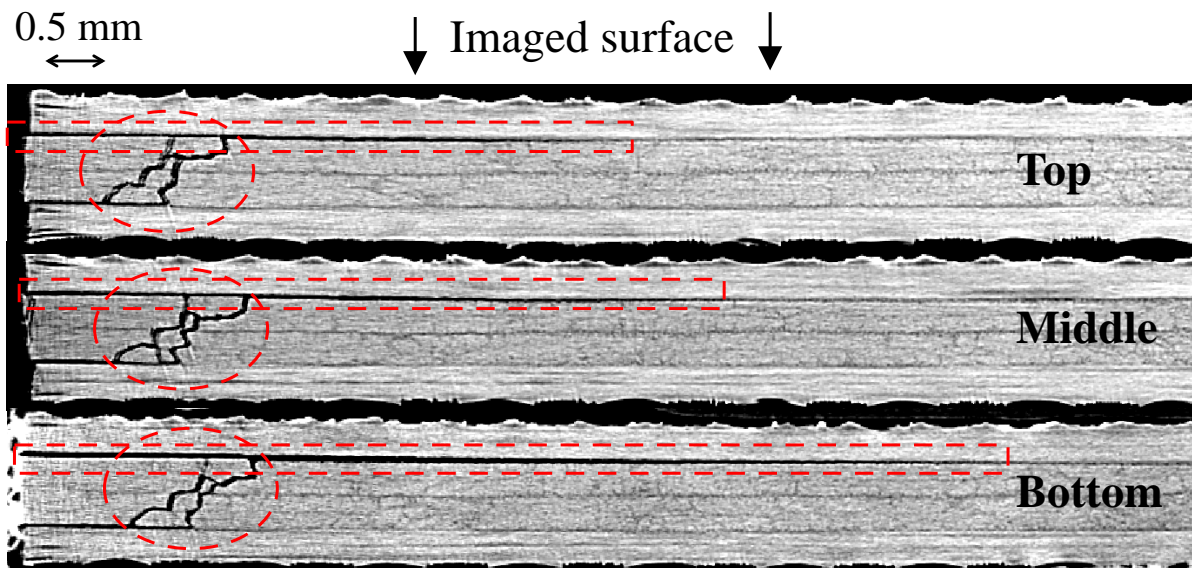
Figure 17: X-ray CT width-wise cross sectional images of the fatigued CFRP specimen. Delaminations and longitudinal splitting are highlighted in red.

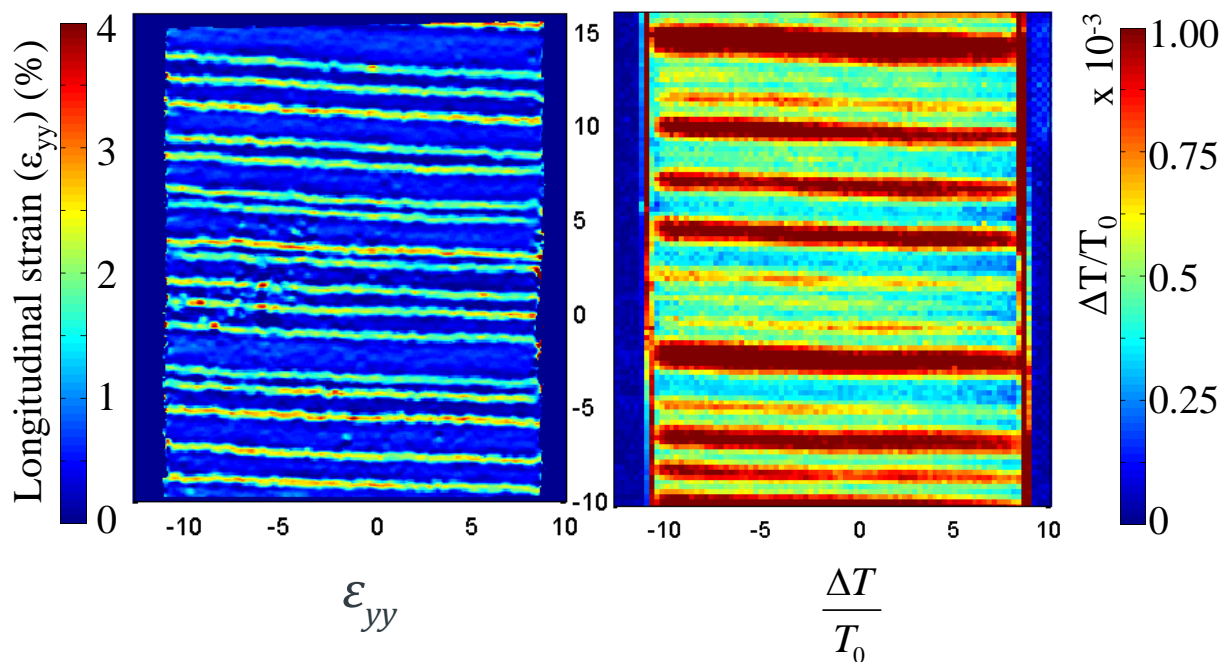
Figure 18: Longitudinal strain (ϵ_{yy}) and normalised thermoelastic response ($\Delta T/T_0$) at the start of fatigue life of the damaged crossply CFRP specimen.

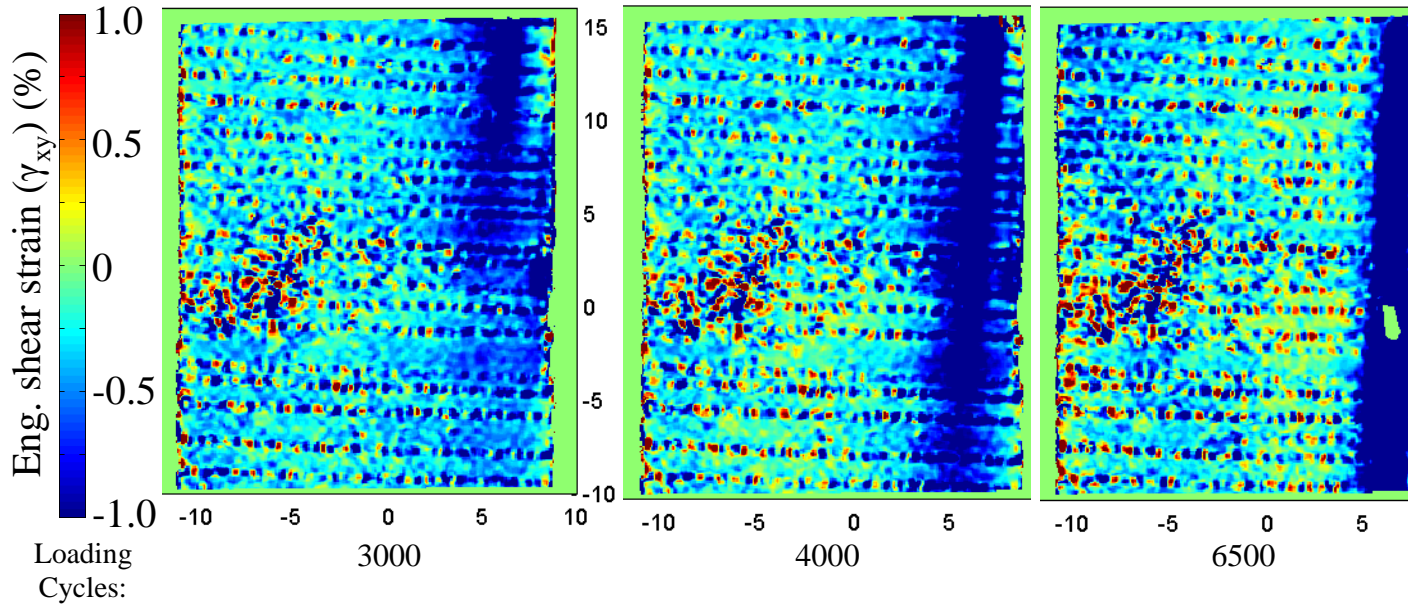
Figure 19: Development of **engineering** shear strain (γ_{xy}) in the damaged crossply CFRP specimen.

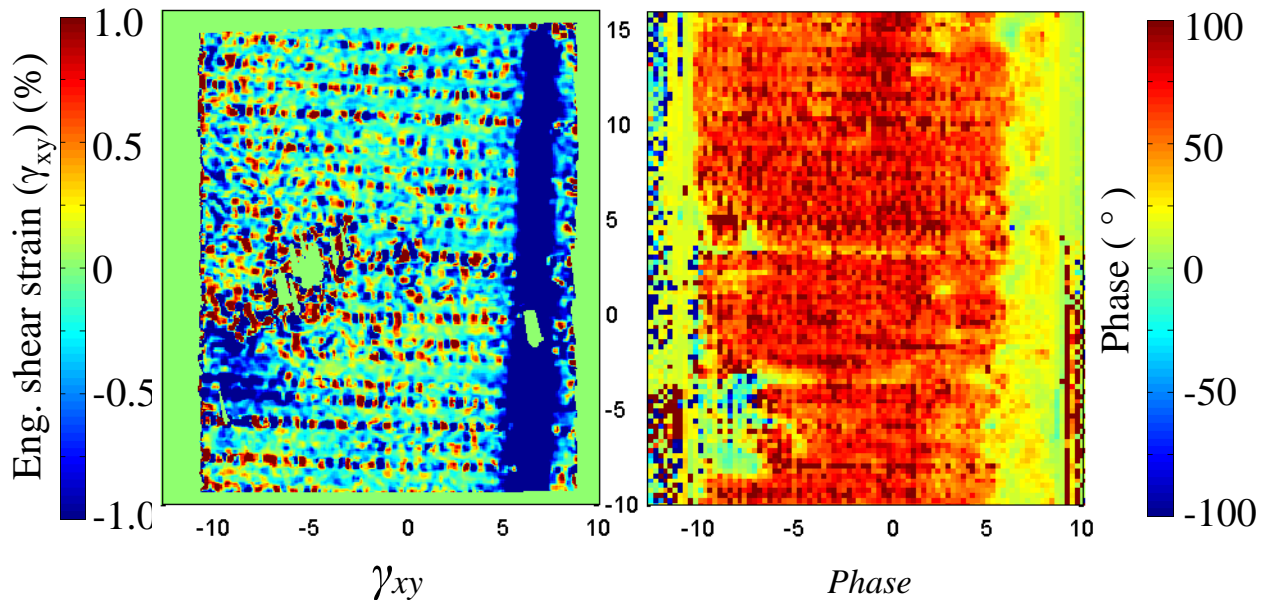
Figure 20: **Engineering** shear strain (γ_{xy}) and TSA phase data at 240000 loading cycles of the damaged crossply CFRP specimen.

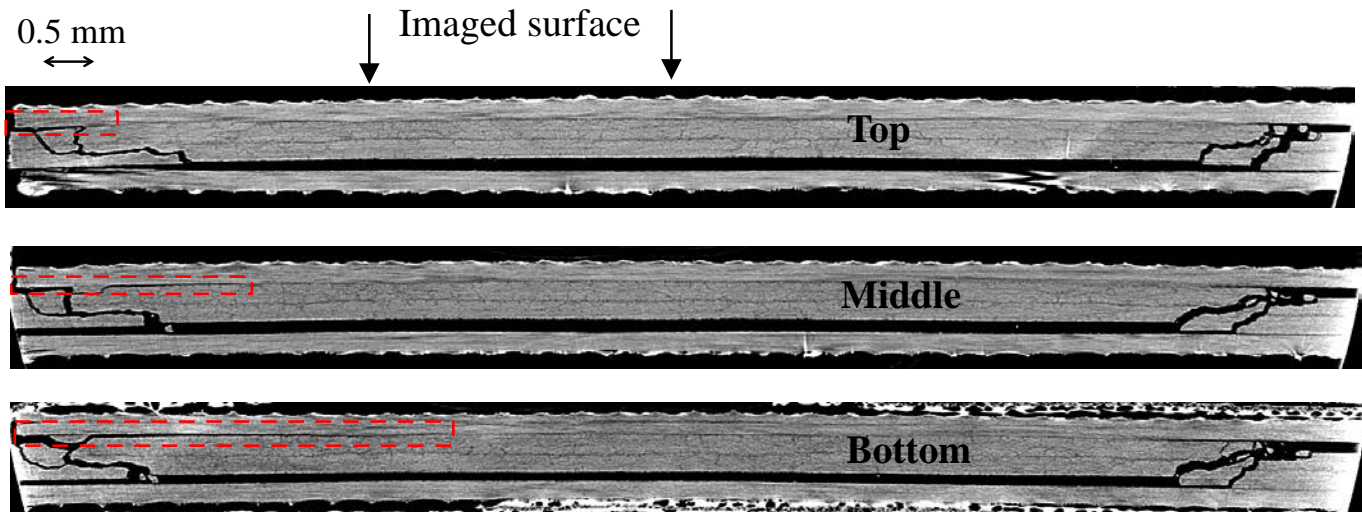
Figure 21: X-ray CT width-wise cross sectional images of **the** fatigued CFRP specimen previously loaded at intermediate strain rate. Delaminations highlighted in **red**.
