International Conference on Case Histories in Geotechnical Engineering

Technical Analyses and Lessons of The Embankment Failure at the Ajka Red Mud Reservoir

TECHNICAL ANALYSES AND LESSONS OF THE EMBANKMENT FAILURE AT THE AJKA RED MUD RESERVOIR

József Mecsi

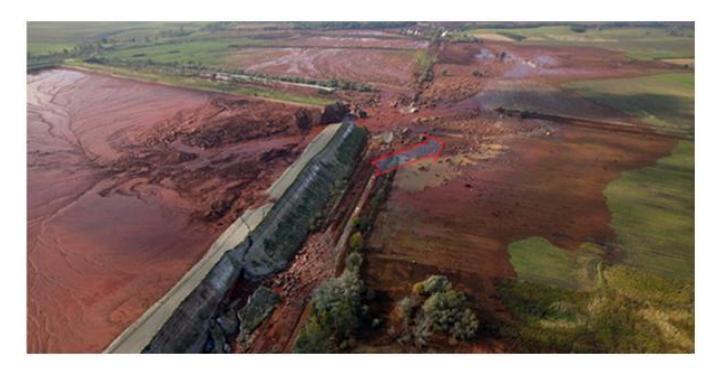
Fig. 2. The corner of the North and the West with water extension dam (photo: Sándor H. Szabó, MTI)

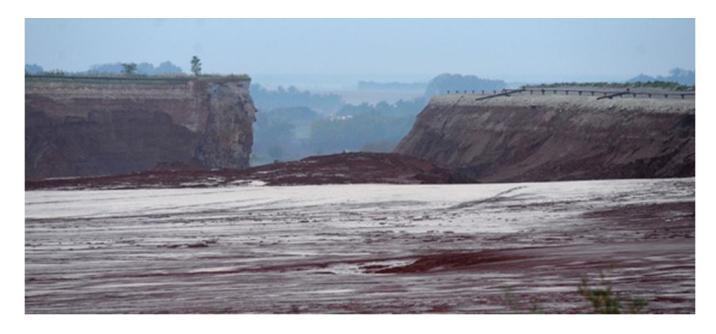
Fig. 3. The west and the north dam after the failure (index.hu, photo: AFP - Samuel Kubani)

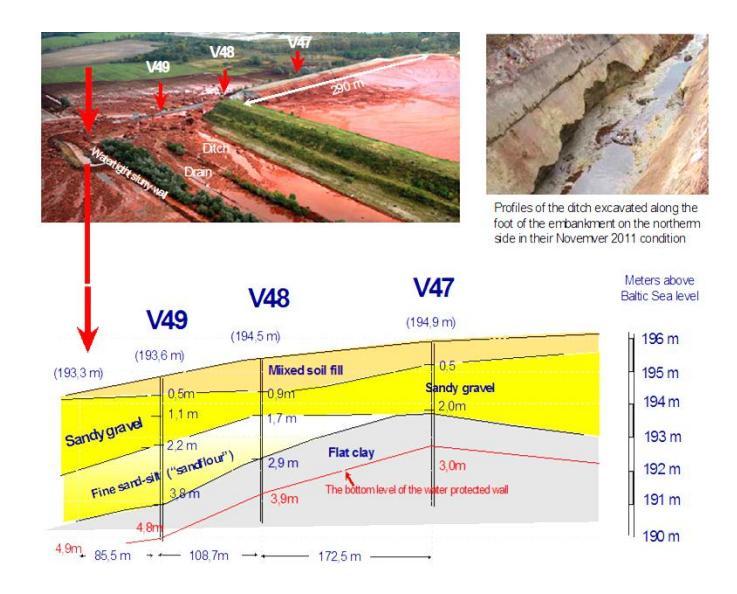
In the year 1989 soil excavations and geophysical measurements were conducted at the leg of reservoir No. 10.'s dam, and the soil profiles were recorded. Figure 13 shows the soil profiles near the north-west corner of the reservoir No. 10, and the photo illustrates the testing locations. It is important to remark that near the north-west corner of reservoir No. 10 sand-silt is to be found (the former Hungarian naming standards "flour sand" soil) and sandy-gravel layers above the fat clay. This "sand-floor" layer was 1.2 to 2.4 m thick.

On the right upper part of the Figure illustrates when 2011. in November created a drainage ditch, highlighting the liquefiable -unstable soil conditions. The trench sidewalls suddenly of excavation collapsed.

Fig. 13. Soil profile near the West –North corner of the reservoir No. 10. The top right side of the figure shows the position of the soil investigations

This soil layer unfavorable is that in fine sandy-silt fractions may move under higher water pressure conditions. As a result, grain size becomes coarser on the inner side, while a "clay plug" may develop towards the edge of areas in motion. Such a clay plug is characterized by a sudden movement under a significant change in pressure and consequently a mudflowlike grain movement may evolve. Such a process may be extremely fast and unexpected.

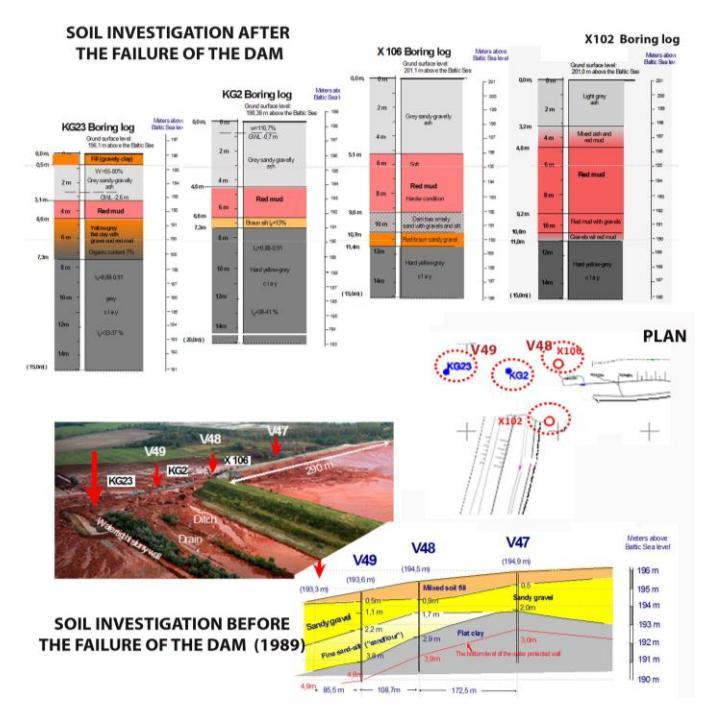
Figure 14 shows the typical results of the soil investigations by the boring logs after the failure. Compare with the earlier investigation results you can see that the instable fine sand-silt layer change to the red mud layer.

Fig. 14. Soil investigation results after the failure of the dam. Boring logs- photo and plan with the soil investigation places, and compare the soil profile before the failure

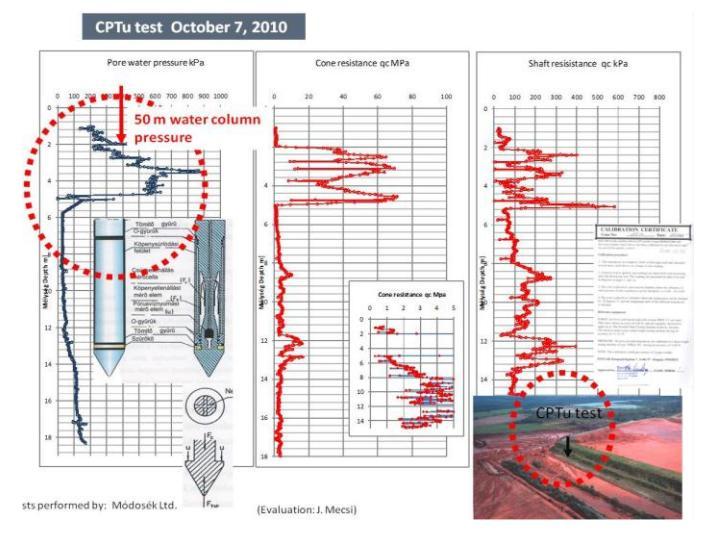
The CPTu static penetration tests performed on October 7, 2010 in the direct vicinity of the damage location did not show any resistance until a depth of 2 m, below which it indicated a sandy gravel layer of a thickness of 3 m. Fig.15. The value of peak resistance was 40-50 Mpa, which indicates a compacted condition. An extremely high water pressure value of su=500-750 kPa was measured in the water bearing layers of sandy gravel and gravel, which equals to the water pressure of a 50-70(!) m water column. Note: the order of magnitude of the measured value is significant even considering the fact that pore water pressure increases during CPTu penetration.

A clay-silt layer of very low resistance is located under the compacted gravel layer, which is extremely soft until a depth of 12 m, with a gradually increasing rigidness at larger depths. Pore water pressure in the clay layer is insignificant, which shows that it is the sandy gravel layer that was affected by an extremely high water pressure.

Fig. 15. CPT test results 3 days after the failure

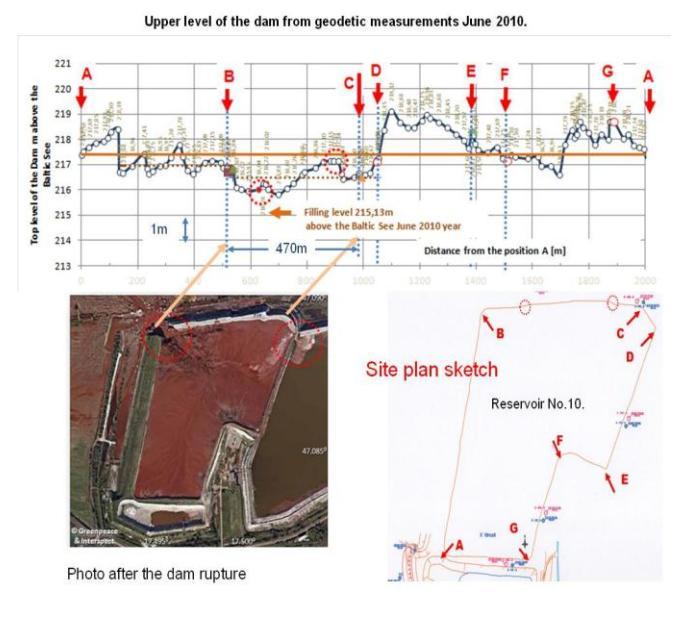
As it can be observed, the highest section of the dam crown is between points 'D' and 'E', i.e. at the embankment between Reservoirs No. 9 and 10, showing an altitude of 218,0-219 mBf (meters above Baltic Sea level).

The embankment at the northern side of Reservoir No. 10 is the lowest in altitude, sloping towards the west. The degree of slope is 1.3-1,5% (as the altitude difference of 1.2-1.4 m develops at a very long section).

Fig. 16. Altitude data of the crown level of Reservoir No. 10

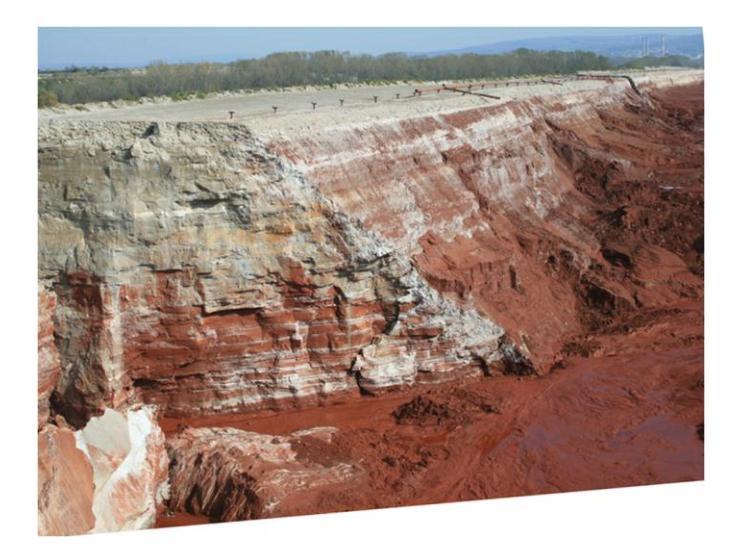
Fig. 19. Material of the northern embankment of Reservoir No. 10 after the embankment failure (photo: Dr. Tibor Horváth, November 2010)

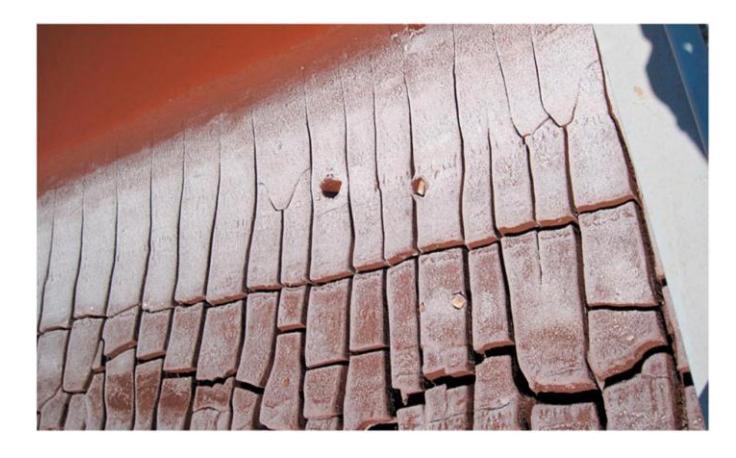
The extraordinary volume changing character is shown by the fact that after the desiccation of its surface, cracks of 3-8 cm appear on it (Figure 20). In spite of the fact that the cracks penetrate into a depth of as much as a meter, the substance is characterized by a creamy consistency only a few millimeters under the surface.

Fig. 20. The extraordinary volume changing character after the desiccation of red-mud surface, cracks of 3-8 cm appear on it (Surface of the "red mud" in dry condition (photo: J. Mecsi)

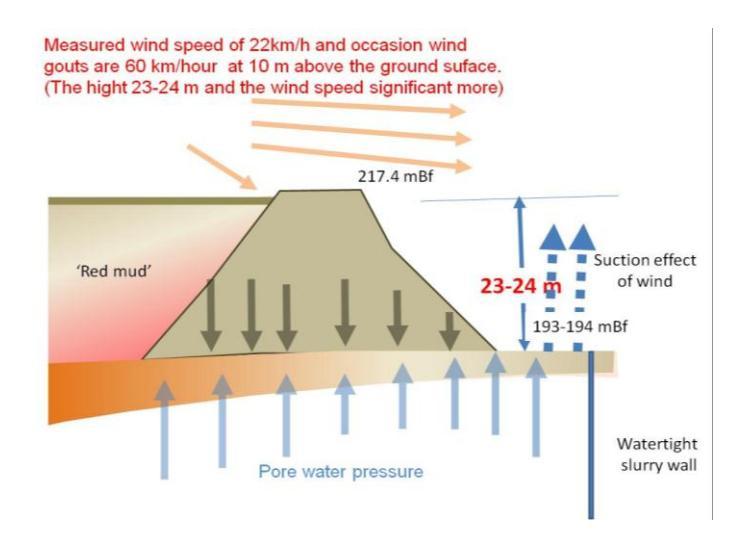
Fig. 23. Effects of the wind speeds between September 25 and October 4, 2010

There is reason to assume that these unusual wind direction and wind speed conditions contributed to the development of the embankment failure. In addition, the possible sucking effect of the wind on the northern side of the embankment must also be taken into consideration. Fig. 23.

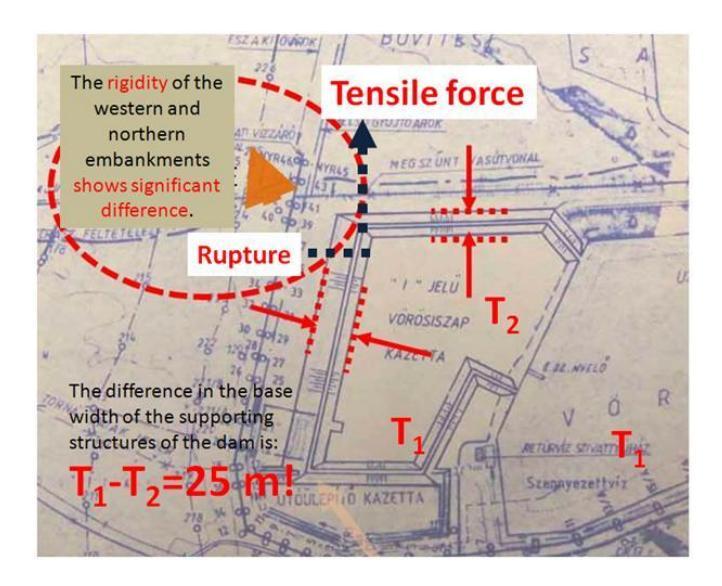
The base width of the northern embankment is significantly different from the size of the other embankments, as it was considered a temporary structure, bearing in mind the possibility of a future extension. The slightly more than 20 m height of the solid part of the embankment is lower than the 26–27 m heights of the other embankments.

Fig. 25. Dimensions of the western and southern dams

Its effect manifested at the northern embankment – being by 25 m less in base width than the western embankment – as the resistance against displacement here was significantly lower, and also because the rigidity of the western and northern embankments showed significant difference at an unfavourable connection at the corner of the reservoir.

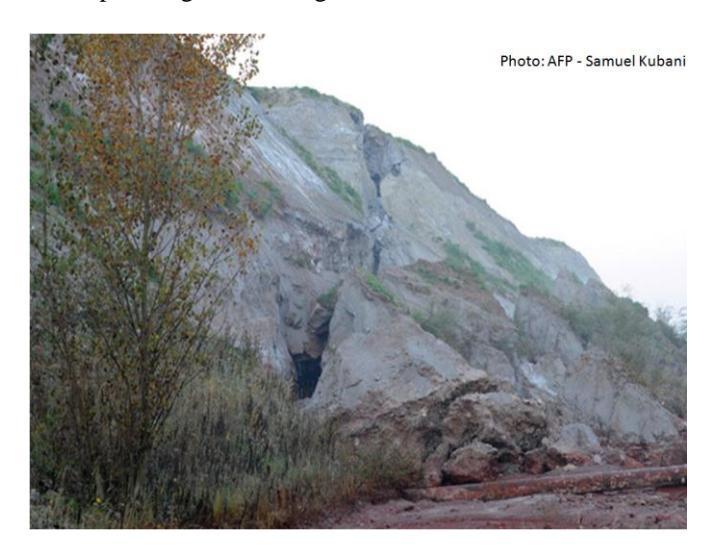
We concluded, that at the connection of the stronger west dam and softer north dam a very big tensile force could occur, while at the middle of the north dam big torsion force developed. Fig. 25. and Fig 26.

Fig. 26. The cracking at the middle of the north dam

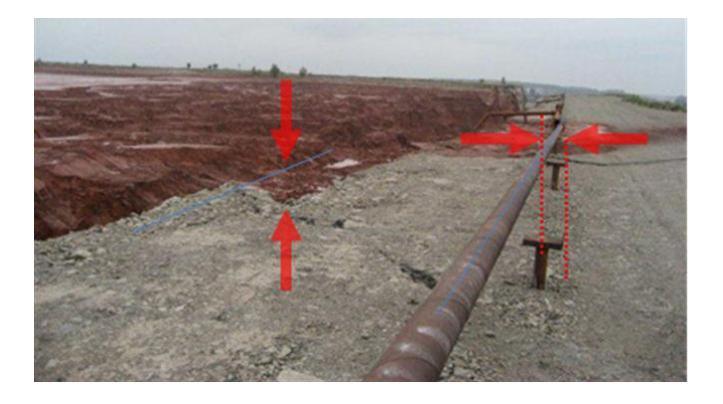
Fissures started developing on the crown level of the northern dam section at a gradually increasing pace 3 days after the dam failure, following which the embankment subsided in 30-40 m pieces, with 20-30 cm settlements. Fig 27.

The leaking red mud stored in the reservoir left a crater by the inner side of the embankment, as a result of which the foot of the dam became exposed. (On in situ observations by J. Mecsi)

Fig. 27. Picture of the North dam of the reservoir No. 10 on October 7, 2011 based on in situ observations (photo: J. Mecsi)

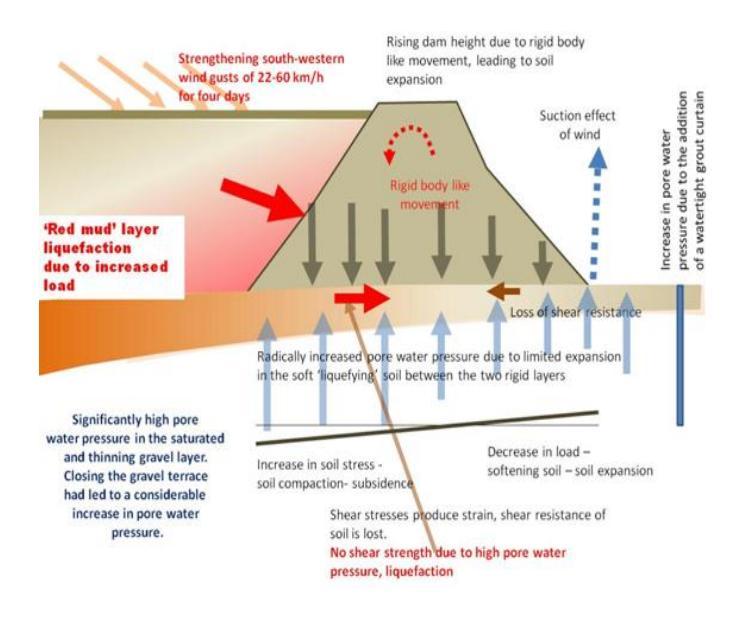
Significant pore water pressure may have developed in the soil layer underlying the embankment as a result of the geological properties of the enclosed gravel terrace functioning as a drainage basin and due to extremely high precipitation levels causing high water pressure conditions. Fig. 29.

Fig. 29. Summarizing some effects for the dam failure
