(2008) - Sixth International Conference on Case Histories in Geotechnical Engineering

IMPLICATIONS OF SWELLING CLAYS ON ASPHALT PAVEMENT PERFORMANCE IN COLORADO

Scott Shuler, Ph. D., P. E.

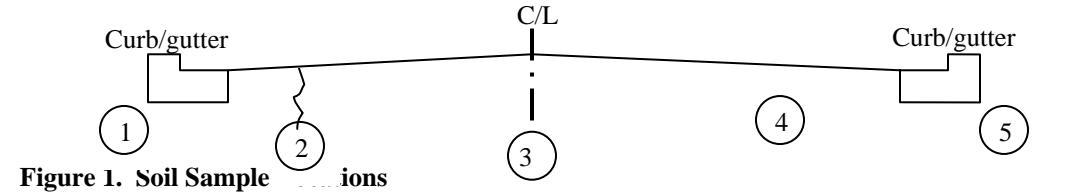
Subgrade soil samples were taken from four locations at each site. These were at the centerline of the pavements, under the

cracks, on the opposite side of the pavement if no crack was present and behind the curb on the side of the pavement with the crack. Figure 5 is a schematic showing these locations.

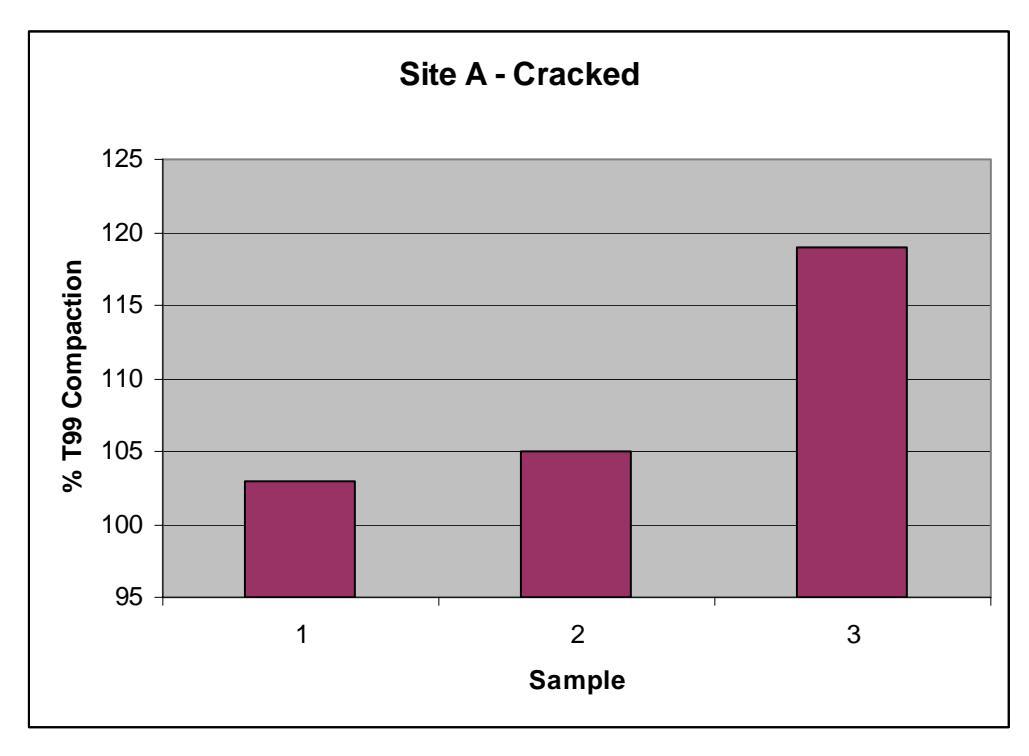
Figure 2 – Percent of AASHTO T99 for Site A

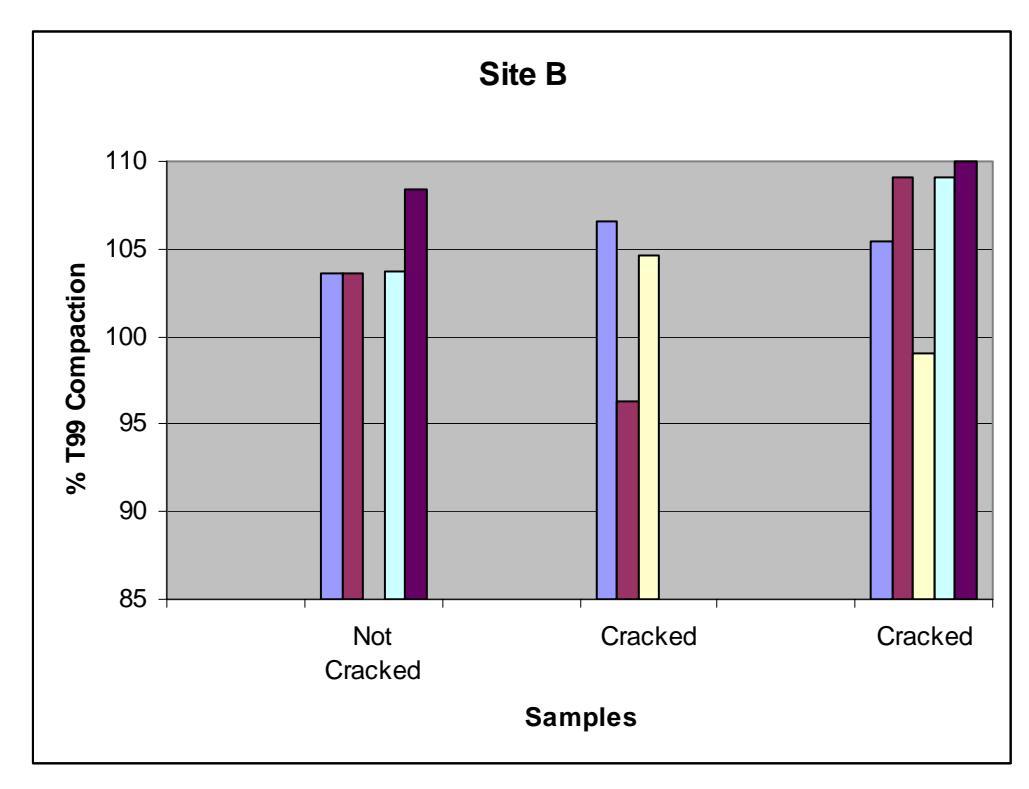
Figure 3 – Percent of AASHTO T99 for Site B

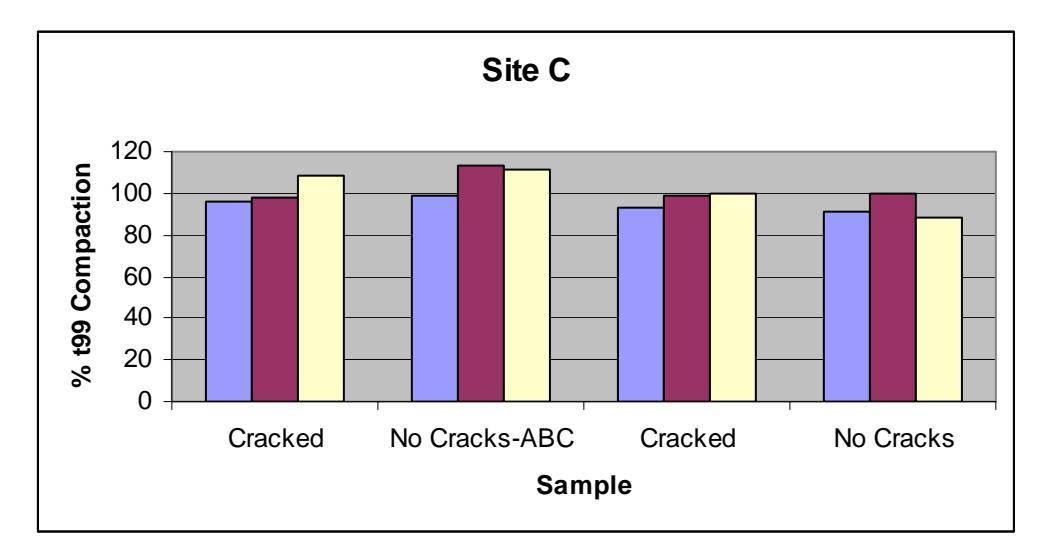
Figure 4 – Percent of AASHTO T99 for Site C

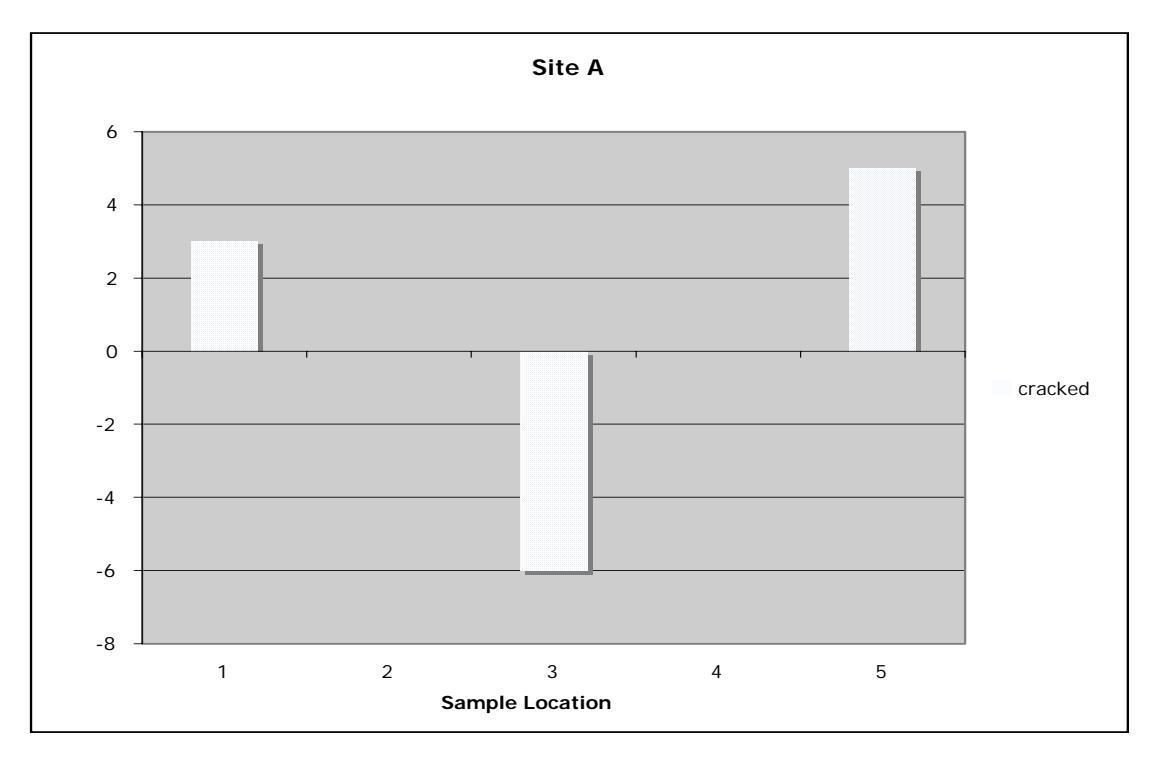
Figure 5 – Difference in Subgrade Moisture Between Insitu and T99 for Site A

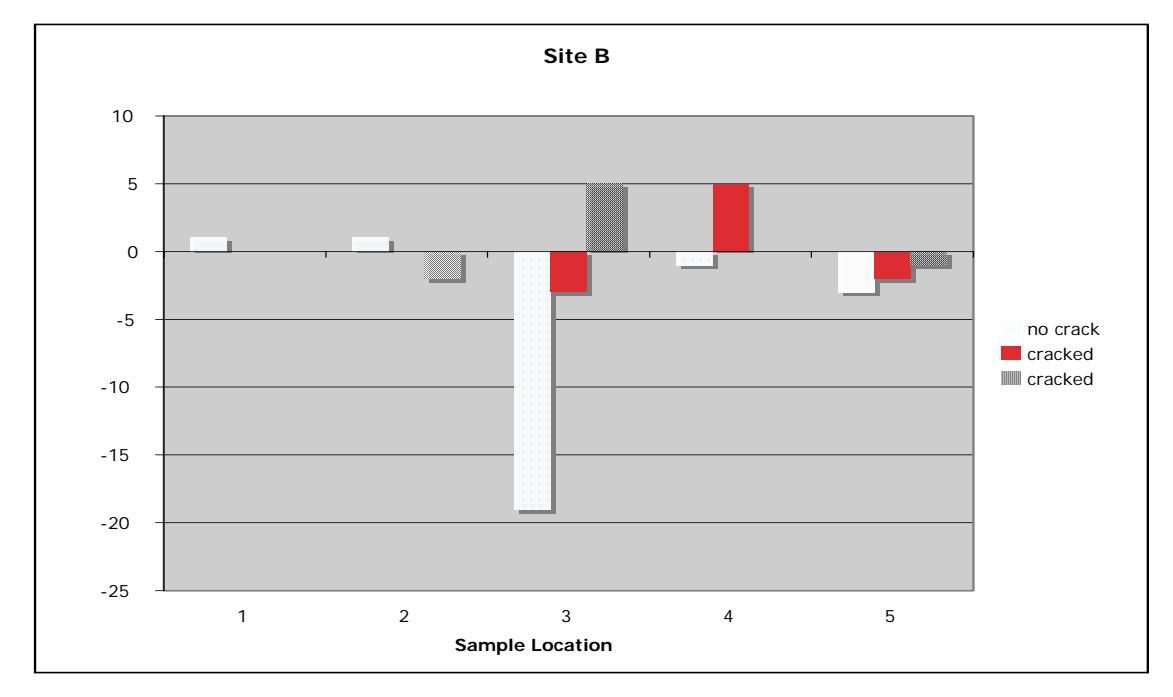
Figure 6 – Difference in Subgrade Moisture Between Insitu and T99 for Site B

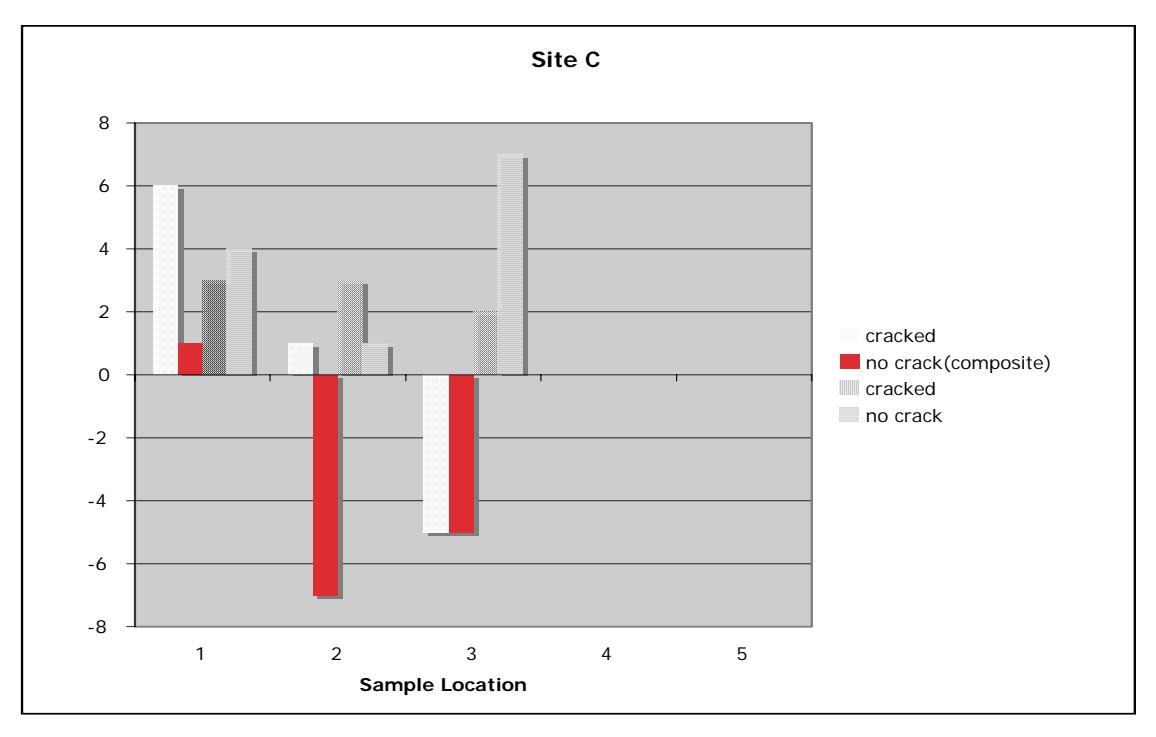
Figure 7 – Difference in Subgrade Moisture between Insitu and T99 for Site C

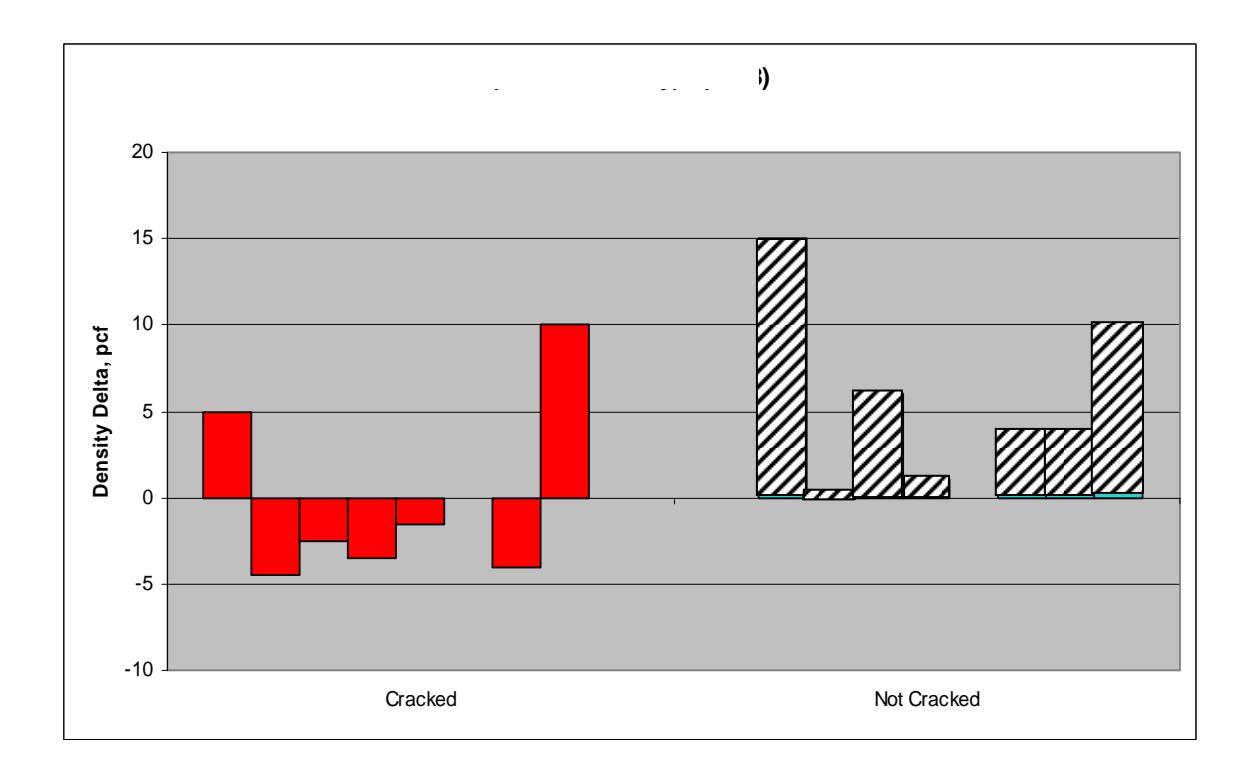
Figure 8 compares the difference between subgrade insitu density and the maximum density determined by AASHTO

T99 for the cracked and uncracked pavements. There appears to be a trend to densities lower than optimum under the crack. Compaction of the subgrade under the pavement is directly related to the load carrying capacity of the pavement. This factor could have much to do with edge cracking.

Figure 8 – Difference between Density Insitu and Maximum Density (AASHTO T99)

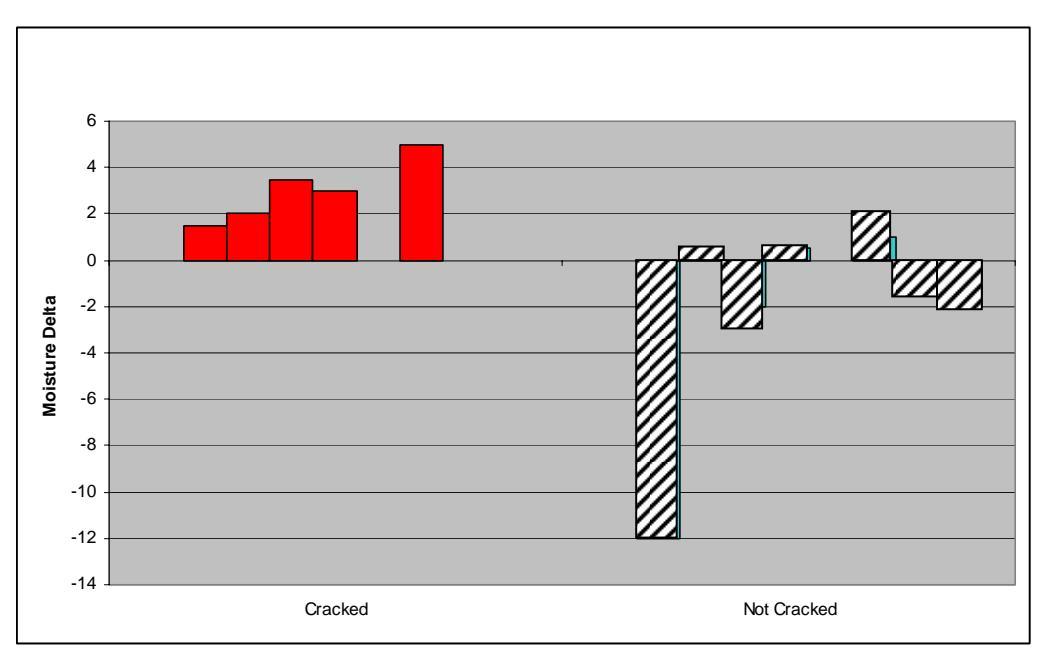
Figure 9 compares the difference between subgrade insitu moisture content and the optimum moisture content determined by AASHTO T99 for the cracked and uncracked pavements. Moisture content appears to be at least 1% lower than optimum under the uncracked pavements and

approximately 2% or greater above optimum under the cracked pavements. The moisture content of the subgrade under the pavement is directly related to the load carrying capacity of the pavement. This factor could have much to do with edge cracking and could be the reason compaction was lower than desired.

Figure 9 – Difference between Moisture Insitu and Optimum Moisture (AASHTO T99)

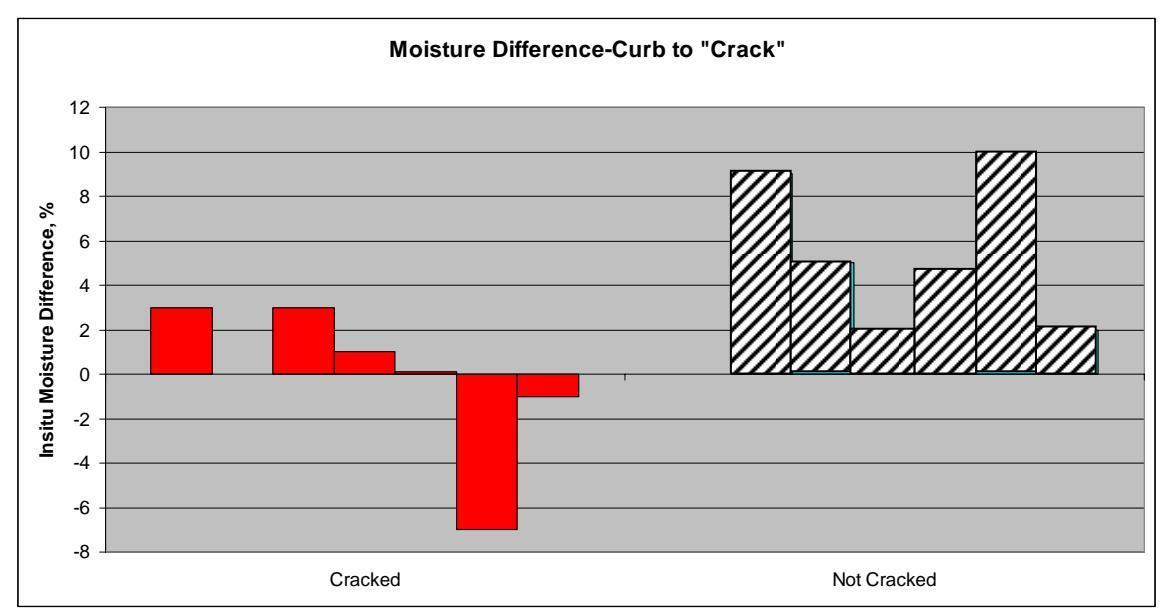
Figure 10 – Moisture Difference From Behind Curb to Crack Location

These data indicate that edge cracking occurs more frequently when the moisture content of the subgrade behind the curb is equal to or lower than moisture under the crack location.

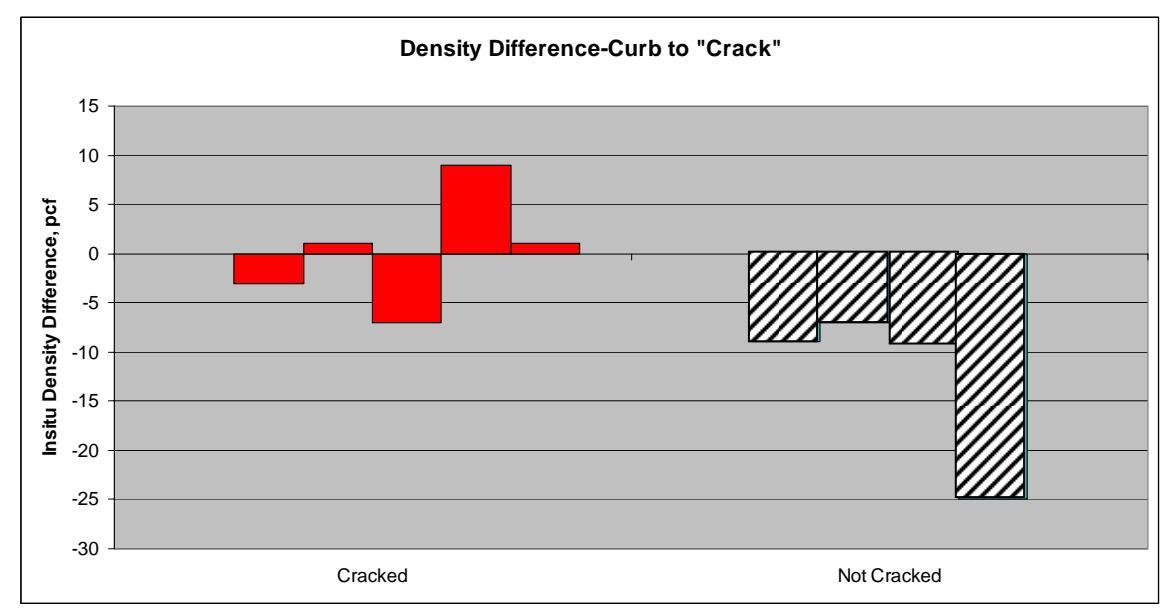
In addition, it appears that edge cracking occurs more frequently when the density of the subgrade behind the curb is

higher than density under the crack or potential crack location. Therefore, it appears a lack of support under the curb and gutter due to high moisture or low density is not the cause of edge cracking for the sites studied.

Figure 11 – Density Difference From Behind Curb to Crack Location
