## Large Horizontal Displacements of Houses in Rotterdam

G. Hannink Delft Geotechnics, The Netherlands

A. F. van Tol Rotterdam Public Works, The Netherlands

Proceedings: Second International Conference on Case Histories in Geotechnical Engineering, June 1-5, 1988, St. Louis, Mo., Paper No. 6.68

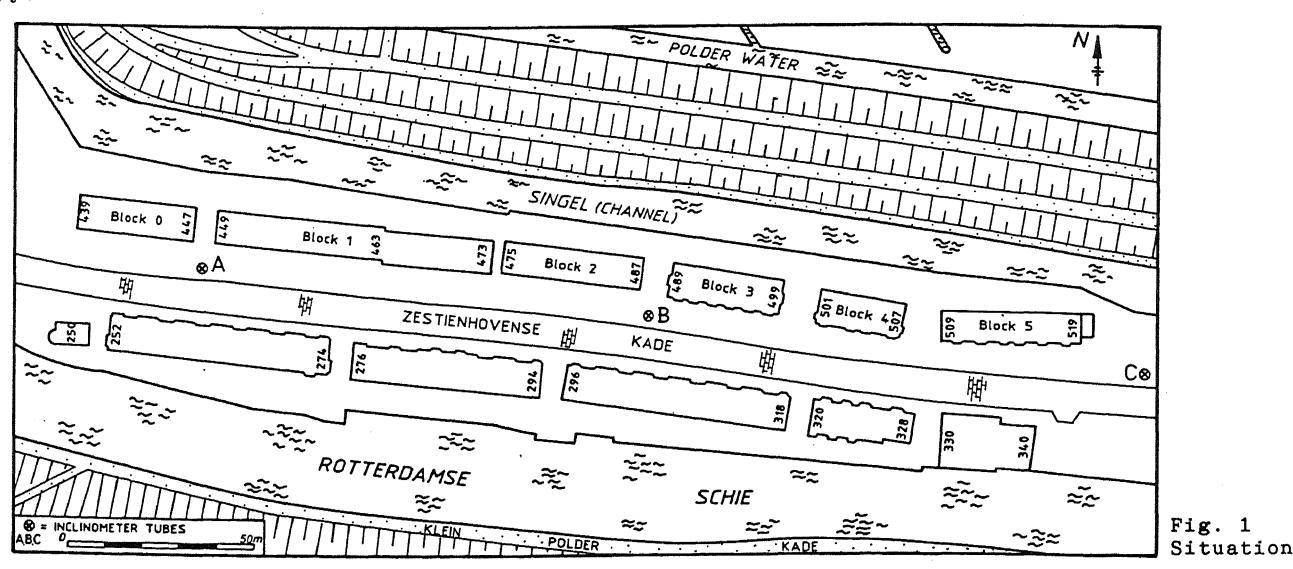
In 1983 the Road Management and Surveying Department of Rotterdam Public Works discovered that six blocks of, in total, 41 terrace houses at the north side of a quay, the Zestienhovensekade, had undergone large horizontal displacements, Figure 1. Research by the Department on previous measurements indicated that the horizontal displacements, given in Table I, must have occurred since the houses were constructed. The degree of accuracy of the absolute displacements up to  $1975\ was$ estimated at within 0.1 m. The degree of accuracy of the displacements in the periods 1975 - 1983 and 1983 - 1984 was estimated at within 0.02 m. To be more certain about what appears, at first sight, to be incredible figures, the magnitude of the displacements was also established from aerial photos taken for mapping purposes. Based on these measurements, it was concluded, beyond doubt, that large displacements had occurred, and that the maximum rate of displacement was about 0.10 m/year.

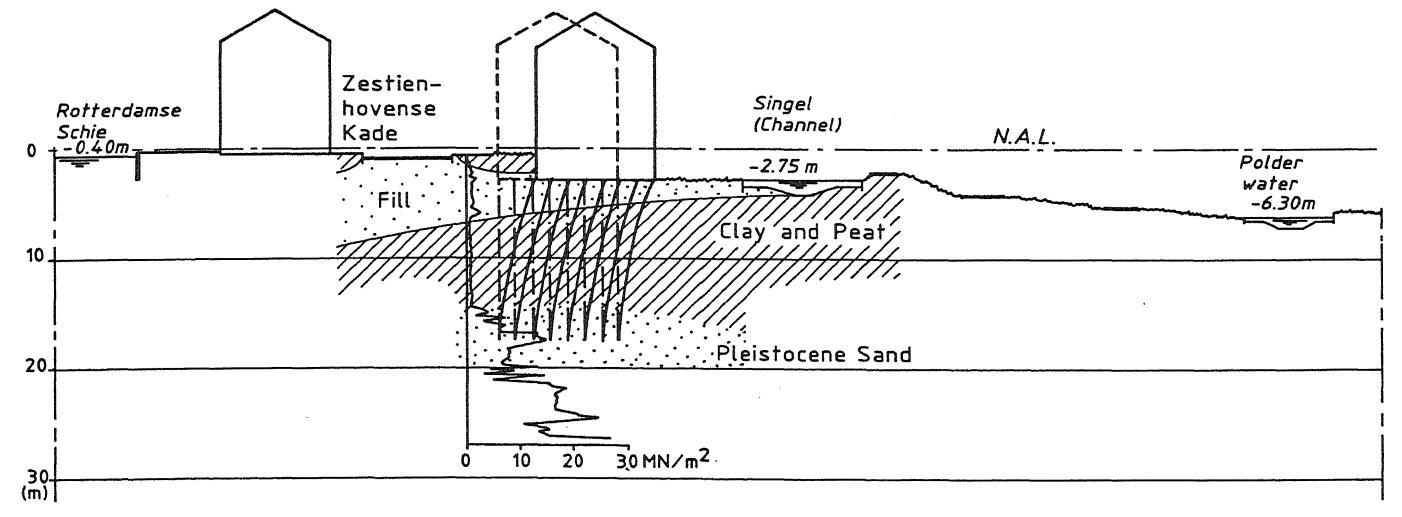
Fig. 2 Cross-section of the quay

The cause of the displacements must be sought in a combination of the following cincumstances. Figure 2:

- circumstances, Figure 2: - the level of the ground surface in front of the houses and behind the houses differs by 2.5 m to 3.0 m
- fill with a unit weight of 18 to 20  $kN/m^3$  occurs at the front of the houses down to a level of between 5 m and 6 m below the ground surface and peat with a unit weight of about 10  $kN/m^3$  occurs at the back
- the clay and peat layers under the houses are very soft and have unfavourable friction properties

Figure 2 shows the composition of the subsoil in a cross-section of the quay. The subsoil consists of soft holocene clay and peat layers to a depth of 16 m below New Amsterdam Level. Below this level fine to rather coarse pleistocene sand is found. The in-situ porewater pressure was measured in front of Block 2 and an excess pore-water pressure of about 25  $kN/m^2$  was found between 10 to 13 m below New Amsterdam Level. The soil investigations confirmed that the holocene layers have very low shear strength. The lowest values occur behind the blocks where the overburden pressure is small. A preliminary stability analysis showed that a slip circle through the soft clay layers around 11 m below New Amsterdam Level, which takes into account the excess pore-water pressure, gives the lowest factor of safety.

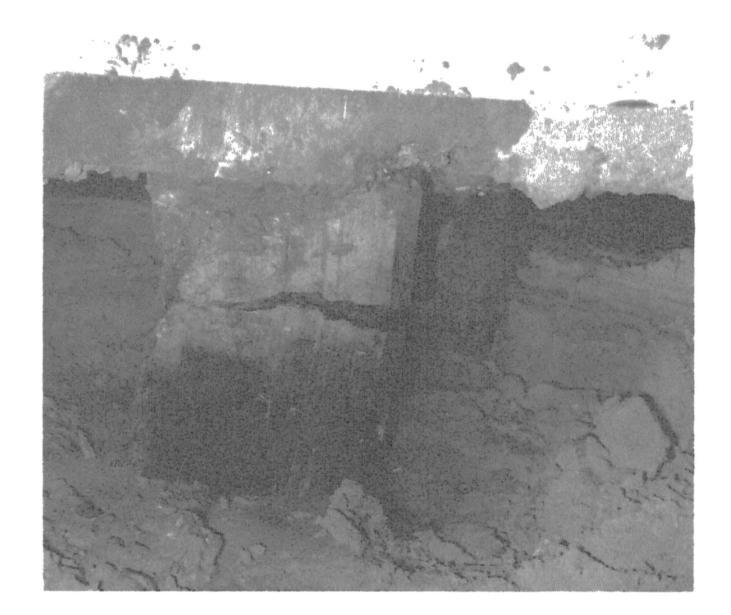
Fig. 8 A cracked concrete pile

- Block 1, consisting of 13 houses, is founded on 55 precast concrete piles, 0.35 m square, and with a length of 19 m. Six pile heads have been inspected. The upper part of these piles have inclinations varying from 6 : 1 till 30 : 1. Several pile heads show serious cracks, Figure 8. Sonic integrity tests on two piles demonstrated that these piles had no cracks on deeper levels.

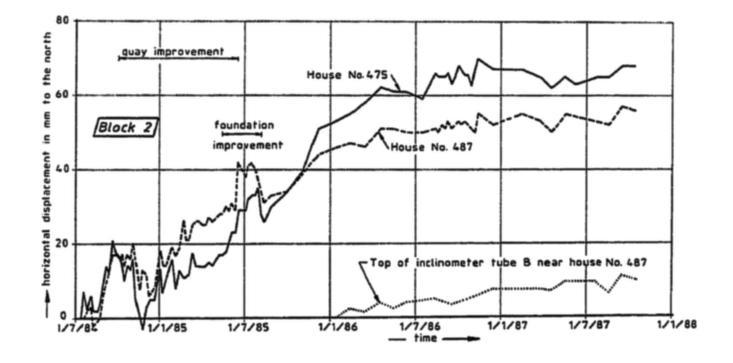
Fig. 13 Horizontal displacements of Block 2

The period 1975 - 1983 is taken as the reference period for the horizontal displacements before improvement of the quay for the analysis of the reduction of the rates of horizontal displacement. Table III shows, for Block 2, a reduction of this rate by a factor of 3 to 10, one year after the improvement of the quay and the foundation. One year later the reduction has increased to a factor of 25 to 40, the rate of horizontal displacement amounting to 1 to 3 mm/year. The reduction factor for Block 5 amounts to 3 to 5, one year after the improvement of the quay. One year later, that is also one year after the improvement of the foundation, the reduction has increased to a factor of at least 9, the rate of horizontal displacement amounting to O to 3 mm/year.

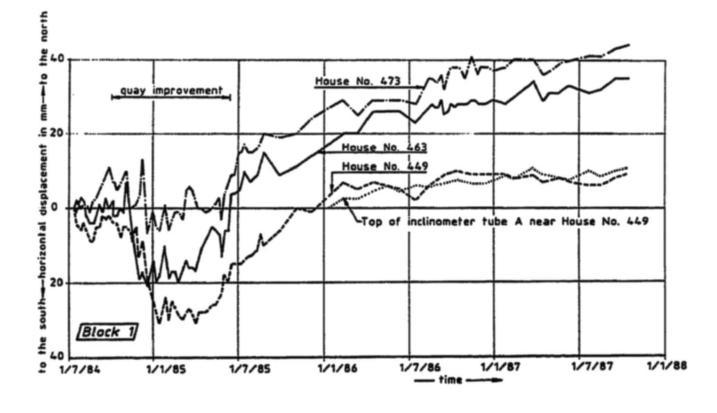
Fig. 16 Horizontal Displacements of Block 1

The reduction factor for Block 3 amounts to about 2, one year and about 3, two years after the improvement of the quay. Improvement of the foundations has only been implemented recently, and future measurements will indicate the effect on the magnitude of the horizontal displacements. House No. 473 of Block 1 shows a reduction factor of about 2 one year and of about 3 two years after the improvement of the quay. Improvement of the foundations is still in the design stage. The inclinometer tubes also show decreasing rates of horizontal displacement. Data before the improvement of the quay are not available. Comparing 1987 with 1986, however, shows a reduction factor of 2 to 3 for the tops of Tubes A and B. Data of 1987 show a rate of horizontal displacement of about 3 mm/year. Tube C shows a variation of measuring results between the two periods, and is therefore not considered here.

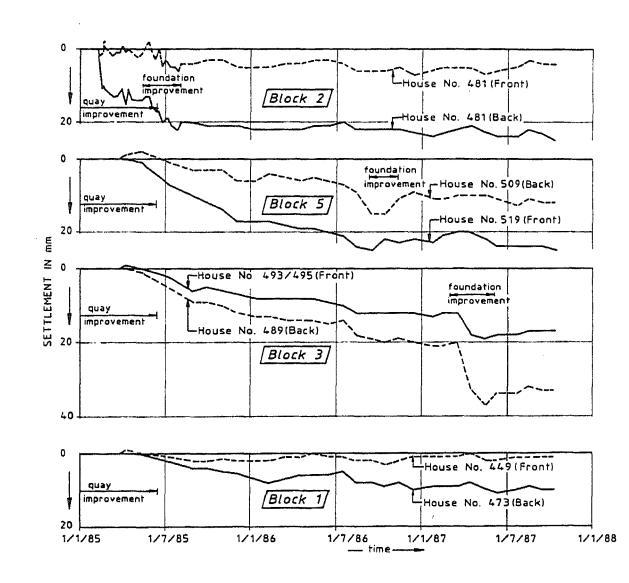
Fig. 17 Vertical displacements of Blocks 2, 5, 3 and 1

The following sequence of improvements was chosen as a result of these inspections: Block 2 and then Blocks 5, 3 and 1. Measurements showed that the houses had also undergone vertical displacements. Absolute displacements could not be established, but the differential displacements since construction varied from 0.2 m for Block 3 to 0.7 m for Block 5. It was striking that despite the large horizontal and vertical displacements, the blocks showed so little cracks. This was caused by the relatively stiff cellar floor that was present under all the blocks. Demands on the foundations
