Archaeological Site Examination of the Field East of the Grapery/Greenhouse, Drive Circle, Straight Walk, and South Lawn at Gore Place, Waltham, Massachusetts

J.N. Leith Smith

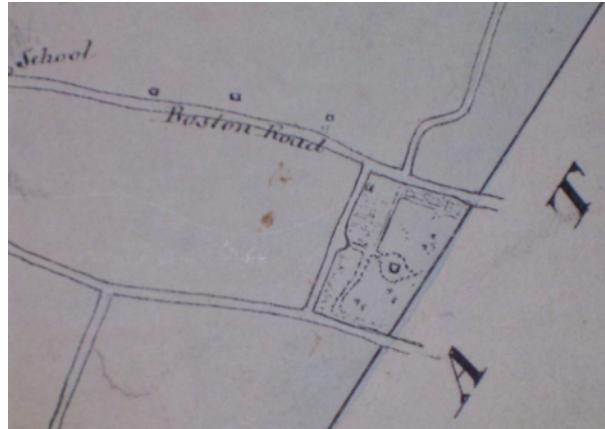
III.1. Detail of 1831 Hales Plan of Waltham depicting the Gore Place property.

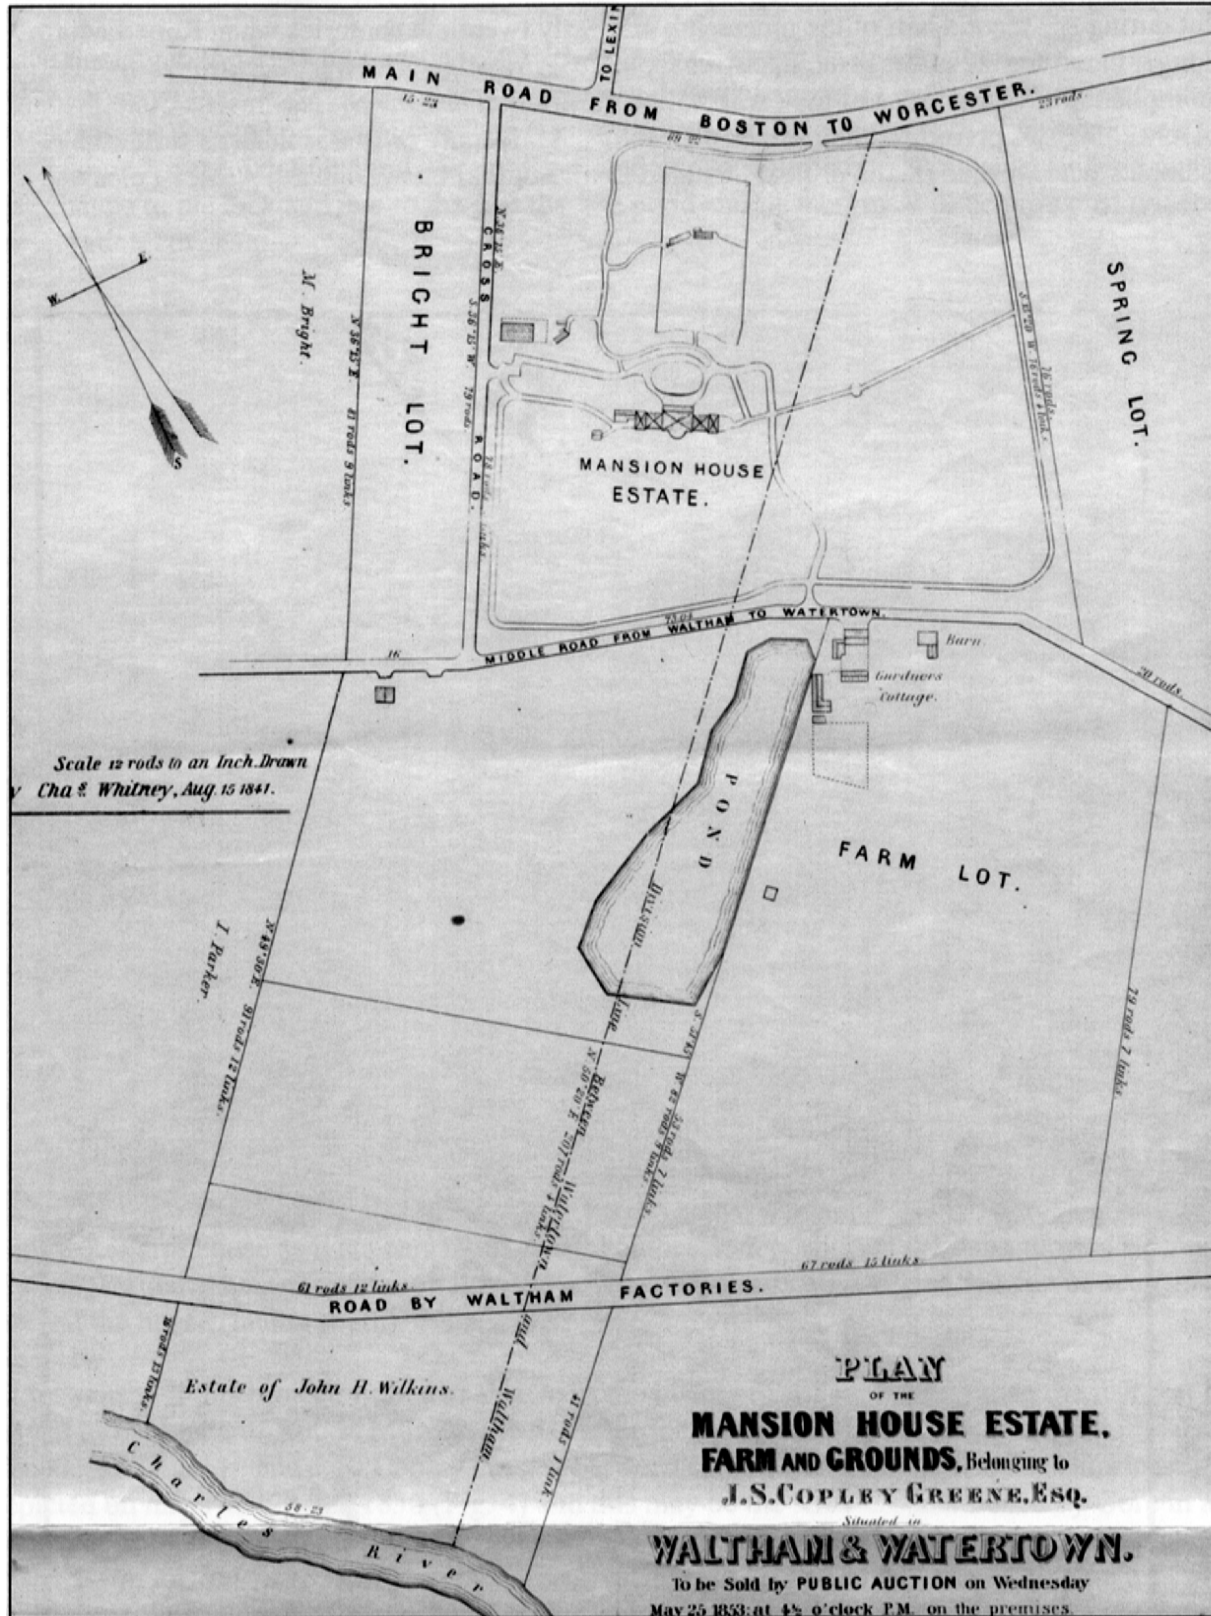
III.5. Estate of J. S. Copley Greene Esq. drawn in 1841.

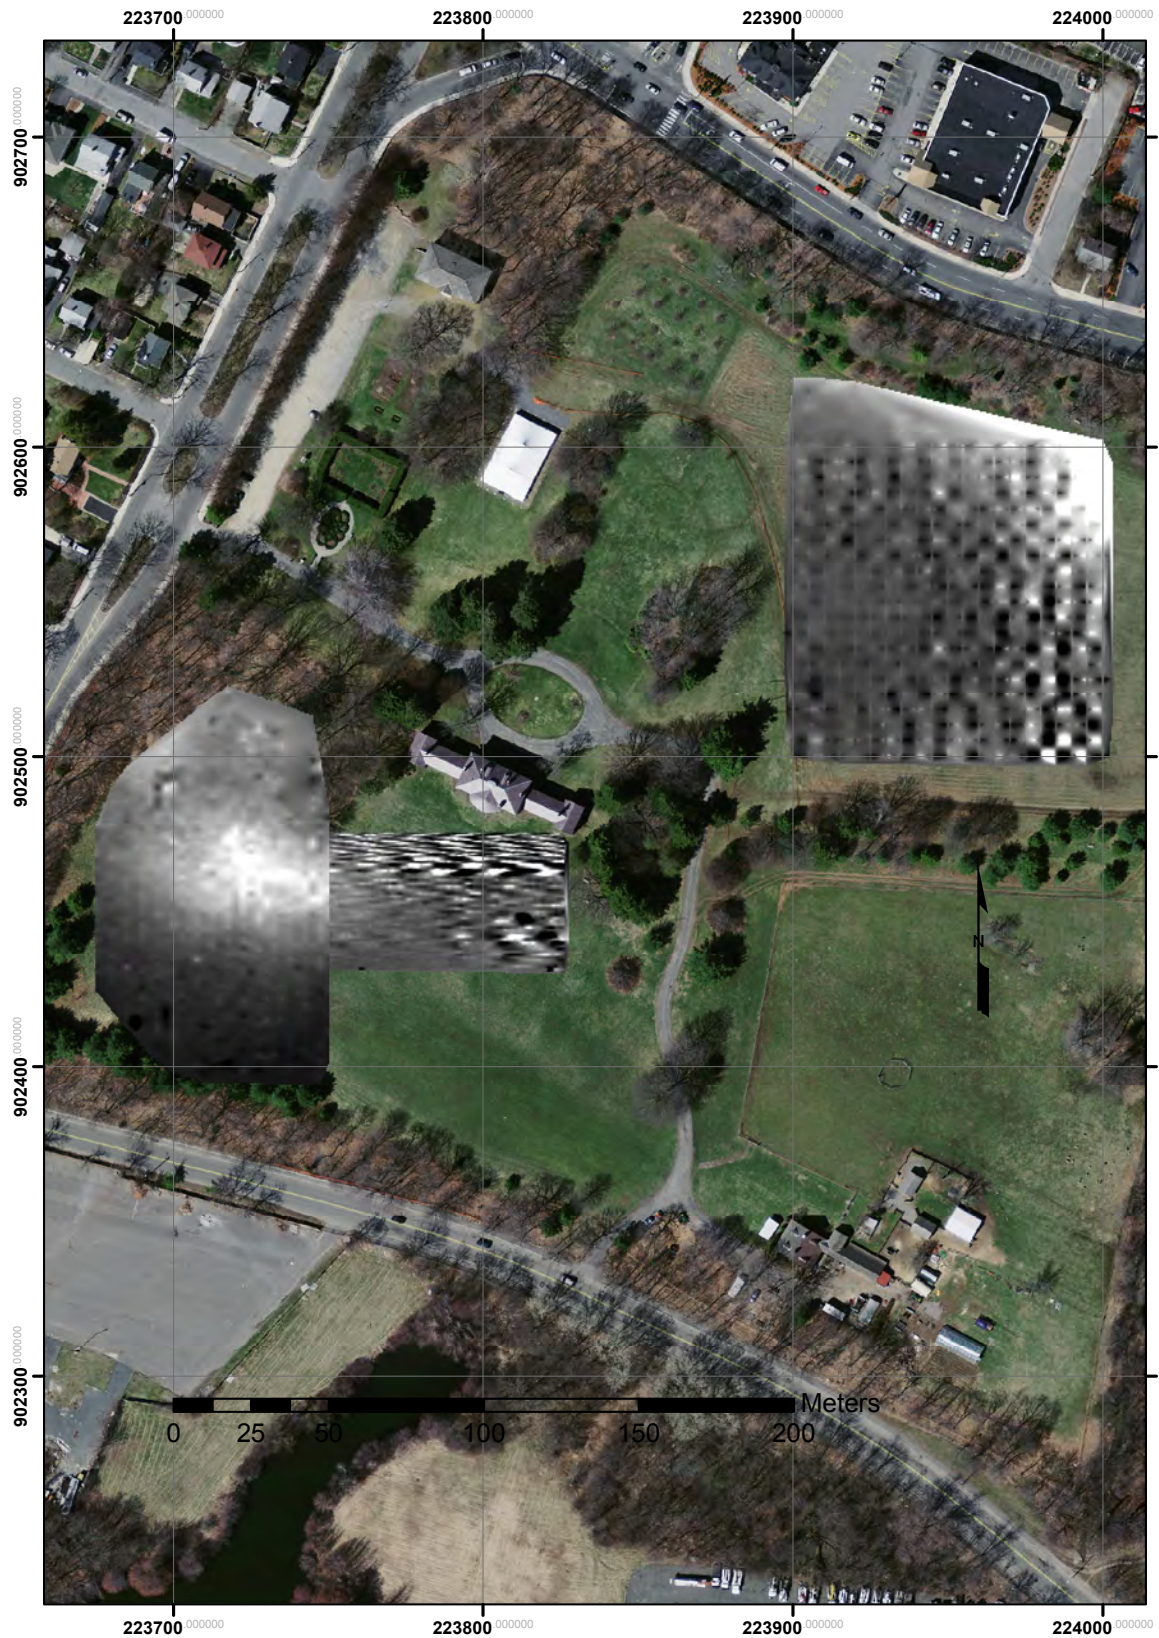
IV.1. Areas surveyed with the EM-31 conductivity meter.

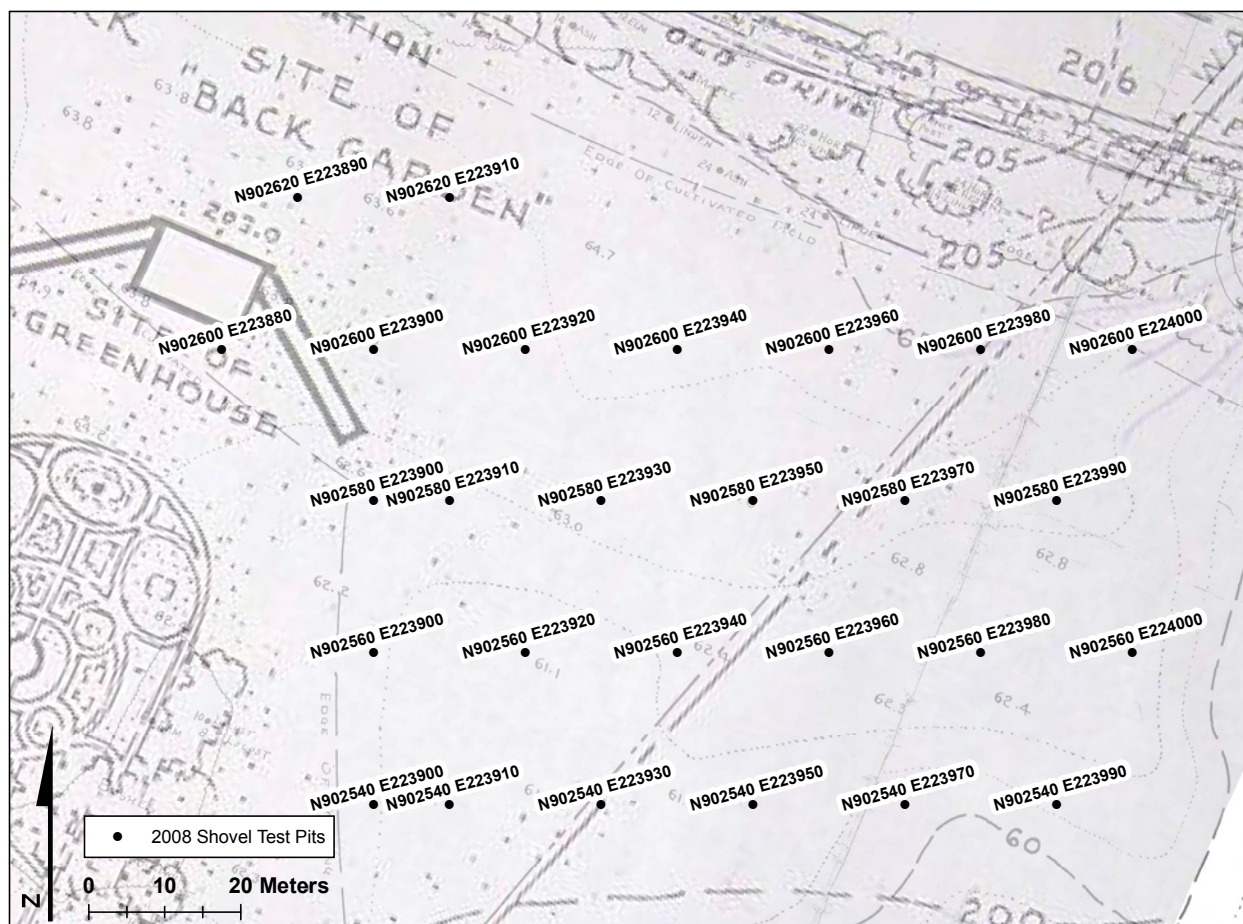
IV.3. Shovel test pit locations in the field east of the grapery/greenhouse site.

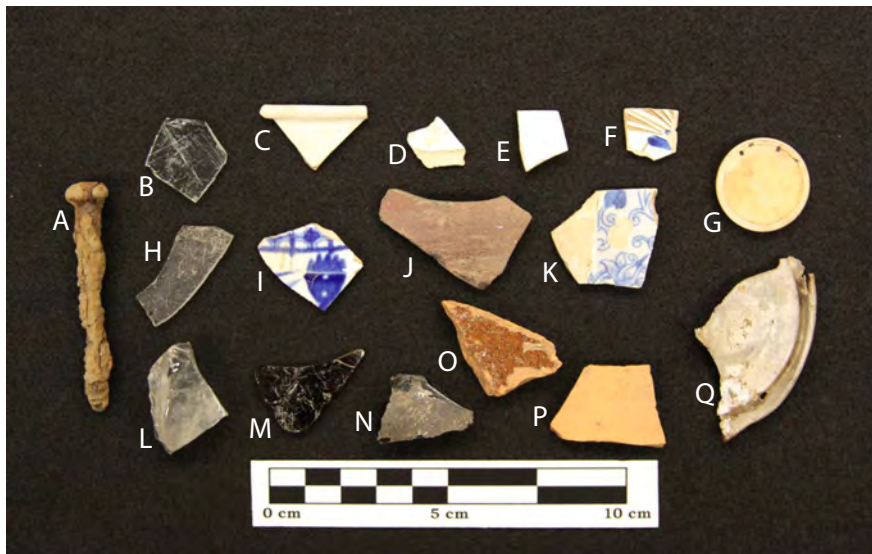
IV.5. Artifacts from field east of grapery/greenhouse. A) Iron screw; B and H) window glass; C) white salt-glazed stoneware, burned (ca. 1720-1805); D) creamware (ca. 1775-1820); E) whiteware (1820+); F) polychrome painted pearlware (ca. 1795-1820); G) plastic button; I) blue printed whiteware (ca. 1820+); J) stoneware; K) printed pearlware (ca. 1783-1830); L) tumbler base; M and N) wine bottle glass; O) lead glazed redware; P) earthenware planting pot; Q) tin can lid.

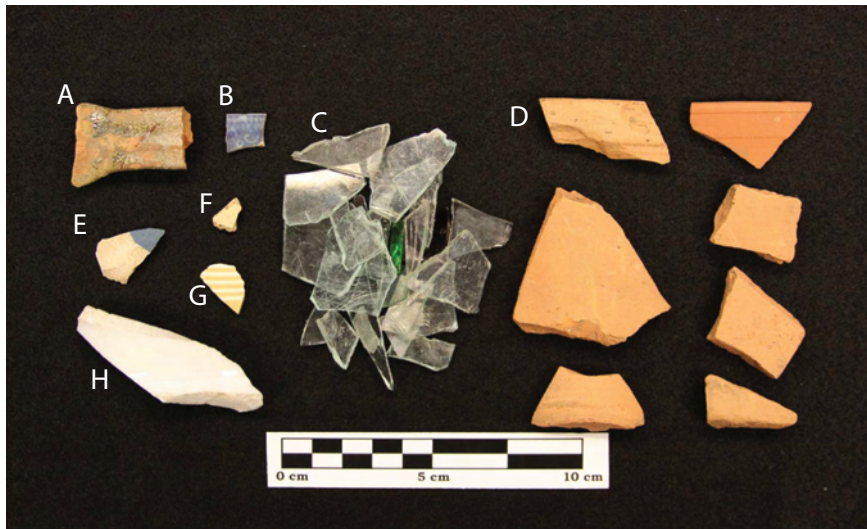
IV.6. Artifacts from greenhouse area. A) Lead glazed redware; B) blue printed willow pearlware (ca. 1795-1830); C) bottle and window glass (ca. 20th century); D) earthenware planting pots; E) factory slipped pearlware; F) creamware (ca. 1775-1820); G) yellowware (ca. 1840-1930); H) porcelain (ca. 1850+).

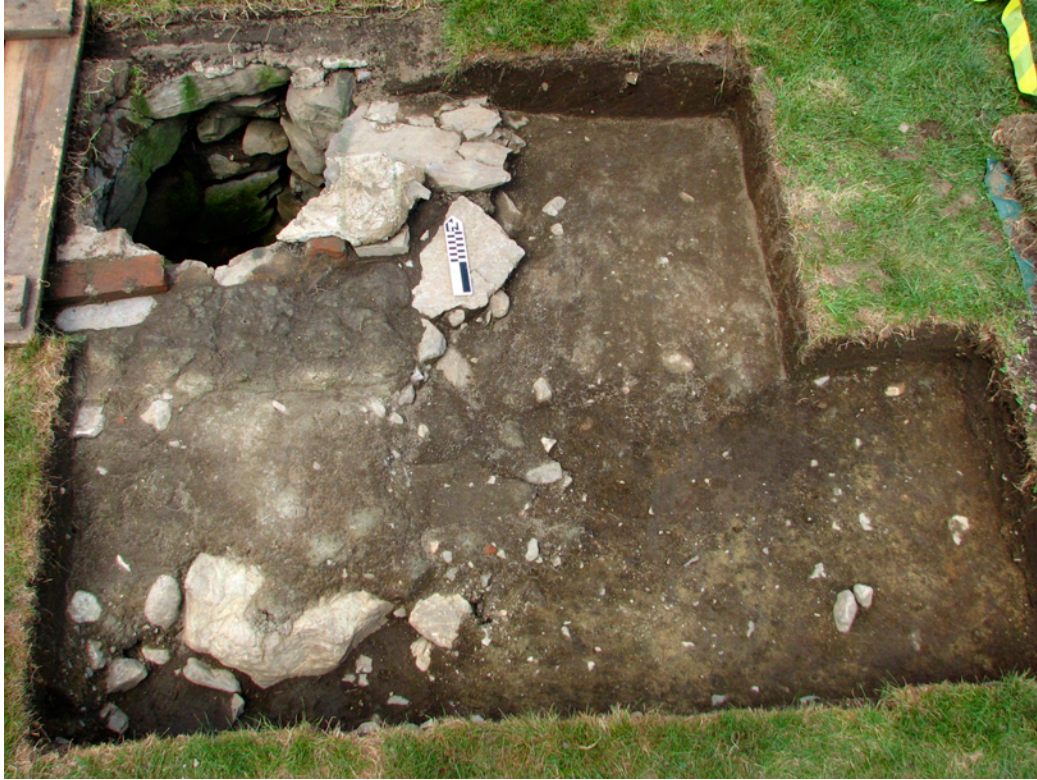
IV.9. View of drive circle well opening facing north showing the remaining bricks and the hard-packed sandy silt seal.

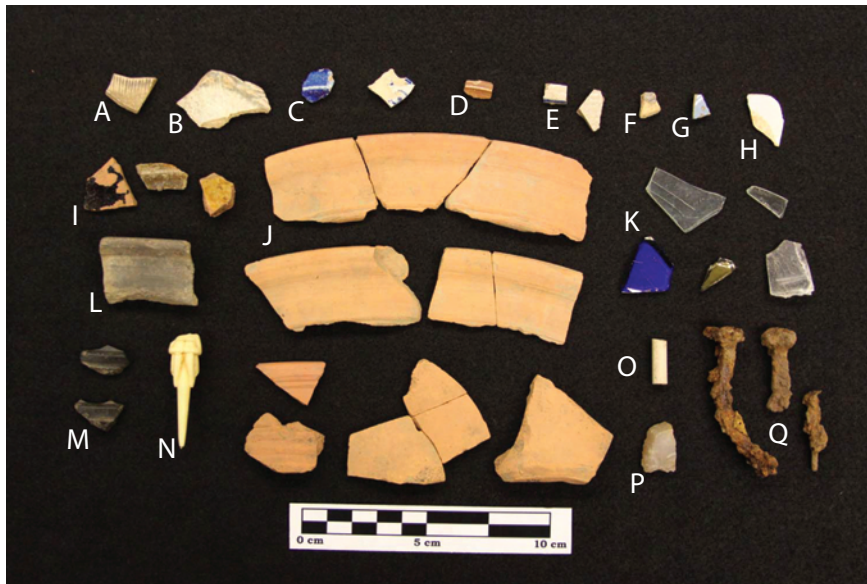
IV.12. Artifacts from the drive circle test excavations. A) Blue shell-edged pearlware plate rim, burned (ca. 1800-1835); B) molded pearlware plate rim, burned (ca. 1780-1830); C) printed pearlware (ca. 1783-1830), underglaze blue painted pearlware (ca. 1775-1830); D) Nottingham stoneware (ca. 1638-1810); E) Rhenish stoneware (ca. 1690-1775); F) tin-glazed earthenware (ca. 1620-1800); G) factory slipped creamware (ca. 1780-1820); H) pearlware (ca. 1775-1830); I and L) lead glazed redware; J) earthenware planting pots; K) window glass (above), tableware and wine bottle glass (below); M) clay pigeon targets; N) plastic golf tee (ca. 1920s); O) tobacco pipe stem; P) firearm flint; Q) wrought nails.

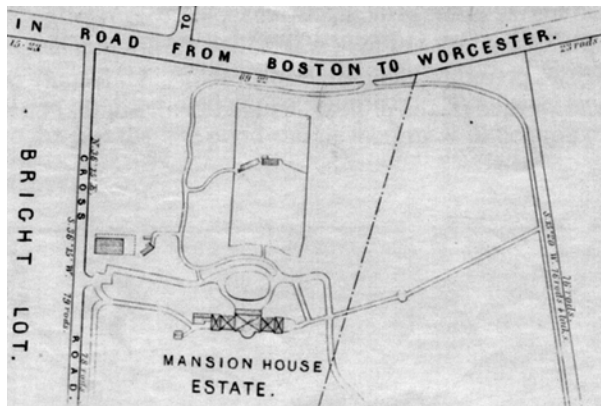
IV.14. Detail of 1841 plan of J. S. Copley Greene estate depicting the straight walk.

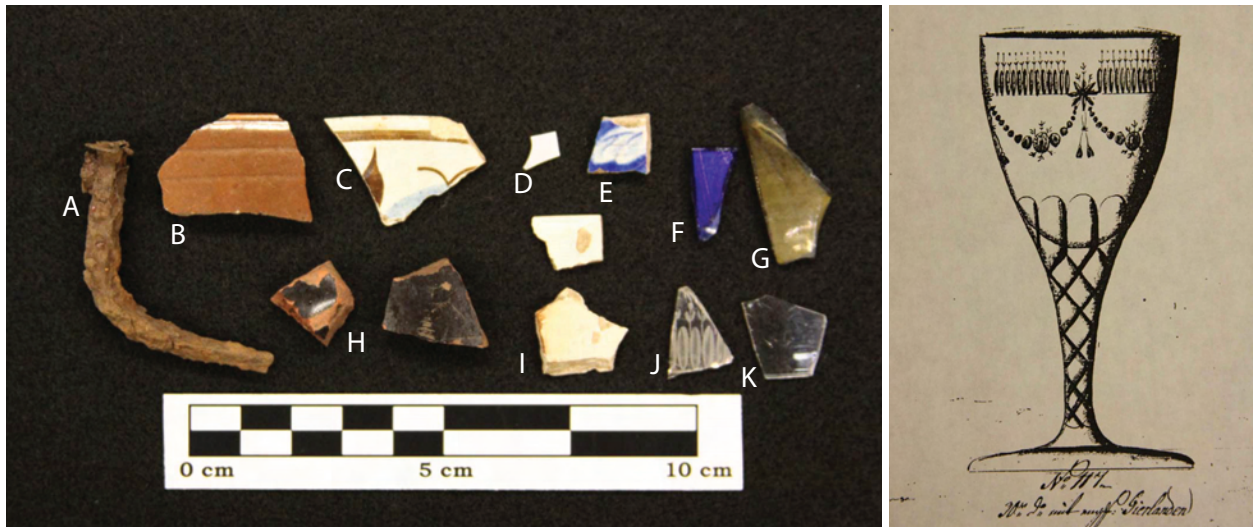
IV.18. Artifacts from straight walk test excavations. A) Wrought nail; B) Nottingham stoneware (ca. 1638-1810); C) polychrome pearlware (ca. 1795-1820); D) tin-glazed earthenware (ca. 1620-1800); E) blue printed pearlware (ca. 1783-1830); F) blue vessel glass; G) wine bottle glass; H) lead glazed redware; I) creamware (ca. 1775-1820); J) engraved table glass; K) lamp chimney glass. At right, stemware with the same pattern as artifact J (Illustration from Frances Dupont Winterthur Museum).

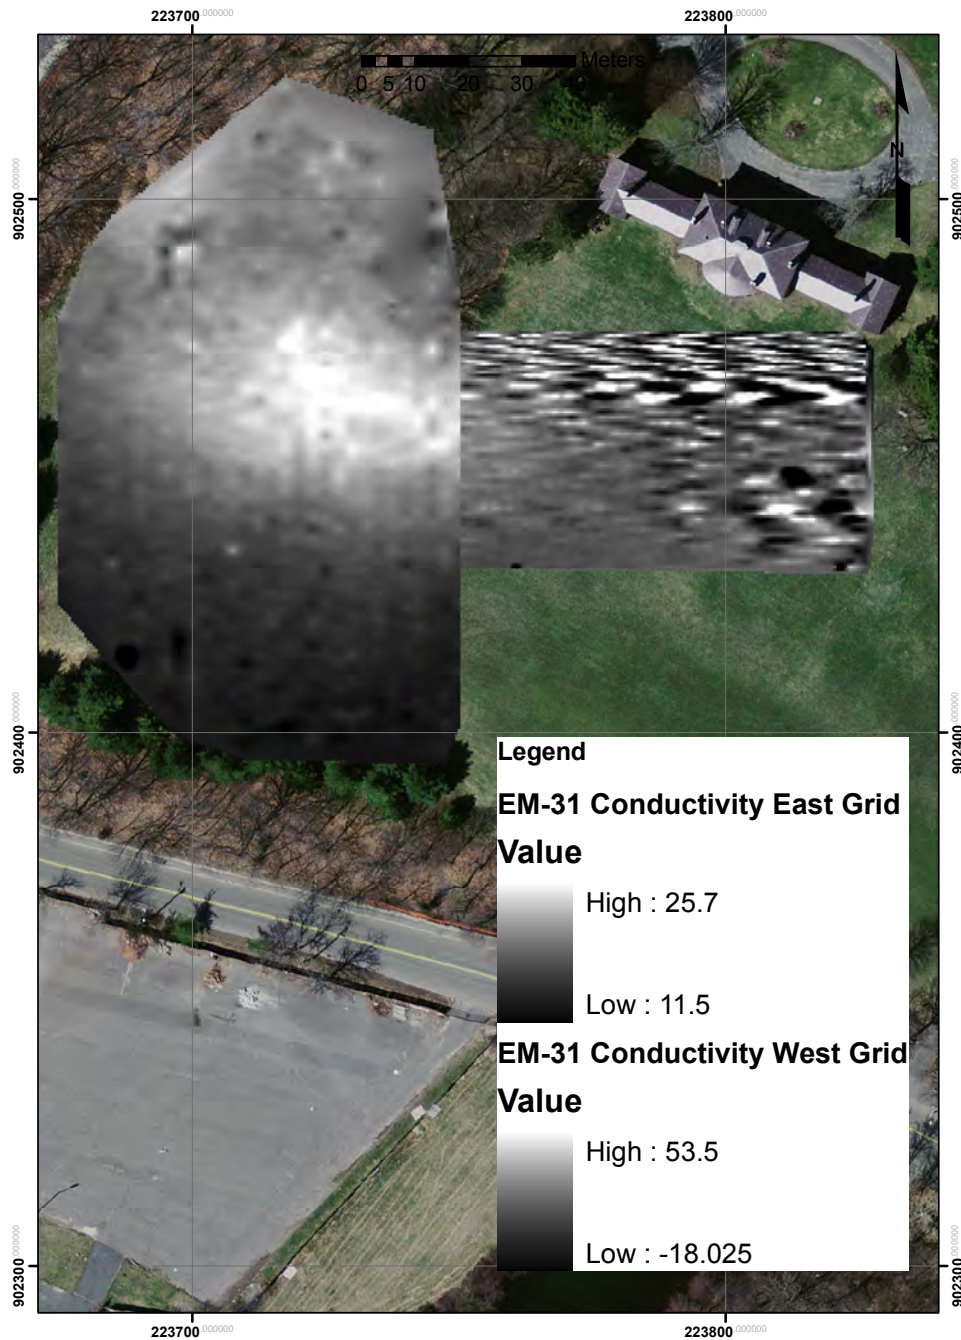
IV.22. Total area of the conductivity survey on the south lawn.

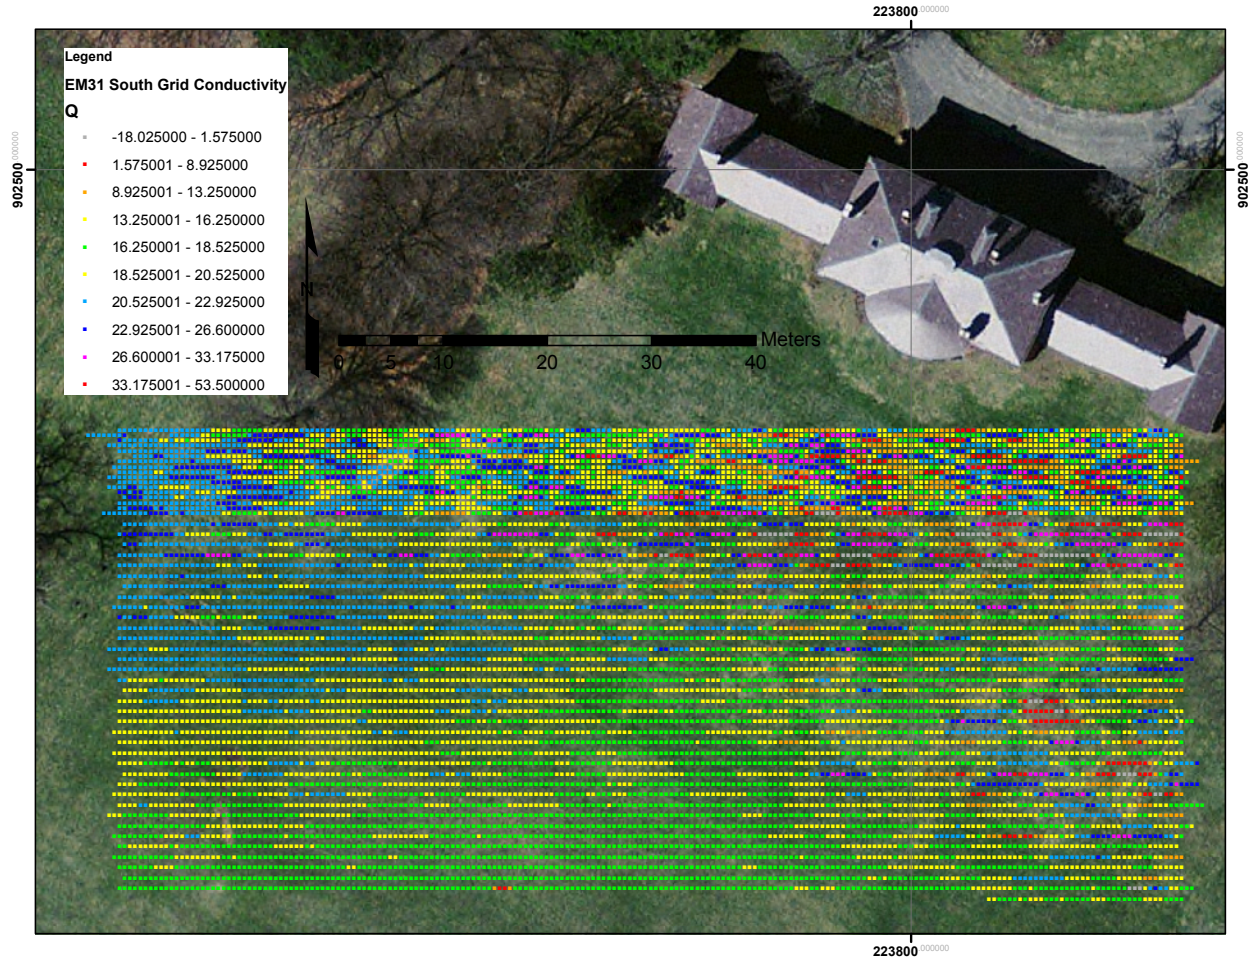
IV.24. Results of the conductivity survey south of the mansion. Note that hues, representing conductivity (Q) value, are concentrated around the mean Q value.

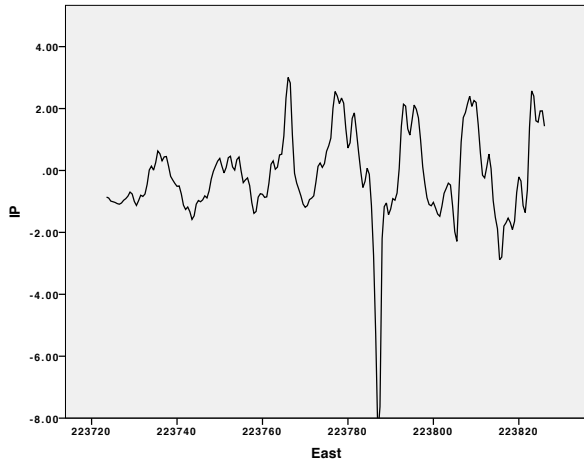
IV.29. The in-phase (IP) values along transect N2471.5 on the y-axis with east value on the x-axis.

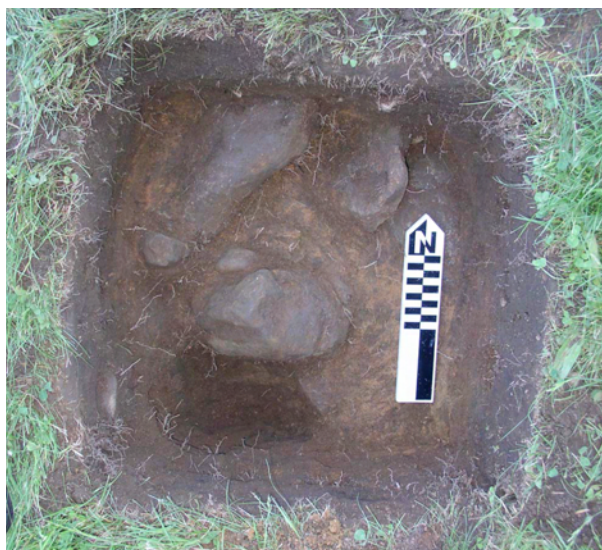
IV.34. Cluster of stones in STP N2400/E3850.

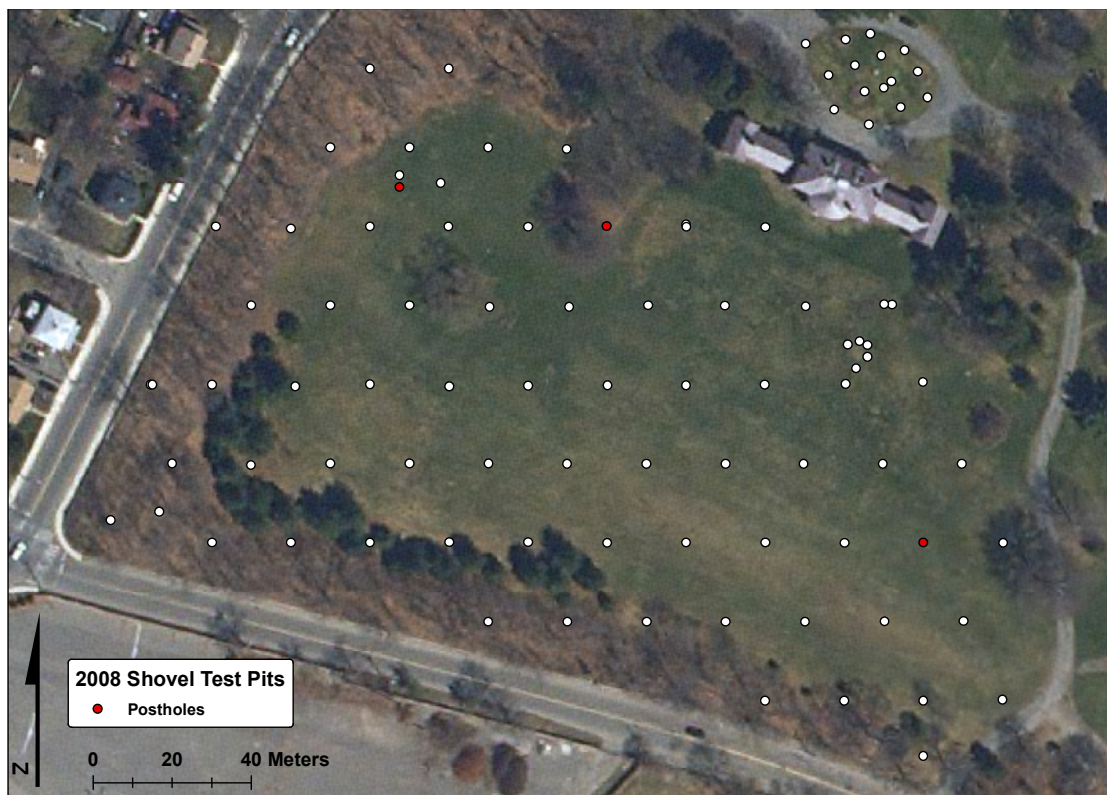
IV.35. Shovel tests in which possible post hole features were identified.

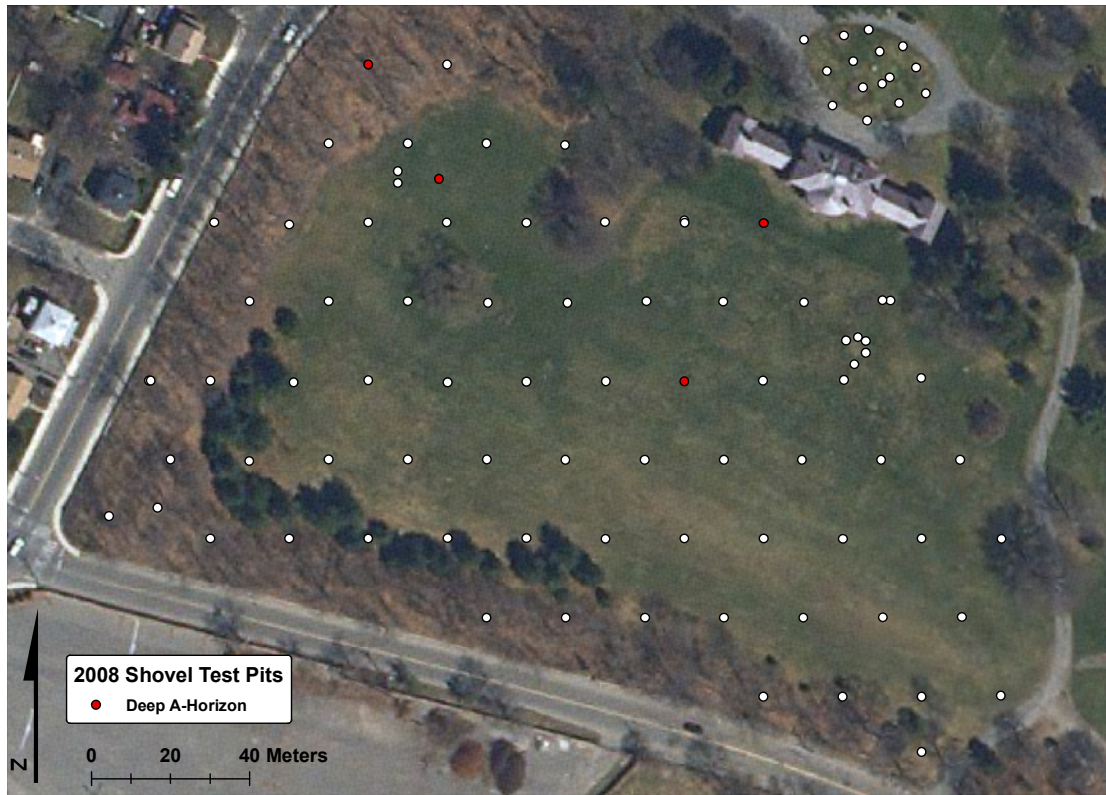
IV.37. Shovel tests in which deep A-horizon soils were identified.

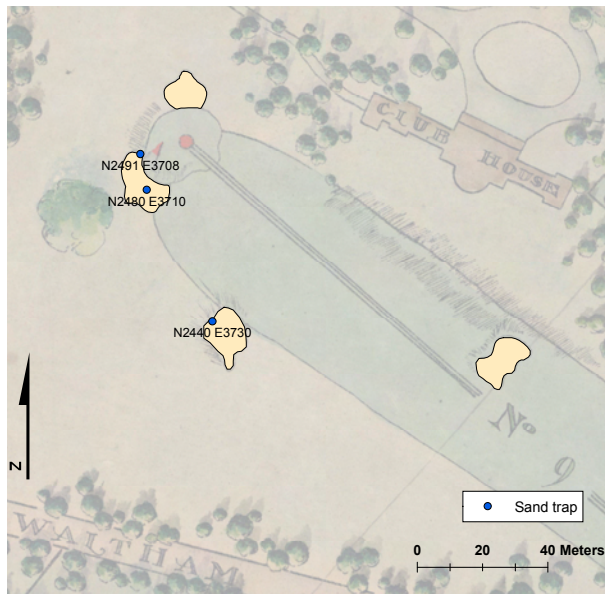
IV.40. Shovel tests in which evidence of golf course sand traps were found overlaid on the Waltham Country Club plan.

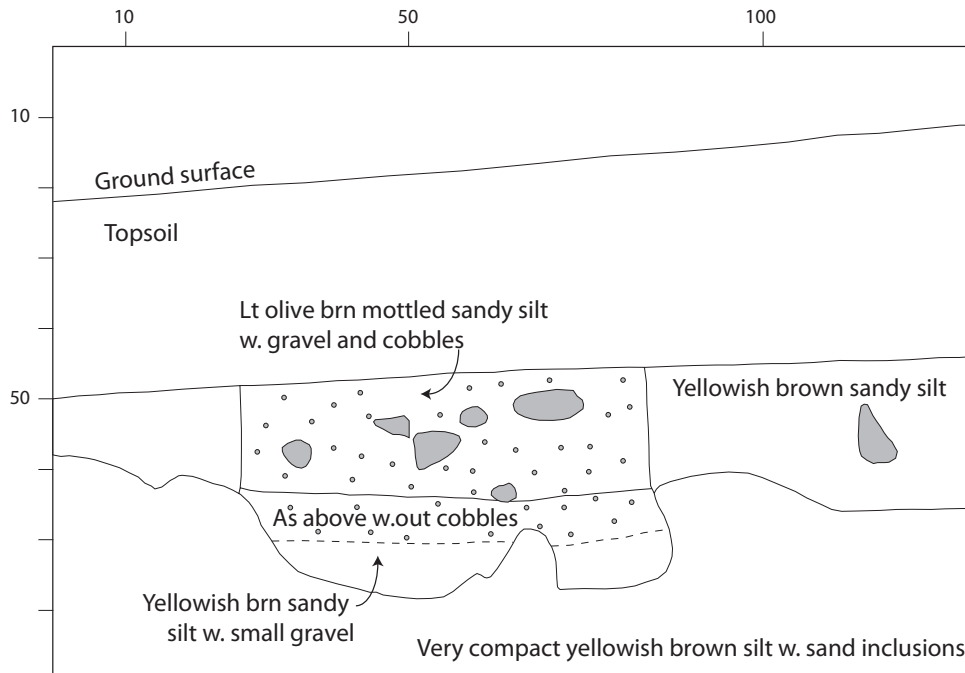
IV.43. West profile of Feature 7 drain.

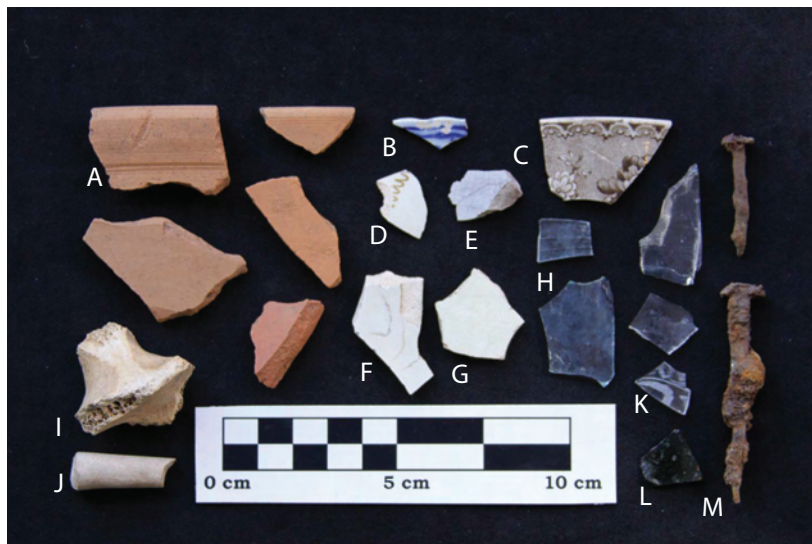
IV.44. Artifacts from fill overlying drain Feature 7. A) Earthenware planting pots; B) underglaze blue painted pearlware (ca. 1775-1830); C) brown printed whiteware (ca. 1820+); D) polychrome pearlware (ca. 1795-1820); E) whiteware (ca. 1820+); F) pearlware (ca. 1775-1830); G) creamware (ca. 1775-1820); H) window glass; I) bone; J) tobacco pipe stem; K) engraved tableware glass; L) wine bottle glass; M) wrought nails.

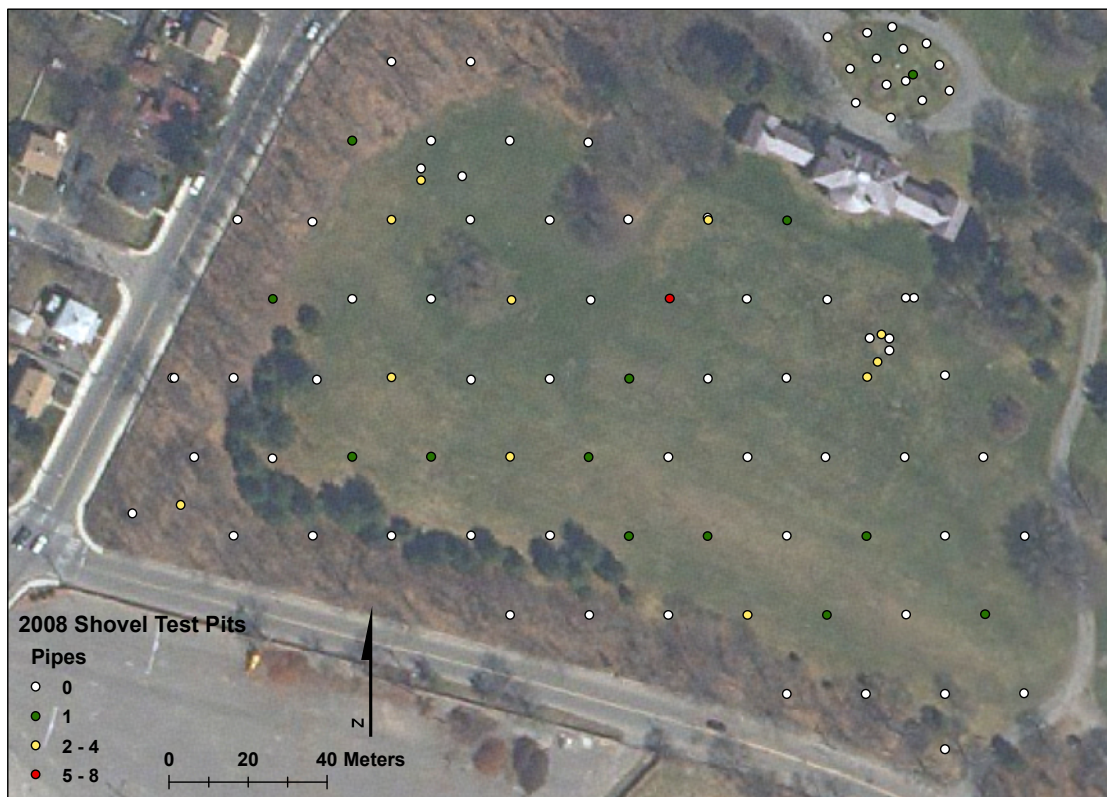
IV.45. Distribution of tobacco pipe fragments across the south lawn.

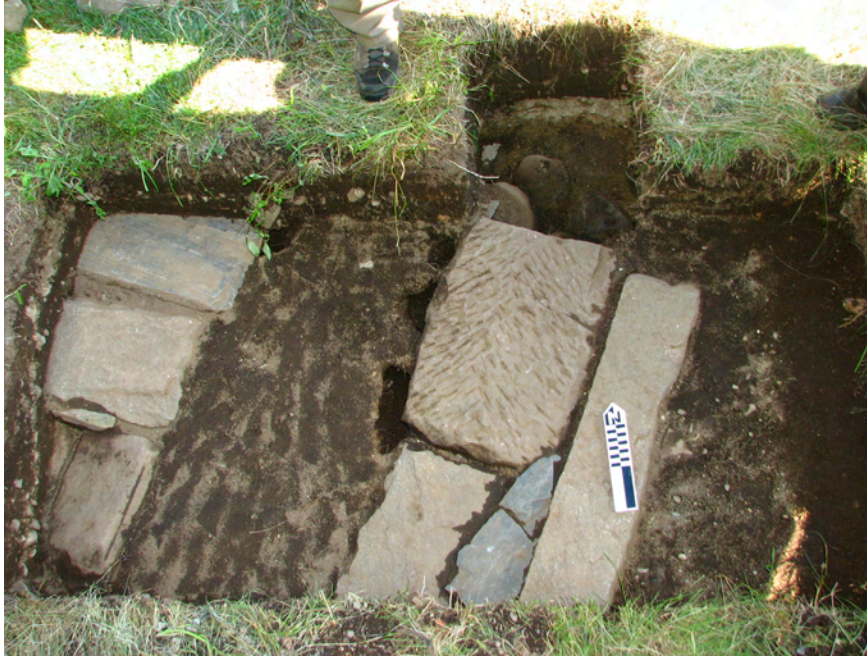
IV.52. View of dry well Feature 1 facing north.

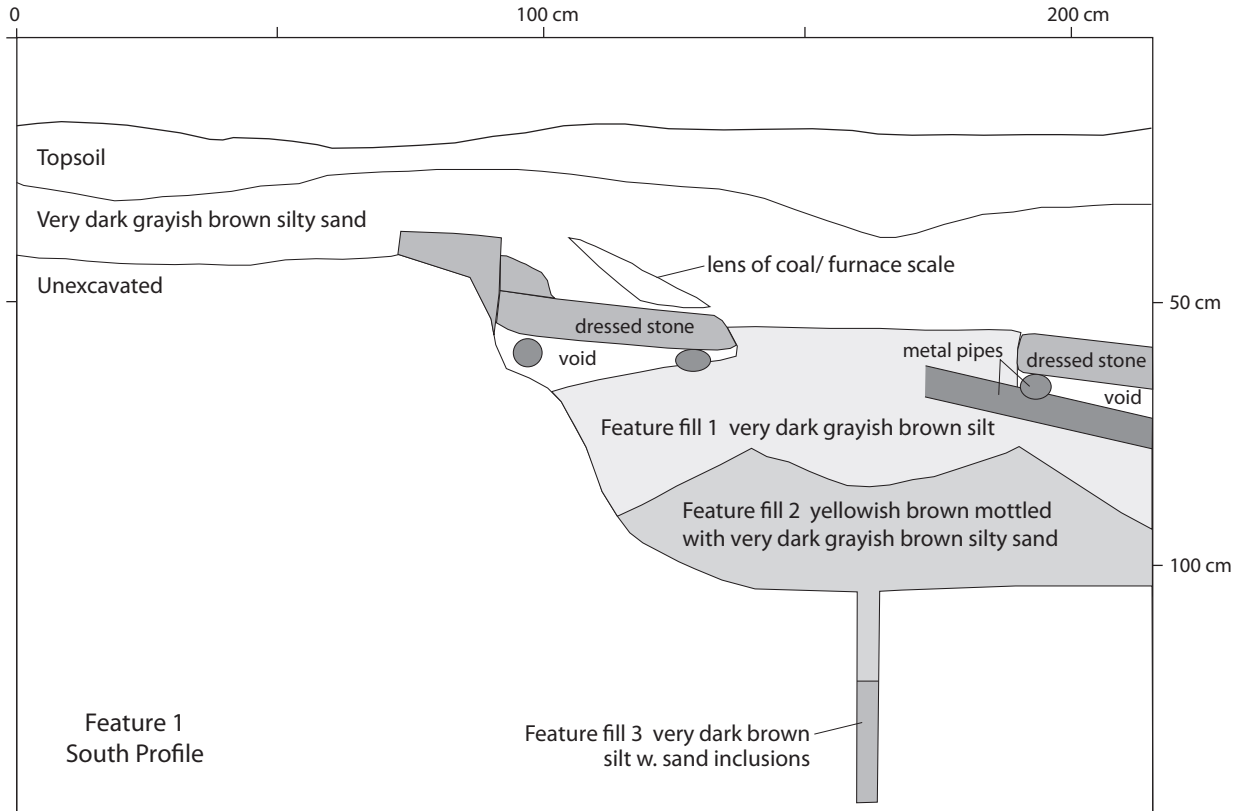
IV.54. Profile of Feature 1 showing pipes and stone cover, interior deposits, and depth of excavation.

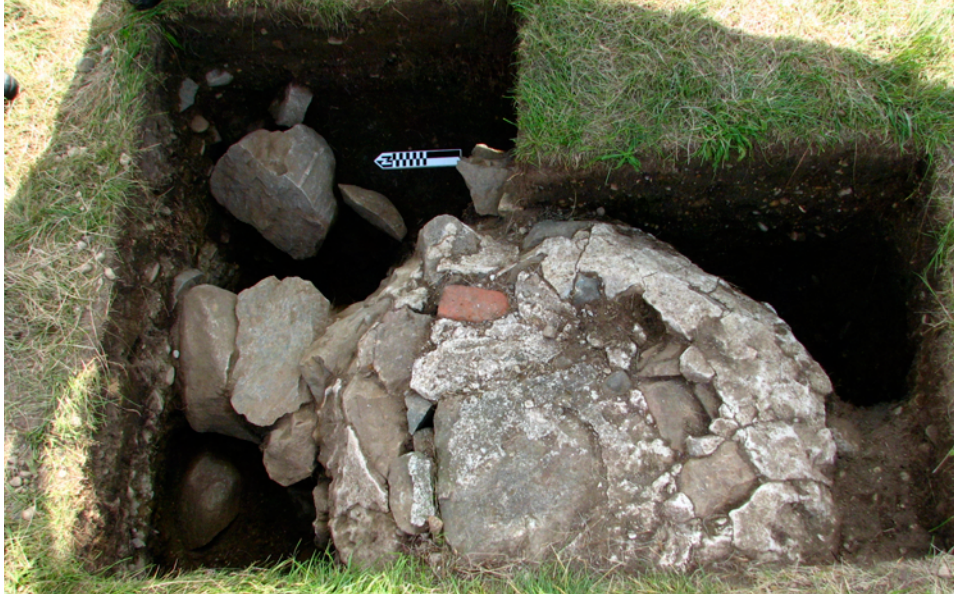
IV.55. View of dry well Feature 2 facing east.

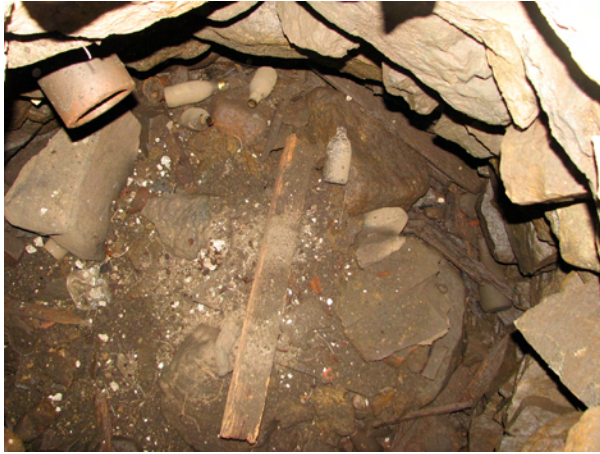
IV.56. View of the interior of dry well Feature 2.

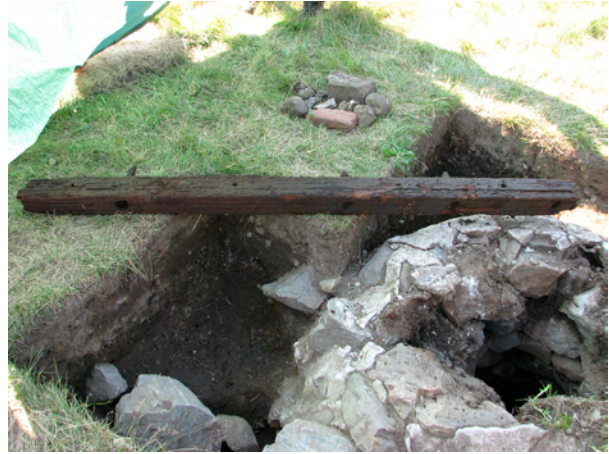
IV.57. Telegraph pole crossarm found in Feature 2.

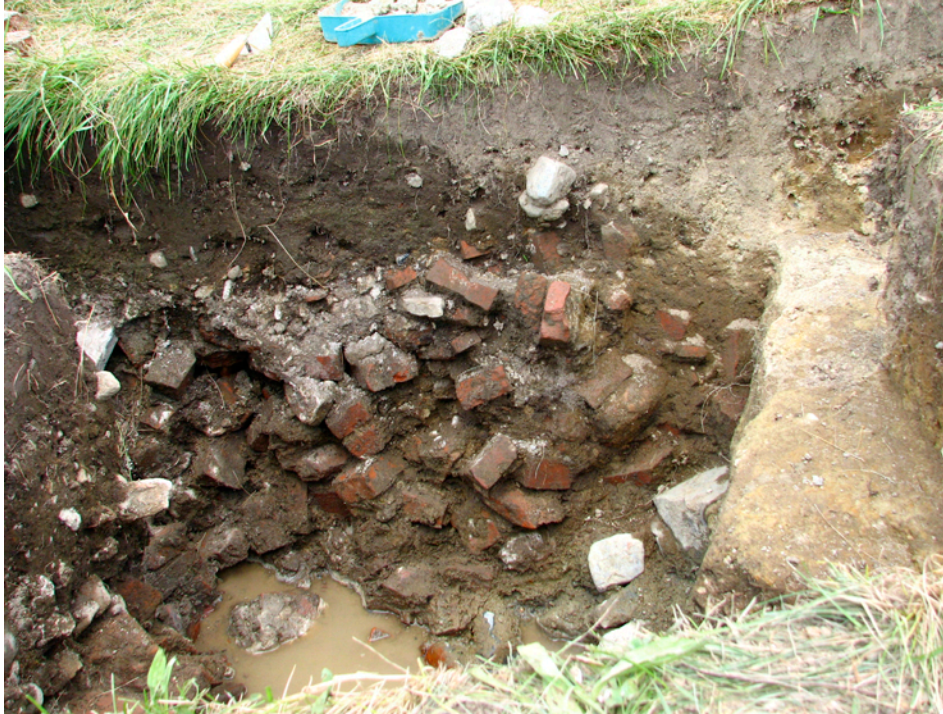
IV.58. View of north profile of Feature 3.

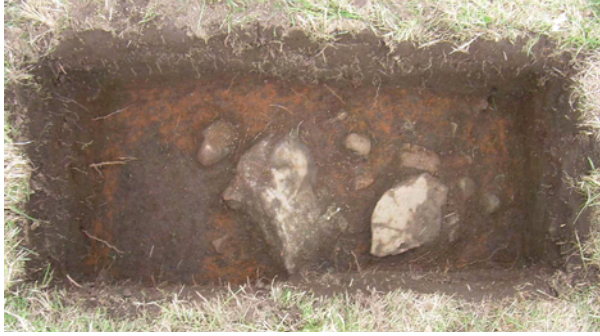
IV.63. Reddened soil and stones representing Feature 8.

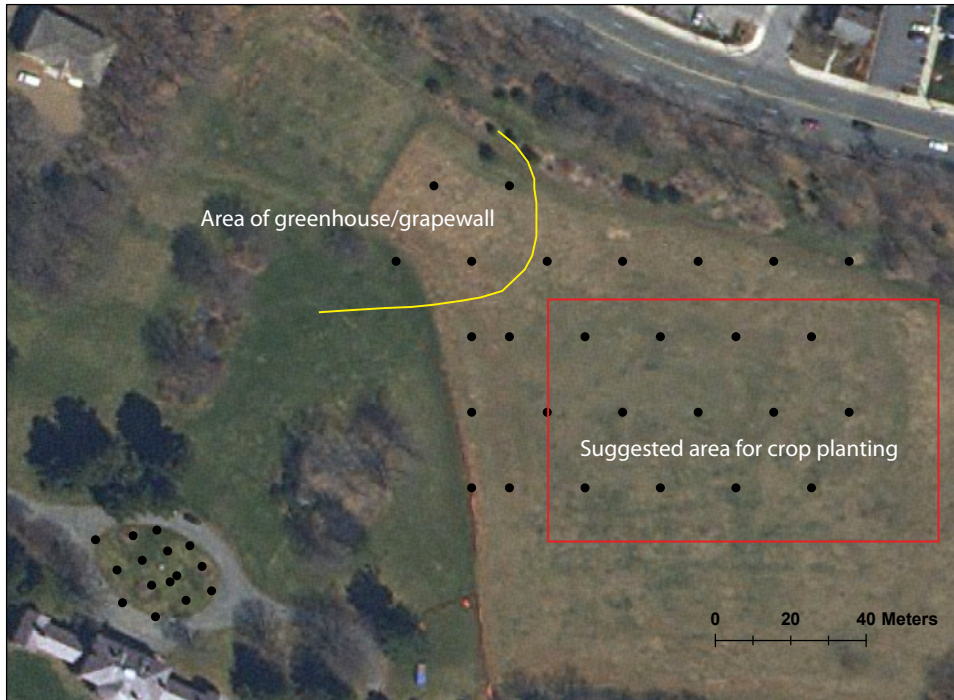
V.1. Borders of the greenhouse area and area recommended for crop production in the field east of the grapery and later greenhouse.

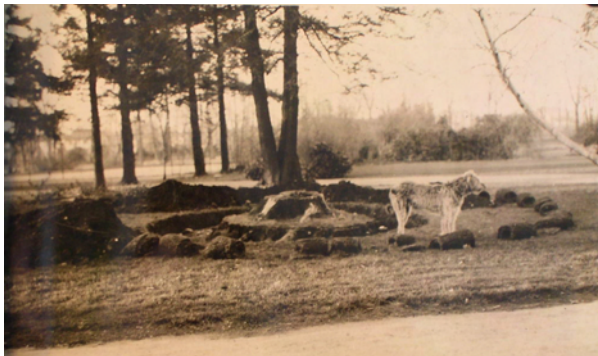
V.2. Removal of tree stump in drive circle in 1936.

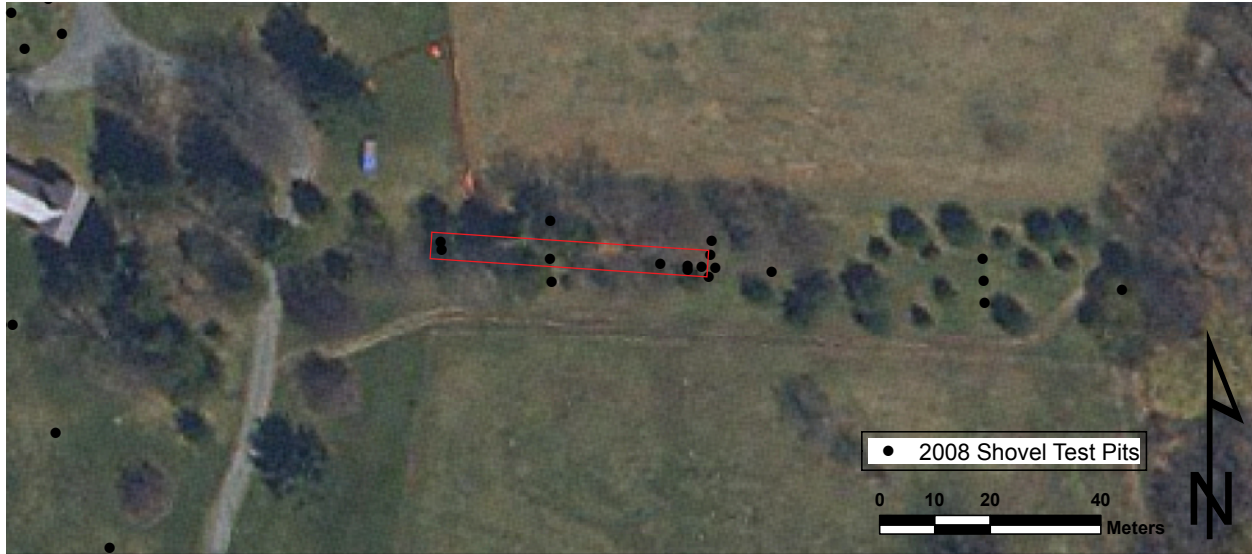
V.4. Location of straight walk bedding.

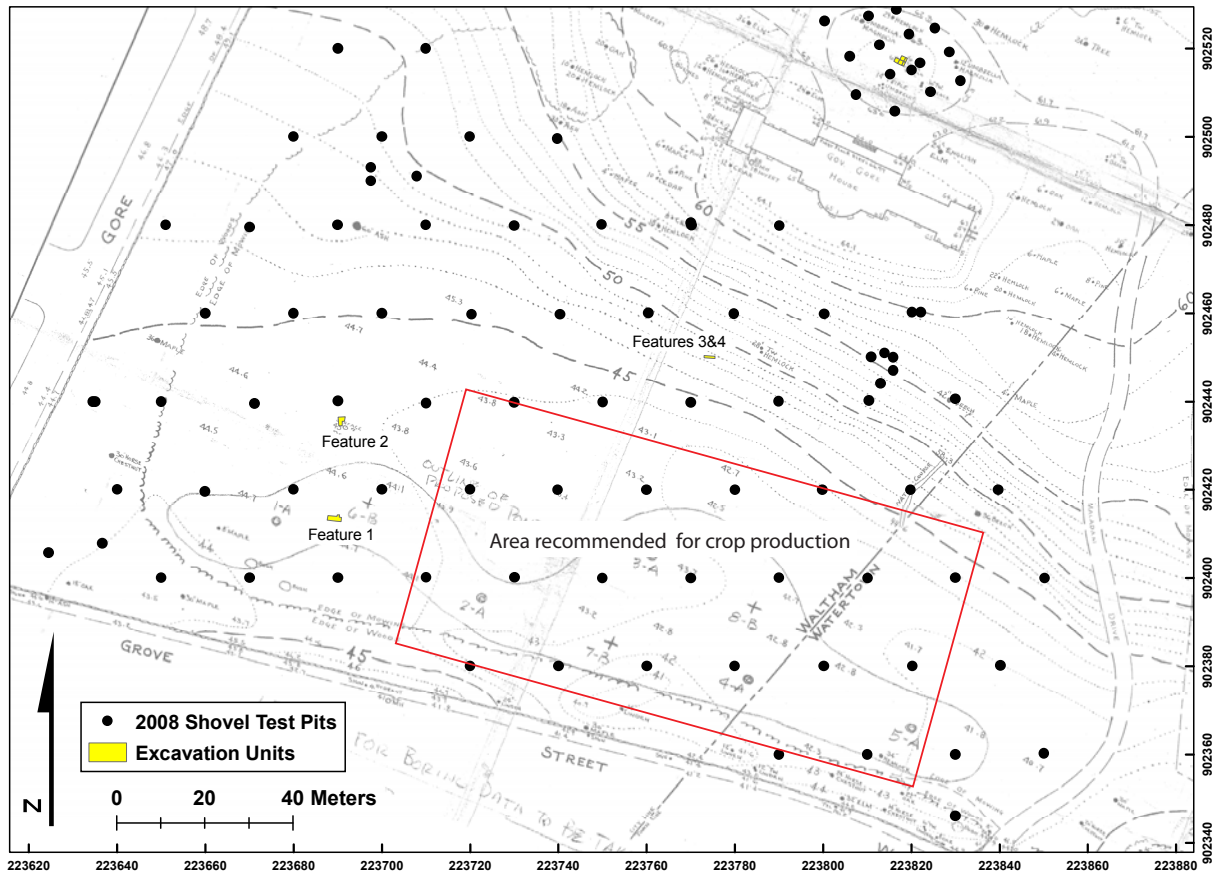
V.5. Area of the south lawn recommended for crop production.
