Archaeological Site Examination of the Field East of the Grapery/Greenhouse, Drive Circle, Straight Walk, and South Lawn at Gore Place, Waltham, Massachusetts

J.N. Leith Smith

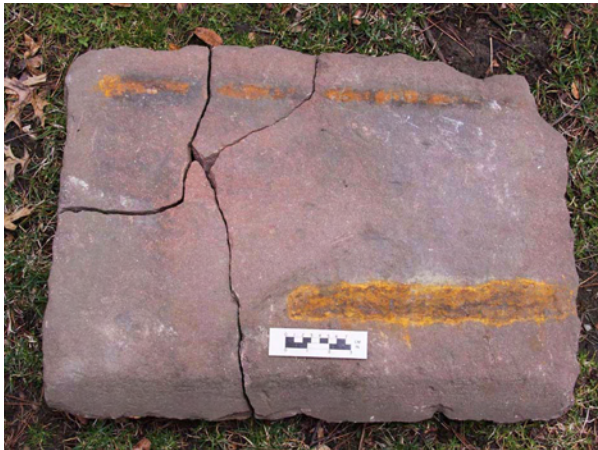
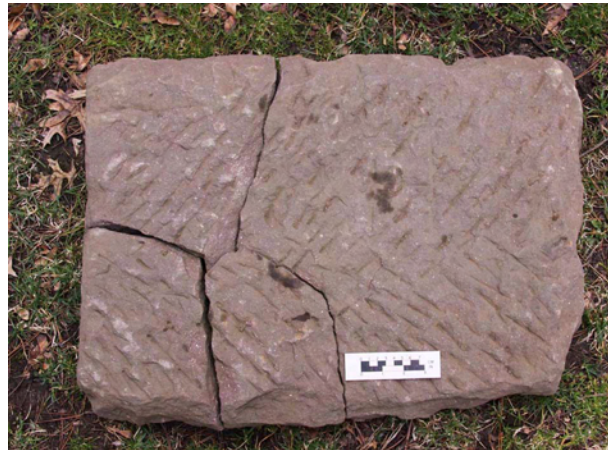
V.6. Front and back of the worked red sandstone incorporated into the cover of Feature 1.
