Thorough Geological Investigation is of Prime Importance When Selecting a Dam Site

Strength and Stability of Structure Often Jeopardized by Location Upon Inadequate Foundation which may Superficially Appear Suitable

By F. L. RANSOME

Professor of Economic Geology, California Institute of Technology

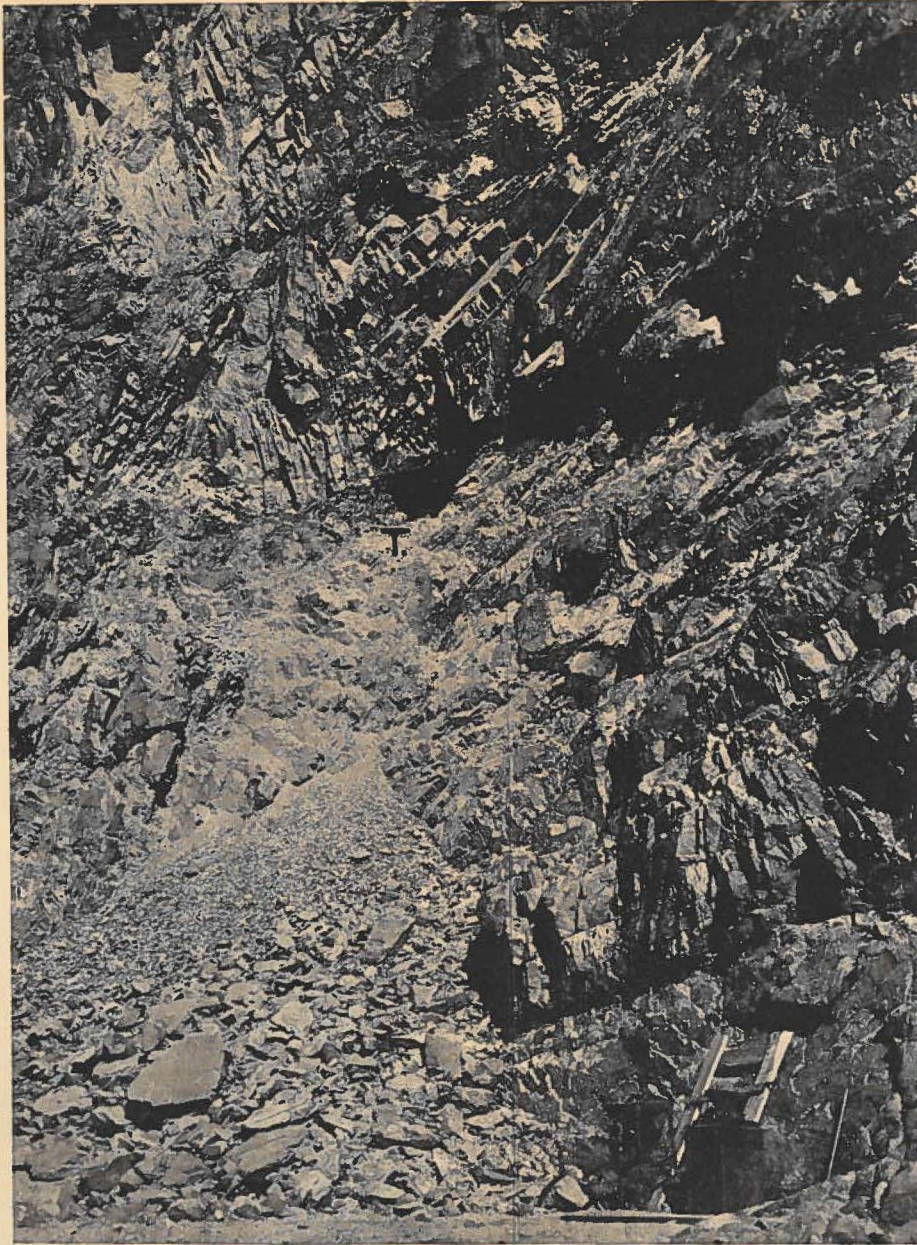
Jointing in granite of the north wall of Boulder Canyon, showing the great number and diversity in direction of the joints. The short tunnel at T shows that these joints become scarcely visible cracks at a distance of less than ten feet from the surface. The tightly fitting blocks between them can be dislodged only by blasting.

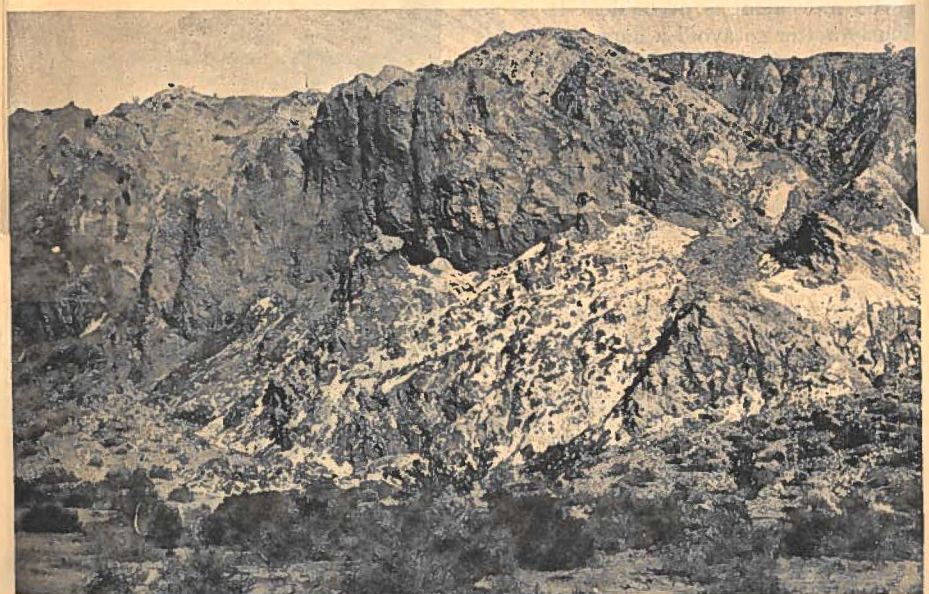
and, although gypsum is going into solution all around its shore, this general solution has not led to any leakage. Rock salt is of course, even less trustworthy than gypsum as a water barrier. Thick beds of salt occur in the proposed Boulder reservoir, along the Virgin River, Nevada, but their position is such that they cannot cause leakage. The question that has been raised, whether these salt beds would render the water of the proposed reservoir too saline for use, is a reasonable one and indicates a possibility that should not be overlooked. In this particular case the effect of solution would be to blanket the salt with silt from overlying beds and the quantity of salt dissolved would probably be negligible in so large a body of changing water.

Massive bed of rock salt, 50 feet or more thick, overlain by silty sediments. Virgin River, in Boulder reservoir site, Nevada.

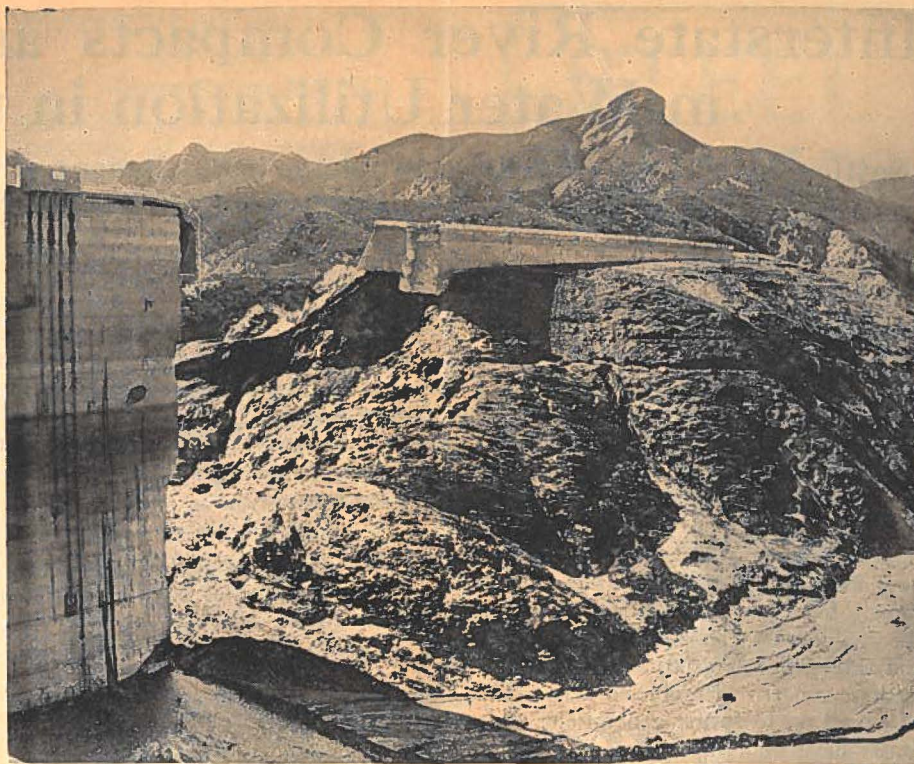
The dam obviously was built across the fault. The southeast end and the middle section rested on schist. The northwest end, including the wind-wall rested on conglomerate. At the southeast abutment the concrete rested against smooth cleavage surfaces of the schist, and although the concrete adheres to these surfaces the schist itself offered little resistance to stresses that might tend to pull the dam away from its abutment or to move it in directions generally parallel with the planes of schistosity. The middle section of the dam, which is still standing, rests on the edges of the schist, and is obviously on a much stronger foundation than were the end sections. The northwest end of the dam abutted against and rested on a rather narrow spur of conglomerate. As already shown, this material, when wet, provided no better foundation than so much muddy sand.

St. Francis dam after the failure, looking southwest. The fault contact between the schist below and the conglomerate above appears near the center of the slope.

It is fairly certain that the dam failed first at its northwestern end. As the conglomerate became water soaked the cementing clay and gypsum was softened and dissolved. The supposed rock on

which that part of the dam rested lost practically all of its strength and became no better suited for a foundation than a mass of wet earth or gritty clay. Seepage through this material probably increased rather suddenly to a jet of water which rapidly attaining appalling proportions washed out the softened conglomerate, permitting the concrete to crack and then to be swept out in huge blocks up to 10,000 ^{tons} pounds in weight, which were distributed for half a mile down the canyon. The terrific swirl of water about the toe of the dam undercut the layers of schist at the southeast abutment. Probably within a few minutes of the opening of the first break, the entire southeastern end of the dam slid down into the canyon, the largest fragments coming to rest against the toe of the standing middle segment.

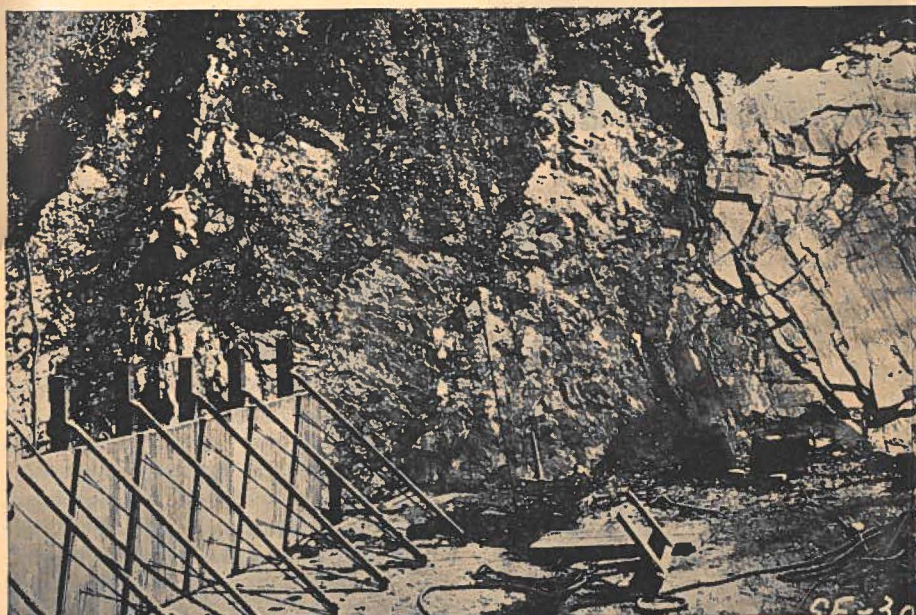
when the directions of stress are parallel with or make only a small angle with these planes. This rather patent generalization was overlooked in the building of the St. Francis dam, as regards its southeast abutment, where the concrete was poured against the flat cleavage planes of thinly laminated schist, in a cut of inadequate depth. Consequently the rock at this end of the structure offered only slight resistance to displacement of the concrete mass, by slipping along the planes of schistosity. The procedure was like building the dam against the upper surface of a gigantic, inclined pack of cards. The concrete adhered to the top card but there was little to pre-

vent the cards from sliding one over another.

St. Francis dam, southeast abutment, showing manner in which the concrete was poured against flat cleavage surfaces of schist.
