Research Report
KTC-89-10

EARTHQUAKE HAZARD MITIGATION OF
TRANSPORTATION FACILITIES
FOR BALLARD COUNTY

May 1989

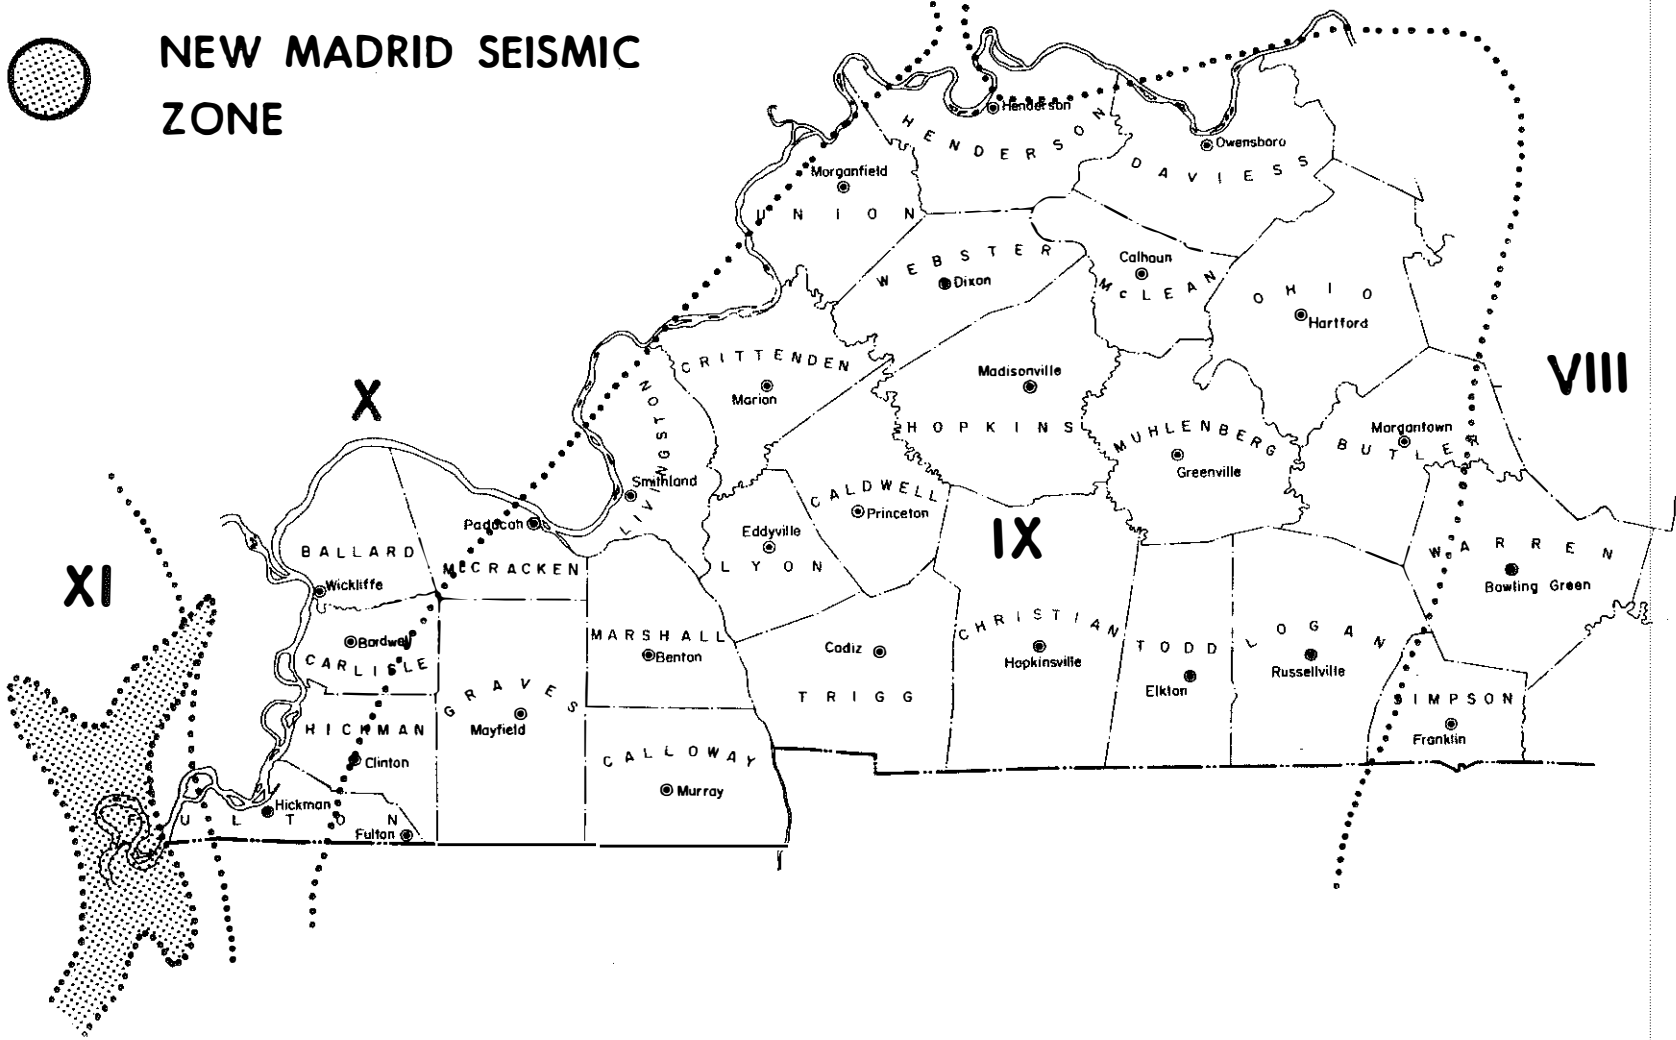
Figure 1: The twenty-six counties included in this study area.

Ballard County is located approximately 31 miles northeast of the center of the New Madrid Seismic Zone. Figure 1 indicates that

Ballard County is located in the X band of the MMI scale. This indicates major damage could occur in Ballard County in the event of a major earthquake.

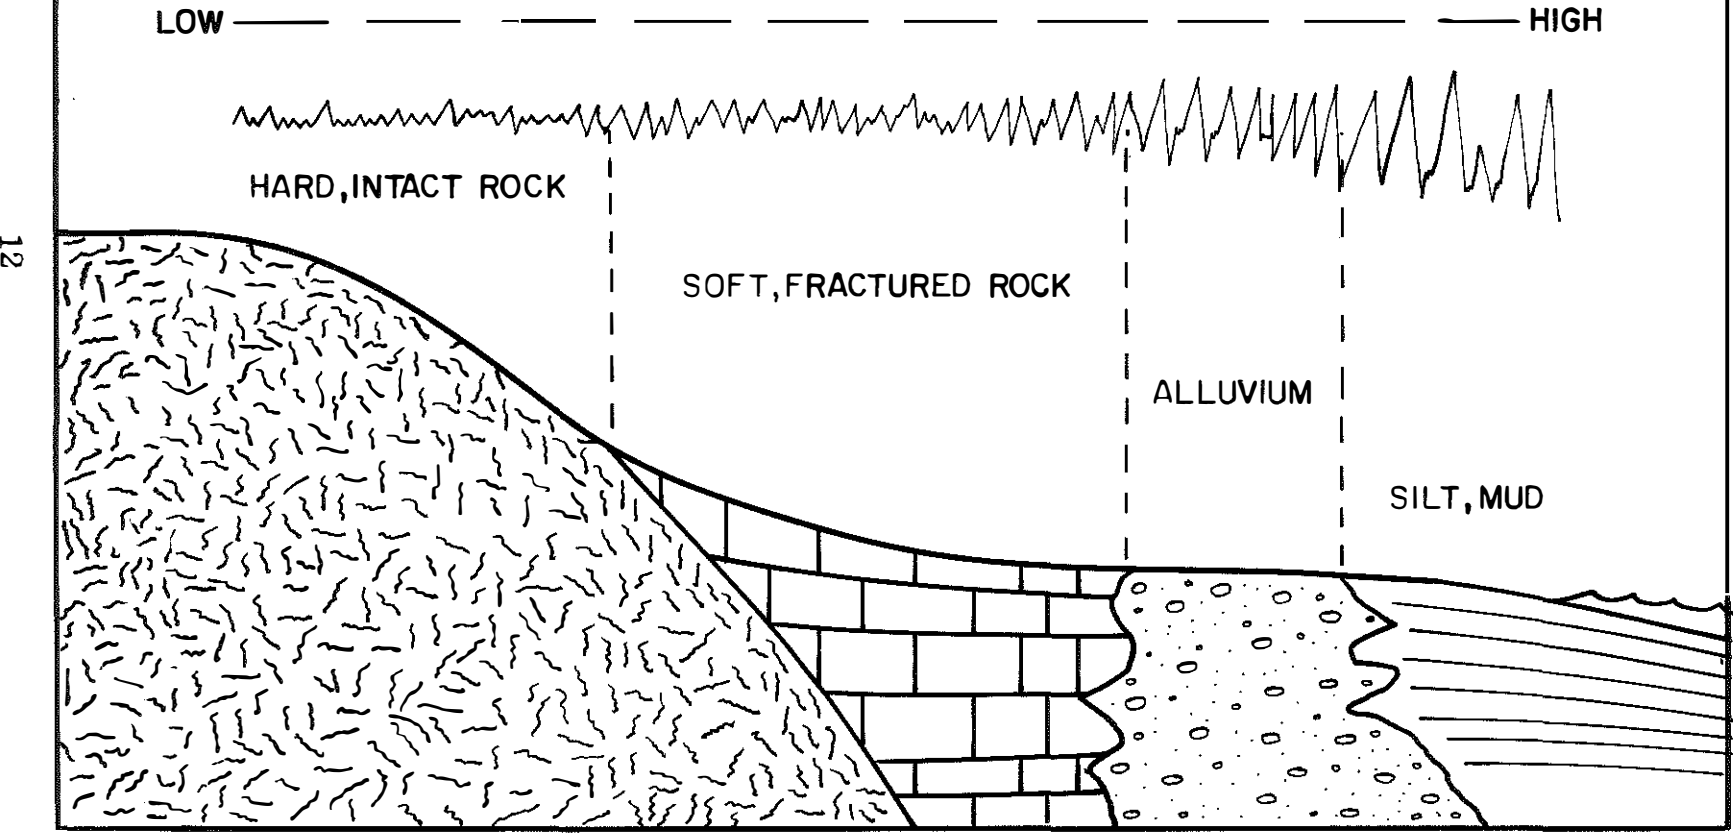
Figure 2 : Amplification of shaking in softer rock & soil during an earthquake.

Soil maps for Ballard County indicate that there are large amounts of alluvium present throughout the county. Alluvium is a loose, fine-grain soil which is deposited by flowing water such as creeks and rivers. Due to the nature of the alluvium, ground motions at the surface of the soil can be many times greater than those within the underlying bedrock and temporary liquefaction can occur (Figure 2). An alluvium map for Ballard County is shown in Figure 3.
