Research Report  
KTC-89-12

EARTHQUAKE HAZARD MITIGATION OF  
TRANSPORTATION FACILITIES  
FOR DAVIESS COUNTY

May 1989

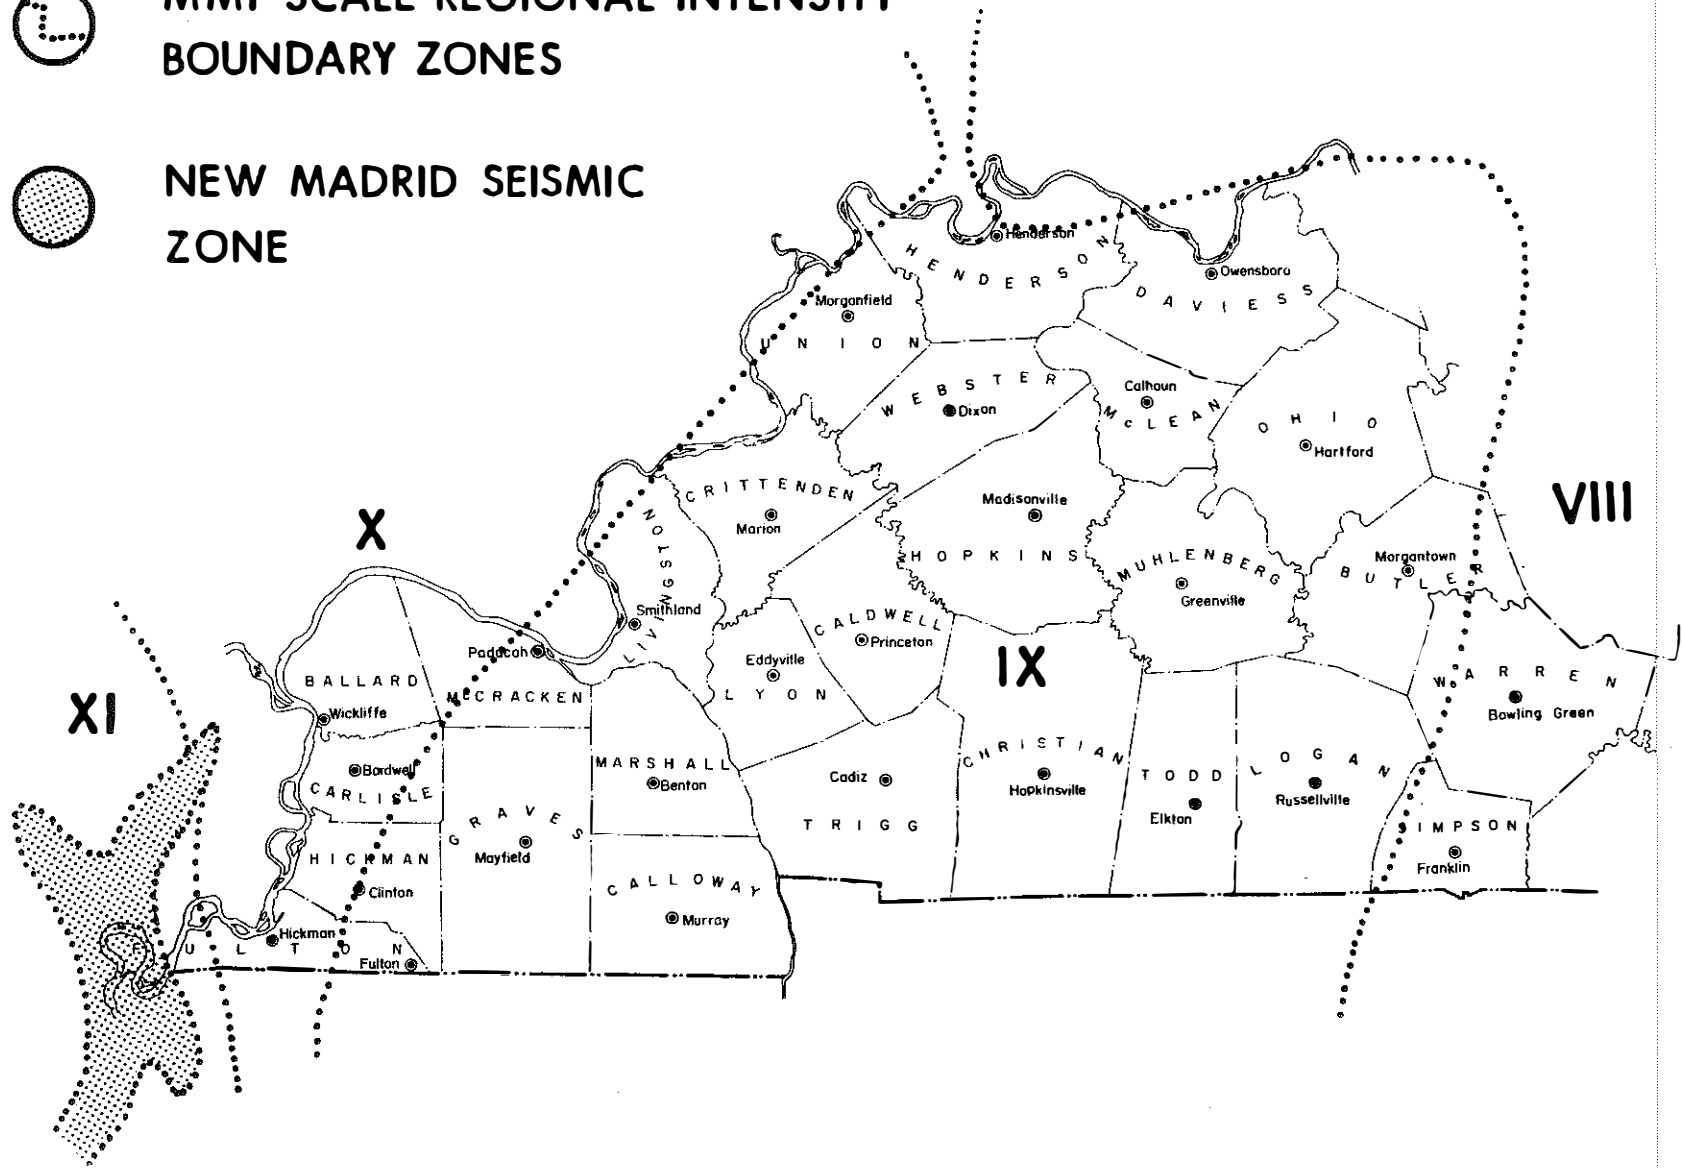
Figure 1: The twenty-six counties included in this study area.

Seismic Zone. Figure 1 indicates that Daviess County is located in the IX and the VIII bands of the MMI scale. Approximately 98 percent of Daviess County is located within the IX band. This indicates considerable damage could occur in Daviess County in the event of a major earthquake.

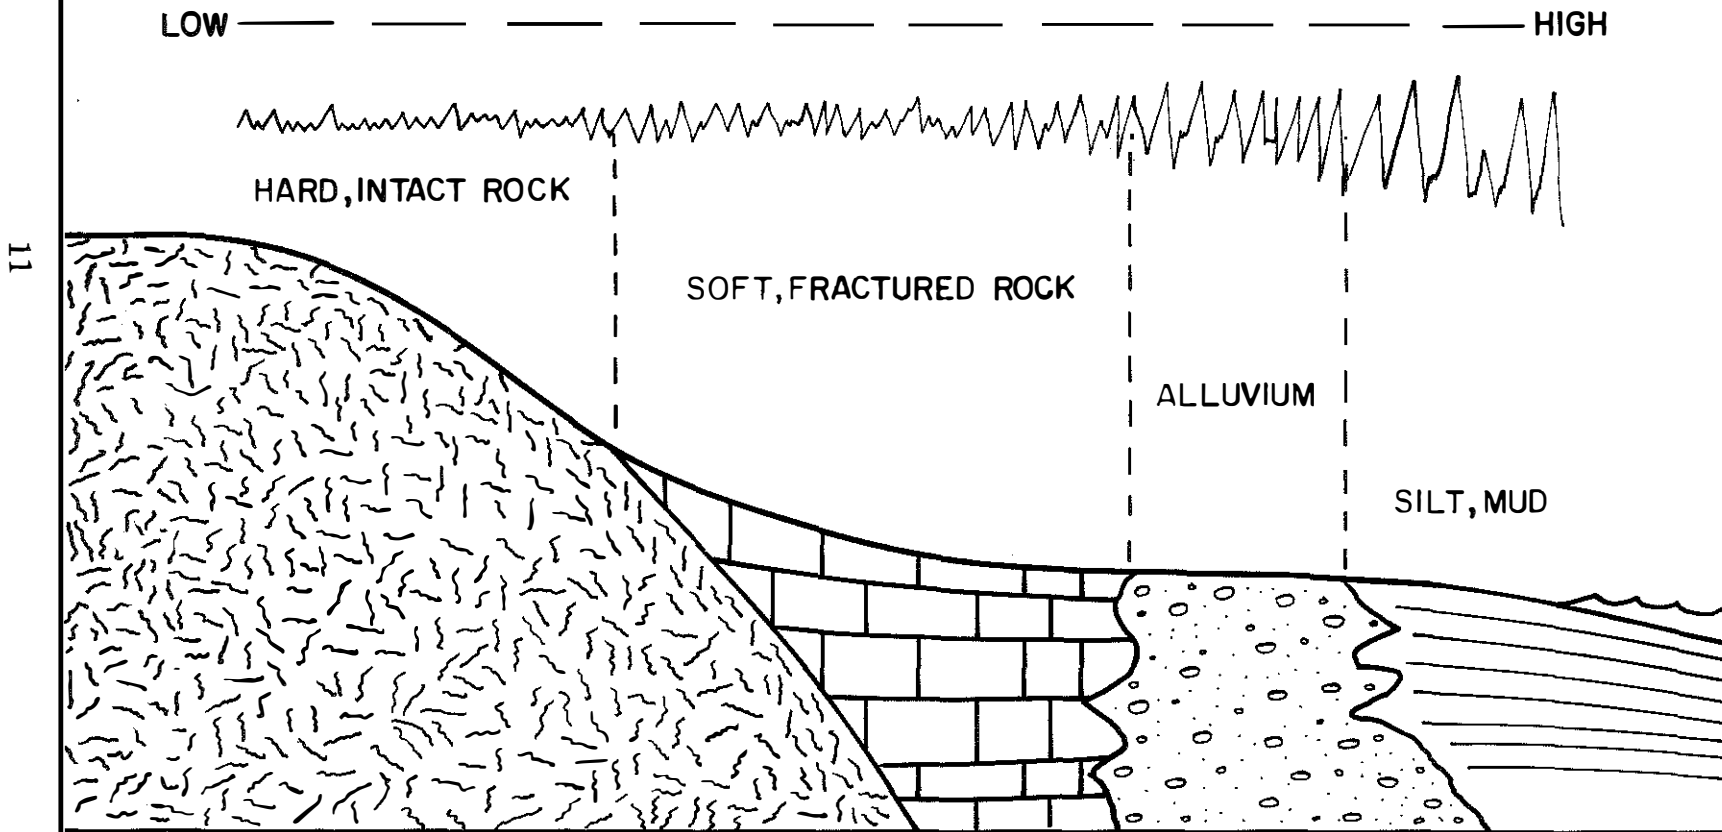
Figure 2 : Amplification of shaking in softer rock & soil during an earthquake.

Soil maps for Daviess County indicate that there are large amounts of alluvium present throughout the county. Alluvium is a loose, fine-grain soil which is deposited by flowing water such as creeks and rivers. Due to the nature of the alluvium, ground motions at the surface of the soil can be many times greater than those within the underlying bedrock and temporary

liquefaction can occur (Figure 2). An alluvium map for Daviess County is shown in Figure 3.
