COMMONWEALTH OF KENTUCKY  
DEPARTMENT OF HIGHWAYS  
FRANKFORT

HENRY WARD  
COMMISSIONER OF HIGHWAYS

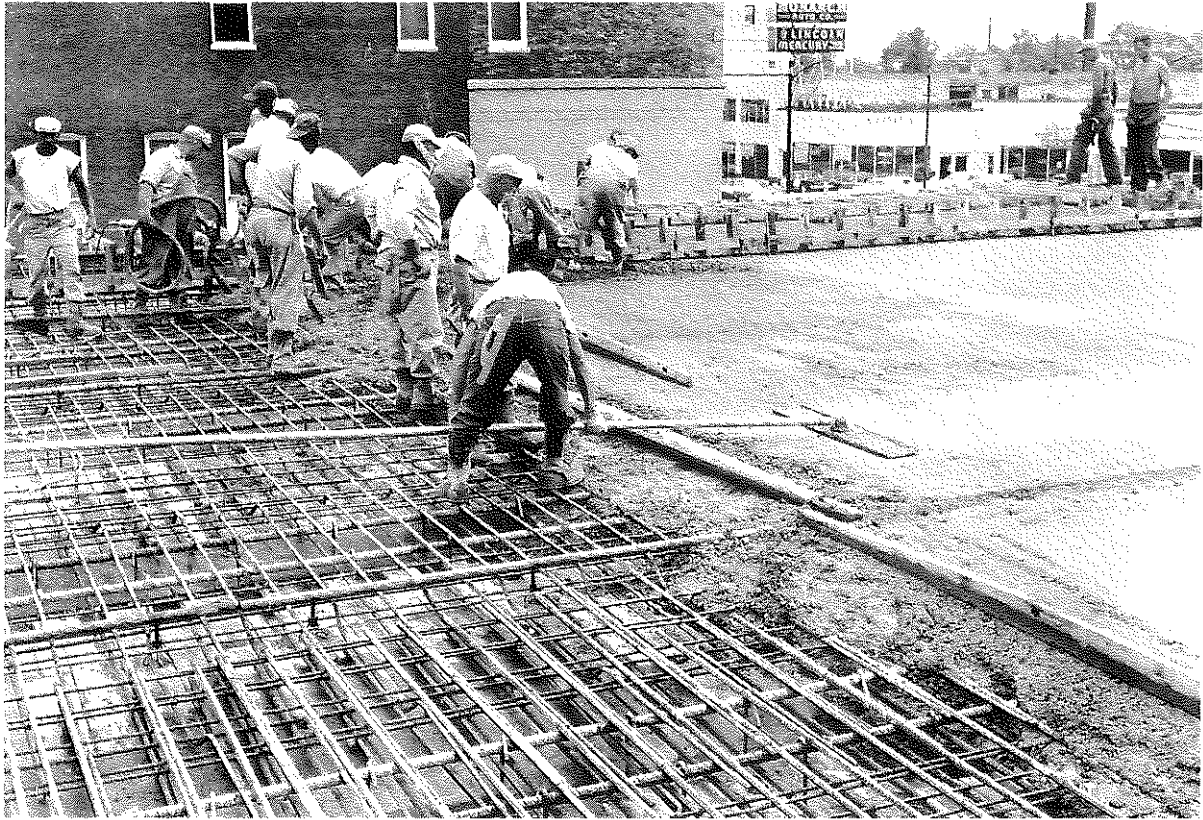
Fig. 3. Same Bridge as Shown in Figs. 1 and 2, but a Different Pour. Note that here the pipe templates are longitudinal to the survey and have been pulled ahead of the pour -- leaving a round groove to be filled in. Note, also, the men standing in the gutter line to manipulate the concrete in the side forms. Final finishing follows the rough leveling shown here ("An Evaluation of Four Retarding Admixtures in Structural Concrete," by Milton Evans, Jr., and Ralph R. Waddle, Feb. 1962; RHMRL, Vol. XVII, Part I, p. 228). It has been observed that scaling or erosion tends to occur along the lines where the templates have been removed and along the gutter line.

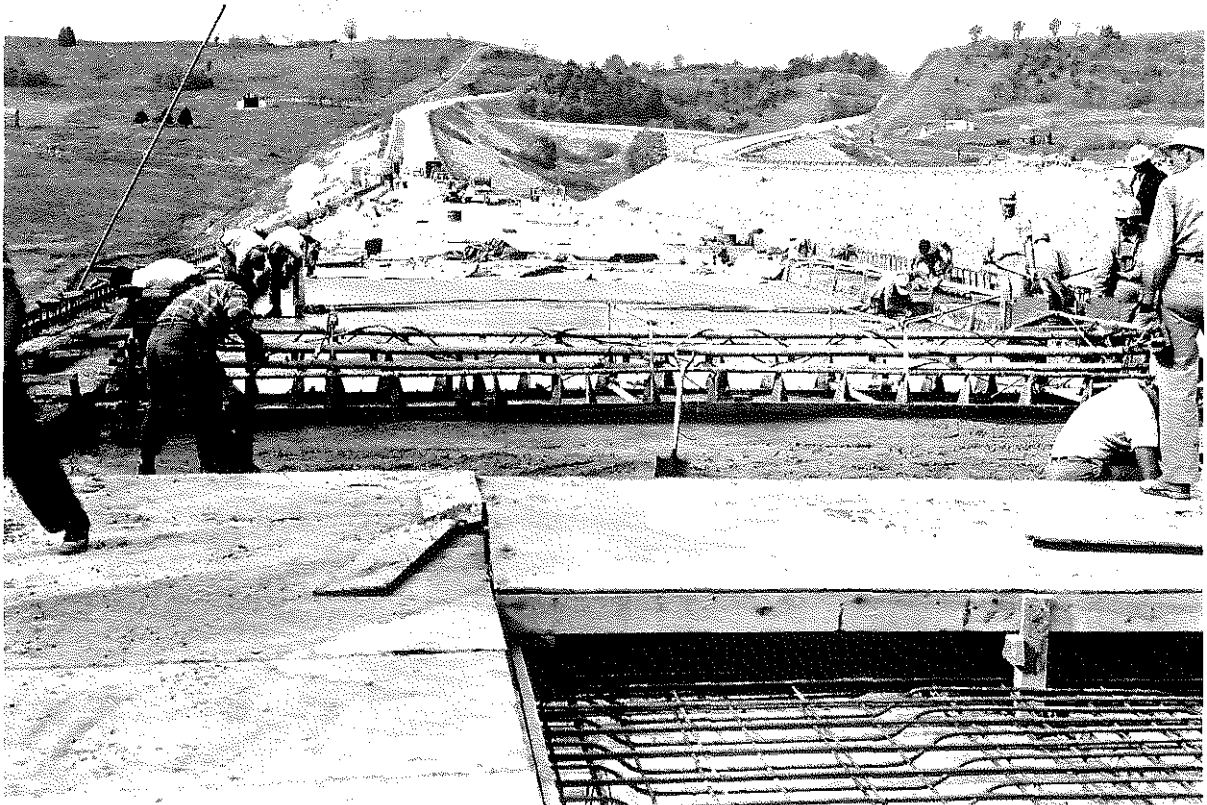
Fig. 4. I-64-4(8)54; Eastbound Bridge over Kentucky River, Franklin County, October, 1962. Full-width, vibrating screed rides on pipe templates set longitudinally about one foot from the curb wall. Note workmen standing in the gutter on each side. Set-retarding admixture (Sika's Plastiment) used in concrete on warm days. Note: A vibrating screed was used about two years previously on the Veach Dale Interchange Bridge, I-64, near Shelbyville (Sta. 990+00). Also, present plans provide for the use of a Rex finisher on the Louisville-Jeffersonville Bridge (I-65).

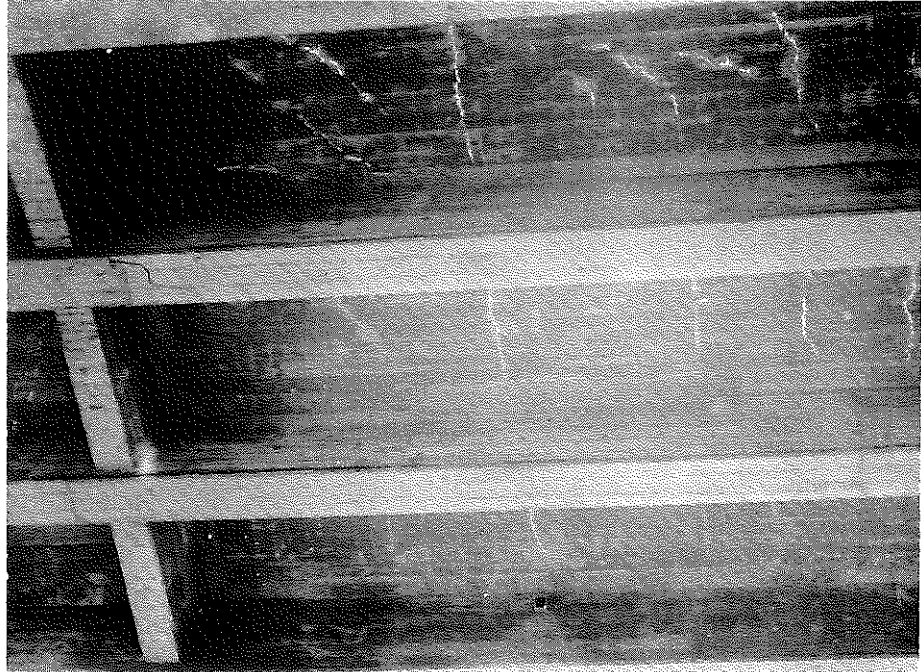
Fig. 5. Tell-Tale Signs of Cracks (Efflorescence) in Comparatively New Deck (State Route 8, Bracken County, Sept. 3, 1957); Cracks Were Sealed in Fall of 1959; Sika Epoxy Bonding Compound.

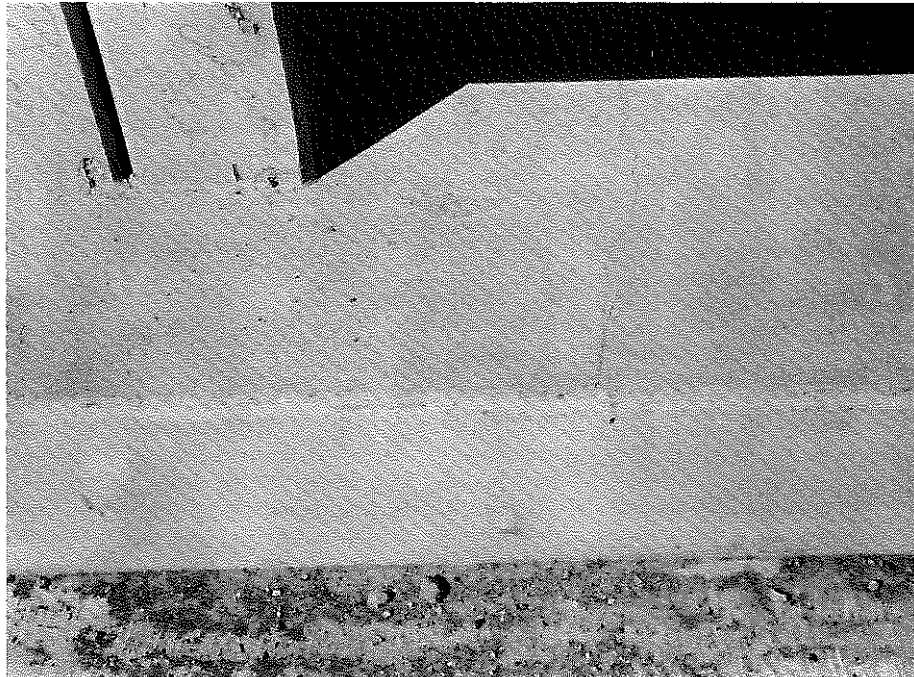
Fig. 6. Early Cracking in Curb-Section; State Route 8, Bracken County, Sept. 3, 1957.

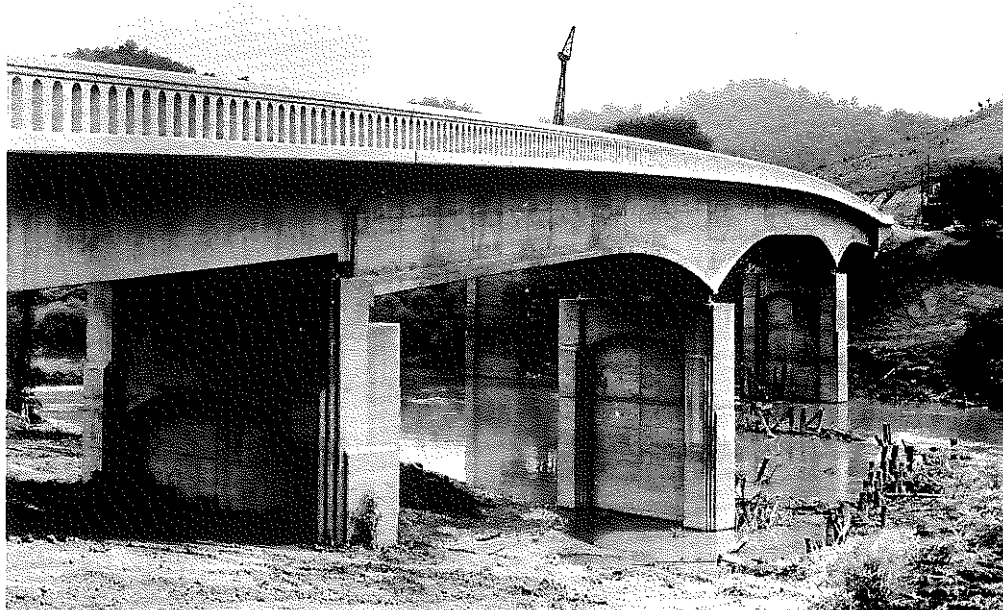
Fig. 7. Levisa Fork Bridge, Ky. 40, S-215(3). Cracks developed in the safety-walk when the false work wedges were removed, Dec. 18, 1957 (Ref.: Memo. to Area Engineer from Director of Construction, 12-20-57; Research Division File C.2.8.). Cracks were sealed, June-July, 1958.

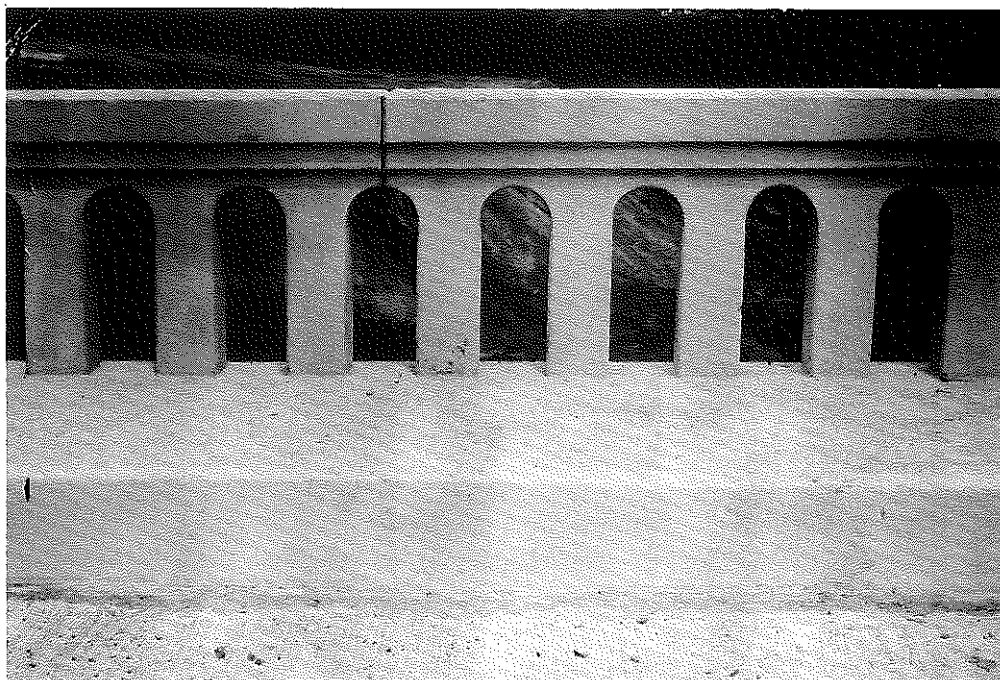
Fig. 8. Levisa Fork Bridge. Cracks patched with Relcote 60 (epoxy) and sand (Ref.: "The Use of Epoxy Resin for Sealing Cracks in a Reinforced Concrete Bridge," by Milton Evans, Jr., July, 1959; RHMRL, Vol. XIV, p. 311).

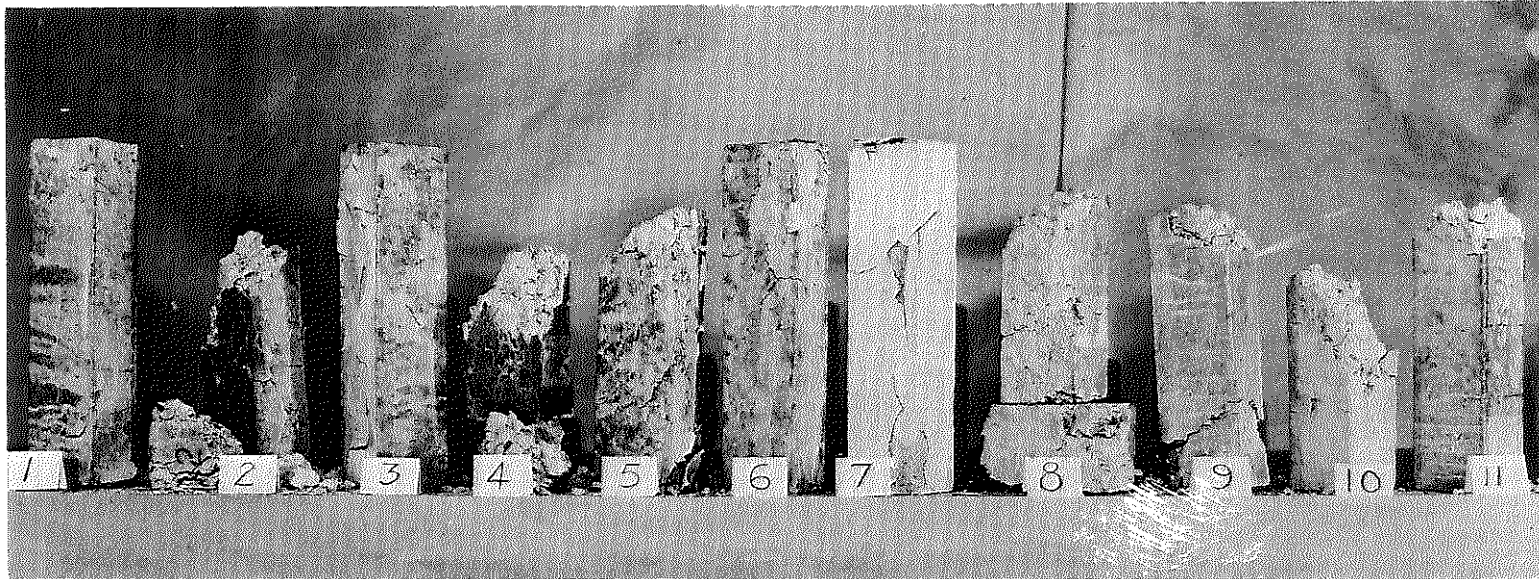
Fig. 9. Concrete Beams, 3x4x16 in.; Cured, Air-Dried, and Coated; Frozen in Air, Thawed in Water; Specimen No. 1, One Coat Meyer 402, Amine-Cured Epoxy (2-component); No. 2, Same as No. 1 (2 Coats); No. 3, Same as No. 1 (3 Coats); No. 4, Meyer 402-1, Cured with Modified Amine (1 Coat); No. 5, Same as No. 4 (2 Coats); No. 6, Same as No. 4 (3 Coats); No. 7, Meyer 401, Filled Epoxy-Amine Paste (Also Used for Caulking Cracks, Salt River Bridge); No. 8 and No. 9, George W. Whitesides; 56-E-2, Polystyrene; No. 10 and No. 11, Control Specimens (Uncoated). Control Specimens sustained 562 cycles of F & T; 4, 5, and 7 sustained 865 to 900 cycles; all others were approximately equal to or inferior to the Control Specimens of additional series (Not Shown), only Guardkote 140 and other thick-build coatings exceeded the durability of the Control Specimens. (July-August, 1960)

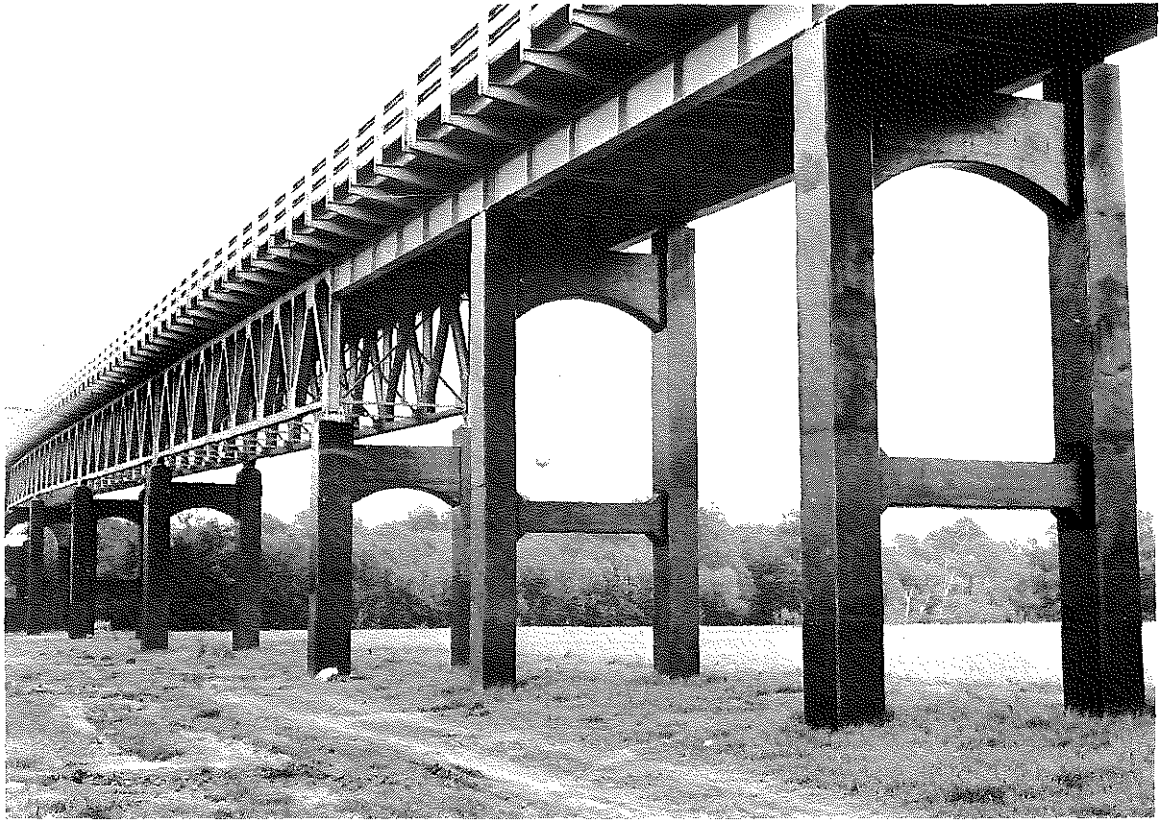
Fig. 10. Green River Bridge, US 62, at Rockport; Tops of Some Piers Repaired with Gunitite; Widespread Surface-Cracking on all Piers; Coated with Poxitar (Coal Tar-Epoxy, Amine-Cured, Inertol Co.) by Bridge Maintenance Crew; Work began in Fall of 1959; Some Gunitite Repairs Made on the Deck. The piers are fully encapsulated with the black coating.

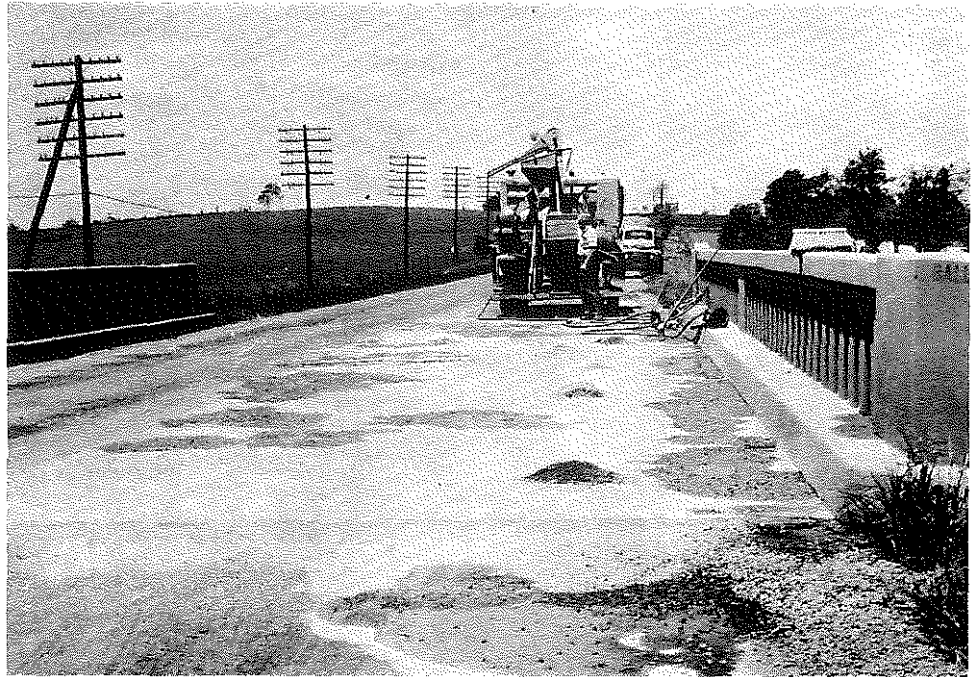
Fig. 11. Ball's Fork Bridge, US 150, Danville-Stanford Road. Gunite Repairs were made in right-hand lane; Daraweld-mortar used to patch left lane (eastbound).

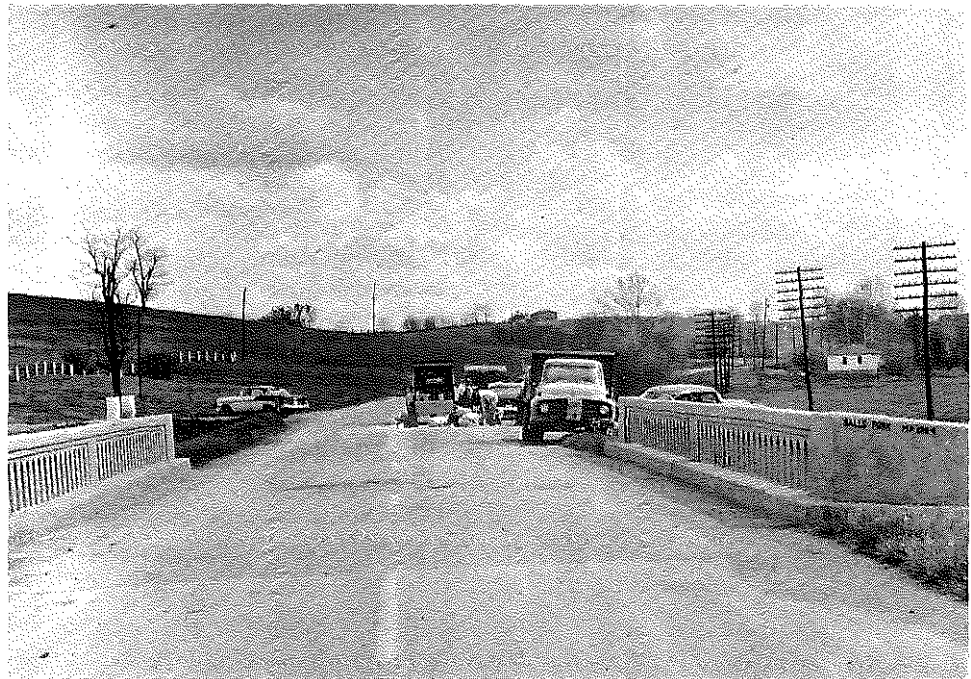
Fig. 12. Ball's Fork Bridge, Summer 1957; Note Spalled Patches in Deck, Gunite in Left Lane.

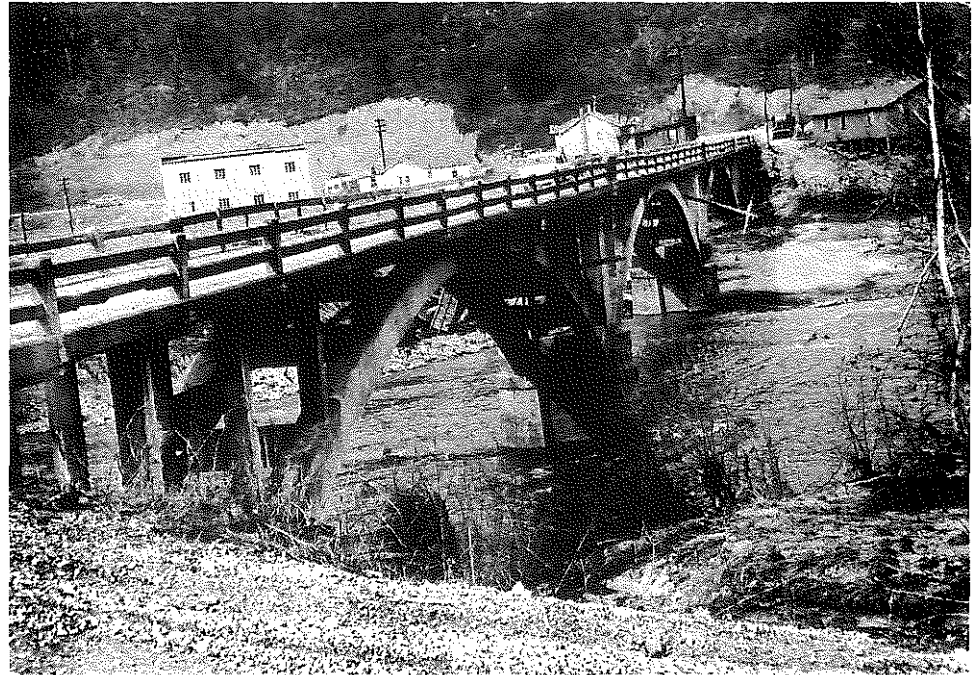
Fig. 13. Russell Fork Bridge, Marrowbone-Ashcamp Road, Pike County, Ky. 195.

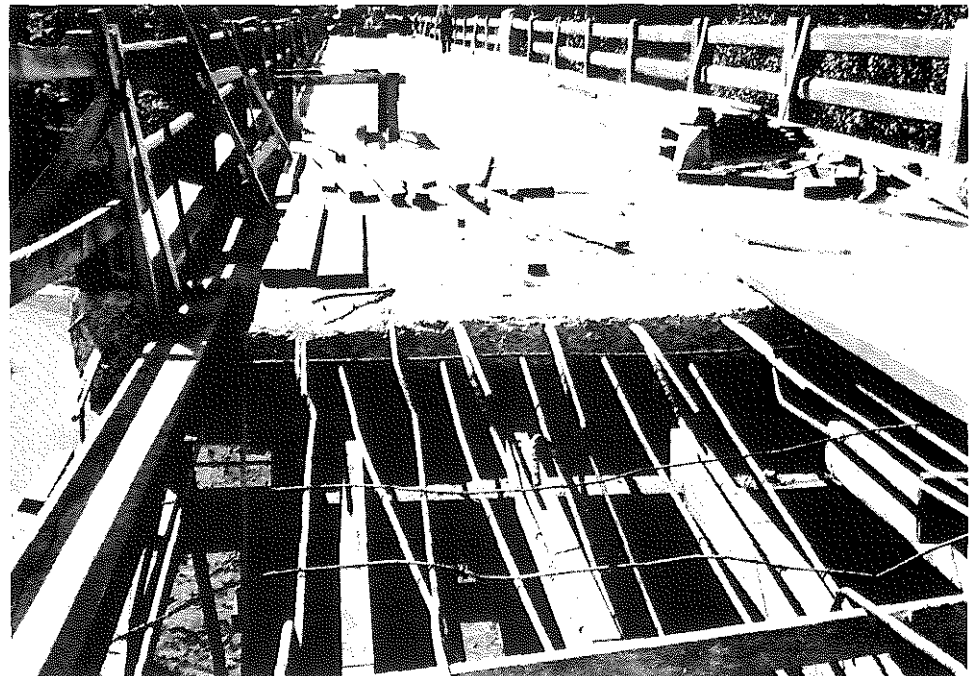
Fig. 14. Section of Deck Removed, Replaced with New Concrete, Russell Fork Bridge.

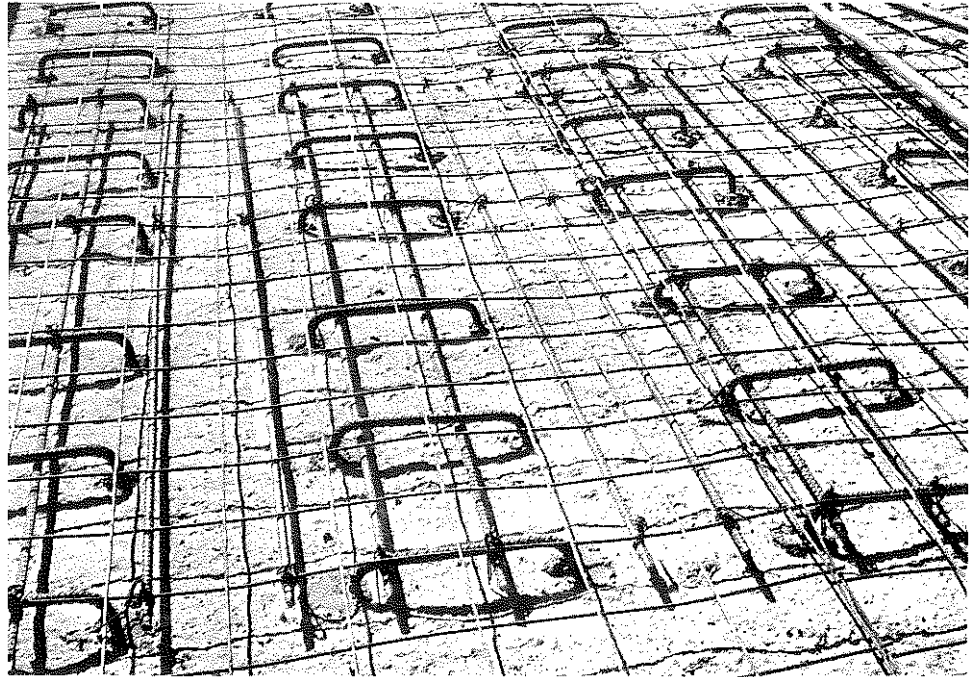
Fig. 15. Russell Fork Bridge, Deck Chipped Down, Anchors or Stirrups Grouted into Deck, and Overlaid with Concrete.

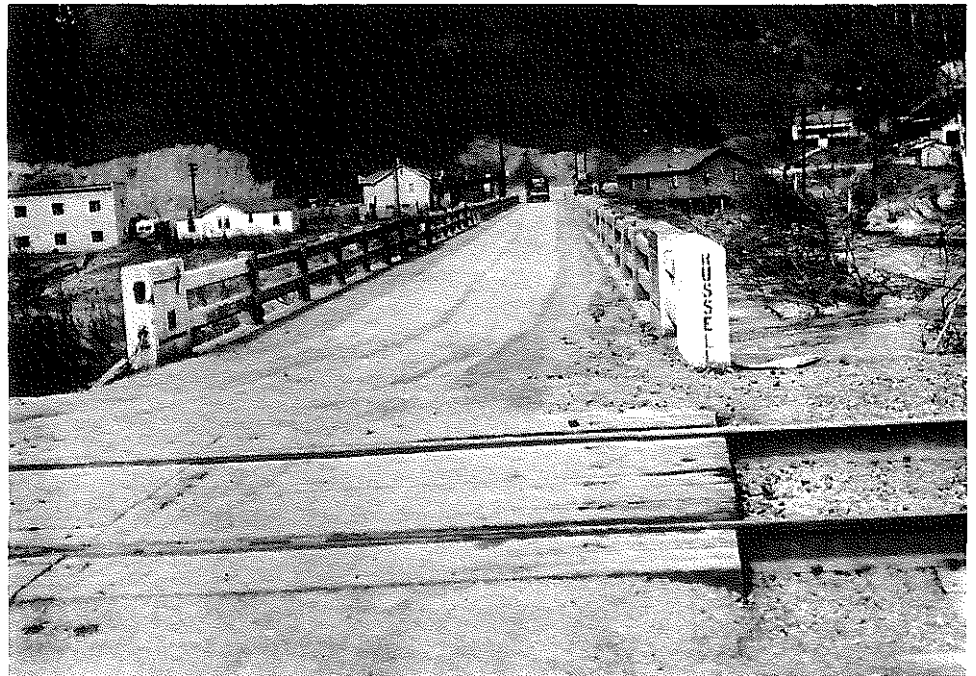
Fig. 16. East End of Russell Fork Bridge After Repairs. Daraweld was used in the first 48 feet.

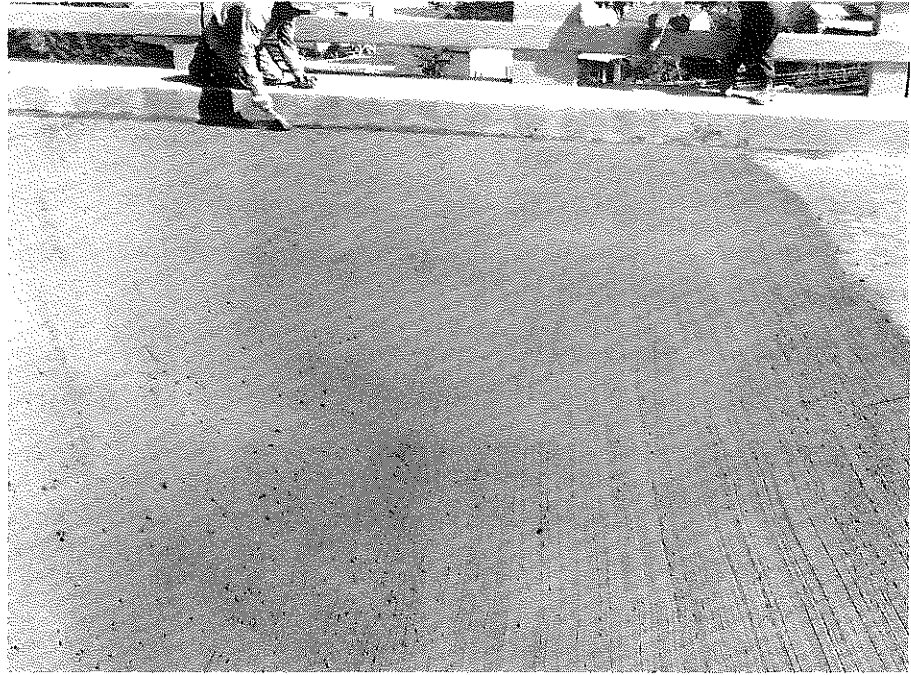
Fig. 17. Railroad Overpass, Beuchel, US 31-E; Daraweld-Mortar, Thin Patch.

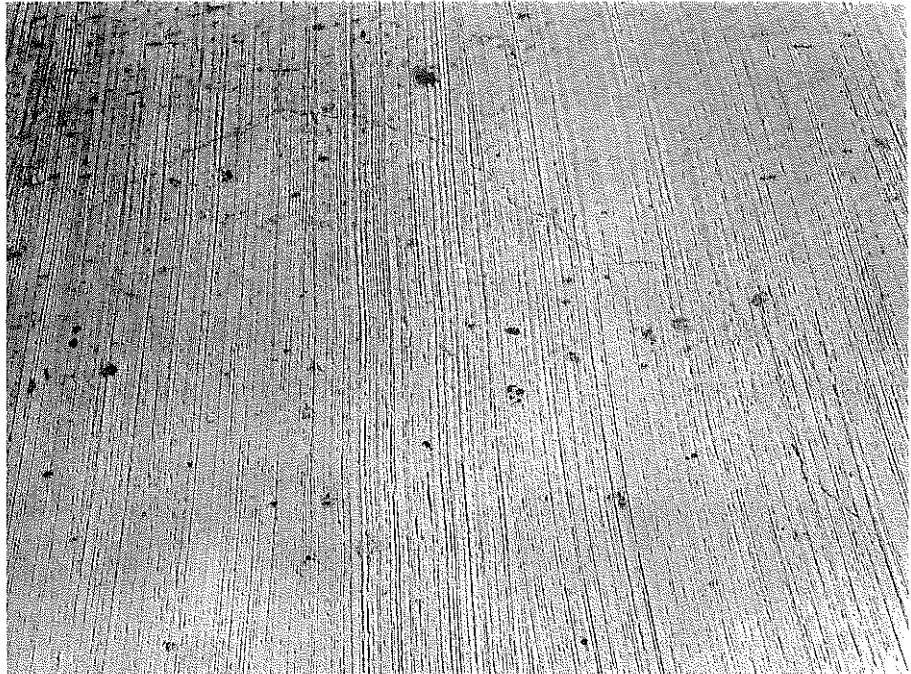
Fig. 18. Reappearance of Cracks, First Year.

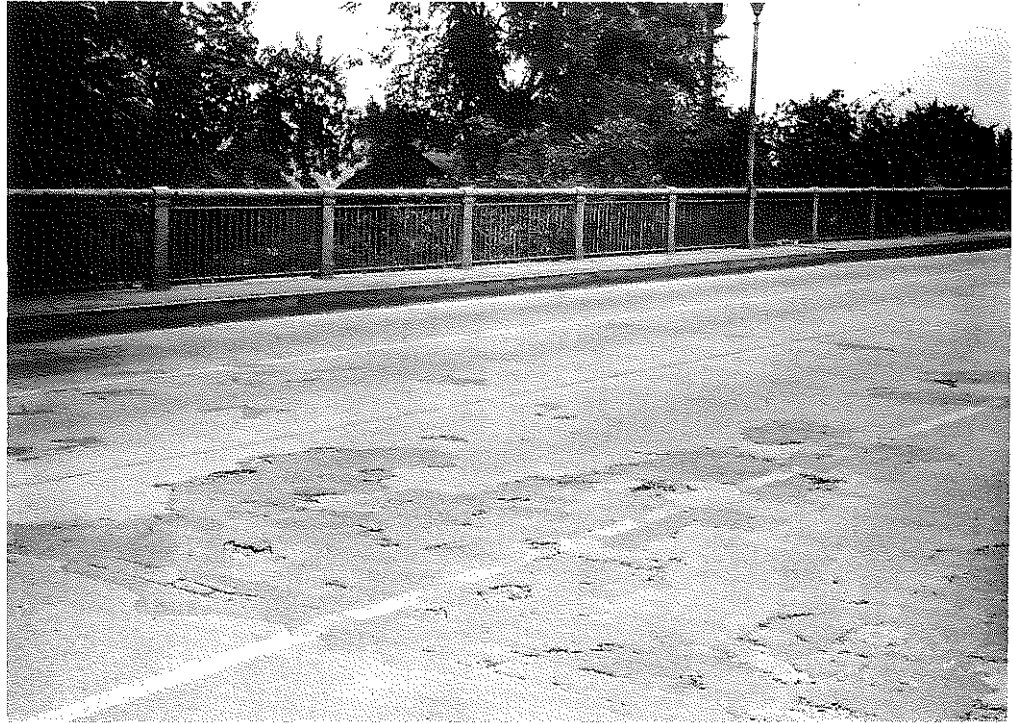
Fig. 19. Clark Memorial Bridge, North Ramp, Showing Bituminous Patches, August, 1958.

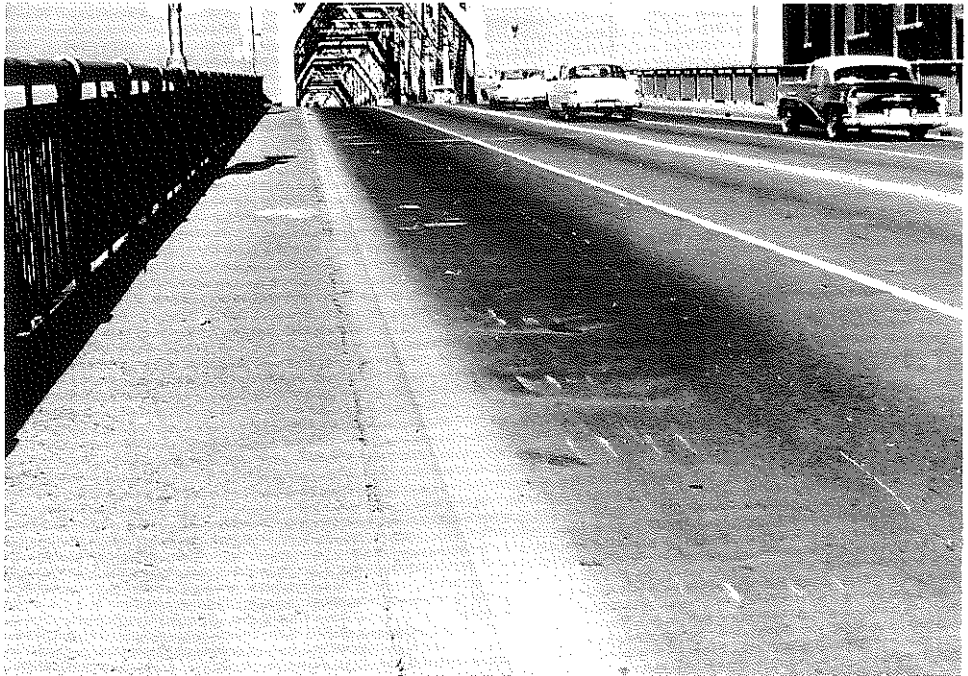
Fig. 22. Clark Memorial Bridge, South Ramp, November, 1959.  
Ripples in foreground are caused by deep sand-asphalt  
patches; one year after surfacing with sand-asphalt.

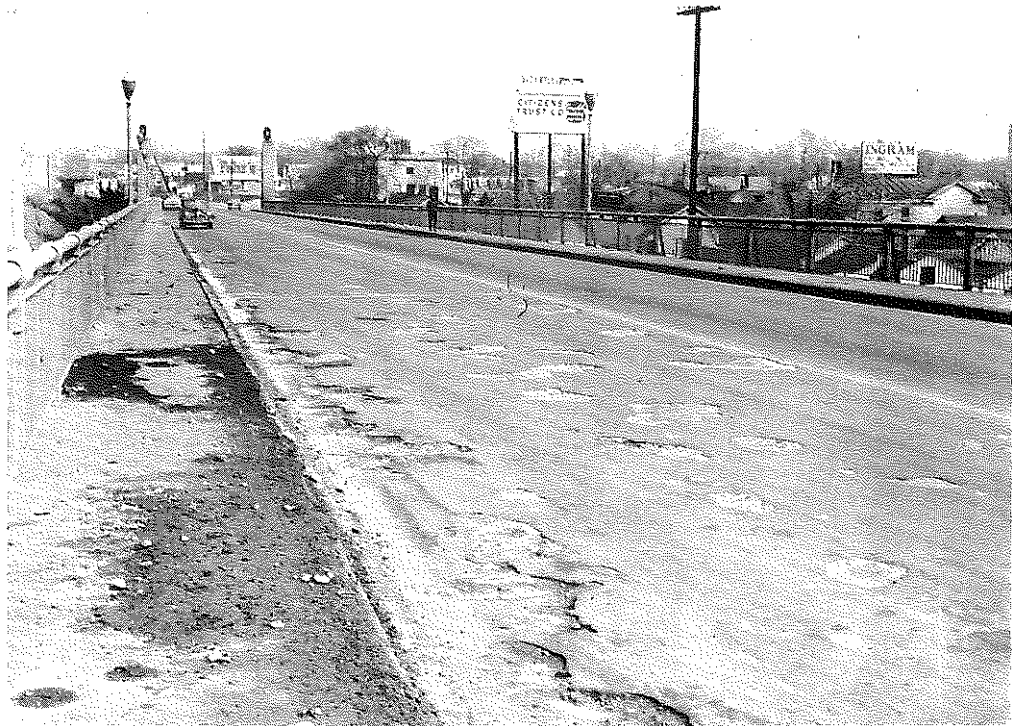
Fig. 23. Clark Memorial Bridge, North Ramp, March, 1960.

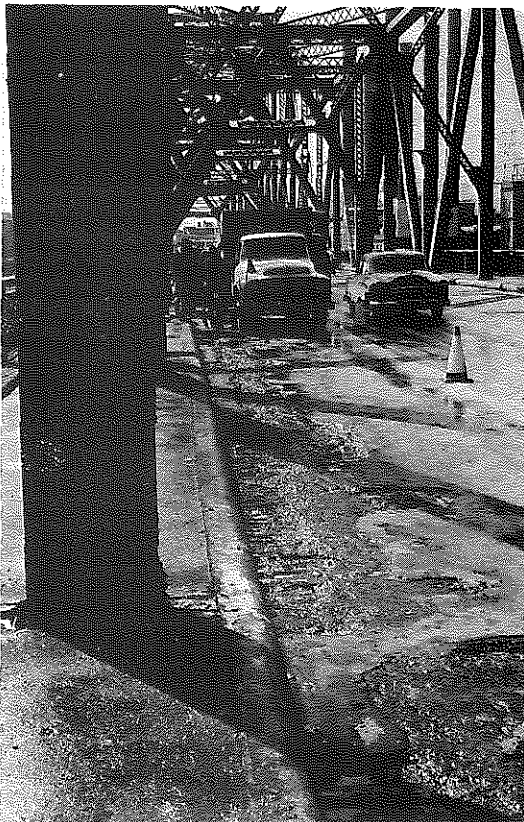
Fig. 25. Clark Memorial Bridge, Removing Dead Material Preparatory to Patching, March, 1960.

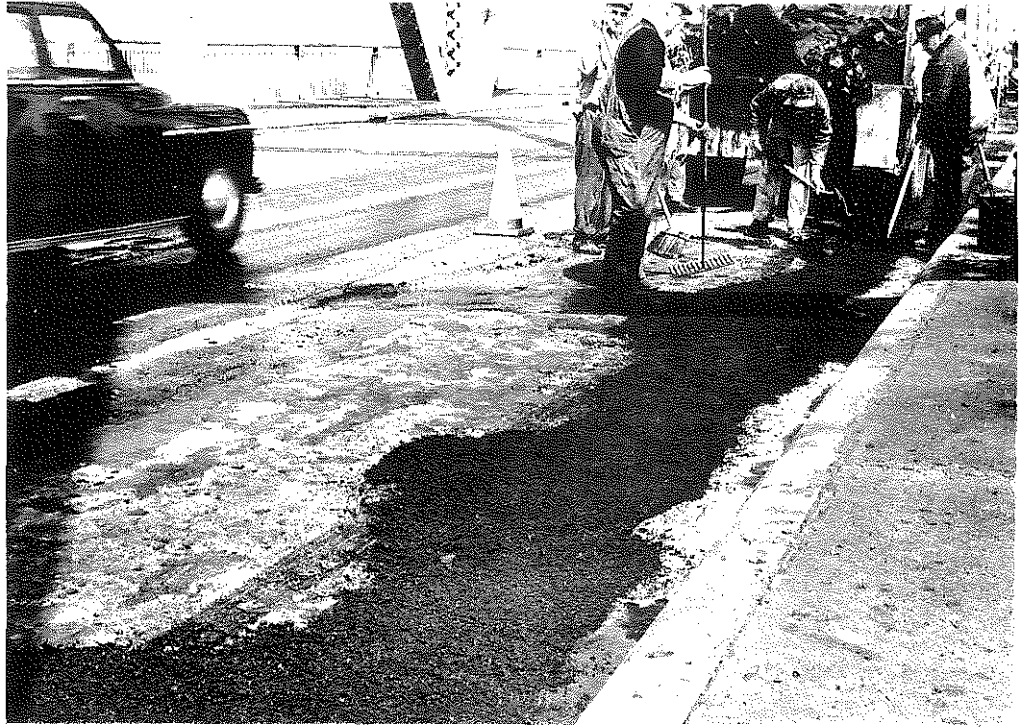
Fig. 27. Clark Memorial Bridge, Patching Deep Spalls, Hot-Mix Sand-Asphalt, March-April, 1960.

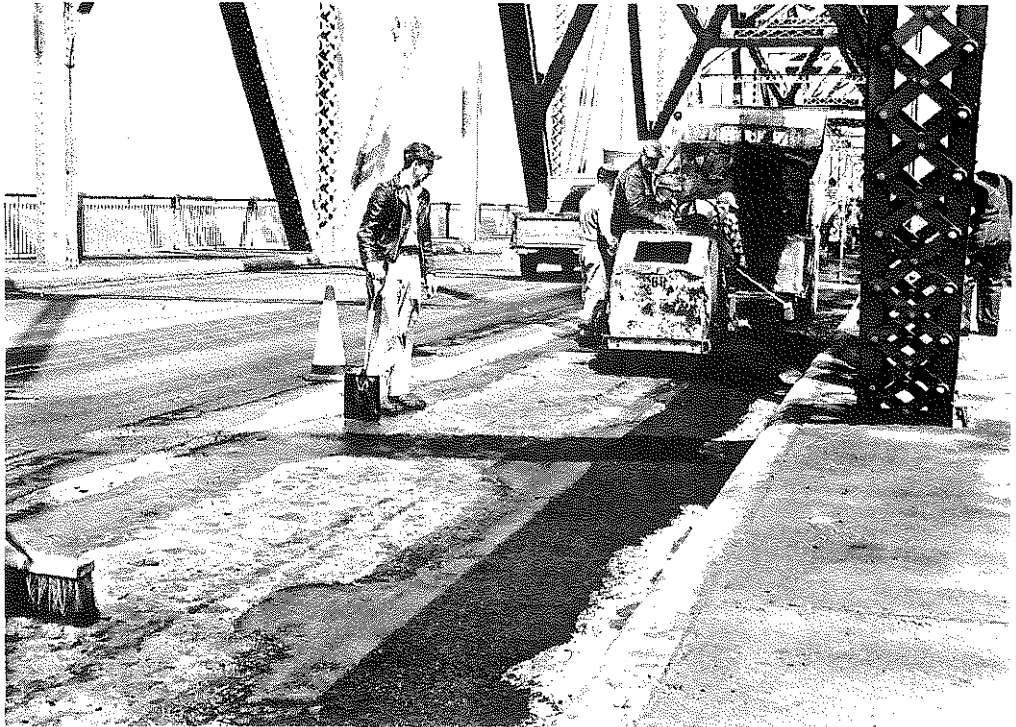
Fig. 28. Same as Above, Showing Rolling of Patch Material.

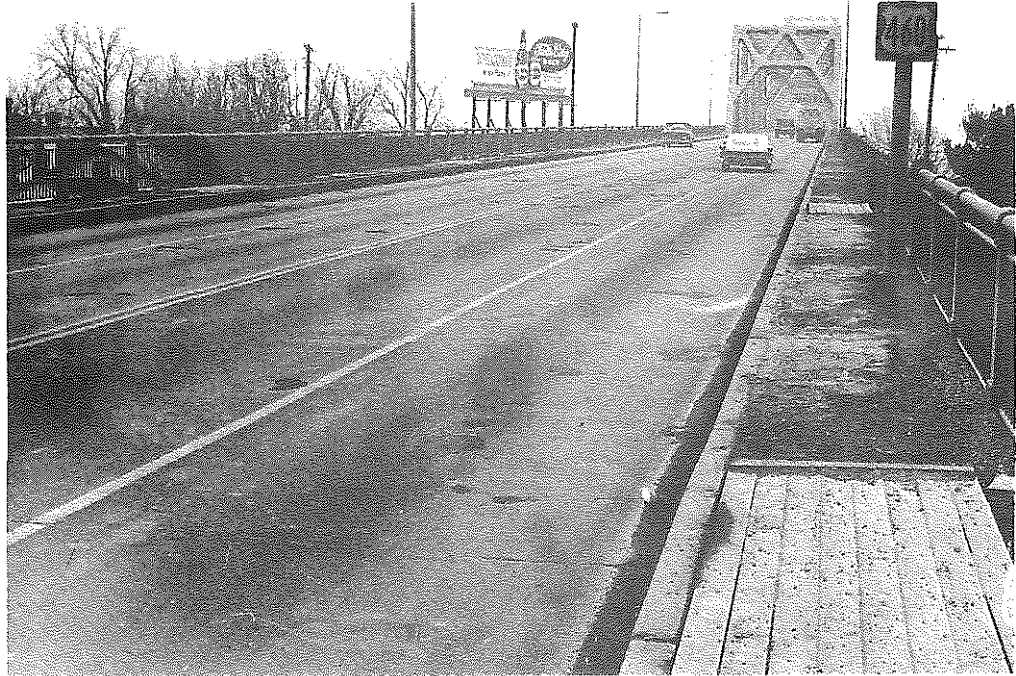
Fig. 29. Clark Memorial Bridge, January, 1962, After Black Beauty Slag Seal. Note Patches and Deterioration of Sidewalk.

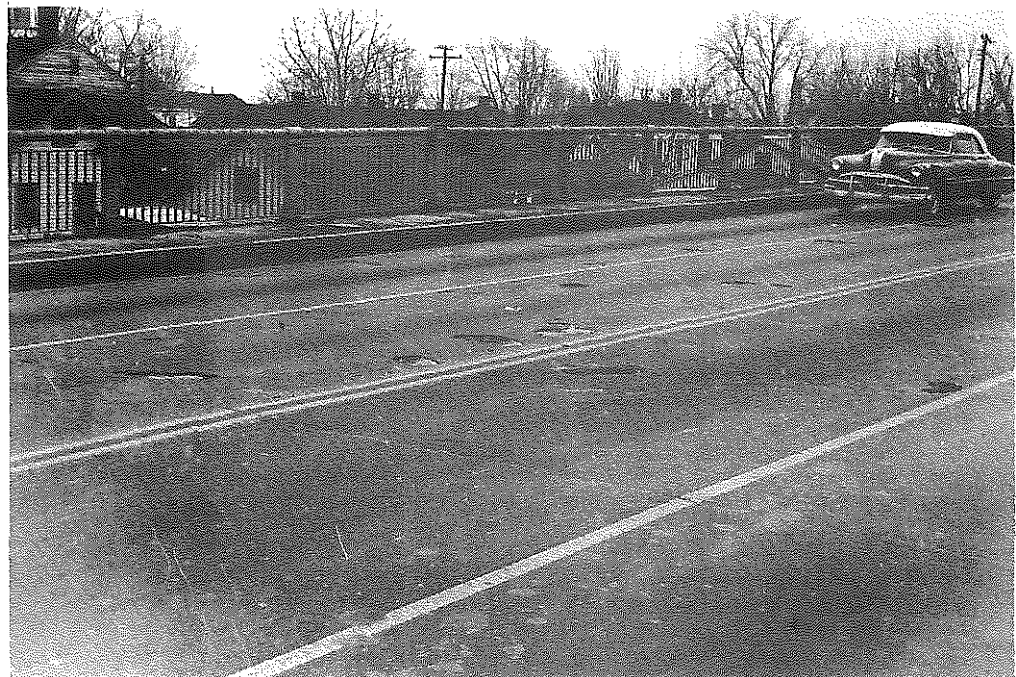
Fig. 30. Same as Above, Slightly Different View.

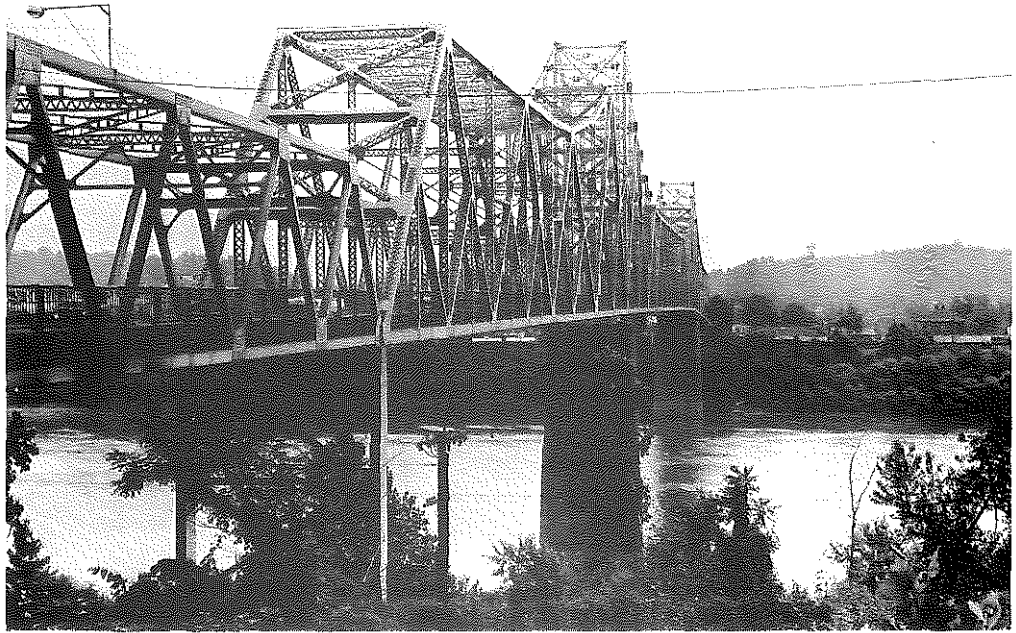
Fig. 31. Ashland-Coal Grove Bridge.

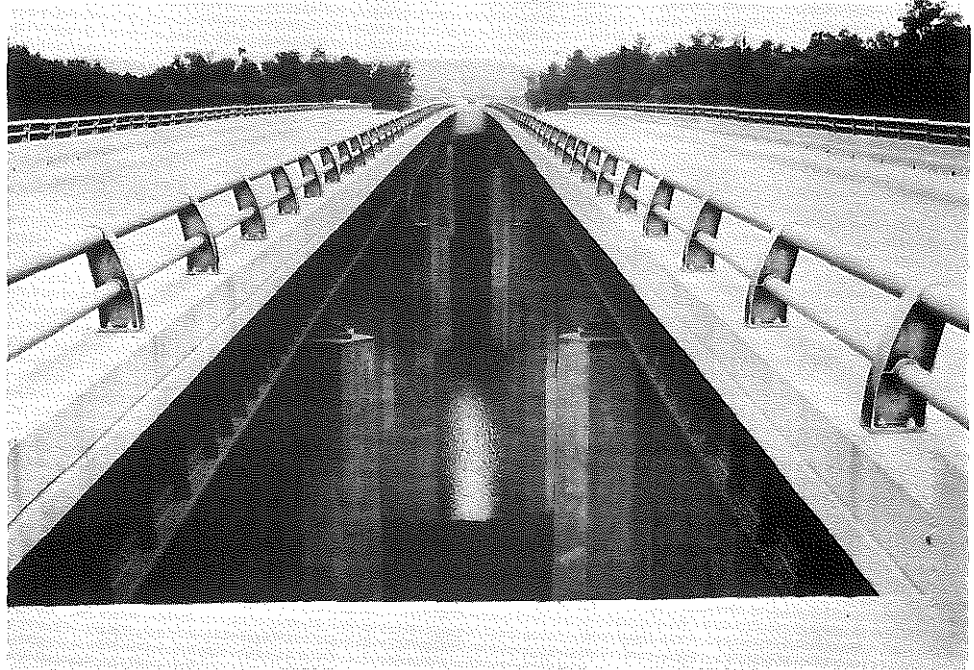
Fig. 39. Twin Bridge, Salt River, Kentucky Turnpike (Looking North).

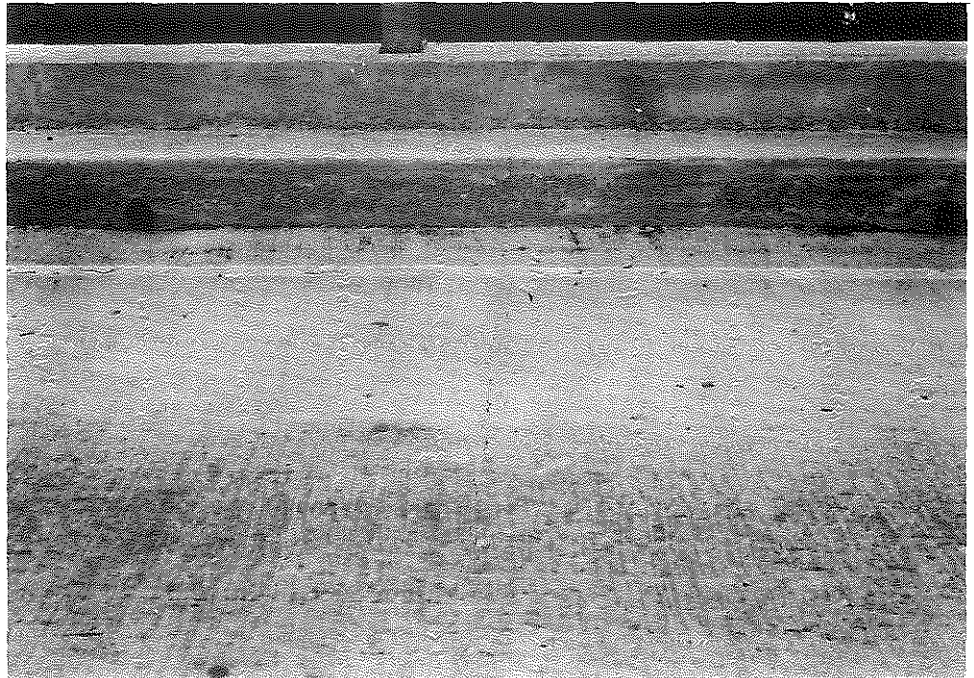
Fig. 40. Salt River Bridge, Kentucky Turnpike; Scaling Along Curb and Plinth, Cracking in Deck.

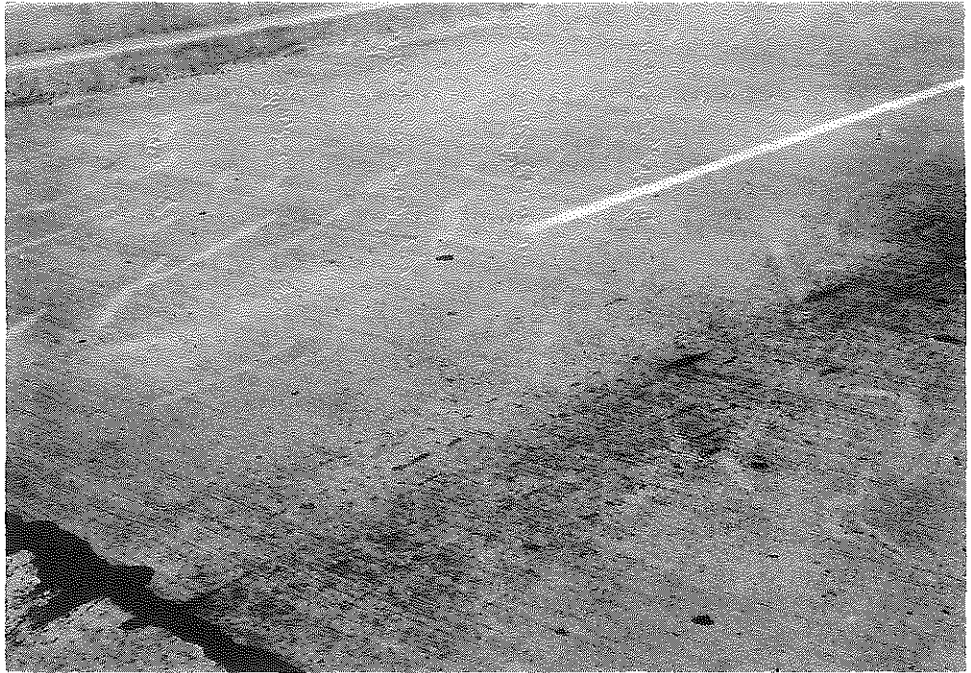
Fig. 41. Salt River Bridge, Kentucky Turnpike; Shrinkage Cracks in Deck, Outlined.

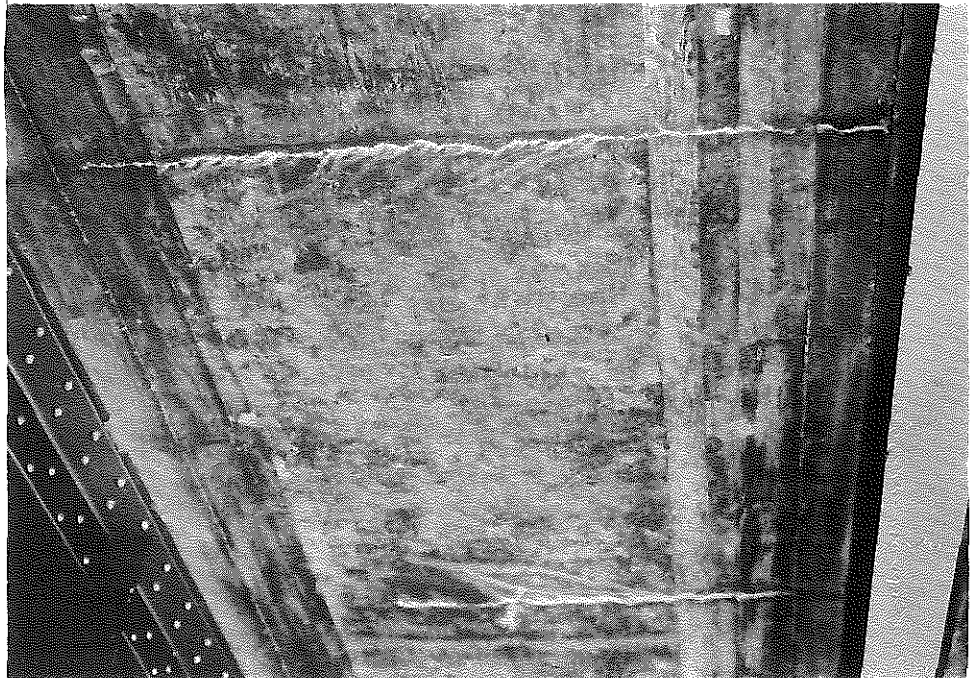
Fig. 42. Salt River Bridge, Kentucky Turnpike; Transverse Cracks, Underneath Side of Deck, Showing Deposits of Salt.

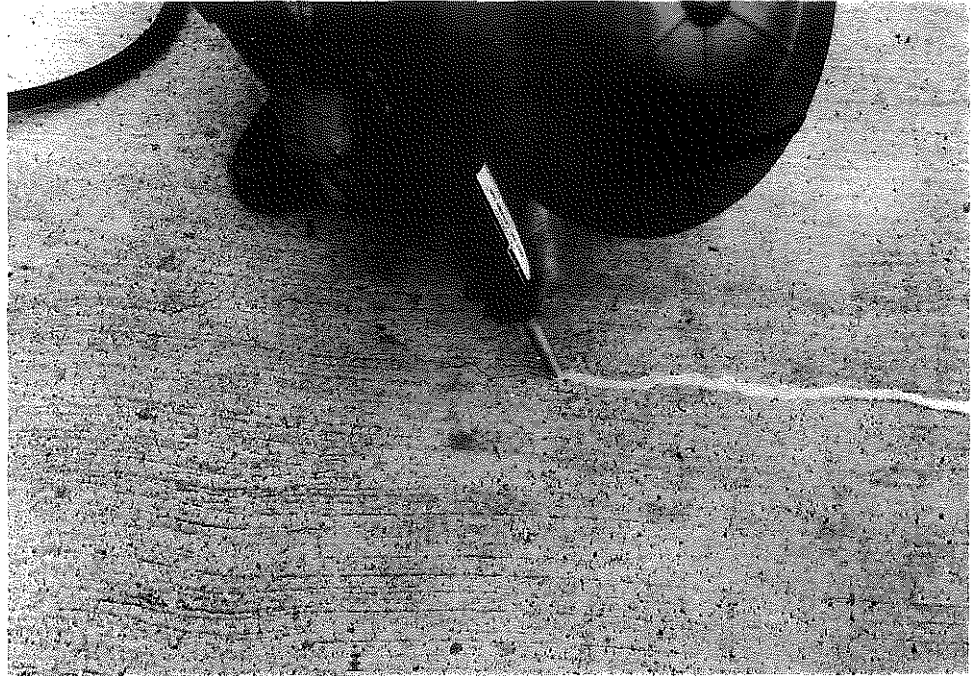
Fig. 46. Salt River Bridges, Kentucky Turnpike; Caulking Cracks, Epoxy Mastic Caulking, Meyer 401 (Filled Epoxy), (7-13-60).

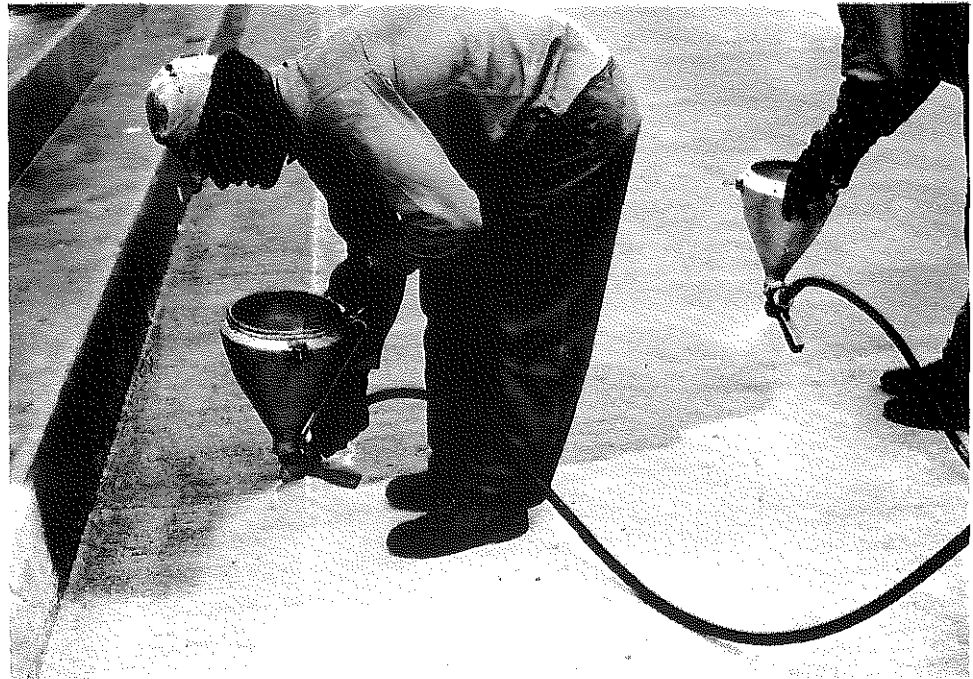
Fig. 47. Salt River Bridges, Kentucky Turnpike; Quickspray Guns (7-13-60).
