COMMONWEALTH OF KENTUCKY  
DEPARTMENT OF HIGHWAYS  
FRANKFORT

HENRY WARD  
COMMISSIONER OF HIGHWAYS

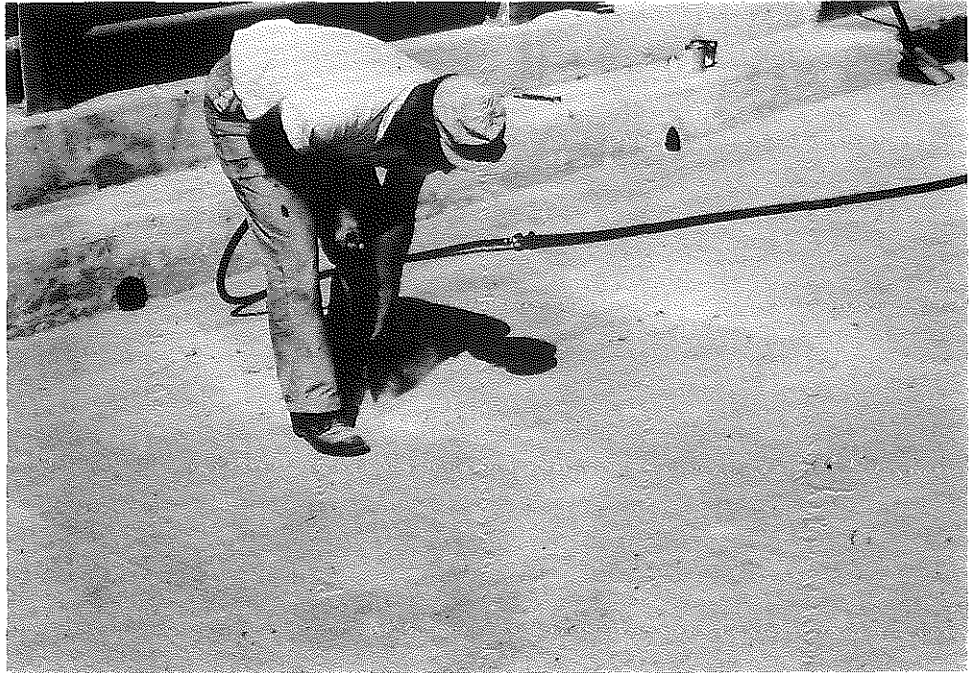
Fig. 53. Salt River Bridge, Kentucky Turnpike; Chipping Cracks, Preparatory to Sealing Them; Penntrowel Section, 8-31-60.

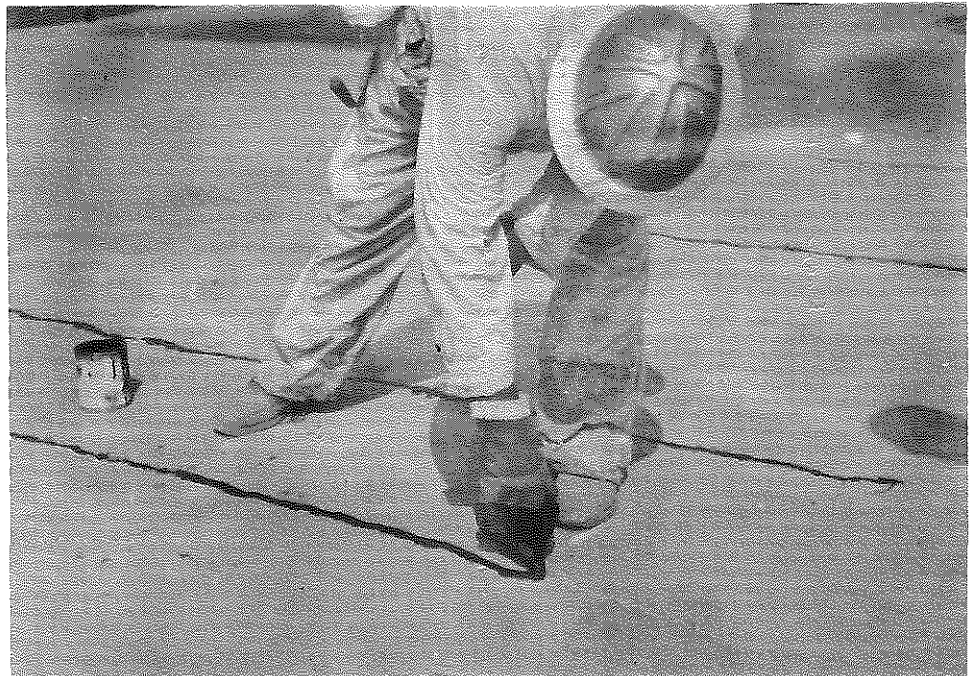
Fig. 54. Salt River Bridge, Kentucky Turnpike; Sealing Cracks with Furof Resin; Penntrowel Section.

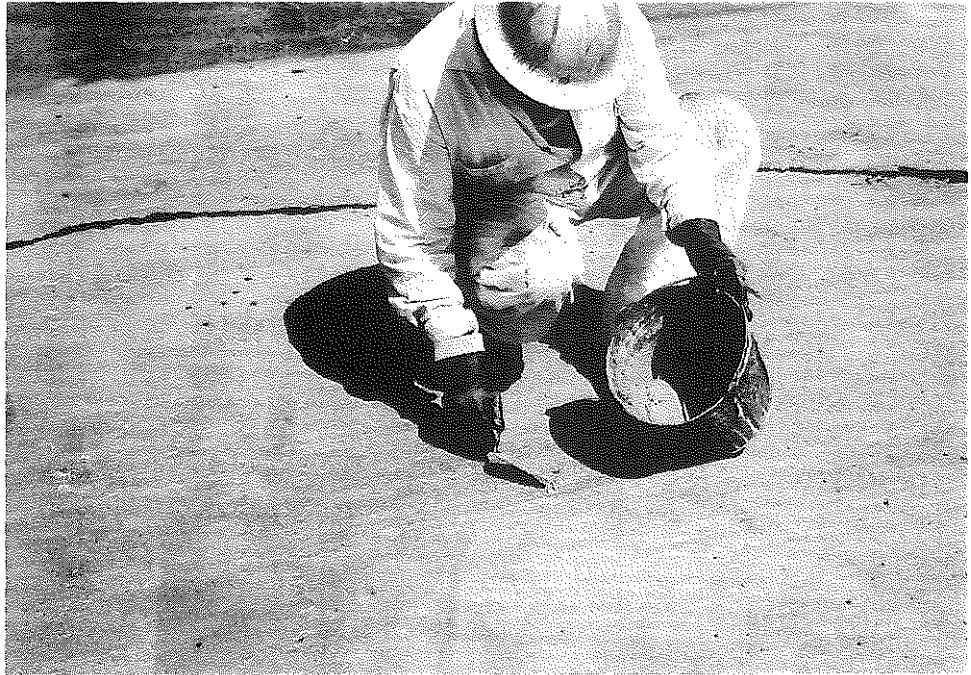
Fig. 55. Salt River Bridge, Kentucky Turnpike; Pointing-Up Pop-Outs with Penntrowel Mortar.

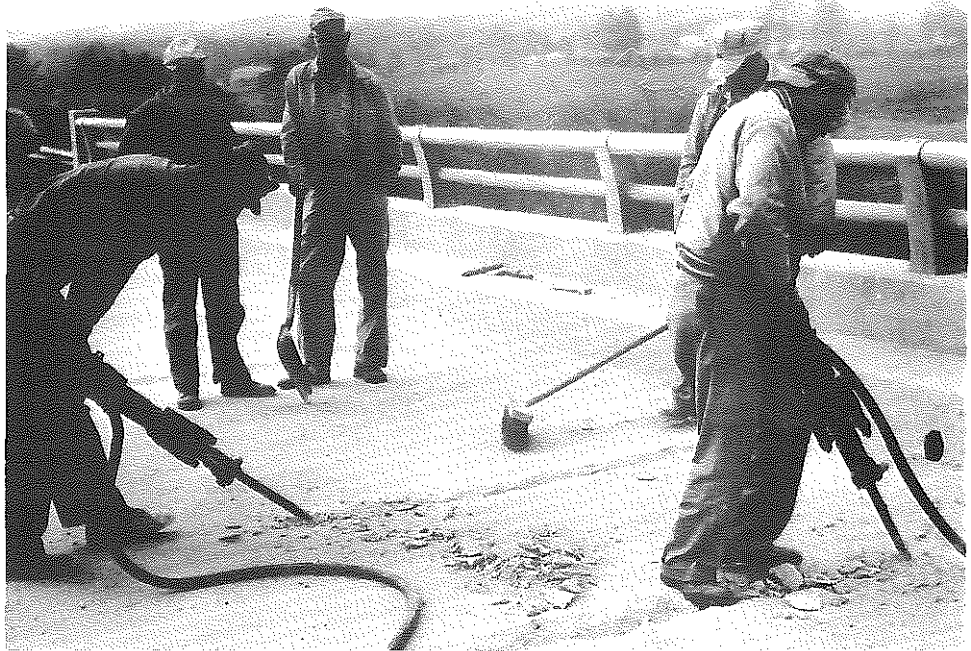
Fig. 58. Salt River Bridges, Kentucky Turnpike; Deep-Routing Transverse Cracks, Preparatory to Placing Latex-Mortar Overlay, October, 1960.

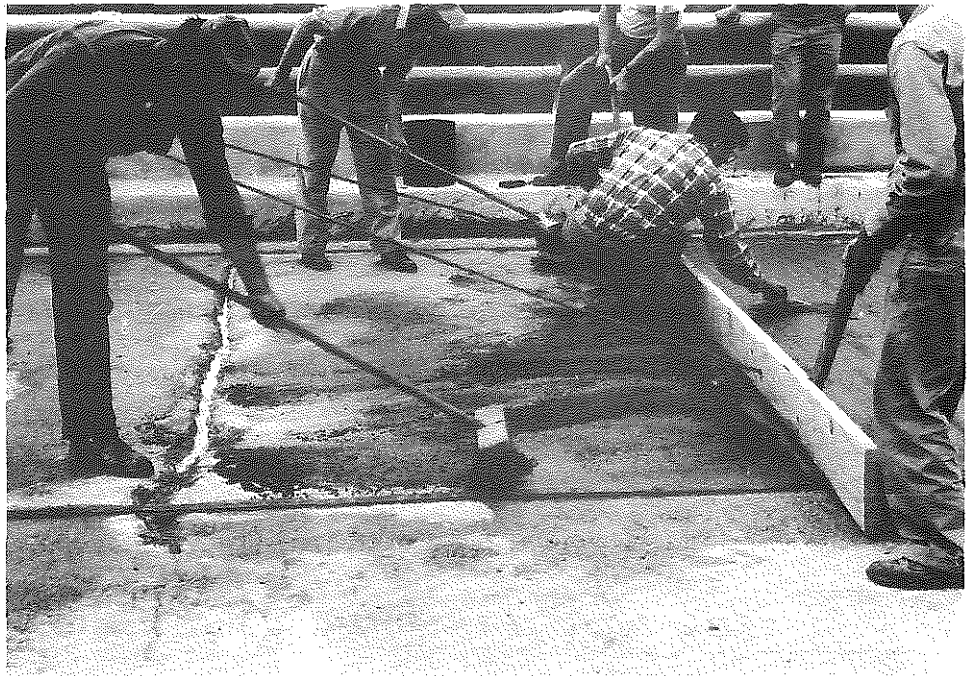
Fig. 59. Salt River Bridge, Kentucky Turnpike; Placing Latex (Dow 2144)-Mortar Overlay; Approximately 1/4 inch, October, 1960.

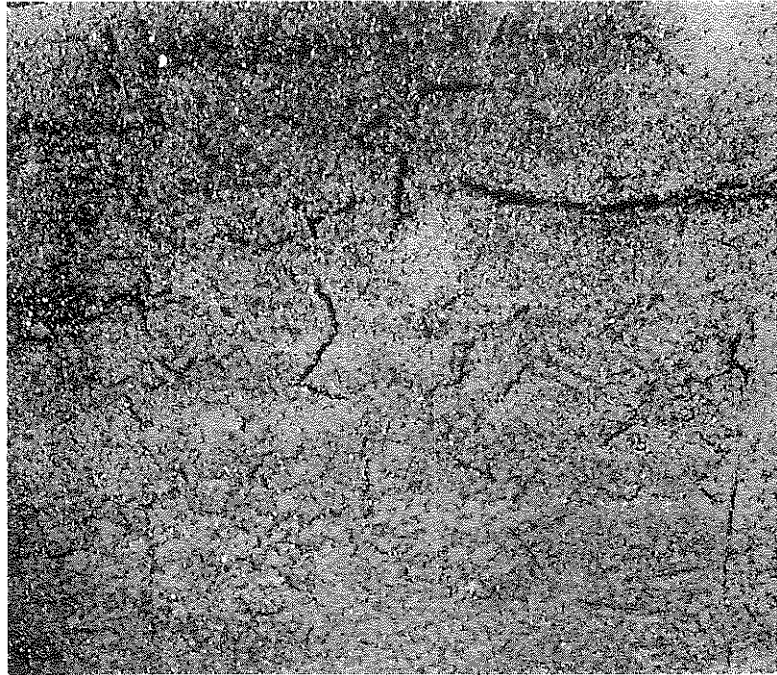
Fig. 68. Salt River Bridge, Kentucky Turnpike; American Bitumuls Heavy Duty Resurfacer; Severe Shrinkage Cracks; Ten Days to Two Weeks Afterwards.

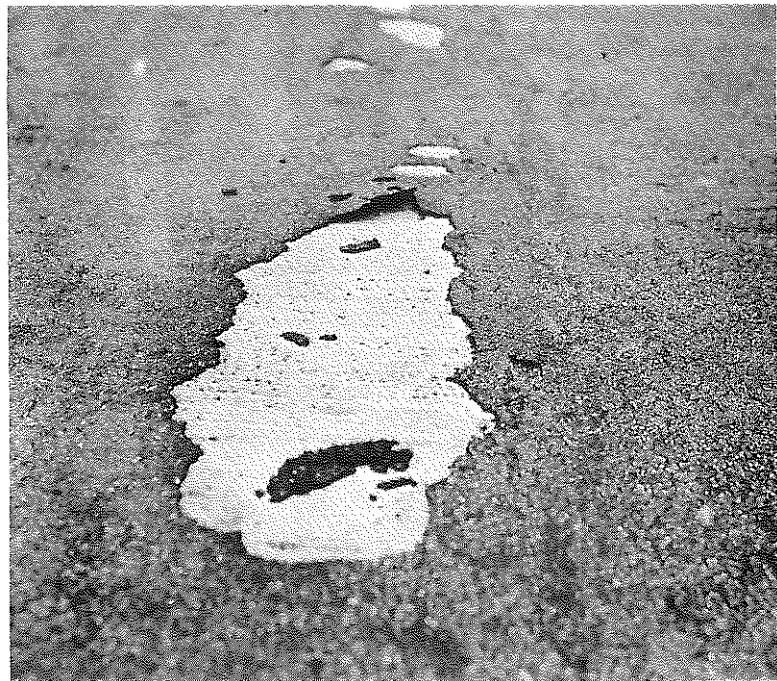
Fig. 69. Salt River Bridge, Kentucky Turnpike; American Bitumuls Heavy Duty Resurfacer; Showing Peeling During First Winter.

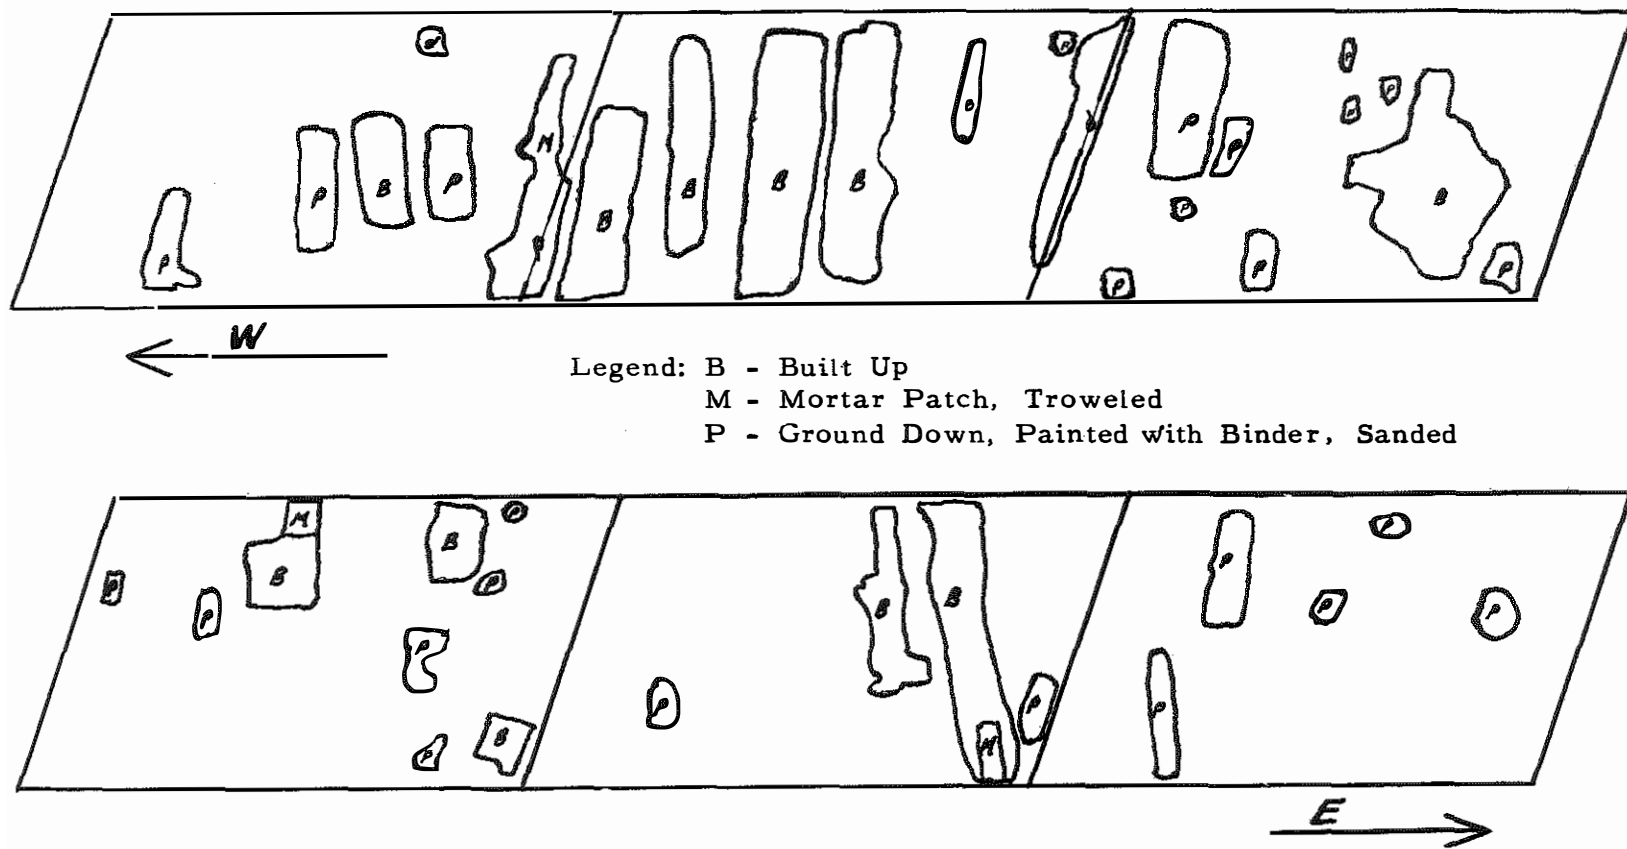
Fig. 76. I-64, Winchester-Mt. Sterling, Twin Bridges over Pruitt Road.

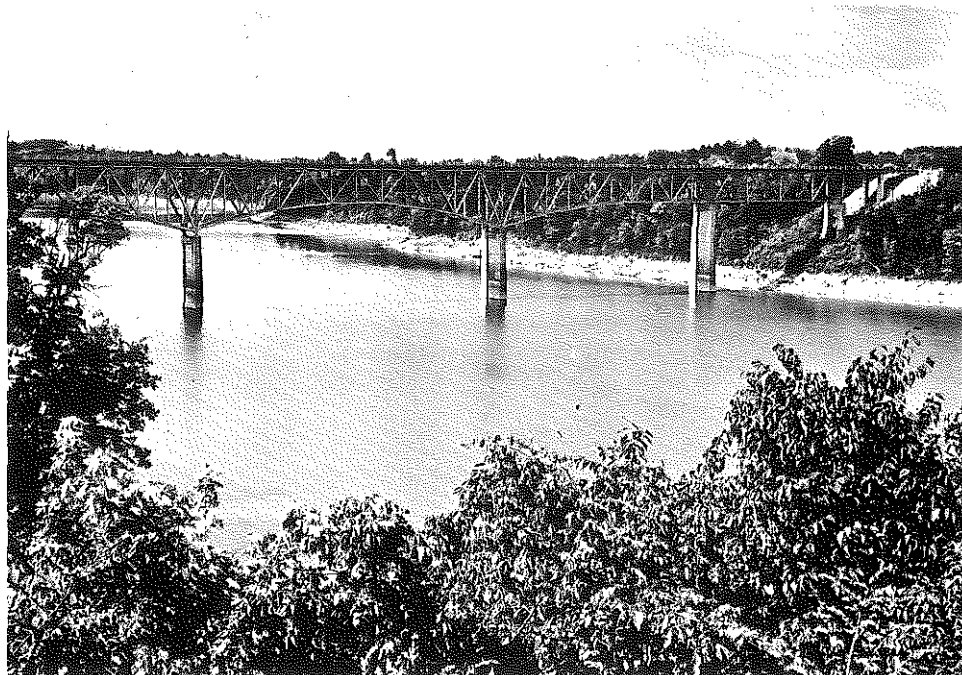
Fig. 83. Lake Cumberland Bridge, Ky. 90, Burnside-Monticello Road.

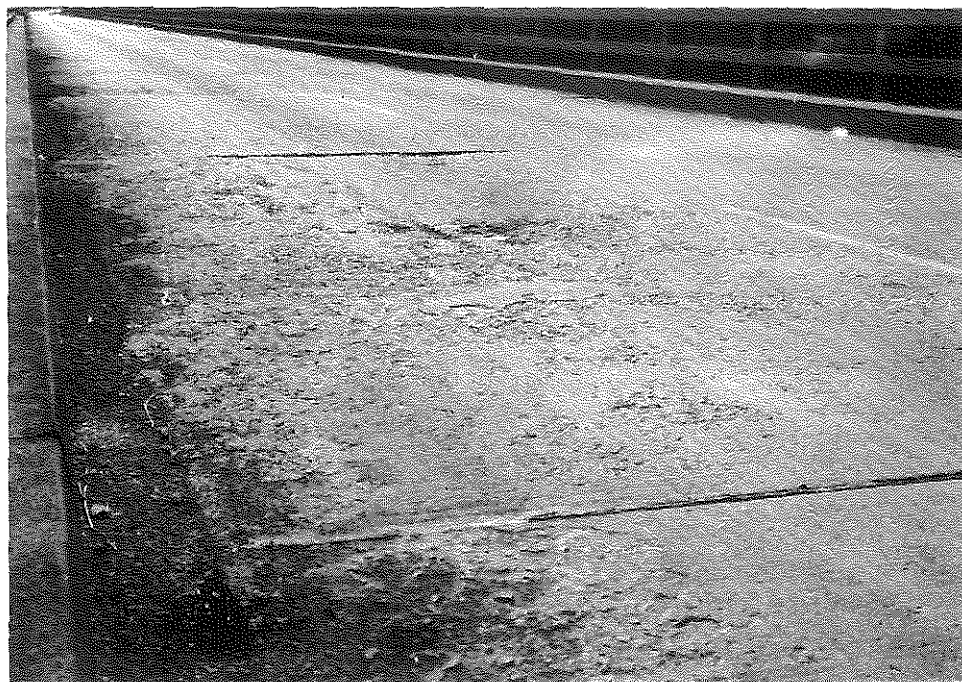
Fig. 84. Close-up View of Deck, Lake Cumberland Bridge. Note raveling and debris in gutter, 6-61.

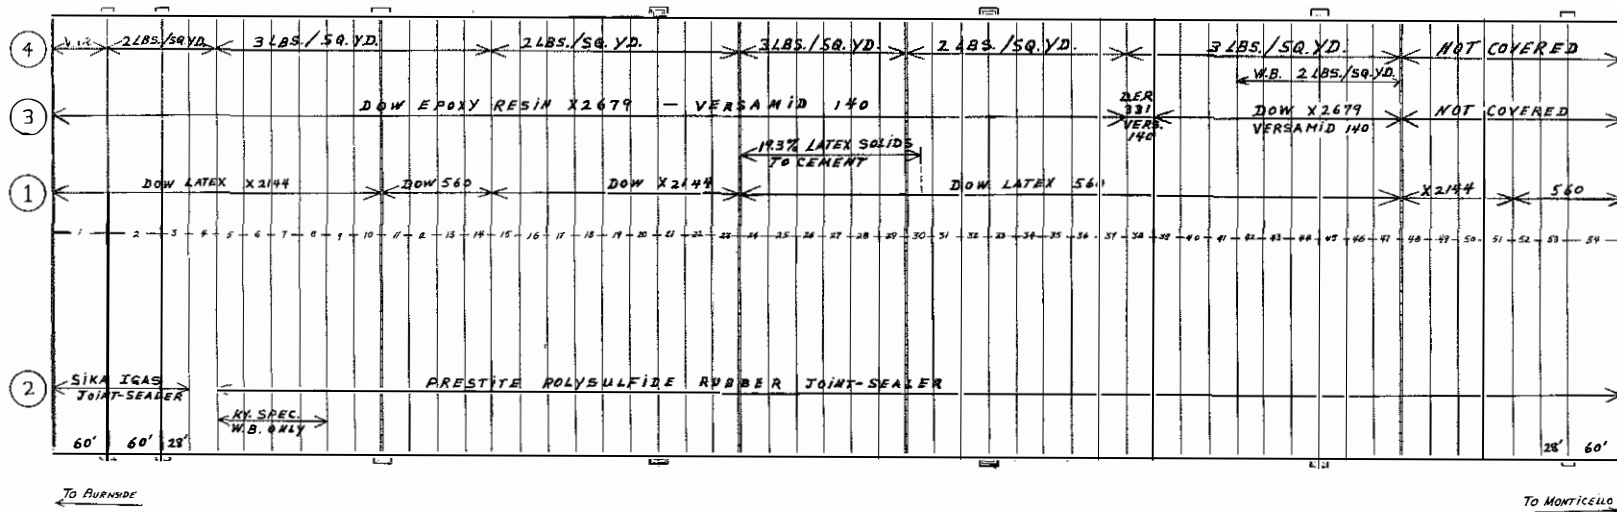
Fig. 87. Diagram of Lake Cumberland Bridge, Showing Location of Experimental Materials used in Resurfacing Deck. Although the eastbound lane (to Burnside) was completed and opened to traffic before work was started on the opposing lane, the lanes replicated each other in regard to apportionment and location of materials (exceptions are noted). Line 1, above, shows the portions (full width) of the deck in which the two latexes were used in the mortar topping (latex-modified mortars). Line 2, in the order of application, shows the location of joint sealers (full width, except as noted). Line 3 shows the scheduling (again full width) of epoxy resin seal materials, and line 4 shows their respective rates of application.

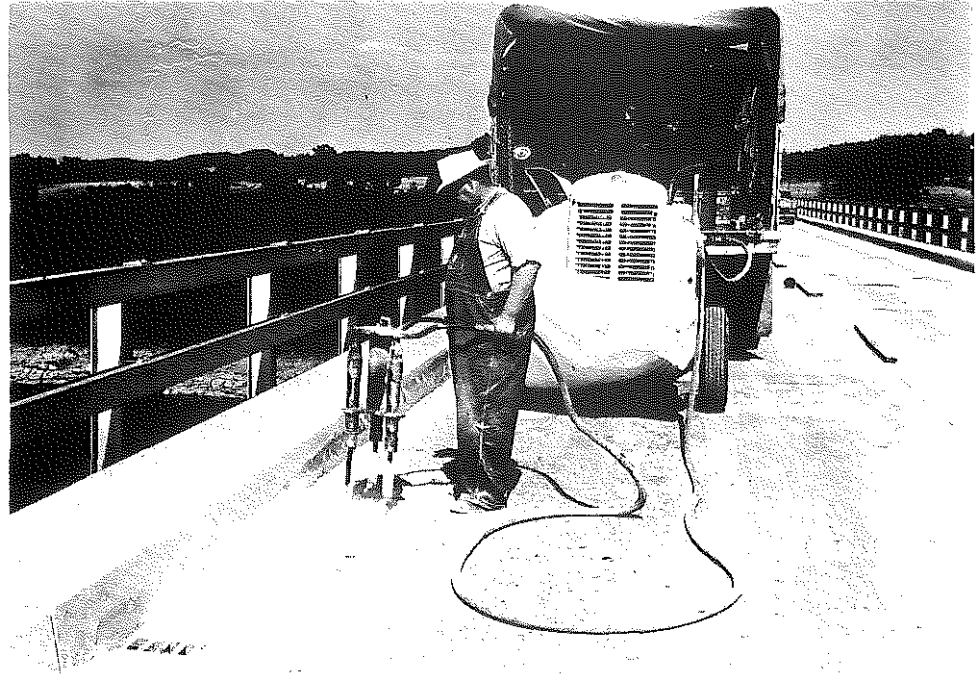
Fig. 88. Triplex Tamper Equipped with Star-Bits; Removing Unsound Concrete. Note diaper on air compressor to catch oil drippings.

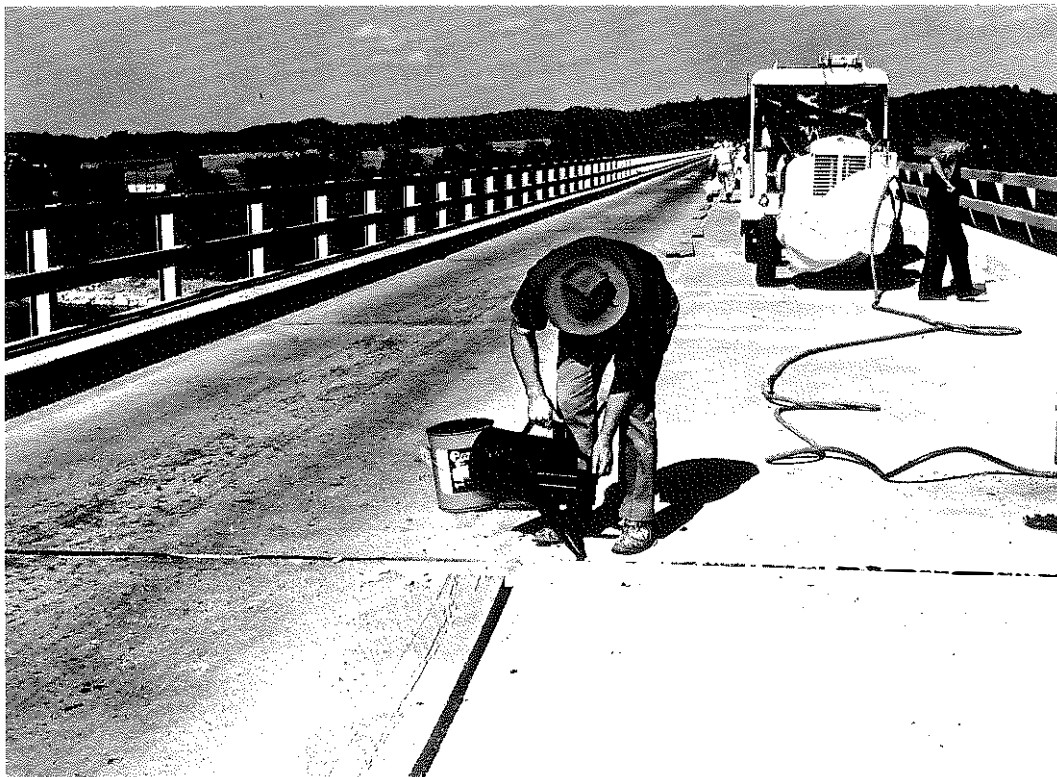
Fig. 94. Filling Joints with Prestite, No. 404, Pourable Joint Sealer (Two-Component, Polysulfide Rubber). Note: This material was later found to be reactive (de-polymerized, re-liquified) toward asphaltic materials. About 35 joints or portions thereof were reopened the following summer, 1962; sponge rubber inserts were installed in the joints to insulate new joint sealer from the asphaltic material below. The joints were repoured with the polysulfide compound.

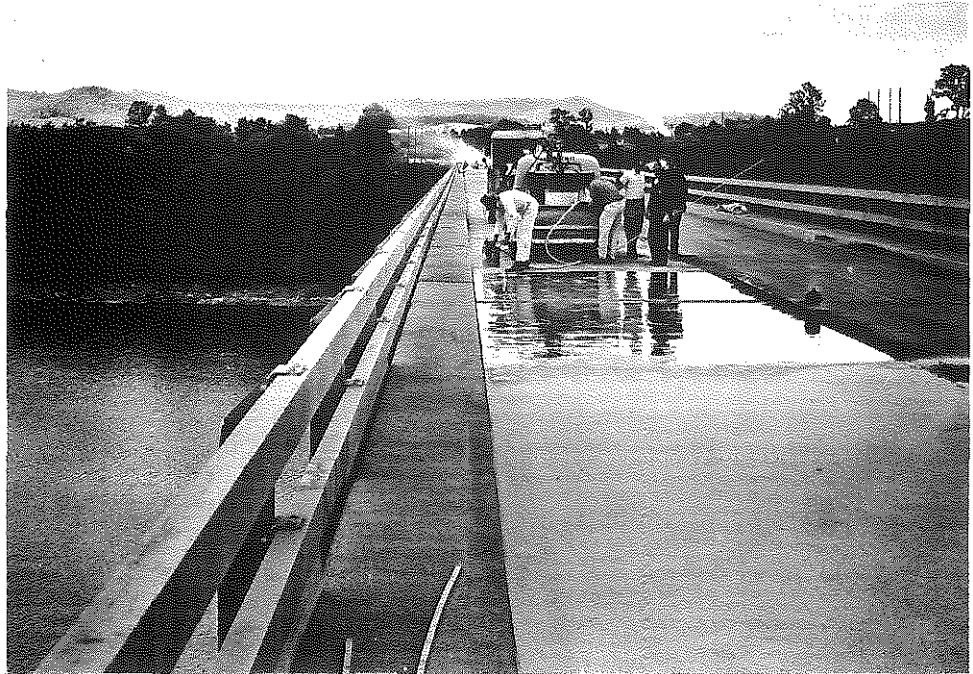
Fig. 96. Lake Cumberland Bridge, Facing East, Broadcasting Sand onto Newly Applied Epoxy Resin, September, 1961. Note: Curb and sidewalk section here were sandblasted and sealed with epoxy-sand ahead of the application to the deck -- elsewhere the two operations were carried along together.

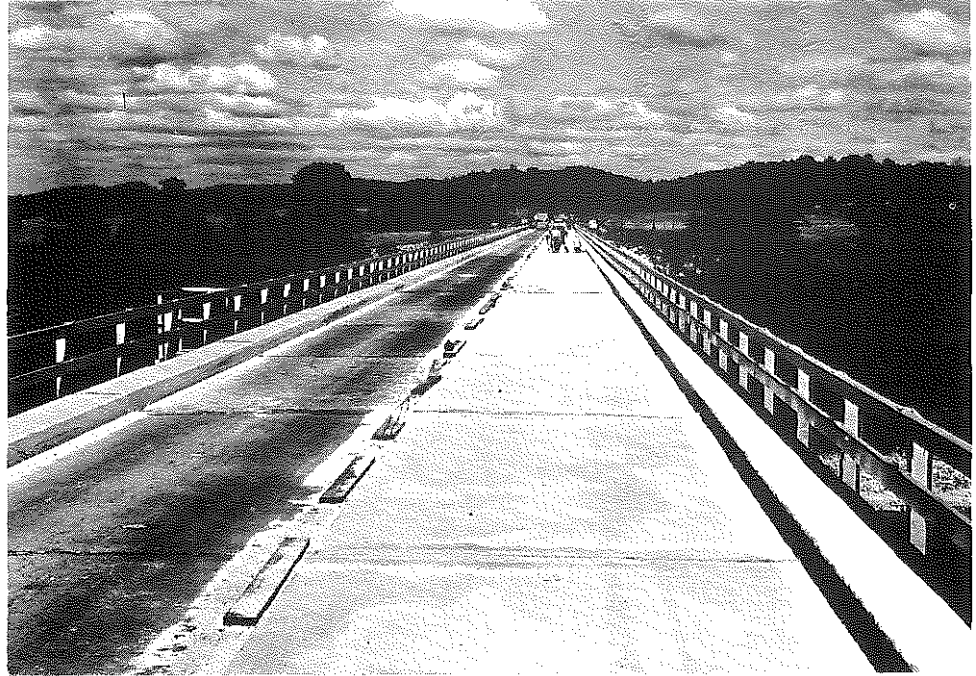
Fig. 99. Lake Cumberland Bridge; Eastbound Lane, Facing East; Showing Completed Surface before Brooming off Excess Sand. Note: Extra application of epoxy at joints caused thicker build-up and resulted in considerable roughness; westbound lanes (not surfaced in photograph) are noticeably smoother and joints there were not built up in this way.

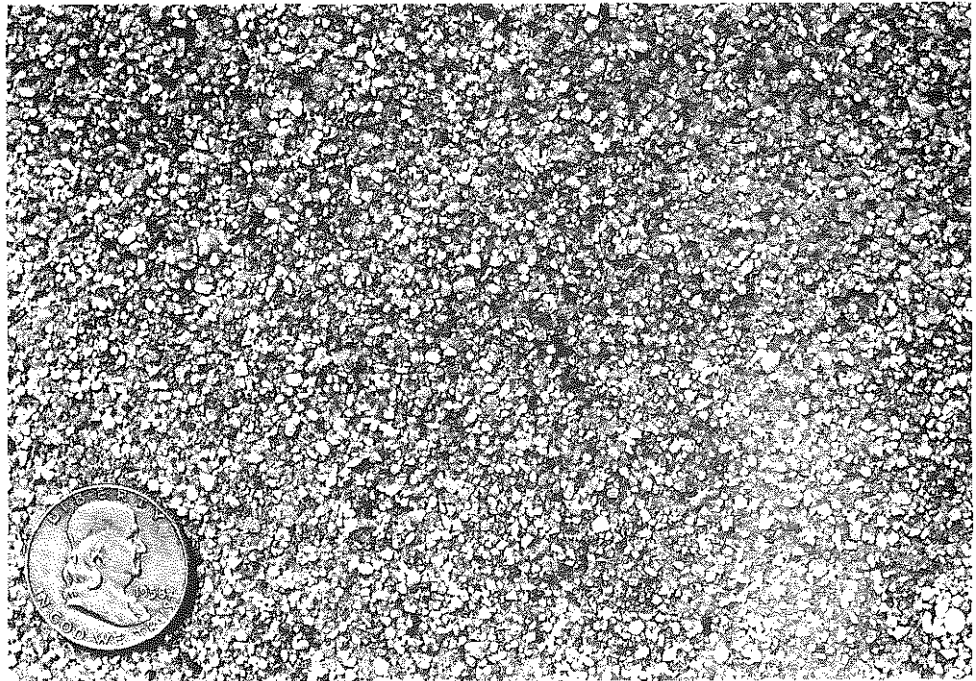
Fig. 100. Lake Cumberland Bridge; Close-up View of Epoxy-Sand Surface after Sweeping off Excess.

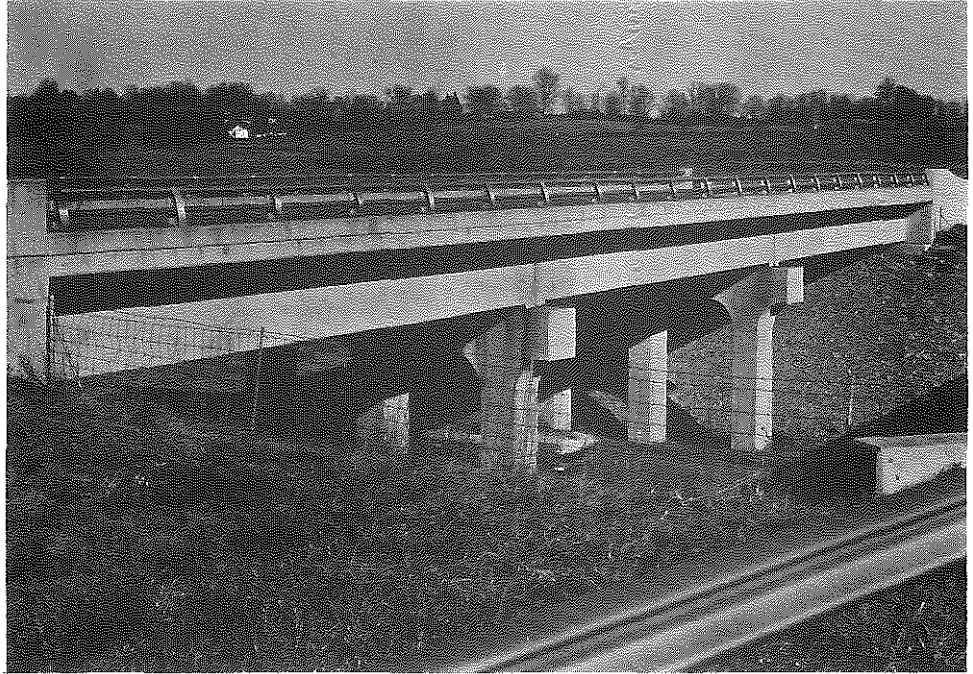
Fig. 103. Cardwell Lane Bridge, I-64, Westbound, MP 37-905-HG6; Oblique View, Facing Eastwardly.

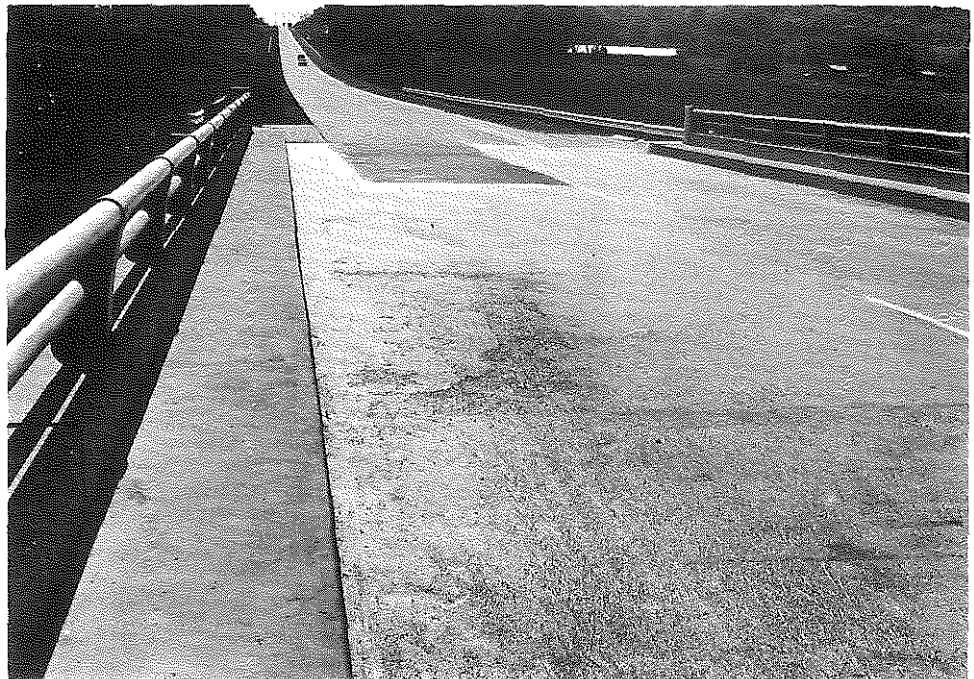
Fig. 108. South Benson Creek Bridge Above; Facing West; Guardian Chemical Company's Clear Bond (Styrene-Buladiene), Unfinished Here, Finished Later. Note scaling in left lane and transverse cracks conforming to construction joint and position of screeding templates.

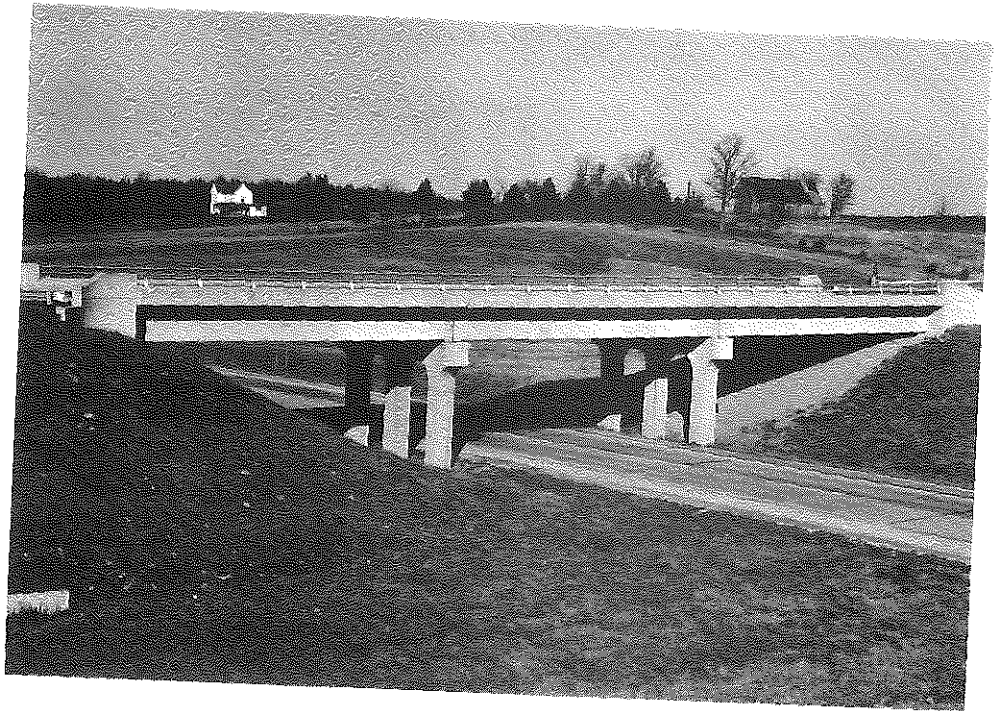
Fig. 109. Alton Road Bridge, I-64, Franklin County, Westbound, MP 37-905-HG2; Oblique View, Facing Eastwardly.

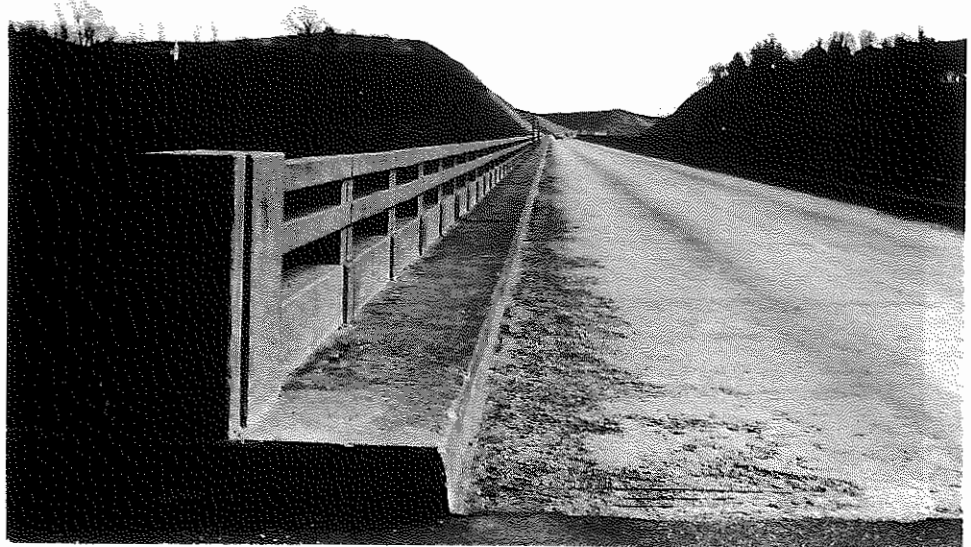
Fig. 128. Clays Ferry Bridge, Present US 25, Future I-75, Northbound Bridge; Lexington-Richmond Road, Facing South; Shows Scaling between Outside Wheel Path and Curb, Feb. 13, 1963.

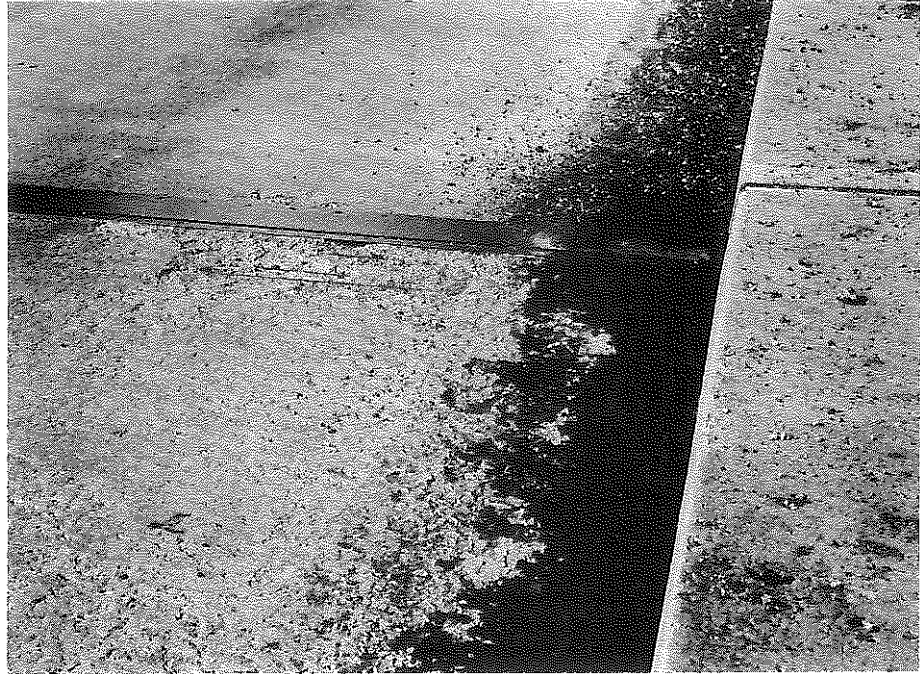
Fig. 130. Clays Ferry Bridge, US 25, Lexington-Richmond Road. A close-up view showing scaling at expansion joint and gutter line. Debris, which appears in the background, has been swept away in the foreground disclosing the persistence of aggravating moisture there.

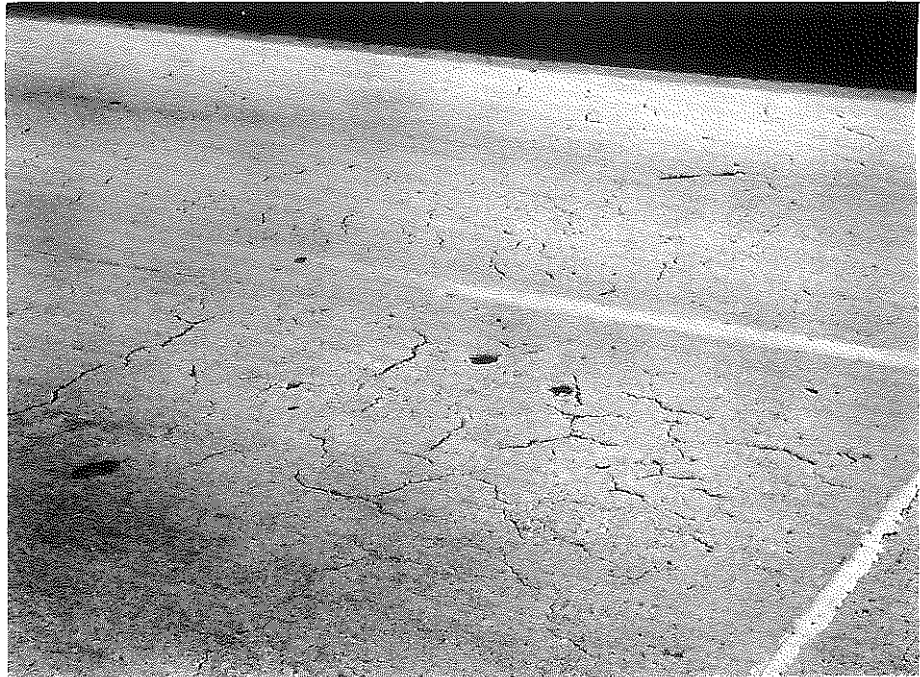
Fig. 131. Clays Ferry Bridge. Close-up view of impending failure of deck, near south end of bridge.
