KENTUCKY TRANSPORTATION CENTER

176 Raymond Building, University of Kentucky
859.257.4513 www.ktc.uky.edu

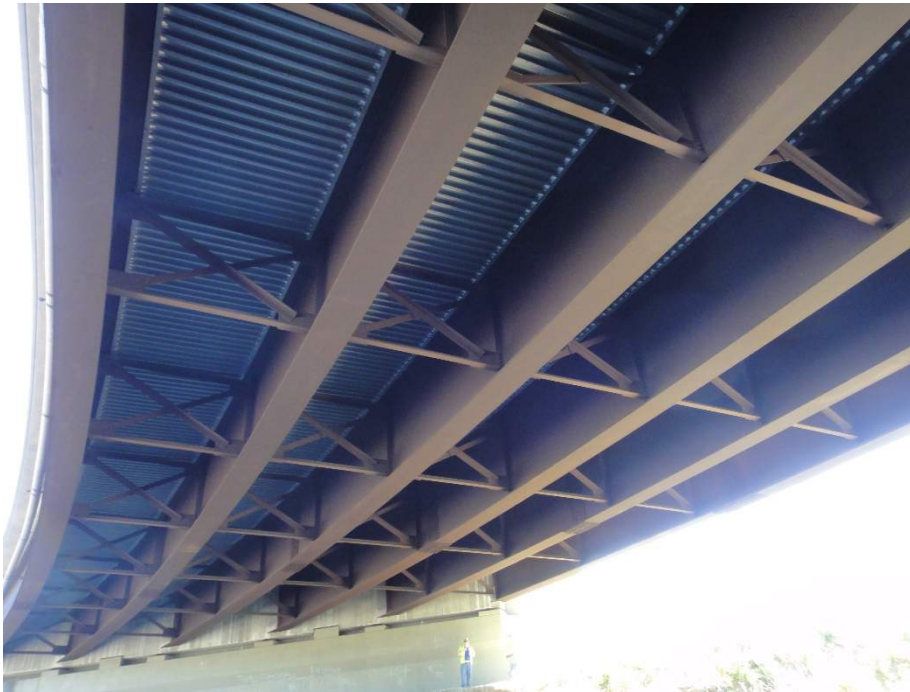
Figure 1. Deck Girder Bridge Showing Proper Appearance of UWS Patina

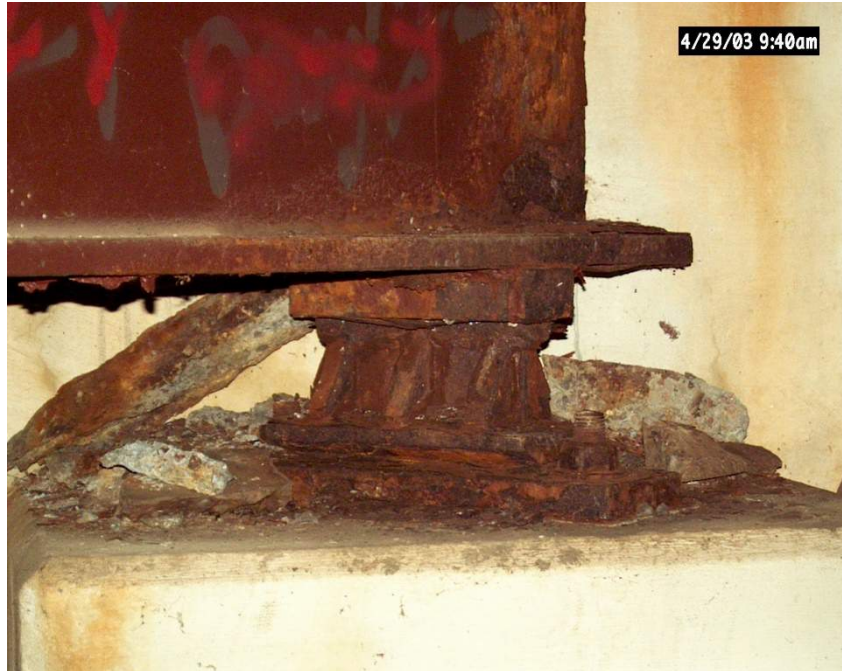
Figure 3. Corroded UWS Bearing Under Leaking Joint

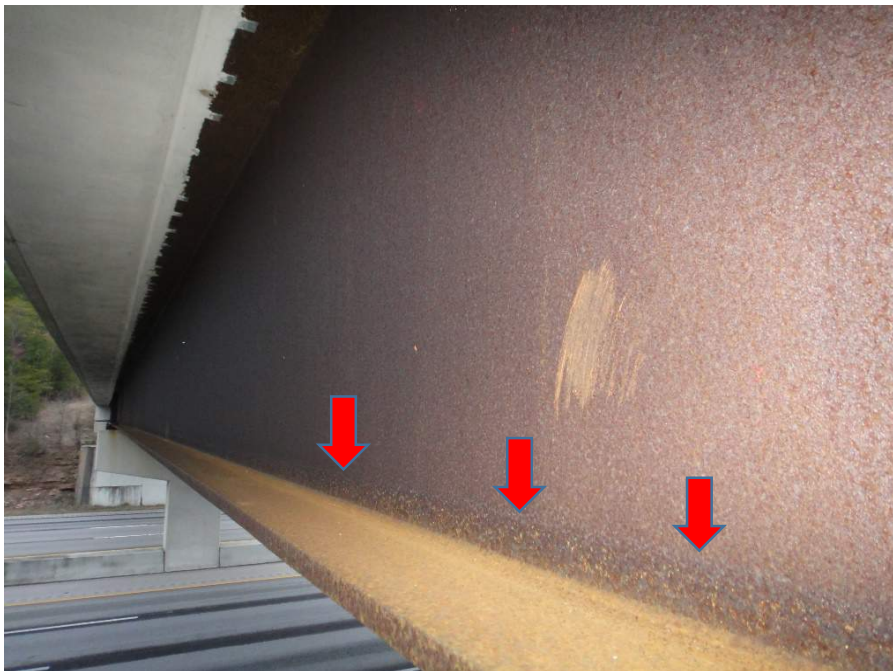
Figure 4. Fascia Beam of I-75 Overpass Bridge Showing Tight Rust in Middle of Web (Scrape Mark) and Scaly Corrosion and Rust Capillary Action on Lower Portion of Web (Arrows)

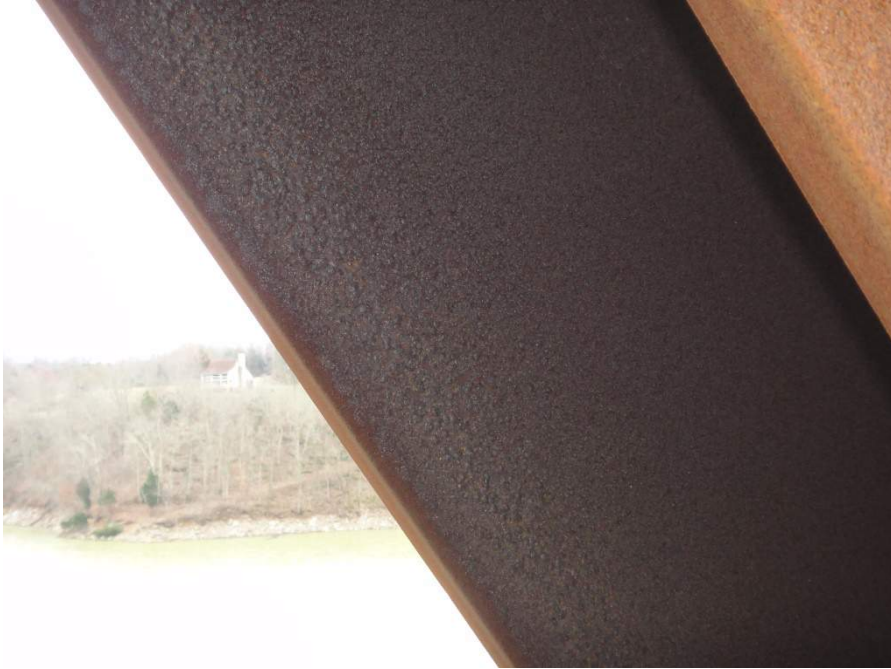
Figure 5. Underside of Truss Diagonal Showing Coarse Rust on KY 90 Bridge

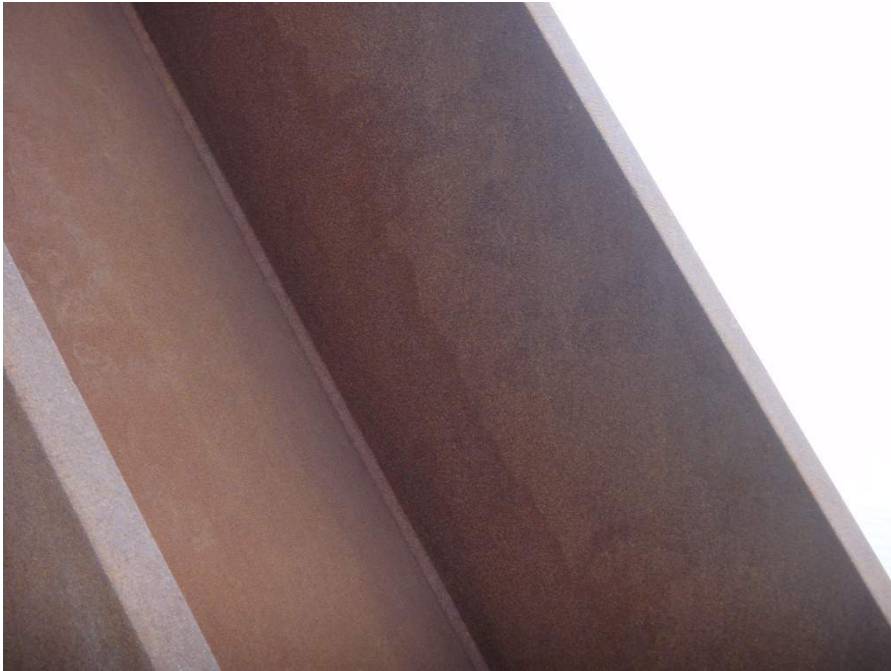
Figure 6. Topside of Same Diagonal Opposite Location Shown in Figure 5

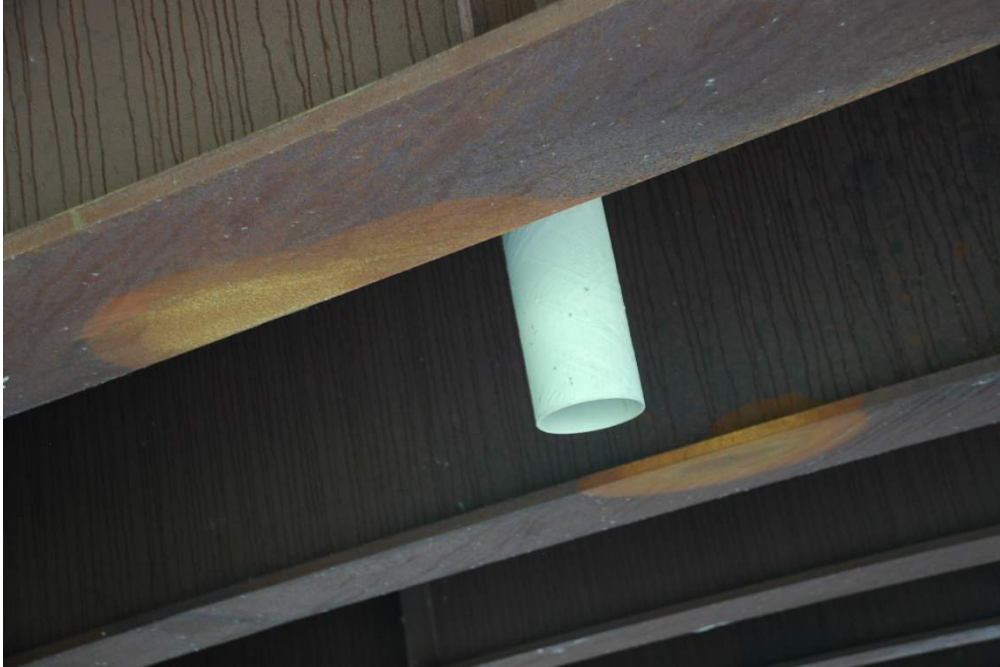
Figure 7. UWS Girder Bridge (Non-KYTC Bridge) Showing Effect of Inadequate Drain Pipe Clearance on Patina Formation

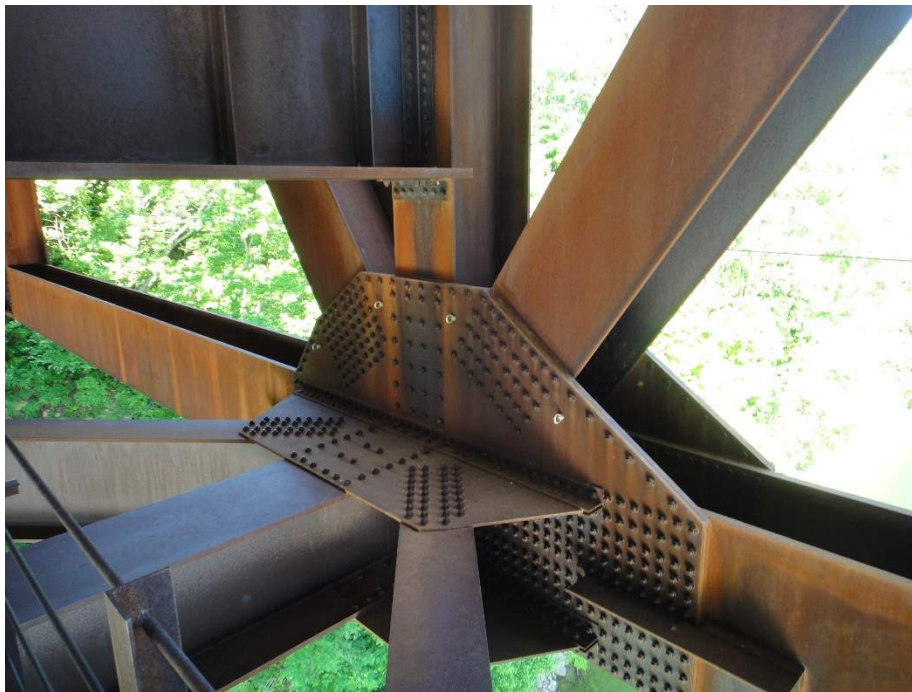
Figure 8. Lower Chord of UWS KY 90 Truss Bridge Showing Various Patina States

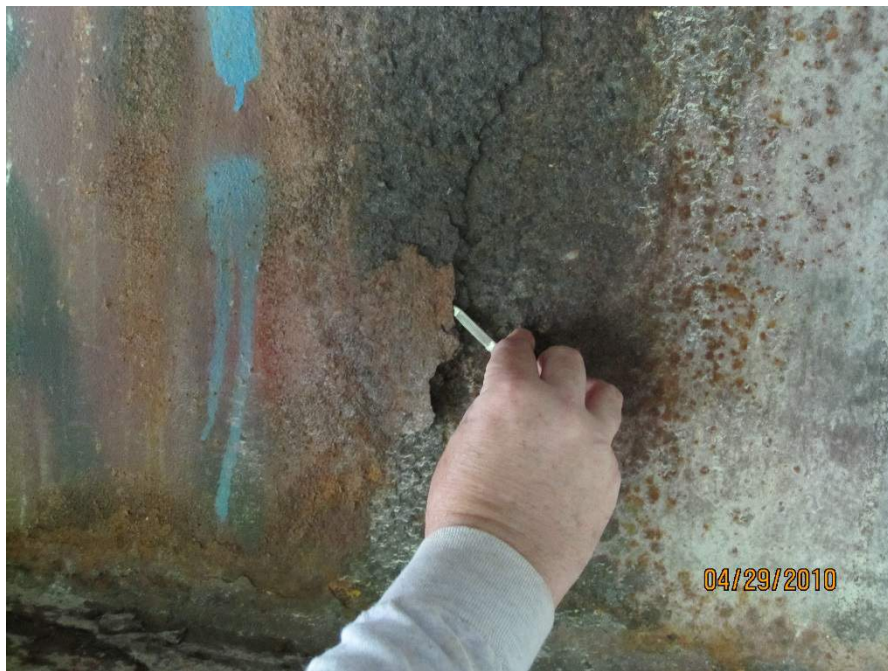
Figure 10. Scaly Rust from Unhindered Corrosion of Web of Beam KY 1893 Bridge

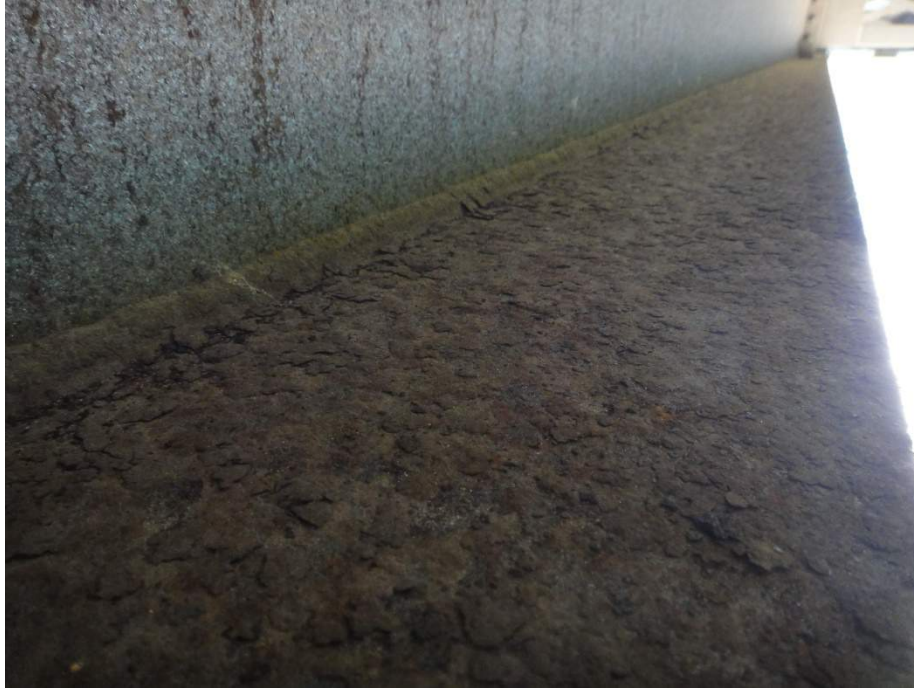
Figure 11. Unhindered Corrosion on Upper Face of UWS Girder on I 75 Overpass Bridge

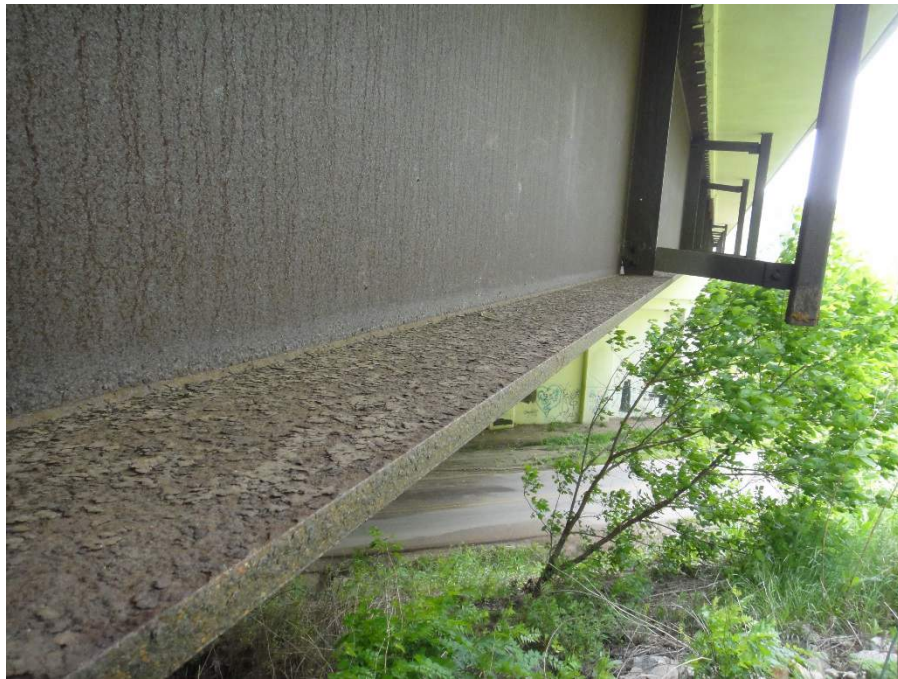
Figure 12. Deposit of Corrosion Debris on Upper Face on Girder Lower Flange of UWS Beam

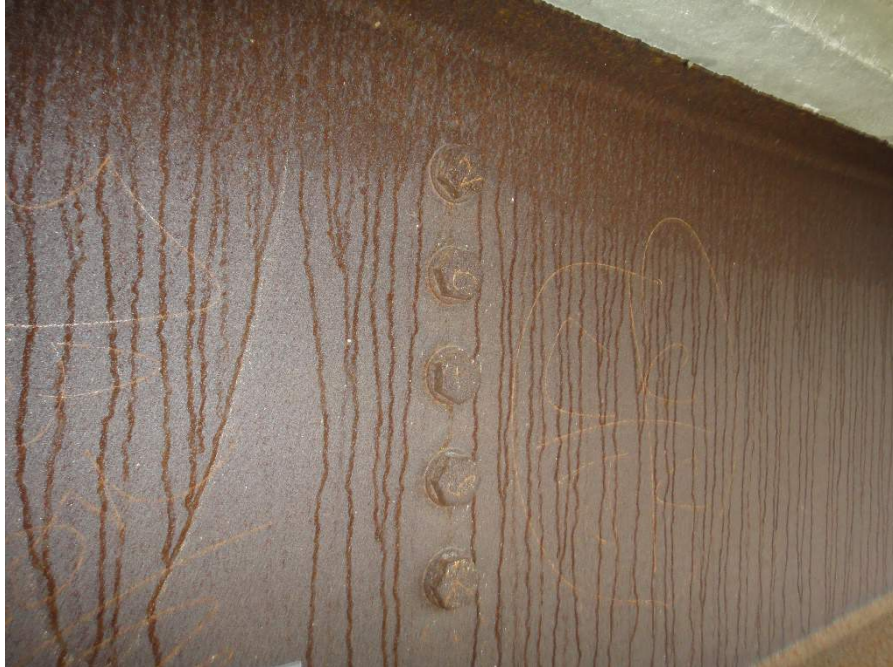
Figure 13. Condensation Drip Marks on Web of KY 90 Approach Span

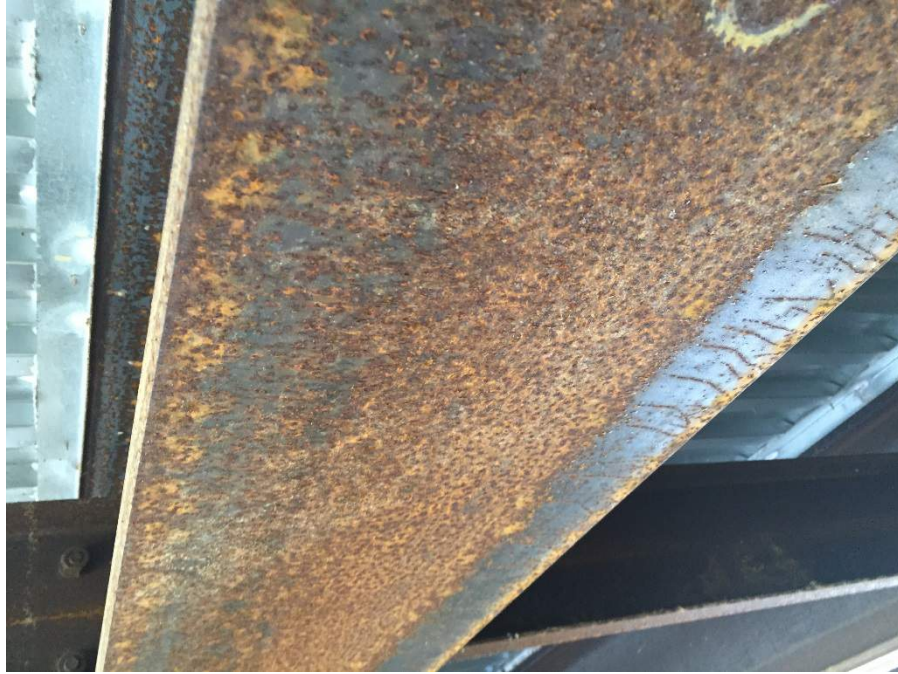
Figure 15. Pitting on Lower Flange of UWS Steel Beam Caused by Presence of Mill Scale on KY 6 Bridge

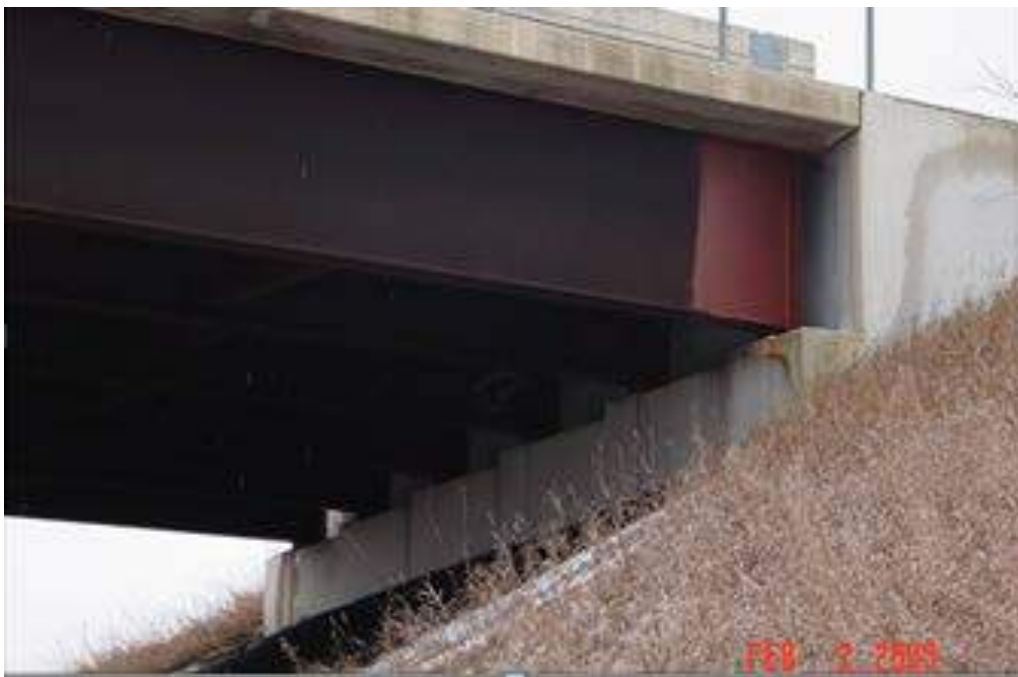
Figure 16. Minnesota DOT UWS Girder Painted about Two Feet from End

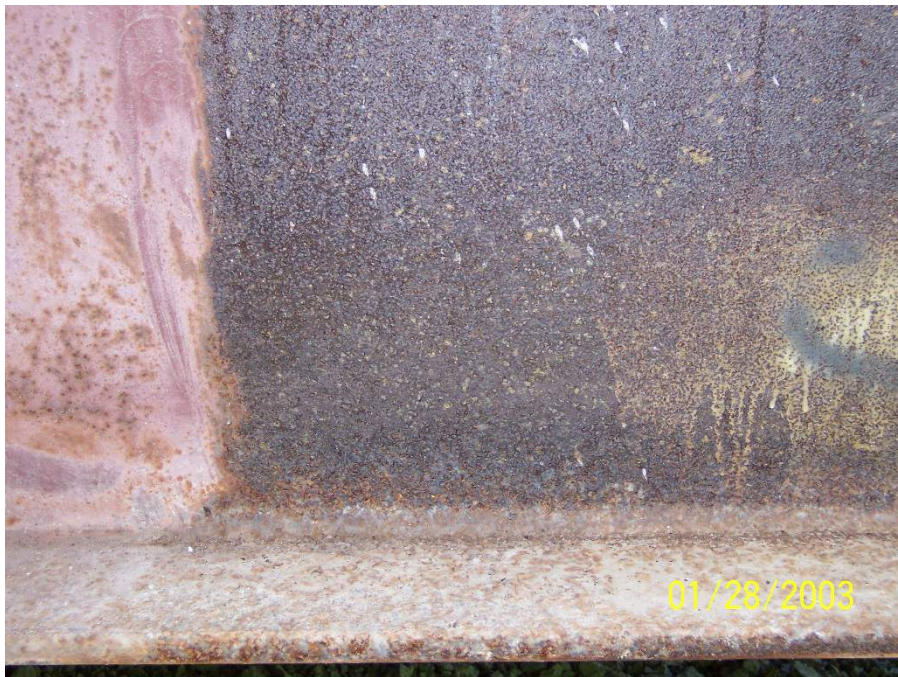
Figure 18. UWS Beam Showing Failed Coating at Beam End.
Note the Severe Pitting in Coating and on Adjacent UWS.

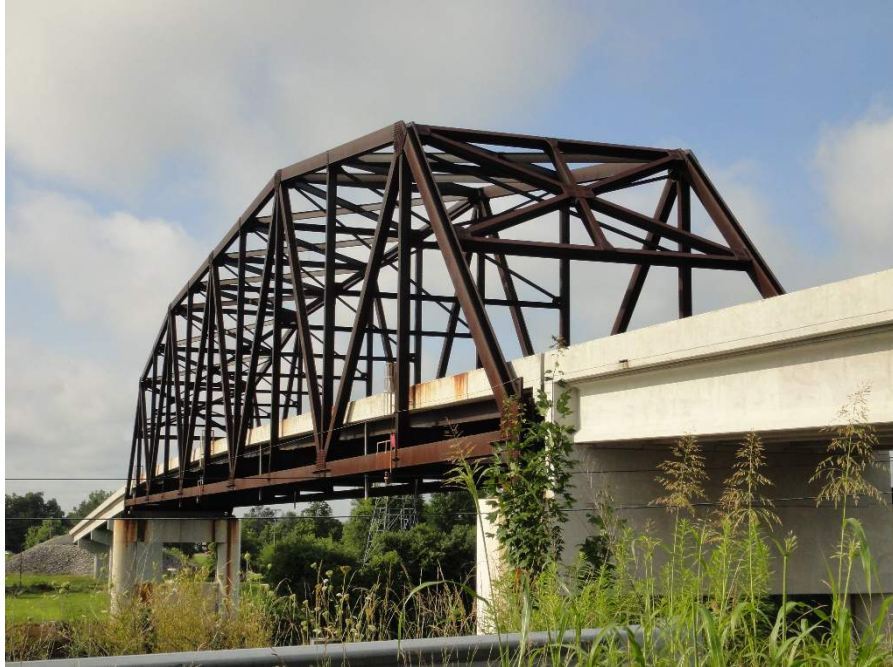
Figure 19. KY 81 UWS Truss over Green River at Calhoun, KY

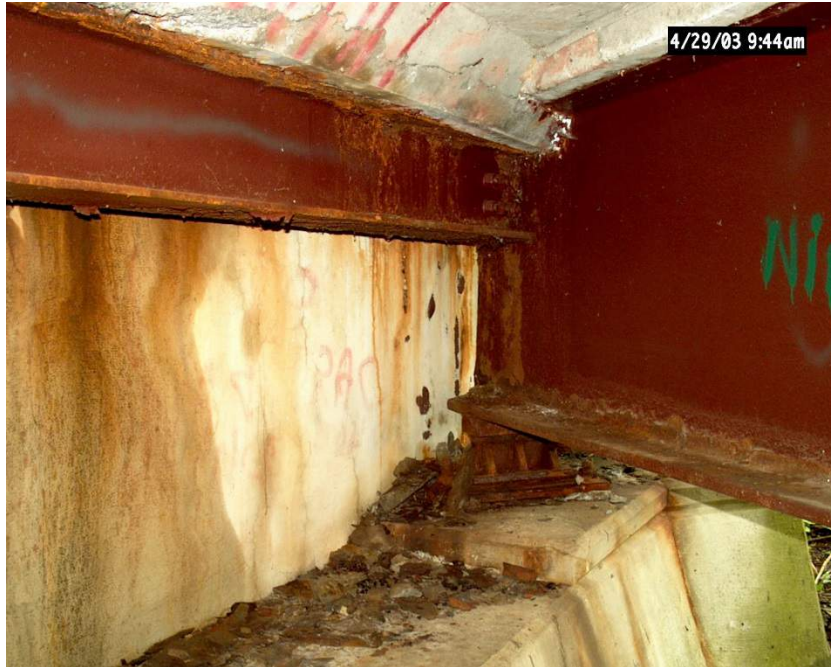
Figure 21. Corrosion under Deck Joint on KY 1893 Bridge at Shawhan, KY

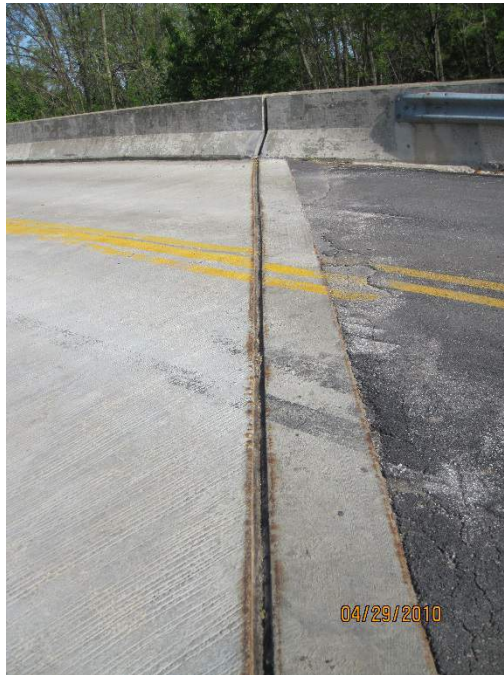
Figure 22. KY 1893 Bridge Deck with New Overlay and Deck Seals

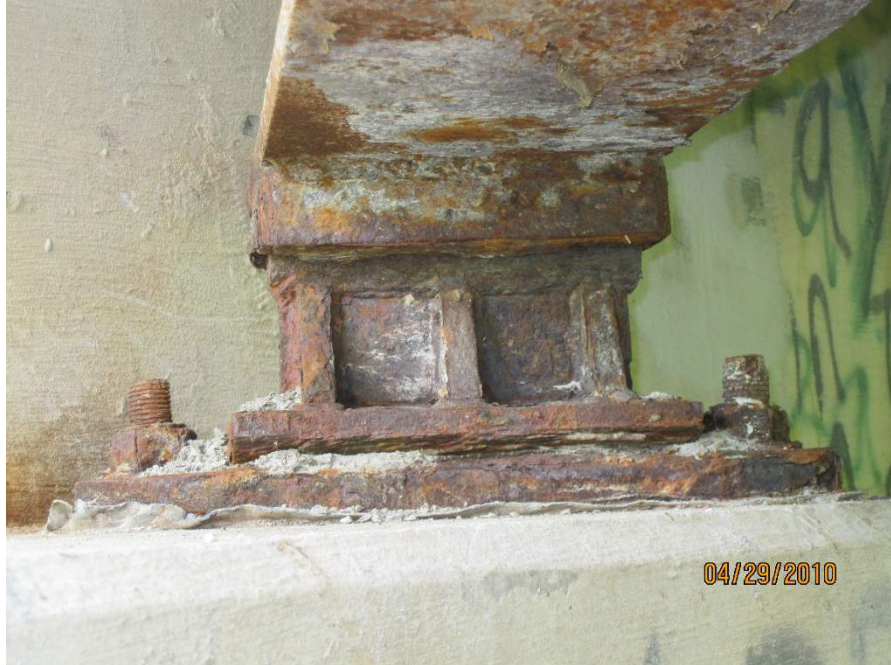
Figure 23. Rocker After Scaley Corrosion Product Removal on KY 1893 Bridge at Shawhan, KY

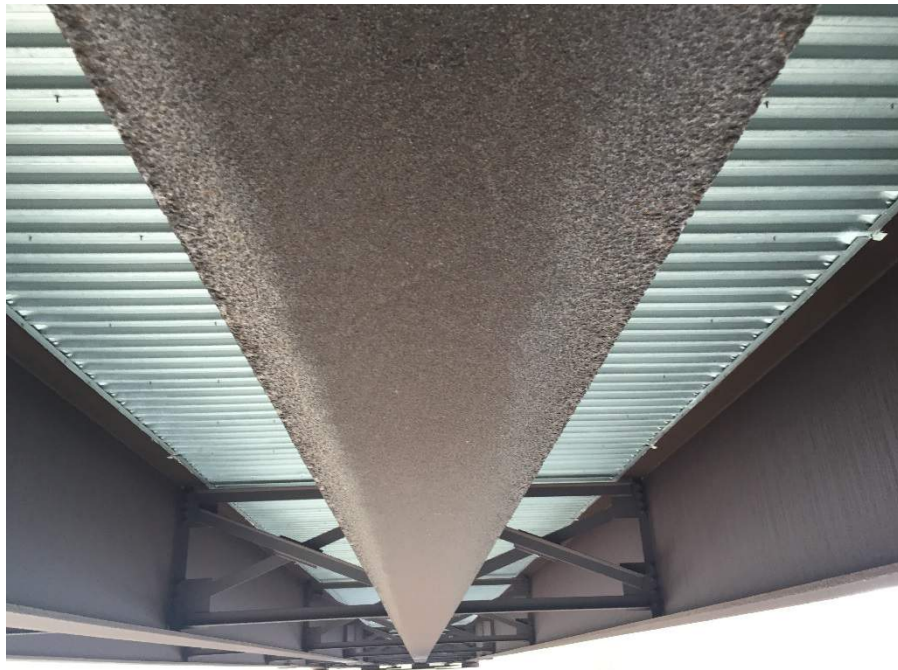
Figure 24. Scaley Corrosion on Bottom Face of Girder Flange of I-75 Overpass Bridge

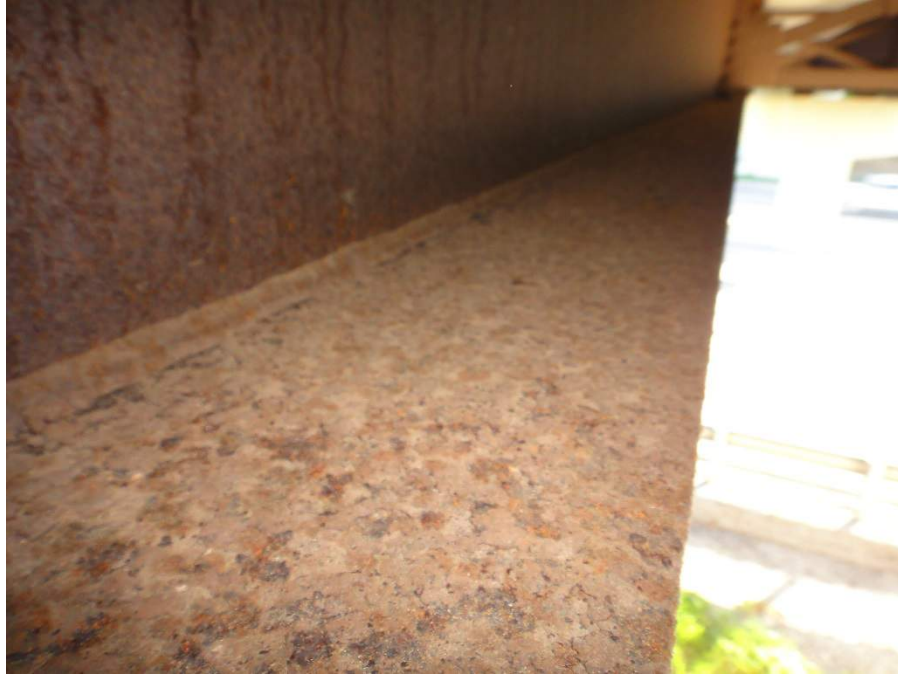
Figure 25. Scaly Corrosion on Upper Flange of Lower Flange on I-75 Overpass Bridge

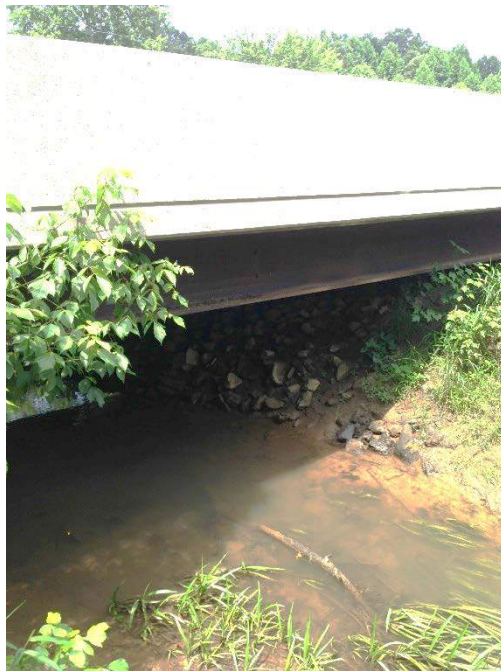
Figure 26. Low Water Clearance UWS Bridge on KY 6 in Knott County

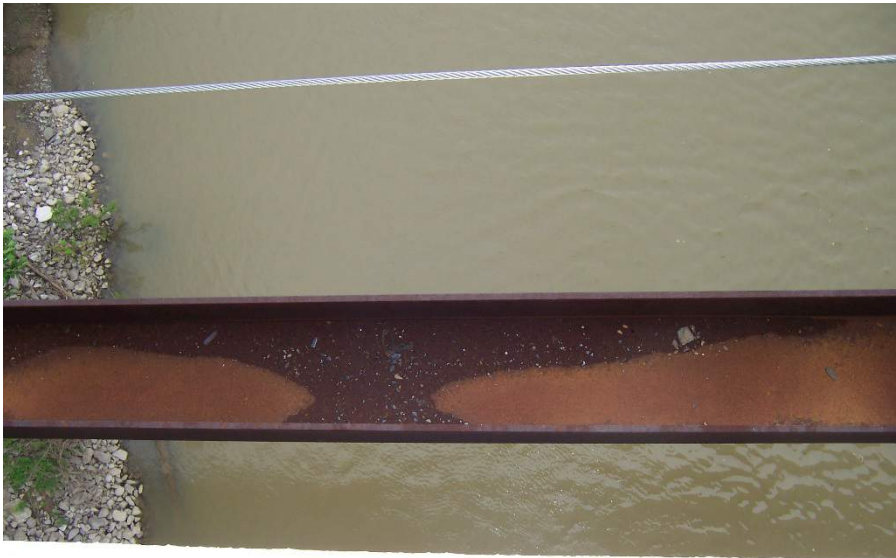
Figure 33. Water Ponding on the Lower Chord of the KY 90 Bridge

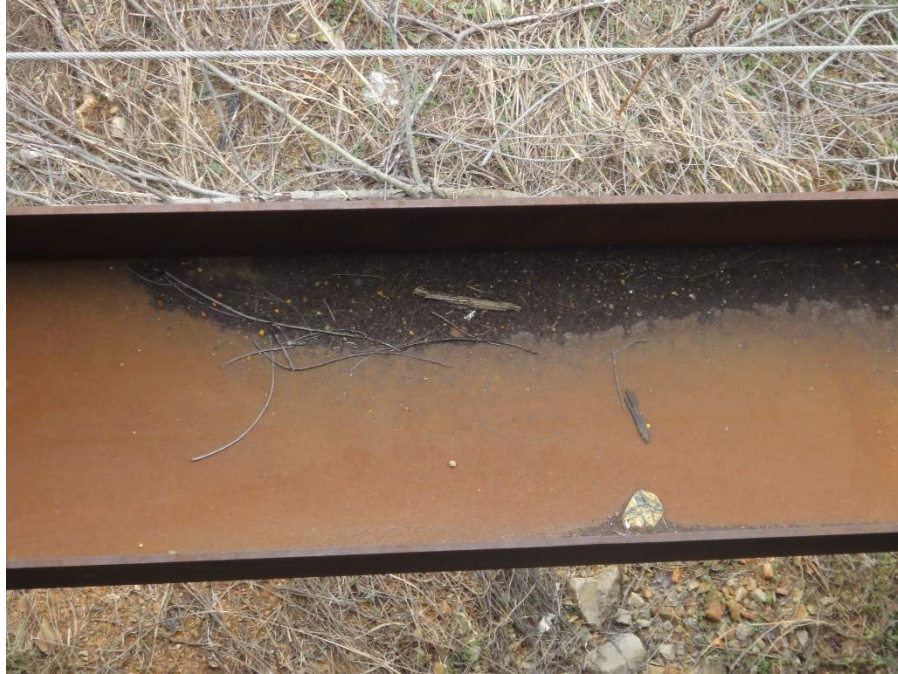
Figure 35. Debris Collected on the Lower Chord of the KY 90 Bridge

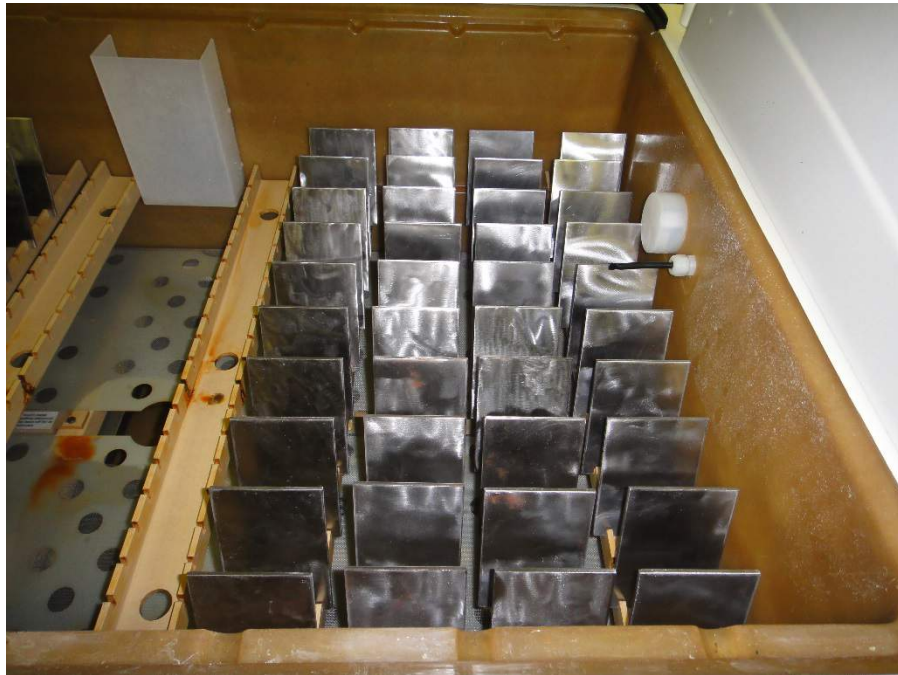
Figure 36. ASTM A 36 Steel Panels Prior to Preconditioning in an Accelerated Corrosion Test Chamber

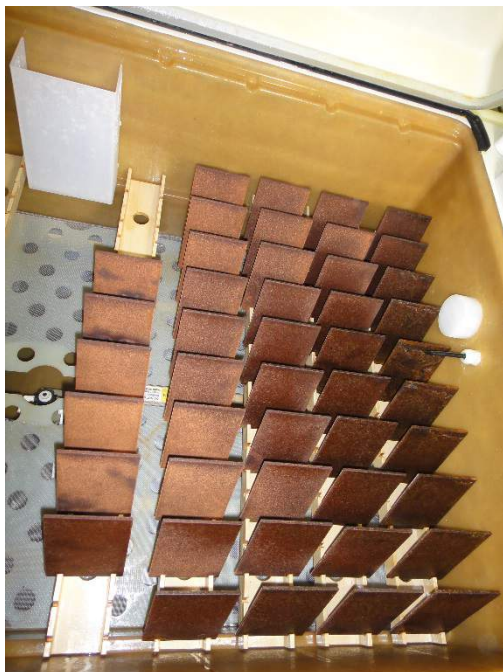
Figure 37. ASTM A572 Steel Panels After Preconditioning in an Accelerated Corrosion Test Chamber

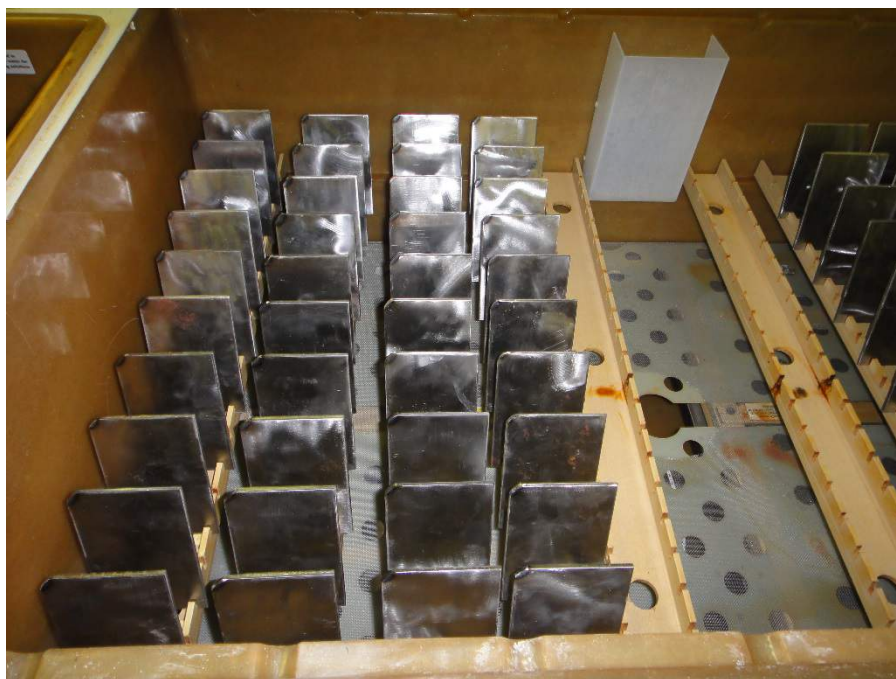
Figure 38. ASTM A 626 Steel Panels Prior to Preconditioning in an Accelerated Corrosion Test Chamber

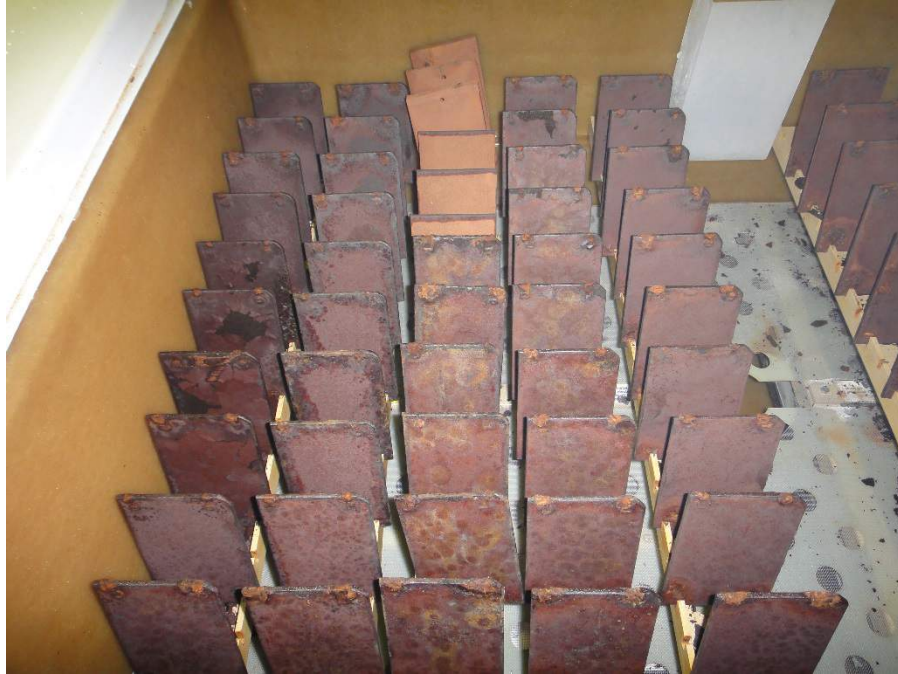
Figure 39. ASTM A 606 Steel Panels After Preconditioning in an Accelerated Corrosion Test Chamber.

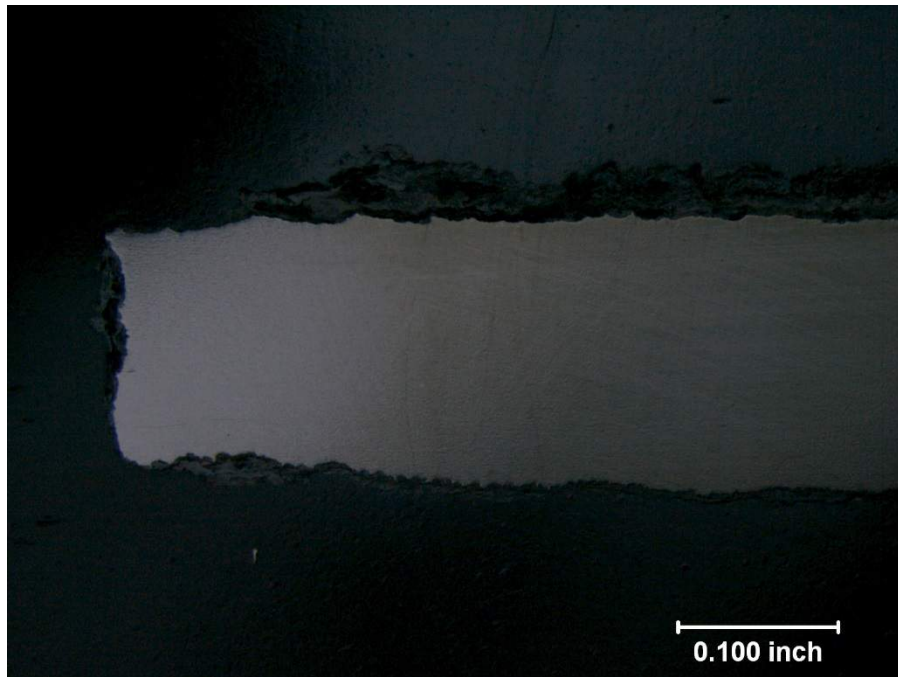
Figure 40. Section View of ASTM A36 Corroded Segment at Low Magnification

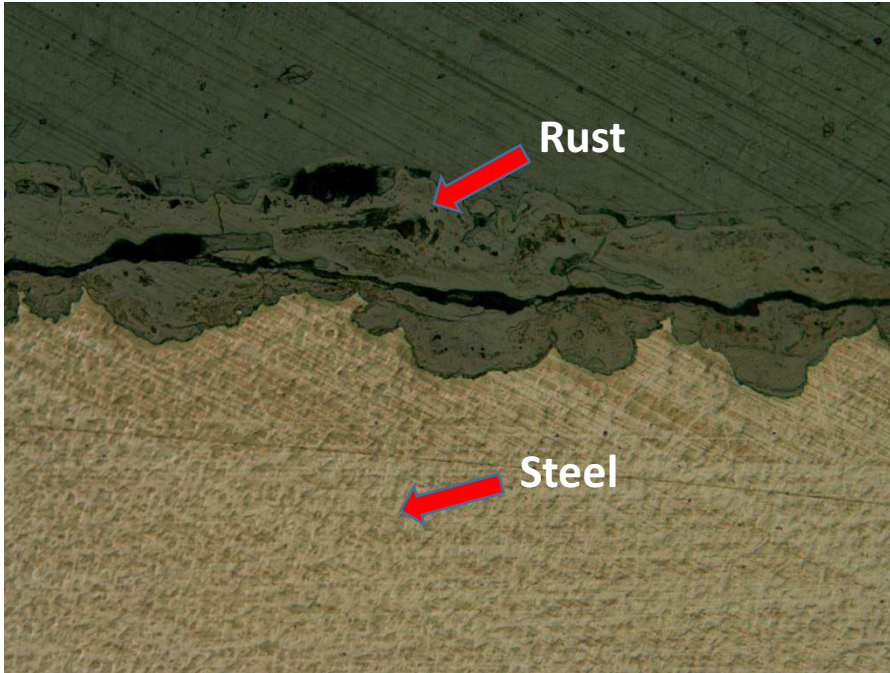
Figure 41. High Magnification Microphotograph of Corroded ASTM A36 Surface (Section View Not to Scale)

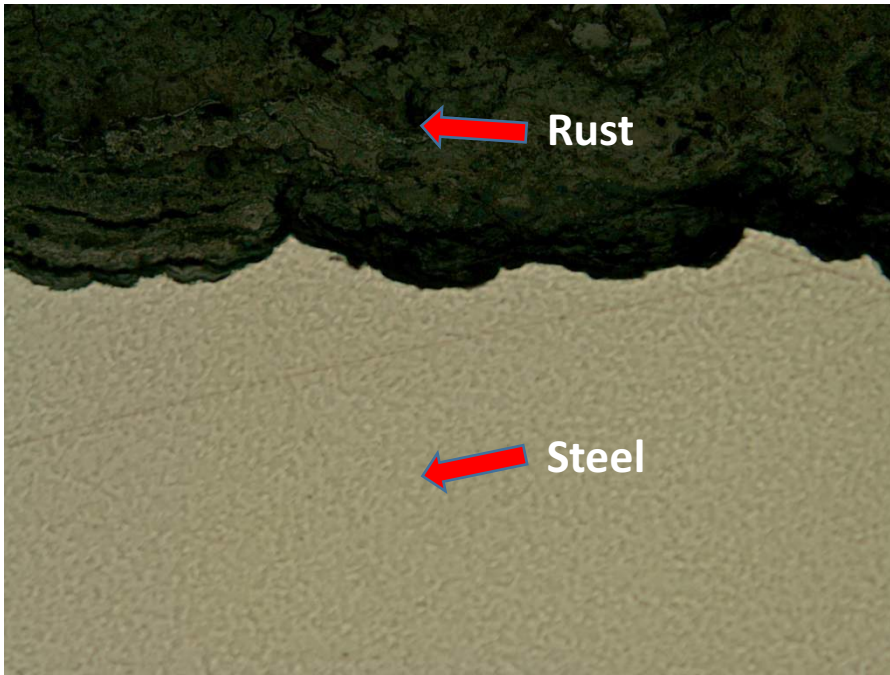
Figure 42. High Magnification Microphotograph of Corroded ASTM A606 Surface (Section View Not to Scale)

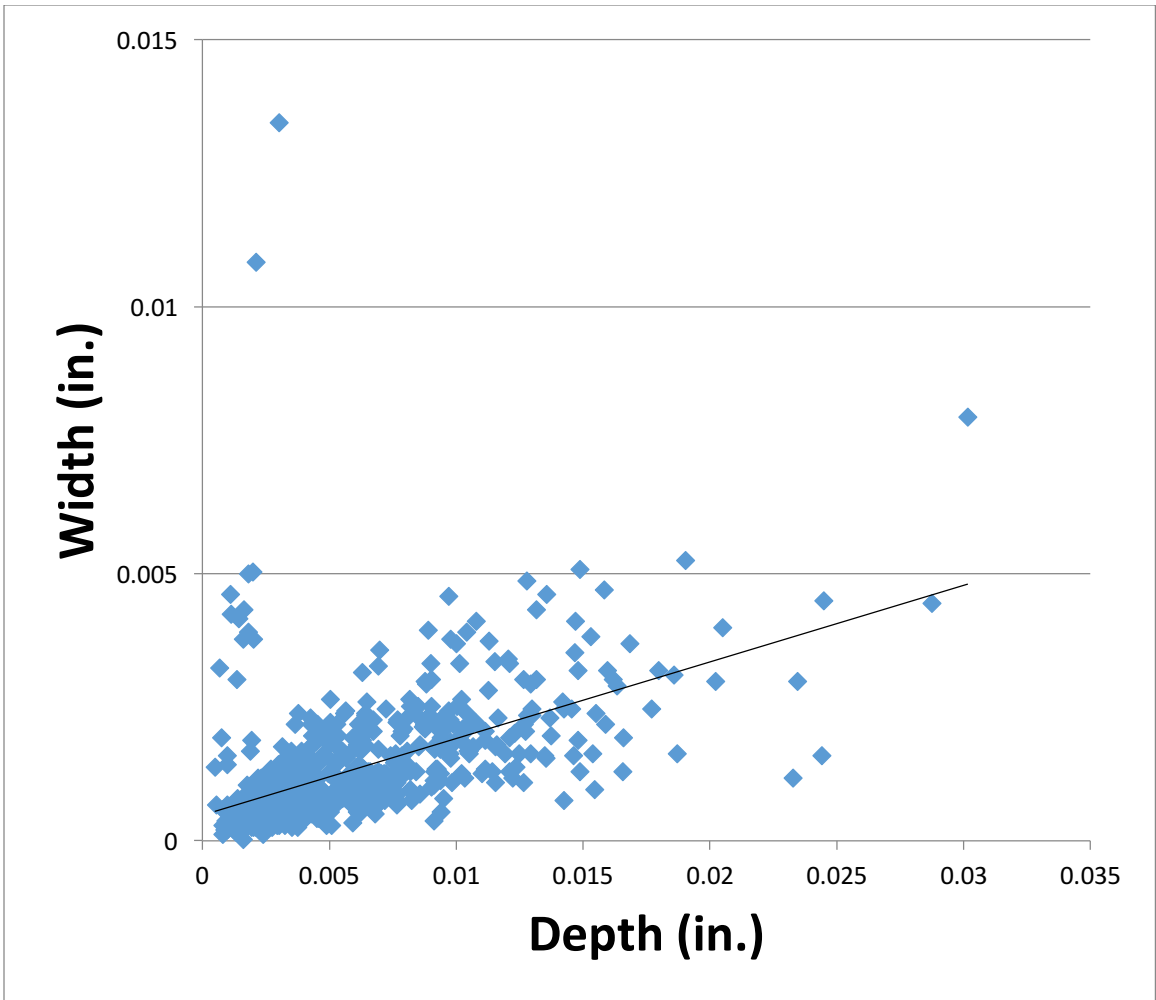
Figure 43. Surface Profile (Peak Width vs. Depth) for Section of Corroded ASTM A36 Steel

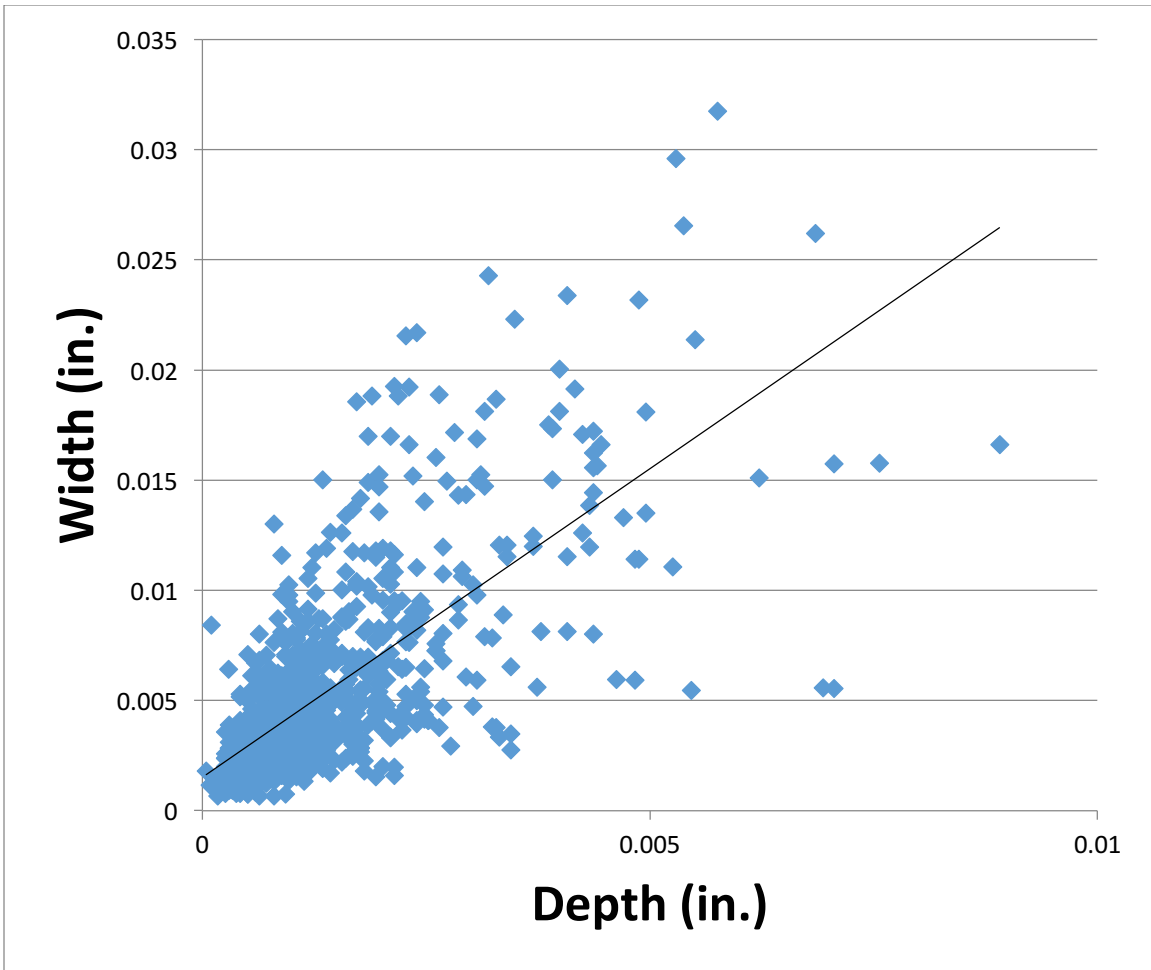
Figure 44. Surface Profile (Peak Width vs. Depth) for Section of Corroded ASTM A606 Steel

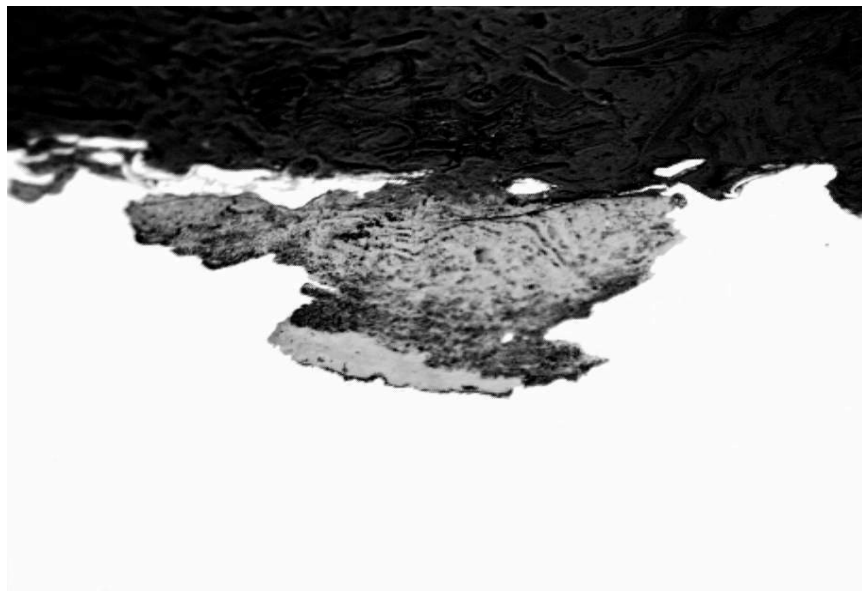
Figure 45. Microphotograph of Section of Blasted ASTM A36 Steel (Polished) Showing Deposit in Pit (Ref. 23)

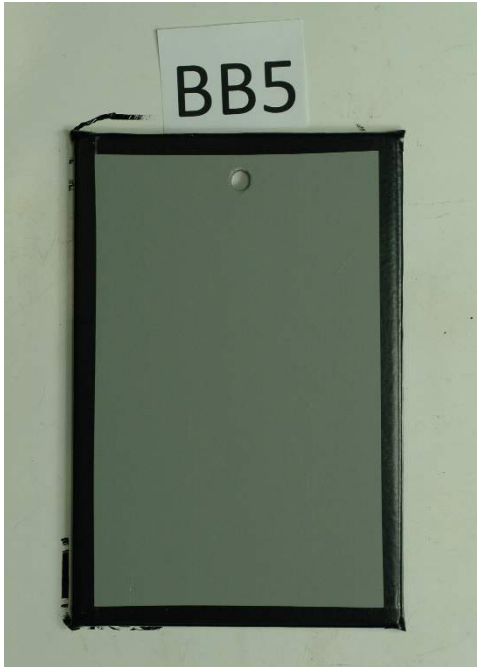
Figure 53. New ASTM A36 Steel (Blasted) Panels Showing Barrier Coating in Un-Scribed (a) and Scribed (b) Condition.

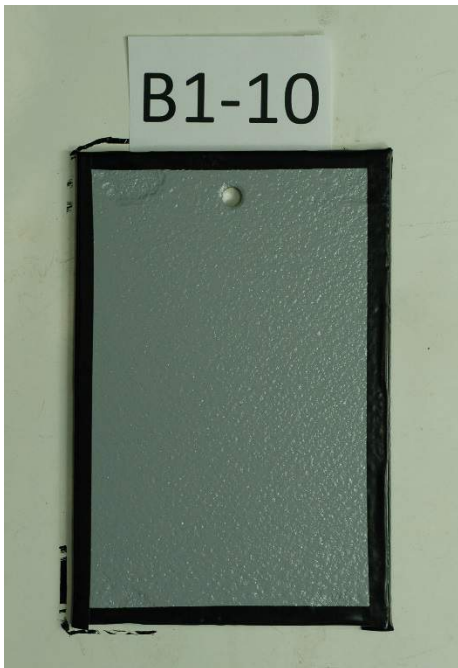
Figure 54. New ASTM A36 Steel (Blasted) Panels Showing Organic Zinc Coating in Un-Scribed (a) and Scribed (b) Condition

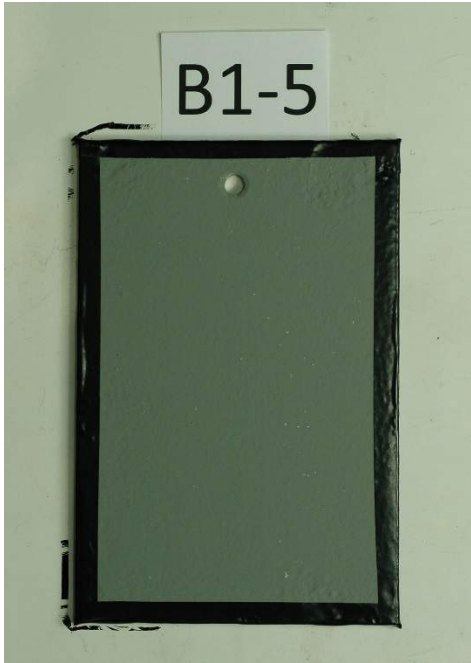
Figure 55. Preconditioned ASTM A36 Steel (Blasted) Panels Showing Barrier Coating in Un-Scribed (a) and Scribed (b) Condition

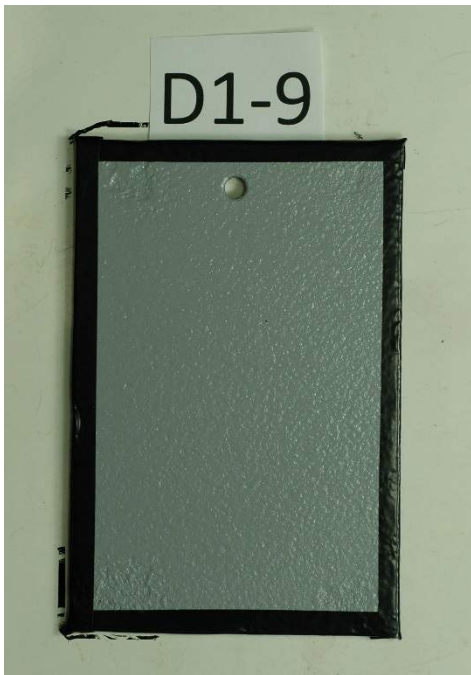
Figure 56. Preconditioned ASTM A36 Steel (Blasted) Showing Organic Zinc Coating in Un-Scribed (a) and Scribed (b) Condition

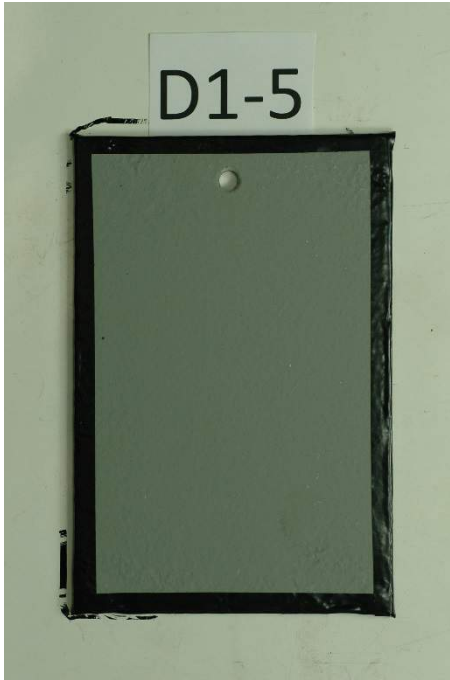
Figure 57. Preconditioned ASTM A36 Steel (Blast and Pressure Washed) Showing Barrier Coating in Un-Scribed (a) and Scribed (b) Condition

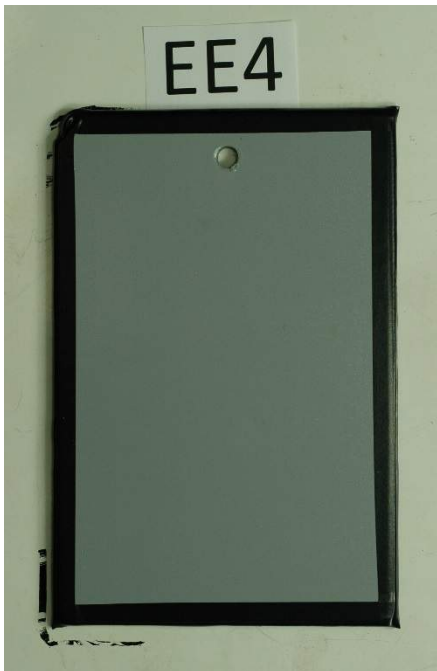
Figure 58. Preconditioned ASTM A36 Steel (Blast and Pressure Washed) Showing Organic Zinc Coating in Un-Scribed (a) and Scribed (b) Condition

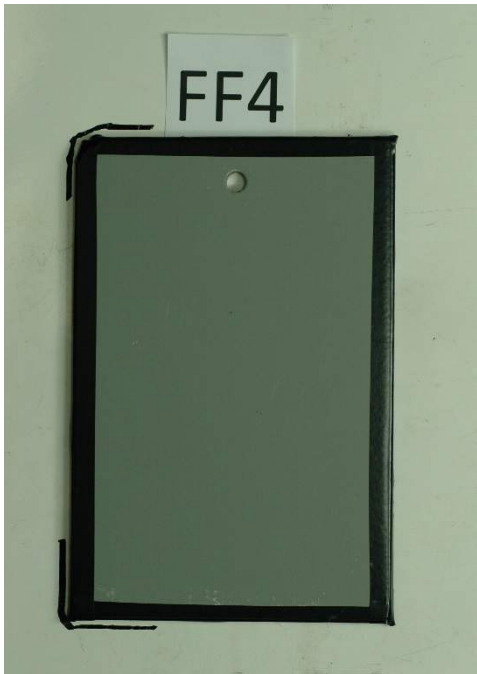
Figure 59. New ASTM A606 Steel (Blasted) Panels Showing Barrier Coating in Un-Scribed (a) and Scribed (b) Condition
