KENTUCKY TRANSPORTATION CENTER

176 Raymond Building, University of Kentucky
859.257.4513 www.ktc.uky.edu

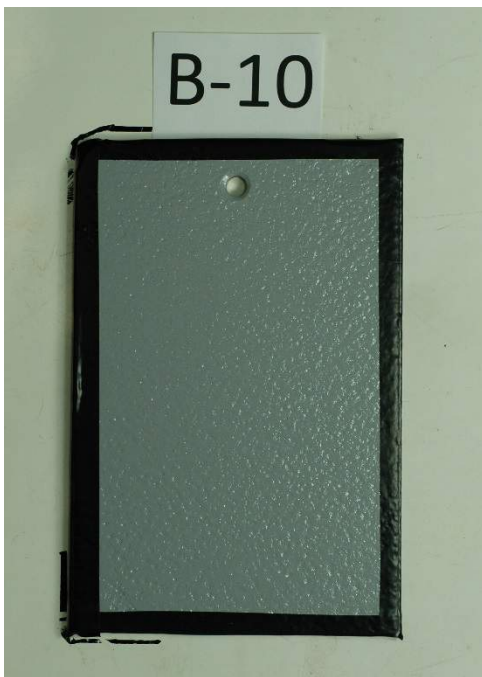
Figure 60. New ASTM A606 Steel (Blasted) Panels Showing Organic Zinc Coating in Un-Scribed (a) and Scribed (b) Condition

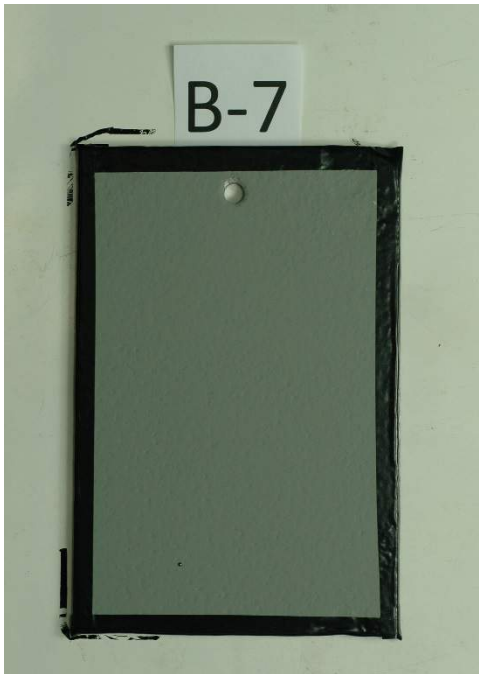
Figure 62. Preconditioned ASTM A606 Steel (Blasted) Panels Showing Barrier Coating in Un-Scribed (a) and Scribed (b) Condition

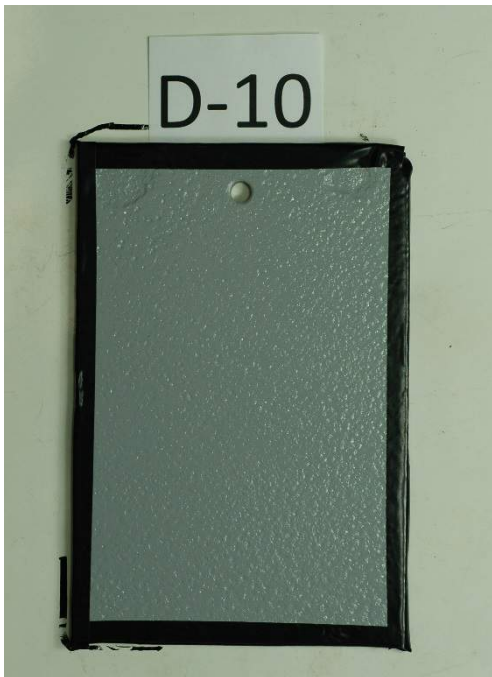
Figure 63. Preconditioned ASTM A606 Steel (Blasted) Panels Showing Organic Zinc Coating in Un-Scribed (a) and Scribed (b) Condition

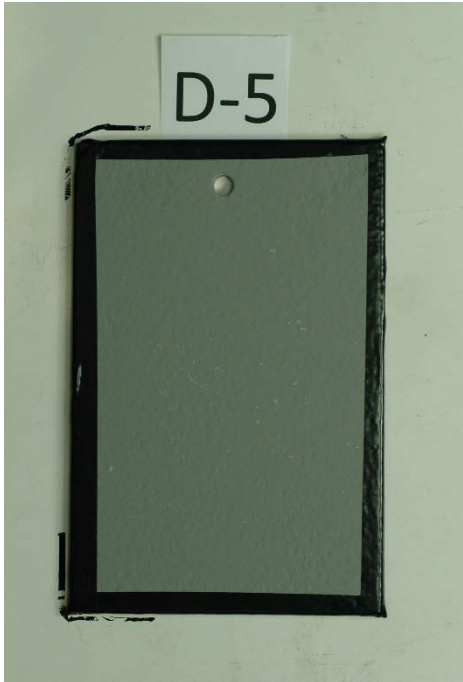
Figure 64. Preconditioned ASTM A606 Steel (Blast and Pressure Washed) Panels Showing Barrier Coating in Un-Scribed (a) and Scribed (b) Condition

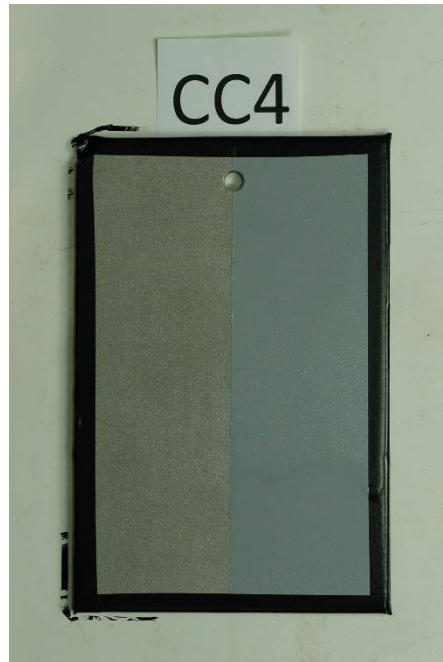
Figure 66. Half-Painted New ASTM A606 Steel (Blasted) Panel with Barrier Coating (Right Side of Panel)

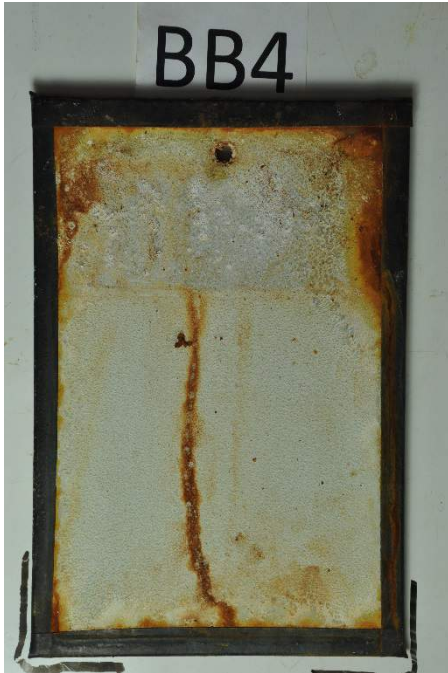
Figure 76. New ASTM A36 Steel (Blasted) Panels Showing Barrier Coating in Un-Scribed (a) and Scribed (b) Conditions after 5,000 Hours of Testing

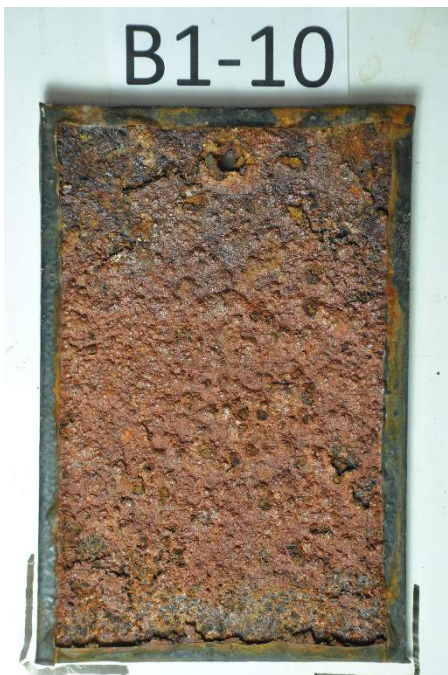
Figure 77. New ASTM A36 Steel (Blasted) Panels Showing Organic Zinc Coating in Un-Scribed (a) and Scribed (b) Conditions after 5,000 Hours of Testing

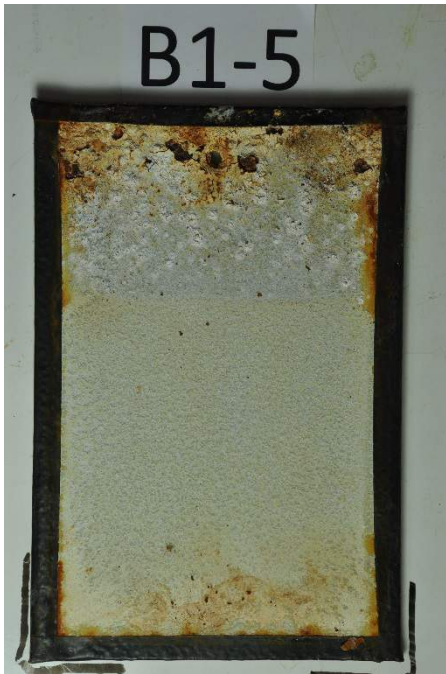
Figure 78. Preconditioned ASTM A36 Steel (Blasted) Panels Showing Barrier Coating in Un-Scribed (a) and Scribed (b) Conditions after 5,000 Hours of Testing

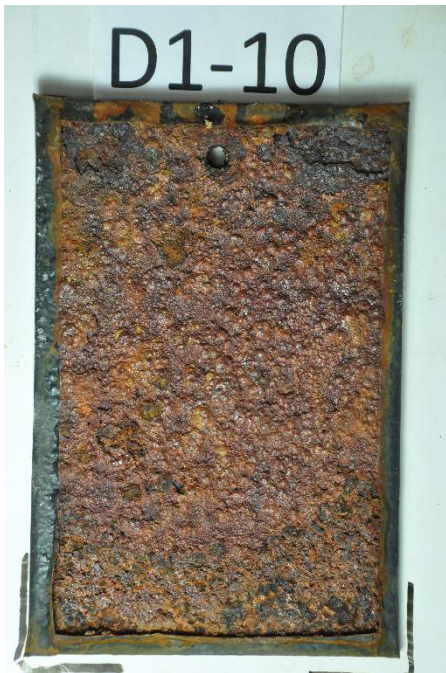
Figure 79. Preconditioned ASTM A36 Steel (Blasted) Panels Showing Organic Zinc Coating in Un-Scribed (a) and Scribed (b) Conditions after 5,000 Hours of Testing

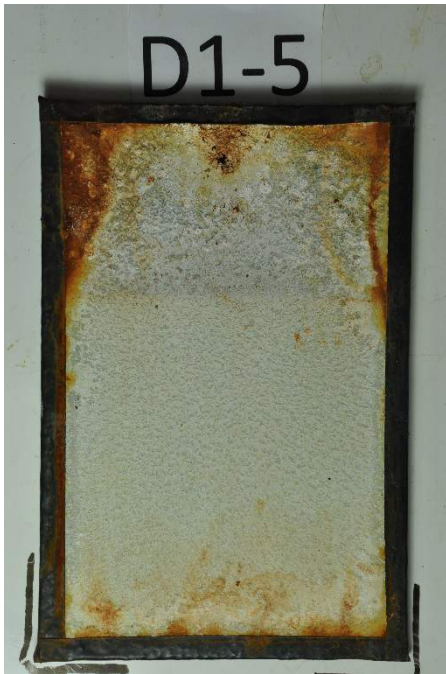
Figure 80. Preconditioned ASTM A36 Steel (Blast and Pressure Washed) Panels Showing Barrier Coating in Un-Scribed (a) and Scribed (b) Conditions after 5,000 Hours of Testing.

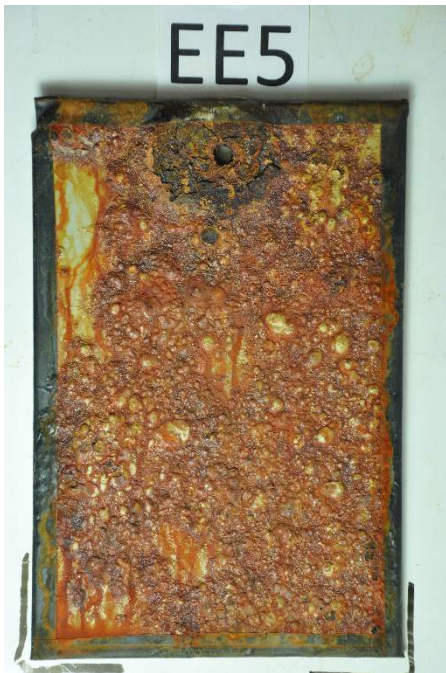
Figure 81. Preconditioned ASTM A36 Steel (Blast and Pressure Washed) Panels Showing Organic Zinc Coating in Un-Scribed (a) and Scribed (b) Conditions after 5,000 Hours of Testing

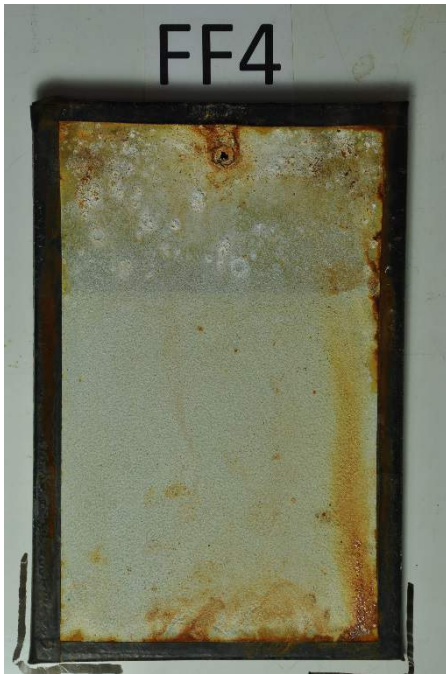
Figure 82. New ASTM A606 Steel (Blasted) Panels Showing Barrier Coating in Un-Scribed (a) and Scribed (b) Conditions after 5,000 Hours of Testing

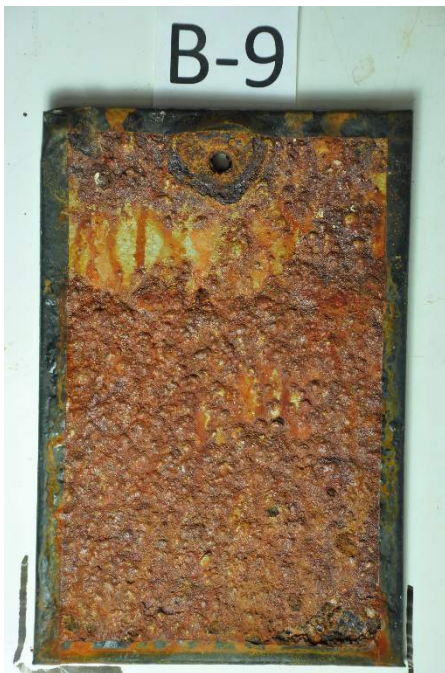
Figure 83. New ASTM A606 Steel (Blasted) Panels Showing Organic Zinc Coating in Un-Scribed (a) and Scribed (b) Conditions after 5,000 Hours of Testing

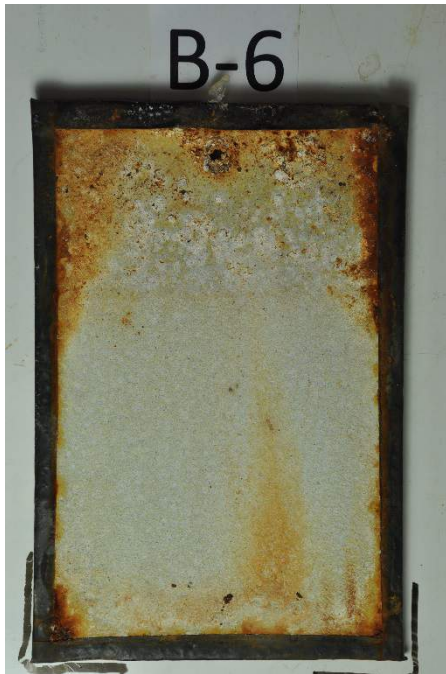
Figure 84. Preconditioned ASTM A606 Steel (Blasted) Panels Showing Barrier Coating in Un-Scribed (a) and Scribed (b) Conditions after 5,000 Hours of Testing

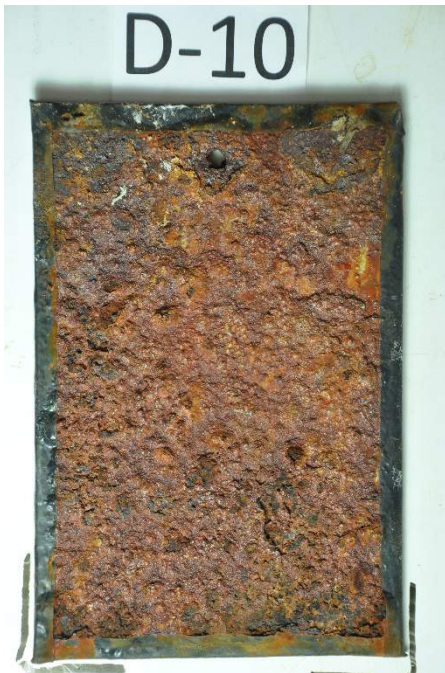
Figure 85. Preconditioned ASTM A606 Steel (Blasted) Panels Showing Organic Zinc Coating in Un-Scribed (a) and Scribed (b) Conditions after 5,000 Hours of Testing

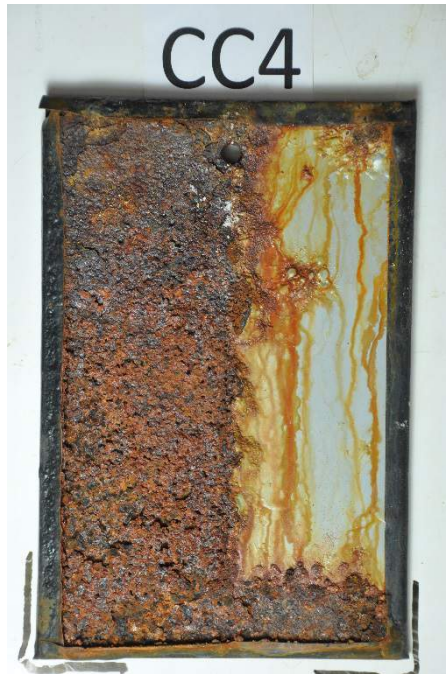
Figure 87. Half-painted New ASTM A606 Steel (Blasted) Panel with Barrier Coating (Right Side of Panel) after 5,000 Hours of Testing
