Truck Route Access Evaluation: Paducah-McCraken County US 60 Business Route and Locust Drive Site # 14

KTC-99-18 Paducah - McCracken County US 60 Business Route and Locust Drive Site # 14

"Freight Movement and Intermodal Access in Kentucky" SPR 98-189

January 1999

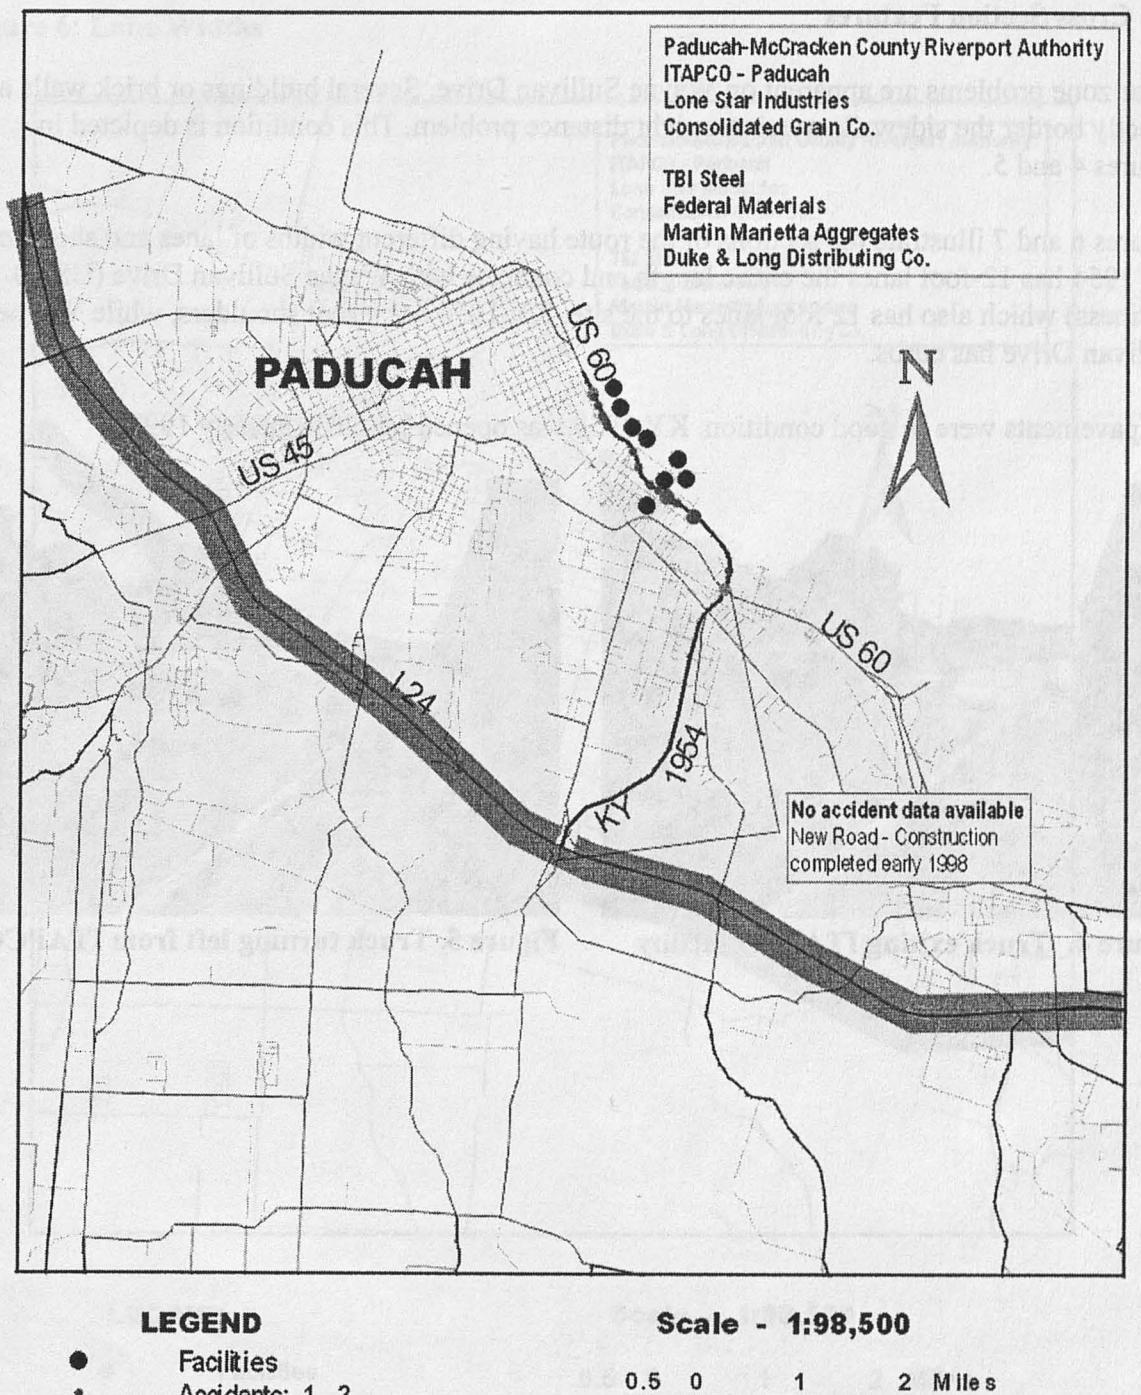
Figure 3 shows the locations of accidents during the years 1995, 1996 and 1997. The figure clearly illustrates that accidents are occurring at intersections as would be expected. A summary of the accidents along the entire truck route is shown in Table 3 for the same three year period. Truck accidents represent a significant portion of the overall accidents along this route. The 7.1% of accidents involving trucks is higher than the percent trucks along US 60X (4.6%). This suggests there are some safety concerns from an accident history point of view that must be addressed along this route.

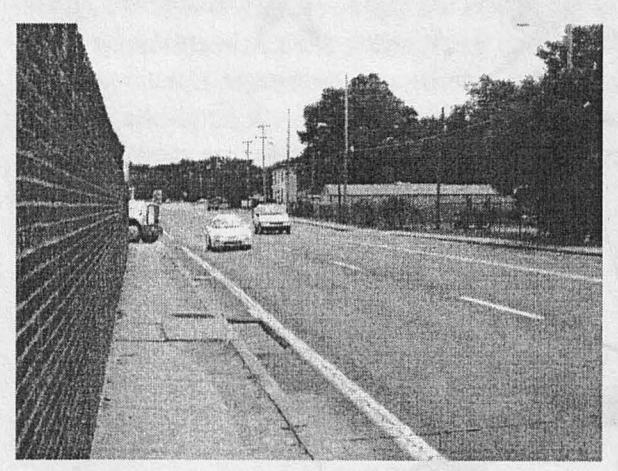
Figure 4. Truck exiting ITAPCO facility

Clear zone problems are apparent on Wayne Sullivan Drive. Several buildings or brick walls are directly border the sidewalk creating a sight distance problem. This condition is depicted in Figures 4 and 5.

No sight distance problems exist along KY 1954. The only area where sight distance could be a potential problem is at the ITAPCO facility where the restricting element is on private property where the driveway connects to Wayne Sullivan Drive. This feature should be rated "less than adequate."

At the ITAPCO facility, shown in Figure 4 and Figure 5, trucks enter off Wayne Sullivan Drive and travel only a few feet to the loading area. After the vehicles are loaded, they continue in a semi circle path to the exit. There are several large aboveground storage tanks on the property which provides the need for a seven foot brick retension wall along the front of the property. The wall abuts the sidewalk and is open across the front of the loading area. Trucks enter and exit in a semi circle path. As a truck proceeds to the exit area the vehicle must pull slightly into the westbound lane to permit adequate sight distance in both directions. The roadway is straight in the westbound direction but curves to the left in the eastbound direction (approximately 0.15 mile from the facility). The route to I-24 via KY 1954 leads to the left from the facility which necessitates a left turn across traffic in a 45 mph speed zone. Several loaded tanker trucks were observed turning left into the traffic flow causing traffic to slow. The problem appears to be the location of the wall on private property, but a lower speed limit could potentially improve this situation. "Trucks Entering Highway" warning signs are located approximately 0.15 mile in each direction from this facility. Both have flashing warning lights attached to the signs. Preceding these signs are "Congested Area" signs.

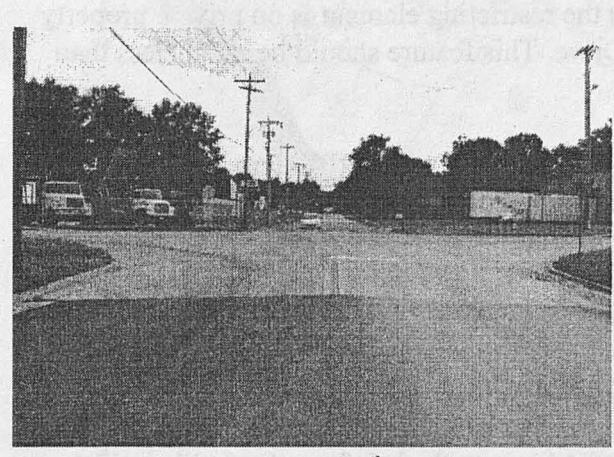
Figure 8. Intersection of 4th Street (Southbound) with Wayne Sullivan Drive.

Figure 8 shows the intersection of 4th Street at Wayne Sullivan Drive as viewed when leaving the industrial area. Figure 9 shows the same intersection from Wayne Sullivan Drive traveling west. Locust Drive enters from the left and 4th Street enters from the right. The 40 foot width of 4th Street allowed sufficient turning distance. Therefore, the turning radius was rated "preferred" and no evidence to the contrary was detected.

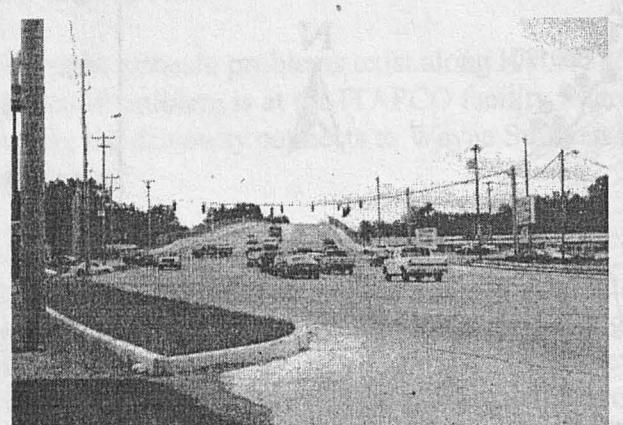
Figure 11: KY 1954 Bridge near US 60 X Intersection (Southbound)

The location of bridges along the routes are shown in Figure 10. The bridge on KY 1954 near the intersection with US 60/62 and Wayne Sullivan Drive was opened to traffic in early 1998 and no information is yet available. It is a new bridge and can be assumed to have a "preferred" rating. The proximity of the downgrade of the bridge on KY 1954 to the intersection could present some difficulty during icing conditions. Since the bridge had not been opened to traffic during a winter season at the time of visit, no experience has been gained with regard to winter operations.
