# Erosion of fractured banks, Lake Sakakawea, western North Dakota

Mark C. Elliott  
*University of North Dakota*

A Thesis

Grand Forks, North Dakota  
August  
1991

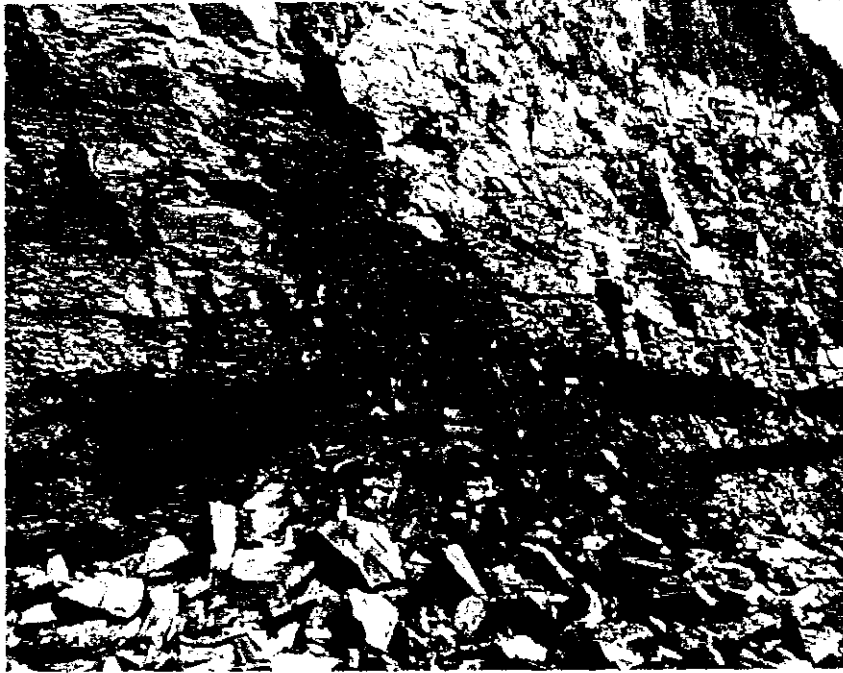
Figure 9. Blocky Fracture Pattern and Variable Lithologies,  
Sentinel Butte Formation.

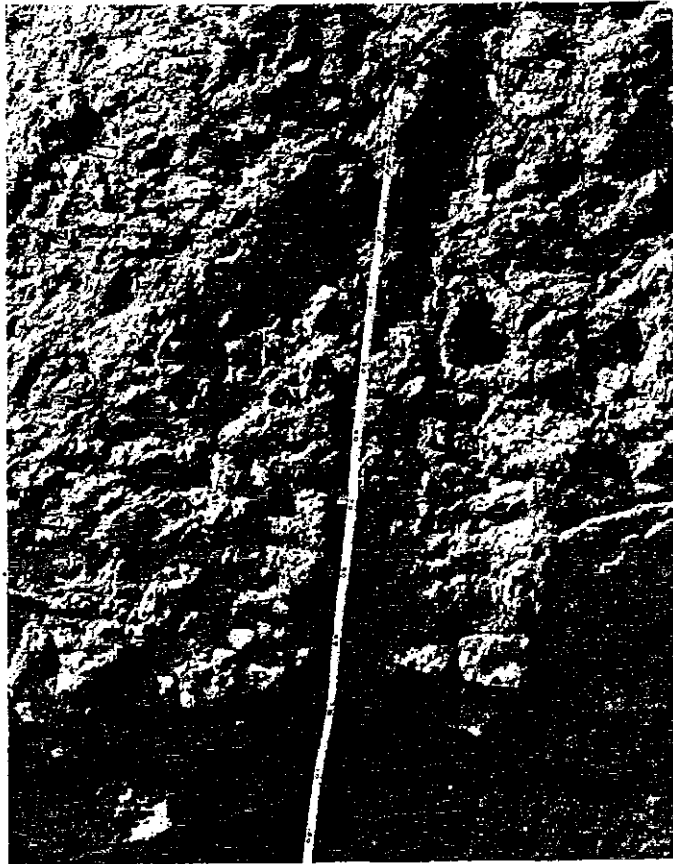
Figure 17. Close-Up of Upper Medicine Hill Till Fractures,  
Station 51.

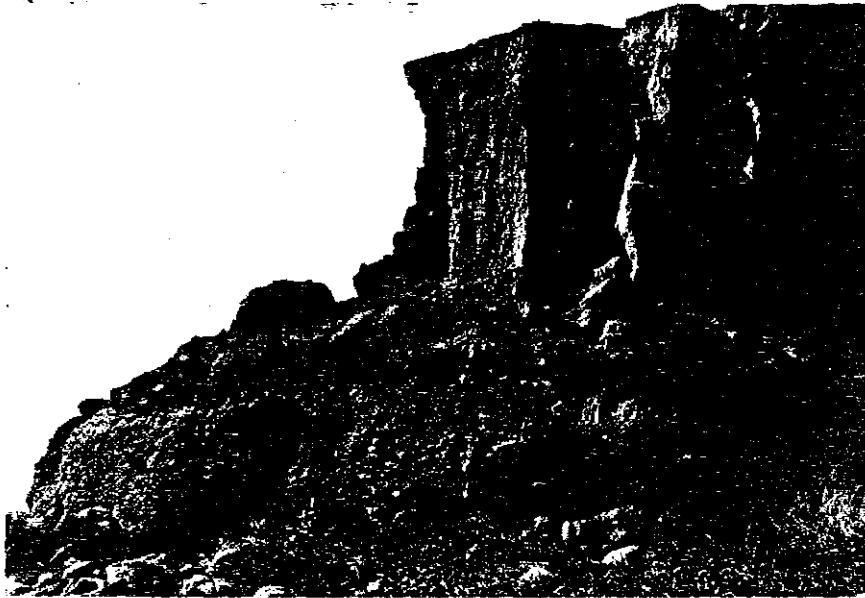
Figure 21. Upper Horseshoe Valley Till with Strong Columnar Jointing Overlying Upper Medicine Hill Till, Station 51.

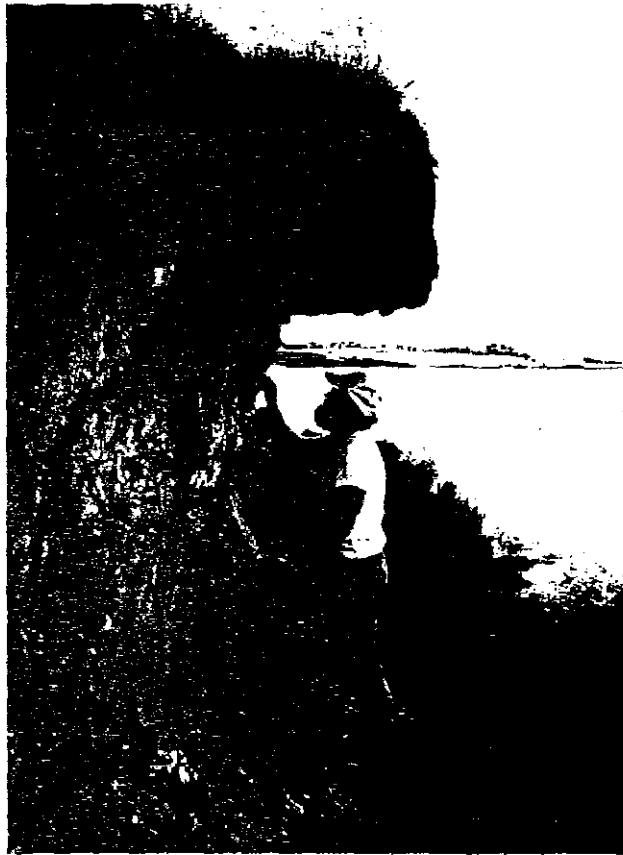
Figure 27. Relatively Resistant and Densely-Rooted Oahe Formation Overlying Upper Snow School Till; Lake Sakakawea State Park.

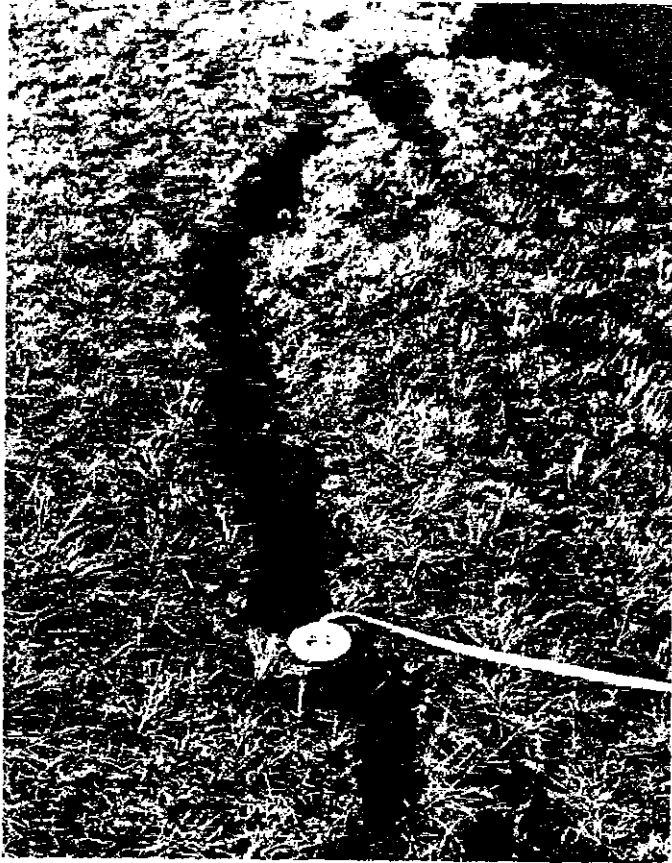
Figure 28. Bank-Parallel Bank-Top Fracture, Lake Sakakawea State Park.

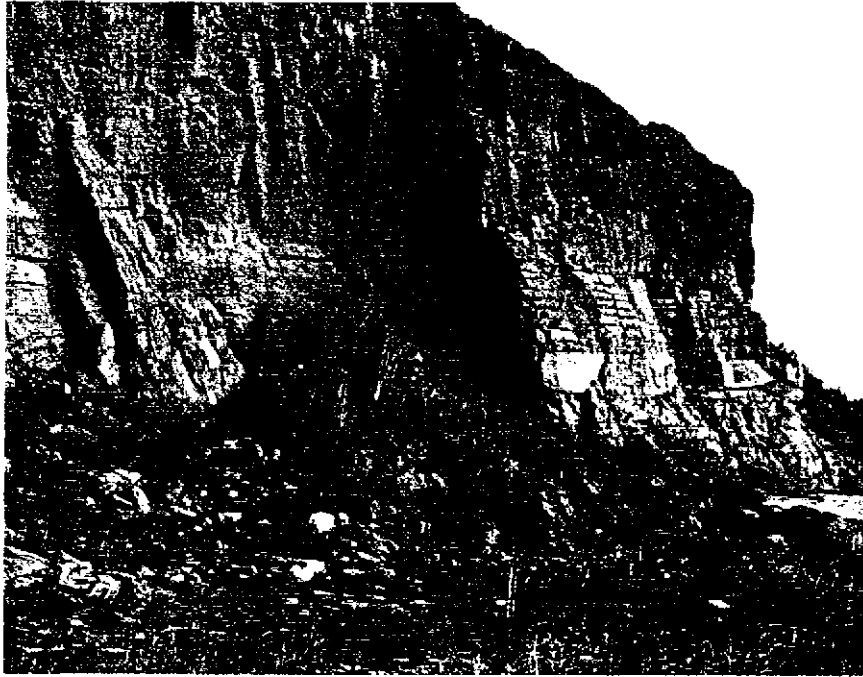
Figure 31. Failure Along Large Vertical Bank-Parallel Tension Fractures in Upper Snow School Till and Underlying Sentinel Butte Formation; Fort Stevenson State Park.

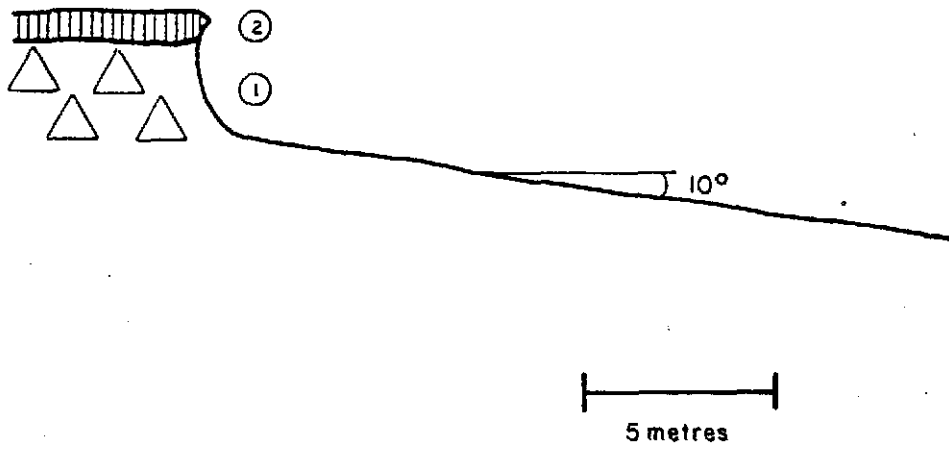
Figure 38. Station 1.

**Dominant Bank Failure Mechanisms:** Minor toppling and high-angle sliding along vertical bank-parallel tension fractures.

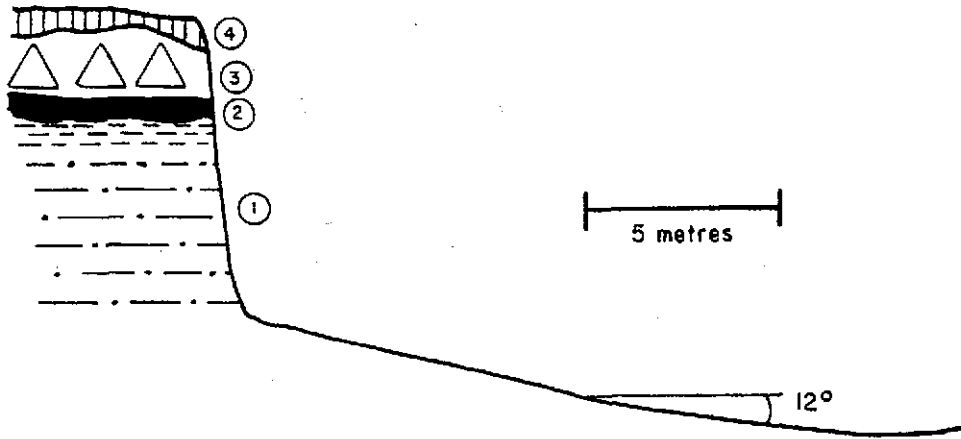
Figure 39. Station 2.

Dominant Bank Failure Mechanisms: Top half of bank failing due to high-angle slides and topples along large vertical bank-parallel fractures. Small-scale block toppling is the dominant failure mechanism for the bottom half.

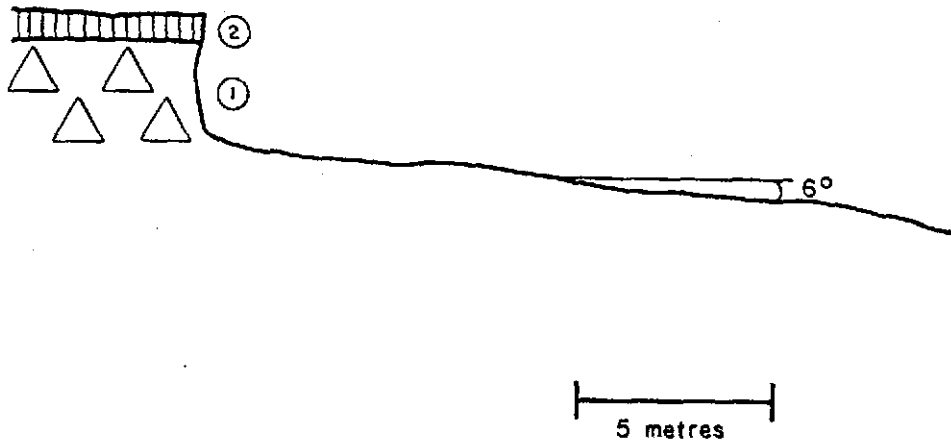
Figure 40. Station 3,

**Dominant Bank Failure Mechanisms:** Minor toppling and high-angle sliding along vertical bank-parallel tension fractures.

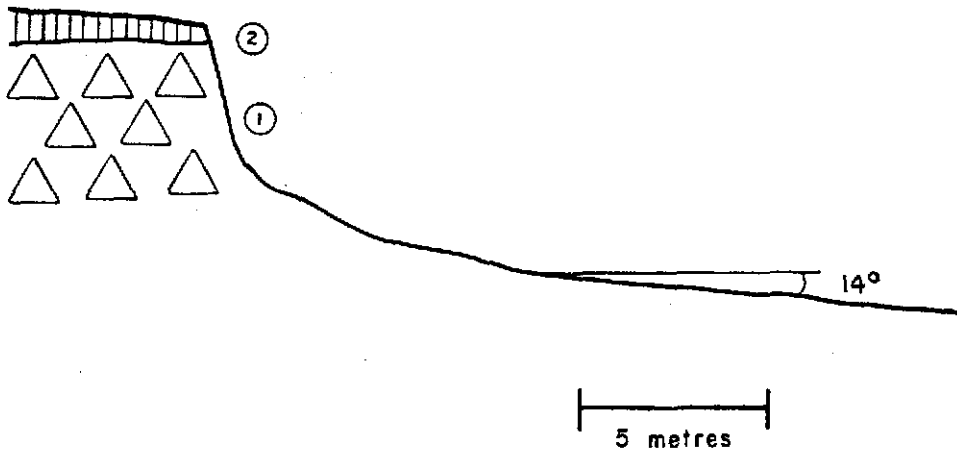
Figure 41. Station 4.

**Dominant Bank Failure Mechanisms:** Toppling and high-angle sliding along vertical bank-parallel tension fractures.

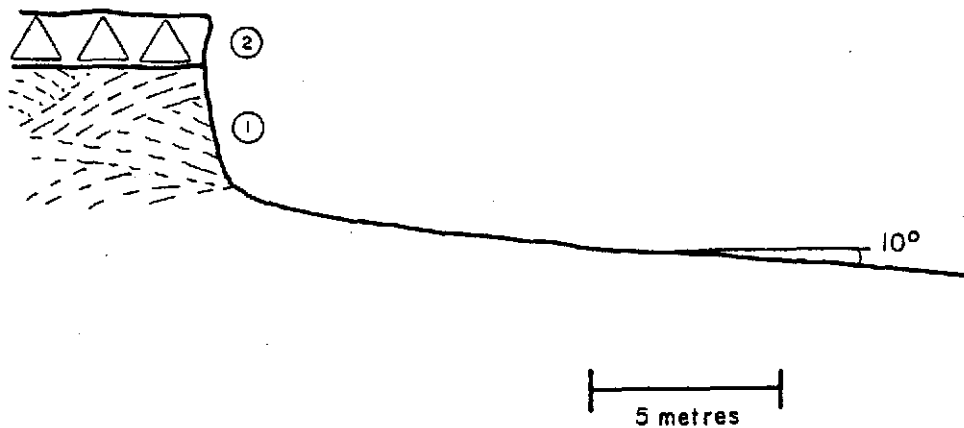
Figure 42. Station 5.

Dominant Bank Failure Mechanisms: Minor toppling at the top one to two metres of the bank in the Upper Snow School till.

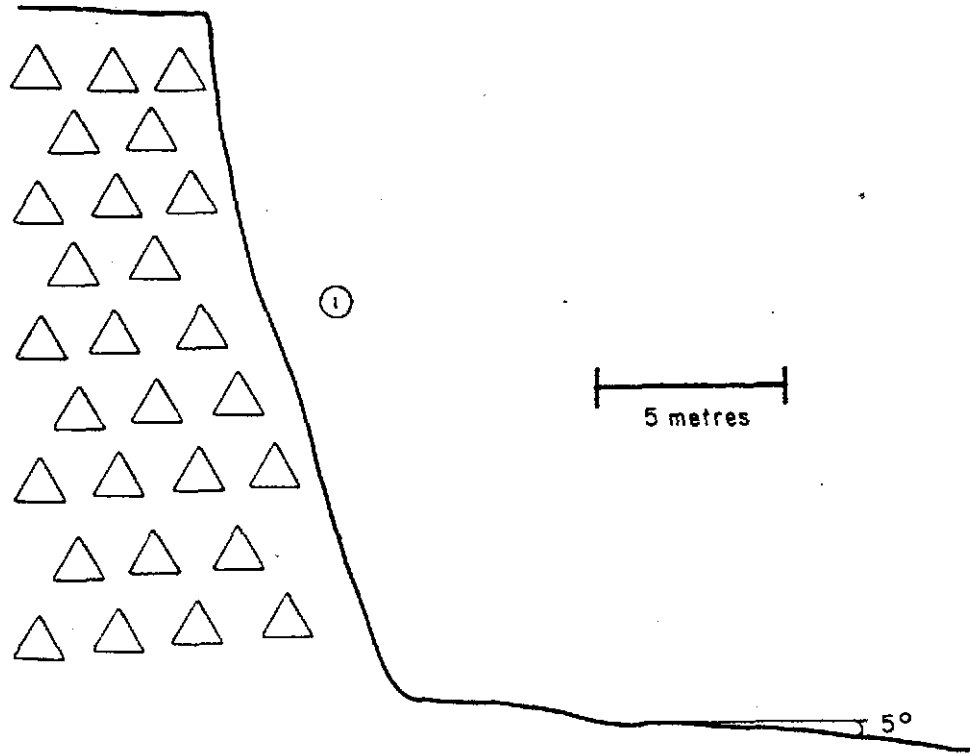
Figure 43. Station 6.

Dominant Bank Failure Mechanisms: Toppling and high-angle sliding along large vertical bank-parallel tension cracks.
