Dune Monitoring Data Update Summary

Kevin P. O'Brien
Virginia Institute of Marine Science

March 2009

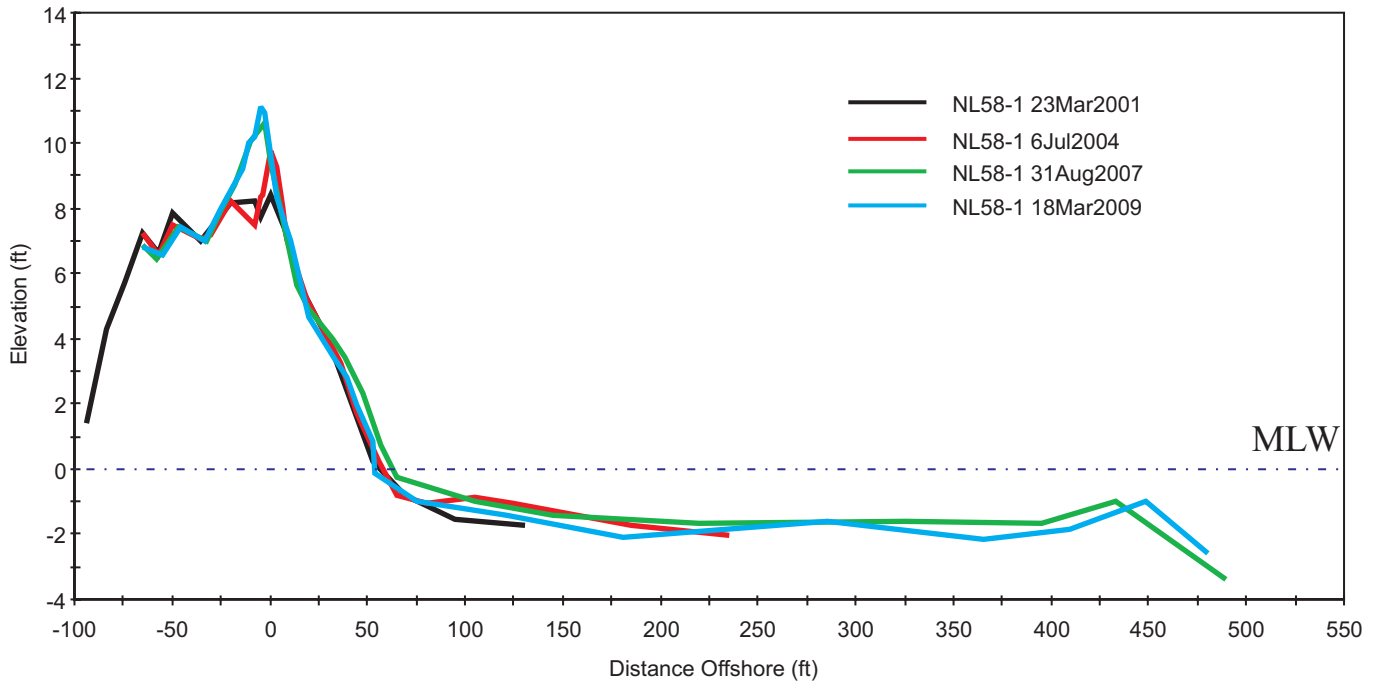
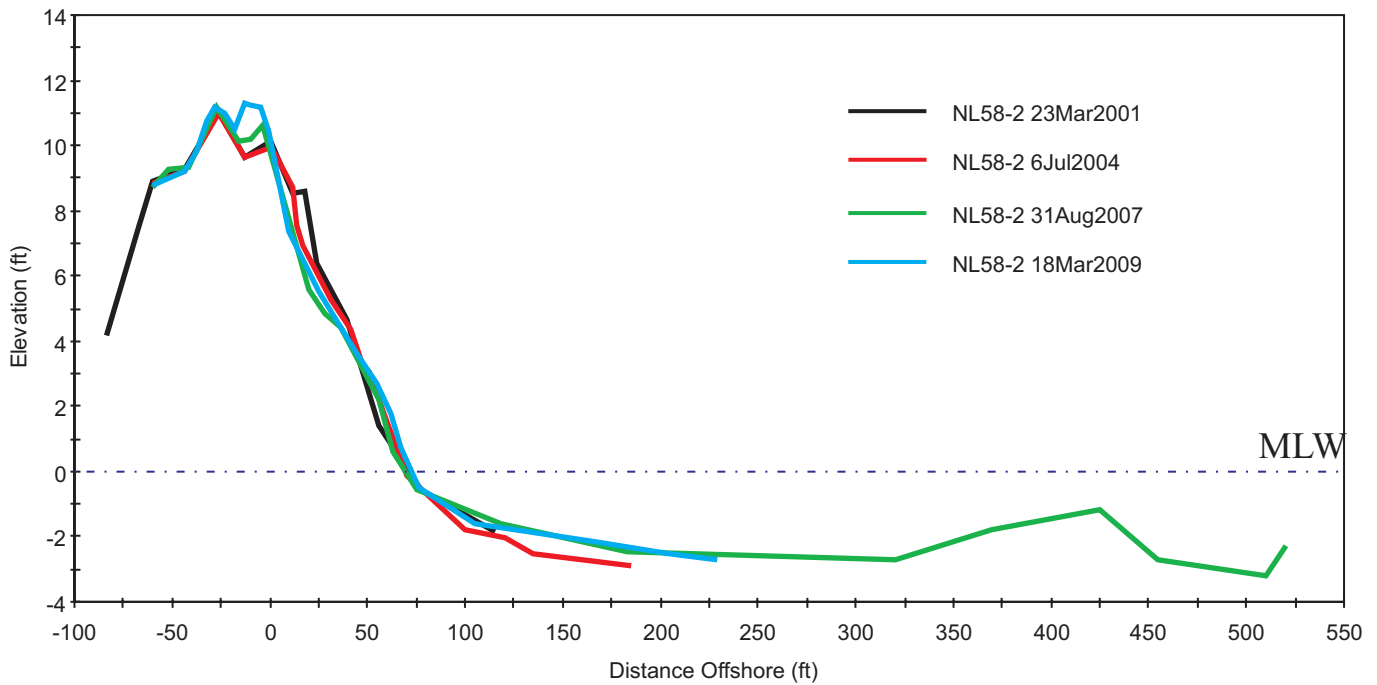
Figure 7J. Individual profile change through time.

(Milligan *et al.*, 2005)(Figure 11). Even before the monitoring program, this profile was receding. What was originally thought to be a primary dune was actually a secondary dune whose primary dune had been eroded. The hurricane caused the shoreline to become erosional overall (Milligan *et al.*, 2005). To this day, the site is still slightly erosional, but there are some signs of growth with the NL58-3 front dune face and beach accreting since 2004 (Figure 7J-K).

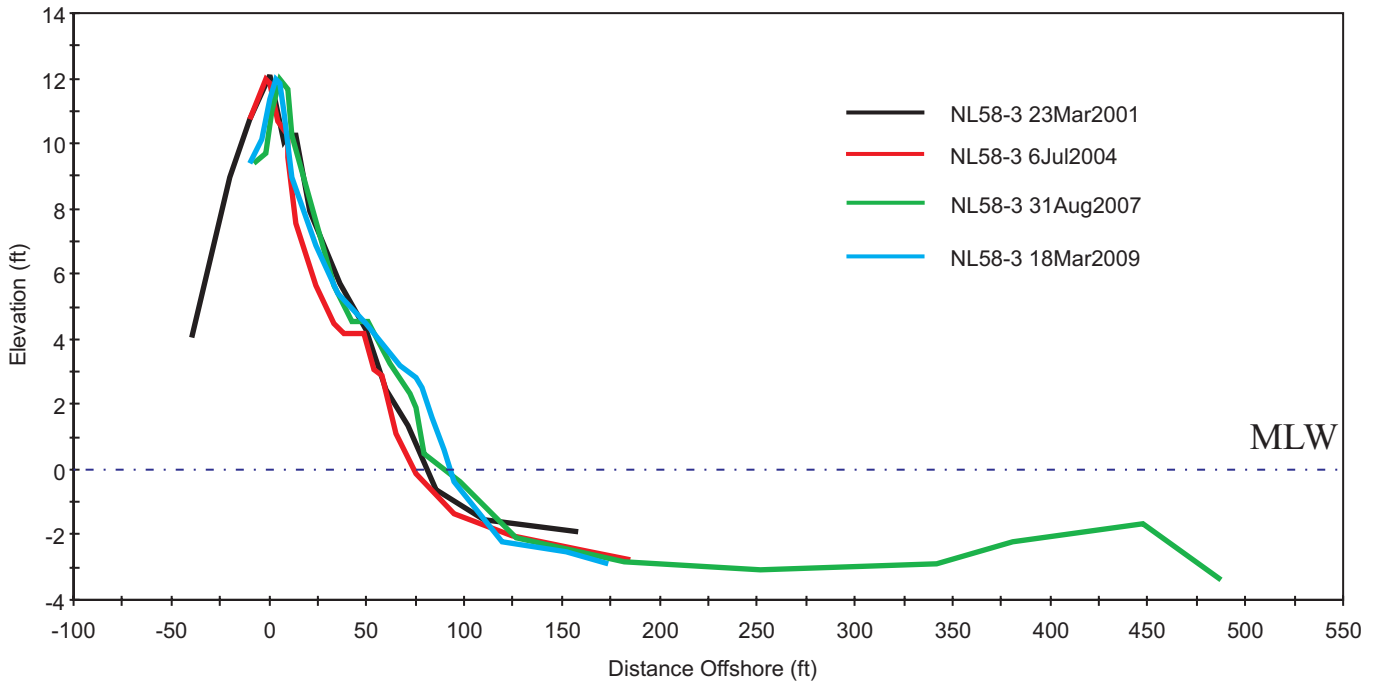
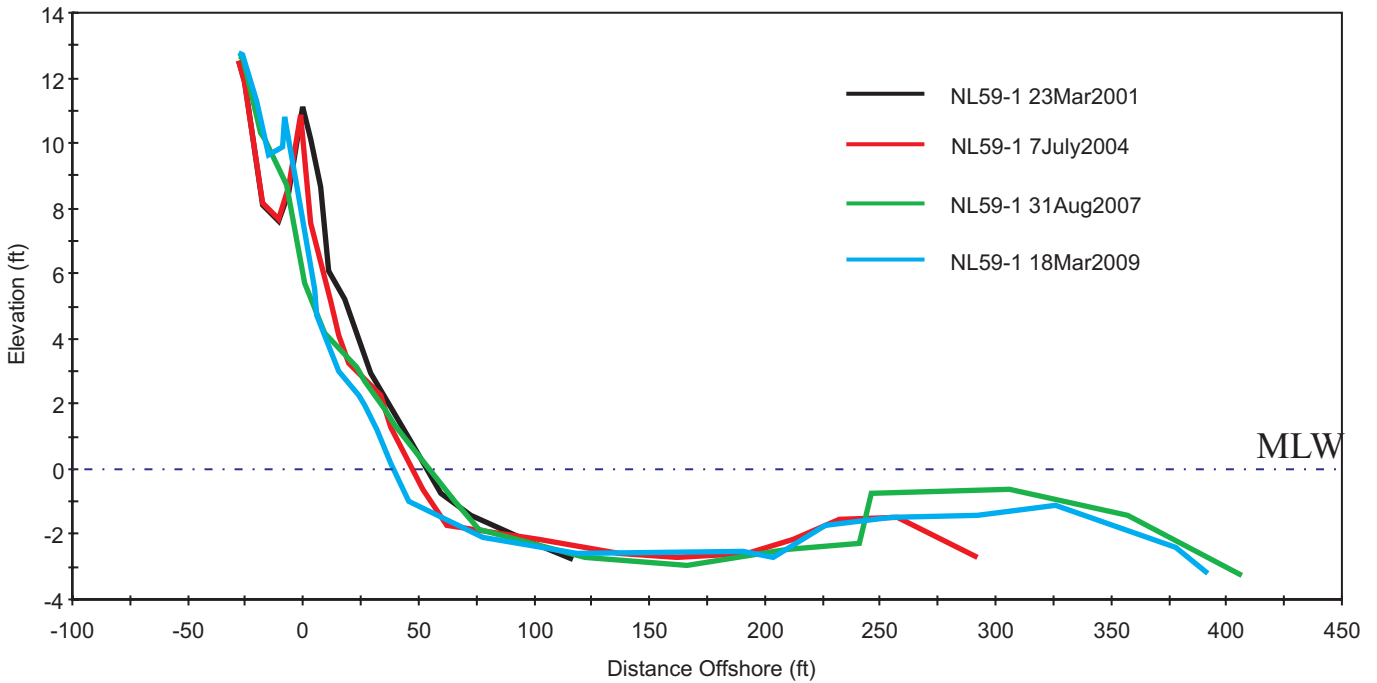
Figure 7K. Individual profile change through time.

Portions of NL59 are adjacent to the creek mouth barrier of Black Pond, but much of it abuts the adjacent upland. It is wider toward Hack Creek since sand tends to accumulate at the jetties. Groins were installed along the shore in the 1960s, and by 1976, these had accreted a wide enough beach for a dune to develop (Milligan *et al.*, 2005). Most of the site was erosional over the course of the monitoring program. Between 2004 and 2007, the primary dune at NL59-1 and NL59-2 was completely eroded, but at NL59-1, the dune is starting to show signs of growth (Figure 11). Profile NL59-3 lost its primary dune making the secondary dune the primary (Milligan *et al.*, 2005). It has been relatively stable between 2007 and 2009 (Figure 7K-L).

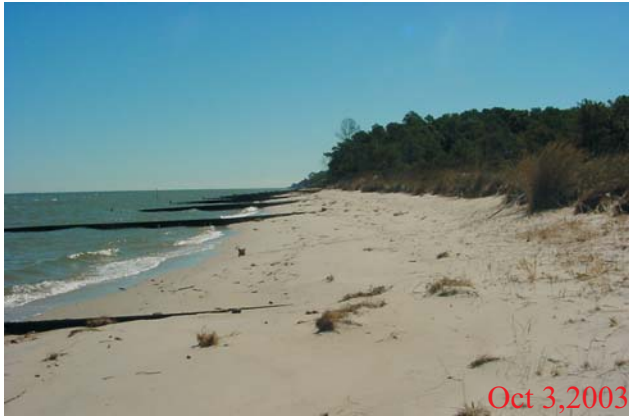
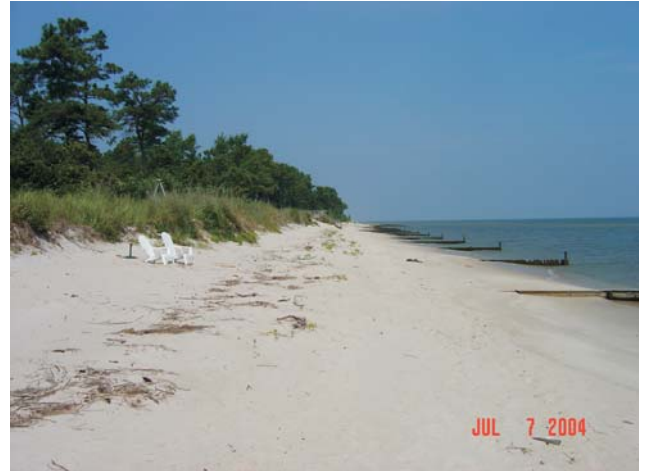
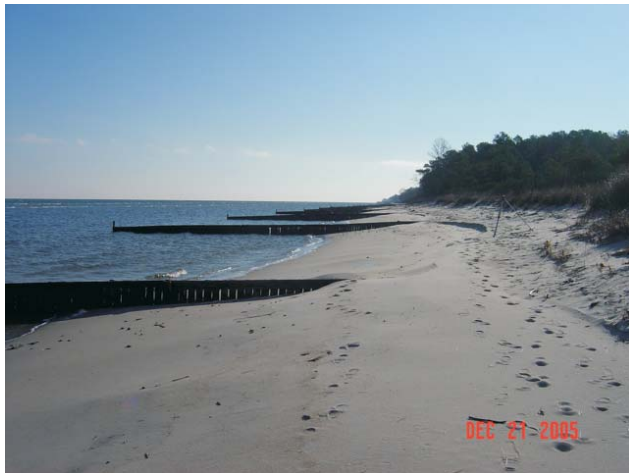
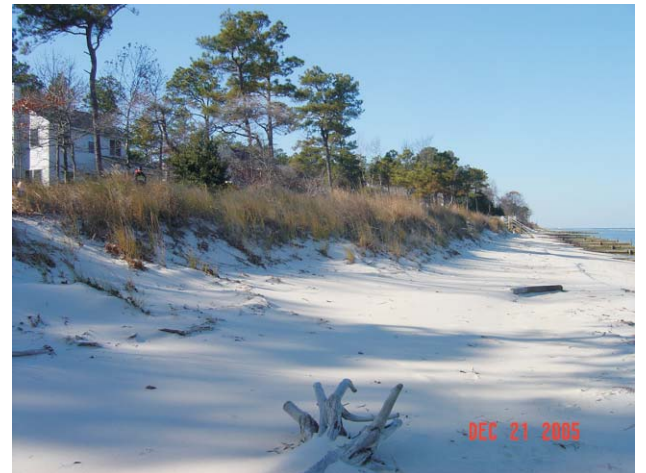
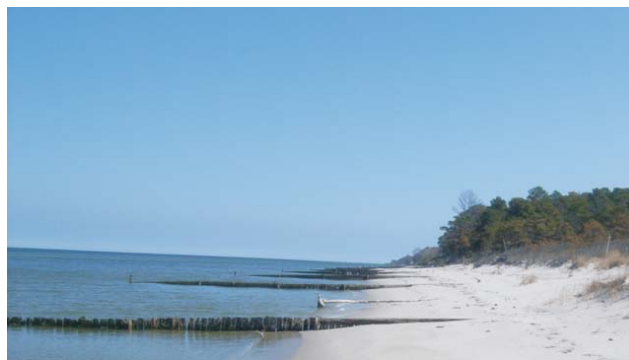
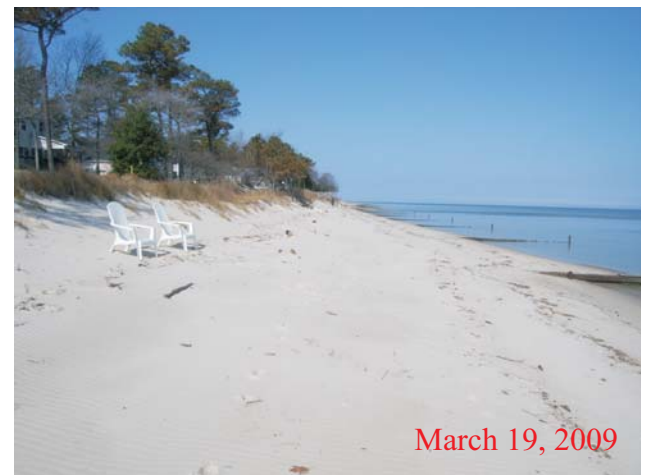
Figure 11. Photographs of NL58 and NL59 during the course of surveying.

NL58 and NL59 are similar sites that exist on either side of a tidal creek emptying into the Potomac River. Eroding fastland updrift provides the sediment necessary for dune growth. NL58 has had a dune field since 1937 which has allowed a secondary dune field to become established along sections of the shore (Milligan *et al.*, 2005). However, as development of the shore occurred, groins were installed along the shoreline leading to the degradation of the dune field downdrift. Groins were built at the site by 1987. Before the hurricane, the shoreline was accretionary at NL58-1 and NL58-2 while the more downdrift profile NL58-3 was erosional
