Report of Trip to Investigate Area Around Heron Island Bar in the Potomac River

REPORT OF TRIP TO INVESTIGATE AREA AROUND
HERON ISLAND BAR IN THE POTOMAC RIVER

Marine Resource Report #81-8

10 July 1981

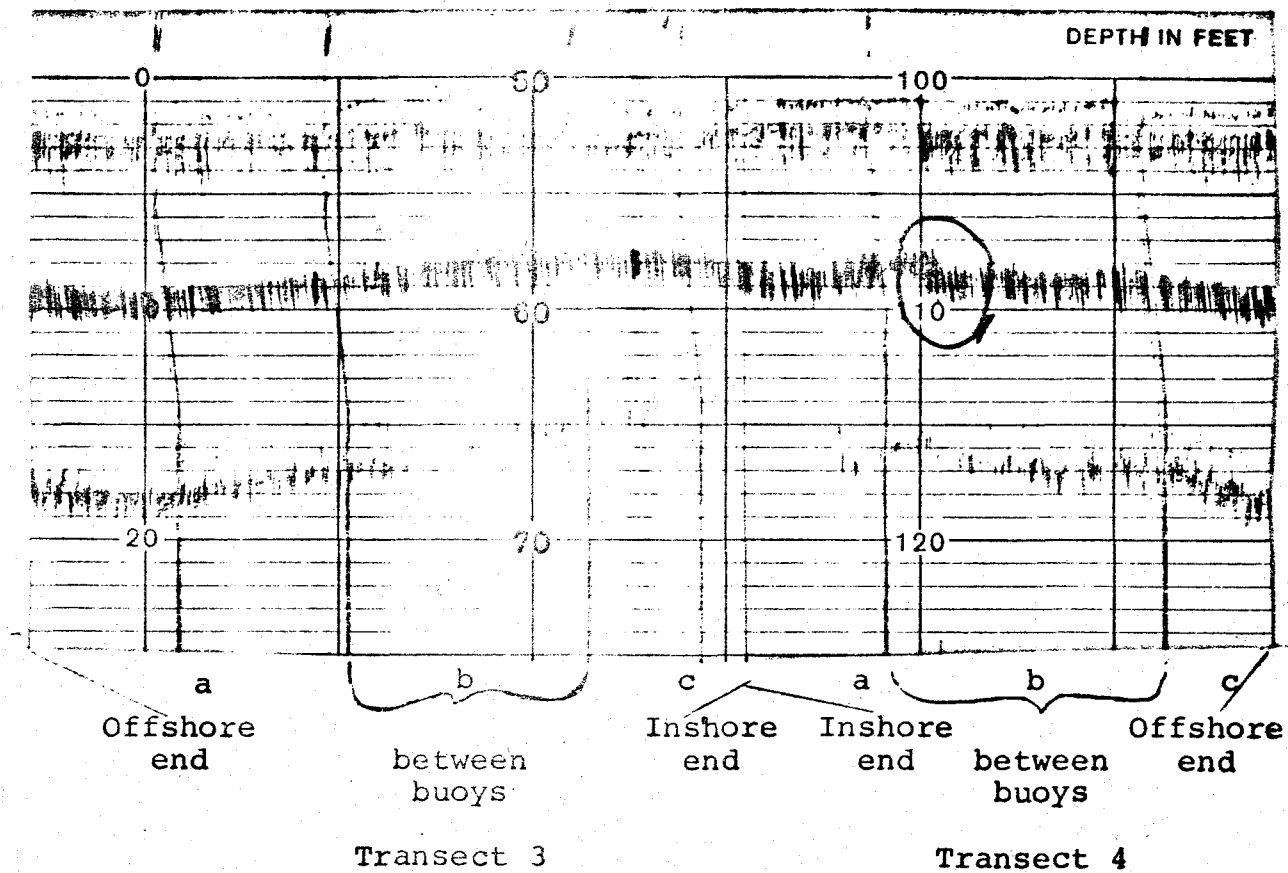
Figure 4. Fathometer tracing of the bottom along transects 3 and 4 in the Potomac River near Heron Island Bar; made 6/17/81. Circled portion is suggestion of recent disturbance.

Transect 3 - A smooth, even sloping bottom is shown on this trace (Figure 4). This transect was about 90 feet downriver of the previous transect (Figure 2).

Transect 4 - On this transect which was about 90 feet downriver of transect 3 (Figure 2) there appeared an abrupt one-foot change in the bottom near the inshore buoy (transect 4b); this alteration of the bottom occurred over a distance of 70 feet. The abruptness and magnitude of the change (which is circled in Figure 4) suggests that it was caused by a recent disturbance. The rest of the bottom appeared smooth and even.

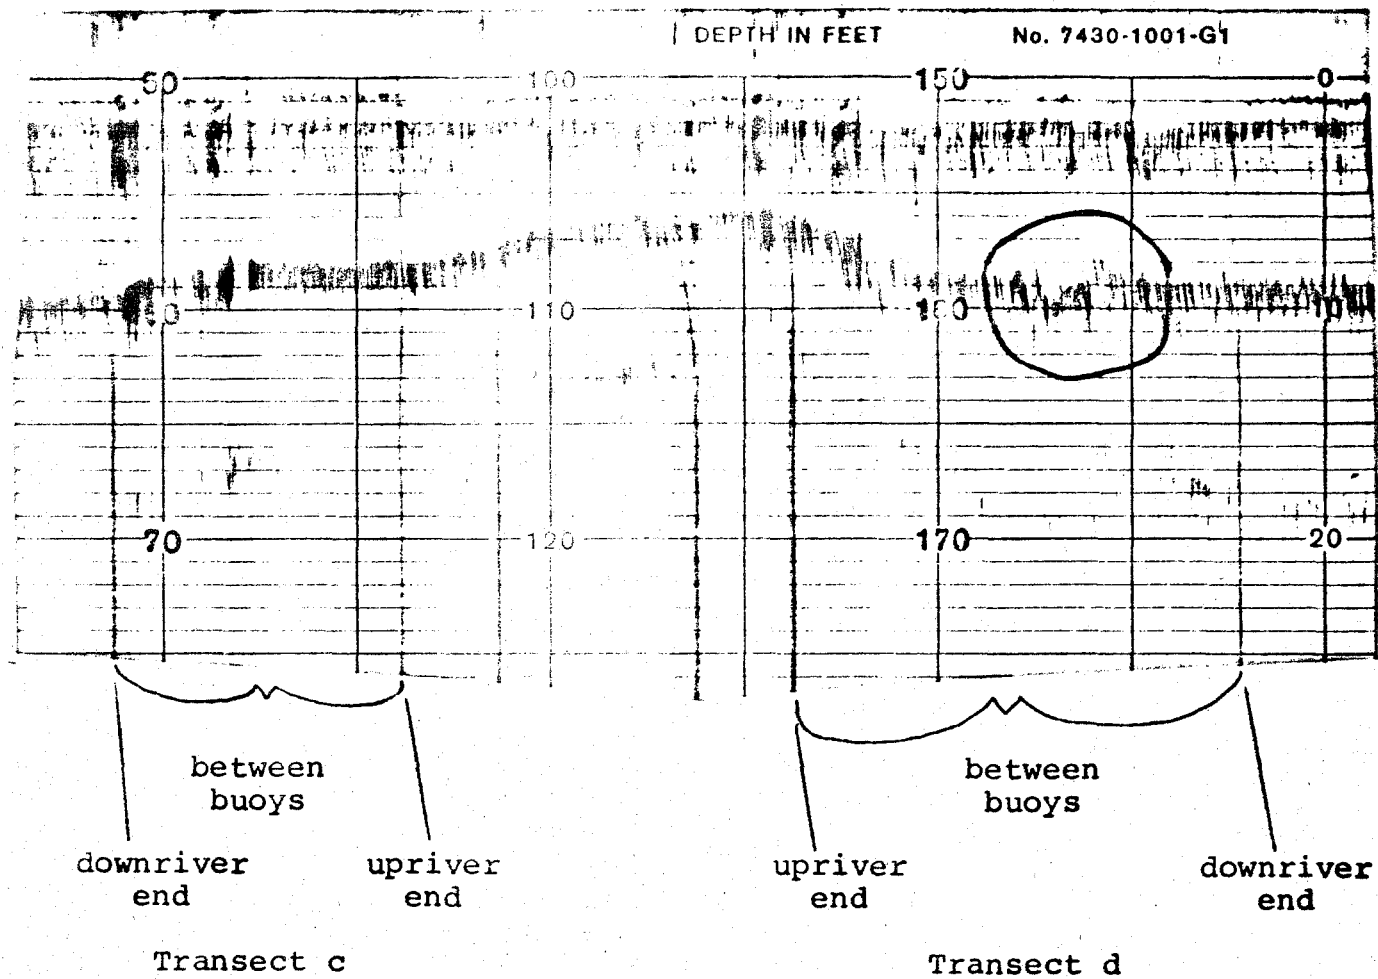
Figure 8. Fathometer tracing of the bottom along transects c and d in the Potomac River near Heron Island Bar; made 6/17/81. Circled portion is suggestion of recent disturbance.

Transect c - Between the two offshore buoys where this transect was run (Figure 2) the fathometer produced a tracing that was mostly smooth. The one rough area shown on the fathometer trace is not subject to interpretation since the movement of the paper stalled at that point and left no clear picture of the bottom (Figure 8).

Transect d - This transect was run approximately 90 feet inshore of the buoyed area (Figure 2). A smooth bottom is indicated for the most part; near the middle of the transect (roughly, between transects 5 and 8) is a depression and an adjacent mound. The height difference between the top of the mound and the bottom of the depression is a little less than one and a half feet (Figure 8). This feature just mentioned suggests recent disturbance; the disturbance continued for 241 feet.
